April 6, 2023

KA Project No. 066-21115

**RE: Arsenic & Lead Soil Sampling Summary Letter Report Addendum  
Skyline Elementary School Replacement CO#6  
6301 North 23<sup>rd</sup> Street  
Tacoma, WA, 98406**

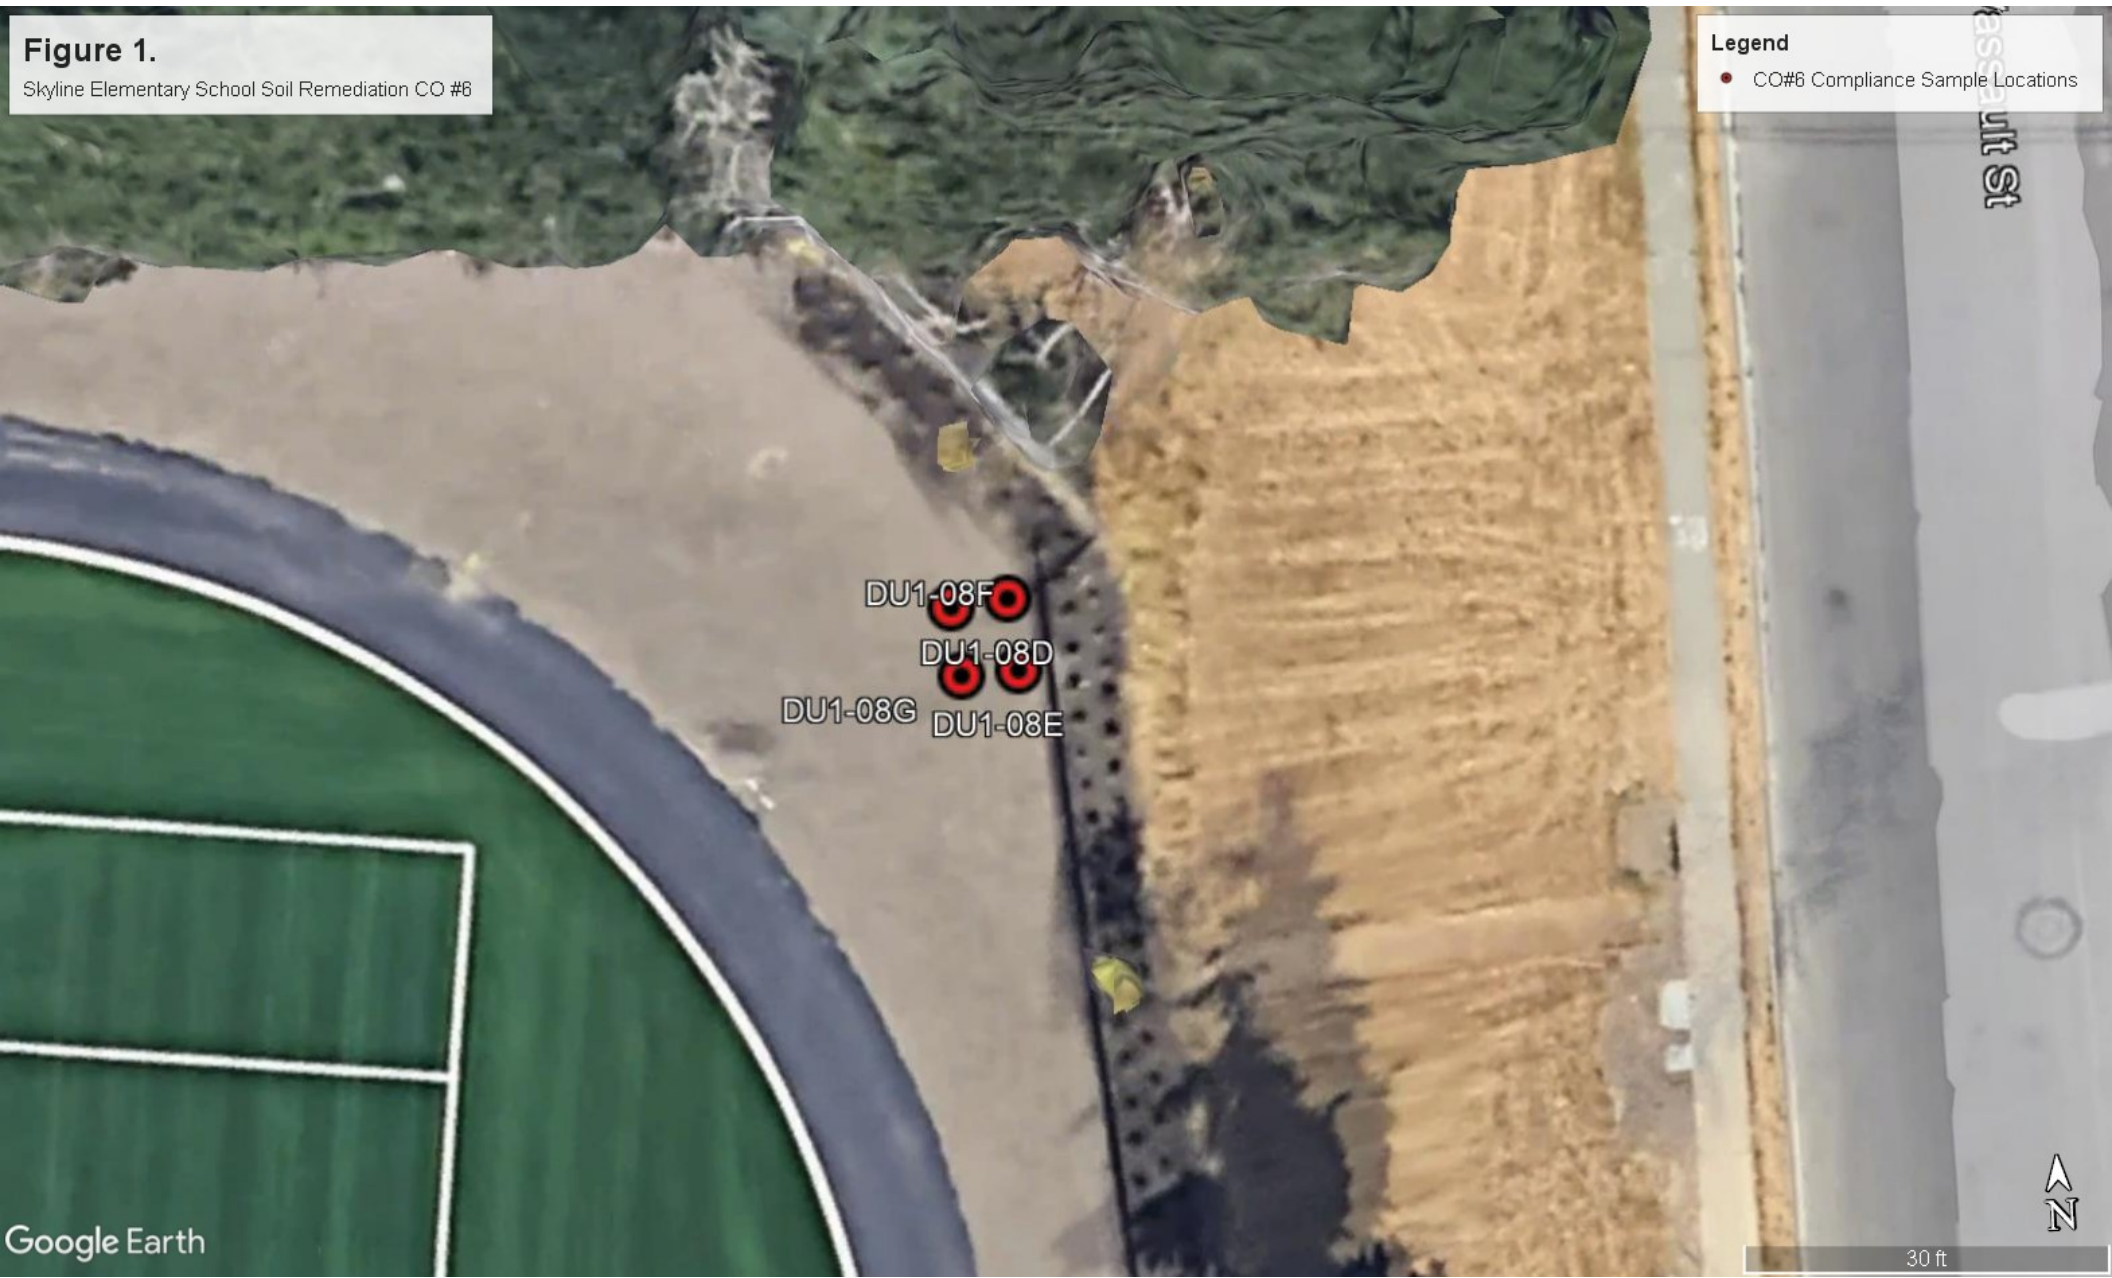
**Figure 1.**  
Skyline Elementary School Soil Remediation CO #6

Based on sampling requirements, four (4) discrete soil samples were collected at four (4) predetermined locations, with the four (4) samples collected at a depth of 0-6 inches below ground surface (bgs). Four (4) composite samples were also collected, with two (2) from the excavated disposal soil stockpile and two (2) from the imported soil stockpile. A total of eight (8) samples were taken from the site. Each of the discrete soil locations was evenly spaced from the others within the dictated test pit in the 10ft by 10ft by 3ft excavation at DU1-08 from CO#4. See Figure 1. Sample Location Map following the text for soil sample locations.

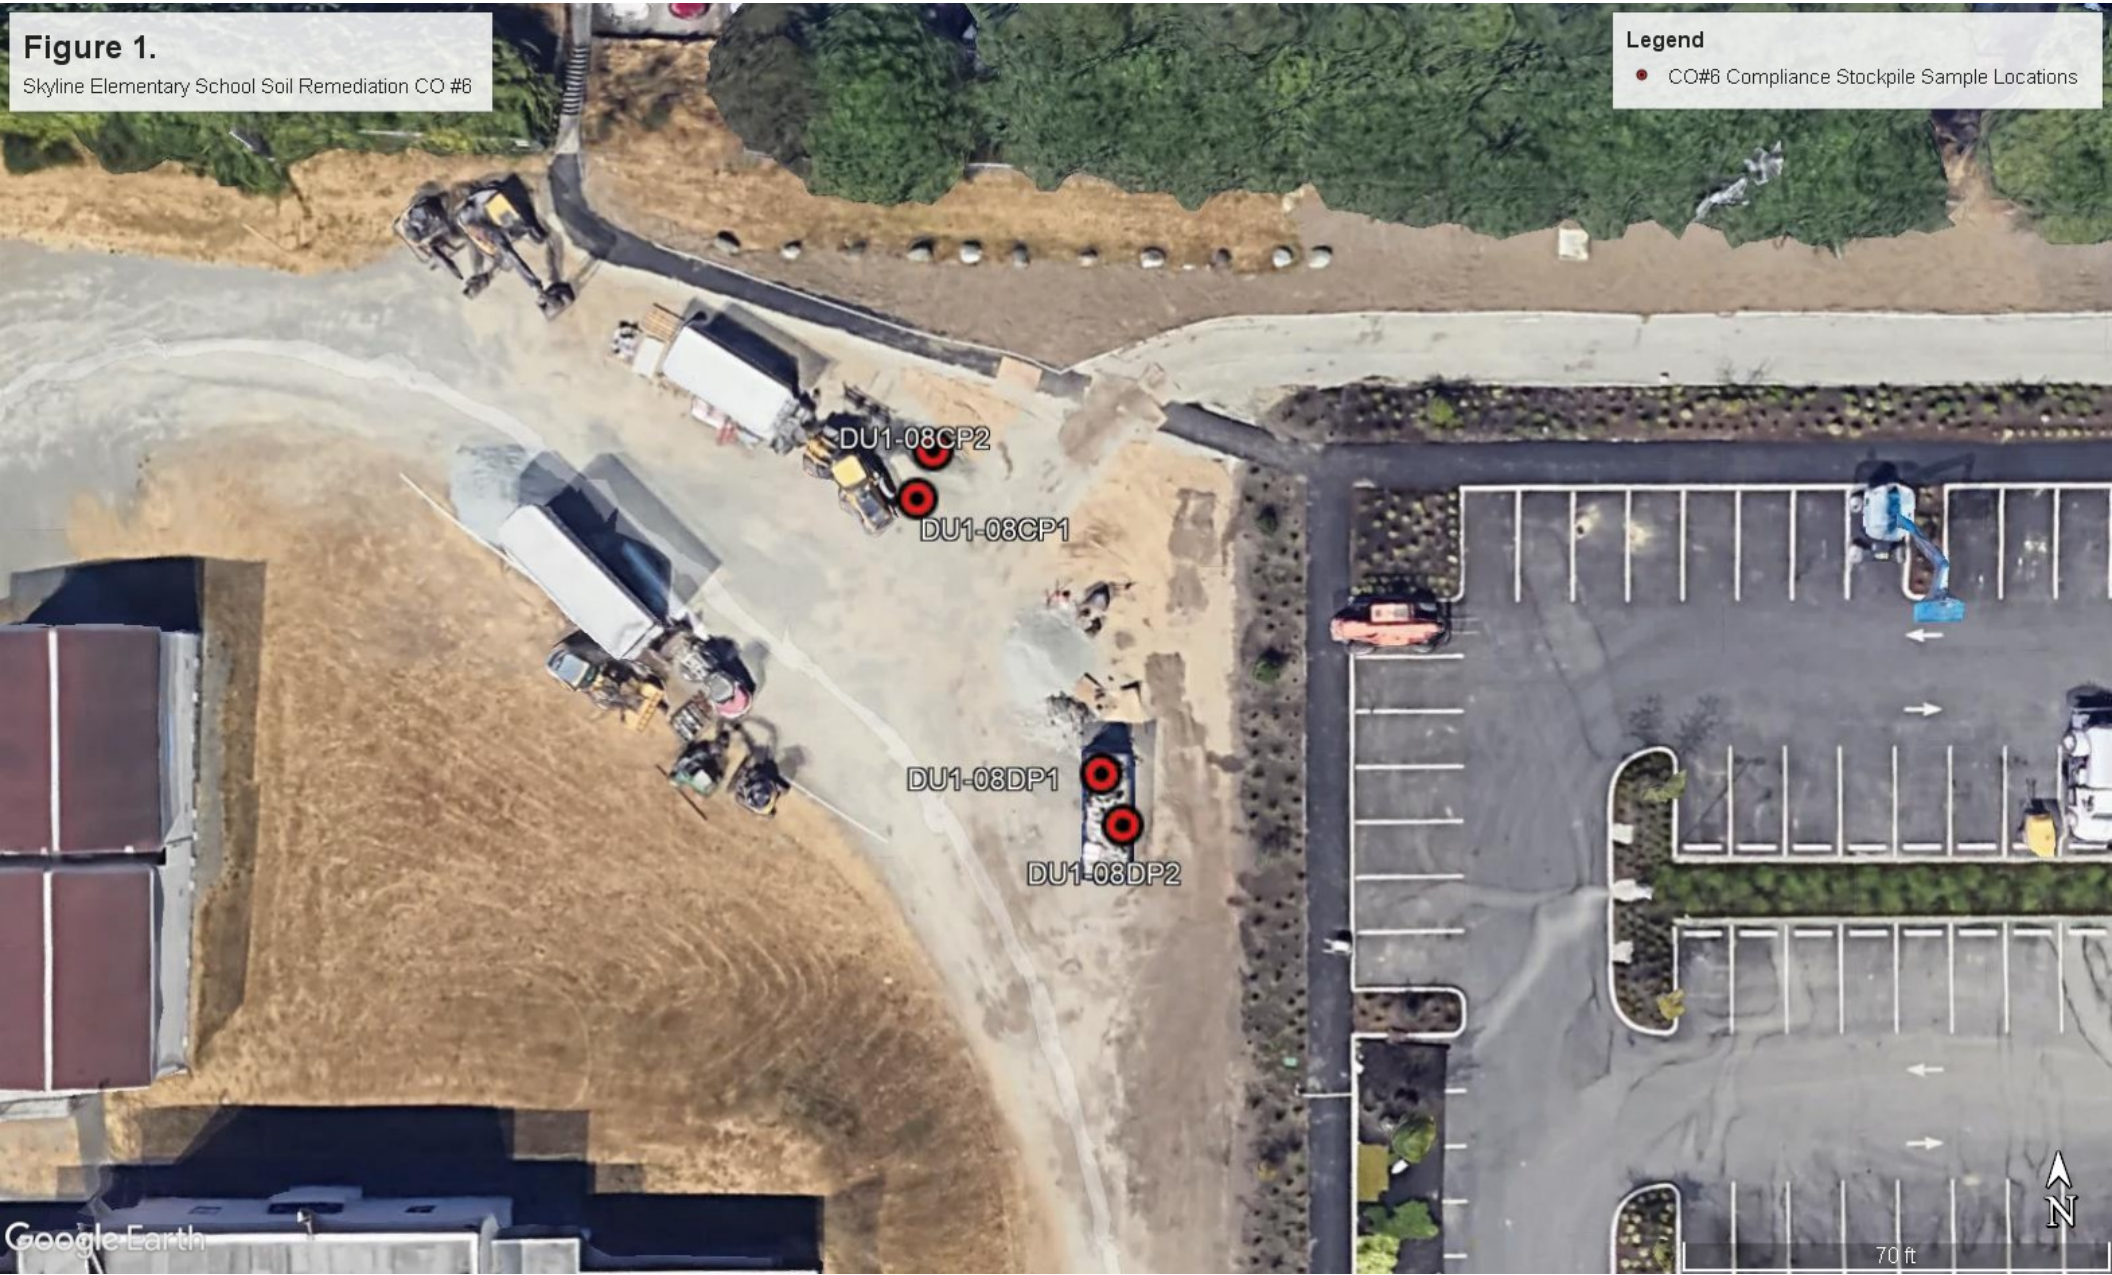
**Figure 1.**  
Skyline Elementary School Soil Remediation CO #6

**Legend**  
● CO#6 Compliance Stockpile Sample Locations
