Subject: Fourth Quarter 2022 Progress Report, Southwest Harbor Project Remediation Areas 1, 2, 3, and 5 Ecology Facility/Site Numbers 2384, 2385, 2127, and 2383

**Subject: Terminal 5 Landfill Gas Collection System
Fourth Quarter 2022 Monitoring Results**

Semiannual Inspection of T-5 Ecology-lead Sites: 2022 Year-End Inspection – Fourth Quarter 2022

Port of Seattle: Terminal 5 Cap Inspection Report

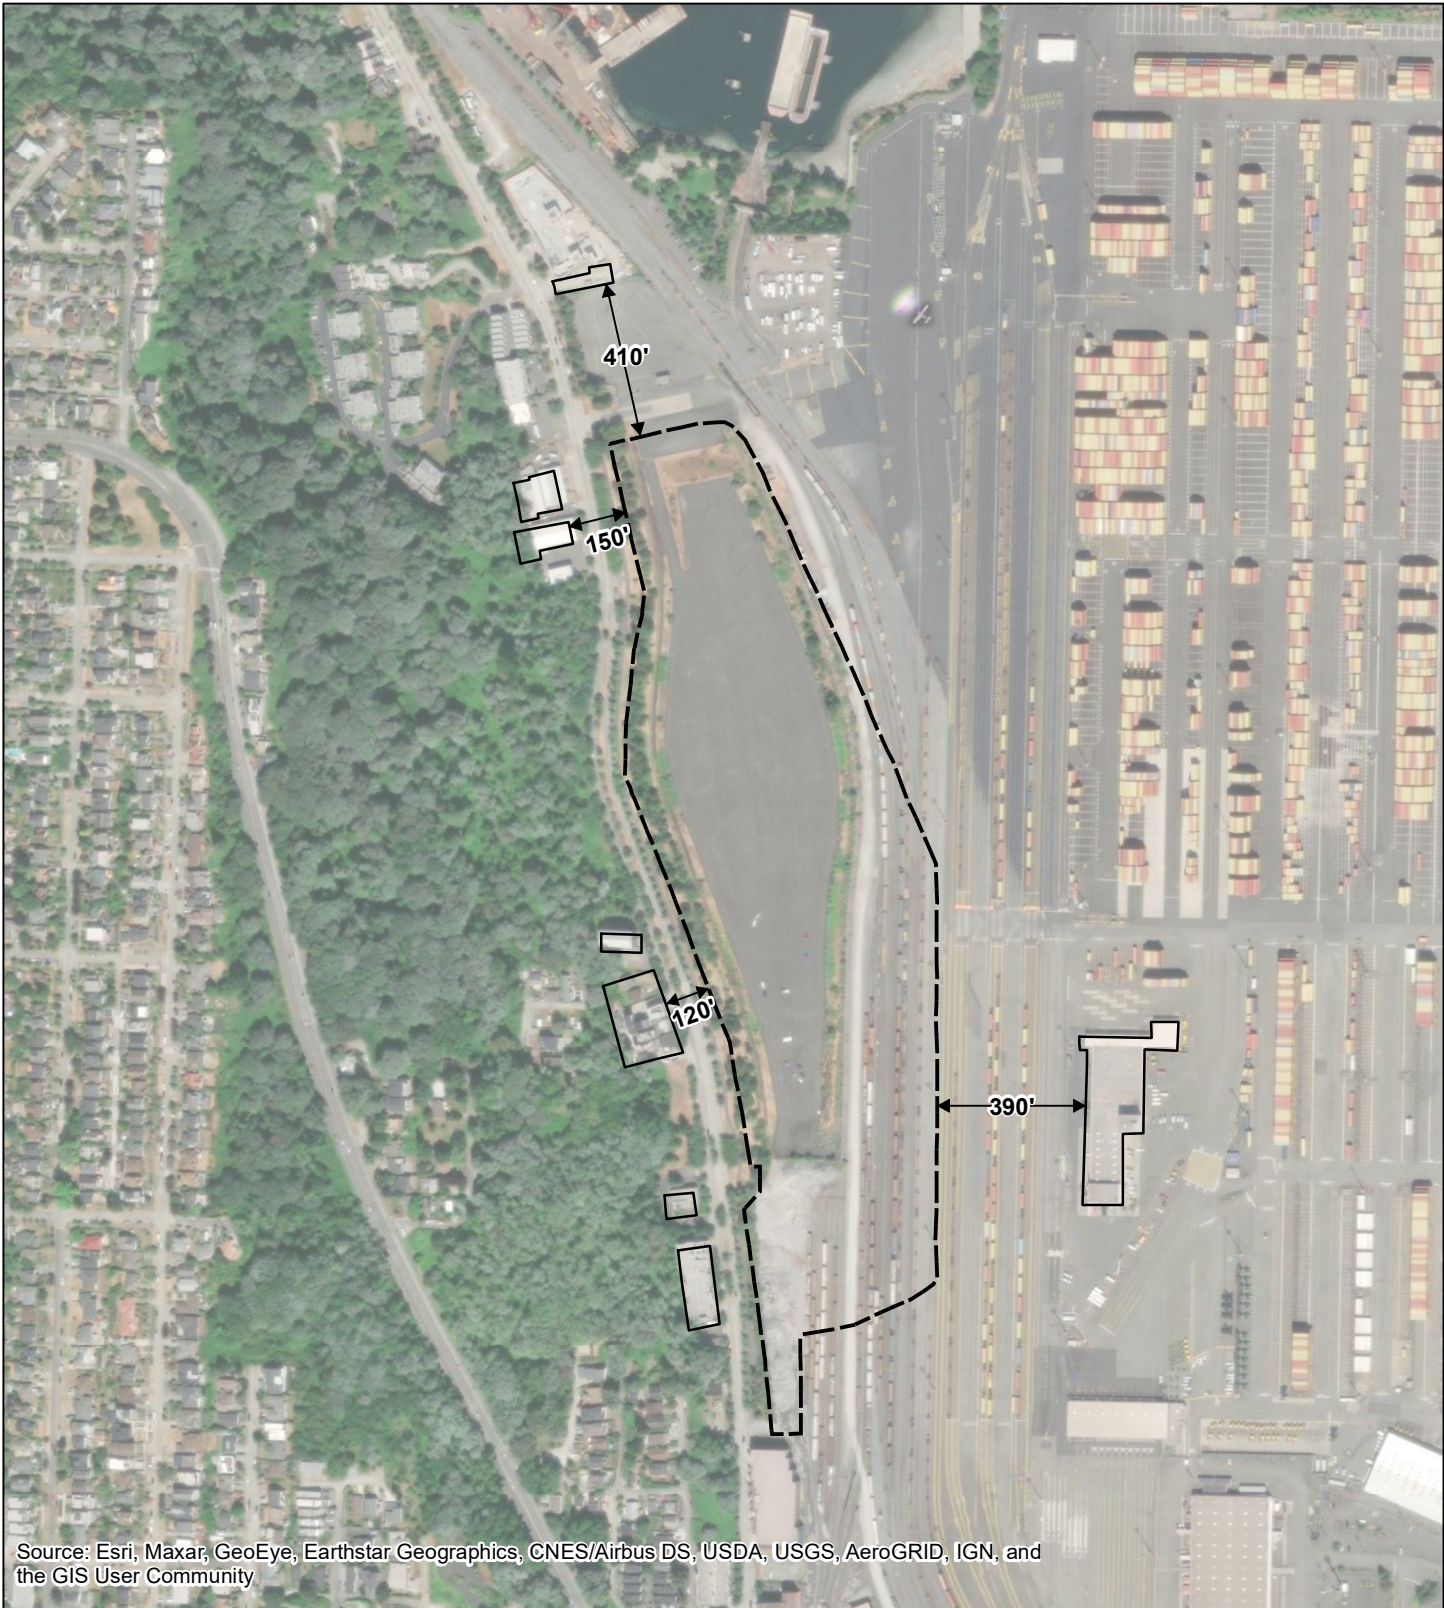
Figure 3 – Cap Schematic Cross Section

This memorandum summarizes the results of the quarterly monitoring at the Terminal 5 (T-5) Remediation Area 3 former landfill. The location of the former landfill in relation to nearby features is shown on Figure 1. The landfill gas collection system, soil gas probes, and system monitoring points are shown on Figure 2. A schematic cross-section through the landfill is shown on Figure 3.

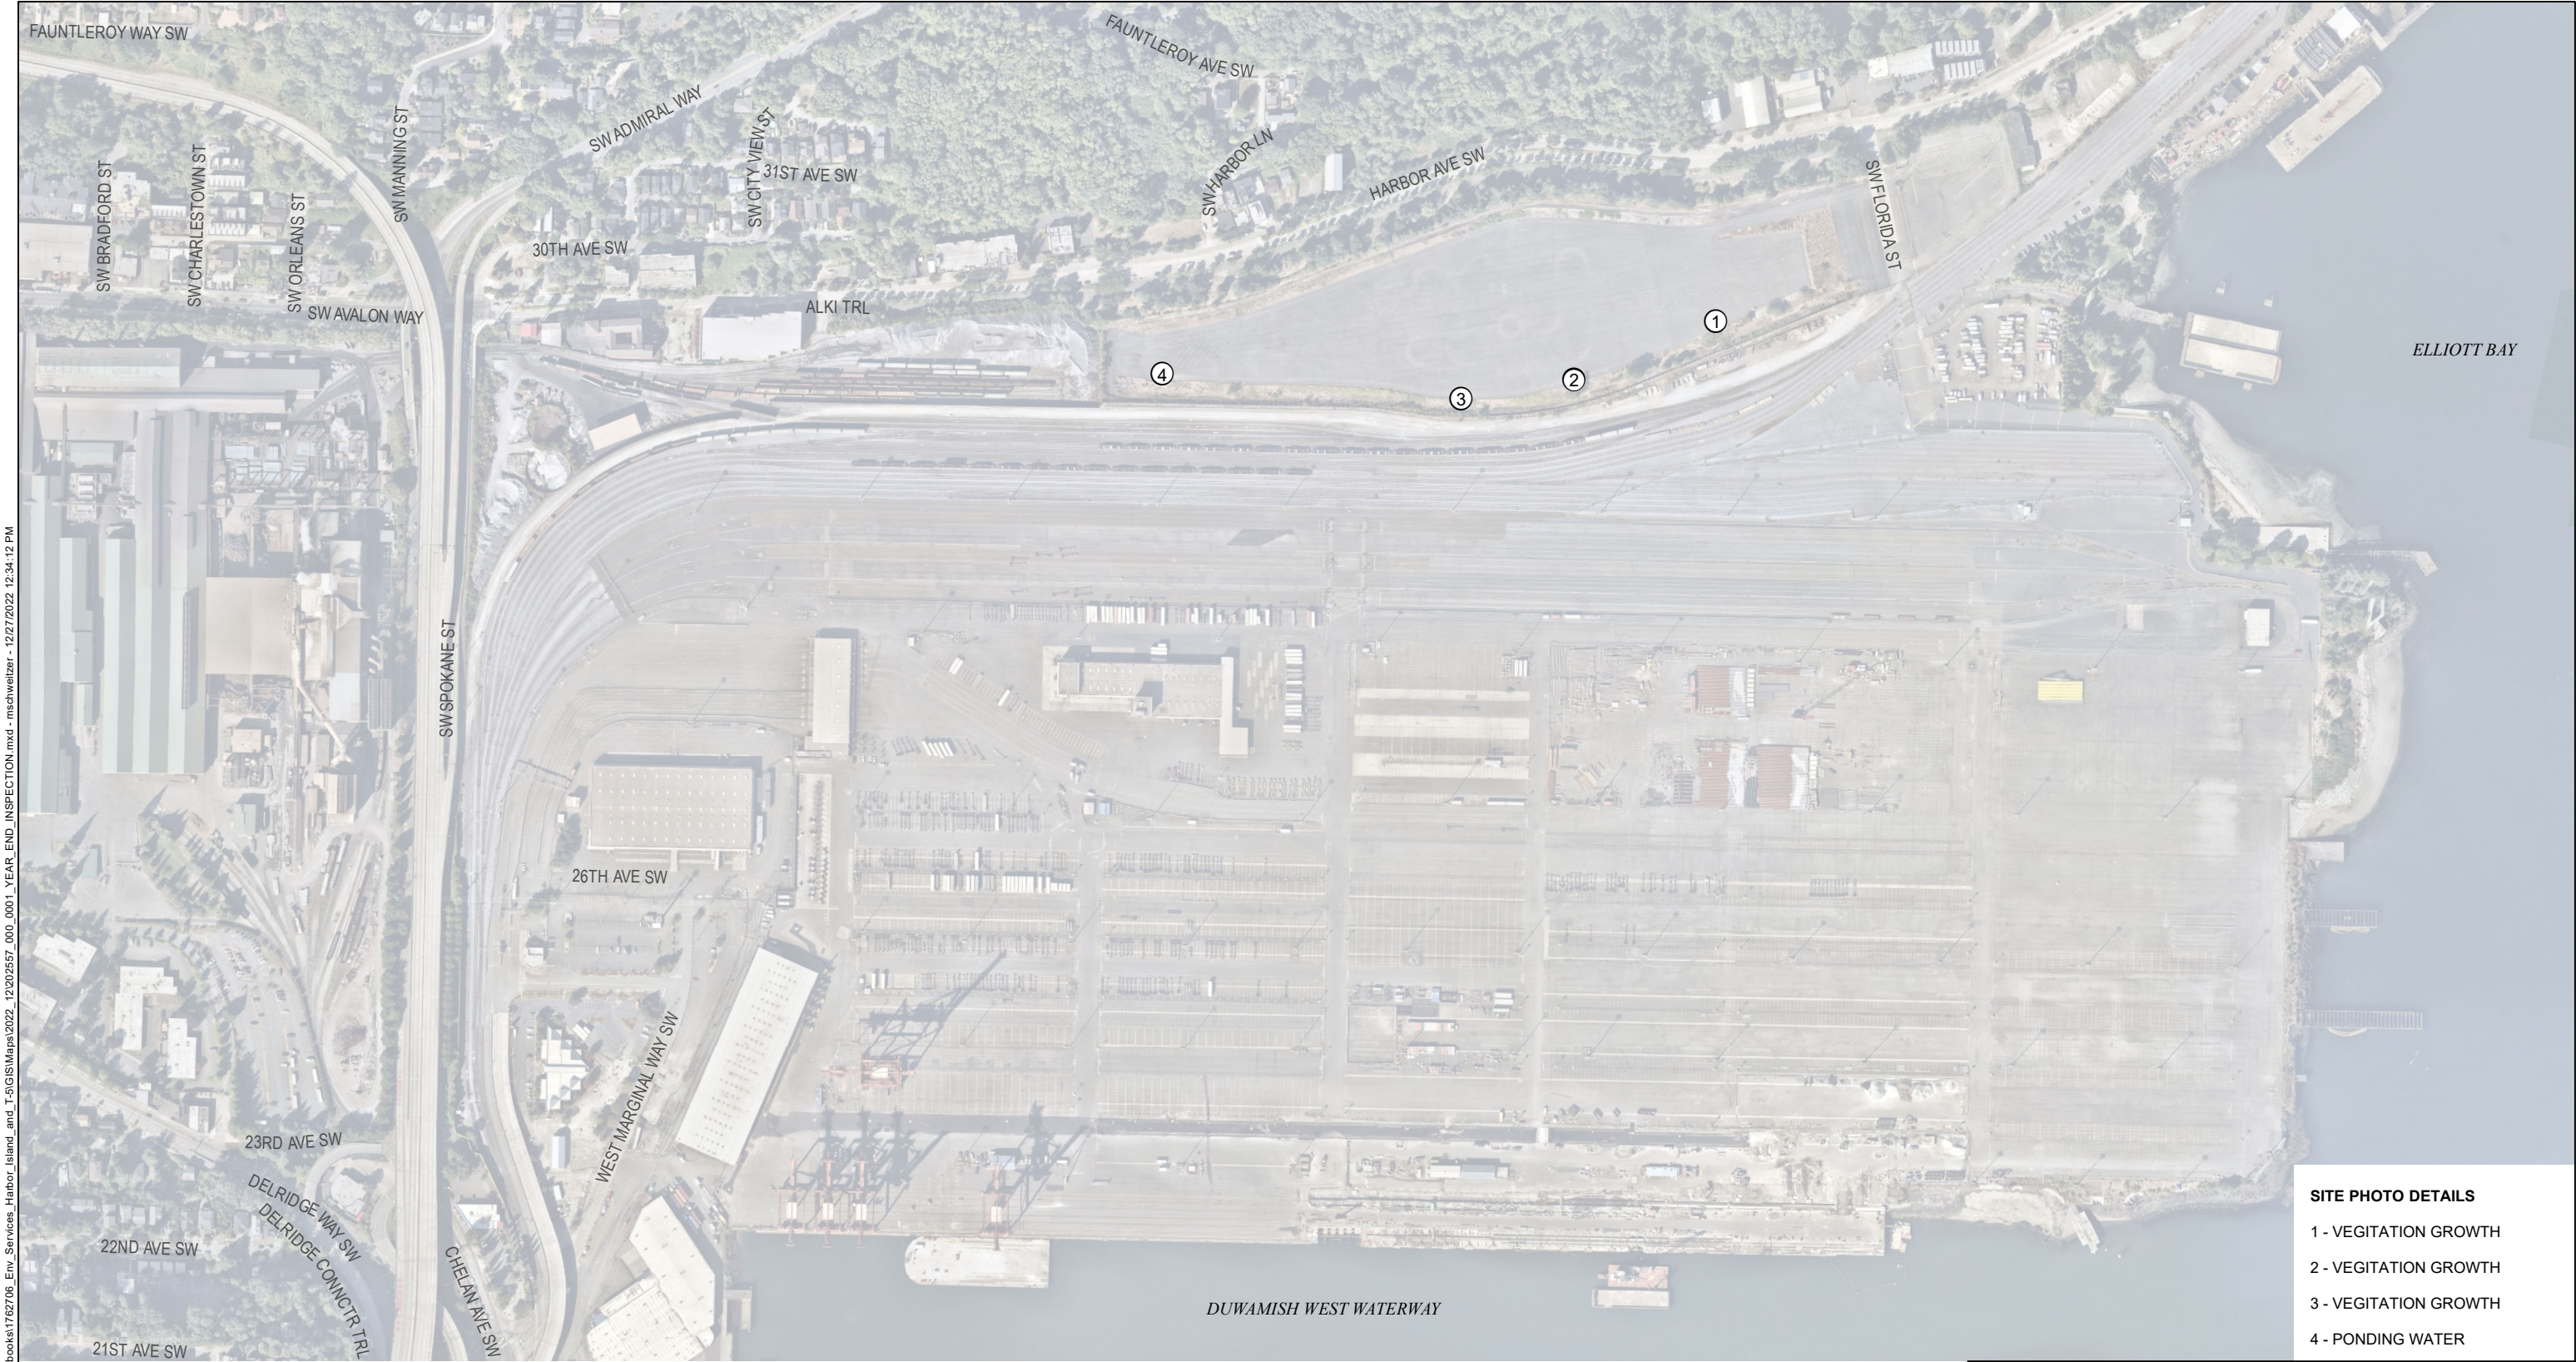
TERMINAL 5 ECOLOGY-LED
REMEDATION AREAS LOCATIONS OF
OBSERVATIONS NOTED IN 2022
YEAR END CAP INSPECTION

- 1 - VEGETATION GROWTH
- 2 - VEGETATION GROWTH
- 3 - VEGETATION GROWTH
- 4 - PONDING WATER

Condition Noted	Map (Attachment 1) reference	Recommendation
Vegetation growth along the drainage swale	1, 2, 3	Remove vegetation from these locations during maintenance. Check during future inspections.
Ponding water	4	Check during future inspections

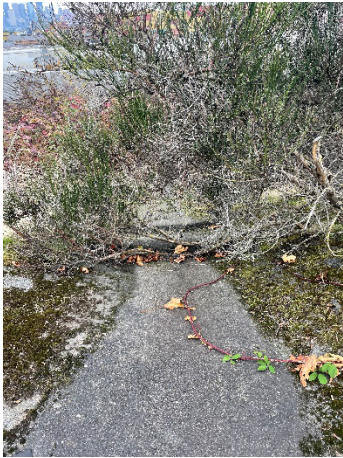
Vegetation growth was observed in the drainage swale at three locations impacting the function of the existing stormwater drainage system (Attachment 1: map notes 1, 2, and 3; Attachment 2: photos 1, 2, and 3).

Photo 1: Vegetation overgrowth obstructing drainage swale (Figure 1, Note 3).

Maintenance/Repair Type/Location: Vegetation growth in drainage swale of the consolidated landfill should be removed to aid with stormwater drainage.

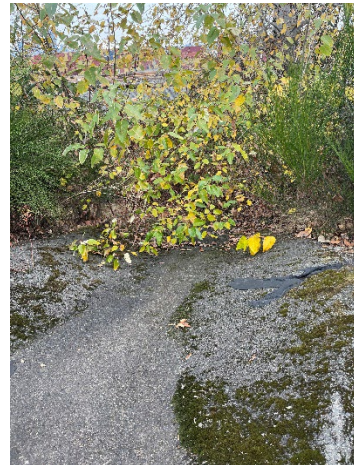
Photo 2: Vegetation overgrowth obstructing drainage swale (Figure 1, Note 4).

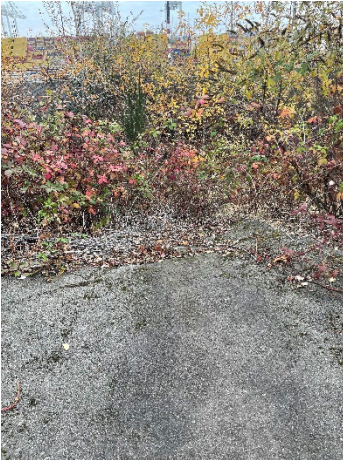
Photo 3: Vegetation overgrowth obstructing drainage swale (Figure 1, Note 5).

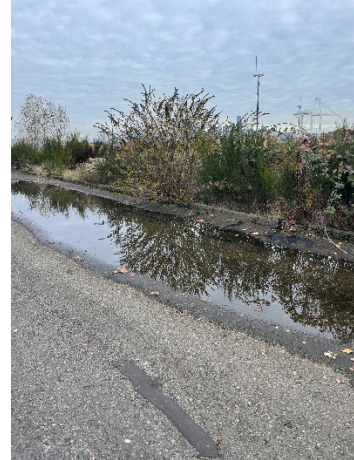
The pavements, ballast covers, fencing, and surface features associated with the stormwater drainage systems were examined during this inspection. Some ponding as a result of depressions on the asphalt layer was observed in the consolidated landfill area (Attachment 1: map note 4; Attachment 2: photo 4). The depressions are likely the result of previously stored equipment or machinery.

Water ponding was observed in the consolidated landfill area

Photo 4: Ponding water (Figure 1, Note 6).
