# INITIAL INVESTIGATION FIELD REPORT

| <u>Site Name (Name over door):</u><br>Big Gulch Creek Subbasin 9 | <u>Site Address (including City, State and Zip):</u><br>Drainage Ditch S of Falcon Drive (see gps coordinates and figures below)<br>Everett, WA 98204 | <u>Phone</u><br><u>Email</u> |

Shannon & Wilson submitted a data report on behalf of Snohomish County Public Works. The data report includes the results of PFAS sampling in two areas on the south end of Paine Field.

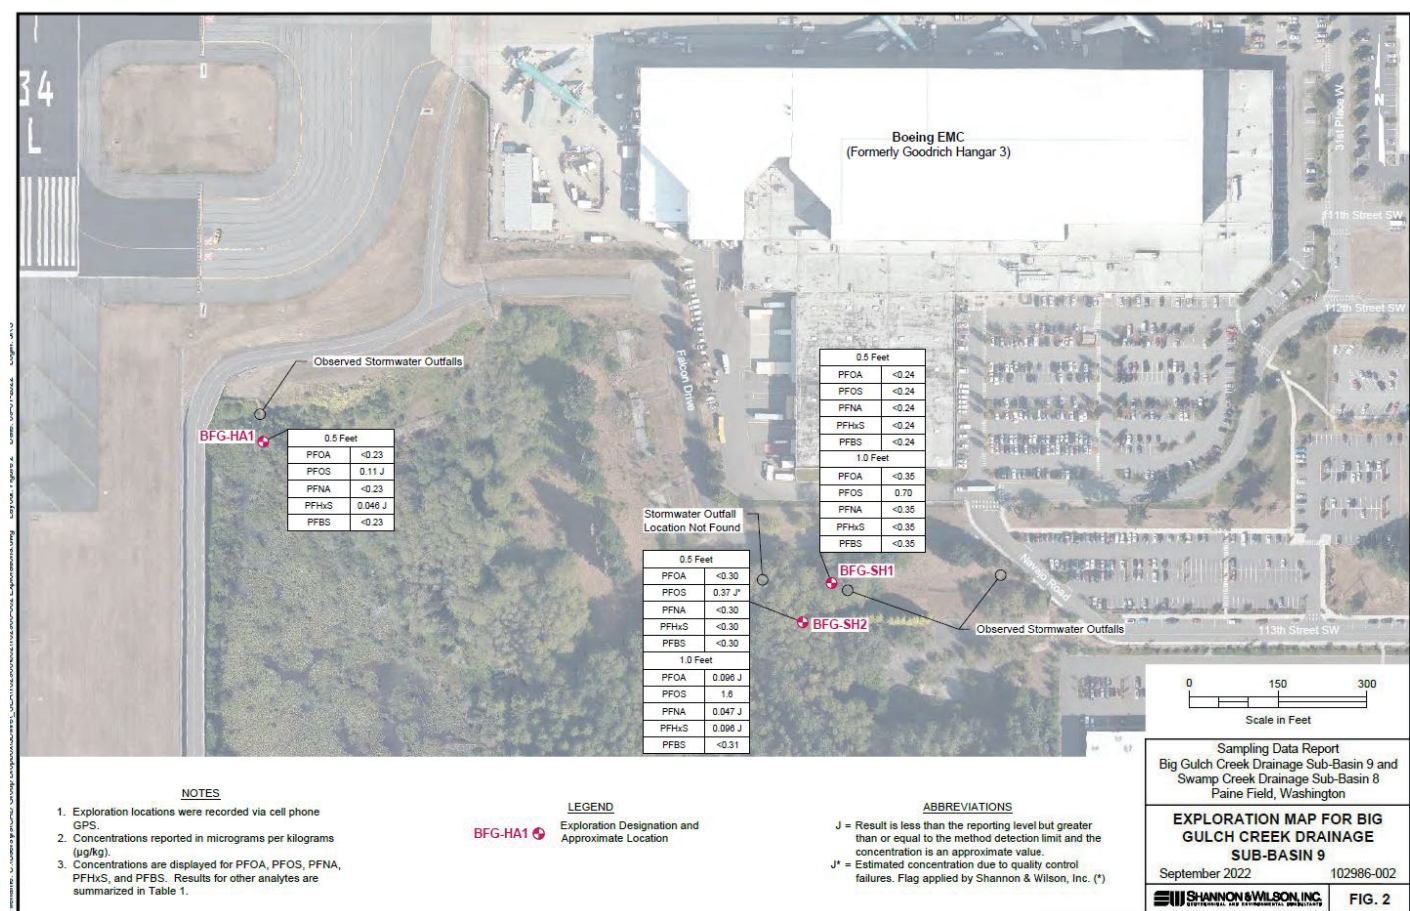
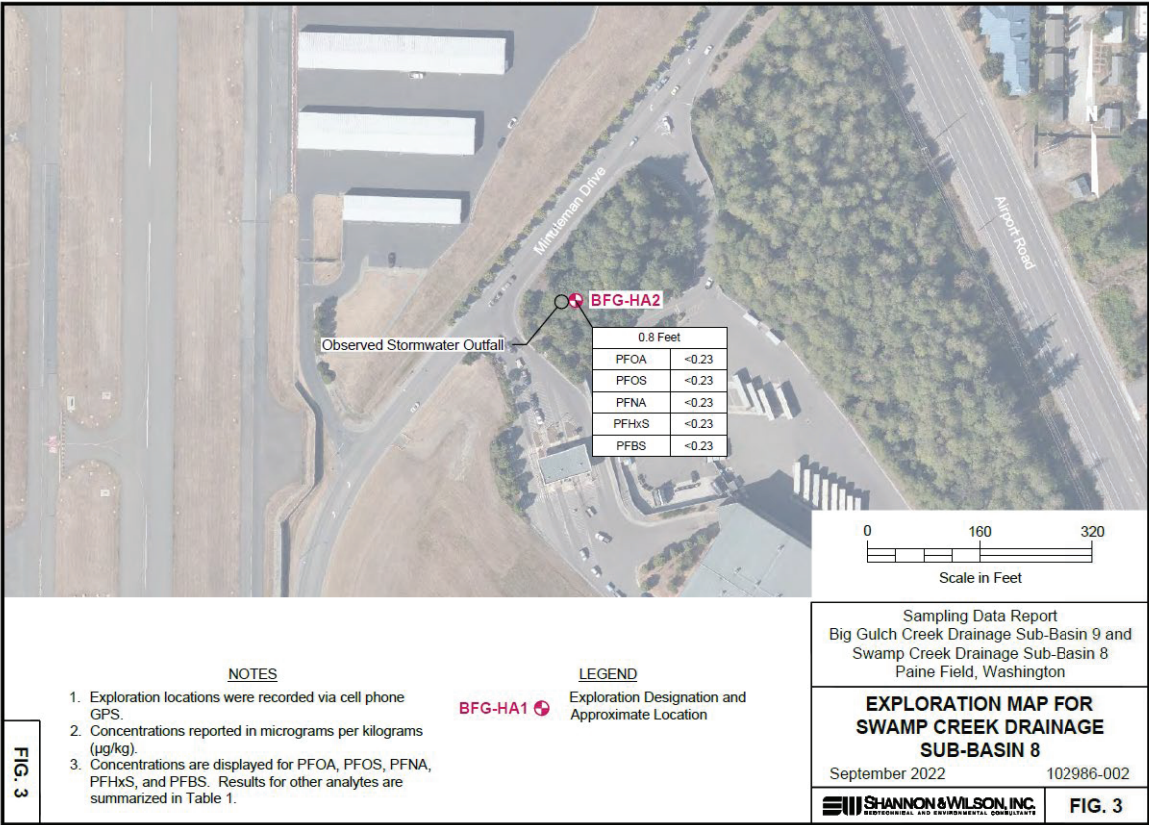
PFAS were primarily detected in the two samples collected on the eastern side of the Big Gulch drainage area (samples BFG-SH1 and -SH2). Two samples were collected in both of these locations, and the samples collected at 12 inches bgs had a greater number of PFAS detected and higher concentrations present than the samples collected 6 inches bgs in both locations.

PFOS, N-EtFOSAA, and N-MeFOSAA were the PFAS compounds present at the highest concentrations in both locations. Cleanup levels have not been established for any media for N-EtFOSAA and N-MeFOSAA. The maximum sample concentration of PFOS was 1.6 µg/kg. This is below the established Method B soil cleanup level based on direct contact (240 µg/kg, but above the Method B cleanup level protective of soil leaching to groundwater (0.17 µg/kg). Sediment cleanup levels for PFOS have not yet been established.

Results of PFAS sampling from both areas, including PFAS for which there are existing cleanup levels. Results for additional PFAS area available in the report. Figures from Shannon & Wilson (2022).

PFAS concentrations in samples from Big Gulch drainage area indicate that a release has occurred, and that additional site investigation is warranted to determine the extent of contamination and the potential for inter-media contaminant transport. Recommendation: add to Confirmed and Suspected Contaminated Sites List.
