**2022 ANNUAL SITE REPORT  
SEAPORT SEATTLE TERMINAL  
(FORMER ARCO/BP HARBOR ISLAND TERMINAL)  
CLEANUP SITE ID: 4426  
1652 SW LANDER STREET  
SEATTLE, WASHINGTON**

**CONSENT DECREE NO. 00-2-05714-8SEA**

**APRIL 2023**

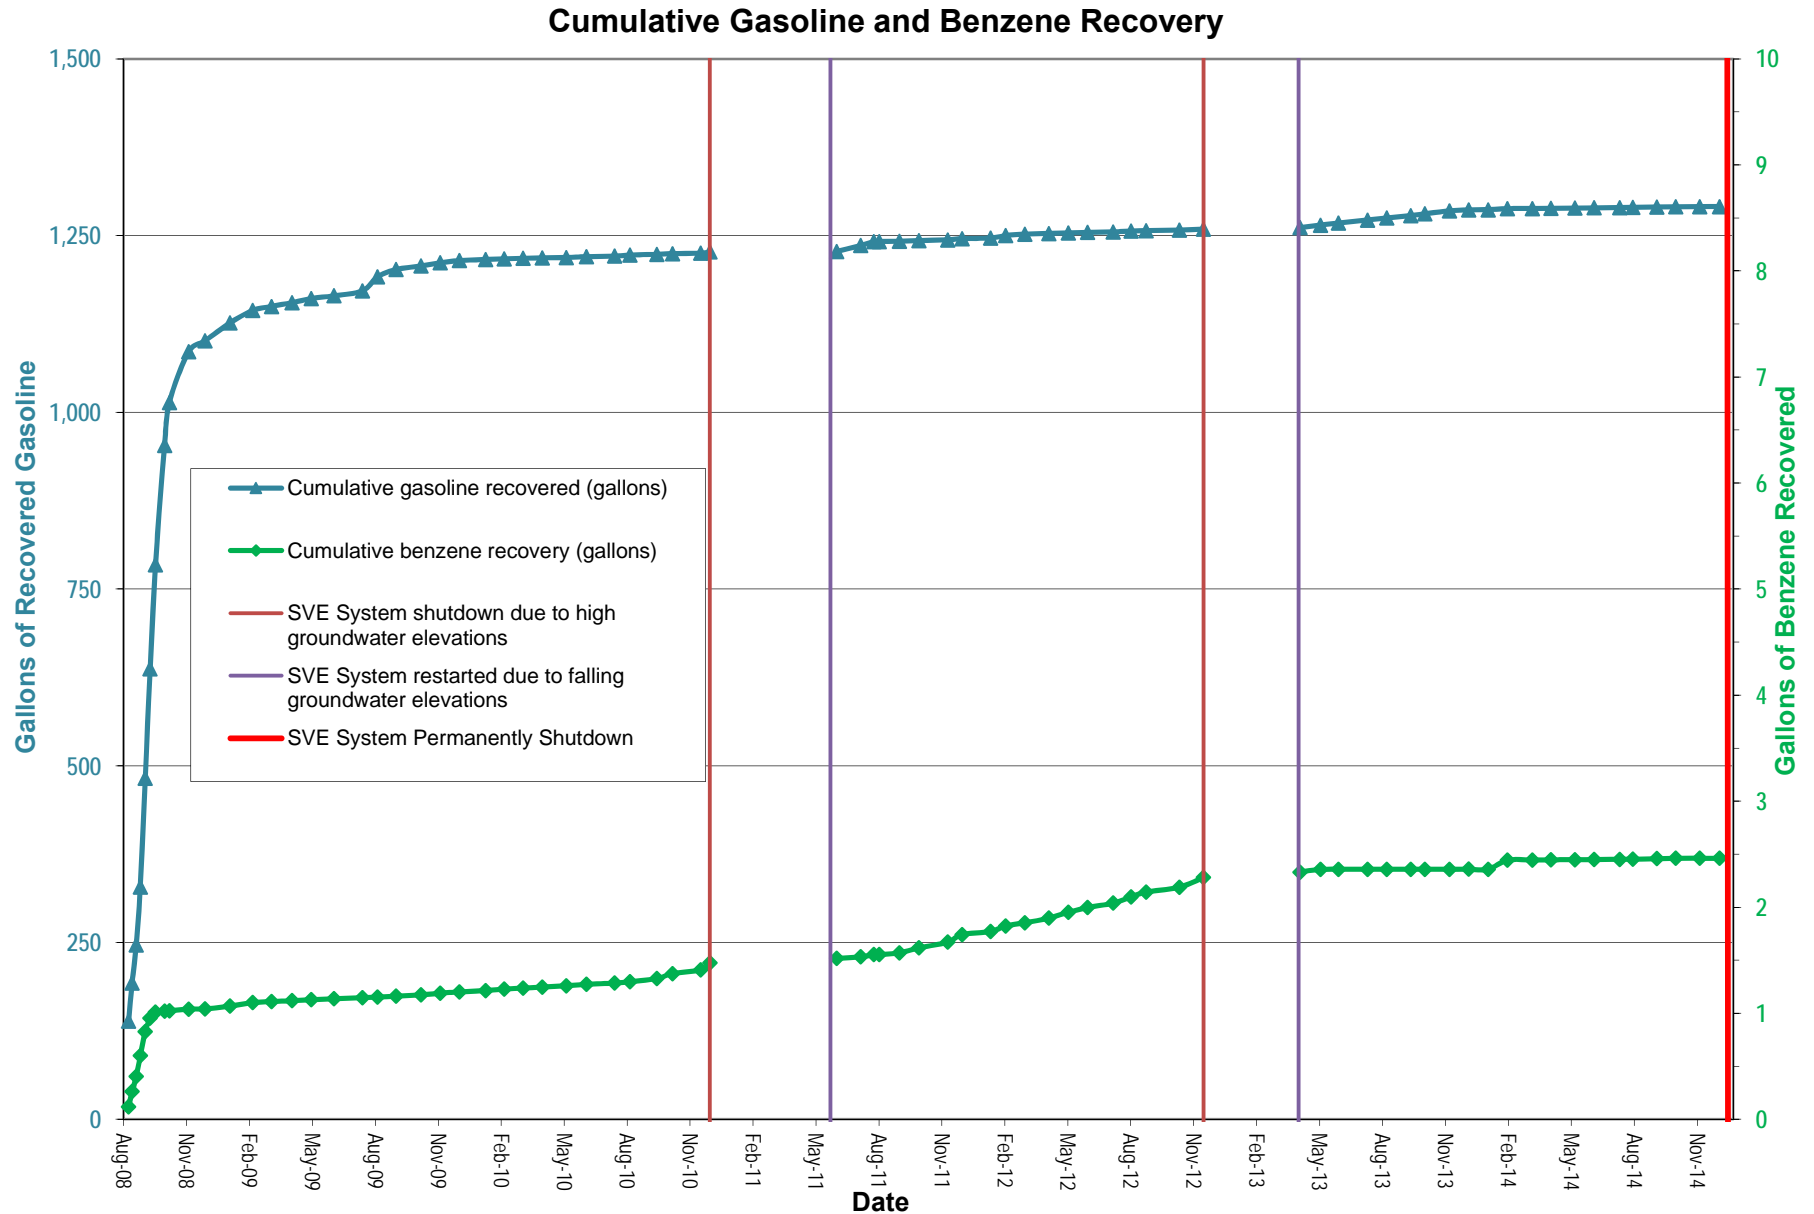
**Figure 14. Inland SVE System Cumulative Hydrocarbon Recovery**  
**Site: Former BP Harbor Island Terminal**

Note: Benzene and gasoline recovery are biased high as recovery is calculated assuming that benzene and gasoline are present at the laboratory detection limit for all samples reported as non detections from the laboratory.

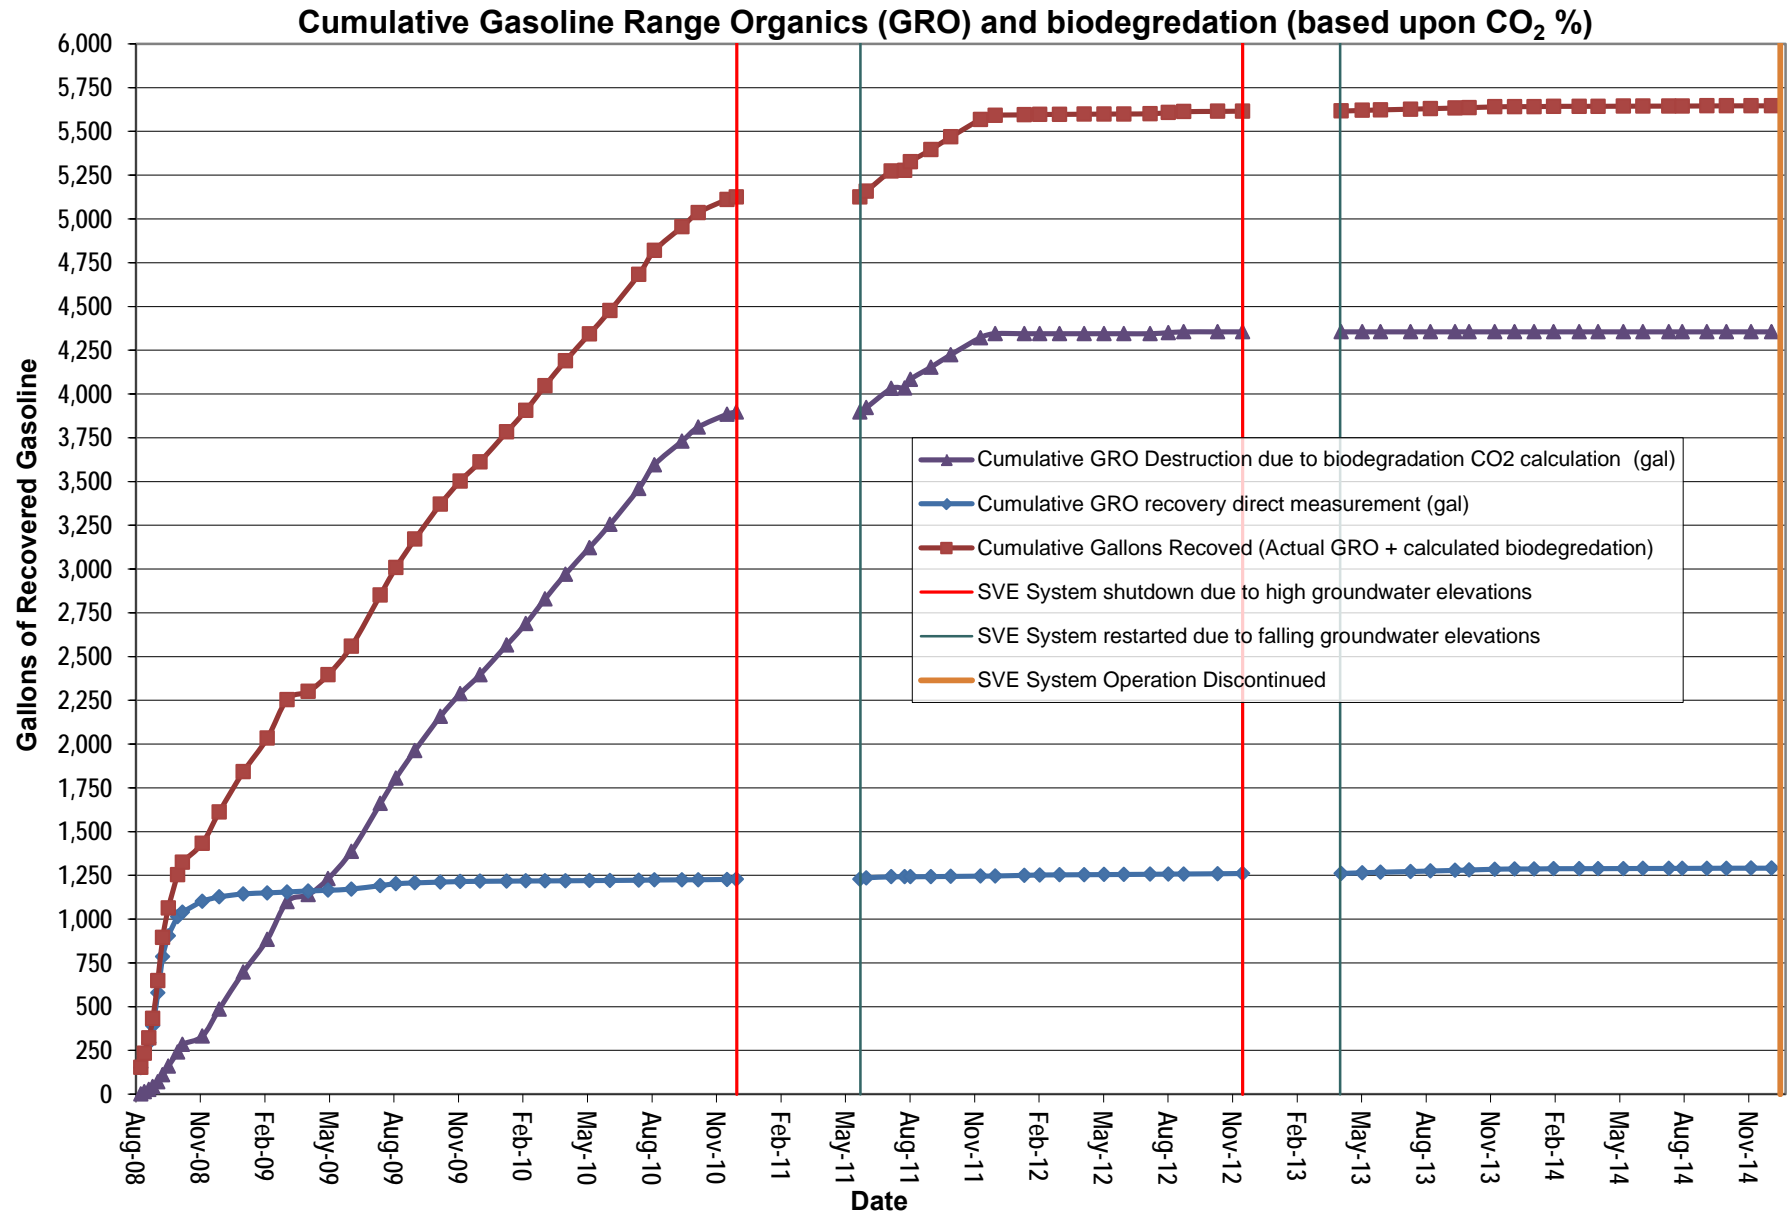
**Figure 16. Inland SVE Biodegradation and Vapor Recovery**  
**Site: Former BP Harbor Island Terminal**
