Remedial Investigation Work Plan – Phase I

Port of Port Angeles Terminals 5, 6, and 7

Main-File
Rgnl WA Cla POPA CH2M 1989
0013363
Focused Site Investigation of the Former
Merrill & Ring Property, Port Angeles,
Washington

FOCUSED SITE INVESTIGATION

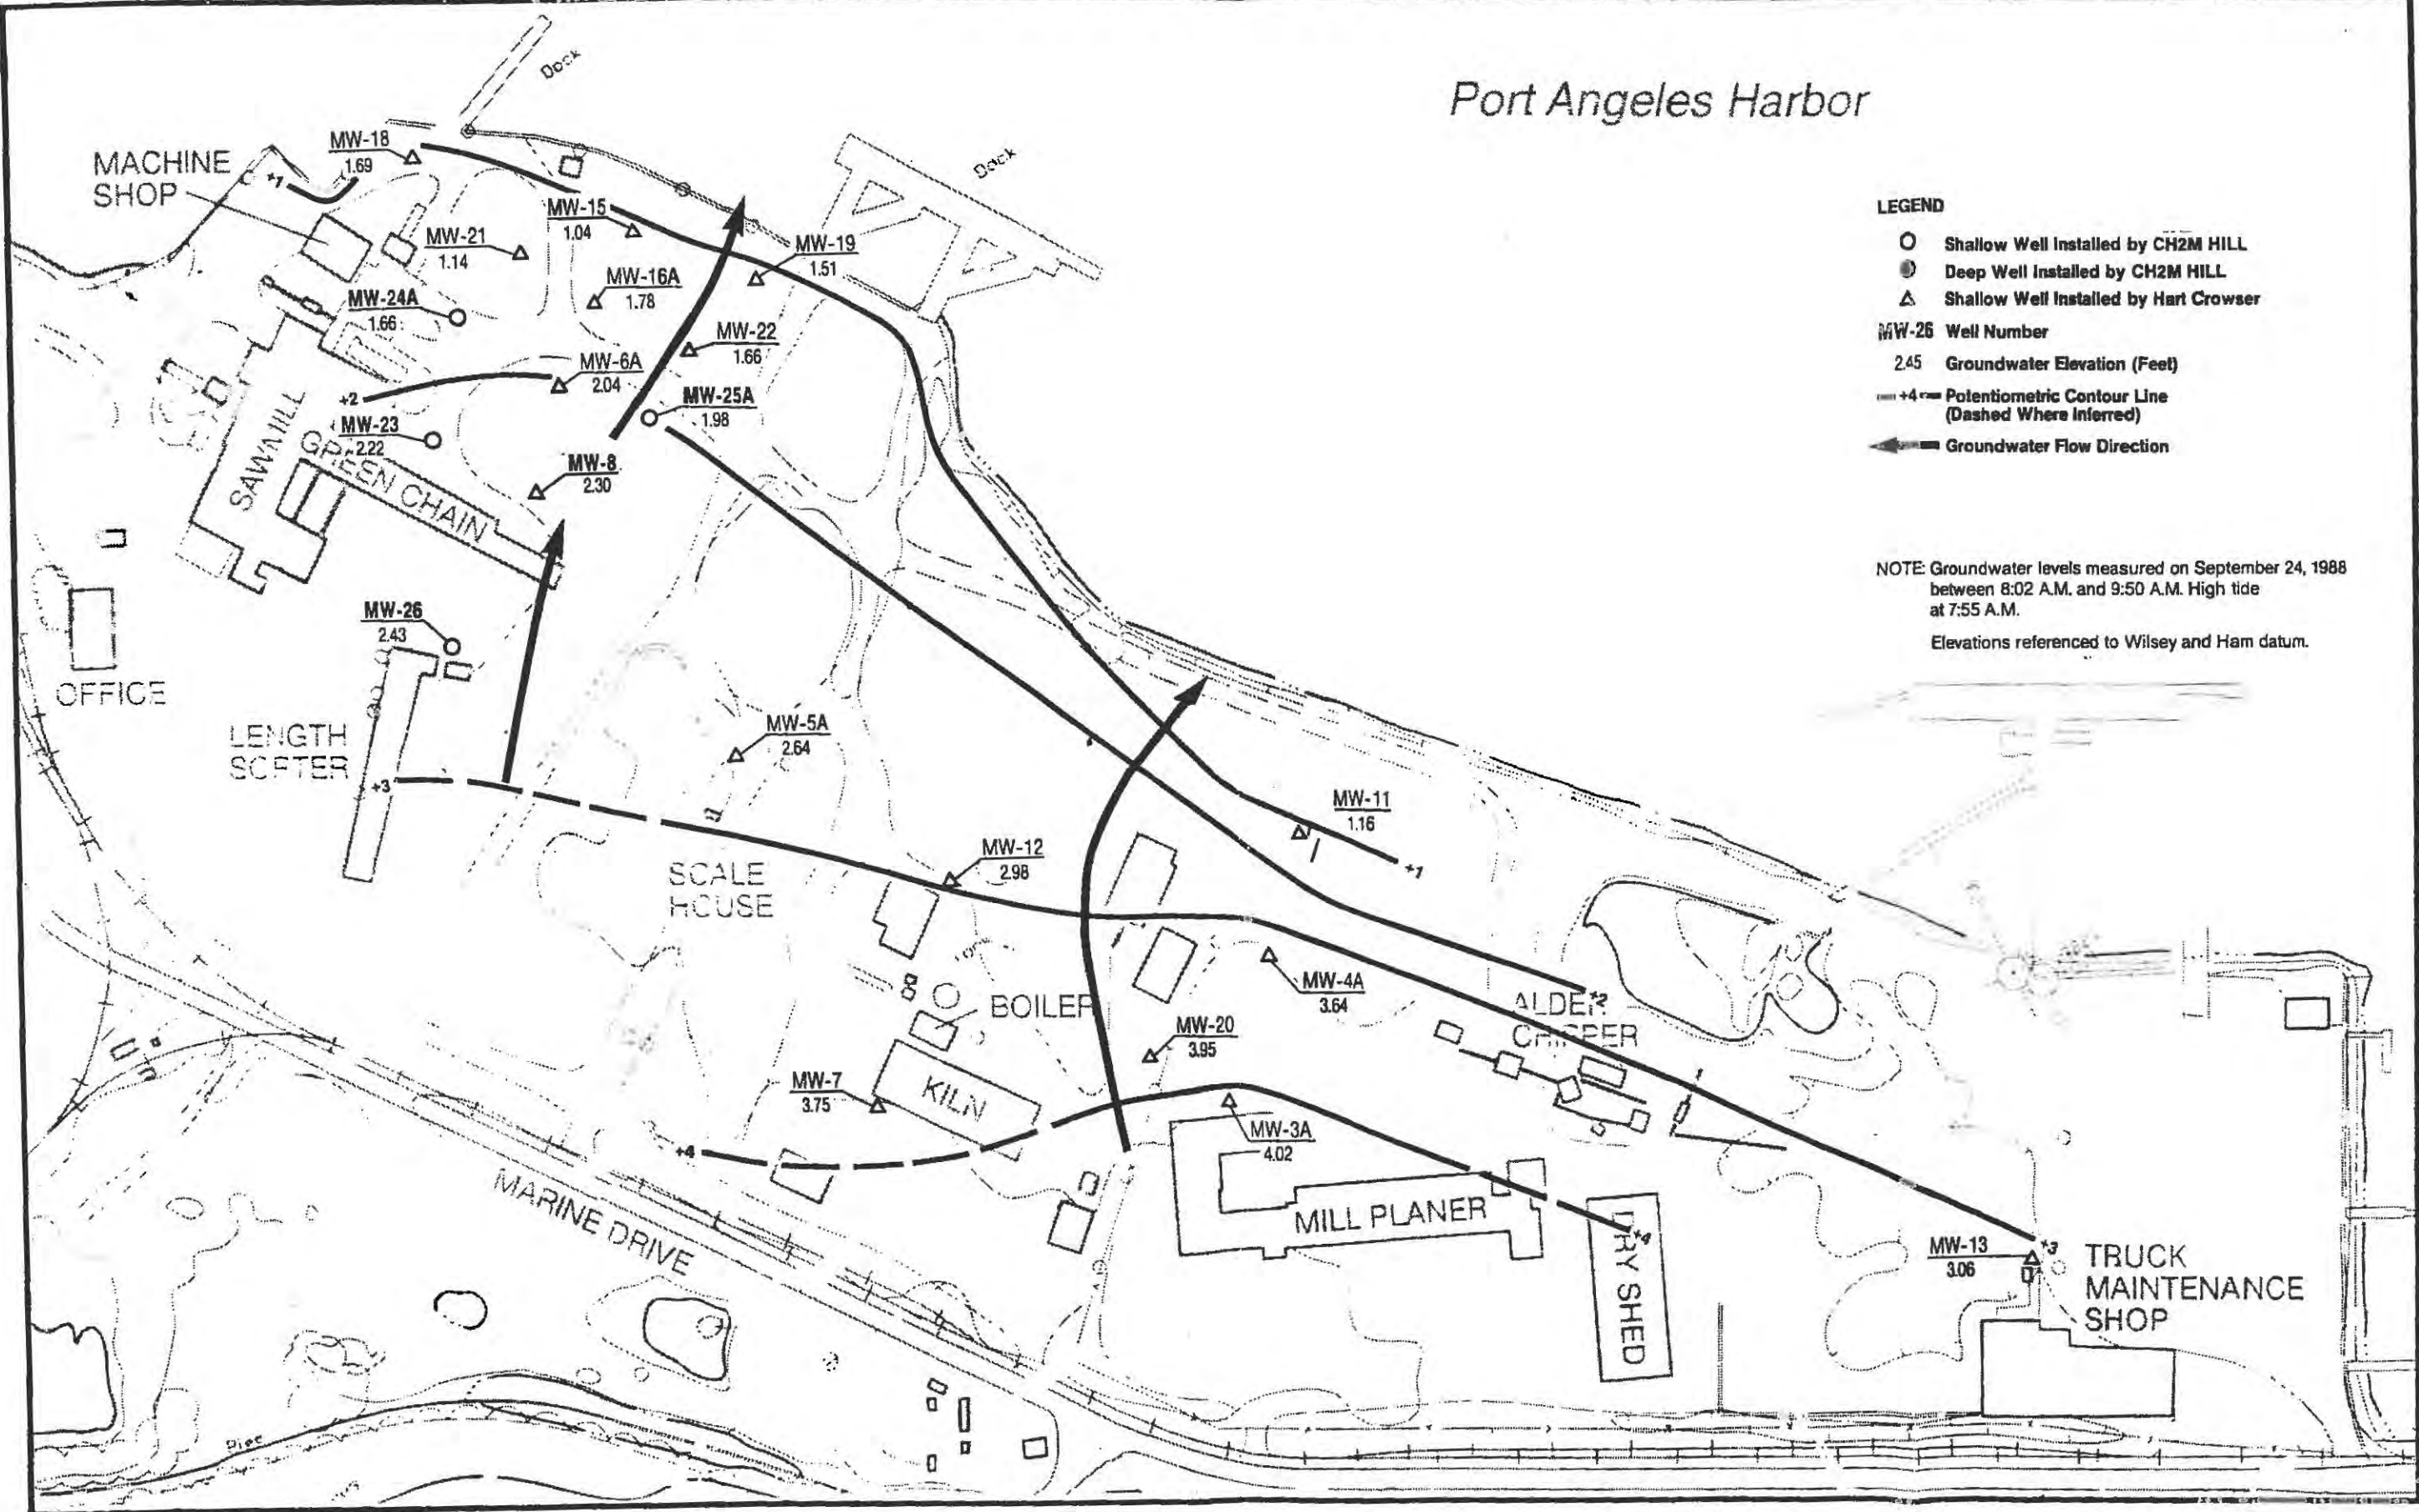
- LEGEND**
- Shallow Well Installed by CH2M HILL
 - Deep Well Installed by CH2M HILL
 - △ Shallow Well Installed by Hart Crowser
 - MW-26 Well Number
 - 2.45 Groundwater Elevation (Feet)
 - +4--- Potentiometric Contour Line (Dashed Where Inferred)
 - ← Groundwater Flow Direction

NOTE: Groundwater levels measured on September 24, 1988 between 8:02 A.M. and 9:50 A.M. High tide at 7:55 A.M.
Elevations referenced to Wilsey and Ham datum.
