## **Second Periodic Review Manito Shopping Center**

**802 E 29<sup>th</sup> Avenue, Spokane, WA 99203**

**Facility Site ID: 9406814, Cleanup Site ID: 1654**

**Toxics Cleanup Program, Eastern Region**

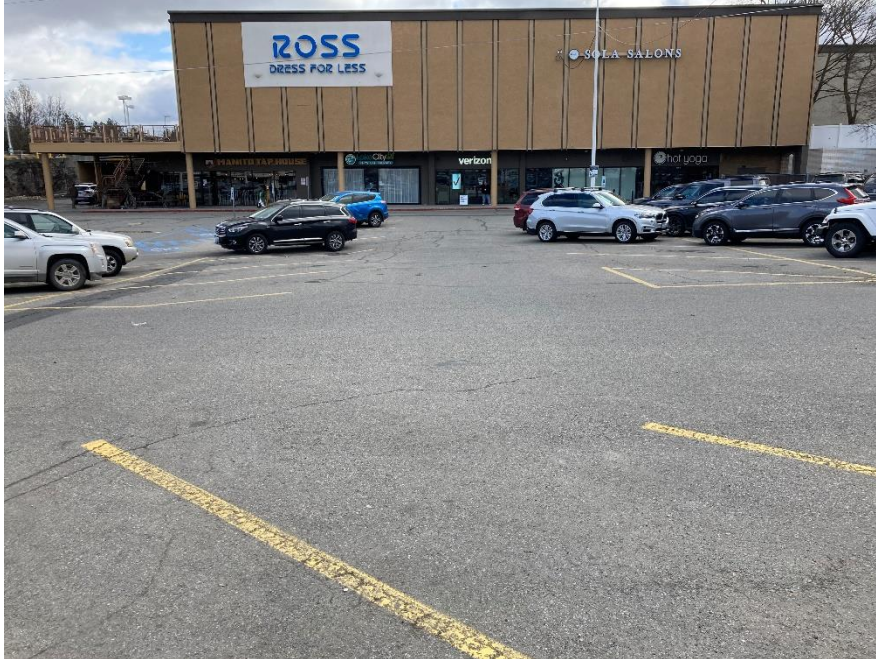
**Photo 1: Manito Shopping Center Site – from the west**

During the Site visit Ecology conducted on March 31, 2023, the observed conditions remained in compliance with the cleanup standards and institutional controls established for the Site. The Site continues to operate as a parking lot for nearby businesses. A photo log is in Appendix C.
