Remedial Action Status Report Revision 2

Olalla Landfill Southeast Burley-Olalla Road Kitsap County, Washington

**Kitsap County Public Works Solid Waste Division
614 Division Street MS-27
Port Orchard, Washington 98366**

March 29, 2023

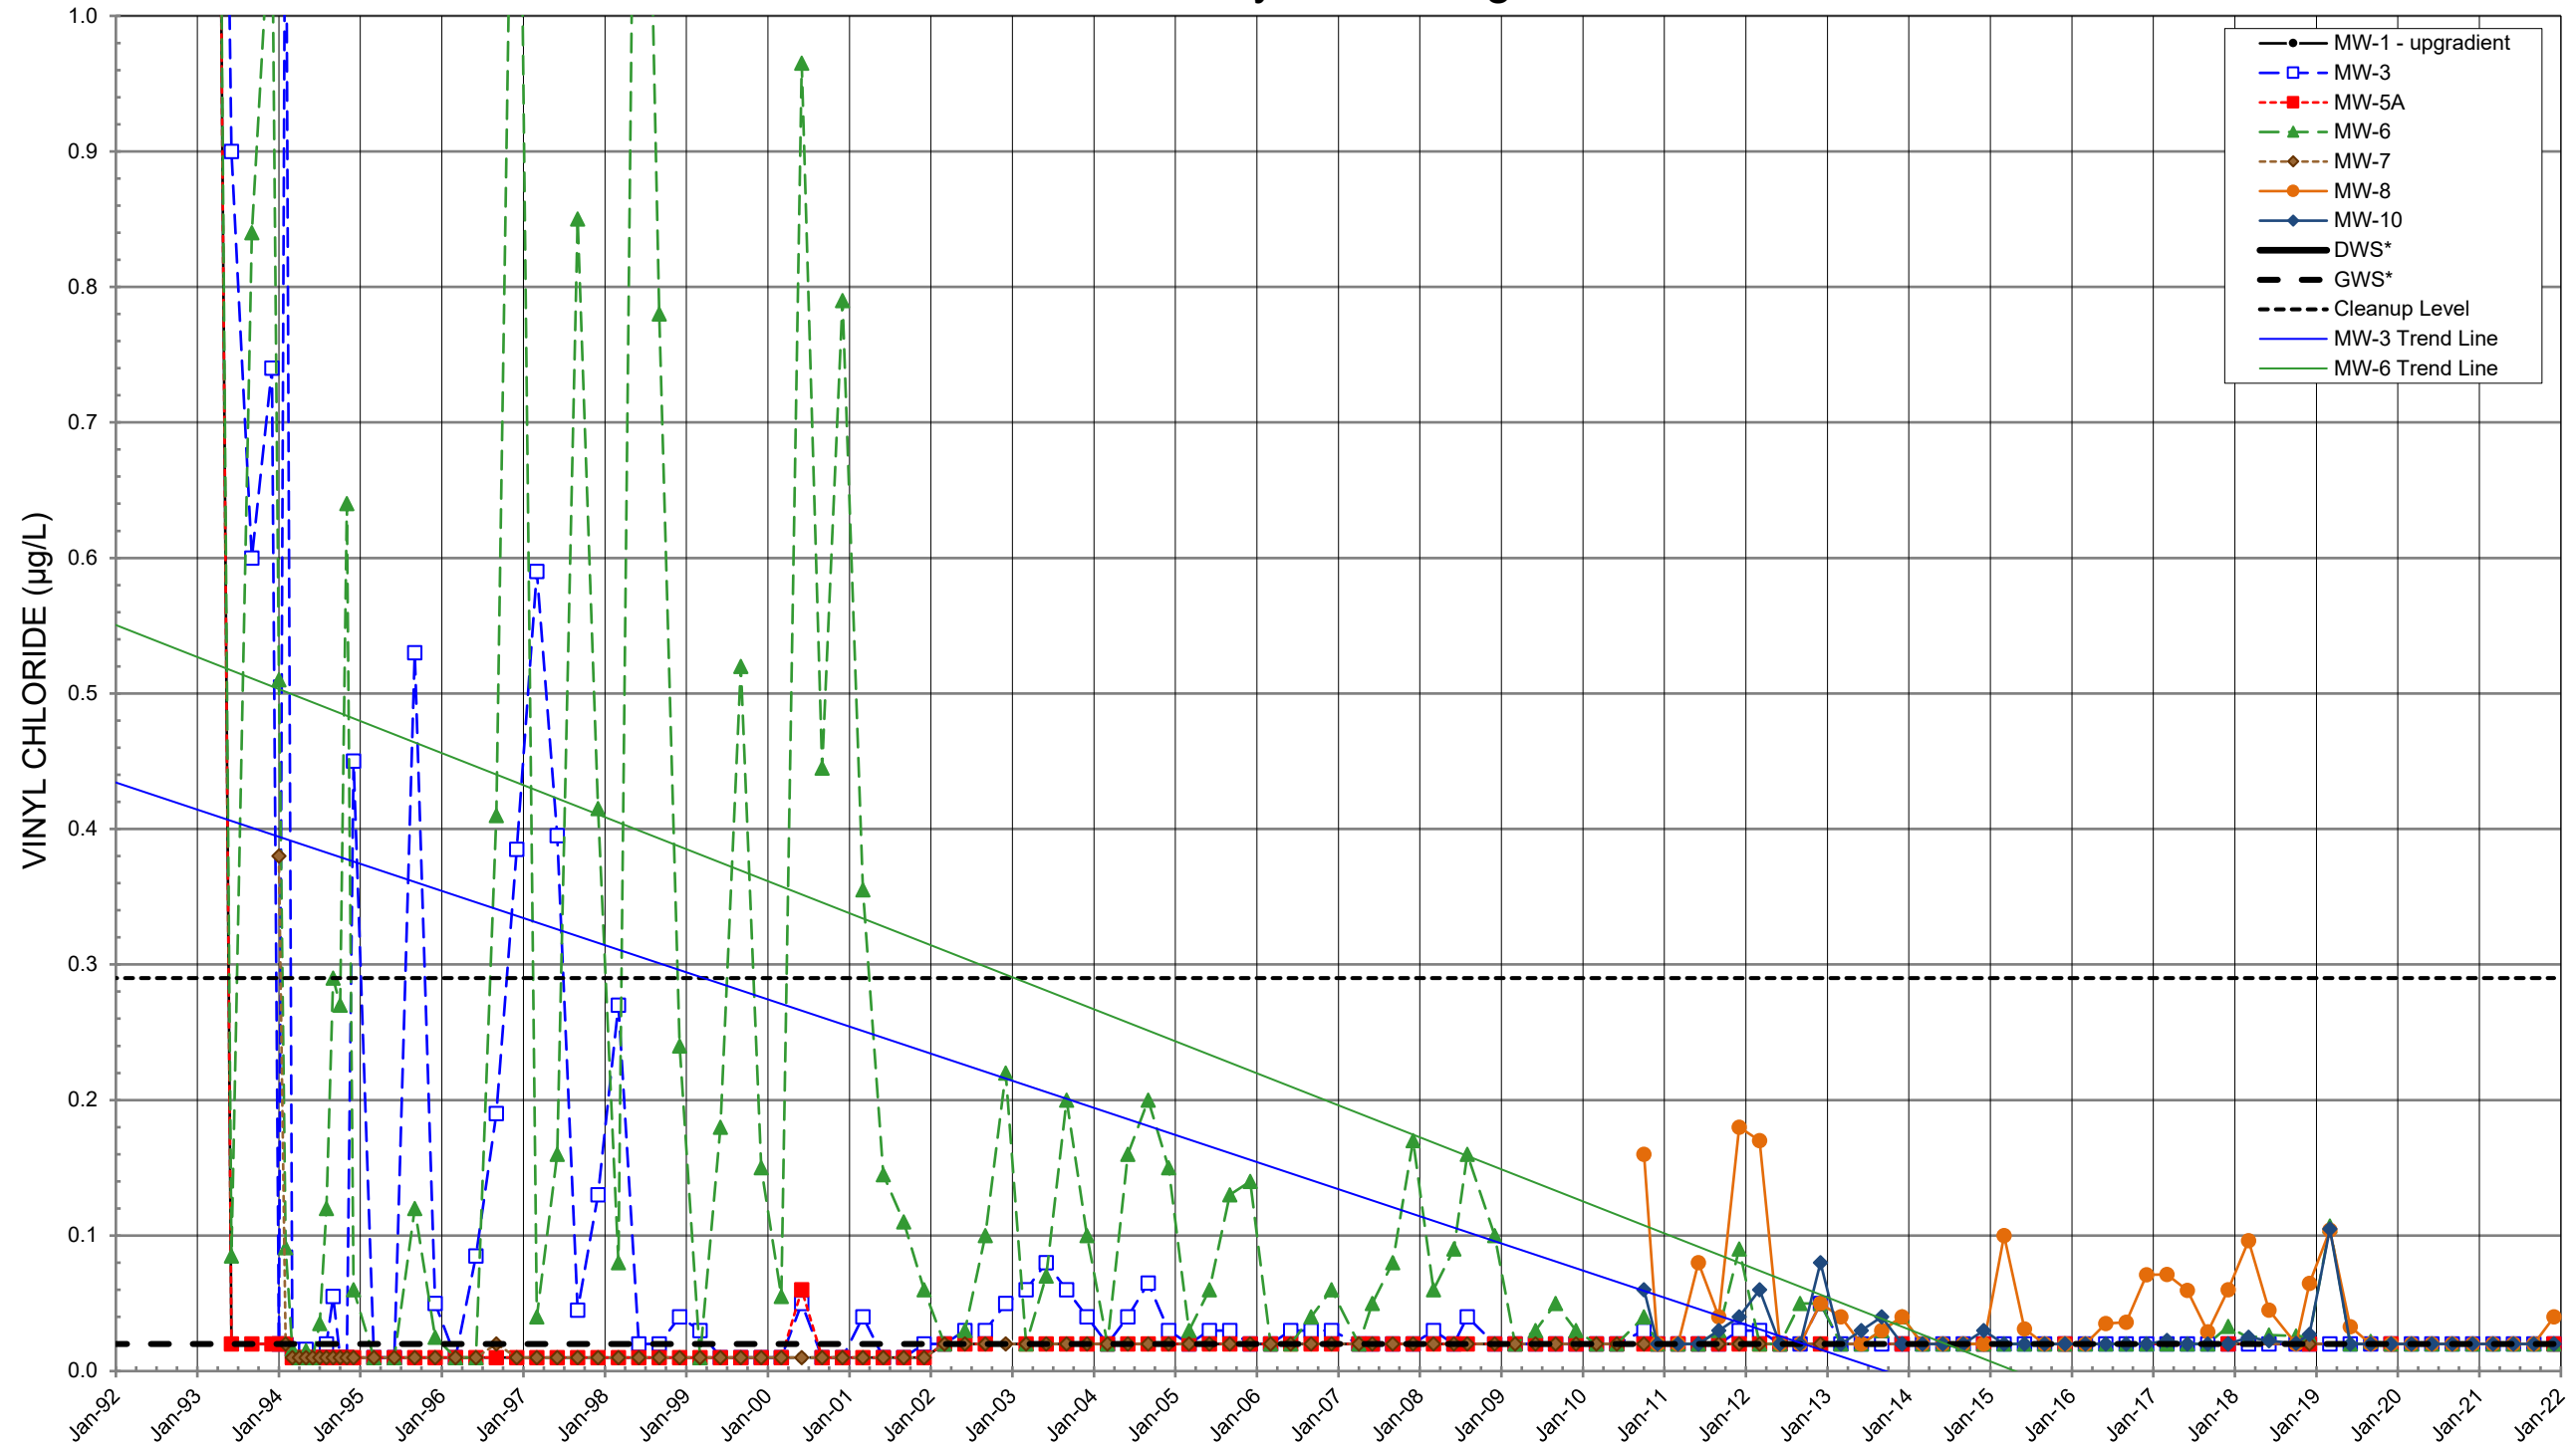
DISSOLVED MANGANESE (POST-CAP)

Site-Specific Cleanup Level = 0.29 µg/L
 Primary Drinking Water Standard (DWS) = 2 µg/L (off scale)
 Primary Groundwater Standard (GWS) = 0.02 µg/L

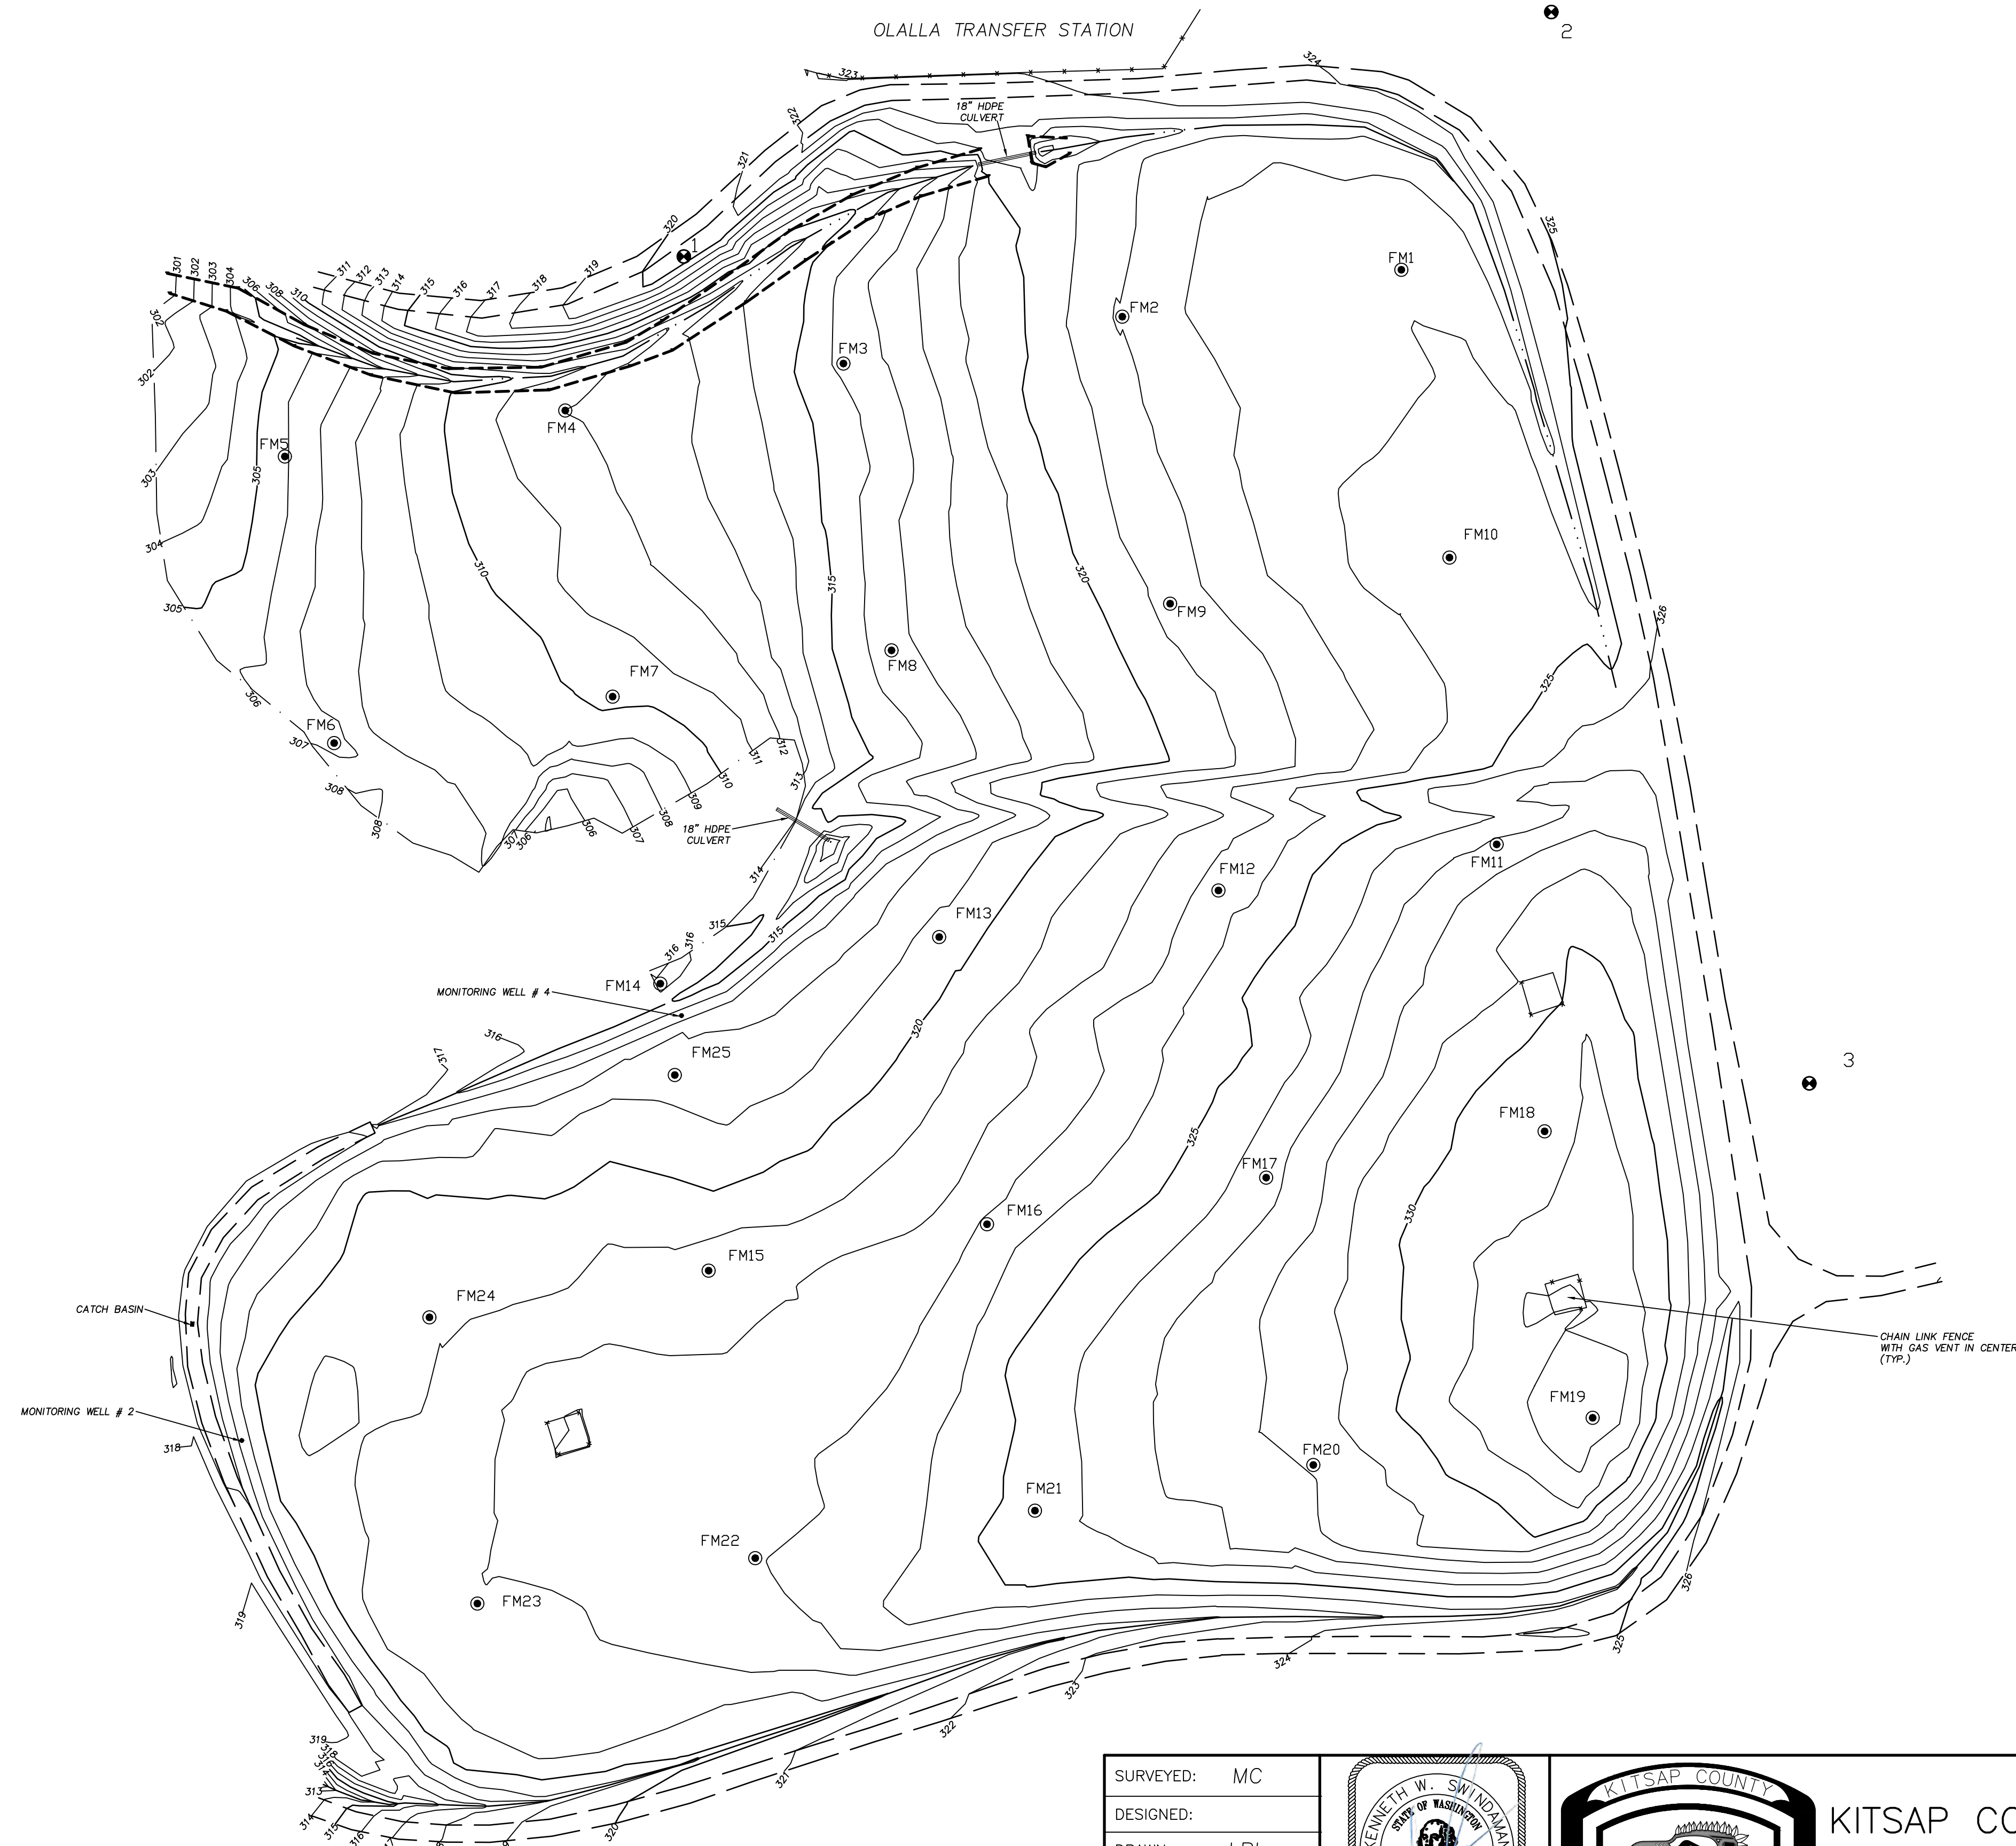
POST-CLOSURE SURVEY
OLALLA LANDFILL

Inspection reports issued by KPHD from 2014 to 2020 indicated that the Landfill cap and stormwater conveyance system were functional over that period and the engineering controls inspected comply with landfill closure requirements in WAC 173-304. The Landfill cap remains in good condition with no significant recent settlement, erosion, or damage reported. Stormwater drainage ditches at the stormwater detention pond were inspected and reported to be good condition and properly maintained. Inspection documents indicate that the Landfill cap and stormwater collection and conveyance systems have been well-maintained, repaired as needed, and are effective at limiting the amount of infiltration that

Base map prepared by Kitsap County Public Works Survey Department August 2019, from field survey data gathered July 2019.

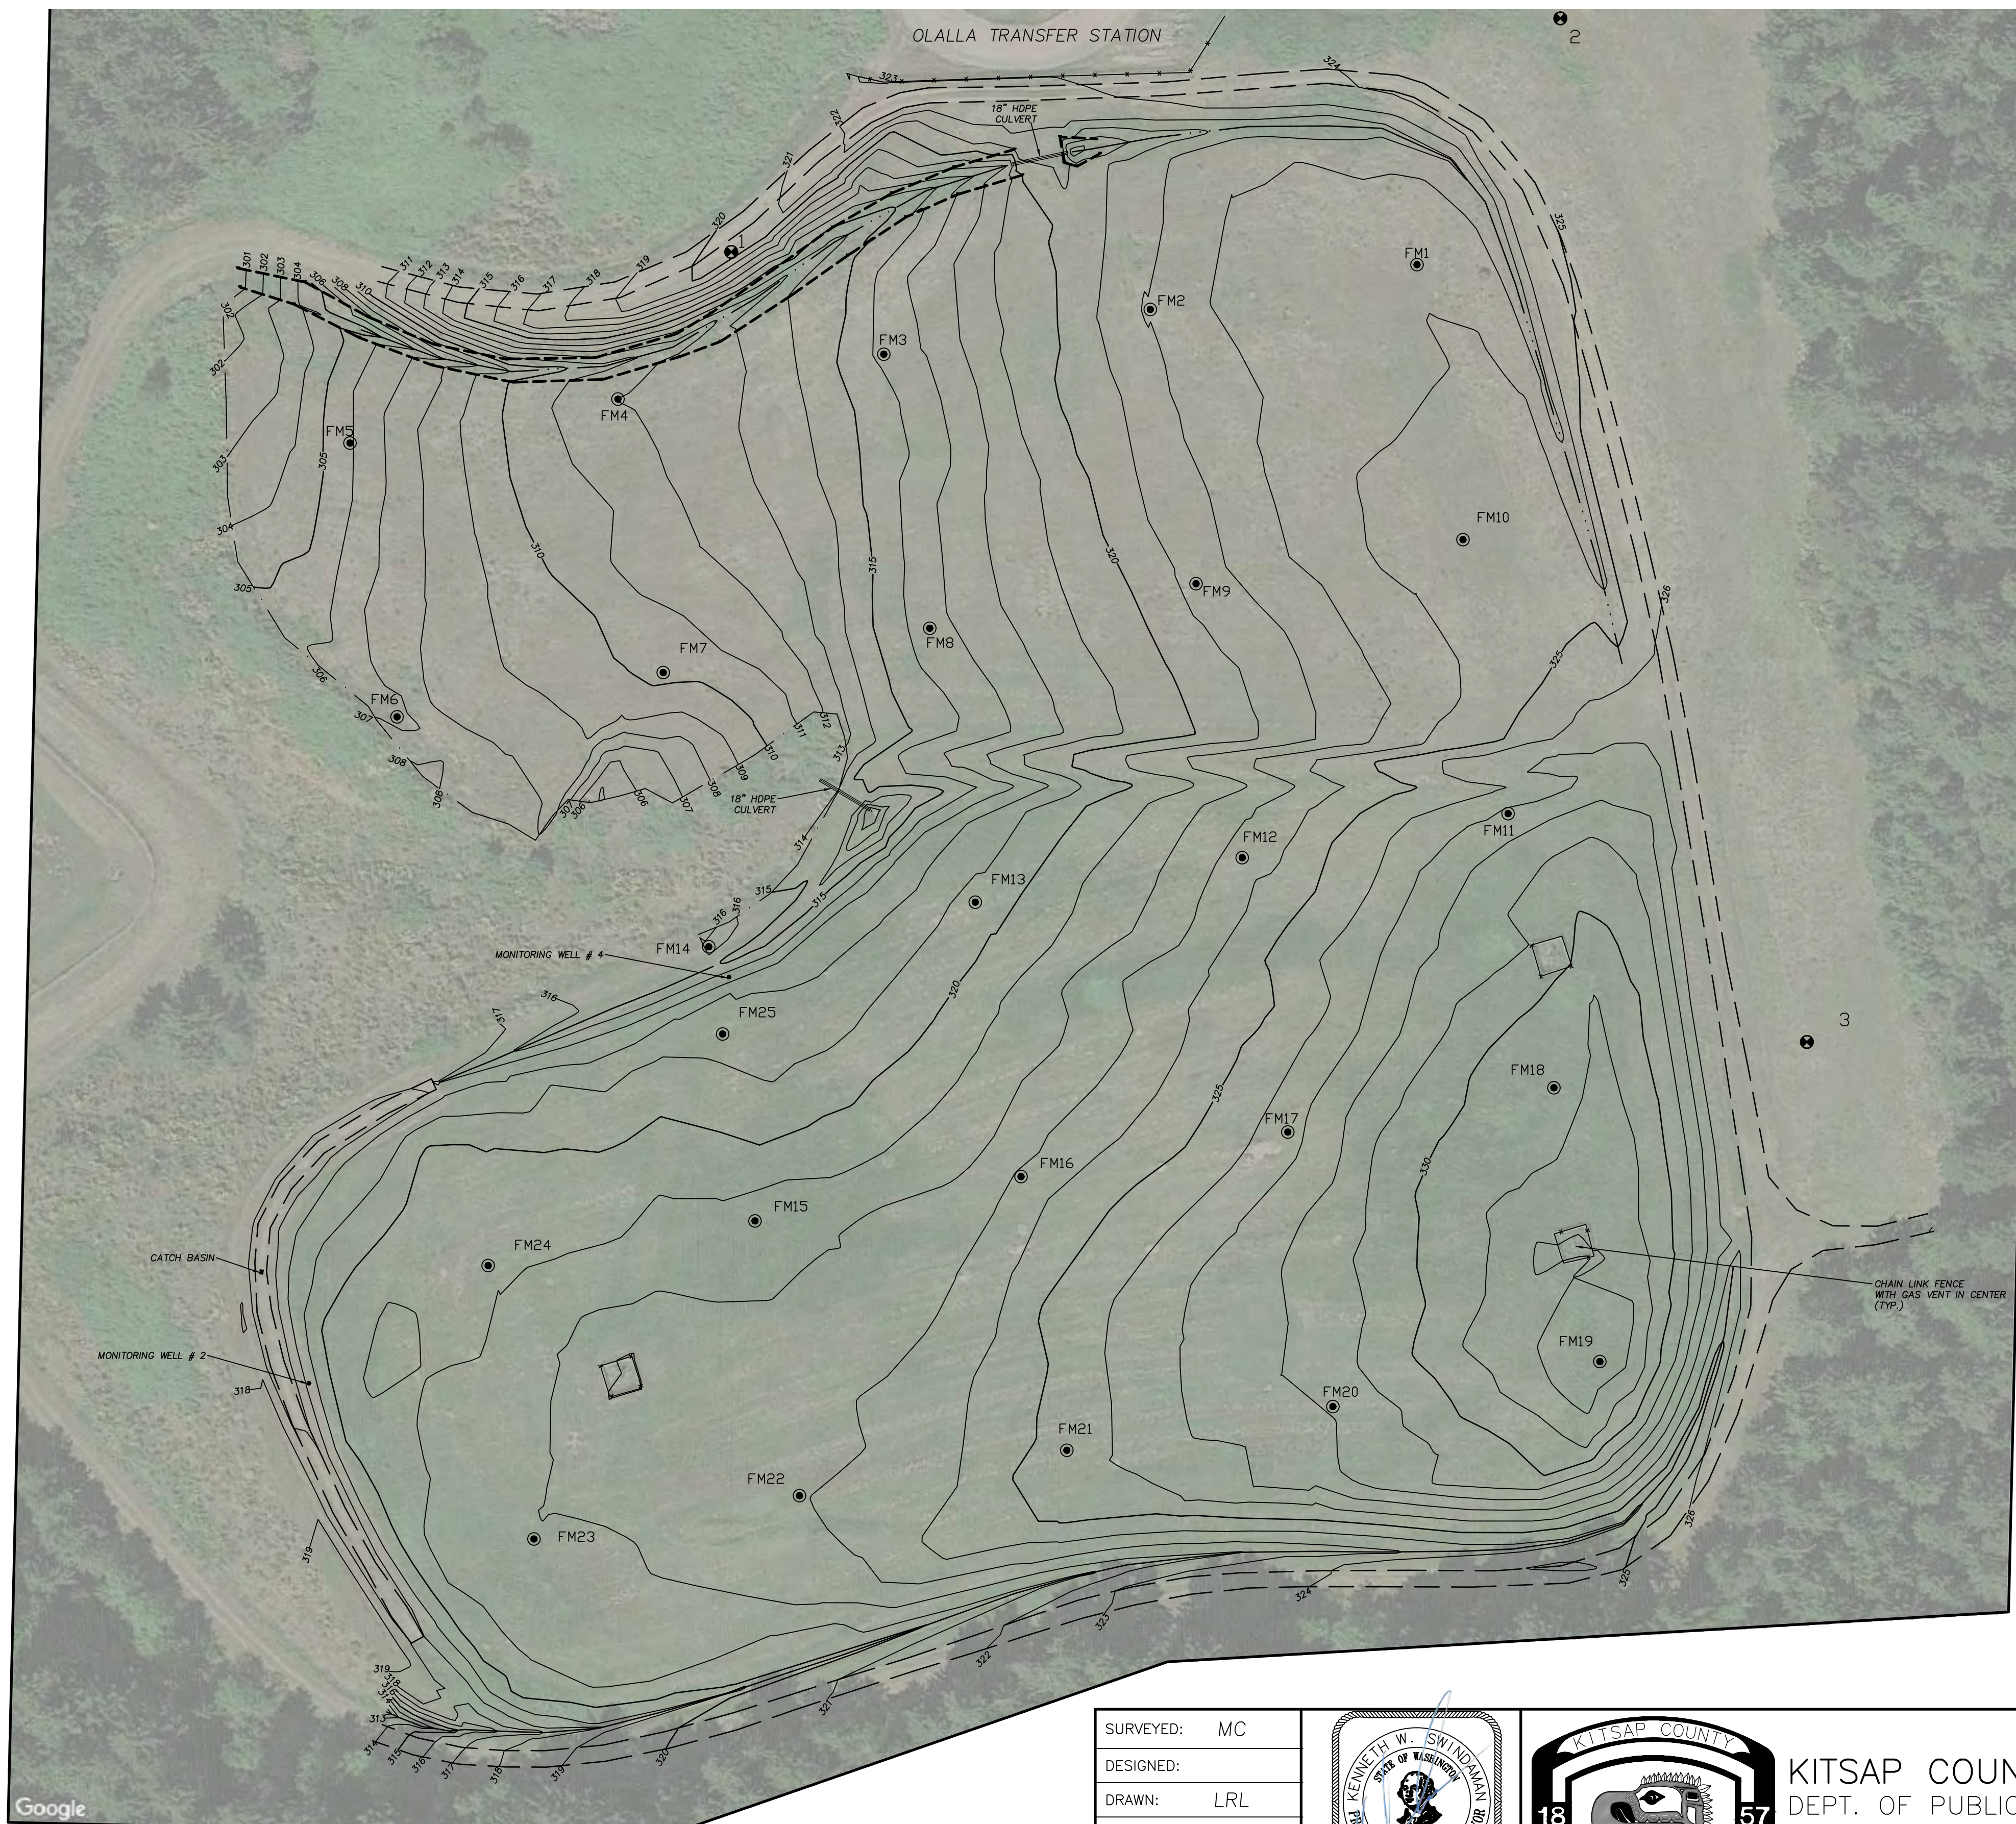
SHEET
1 OF 2
SHEETS

Base map prepared by Kitsap County Public Works Survey Department August 2019, from field survey data gathered July 2019.

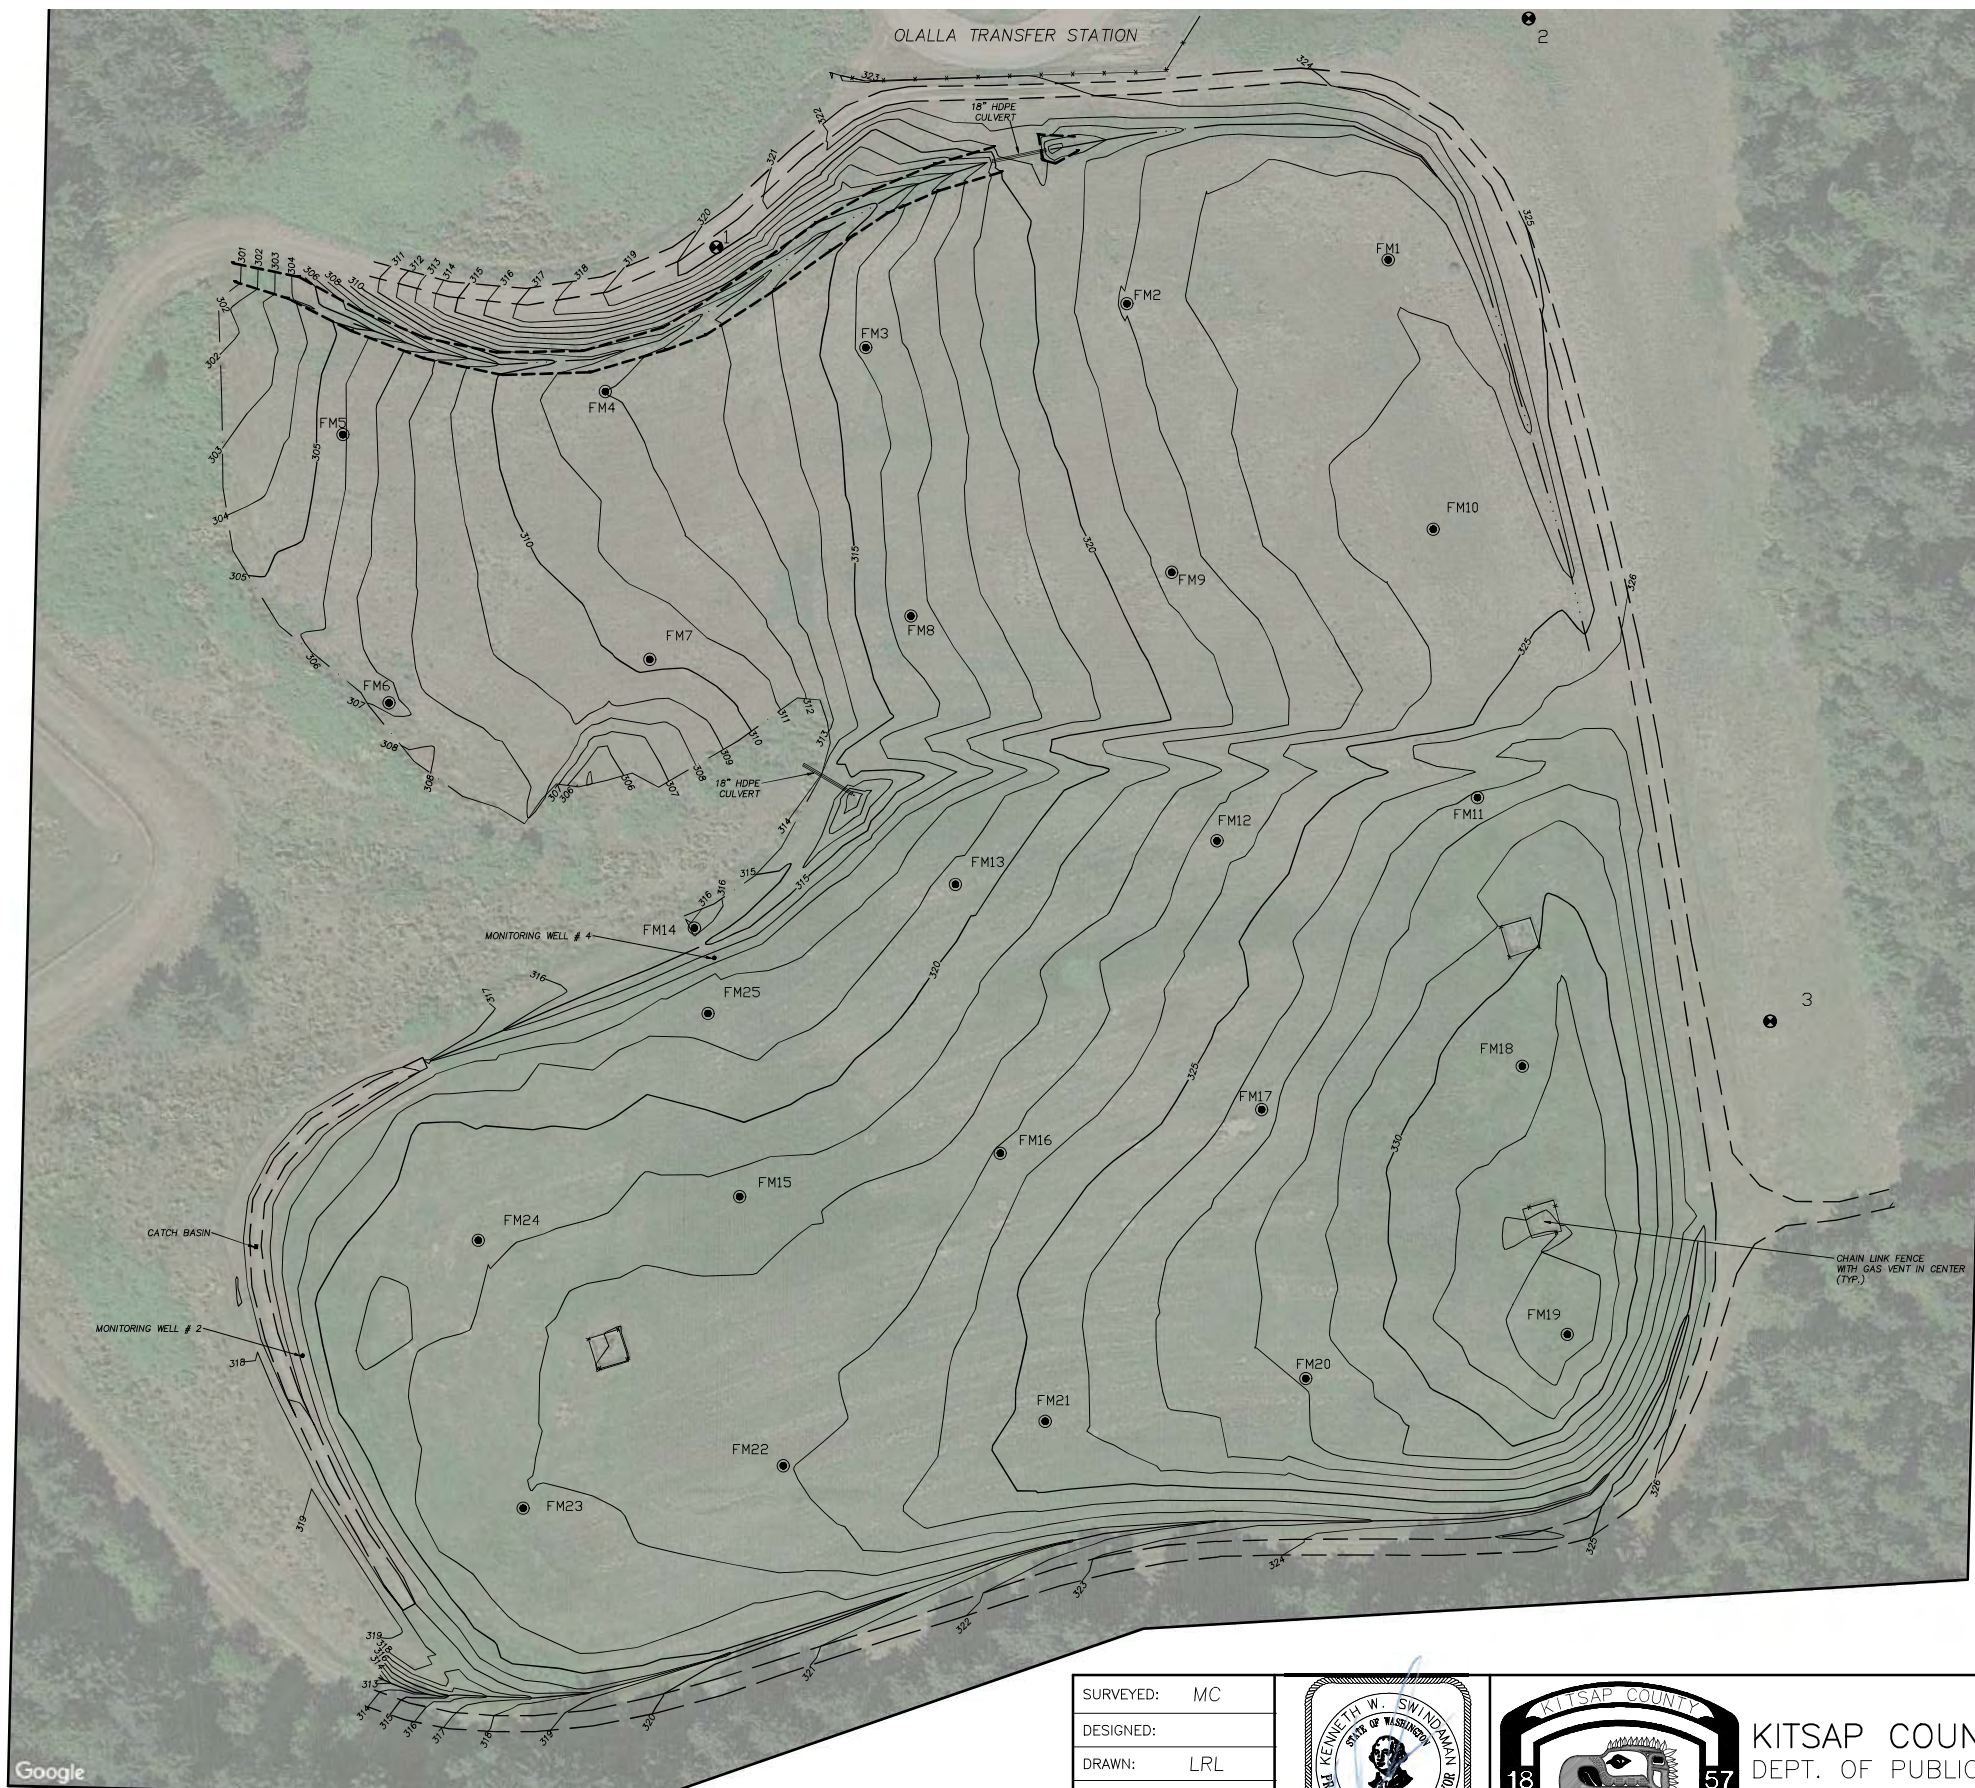
SHEET
1 OF 2
SHEETS

Base map prepared by Kitsap County Public Works Survey Department August 2019, from field survey data gathered July 2019.
