RE: Limited Assessment of Electric Avenue Waste Disposal/Fire Pit Training Area
Spokane International Airport
Spokane, Washington
SIA Contract #19-43-9999-006
SES Project No.: 0270-003

SIA ELECTRIC AVENUE BURN PIT
LIMITED SITE ASSESSMENT
SPOKANE, WASHINGTON

PHOTOGRAPHIC LOG

Limited Assessment
6222 E. Desmet Avenue
Spokane, Washington

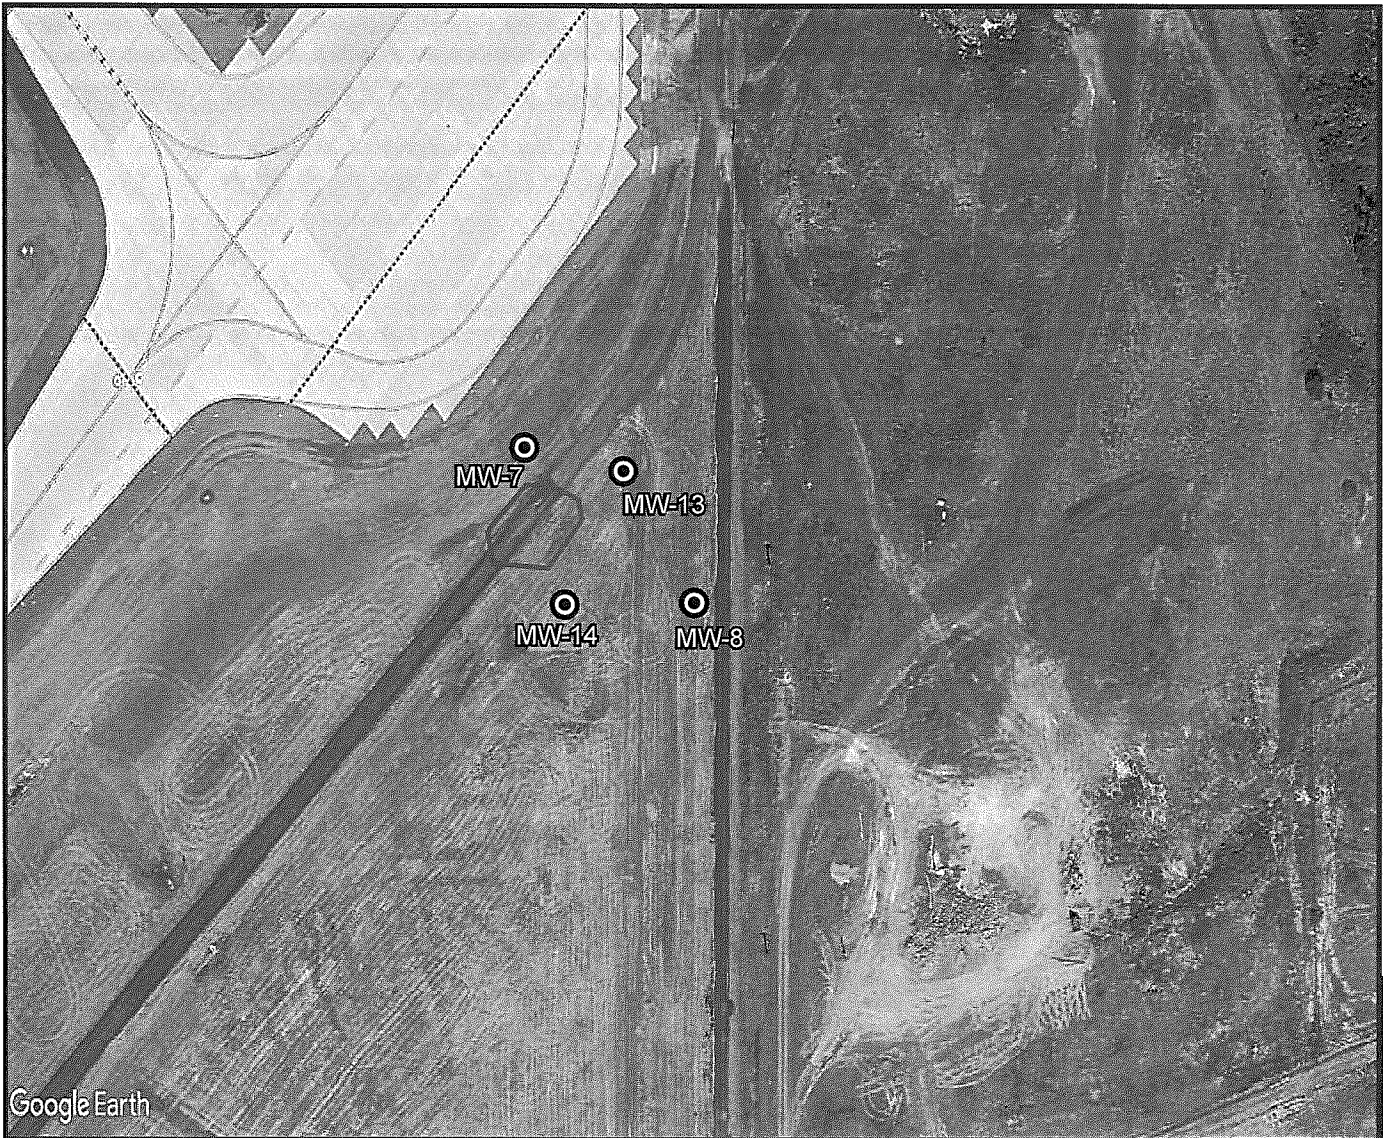
FIGURE 2

There are four pairs of monitoring wells located on site. Each pair consists of a shallow- and a deep-screened well. Monitoring well pairs MW-7 and MW-8 were installed by the Army Corps of Engineers in 1990. Monitoring well pairs MW-13 and MW-14 were installed by SIA in 1992. In each of the well pairs, the well designated by an A suffix is the deeper of the pair and is generally screened across the contact between sequenced flood sediments and the underlying basalt. Specific construction details of those wells sampled during this event are further discussed below. Monitoring well locations are shown on **Figure 2**. Monitoring Well Logs are shown in **Attachment A**.

SITE MAP	
SIA ELECTRIC AVENUE BURN PIT LIMITED SITE ASSESSMENT SPOKANE, WASHINGTON

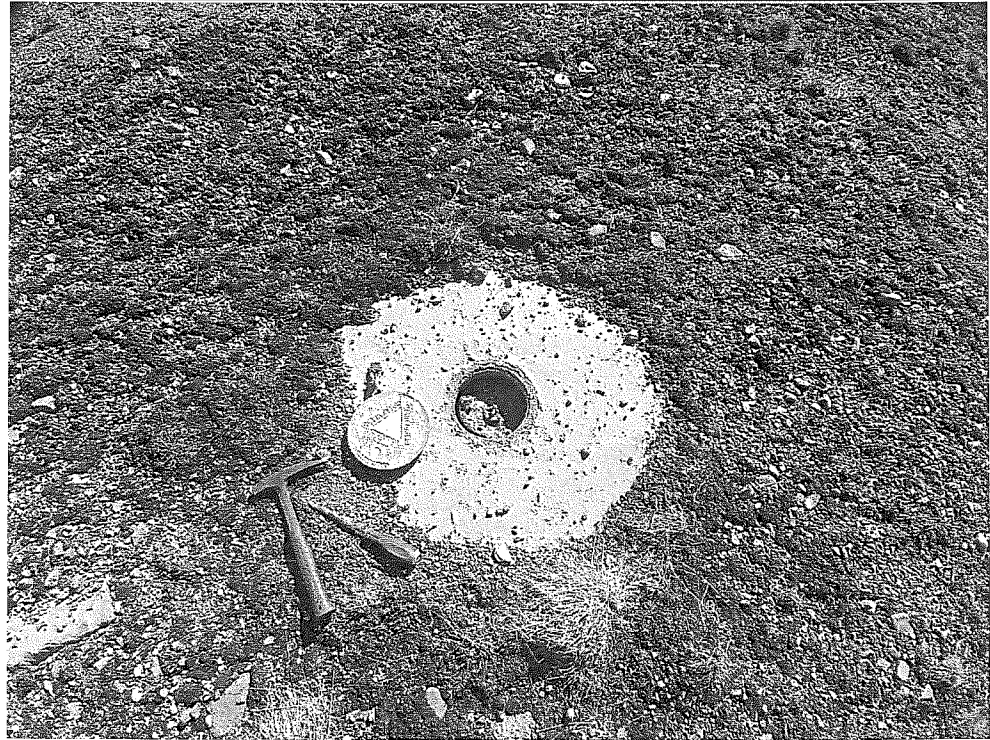
1

View of MW-7. The well cap has been cemented in-place. Potentially an easy fix.

SES found integrity issues with many of the wells. Well monuments and caps were found to be distressed and in need of repair or replacement in order to maintain the structural integrity of the well and to protect groundwater. SES can provide an estimate for the repair of these monuments upon request. Details are provided in the Photographic Log included as **Attachment B**.

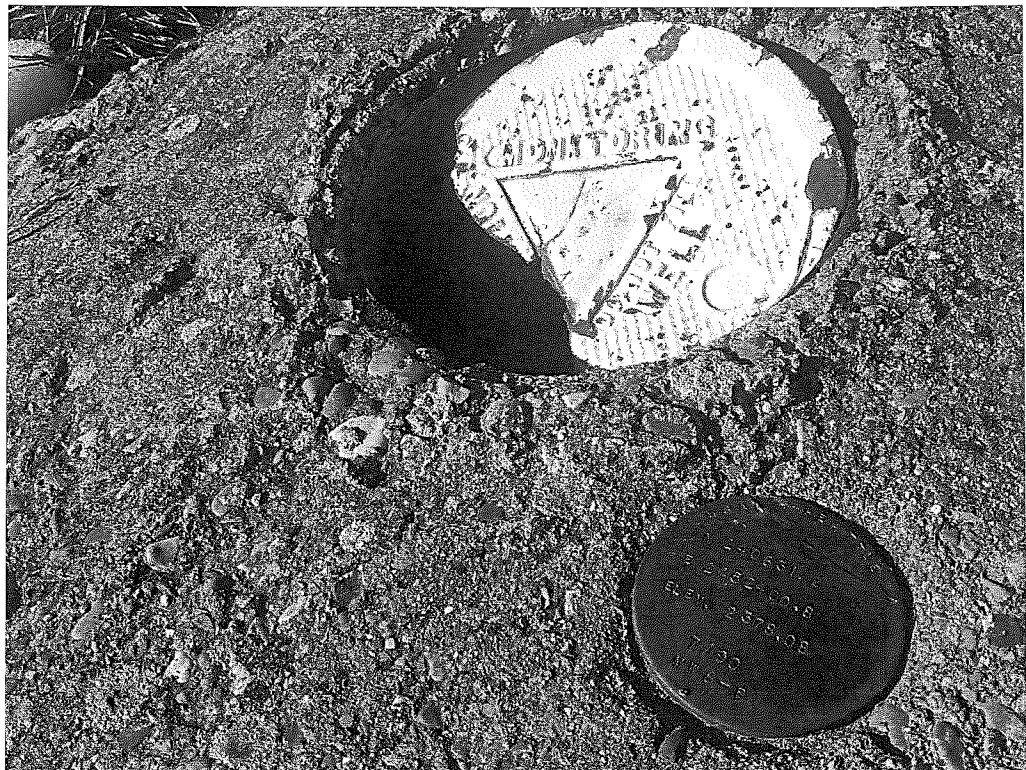
2

View of the broken monument lid on MW-8b. The entire monument should be replaced.
