Memorandum

Subject: March 2023 Vapor Intrusion Priority Monitoring: Precision Engineering, Inc. Agreed

Order No. DE 18079

Passive Sampler Locations

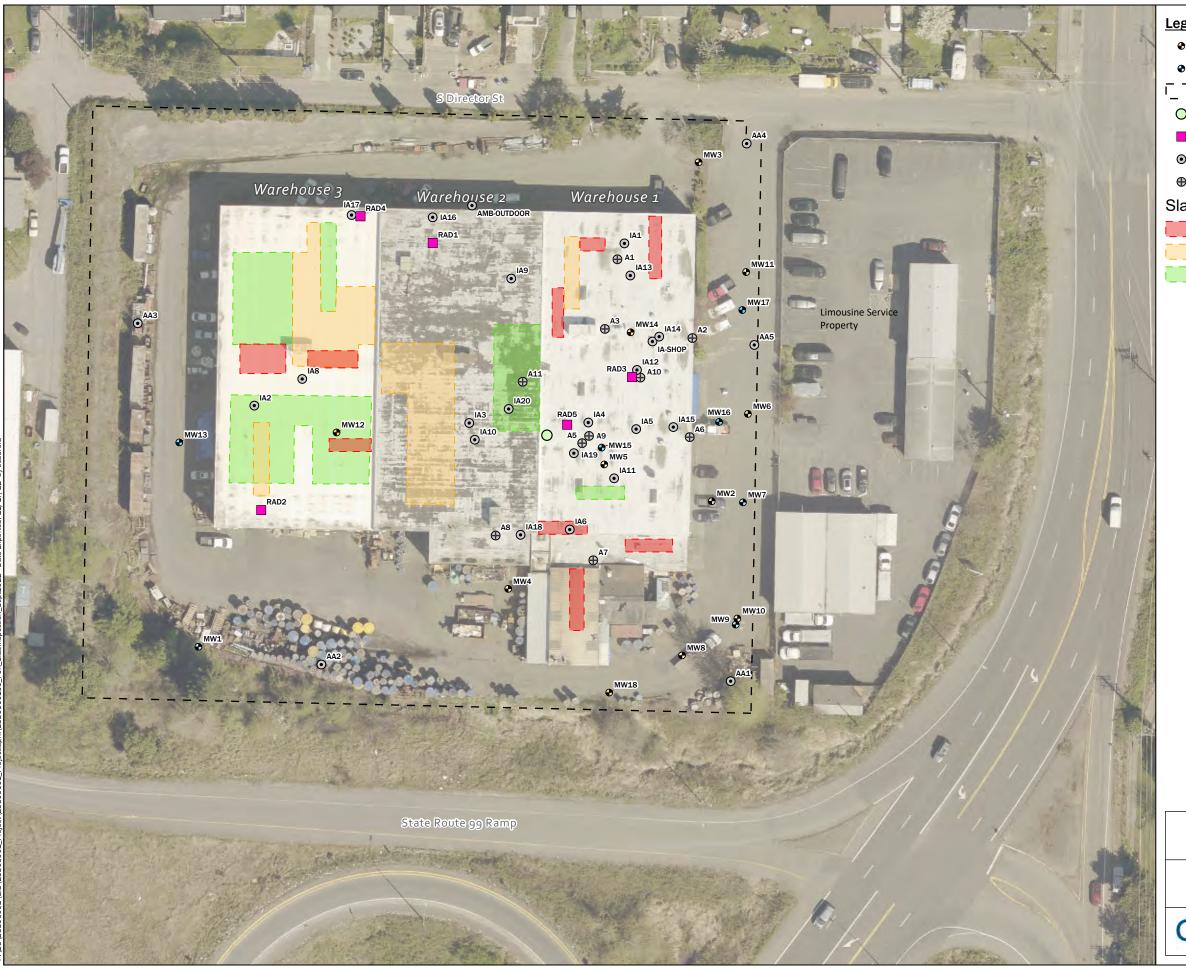
Figure 1

Slab Inspection Areas

Unsealed Crack and Seams^(a)

Sealant Peeling from Seams^(a)

1. The locations of all features shown are approximate.
2. This drawing is for information purposes. It is intended to assist in showing features discussed in an attached document. GeoEngineers, Inc. cannot guarantee the accuracy and content of electronic files. The master file is stored by GeoEngineers, Inc. and will serve as the official record of this communication.
3. The slab inspection was conducted by GeoEngineers on September 16, 2022. Monitoring well locations were surveyed by True North Surveying. All other locations are approximate.
4. (a) Seams are approximately 1-centimeter deep, linear depressions in the concrete slab with a visible bottom. Seams are not anticipated to contribute to vapor intrusion.

Radiello 130 passive vapor samplers were deployed in five locations over a three-week period from February 2 to February 23, 2023. The five locations include the office (RAD1), Warehouse 3 (RAD2), Warehouse 1 store front (RAD3), sewing room (RAD4), and near the former TCE tank (RAD5) per the VIP work plan (see attached Figure 1). The samples were analyzed for trichloroethene (TCE) by United States Environmental Protection Agency (EPA) Method TO-17. The laboratory analytical report is provided as Attachment A.
