*Geotechnical Feasibility Study for the
Proposed Uplands Development and
Environmental Assessment of the
Central Waterfront Project*

*Prepared for
Port of Seattle*

*March 26, 1992
J-3447*

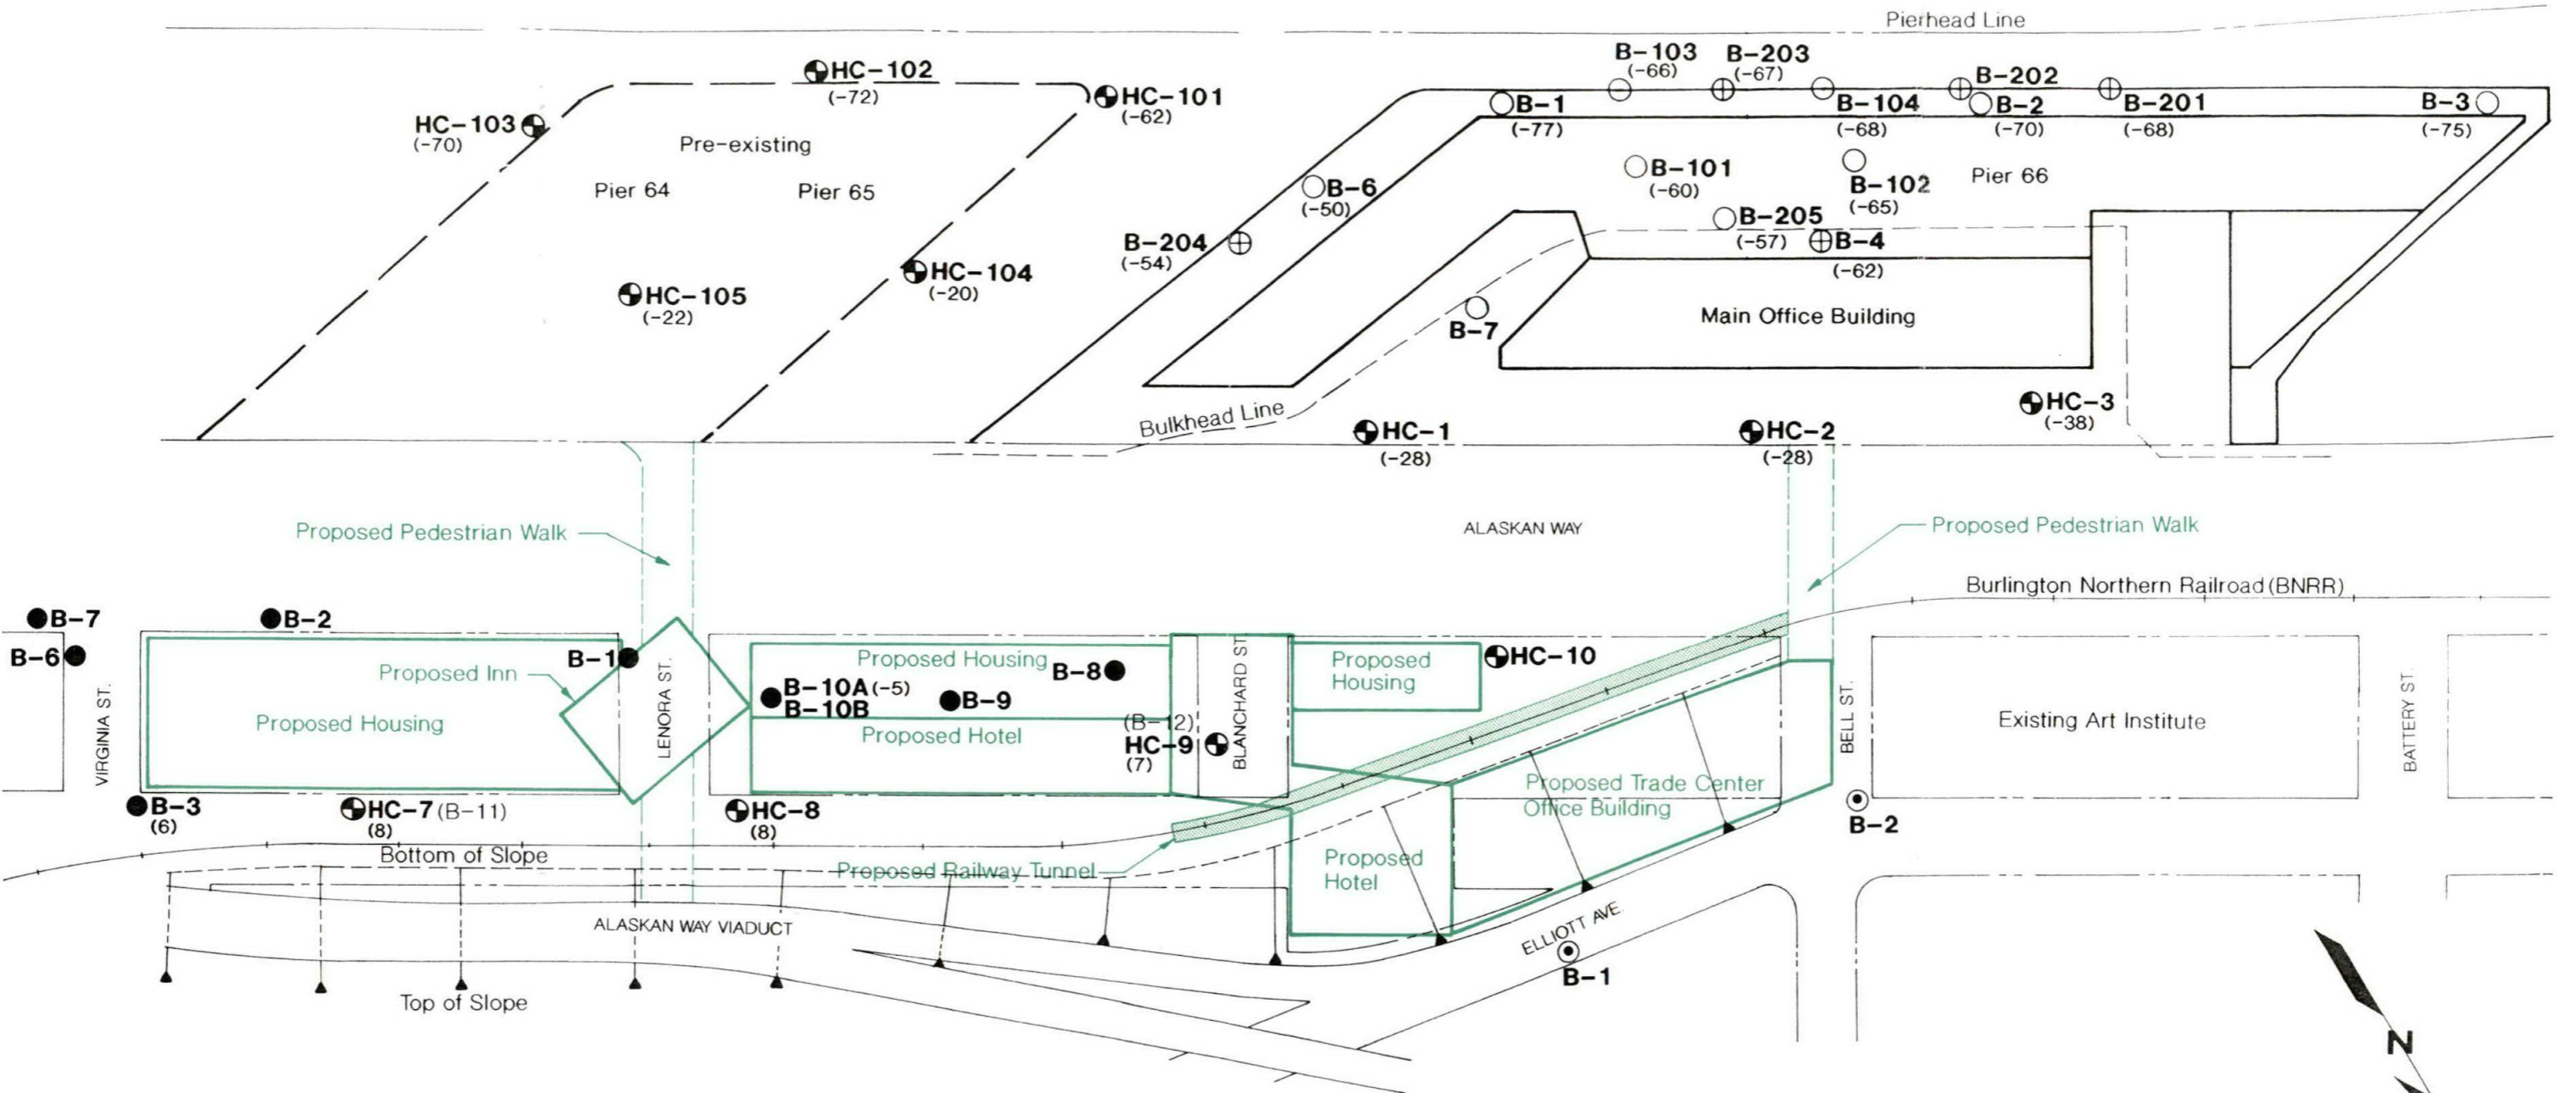
Site and Geotechnical Exploration Plan

- B-1 Boring Location and Number, by Shannon and Wilson, Inc. (1974, 1975, and 1988 Studies)
- B-8 Monitoring Well Location and Number, Hart Crowser, (1986 Study)
- ⊕B-201 Boring Location and Number, AGS, (1988 Study)
- ⊙B-1 Boring Location and Number, Hart Crowser, (1991 Study)
- ⊕HC-101 Boring Location and Number, Hart Crowser, (Current Study)
- (-70) Elevation in Feet of Top of Dense Soil Bearing Layer

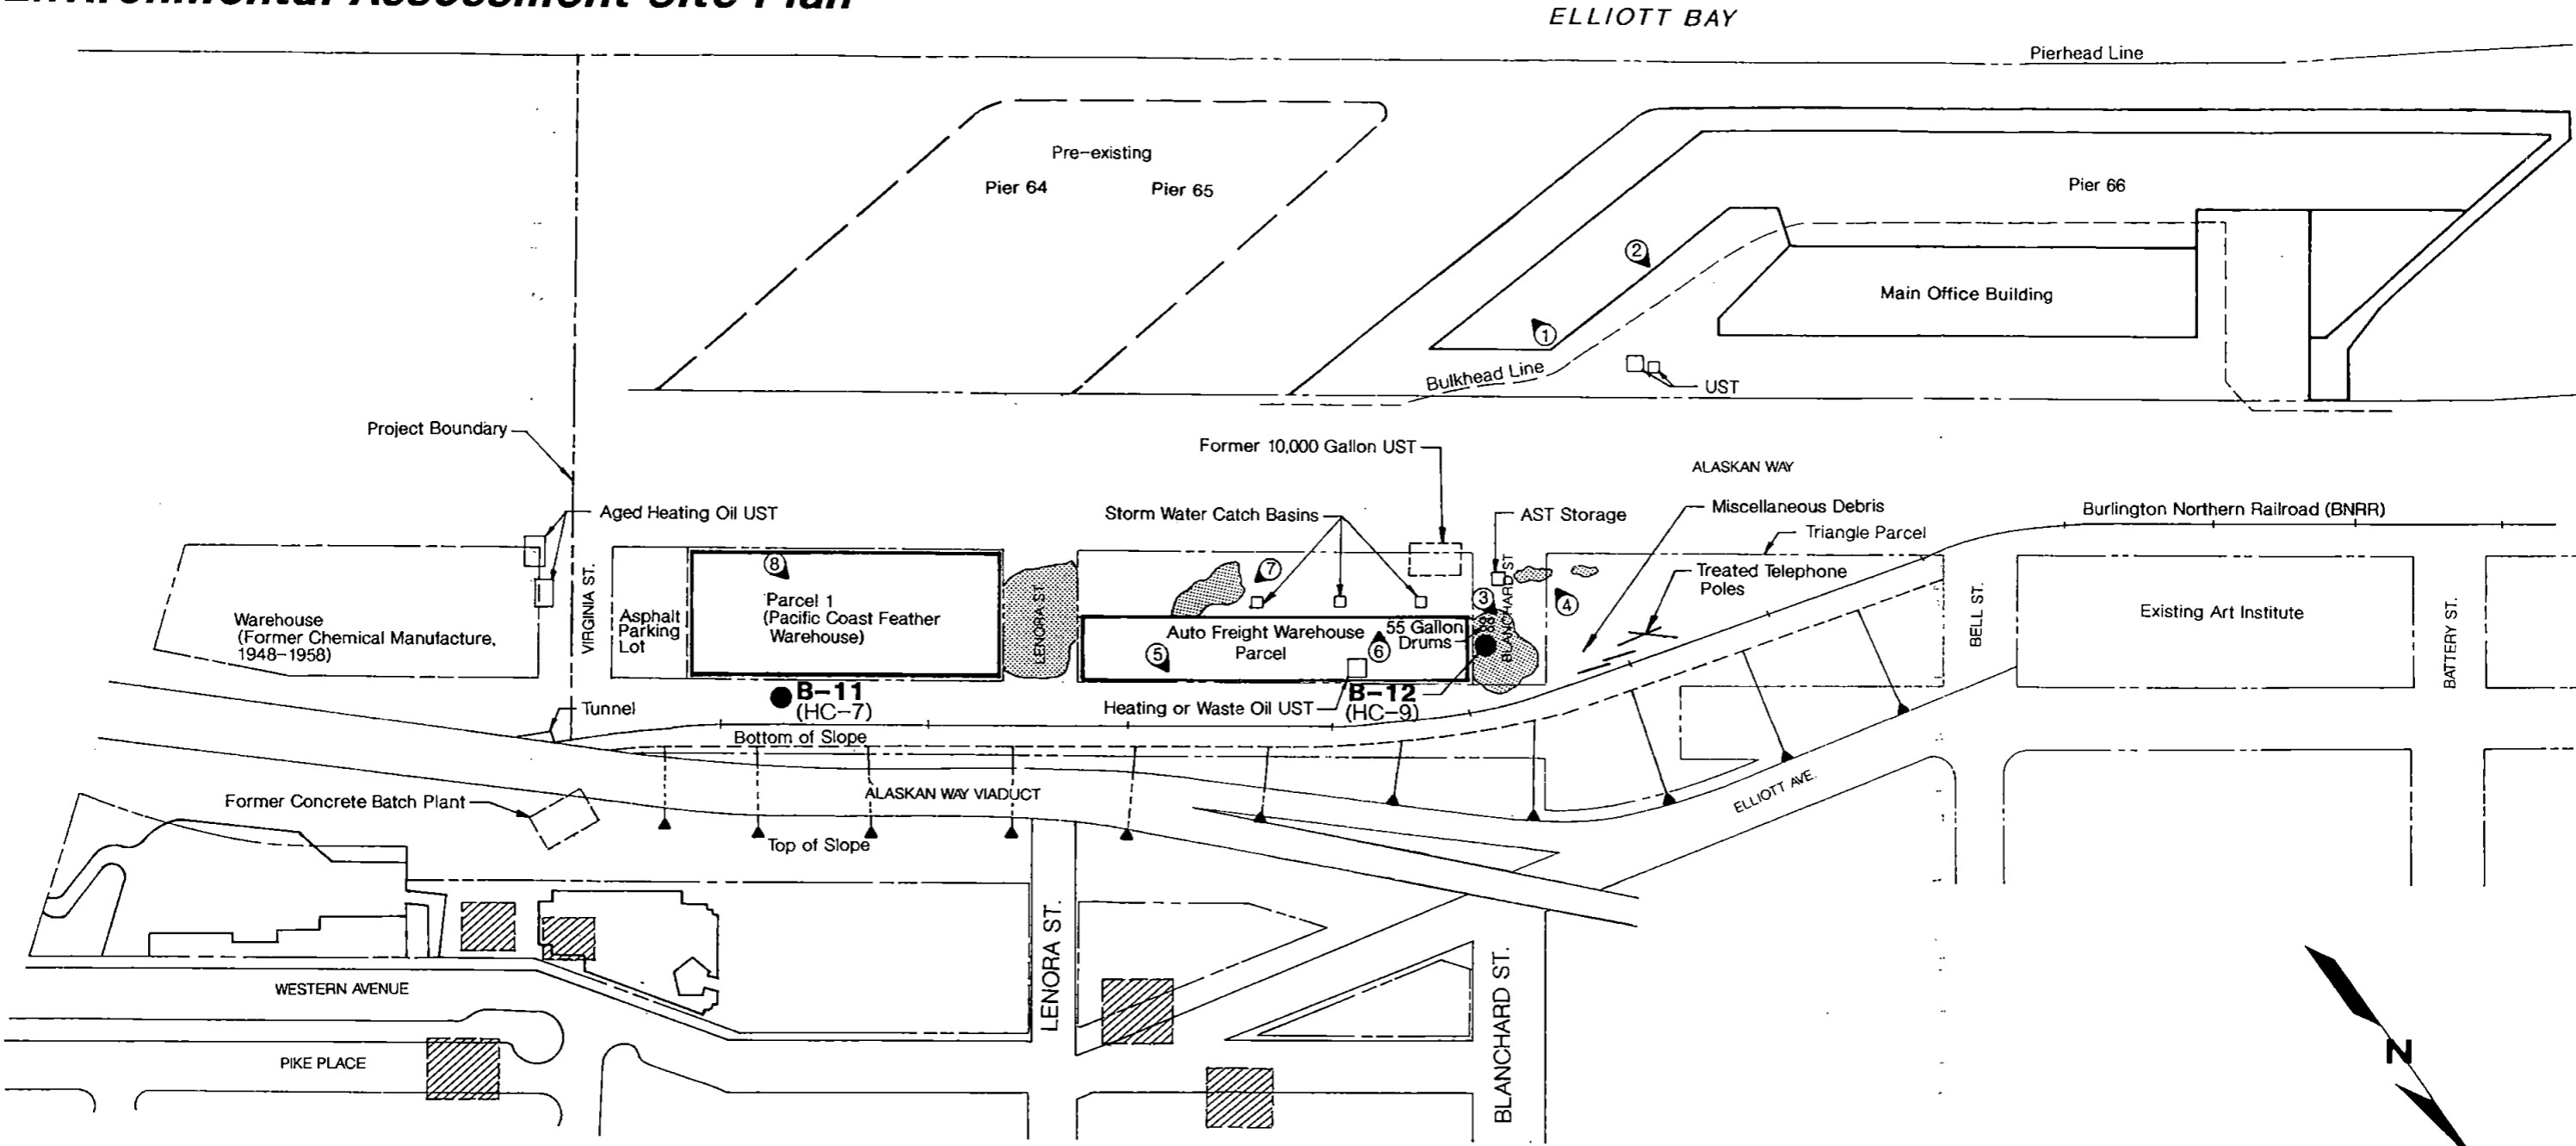
Environmental Assessment Site Plan

- B-11●** Monitoring Well Location and Number
- ① Photograph Location, Number, and Direction
- ▨ Former Gas Station (1916-1969)
- ▨ Oil Stained Surface

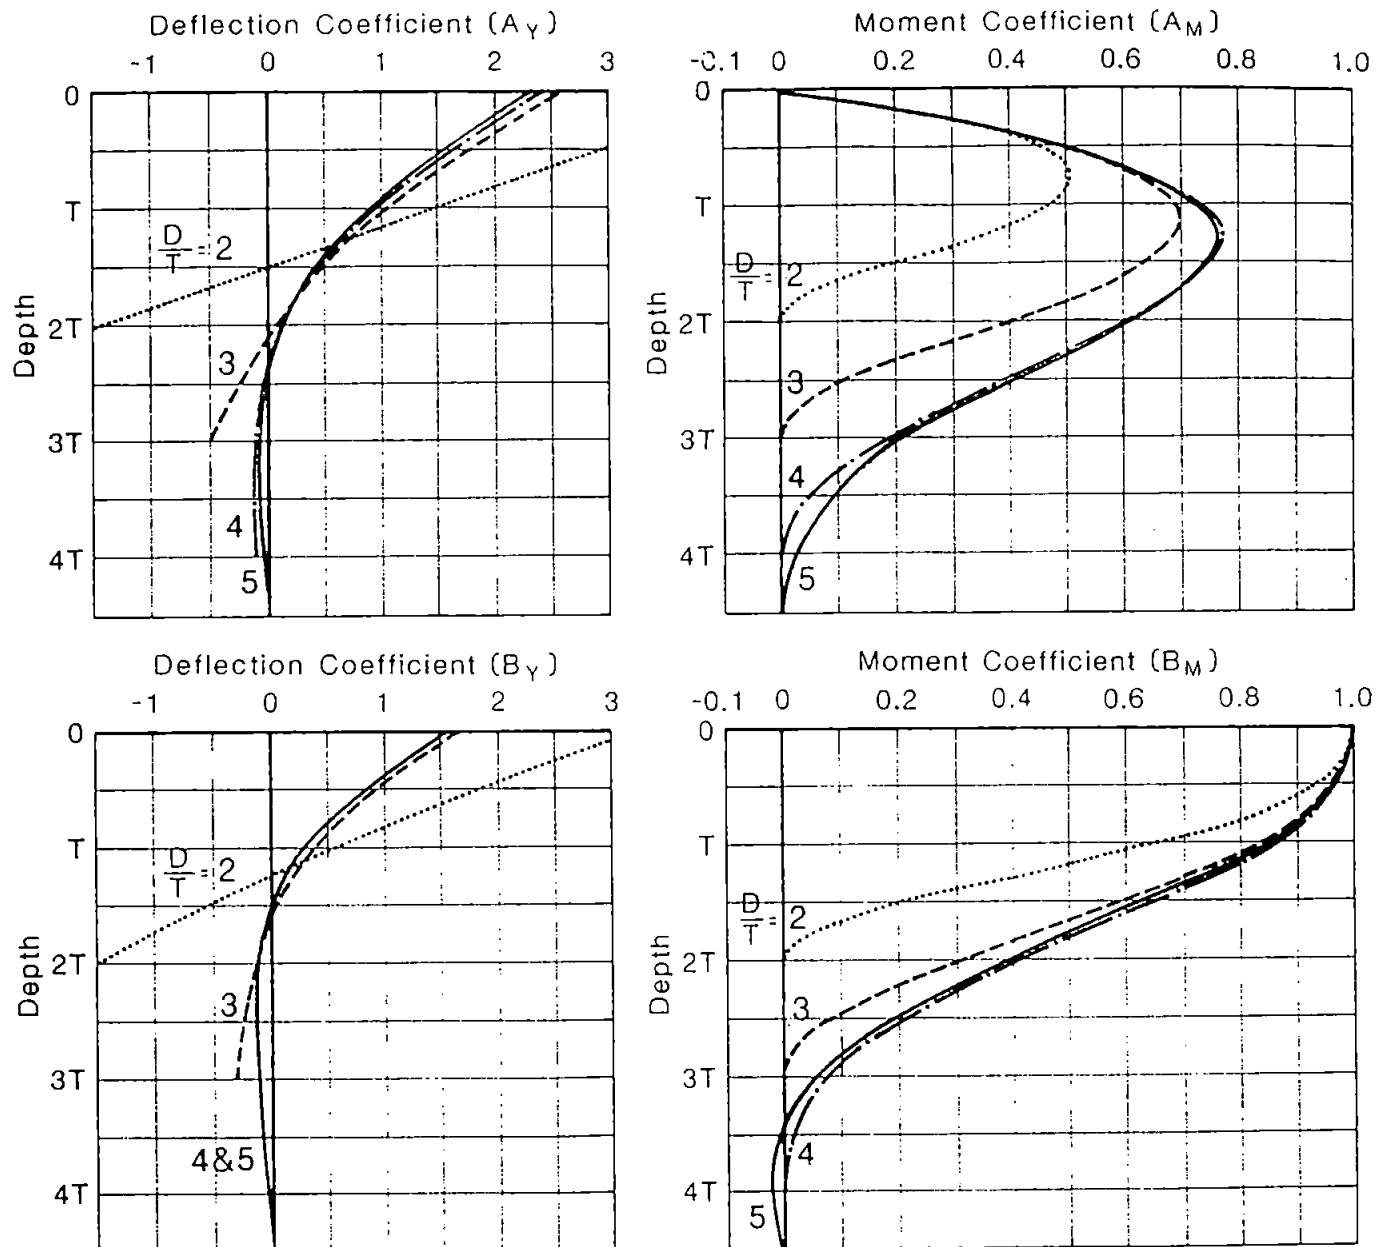
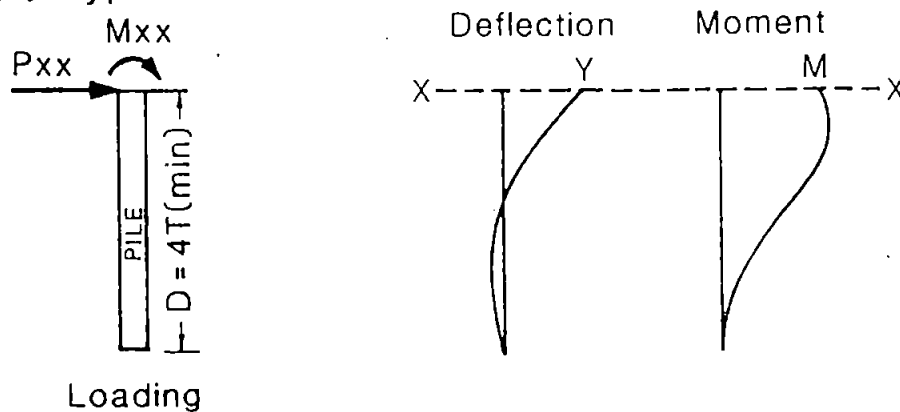
Laterally Loaded Piles in Elastic Subgrade

Free-Headed Pile Condition

(a) Deflection and Moment Coefficients

(b) Typical Deflection and Moment Curves

P_{xx} Pile Shear at Ground Surface
 M_{xx} Pile Moment at Ground Surface
 T Relative Stiffness Factor

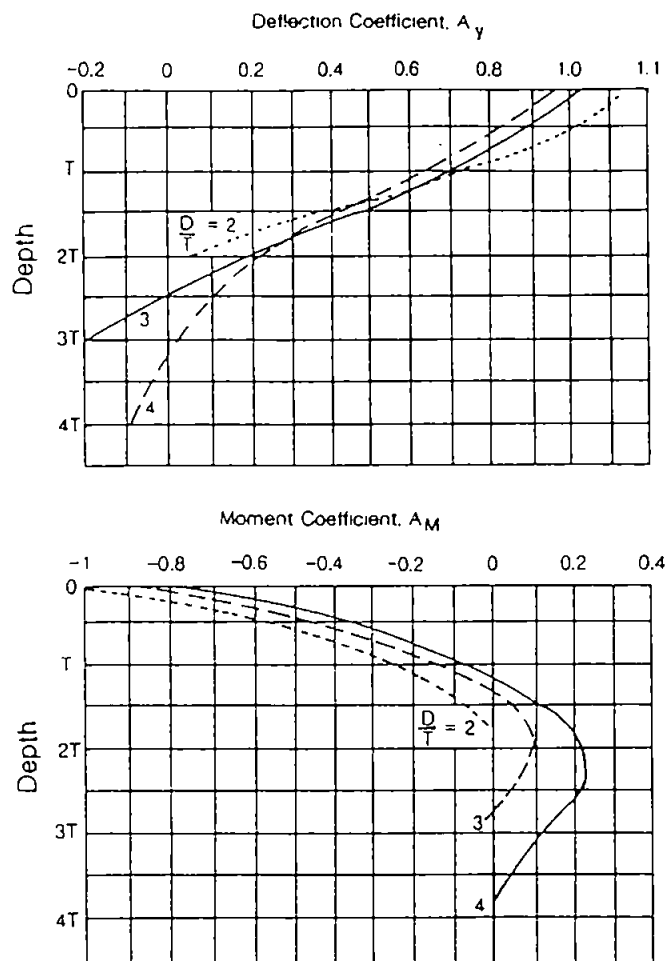
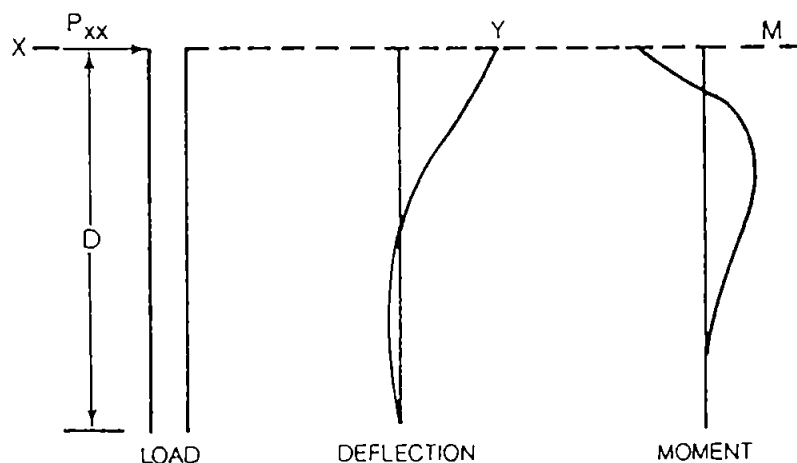
Fixed-Headed Pile Condition

(a) Deflection and Moment Coefficients

(b) Typical Deflection and Moment Curves

P_{xx} Pile Shear at Ground Surface

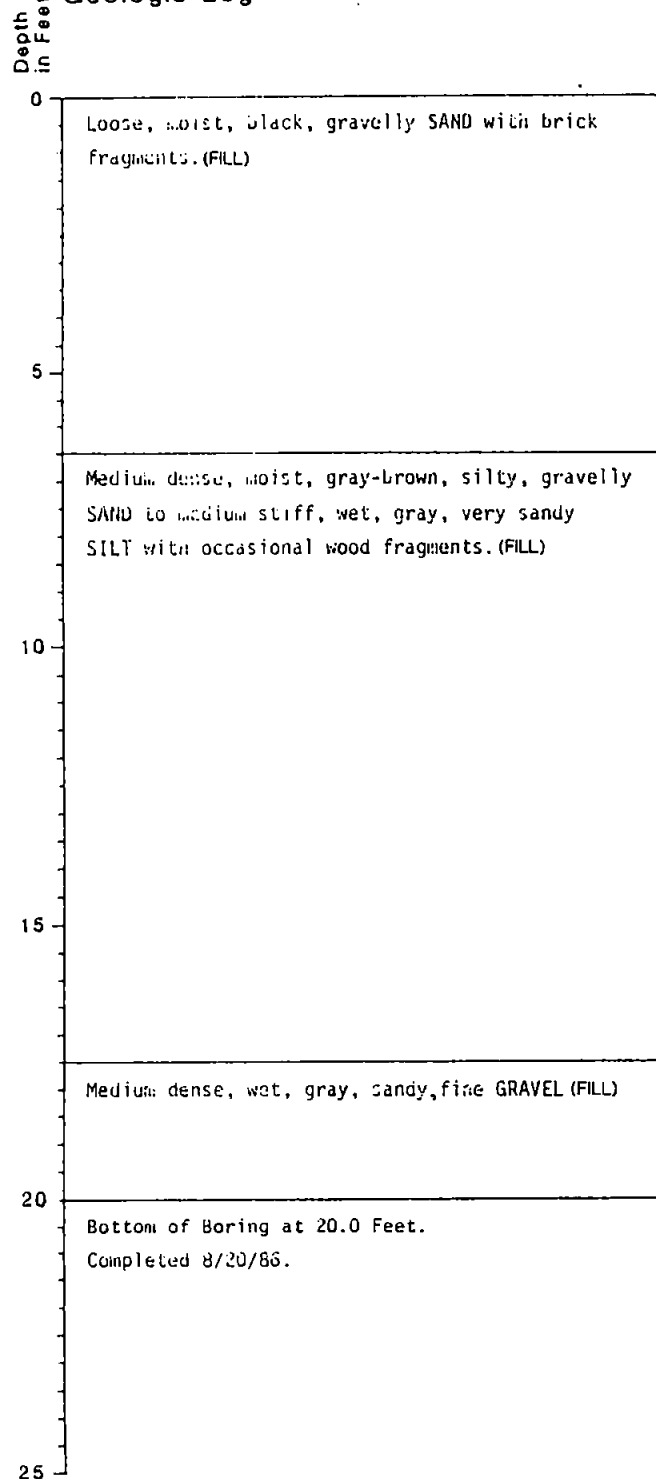
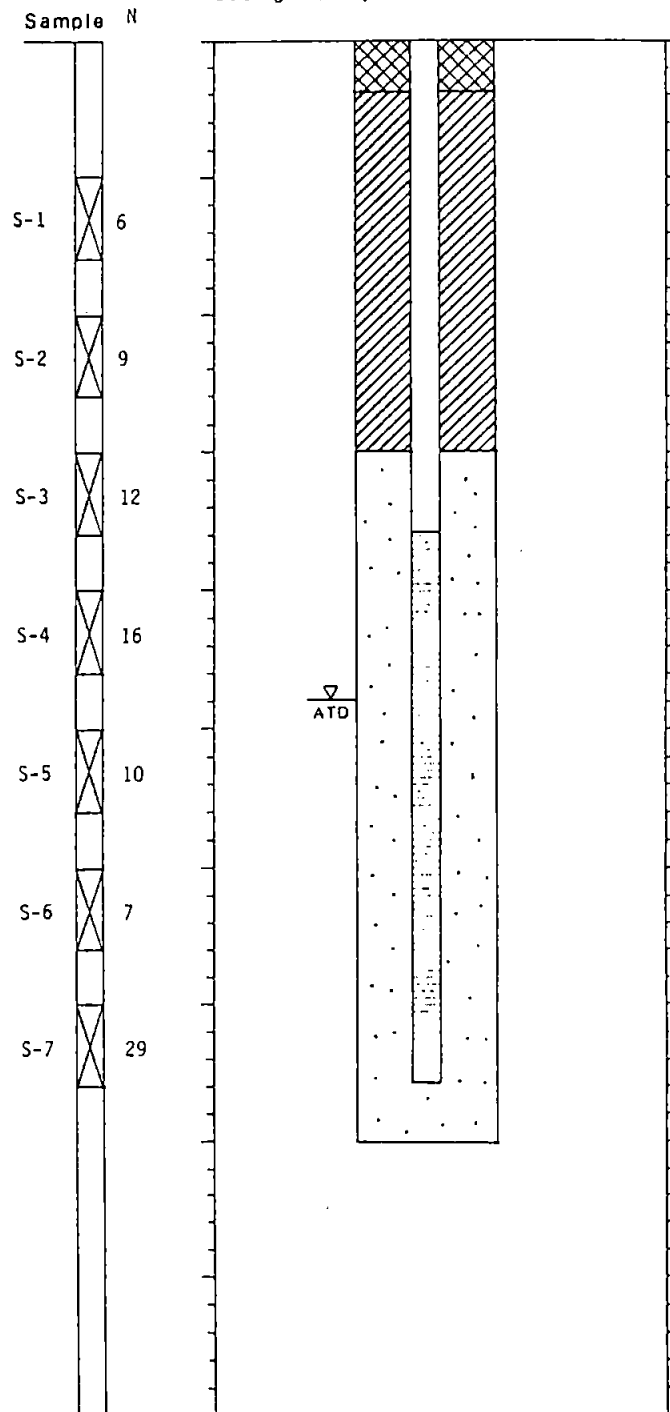
Boring Log and Construction Data for Well B-1

Geologic Log

Well Design

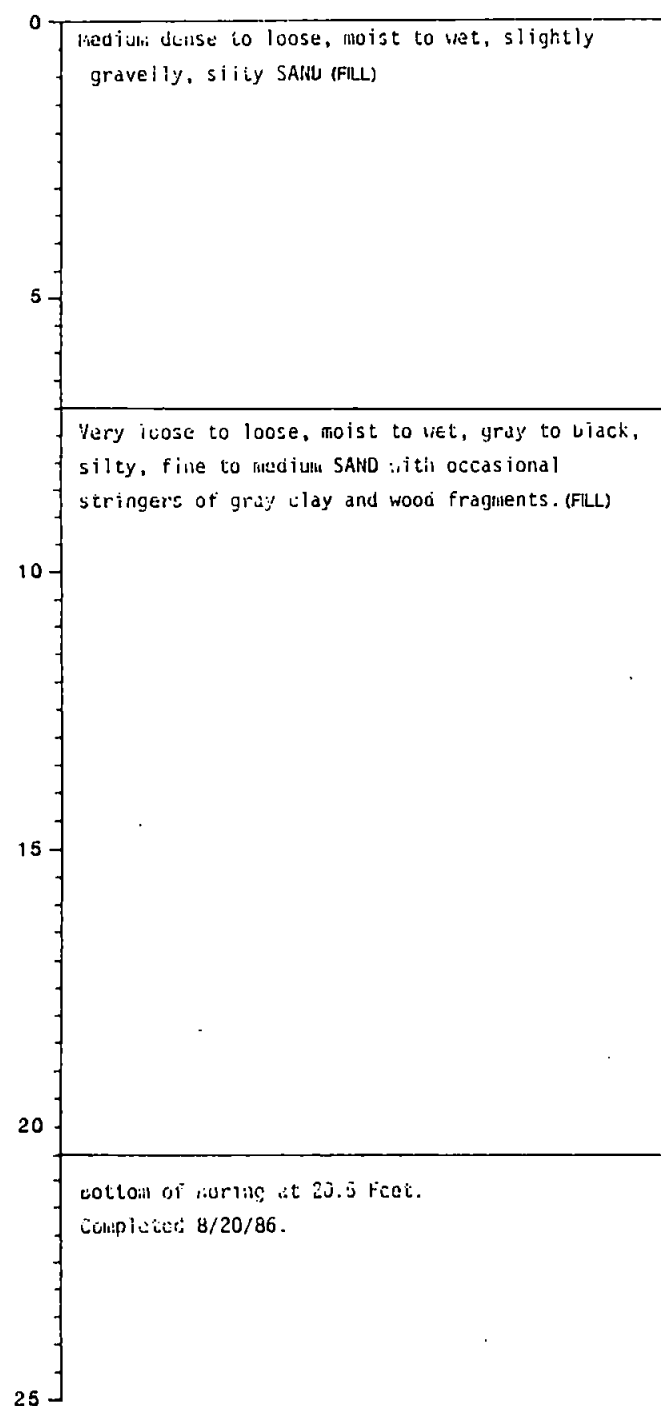
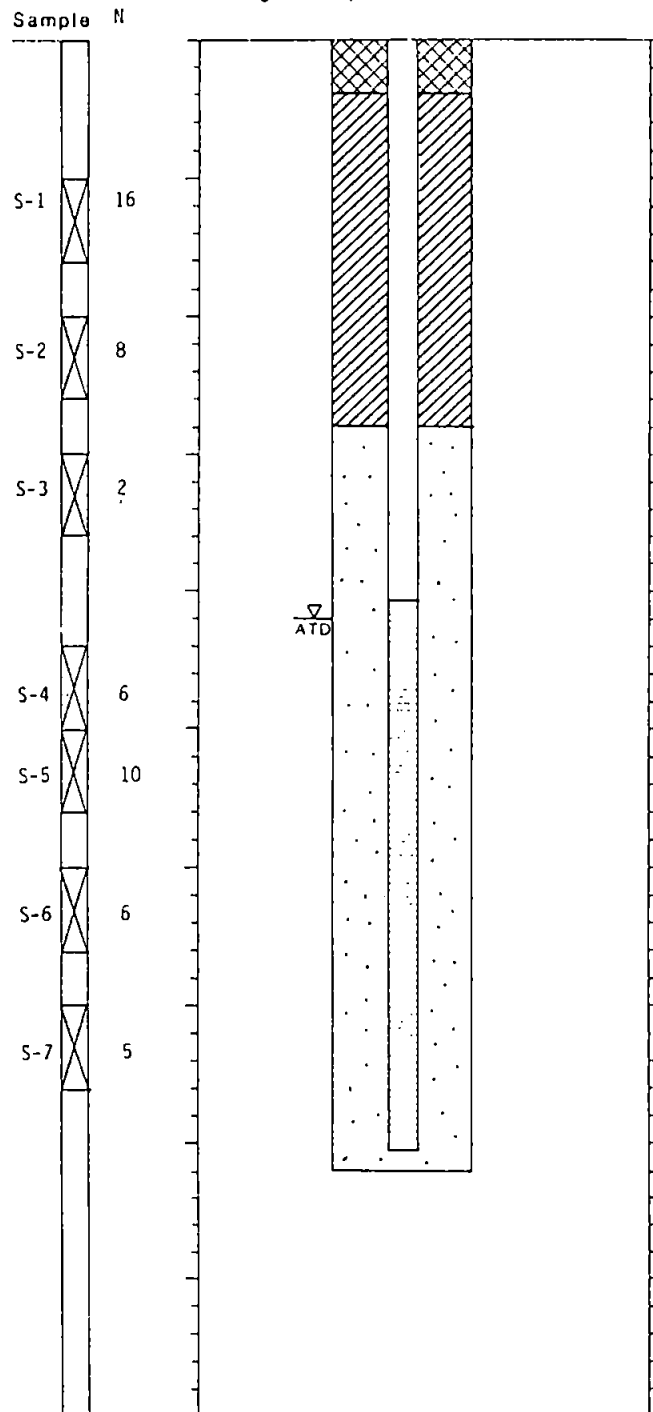
Boring Log and Construction Data for Well B-2

Geologic Log

Well Design

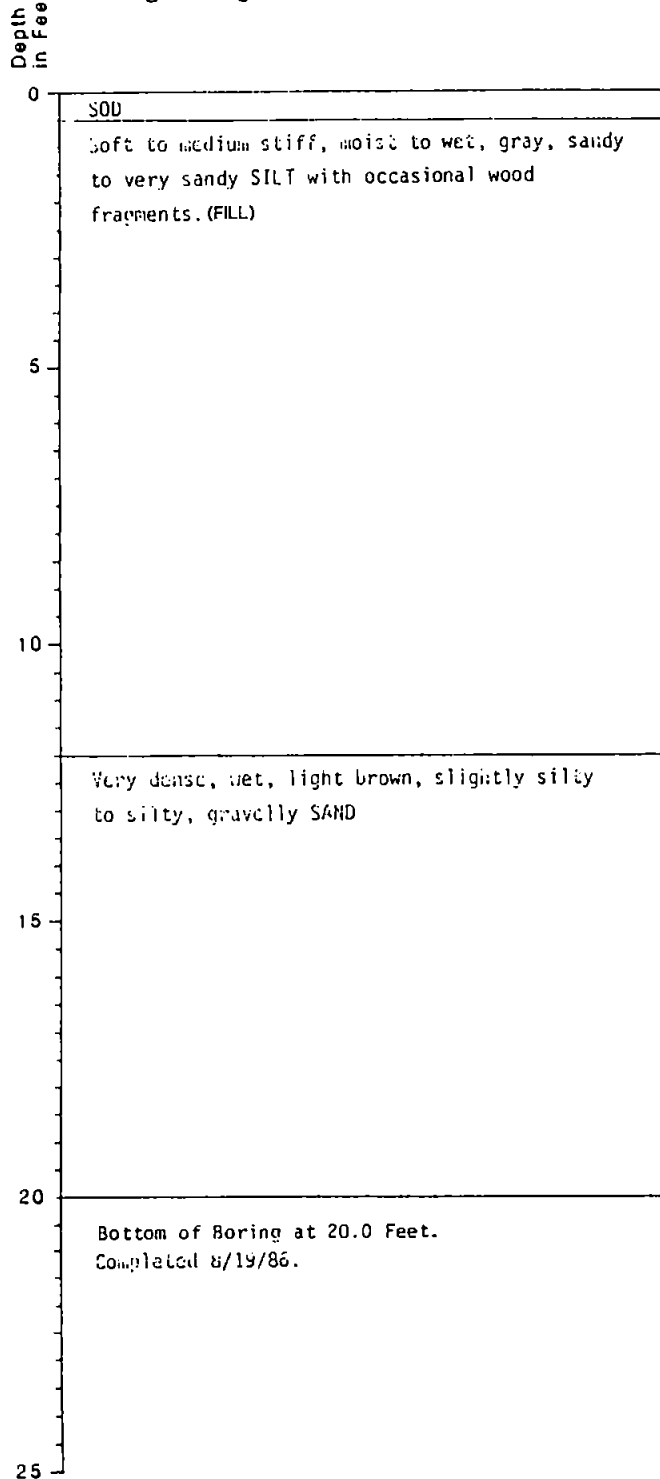
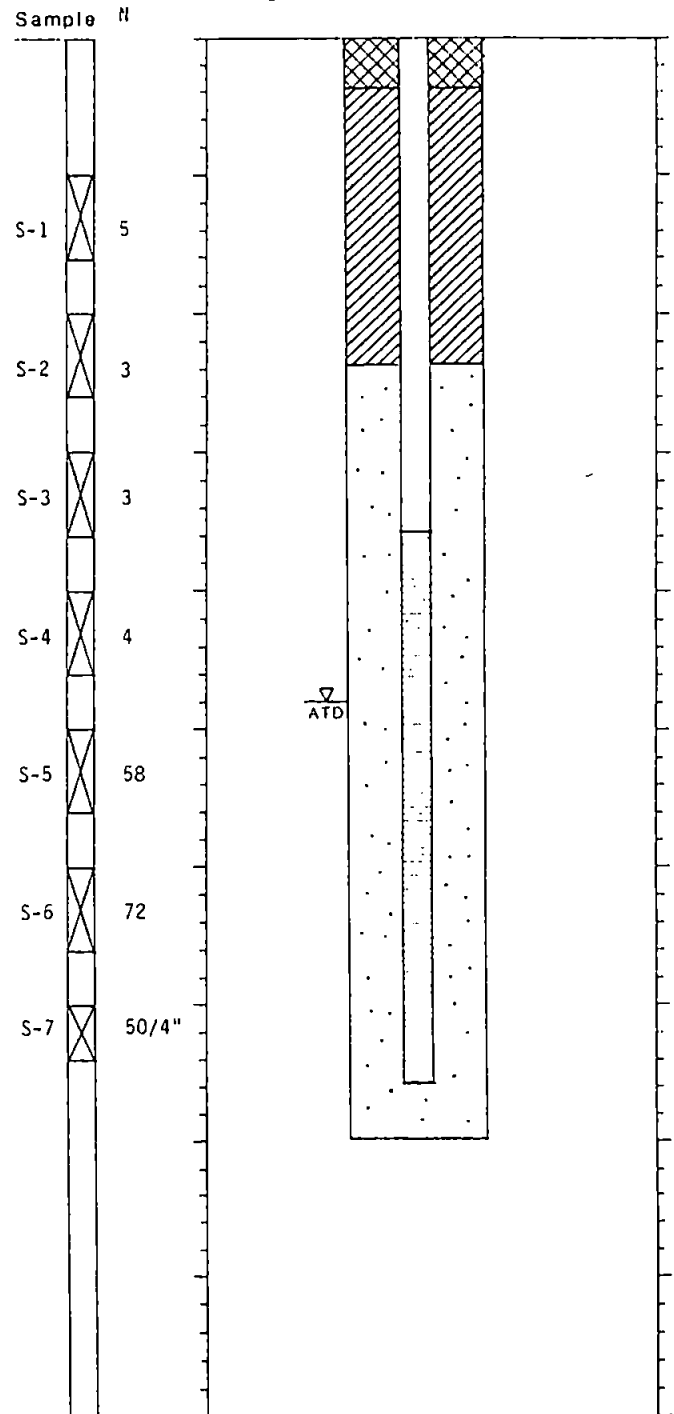
Boring Log and Construction Data for Well B-3

Geologic Log

Well Design

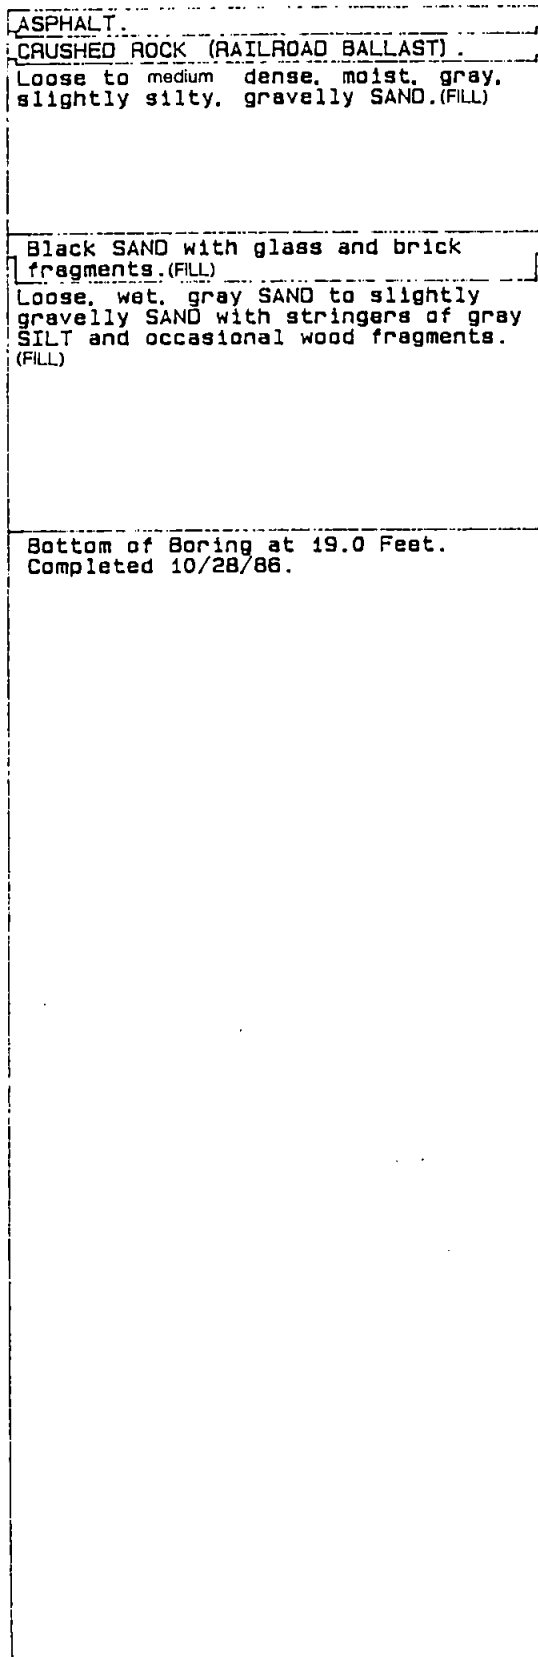
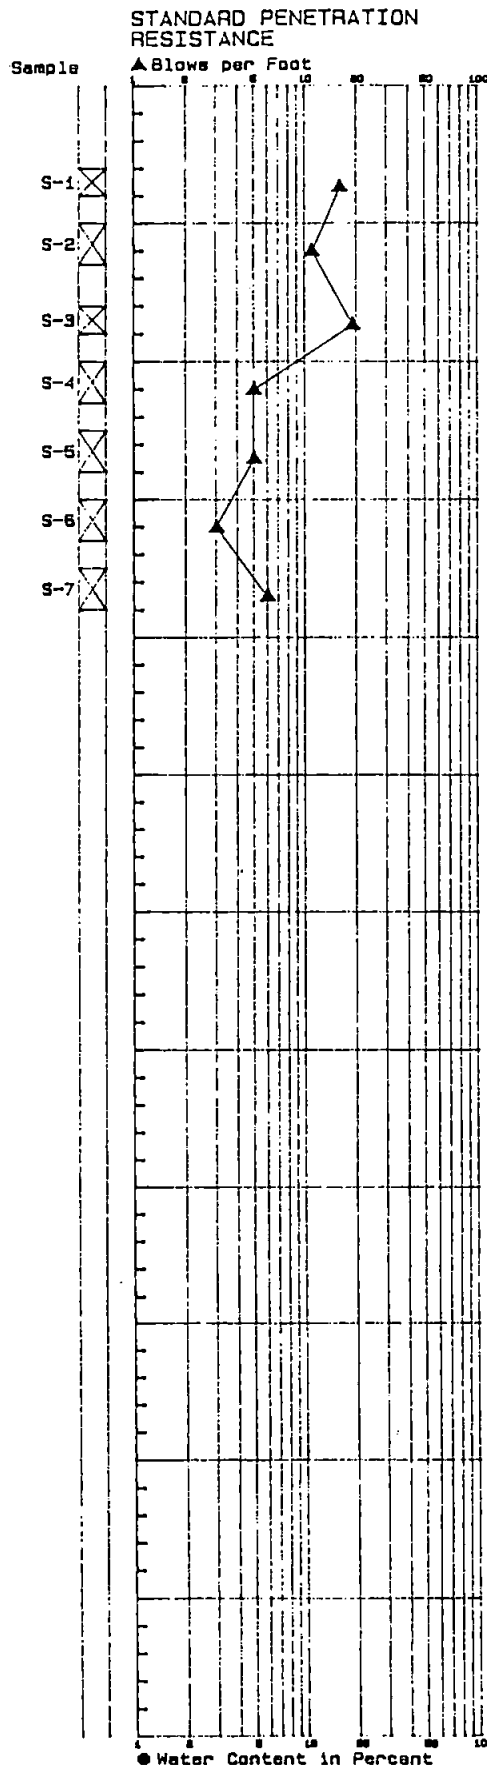
Boring Log B-7

SOIL DESCRIPTIONS

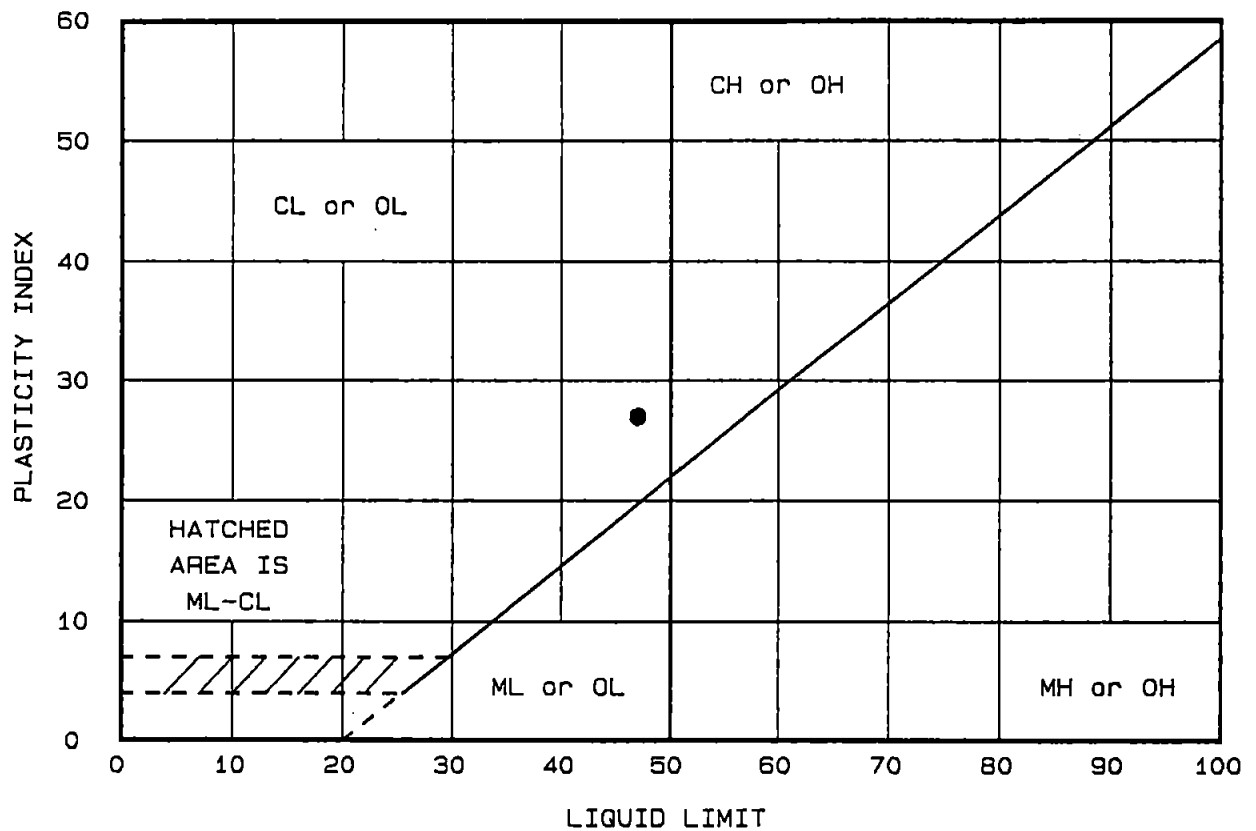
LIQUID AND PLASTIC LIMITS TEST REPORT

Location + Description	LL	PL	PI	-200	ASTM D 2487-85
● H-10, S-2 Depth: 7.5'-9' Nat. W.C. = 35%	47	20	27	100	CL, Lean clay

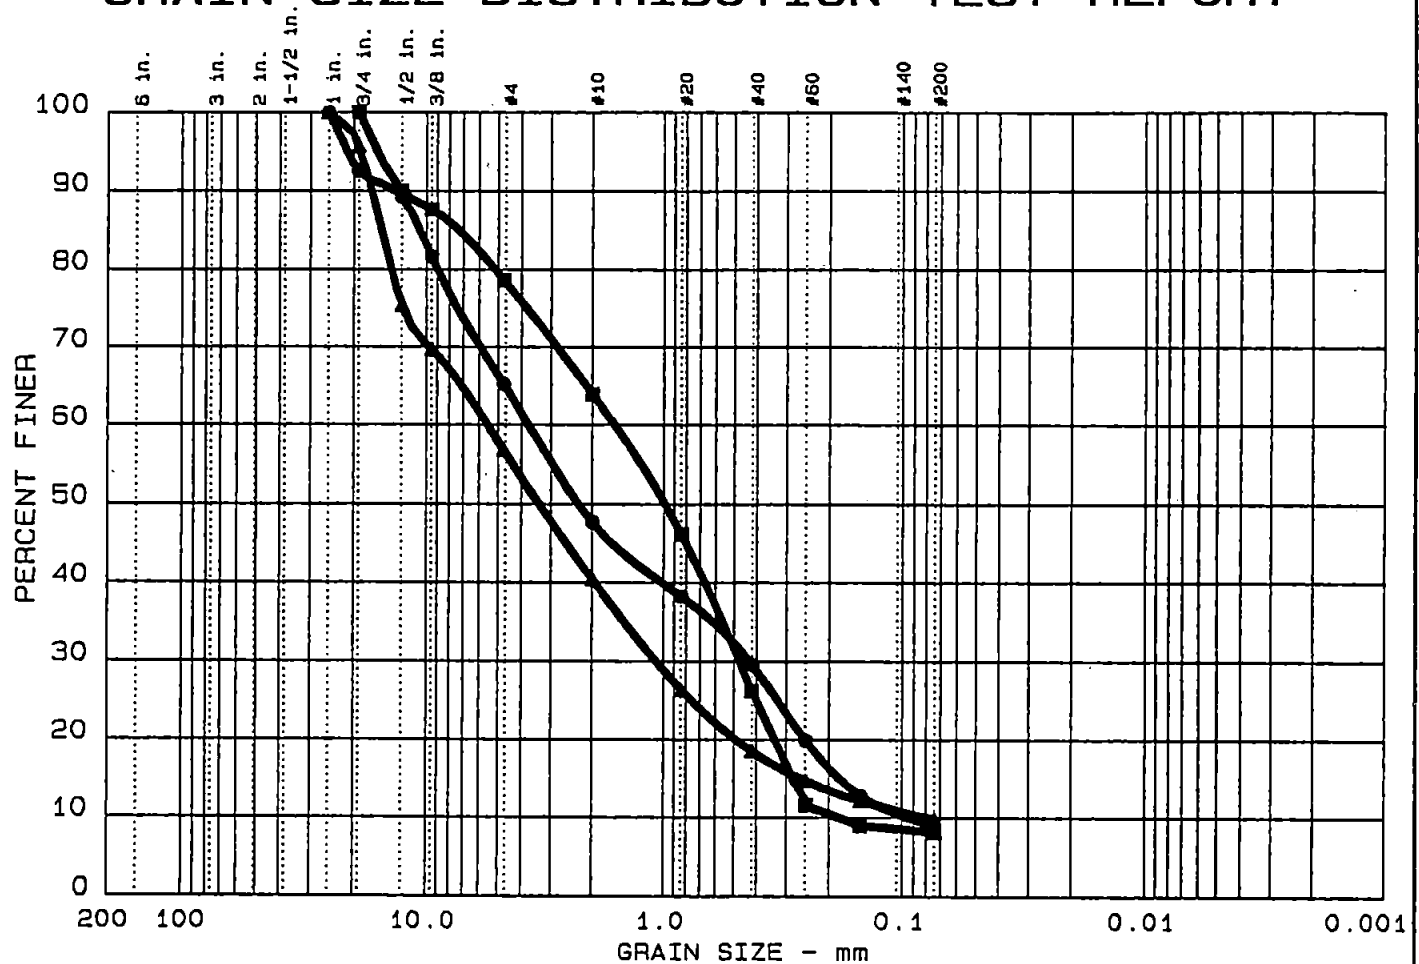
GRAIN SIZE DISTRIBUTION TEST REPORT

%+75 _{mm}	% GRAVEL	% SAND	% SILT	% CLAY
●	0.0	34.7	56.3	9.0	
▲	0.0	43.2	47.0	9.8	
■	0.0	21.4	70.5	8.1

LL	PI	D ₈₅	D ₆₀	D ₅₀	D ₃₀	D ₁₅	D ₁₀	C _c	C _u
●			10.59	3.72	2.26	0.427	0.1799	0.0933	0.52	39.8
▲			15.36	5.51	3.36	1.063	0.2639	0.0797	2.57	69.2
■			7.33	1.60	0.99	0.472	0.2812	0.1837	0.76	8.7

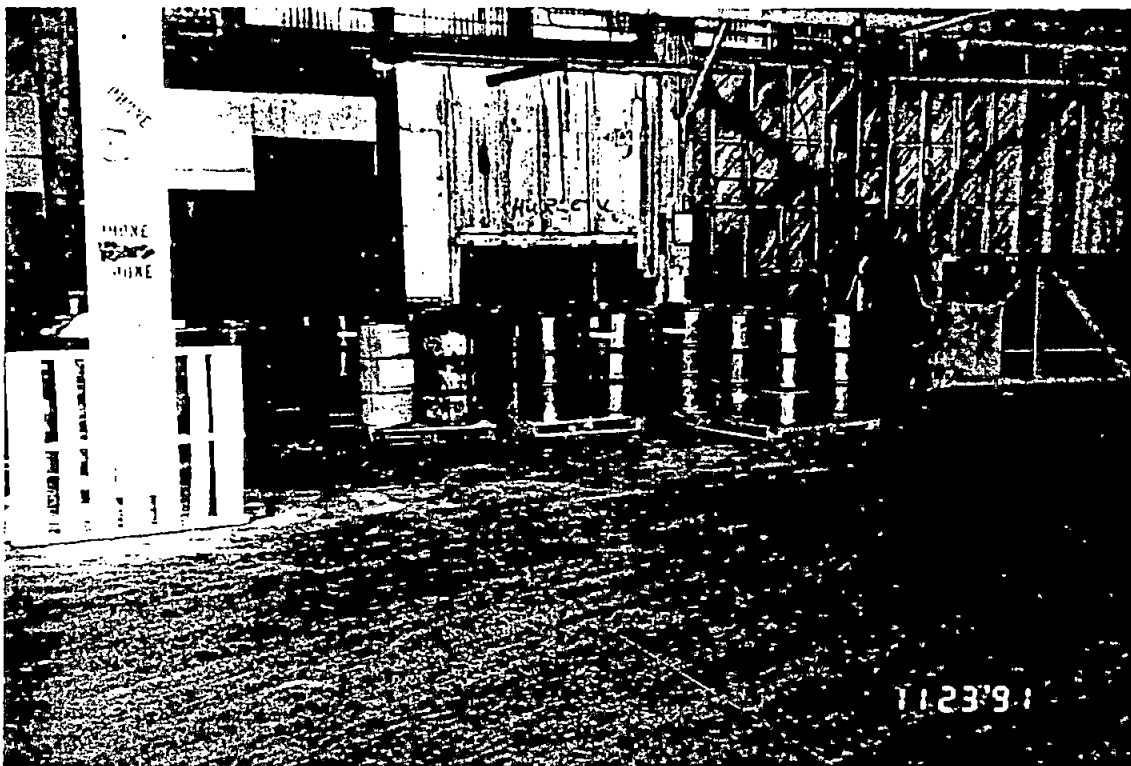
- ▶ Paints, adhesives, solvents, and 55-gallon drums of oils and refrigerants were observed stored in various areas of the warehouse (Photograph 1 and Figure 3).

Photograph 1 Pier 66 - 55-gallon drums of oil and refrigerants.

Materials such as oil, refrigerants, paints, and solvents have the potential to cause a spill situation if they are not removed prior to building demolition.

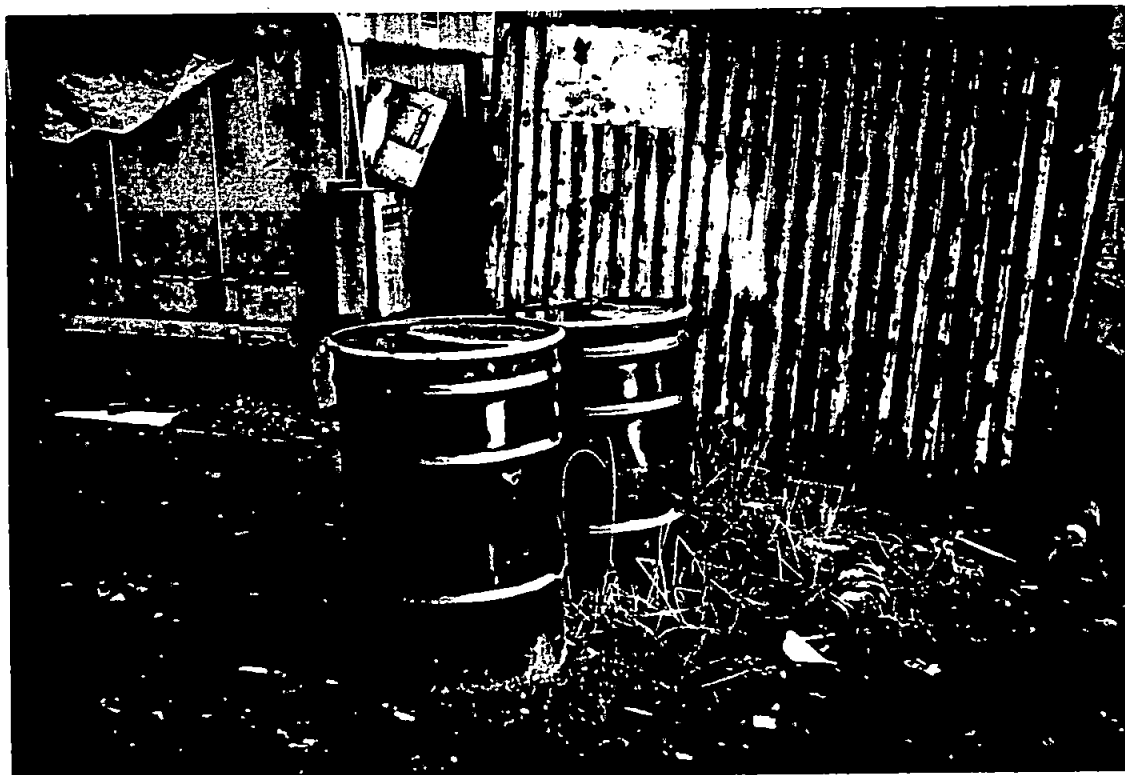
Photograph 4 Triangle Parcel - 55-gallon drum of soil. Note surface soil stains.

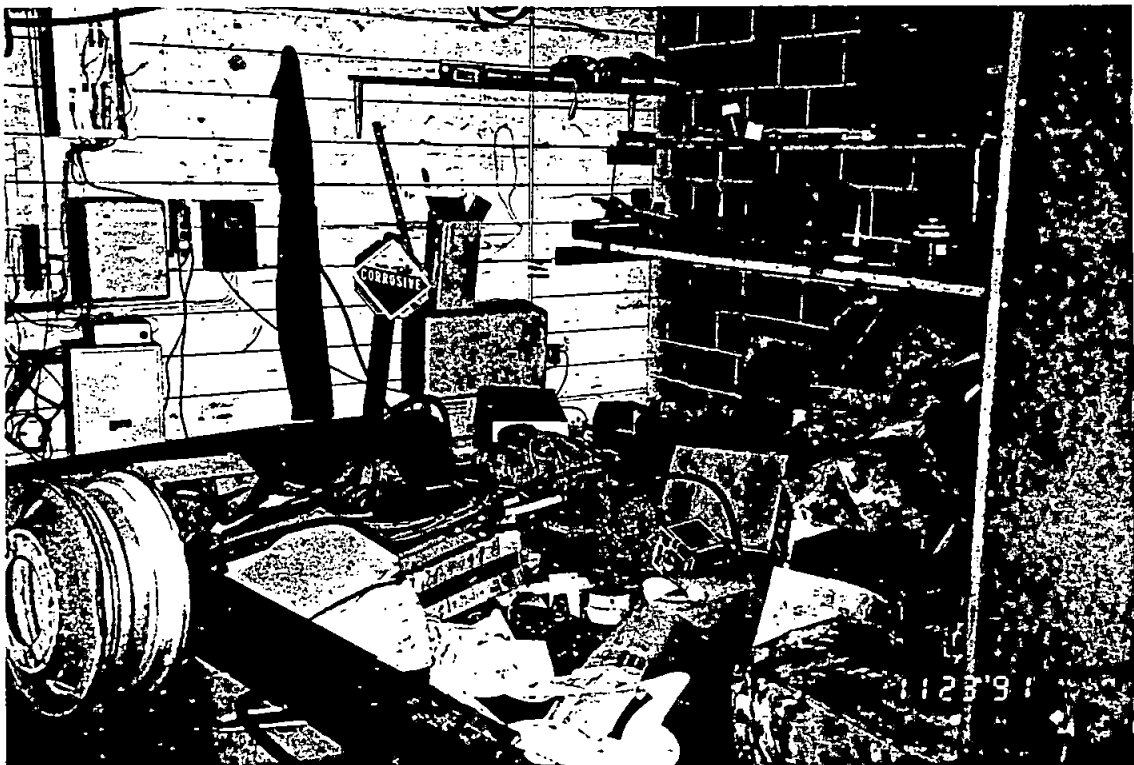
Photograph 6 Auto Freight Warehouse - Storage room of miscellaneous materials including batteries, paint, and wire.

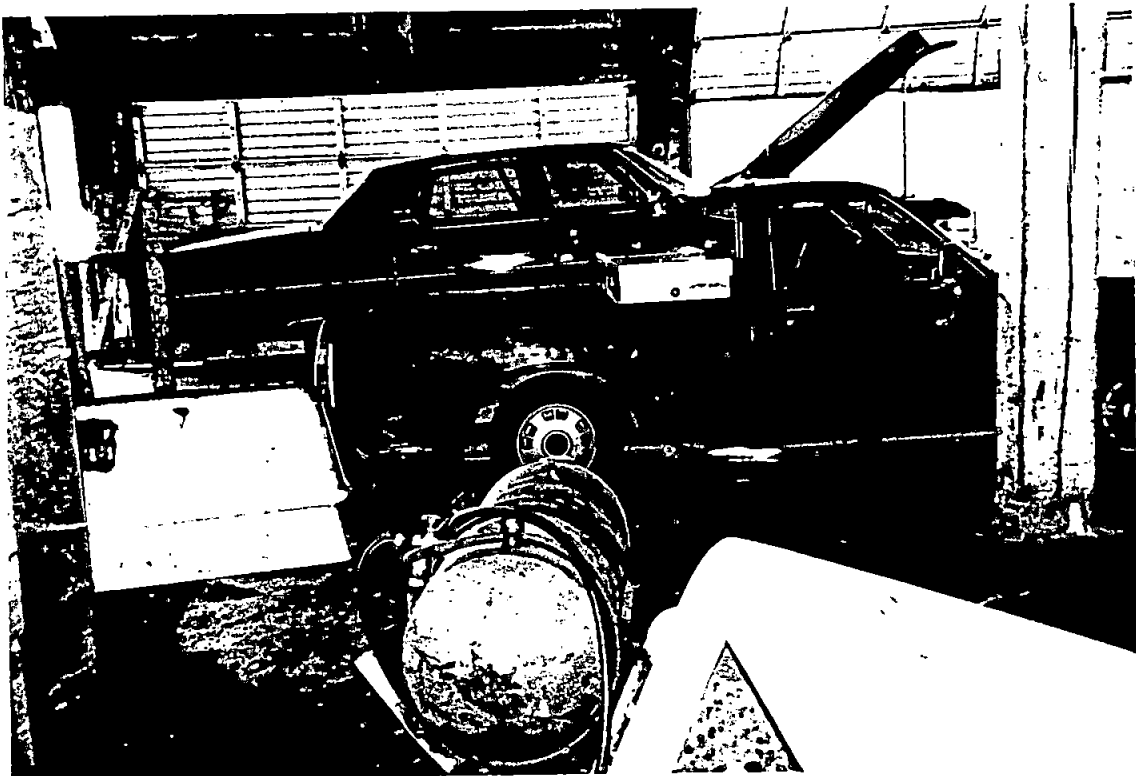
Photograph 7 Auto Freight Warehouse - Automotive repair inside building.
Note oil spills.
