RE: Everett Landfill – 2022 Landfill Gas Annual Report

2022 Annual Report

Landfill Gas Performance Monitoring Everett Landfill Site

Prepared for
City of Everett Public Works Department

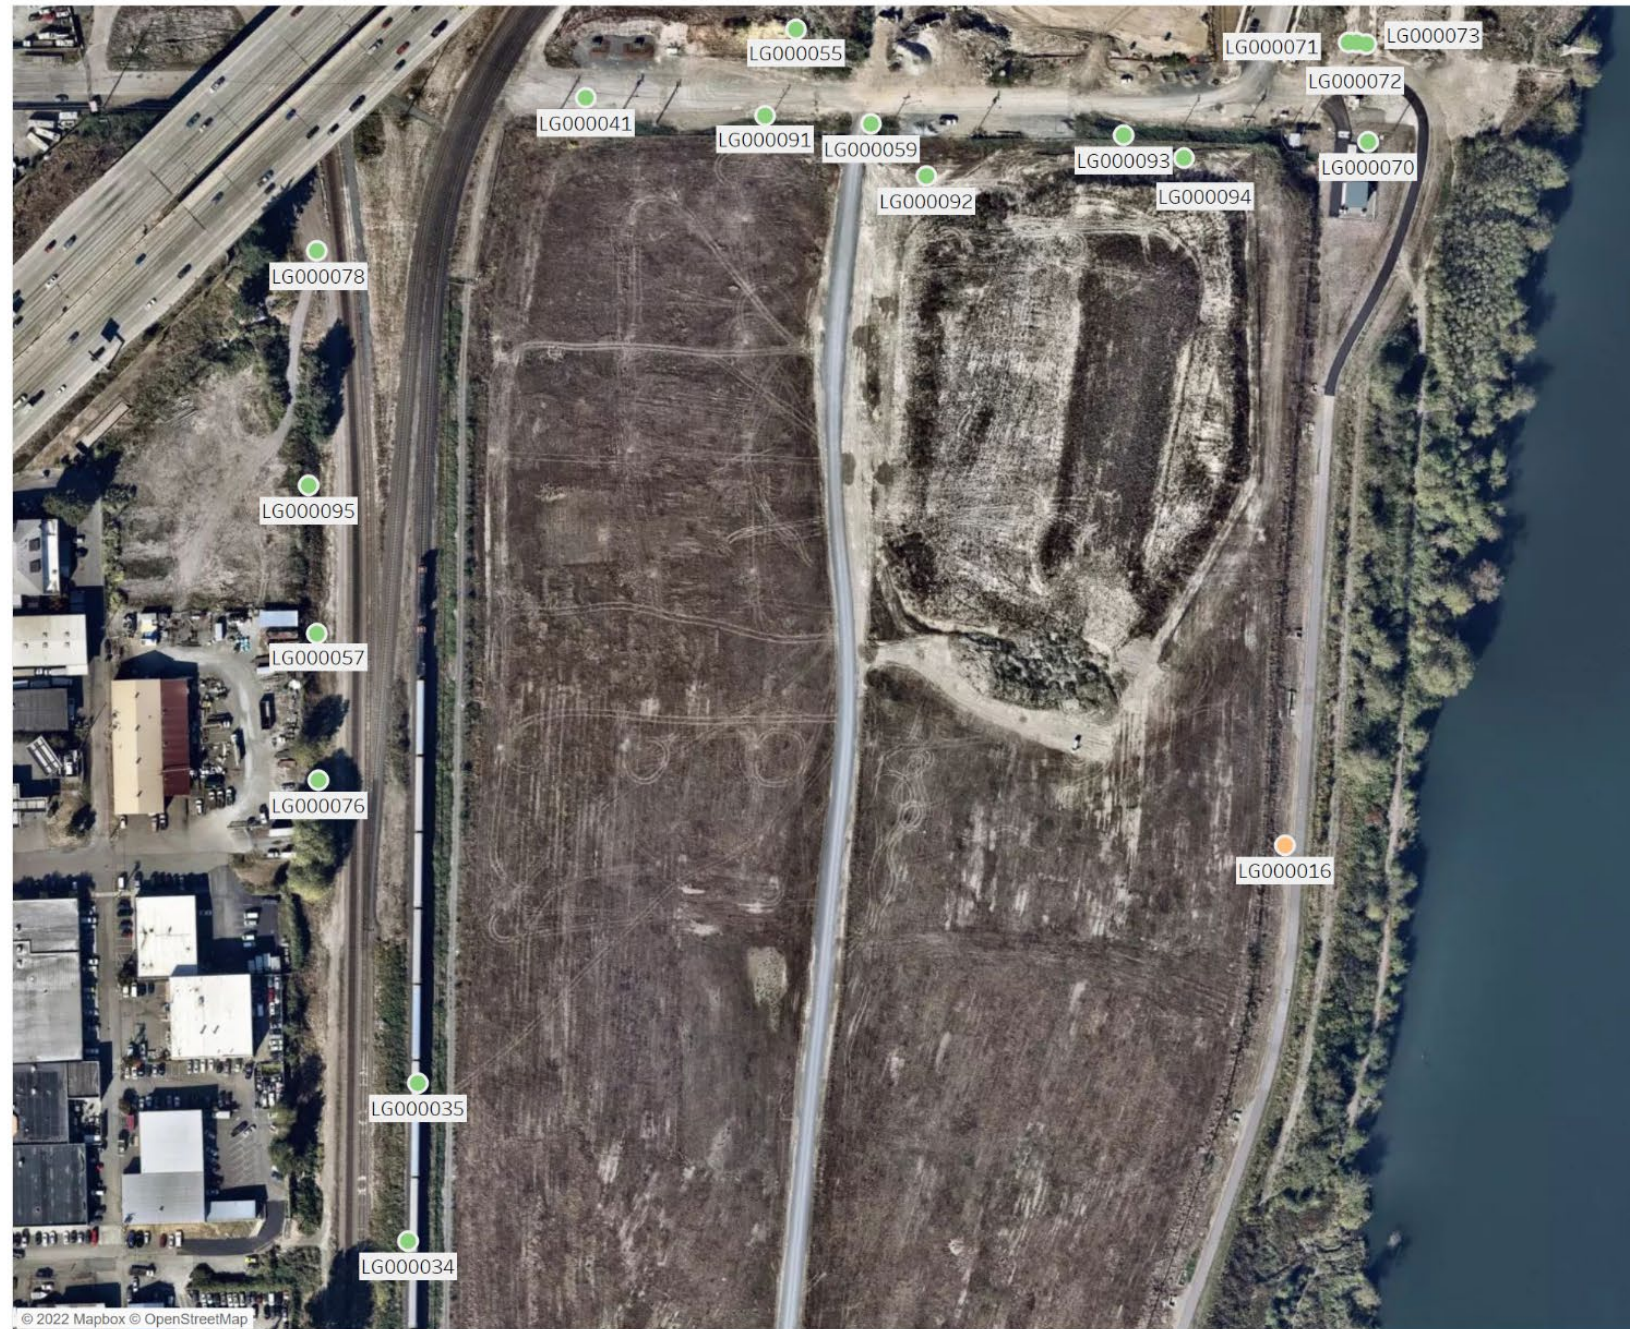
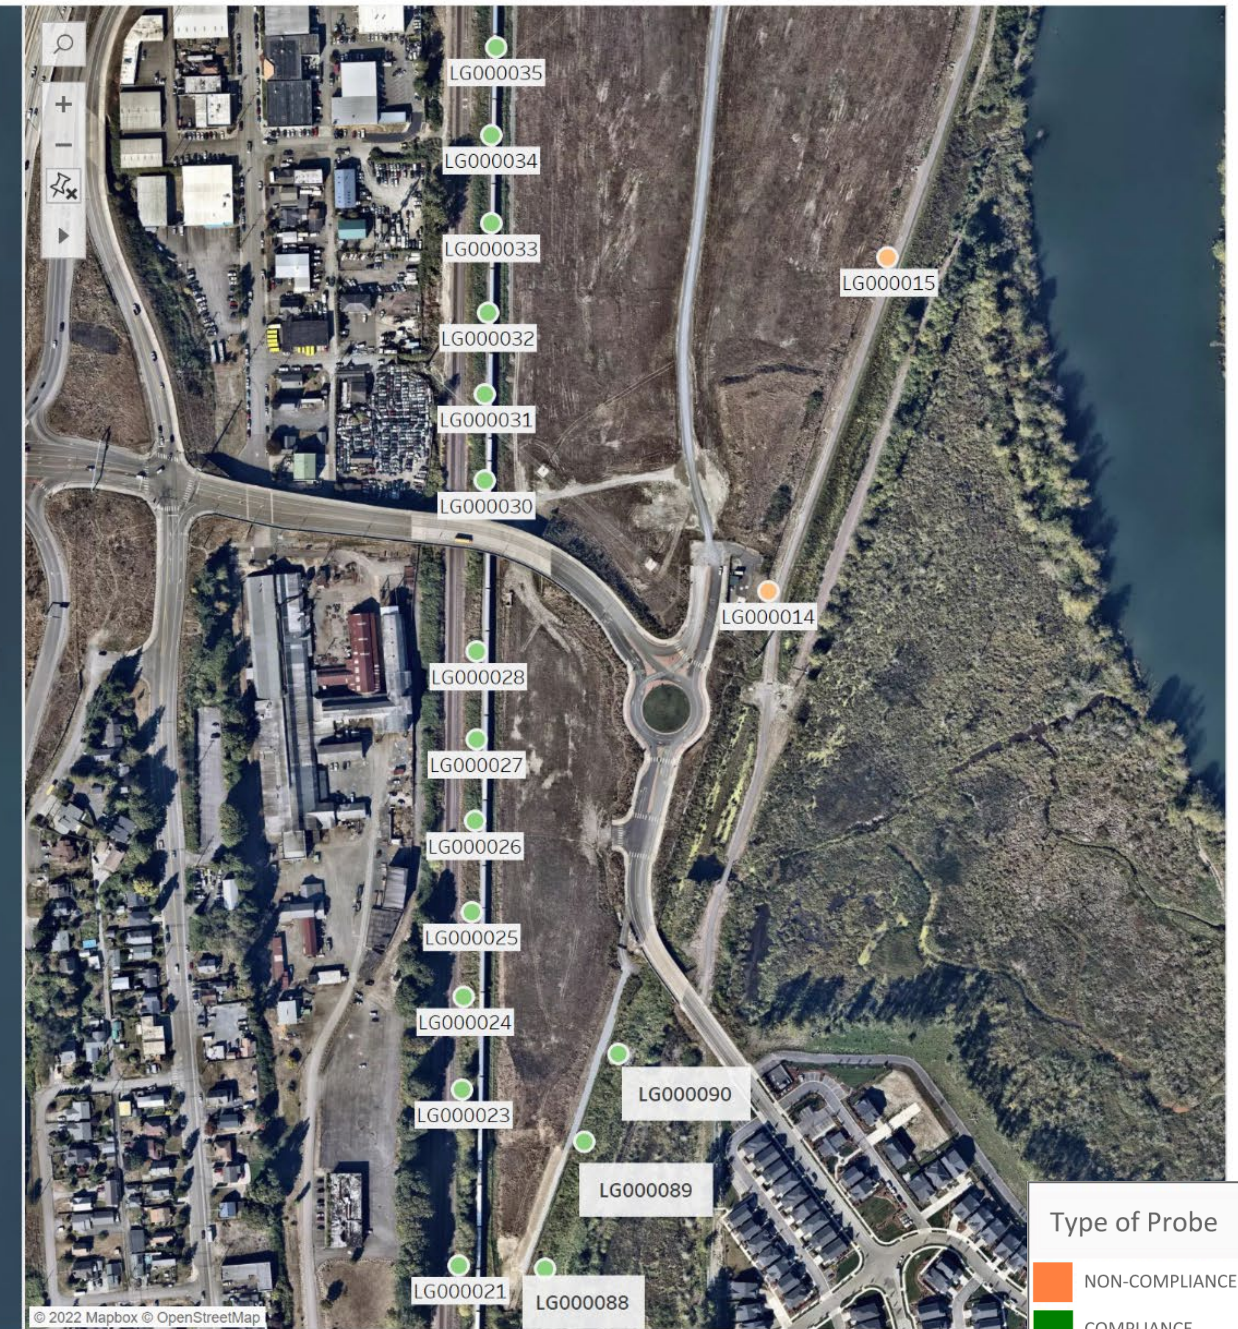
Figure 2. LFG Monitoring Probes.

A network of LFG compliance monitoring probes is established around the perimeter of the landfill site. The locations of these probes are shown in Figure 2. These probes are used to determine if LFG control systems are effective in preventing off-site migration of methane. The CAP and CMCP establish a contingency plan trigger of 5 percent methane by volume, measured at any perimeter compliance monitoring probe.

The three probes on the east perimeter trail – LG-14, LG-15, and LG-16 – shown in orange on Figure 2 – all had a methane reading above 5 percent at least once during 2022. These three probes are not compliance monitoring probes due to their completion in fill but have continued to be monitored to inform operations.

- NON-COMPLIANCE
- COMPLIANCE

Of the 39 compliance monitoring probes, only LG-88 and LG-89 had methane readings above 5 percent. Both exceedances were observed during the third quarter. For the September 2022 monitoring event, LG-88 had a reading of 12.9 percent methane and LG-89 had a reading of 5.4 percent methane. These compliance probes with a methane exceedance above 5 percent are highlighted yellow in Table 3.

While these probe readings were over the 5 percent compliance limit, it was determined the readings were not valid. During these monitoring events, both LG-88 and LG-89 pulled water into the sample collection hose within 30 seconds of the GEM 5000 pump running on the analyzer. These probes are located very close to linear saturated drainage/wetlands (part of Bigelow Creek) that run parallel to the eastern landfill boundary, part of the mapped Everett Riverfront Western Wetland Complex and as a result often get flooded. LG-88 and LG-89, along with LG-90, were installed in October 2019 west of the wetlands to monitor the potential for gas migration east of the landfill boundary. These Probes were installed as replacement compliance monitoring probes for LG-82, LG-83, and LG-84 which were installed at the southeast perimeter of the landfill at the request of Ecology in June 2015. Because LG-82, LG-83, and LG-84 are completed in landfill waste, they have not been monitored for compliance since 2020.

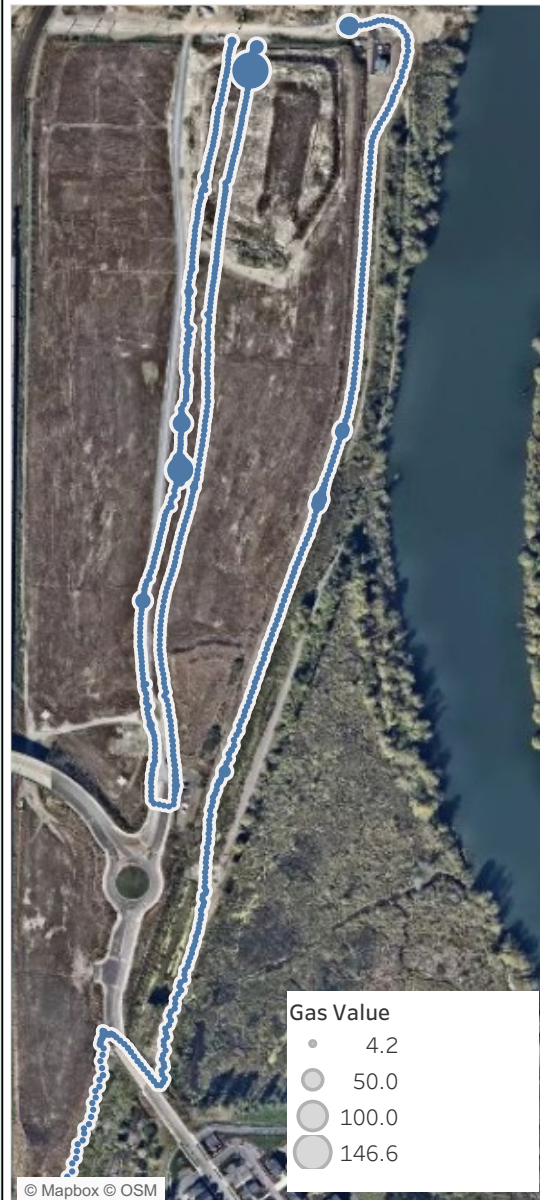
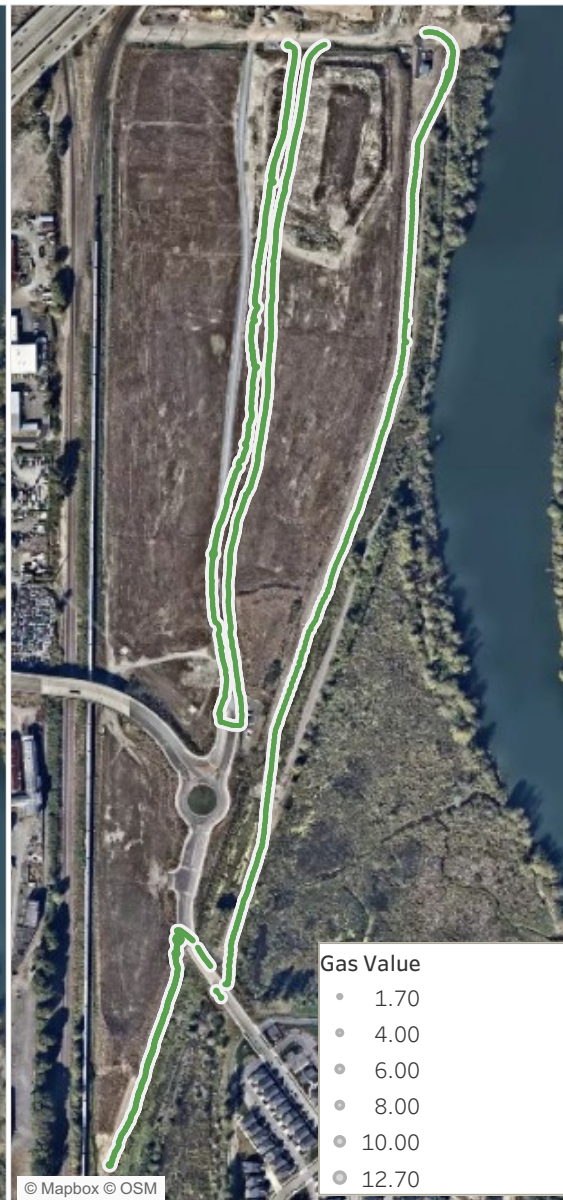
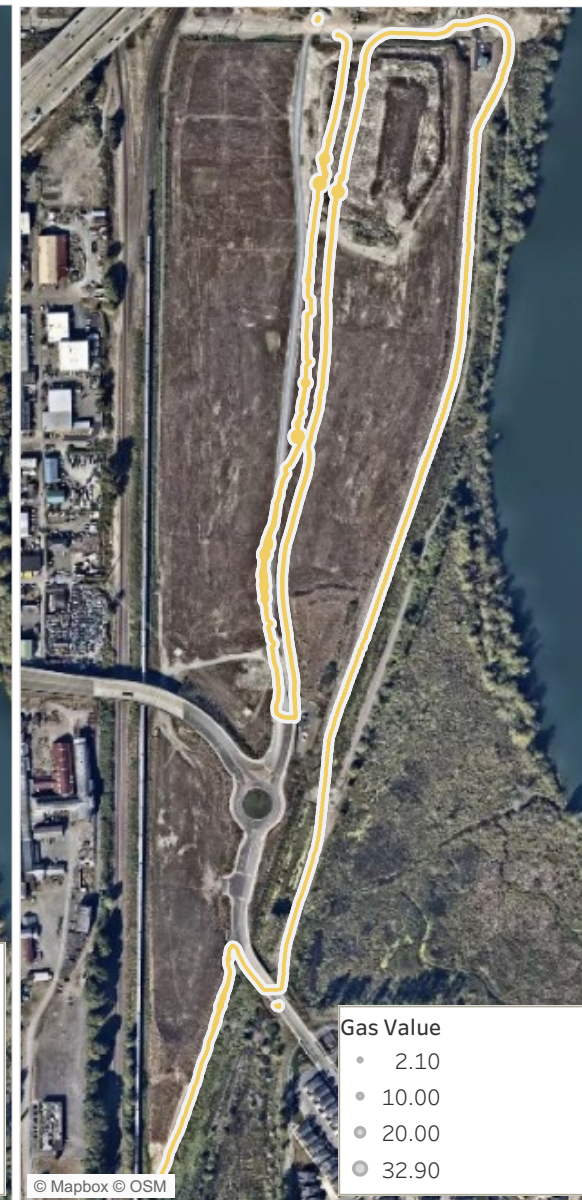
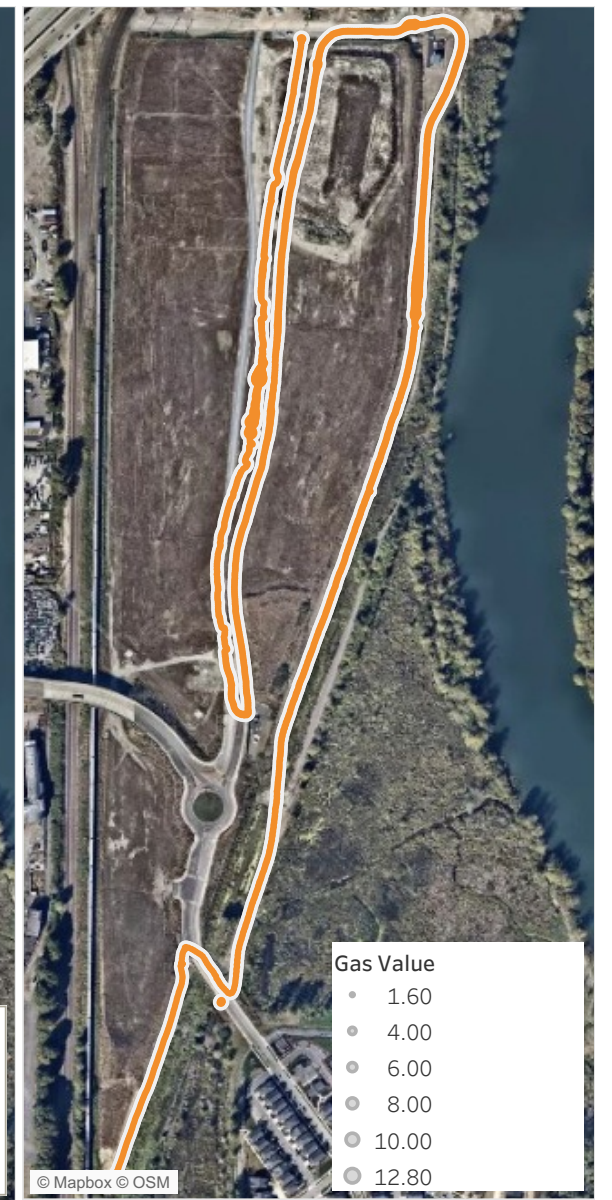
Figure 3. Quarterly Serpentine Monitoring Results

Surface emissions monitoring recording methane concentrations (in parts per million) are collected quarterly with a Landtec SEM 5000 at these three locations:

The SEM 5000 unit is calibrated to the site location and continuously reads methane concentrations. Every five seconds, a data point is logged showing the methane concentration reading and latitude and longitude.

- 1) Riverside Trail: No methane exceedances over 500 ppm
- 2) Riverfront Boulevard: No methane exceedances over 500 ppm
- 3) Four private buildings to the west of the landfill: No methane exceedances over 100 ppm

March 23, 2022: No regulatory exceedances for off-site buildings, Riverside Trail or Riverfront Boulevard.

July 8, 2022 (June 2022): No regulatory exceedances for off-site buildings, Riverside Trail or Riverfront Boulevard.

September 27, 2022: No regulatory exceedances for off-site buildings, Riverside Trail or Riverfront Boulevard.

January 26, 2023 (December 2022): No regulatory exceedances for off-site buildings, Riverside Trail or Riverfront Boulevard.

The threshold for the on-site monitoring identified in the CAP is 100 ppm inside buildings and 500 ppm for exterior areas. None of the quarterly monitoring events that took place during 2022 exceeded these thresholds. As shown in Figure 3, the maximum methane concentration measured for exterior areas for 2022 was 146.6 ppm, well below the 500 ppm threshold. There were no onsite structures to be monitored in 2022.

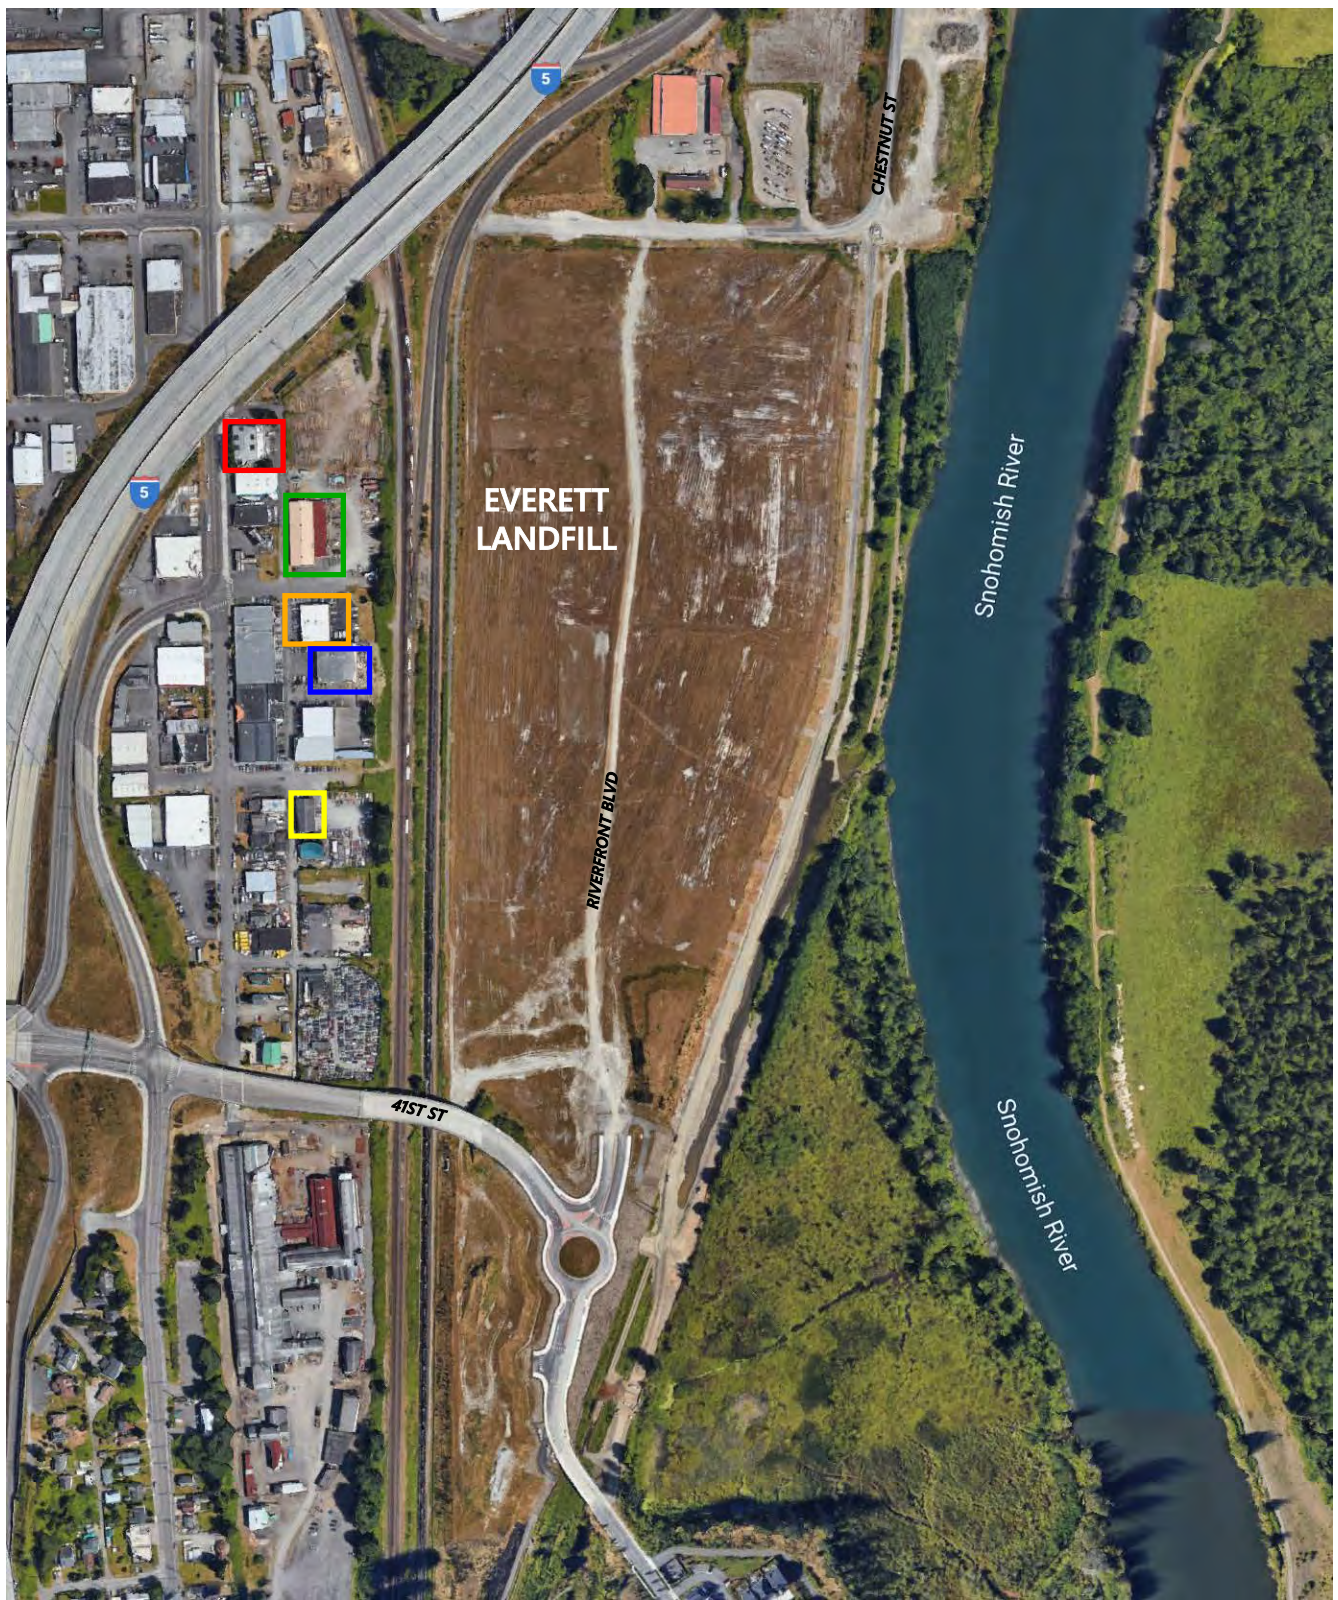
Figure 4.
Vicinity Map of Everett Landfill
Off-Site Monitoring Locations

City personnel used a Landtec SEM 5000 unit and measured the surface methane concentrations at five off-site buildings that neighbor the Everett Landfill to the west. The five off-site buildings are called out on the map in Figure 4.

- Everett Gospel Mission
- H&R Mechanical Systems Inc.
- Cascade Wholesale
- Royell Manufacturing Inc.
- Ron May Towing

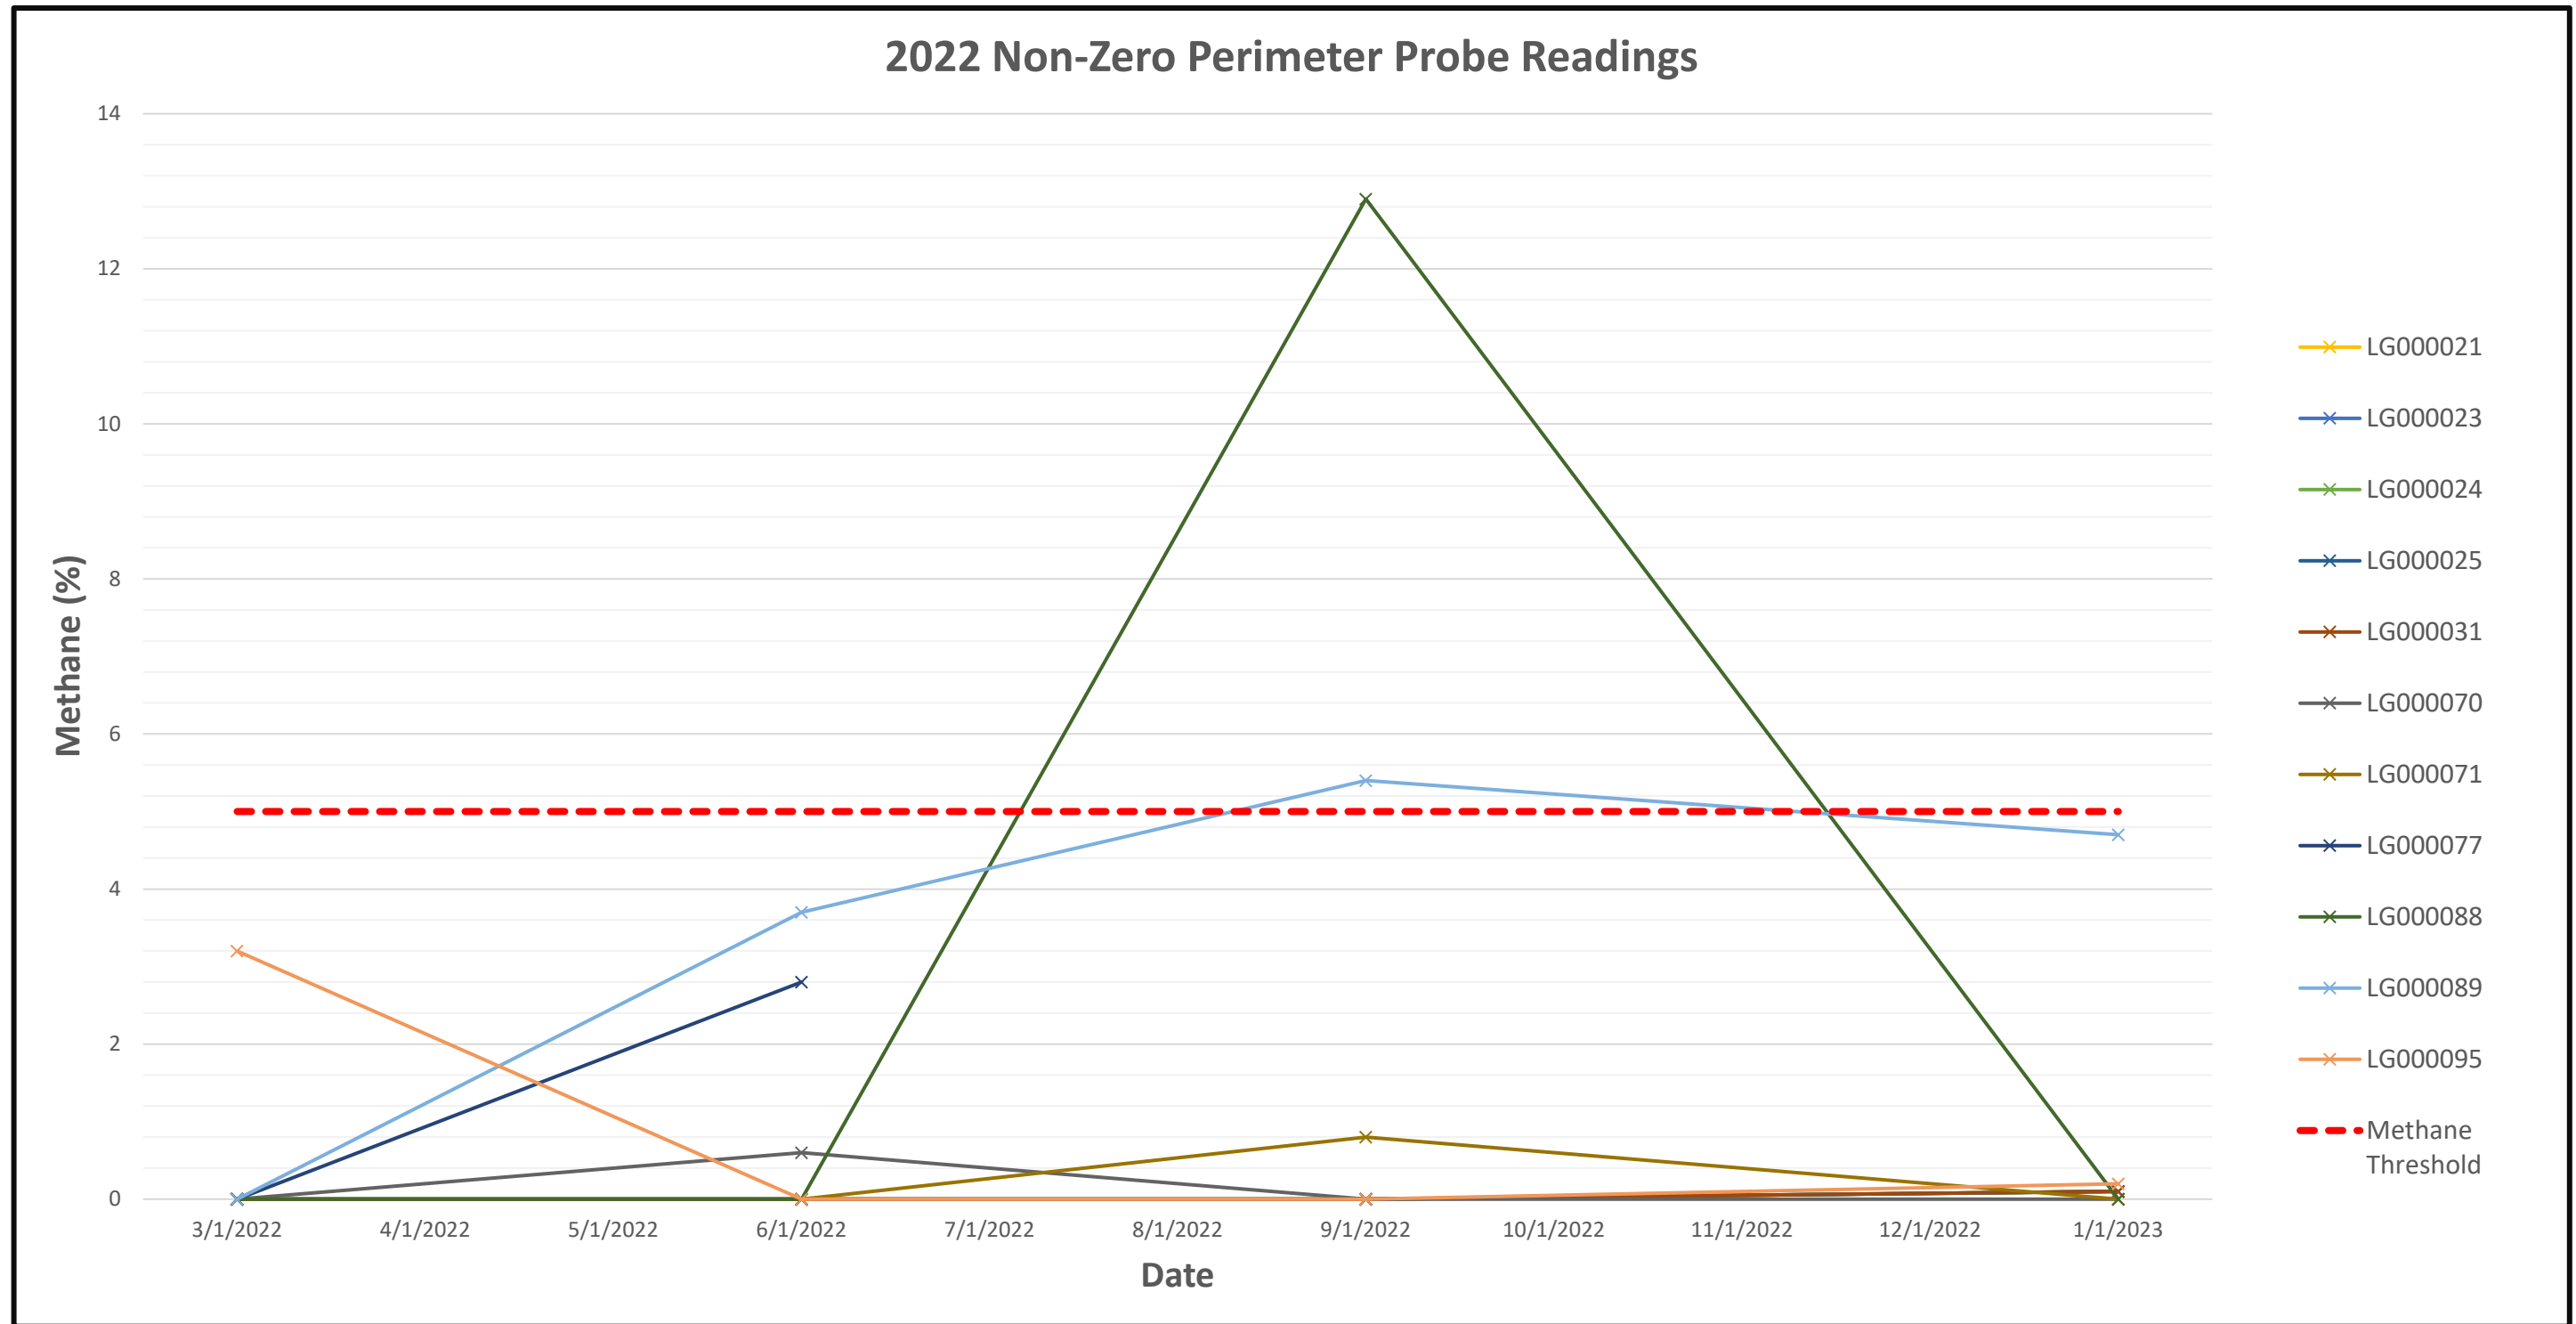
Figure 5. 2022 Non-Zero Compliance Perimeter Probe Readings.

Both LG-88 and LG-89 had methane values below 1 percent for the other three quarters. Figure 5 shows the compliance monitoring probes with at least one non-zero read throughout 2022. The red dashed horizontal line shows the 5 percent contingency plan trigger from the CAP and CMCP for comparison.
