**Re: Supplemental Phase II Subsurface Assessment
Goodwill Industries and Goodwill Storage Property
1400 South Lane Street and 1312 South Dearborn Street
Seattle, Washington
17250-00**

This letter report presents the results of our Supplemental Phase II Subsurface Assessment at the Goodwill Industries and the Goodwill Storage property located in Seattle, Washington (Figure 1). Goodwill has operated from the subject property main building as a retail store, offices, and warehouse distribution center for approximately 50 years. They have owned and operated the storage building since the early 1980s.

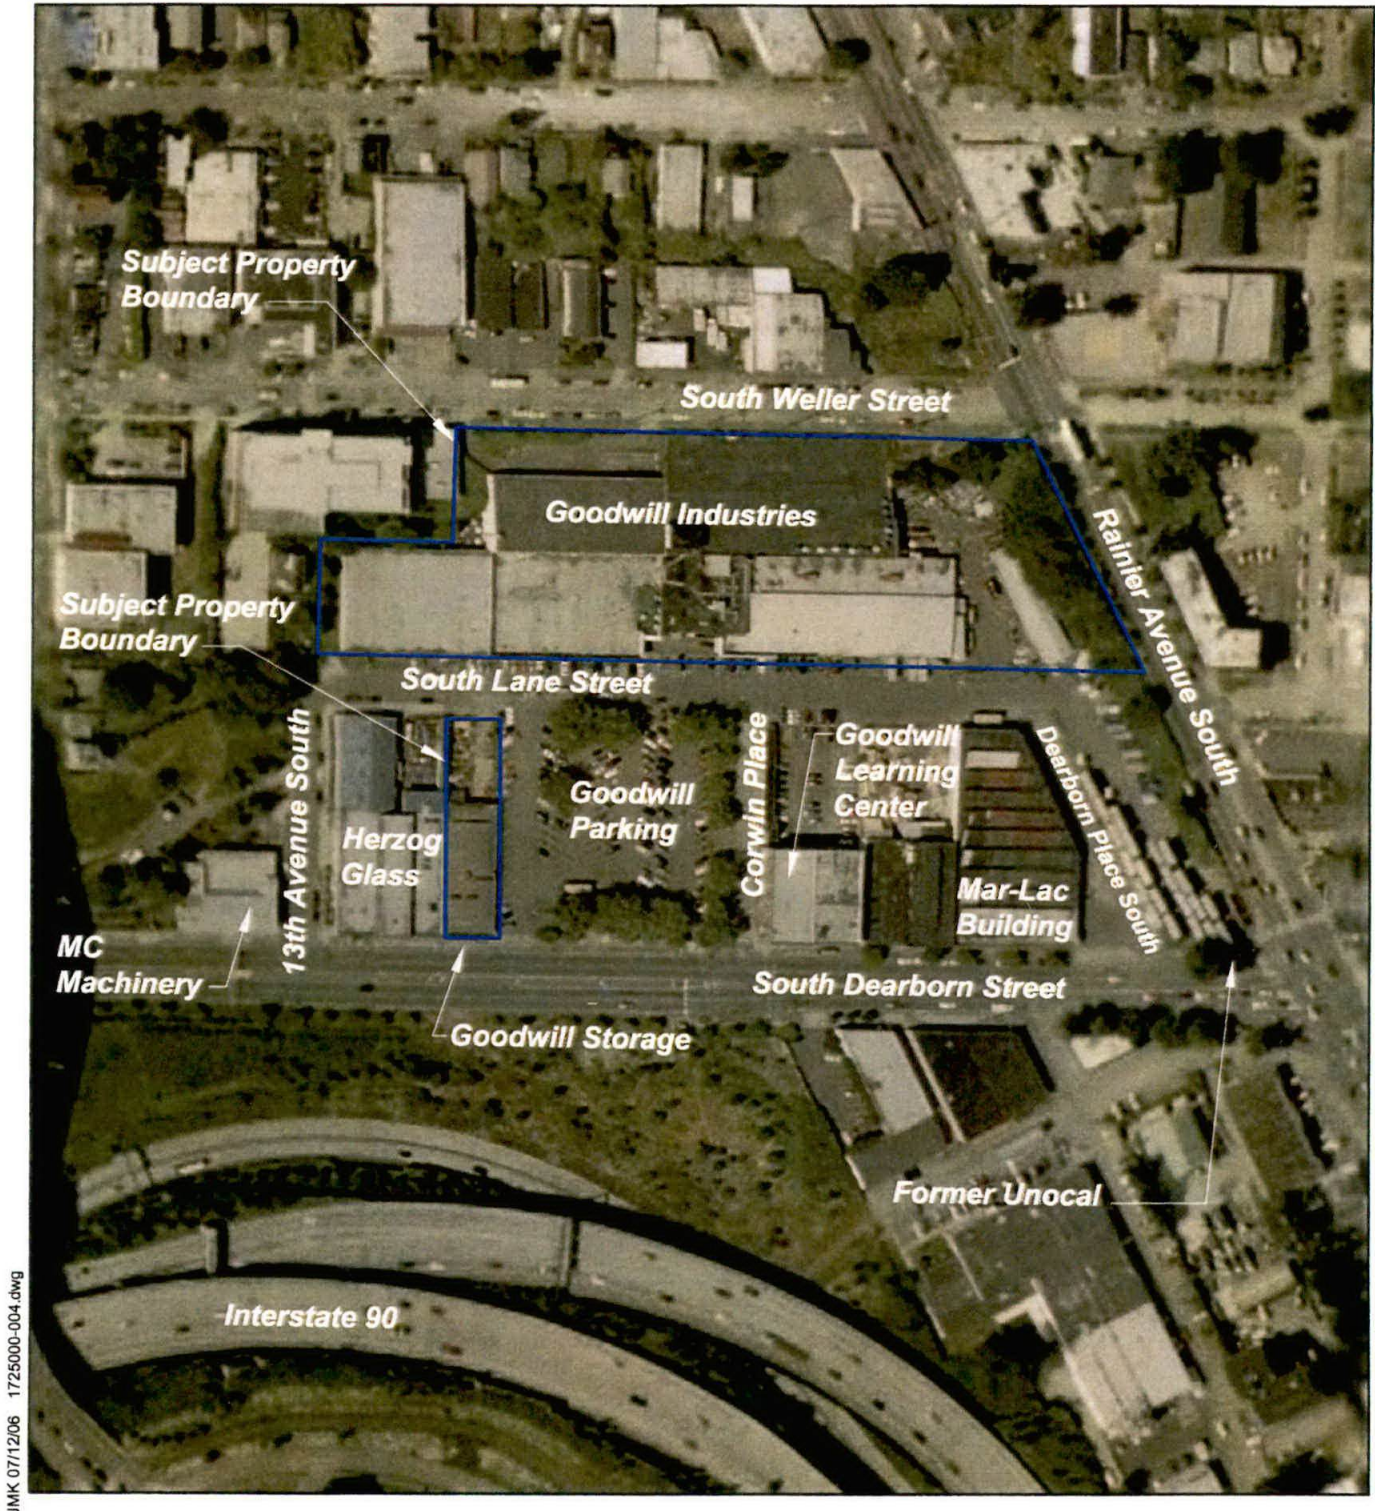
HARTCROWSER
17250-00 7/06
Figure 2

(HP-13) at locations throughout the subject property as shown on Figure 3. Strataprobos SP-G-2-3, SP-4, SP-5A, and SP-8 were advanced on the eastern area of the building near a former gasoline UST and the loading dock of the building (Figure 2). Strataprobos SP-1, SP-6, SP-6A, SP-6B, SP-7, SP-9, and SP-10 were advanced toward the central area of the building near the former boiler and laundry rooms, the former fuel USTs, and the existing PCE AST. Strataprobos SP-5B, SP-11, and SP-12, and one hand probe HP-13 were advanced on the northwest area of the building near a former spray paint area (Figure 2).
