## **Remedial Investigation Data Report**

Dakota Creek Industries  
Anacortes, Washington

# Remedial Investigation Data Report

## Dakota Creek Industries Anacortes, Washington

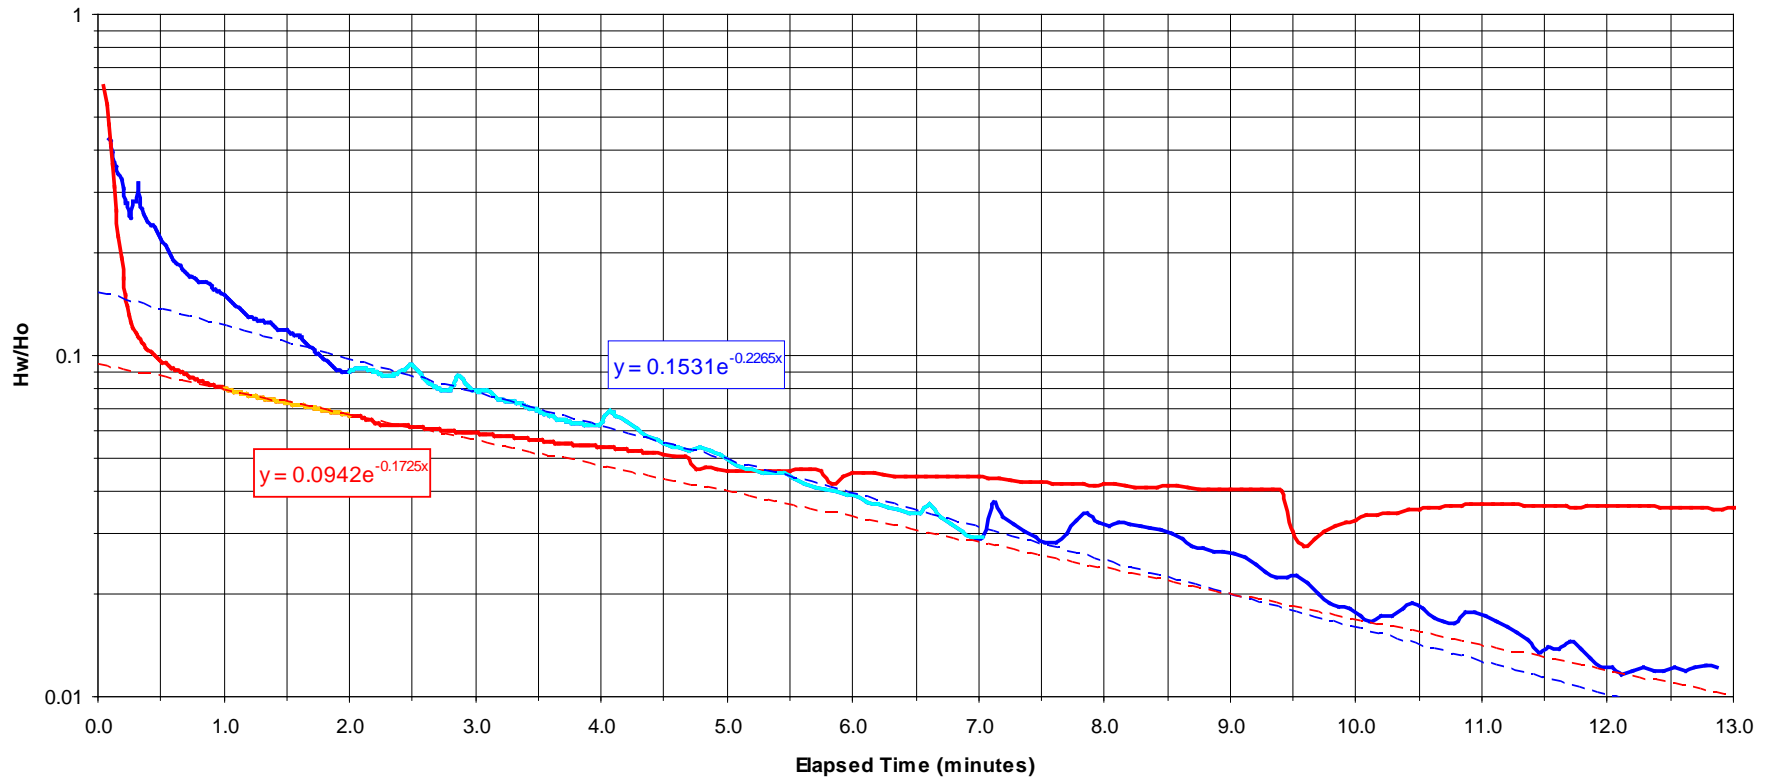
Figure C-5

MW-5 Falling    MW-5 Rising    5F-select    5R-select    Expon. (5F-select)    Expon. (5R-select)

The results of the slug tests indicate the estimated average value of the hydraulic conductivity at the five monitoring wells is  $9.1 \times 10^{-4}$  centimeters per second. This value of hydraulic conductivity is consistent with the stratified soil types (layers of sand, gravel, silt and clay) observed in the monitoring well borings.
