# Cost Allocation Report

## North Boundary Area of the Former Arkema Manufacturing Site

USG Property: Agreed Order No. DE 3405

Arkema Site: Agreed Order No. DE 5668

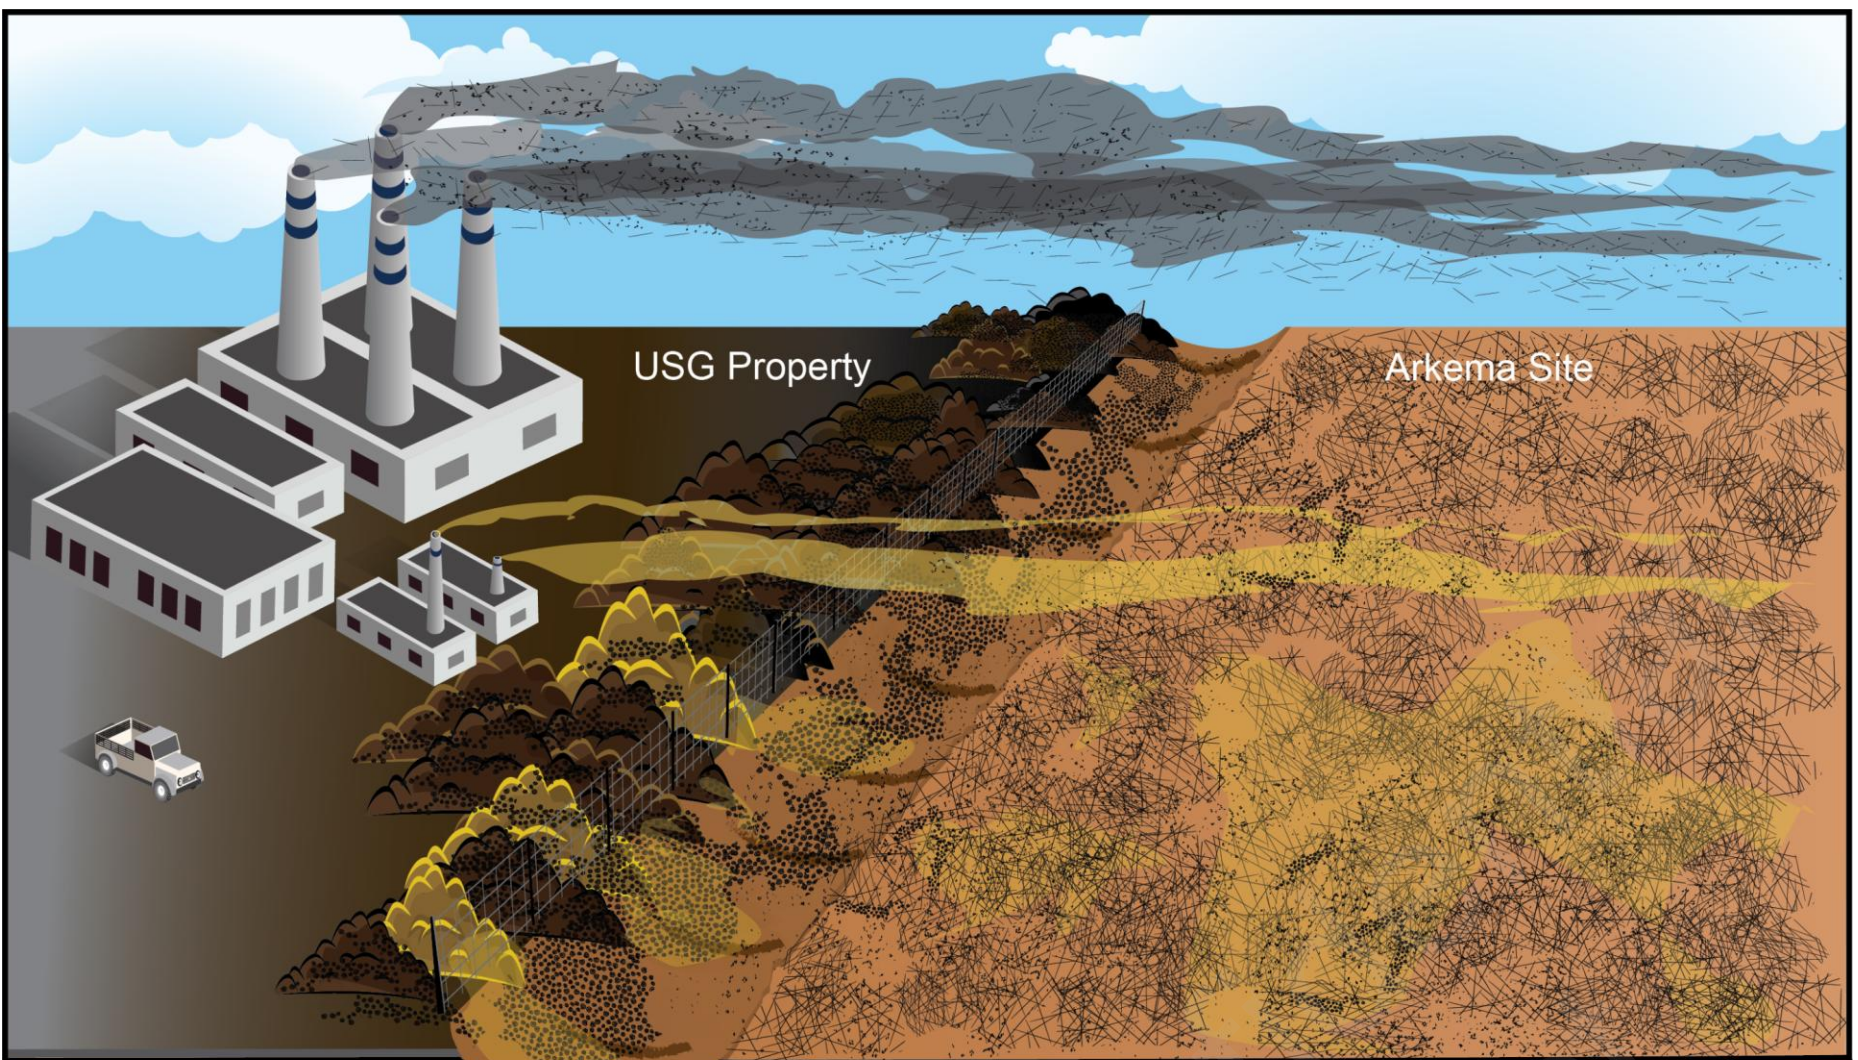
Historical Conditions (e.g., early 1940s - early 1980s)

The apparent absence of the thin layer of USG waste in this area is likely due to soil being moved/mixed during subsequent fill/grading events. It is also possible that a sample of the thin layer of USG was not collected because USG waste particles are not always seen with the naked eye and the geologic sample recovery for shallow samples in this area was relatively low.

Current Conditions

This figure is a conceptual summary of the evaluation conclusion. Arsenic and lead cleanup level exceedances in the NBA were caused by transport of wastes from USG stockpiles, transport of wastes from USG emissions, and/or direct disposal of wastes by USG. The USG waste deposits in the NBA were subsequently covered by fill material (e.g., construction debris, bark sludge) which did not have arsenic and lead concentrations exceeding cleanup levels.

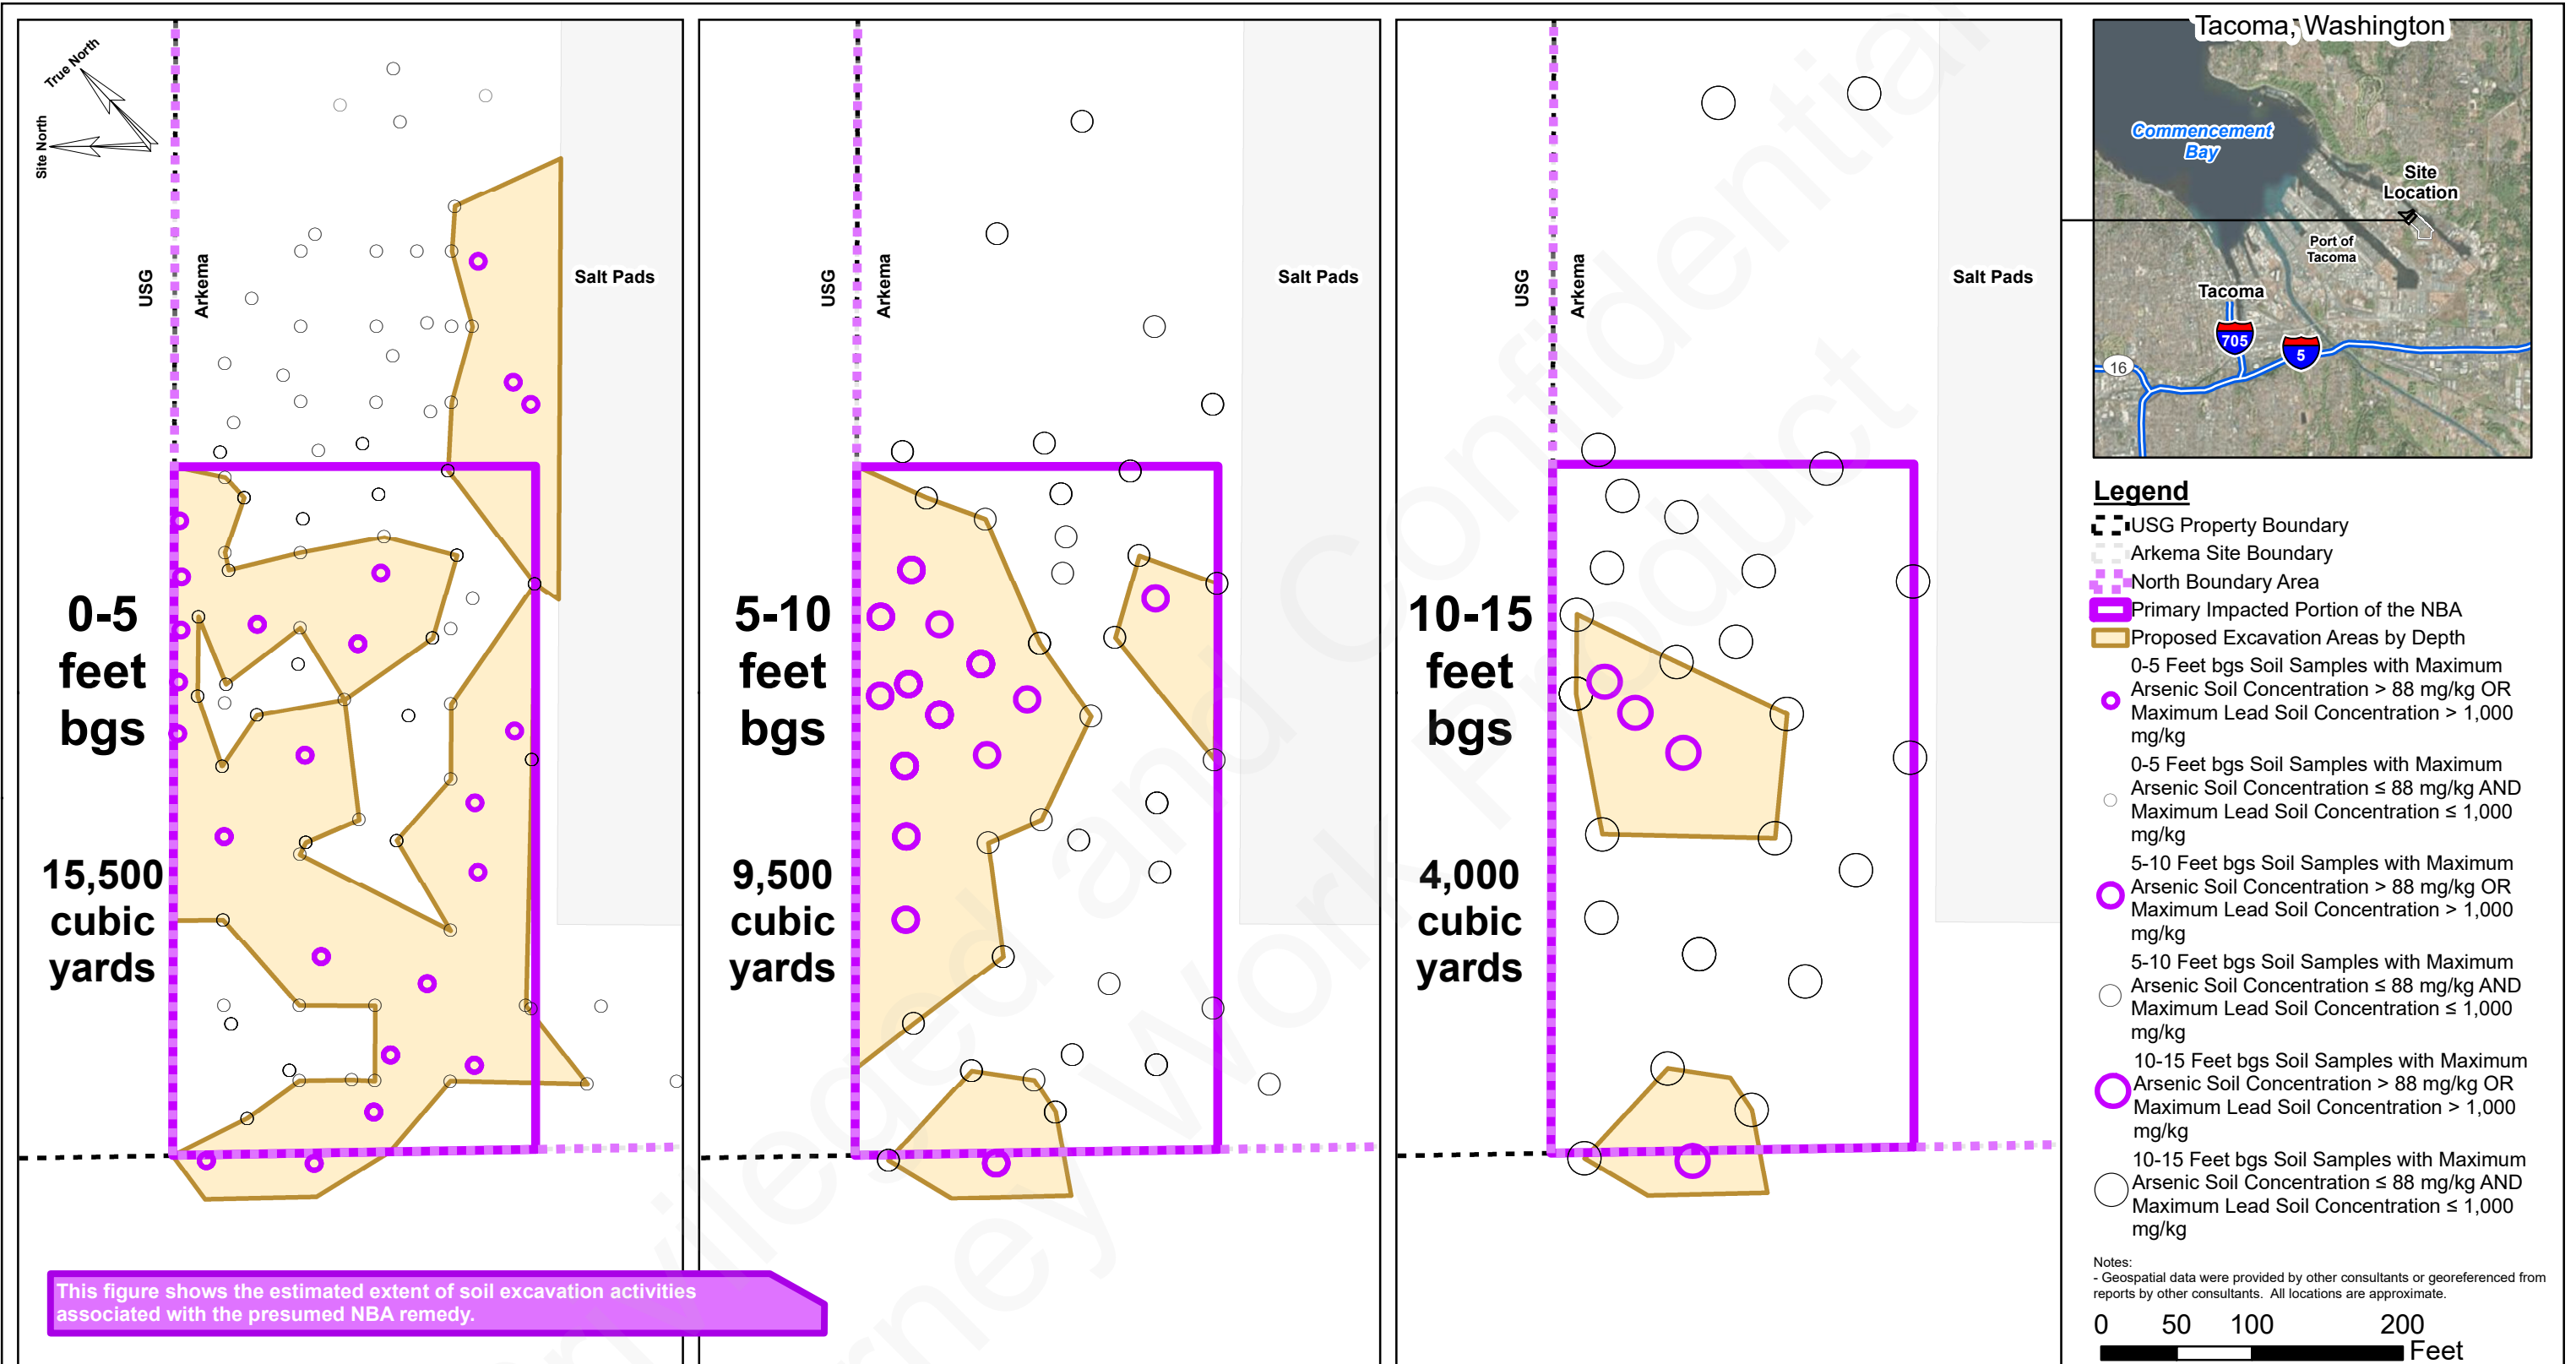
Figure 2

### Anticipated Soil Excavation Areas Cost Allocation Report North Boundary Area of the Former Arkema Manufacturing Site

Based on the presumed NBA remedy outlined in Section 2.7, the cost for anticipated future remedial actions is currently estimated to be \$14,600,000 (see Table 1). The basis for the excavation volumes used in this cost estimate is presented in Figure 3. It should be noted that there are uncertainties associated with the anticipated future costs. For instance, the cost estimate could decrease as more site-specific information is obtained. On the other hand, the cost estimate could increase for a variety of reasons, including the potential for (1) more stringent cleanup levels, (2) more stringent Ecology requirements for the selected remedy, (3) larger excavation volumes, and (4) higher unit costs at the time the work is performed.

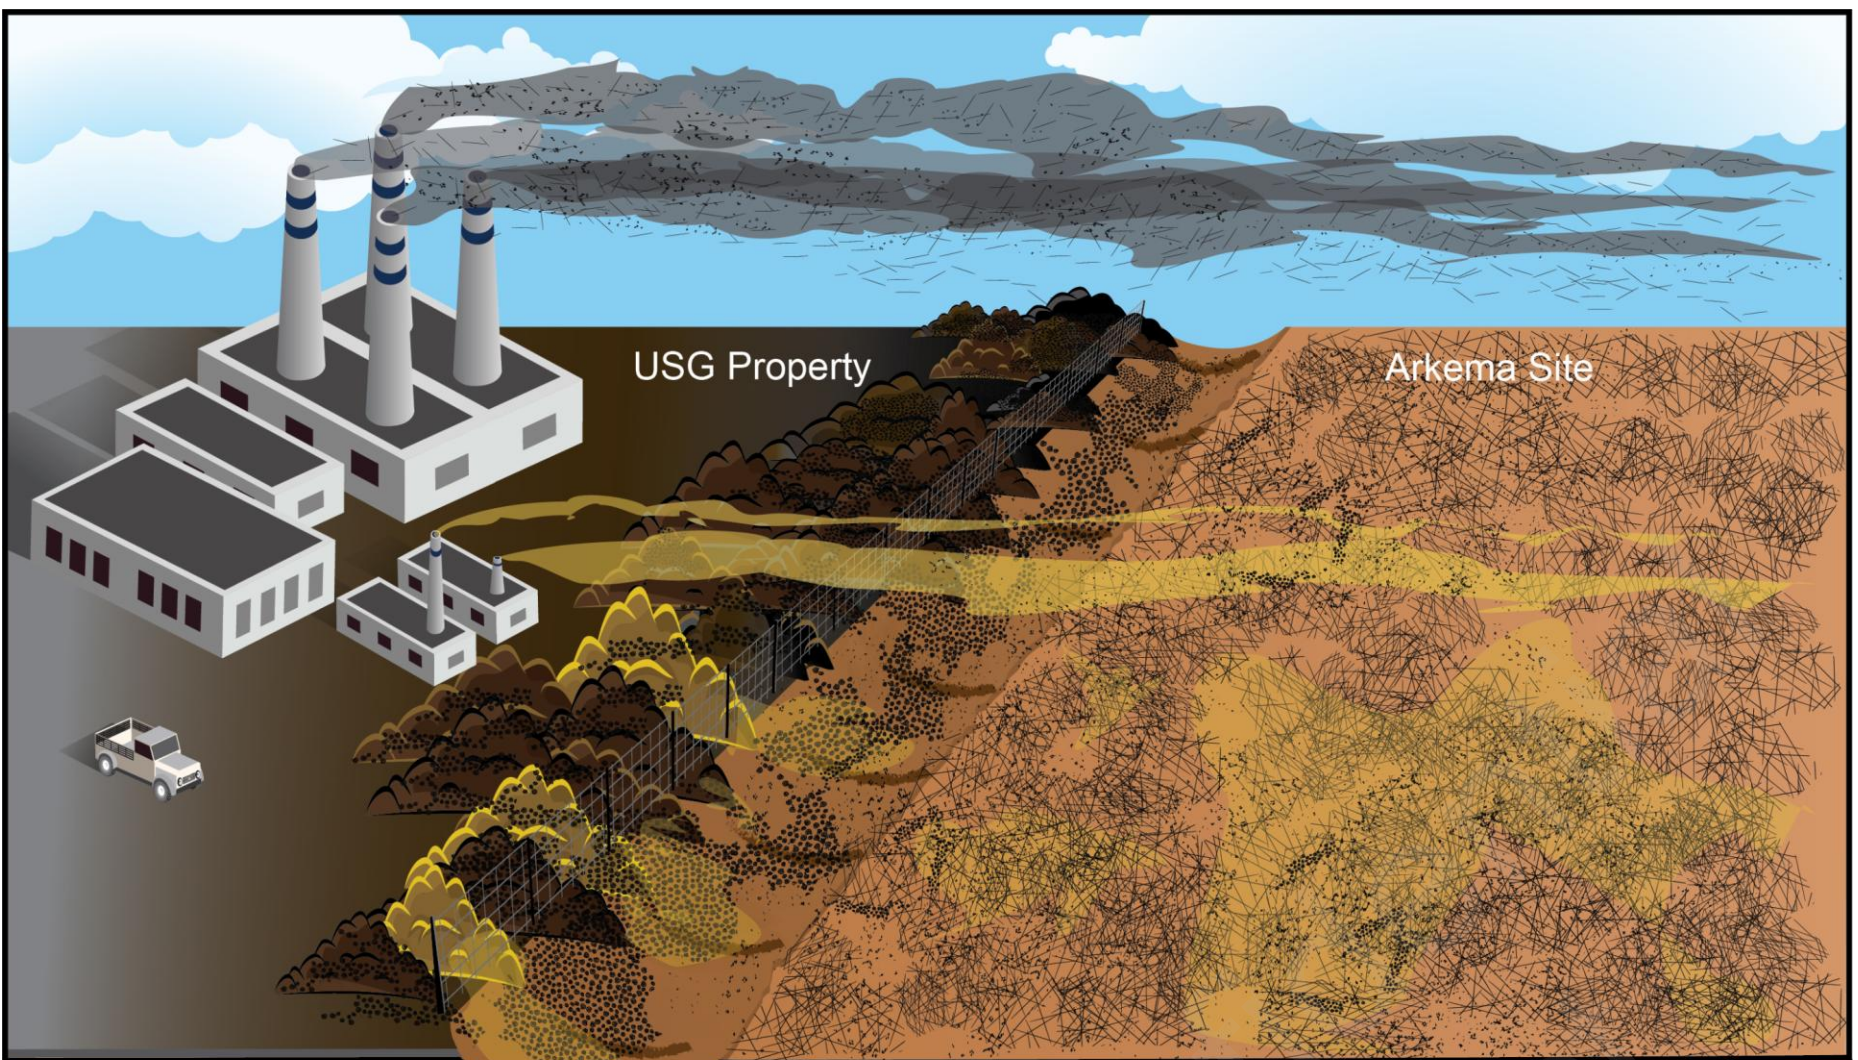
Historical Conditions (e.g., early 1940s - early 1980s)

The apparent absence of the thin layer of USG waste in this area is likely due to soil being moved/mixed during subsequent fill/grading events. It is also possible that a sample of the thin layer of USG was not collected because USG waste particles are not always seen with the naked eye and the geologic sample recovery for shallow samples in this area was relatively low.

Current Conditions

Large quantities of USG wastes containing significantly elevated concentrations of arsenic and lead were emitted from USG manufacturing operations adjacent to the primary impacted portion of the NBA (see Section 3.1.1 for more detail). Historical photographs demonstrate that the emissions contained a significant amount of particulates and that the emissions traveled over the primary impacted portion of the NBA (see Figure 18). These USG emissions and the lack of compliance with PSAPCA air emission rules resulted in 35 unique notices of violation and seven civil penalties in the time between when PSAPCA was formed in 1967 and 1975 (see Appendix E). Three of the seven PSAPCA civil penalties were specifically related to "causing or allowing the discharge of particulate matter to become deposited upon the real property of others." PSAPCA documentation and complaints provide details about the nature of the deposition of particulate matter from USG emissions (see Appendix E). For instance, "Husband works at [redacted] graveyard shift. They blow out insulation pollution in wee hours around 4 or 5 o'clock. He has to wash his car every morning." A cross-section (B-B') based on analytical data, EMP results, and boring logs illustrates how USG wastes were most likely transported onto the NBA via airborne deposition (see Figure 19). Key evaluation findings presented in Figure 19 include:
