NOVEMBER 2022 GROUNDWATER MONITORING
REPORT

Roza Irrigation District Property
125 S. 13TH STREET, SUNNYSIDE, WASHINGTON

Subject: NOVEMBER 2022 GROUNDWATER MONITORING REPORT, ROZA
IRRIGATION DISTRICT PROPERTY, 125 S. 13TH STREET, SUNNYSIDE,
WASHINGTON

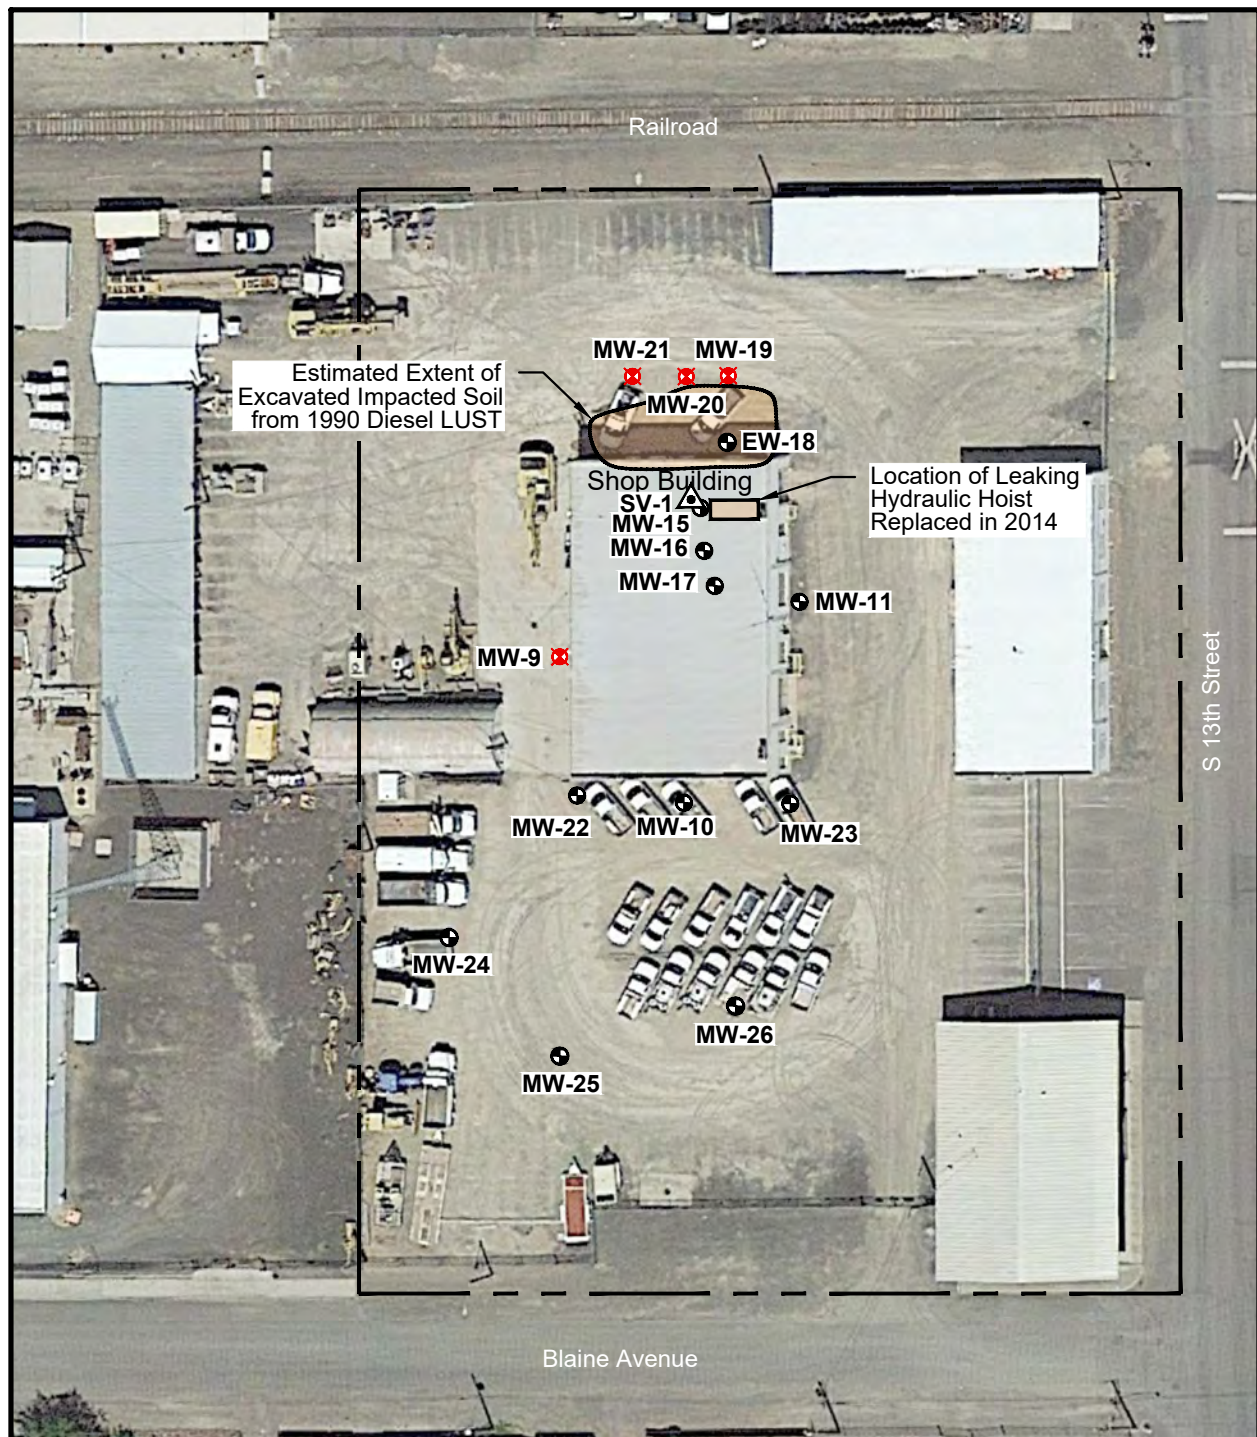
FIG. 2

In 1990, three USTs storing diesel and gasoline, a pump island, and associated piping were removed from the north side of the Shop Building. A leak from piping connected to the diesel UST resulted in impacts to soil and groundwater. Petroleum-contaminated soil (PCS) was excavated from the UST basin to the extent practicable and PCS is believed to remain in place beneath the Shop Building (RID, 1993). The estimated extent of the excavation is shown in Figure 2.
