SITE ASSESSMENT REPORT

Vestal Jobber Manufacturing Company
North 902 Dyer Road, Spokane, Washington

17 August 1993

UNDERGROUND STORAGE TANK SITE ASSESSMENT

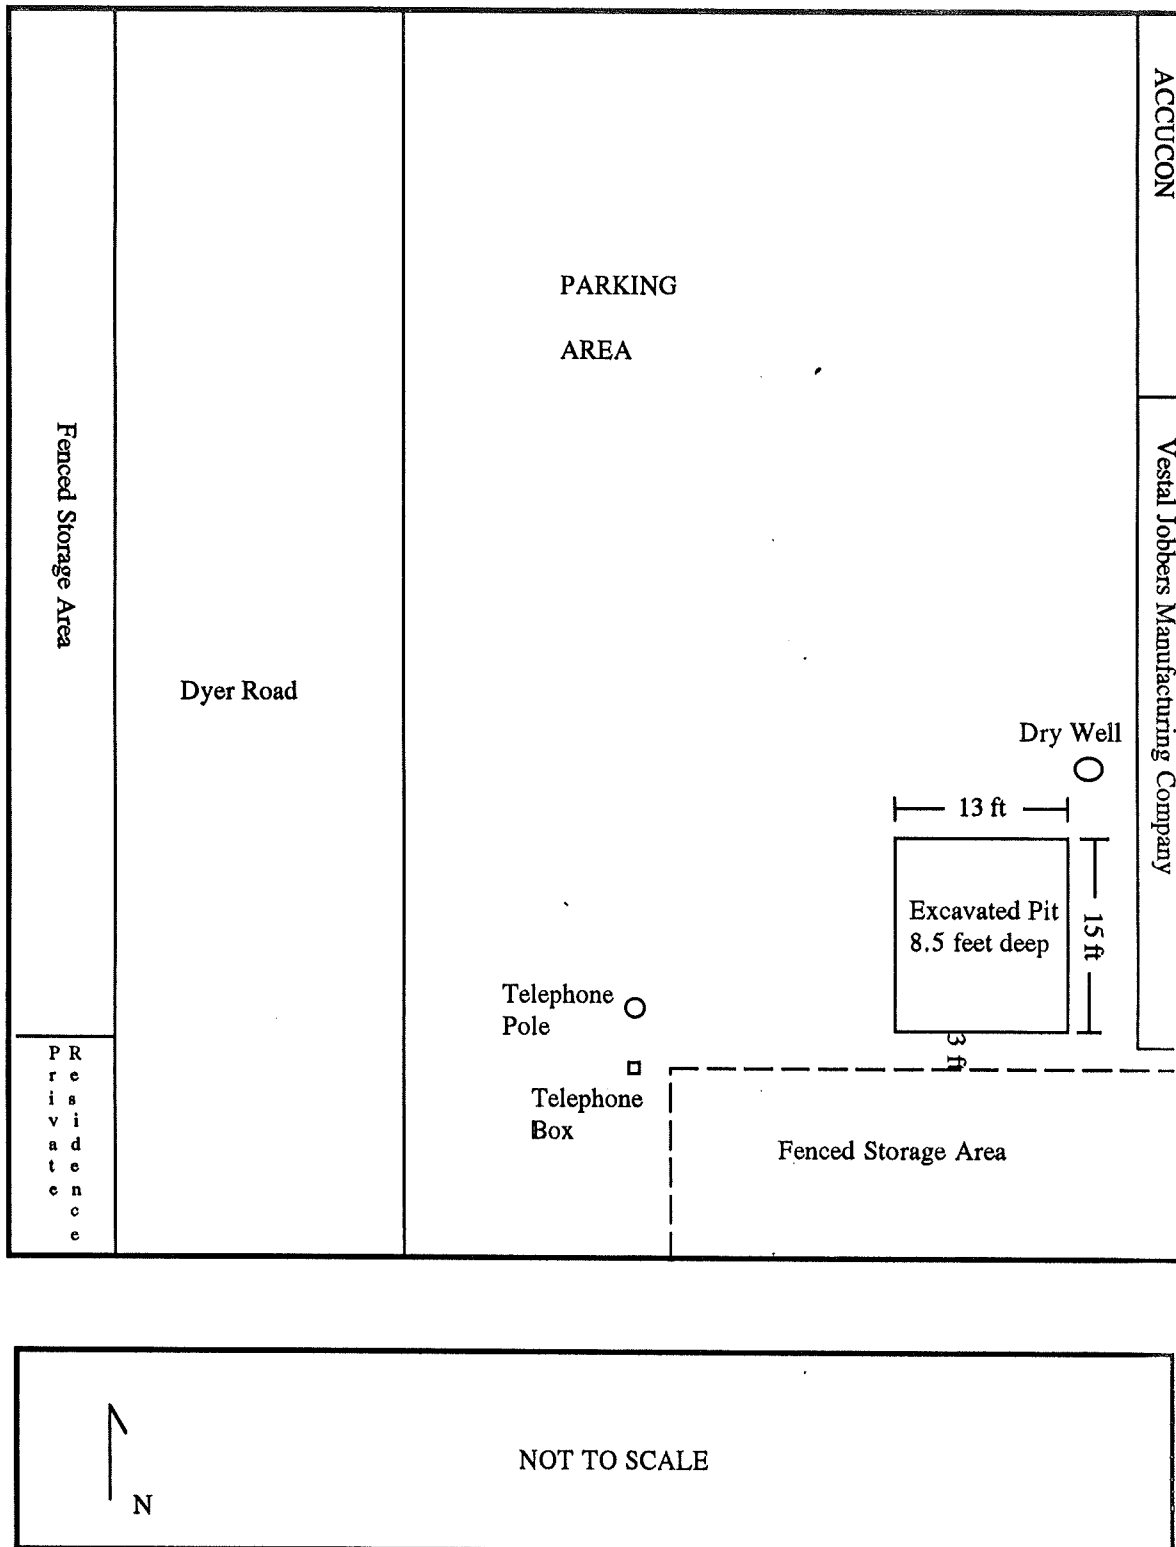
Figure 3: Site plan showing locations of excavation pit in relation to the building.

The UST was located along the southern end of the subject-property next to a fenced storage area which was topped with wire (see Photograph 3). The tank was located approximately sixty (60) feet east of Dyer Road and approximately fifteen (15) feet west of the building (Figure 3). The UST was sitting on end in the pit and was six (6) feet in diameter and six (6) feet in height, giving it a volume of 1,270 gallons.

The UST was located west of the building occupied by Vestal Jobber Manufacturing Company. The total disturbed area for the 1,270 gallon UST was approximately 15 feet x 13 feet x 8.5 feet deep. These dimensions were used to calculate the amount of soil removed during the excavation, approximately sixty-one (61) cubic yards. No surface contamination was evident above the tank as this soil had been previously removed during an earlier excavation.

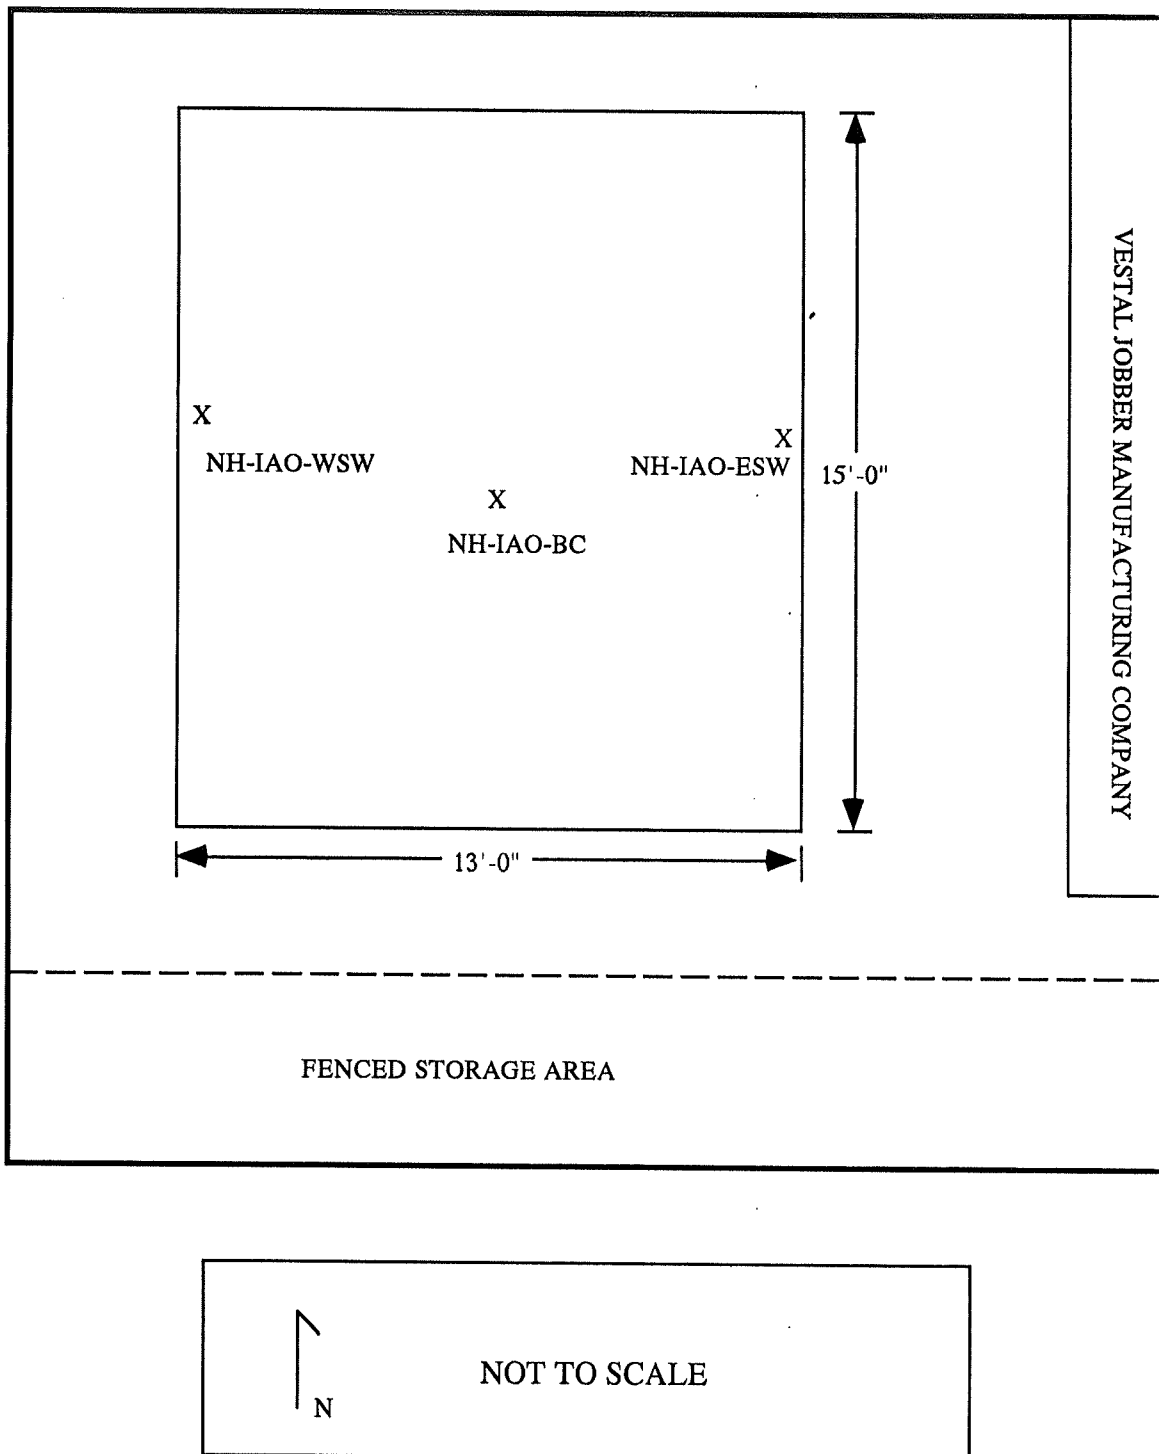
Figure 4: Location of samples for the 1,270 gallon UST.

Number of Samples. Six (6). One sample was collected from the bottom of the excavation, and one was collected from each of the sidewalls (Figure 4).

Three (3) samples were collected from the excavated stockpiled soil.

Results from the samples obtained during the Site Assessment of the 1,270 gallon UST indicate total petroleum hydrocarbon - diesel levels above the action levels set by the Washington Department of Ecology (WDOE), ranging from 1,200 parts per million (ppm) to 21,800 ppm. All other analyses indicated levels below those set by the WDOE with the exception of samples NH-IAO-BC and NH-IAO-ESW, which had chromium levels above those set by the WDOE.

All three (3) samples obtained from the excavation of the 1,270 gallon UST were above the action level threshold values for TPH-D as set by the WDOE. Additional excavation, as well as additional sampling, will be necessary in the pit in order to remove the soil which contains levels of diesel contamination above the action threshold limits set by the WDOE. All three (3) samples obtained from the excavated stockpiled soil were also above the action level threshold values for TPH-D. This soil will either need to be "land-farmed" at a site approved by the Spokane County Health Department and the WDOE, taken to REMTECH in Spokane for incineration, or taken to an approved landfill.

It is proposed that to delineate the extent of vertical and lateral contamination that one of the following methods be utilized.

- (1) An OSHA Certified backhoe operator be retained to further excavate the pit, until such time that the pit is determined to be clean by laboratory testing of soil samples. This method is only practical if the contamination is restricted to the upper twenty (20) feet of the subject-property and has not significantly migrated laterally. Federal regulations require that the sides of the excavation pit be shored to prevent the walls from collapsing if the excavation continues past a depth of twenty feet. The shoring has to be designed by an Engineer and that Engineer must be on-site whenever work is occurring in the pit.

- (2) Four (4) boreholes be drilled around the excavation and sampled at five (5) foot intervals beginning at a depth of ten (10) feet and continuing to a depth of thirty (30) feet or until it is determined that the contamination has been cleared. A single borehole/well is also proposed in the center of the excavation and sampled at five (5) foot intervals beginning at a depth of ten (10) feet and continuing to a depth of thirty (30) feet or until it is determined that the contamination has been cleared. The pit will need to be filled in with clean fill which contains no cobbles as to expedite the drilling process. This borehole/well might eventually be transformed into a vapor extraction well in order to remediate the site per DOE regulations. There is also a possibility that one or more of the boreholes surrounding the pit will need to be transformed into a vapor extraction well in order to remediate the site.

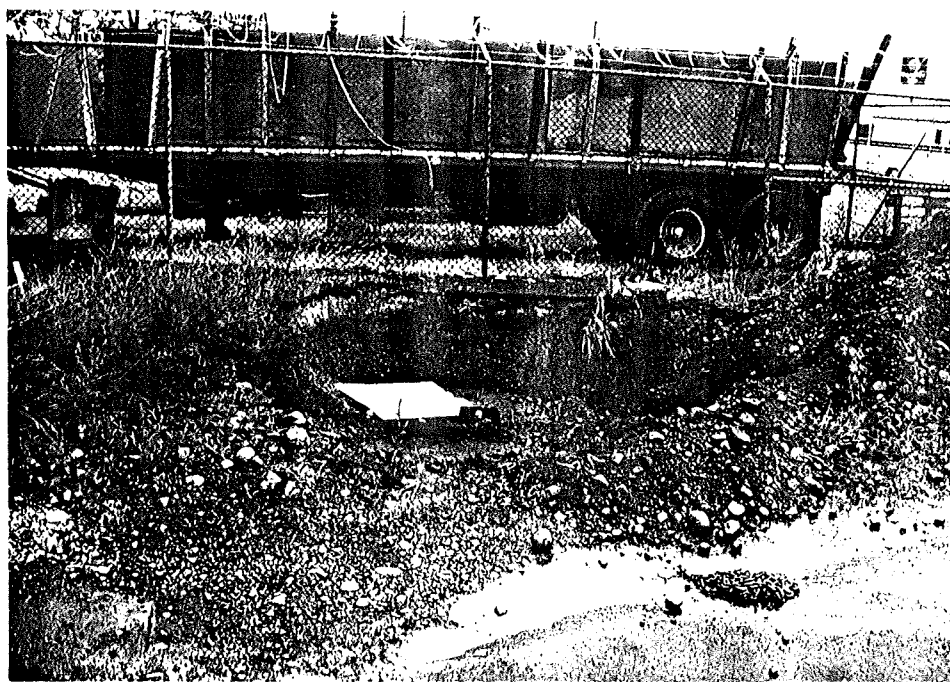
Photograph 1. The UST prior to excavation. The UST has been uncovered since 6 May 1992. Looking south.

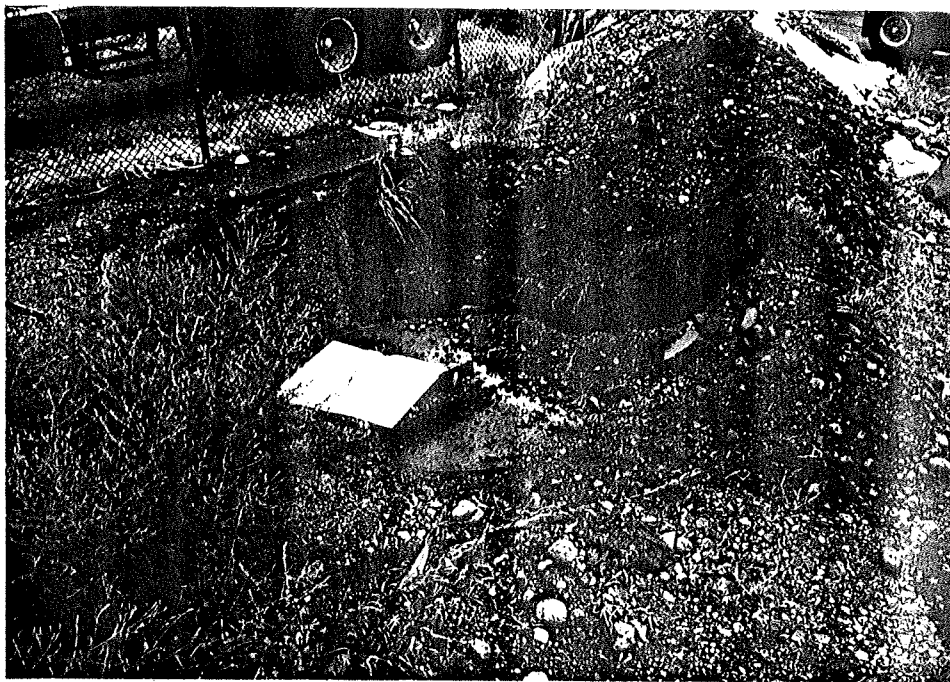
Photograph 2. The UST prior to excavation. The white piece of metal is covering an open hole into the UST. Looking southwest.

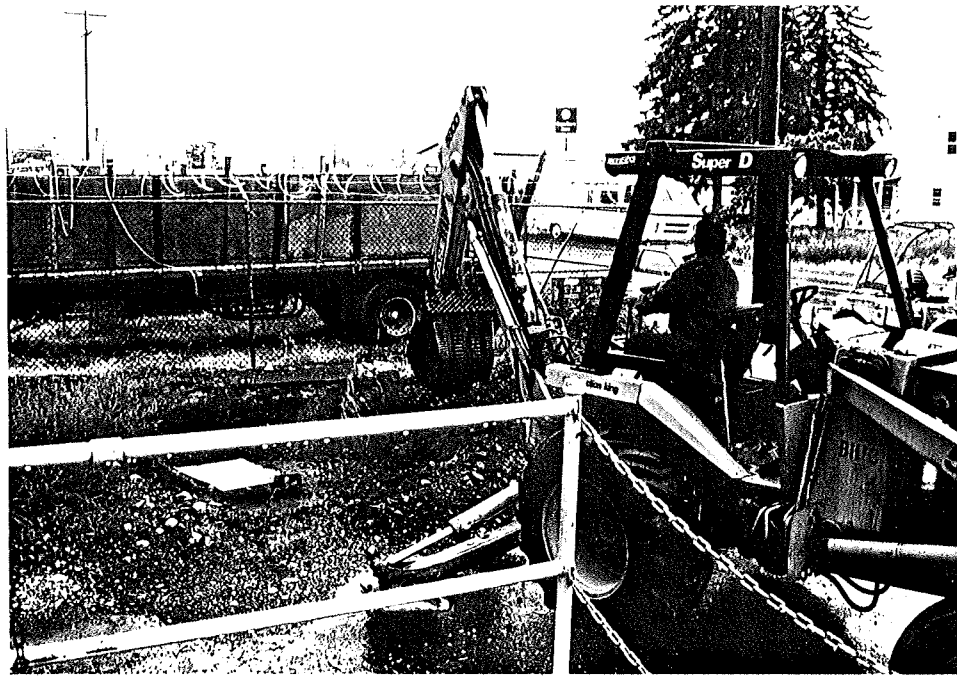
Photograph 3. Don Castleman of Lake Oswego, Oregon excavating the UST. Looking south-southwest.

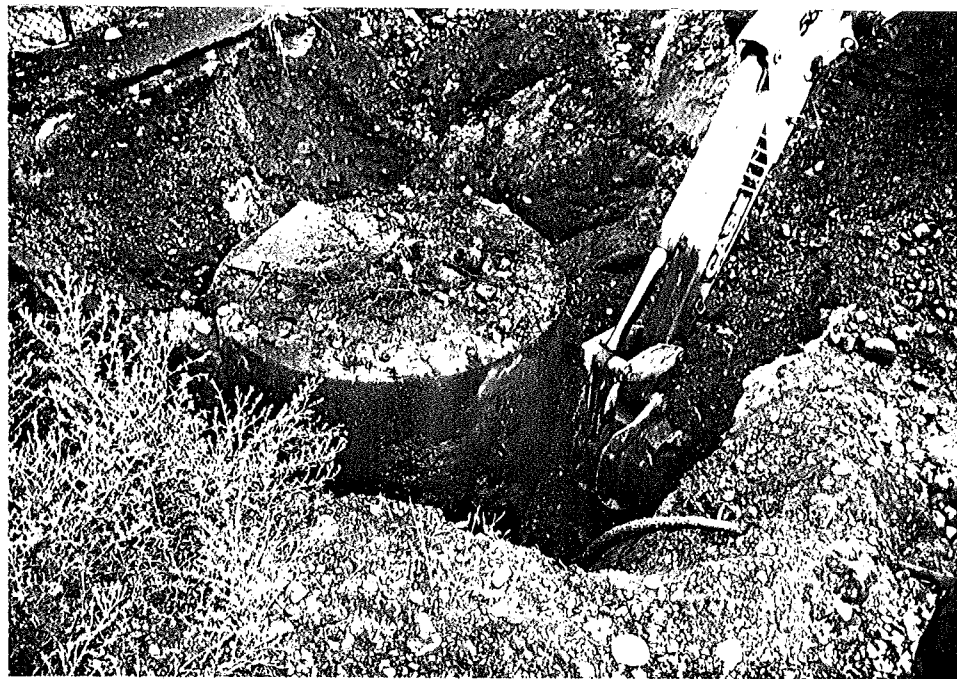
Photograph 4. Excavating the UST. Note the broken water pipe in the lower right corner of the picture, Looking southwest.

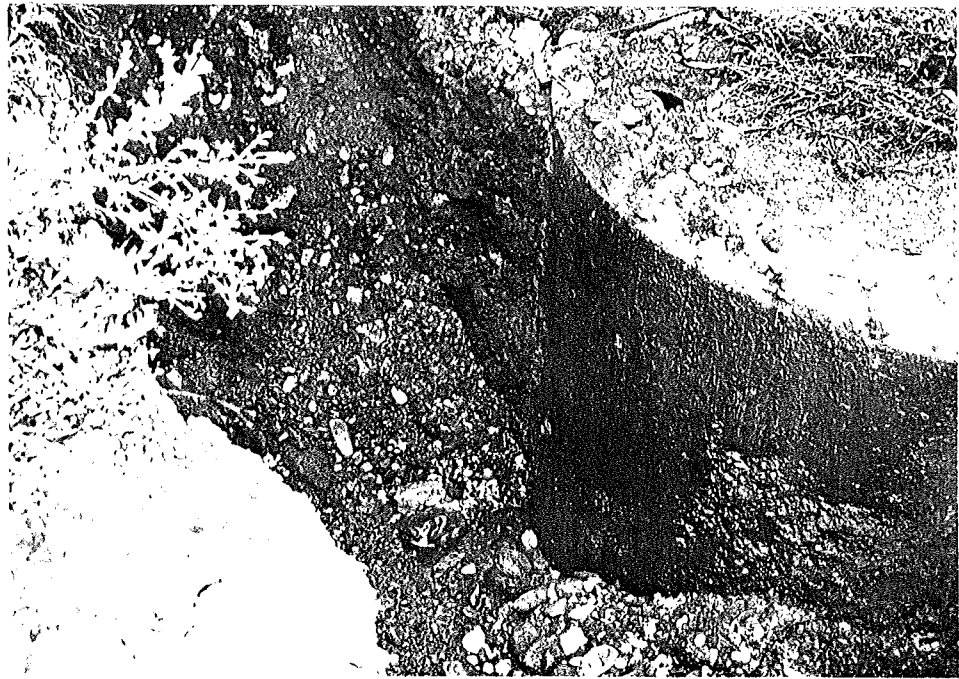
Photograph 5. The excavated UST, looking south-southwest. Note the water in the bottom of the pit from the broken water pipe.

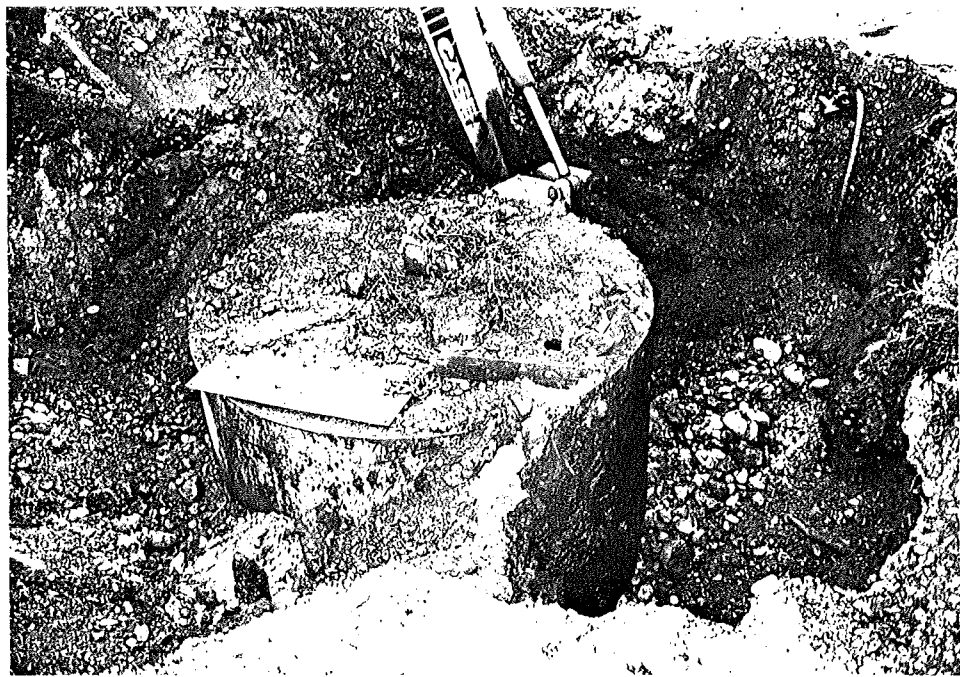
Photograph 6. Excavating the UST, looking northeast.

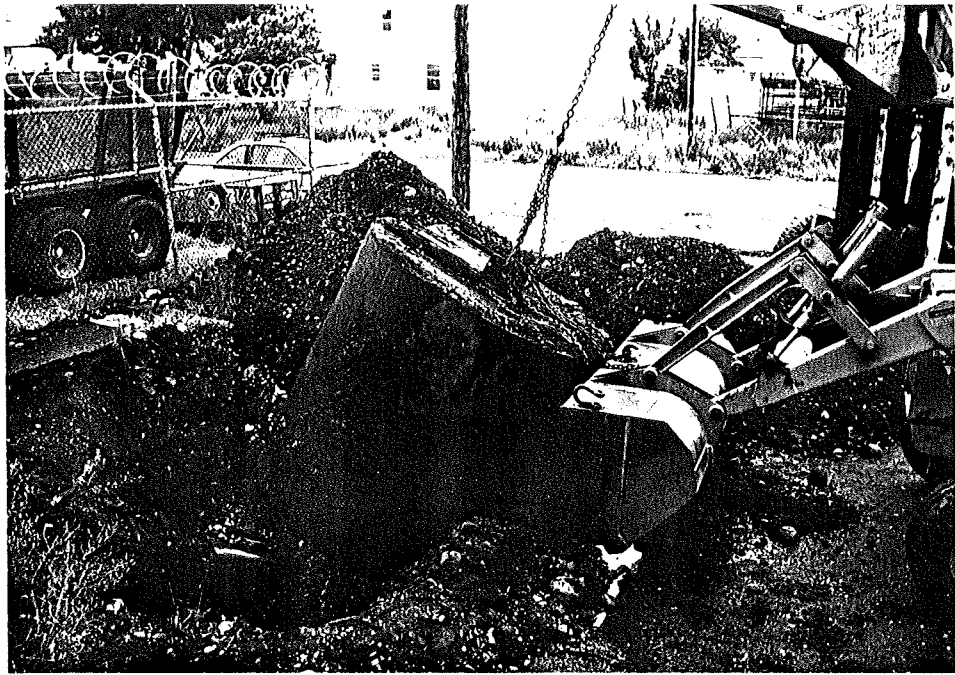
Photograph 7. Removing the UST, looking west-southwest.

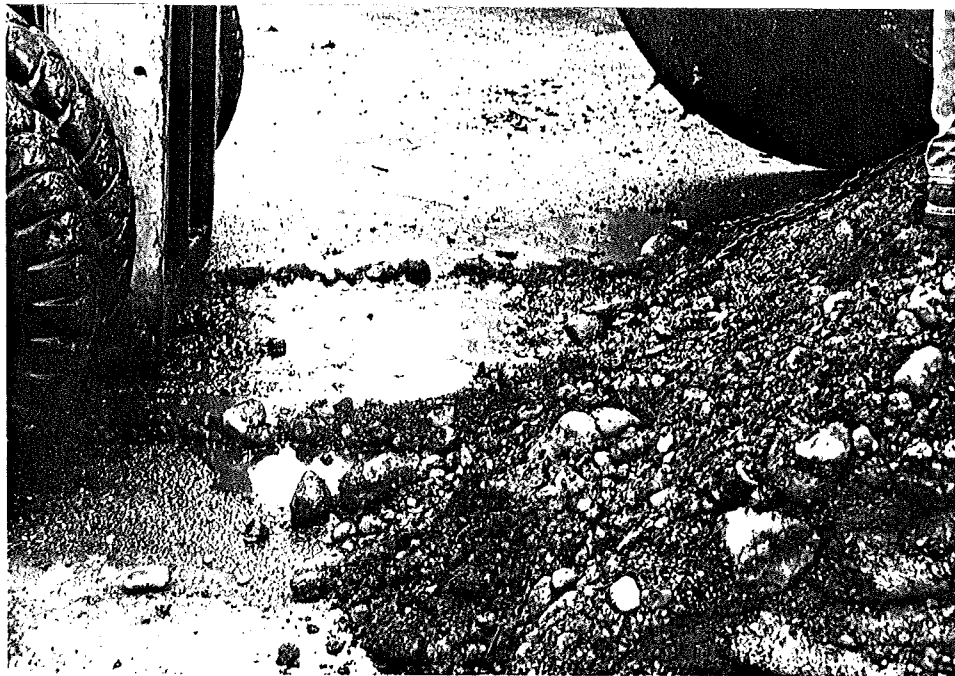
Photograph 8. The liquid which spilled from the tank while it was being removed from the pit.

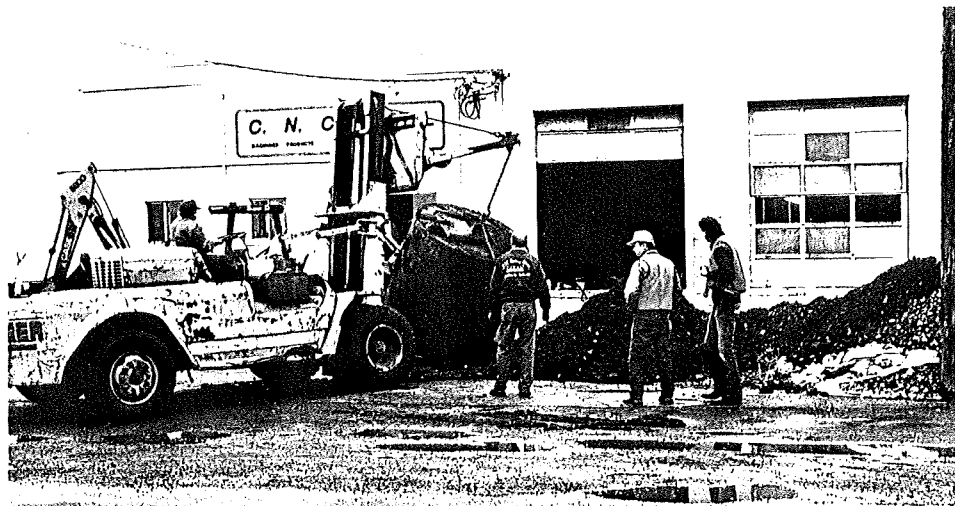
Photograph 10.

Don Castleman righting the UST. From left to right Don Castleman (on the forklift); Norman Harrison, owner; Wayne Peterson, Washington DOE; and Jim Greeves, Washington DOE. Looking east.

- Photograph 9.** A close-up of the liquid which spilled from the tank. Note the petroleum sheen on the water surface.
- Photograph 10.** Don Castleman righting the UST. From left to right Don Castleman (on the forklift); Norman Harrison, owner; Wayne Peterson, Washington DOE; and Jim Greeves, Washington DOE. Looking east.

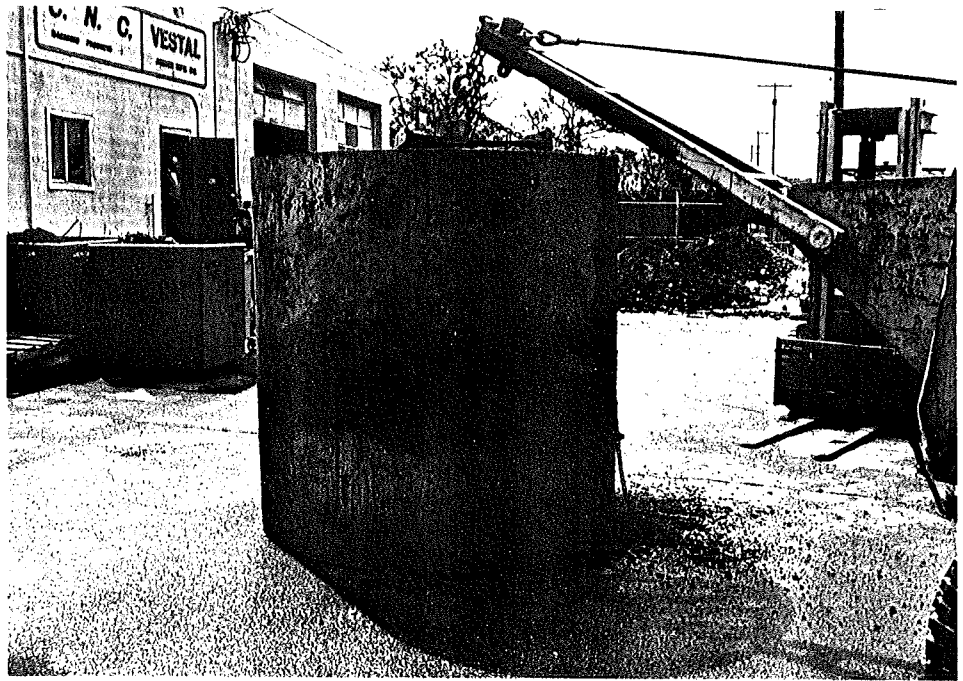
Photograph 11. The UST after it was removed from the pit. Looking south-southeast.

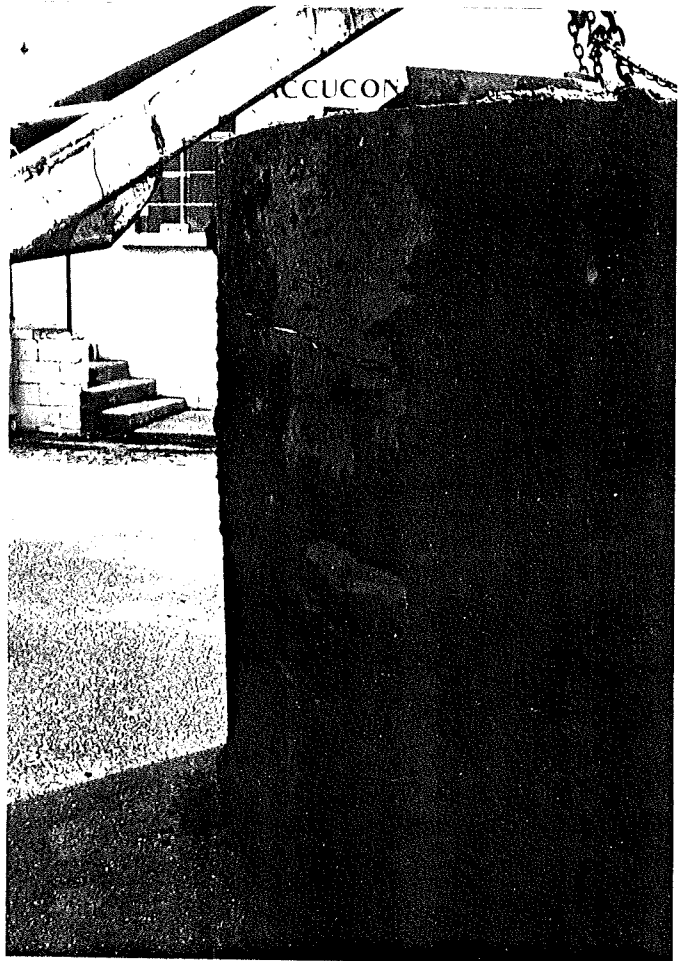
Photograph 12. A close-up of the UST after removal. Note the open bung-hole midway up the tank.

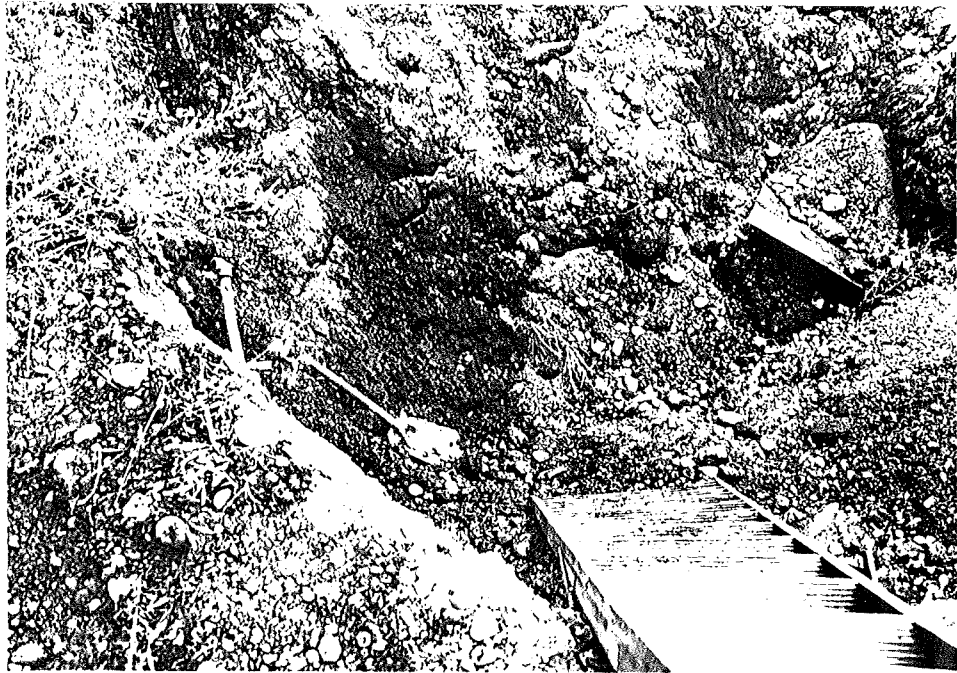
Photograph 13. The pit after the UST was removed. Note the discoloration of the soil directly above the shovel. Looking south-southwest.

The pit which contained the 1,270 gallon UST still contains contaminated soil as is evidenced by the sample results. This contamination problem was discussed with Debbie Charloe of the WDOE. Ms. Charloe stated that according to Washington State Regulations, the extent of vertical and lateral contamination needs to be determined. The pertinent regulations are found in the "Model Toxics Control Act--Cleanup" (MTCA-C) listed in Table 7.

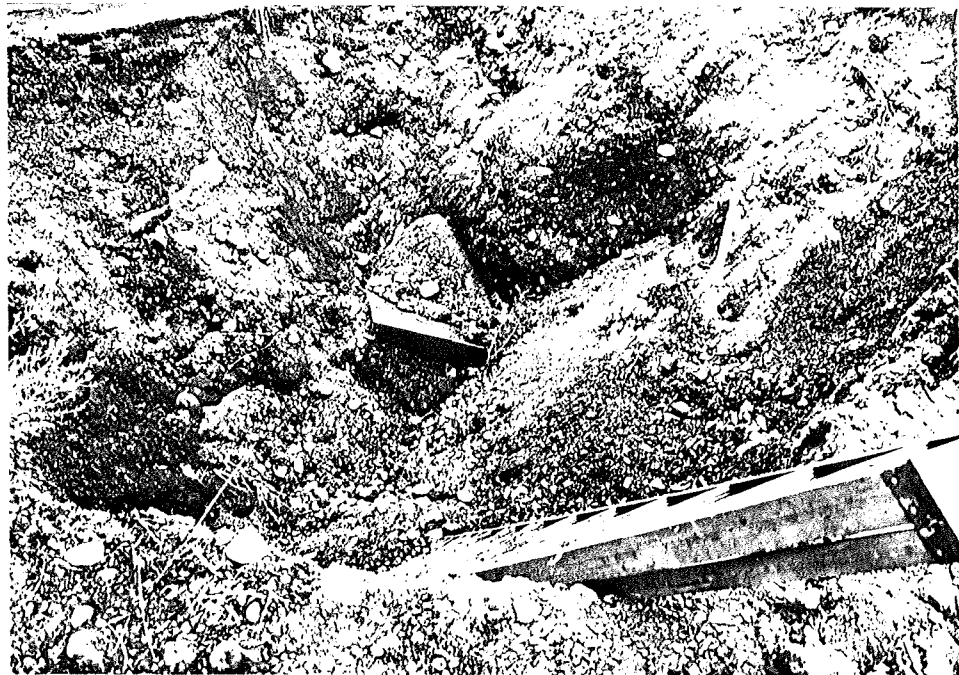
Photograph 14. The pit after the UST was removed. Note the soil discoloration beneath the metal sheet in the center of the photograph. The discoloration along the right side of the photograph is from the liquid spilled from the UST. Looking west-southwest.

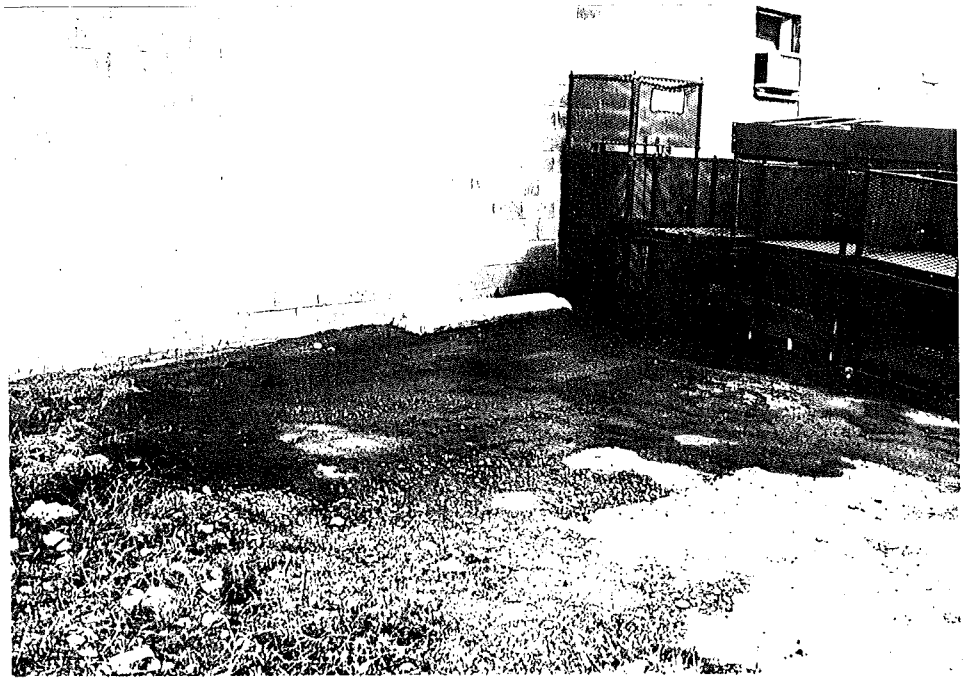
Photograph 15.

The location where the barrels were stored which contained the material from the UST. Note the discoloration of the pavement from the leaking barrels.
