# 2022 ANNUAL ENVIRONMENTAL MONITORING REPORT

Hansville Landfill, Kitsap County, Washington  
Prepared for: Kitsap County Public Works - Solid Waste

Project No. 160423-05 • February 28, 2023 FINAL

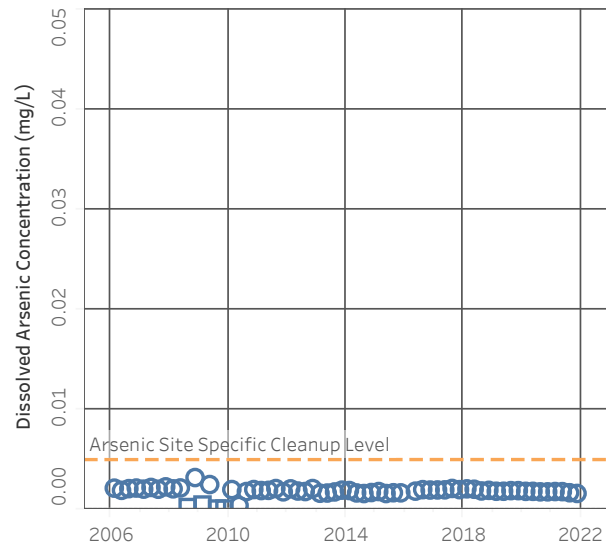
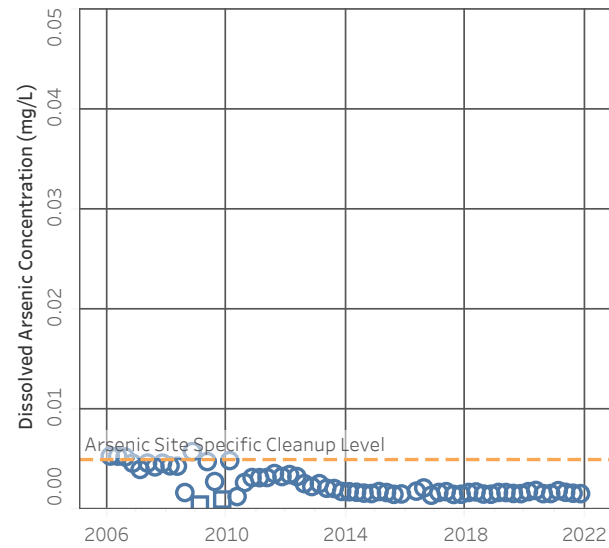
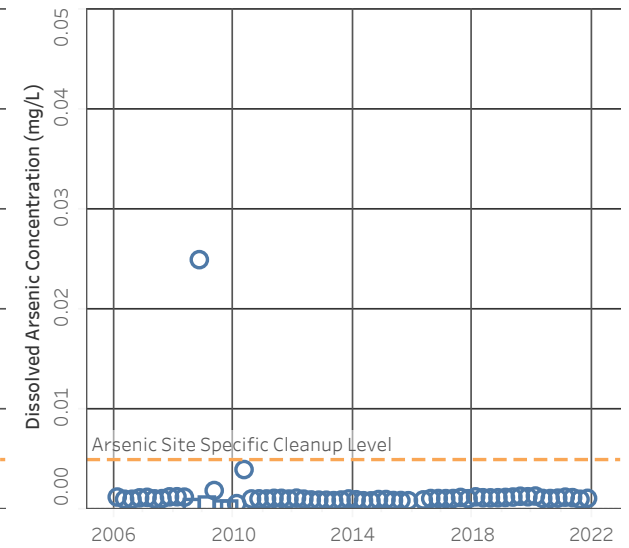
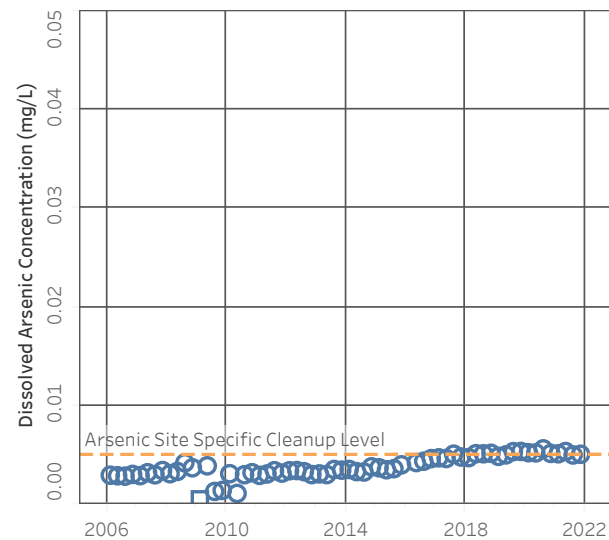
Figure C-1 shows that dissolved arsenic concentrations in groundwater have been less than the cleanup level of 0.005 mg/L at MW-5 (background well), MW-6, MW-7, and MW-12I. A slow and steady increase in dissolved arsenic concentrations has been observed at MW-13D, where concentrations historically hovered below the cleanup level and exceeded the cleanup level for the first time in the second quarter 2020 (Figure C-1). Dissolved arsenic concentrations at MW-14 were above site cleanup levels, but have been decreasing since 2007.

**Note:** Non-detected values are shown at 1/2 the reporting limit.  
Results from First Quarter 2017 were rejected. See text.

Groundwater sampling results since 2007 are shown on time-series plots for dissolved arsenic (Figure C-1) and vinyl chloride (Figure C-2) at all compliance monitoring locations. Concentrations are decreasing or stable in all cases except dissolved arsenic concentrations observed at MW-13D, which have gradually increased to slightly above or at cleanup levels.

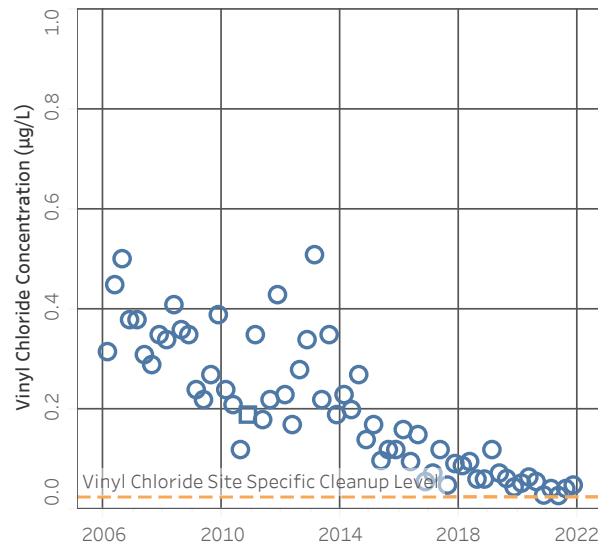
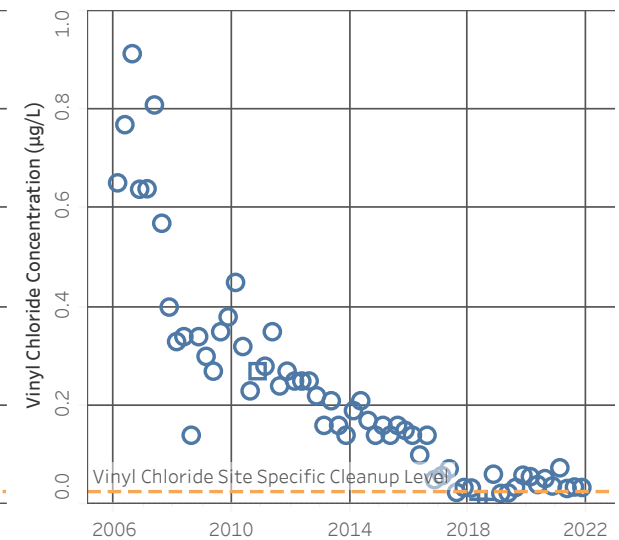
Figure C-2 shows vinyl chloride concentrations in groundwater have been less than the cleanup level of 0.025 µg/L at MW-5 (background well), MW-7, and MW-13D. Vinyl chloride concentrations at MW-6, MW-12I, and MW-14 continued to trend downward over the long-term. During 2022, the vinyl chloride concentration at MW-12I showed both a decreasing long-term trend and seasonality with relatively higher concentrations during the third and fourth quarter compared to the other quarters. A similar seasonality has been observed, where maximum annual concentrations were recorded in the dry season of 2020, 2019, 2018, 2015, 2013, 2012, for example.

**Note:** Non-detected values are shown at 1/2 the reporting limit.

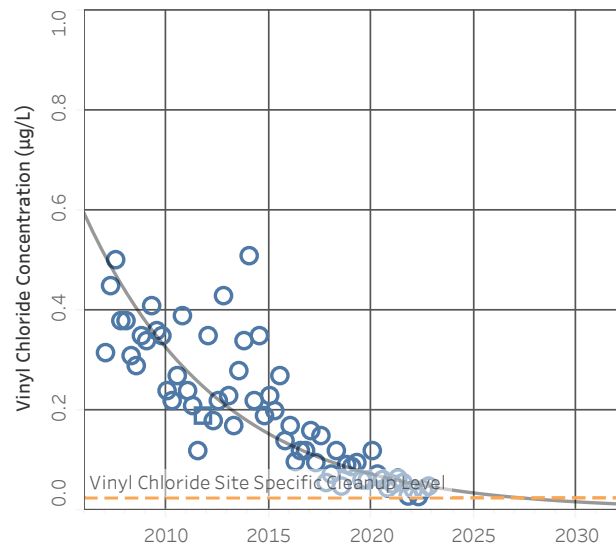
MW-6 Vinyl Chloride Trend

**Note:** Non-detected values are shown at 1/2 the reporting limit.  
Attenuation curves based on exponential least squares fit to the data.
