Interim Action Work Plan

**7730 South 202nd Street
Kent, Washington**

Former Maralco Property

Project No. 033-012

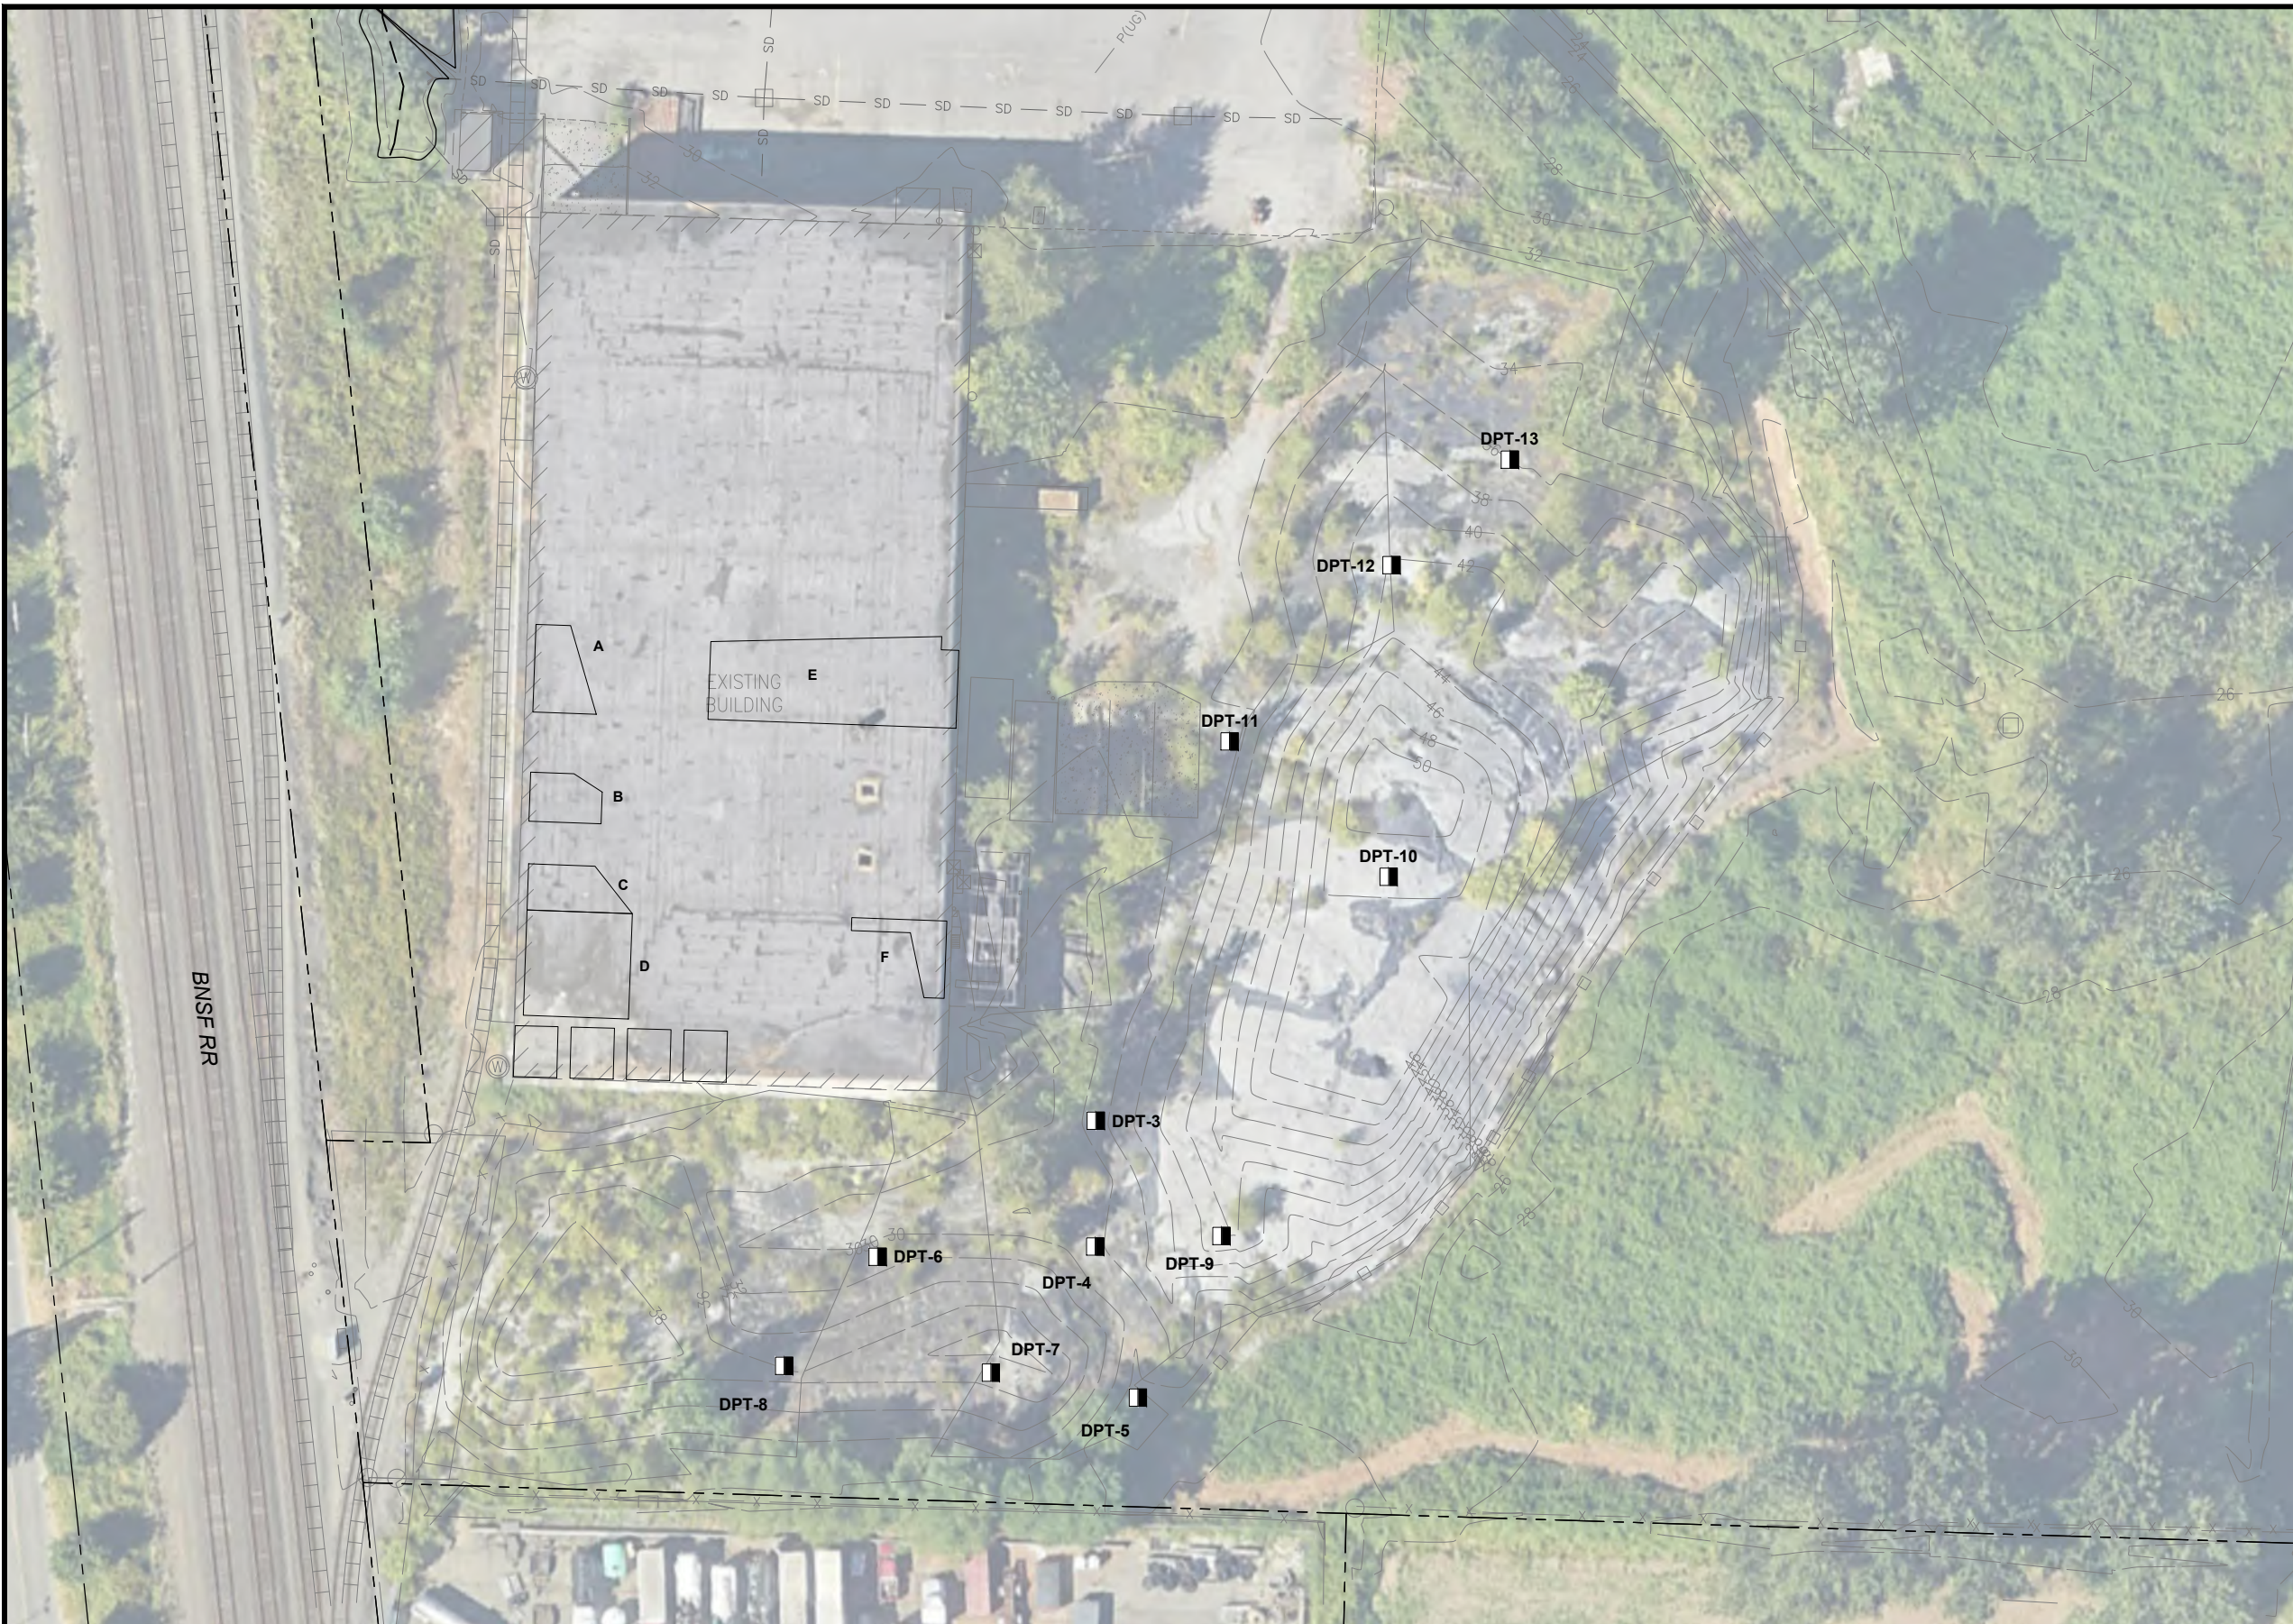
The following stockpiles are located at the property and are shown on Figure 2:

- Outdoor stockpile - Approximately 29,300 cubic yards (cy) of primarily black dross and a smaller amount of aluminum oxide (at the northern tip of the pile). The stockpile was covered during interim actions in the 1990s but the cover is damaged and the pile is partially uncovered and exposed.
- The indoor stockpiles include:
 - 500 cubic yards washed aluminum oxide at 1.1 tons per cubic yard (Piles A and E)
 - 200 cubic yards black dross, including oversized screenings and furnace skimming, at 1.1 tons per cubic yard (Piles B, C, and F)
 - 200 cubic yards (250 tons) of KBI dross (Pile D)
 - 200 cubic yards of bag house dust (contained within the bag house filters and adjacent bins)

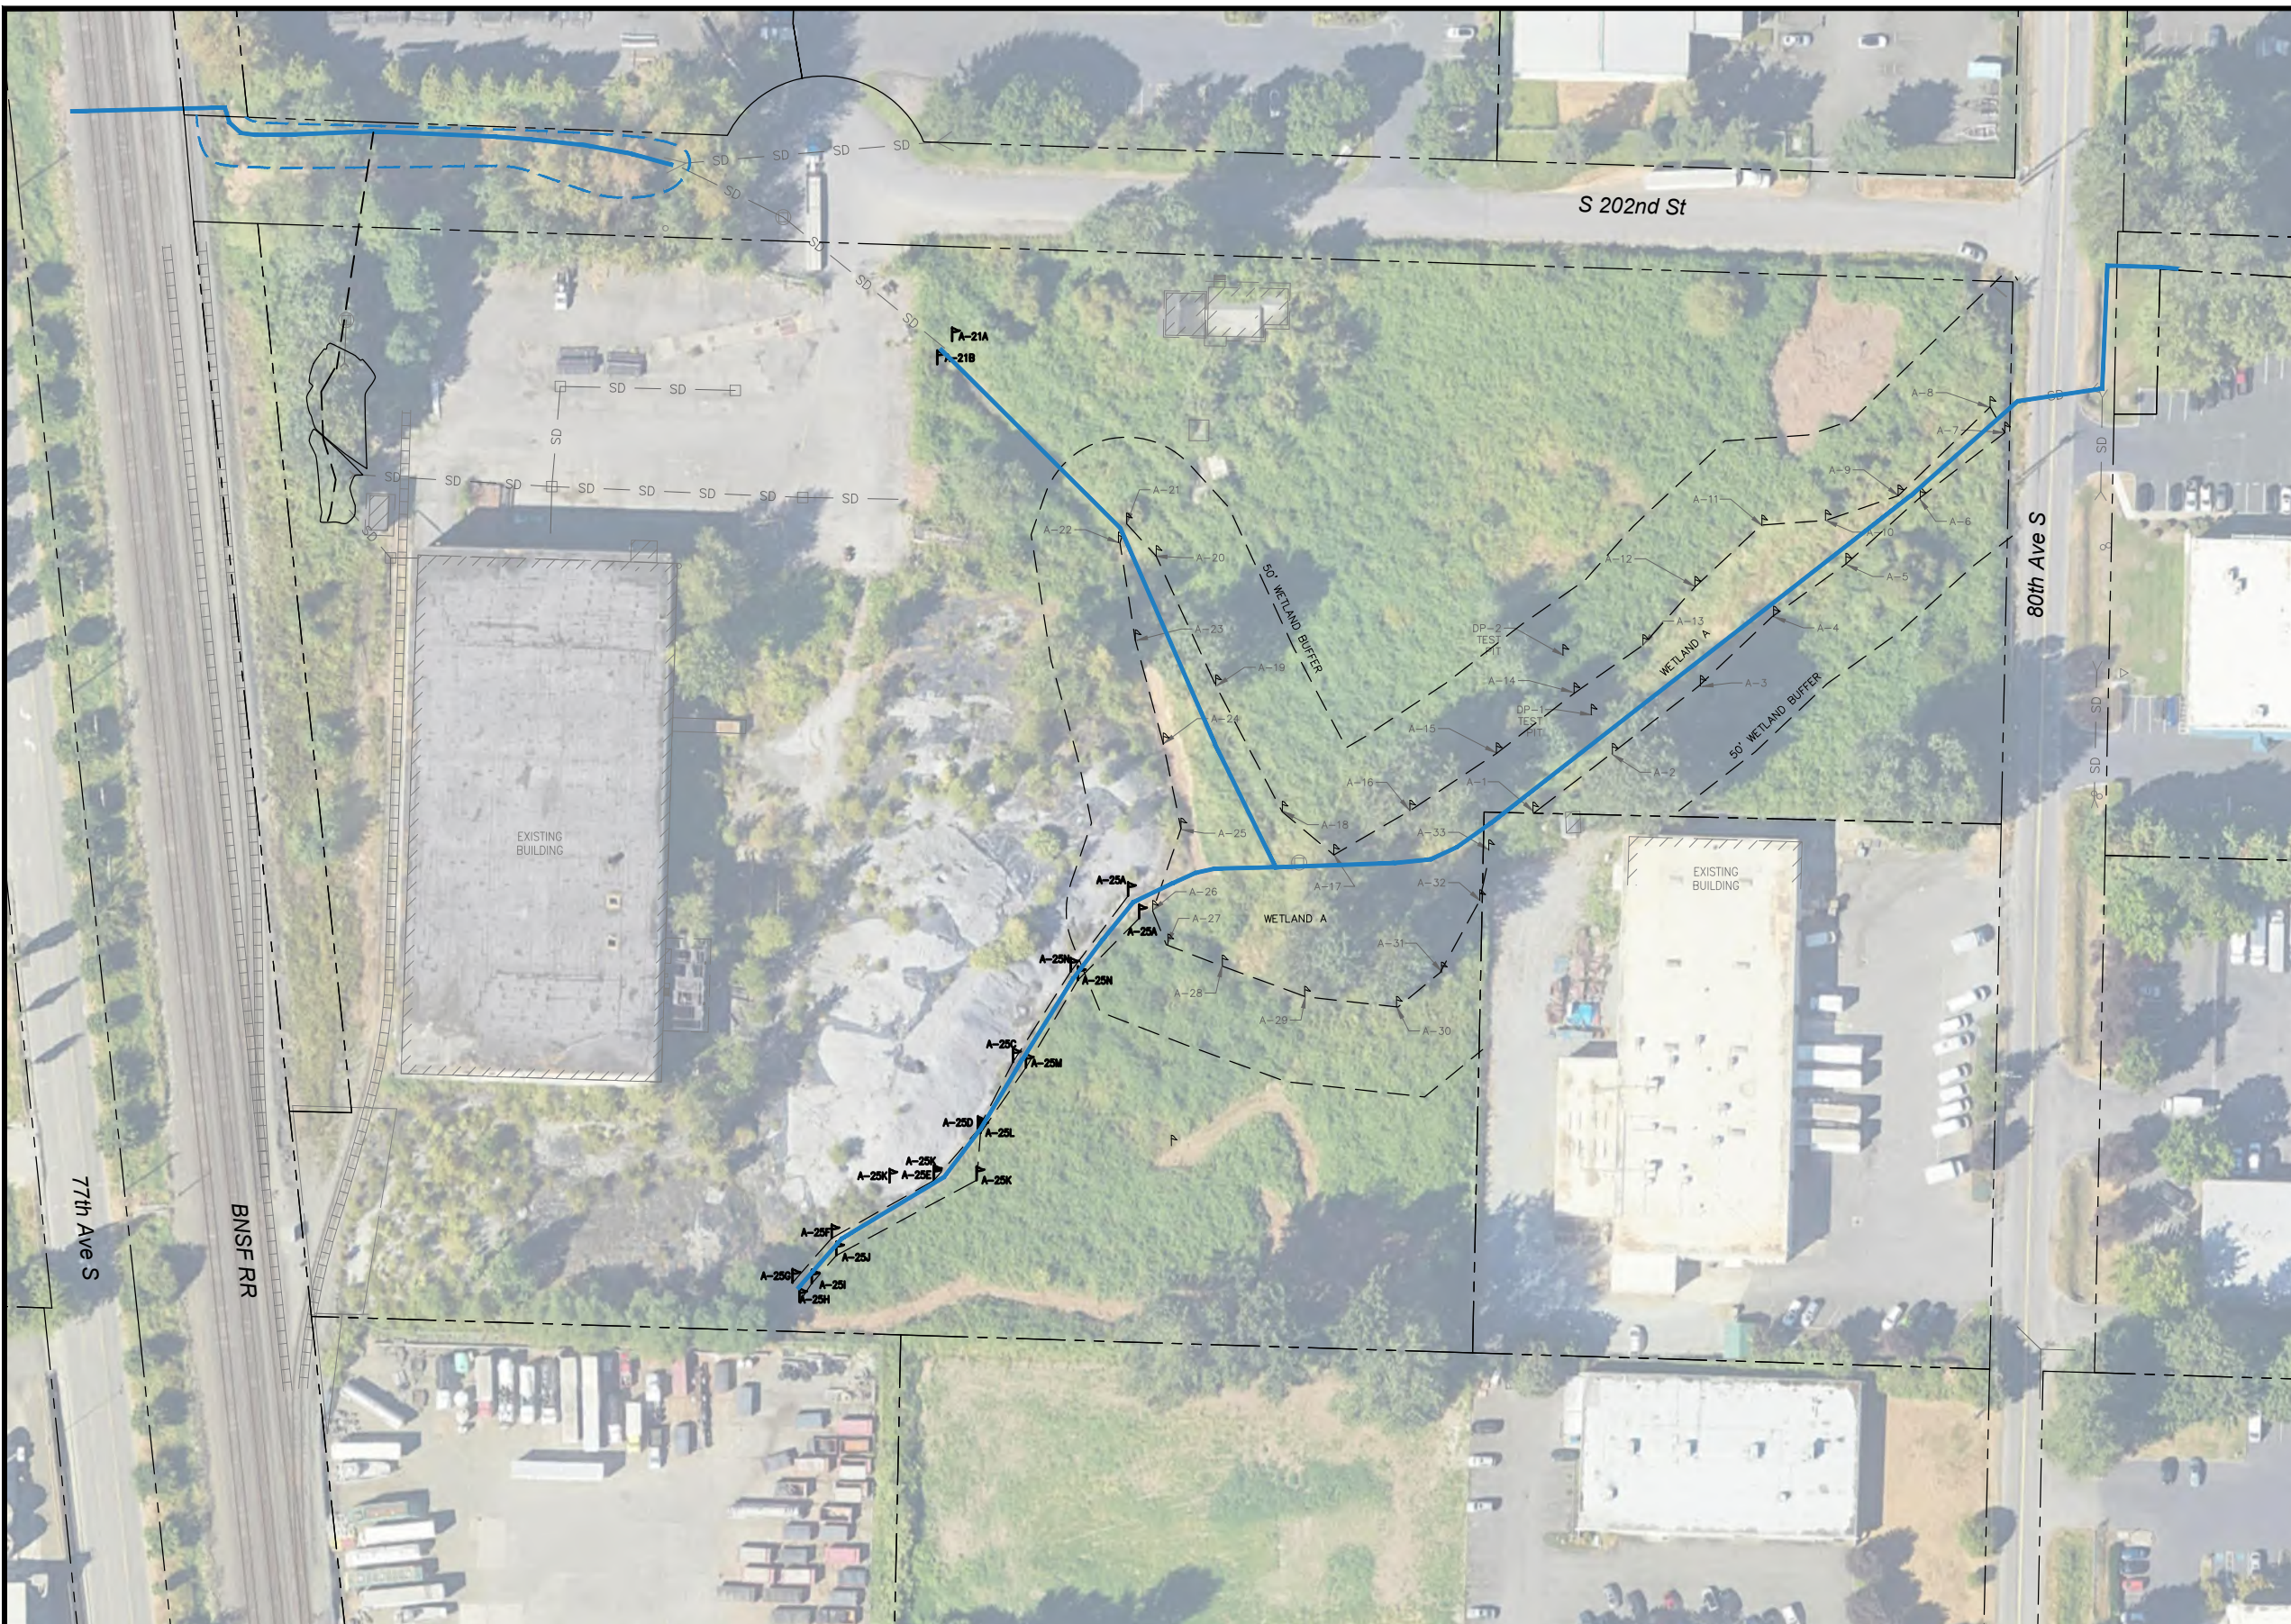
-   Wetland Flag
-

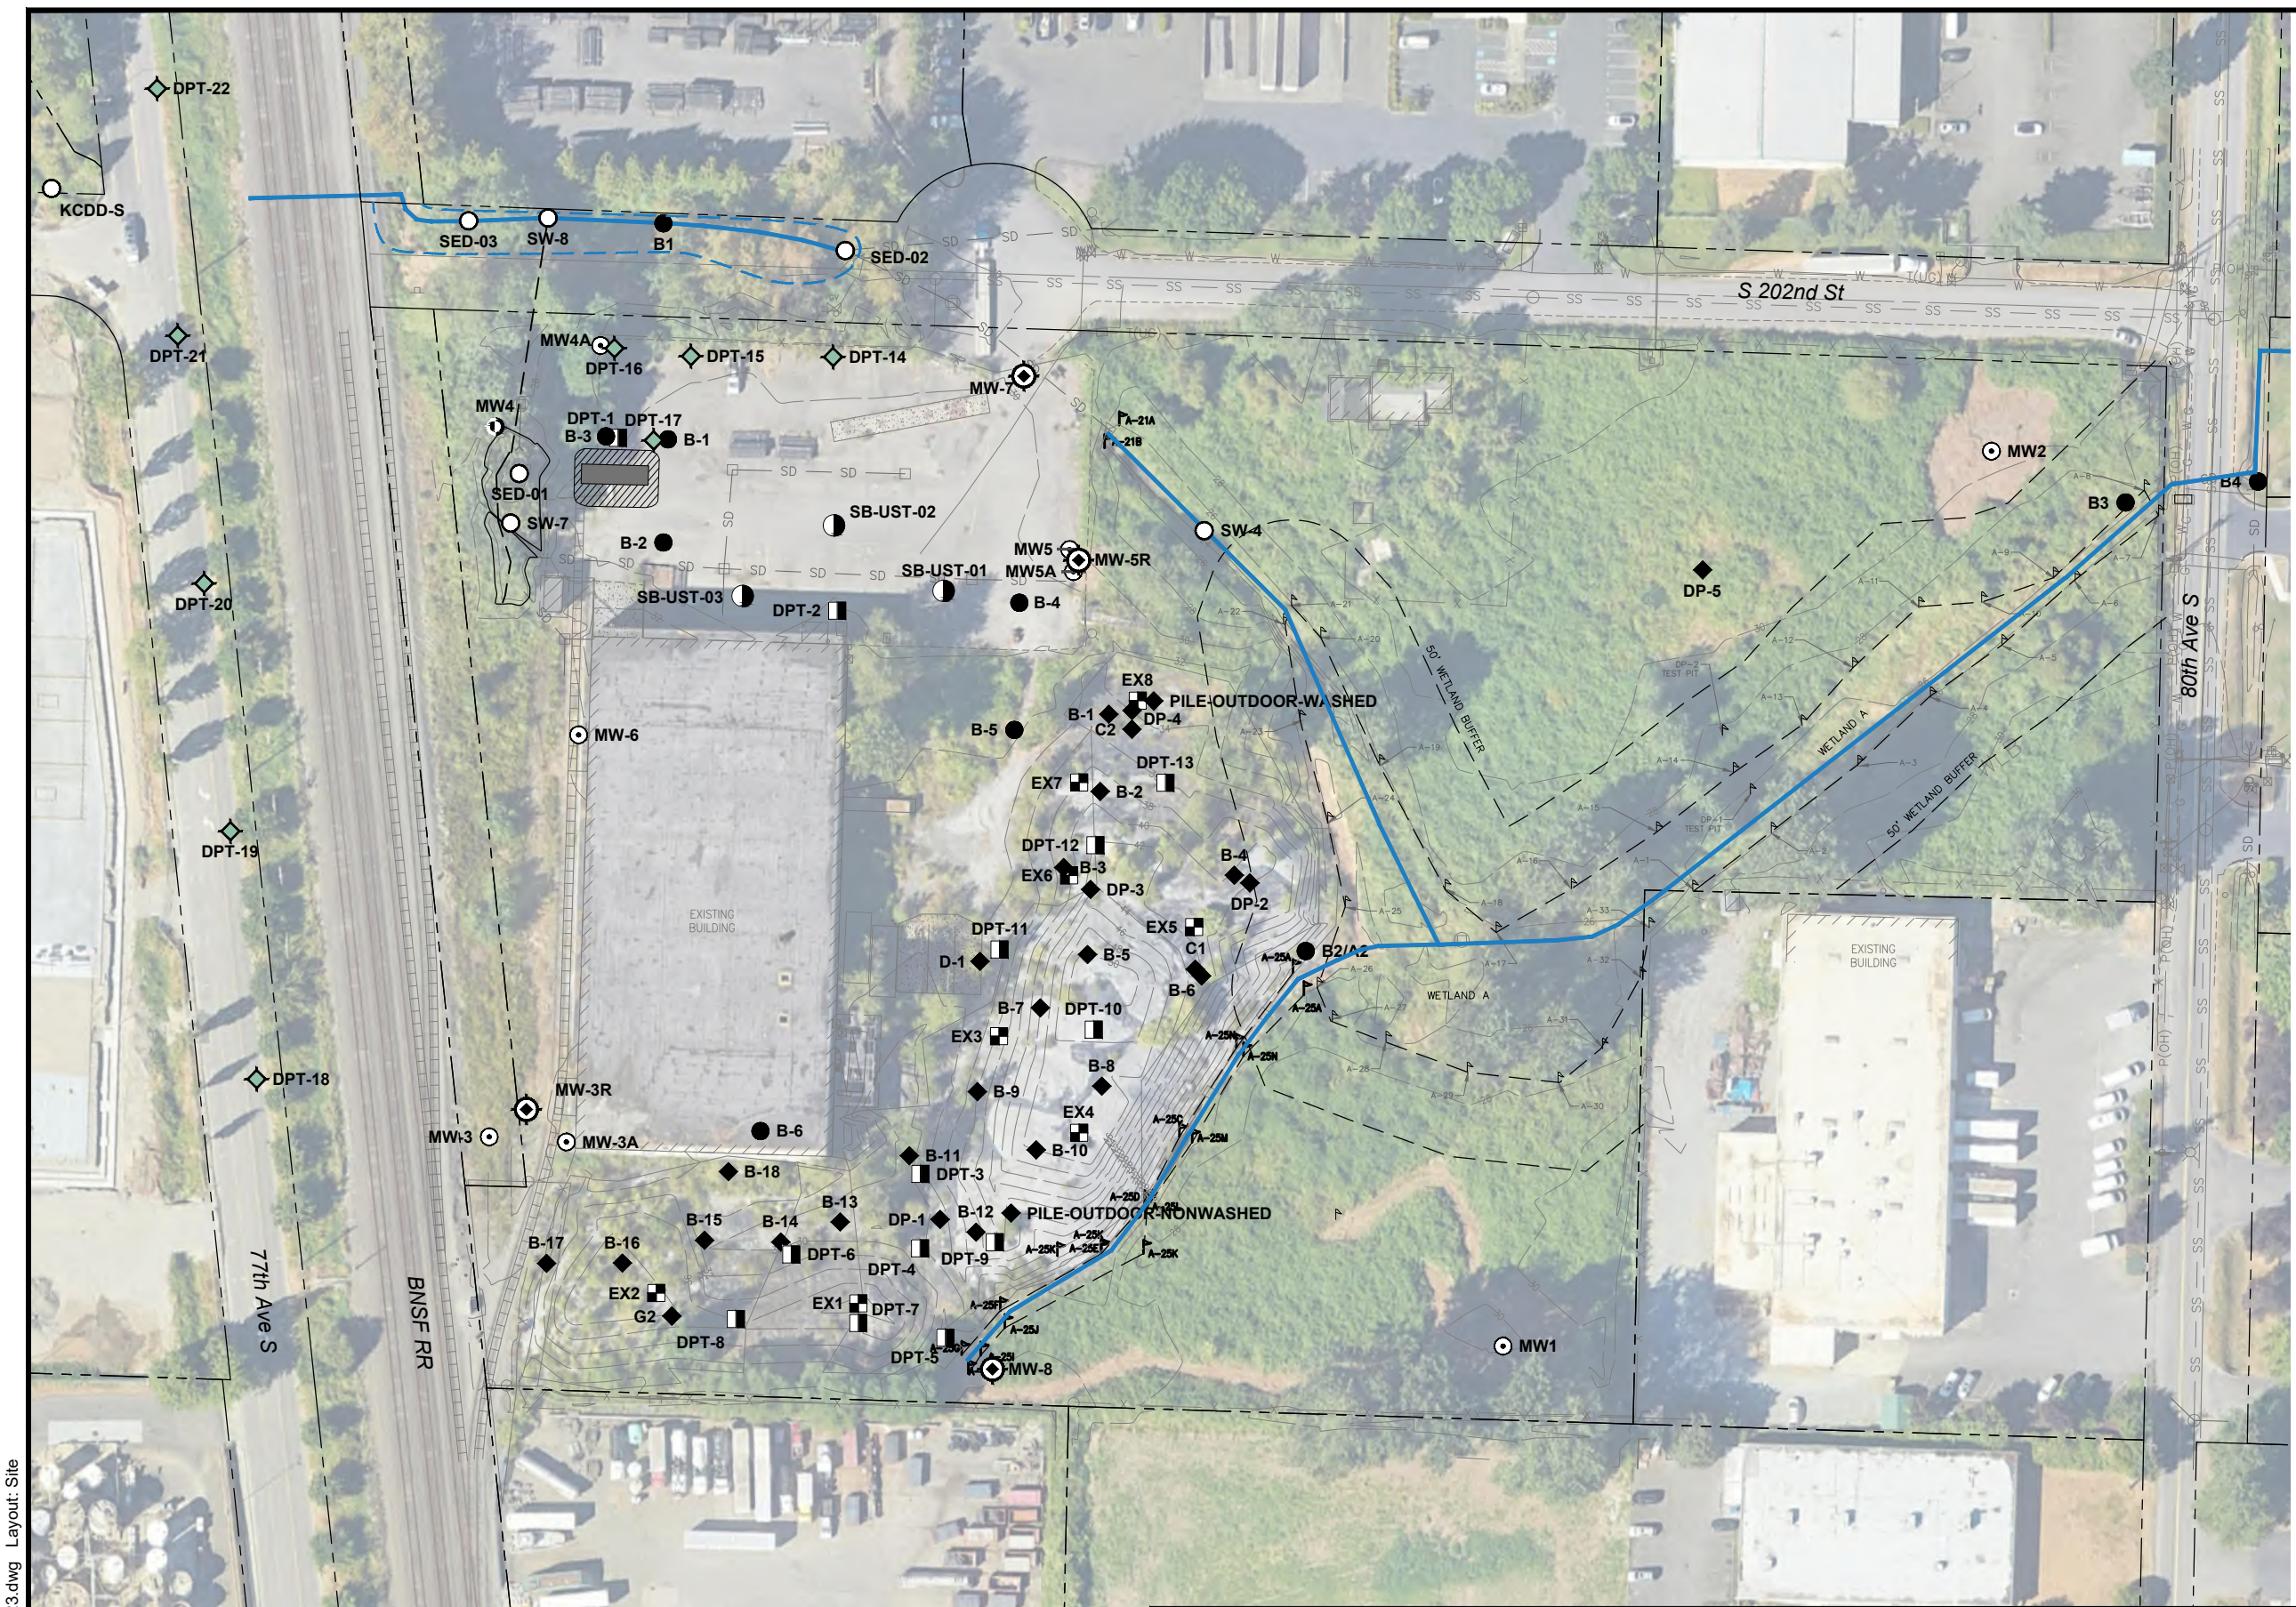
Figure 5
Site Map and Sample Locations

- Approximate Ditch Location
- RI Monitoring Well
- RI Direct Push Boring
- RI Groundwater Grab Boring
- Sediment Sample
- DPT Location (Crete, 2021 & 2022)
- Test Pits (Aerotech, 2017)
- Monitoring Well (Aerotech, 2017)
- Monitoring Well (M-K, 1990)
- Former Monitoring Well
- Historical Boring and Sediment Sample Location
- Former UST
- Former Excavation Location
- Parcel Boundary

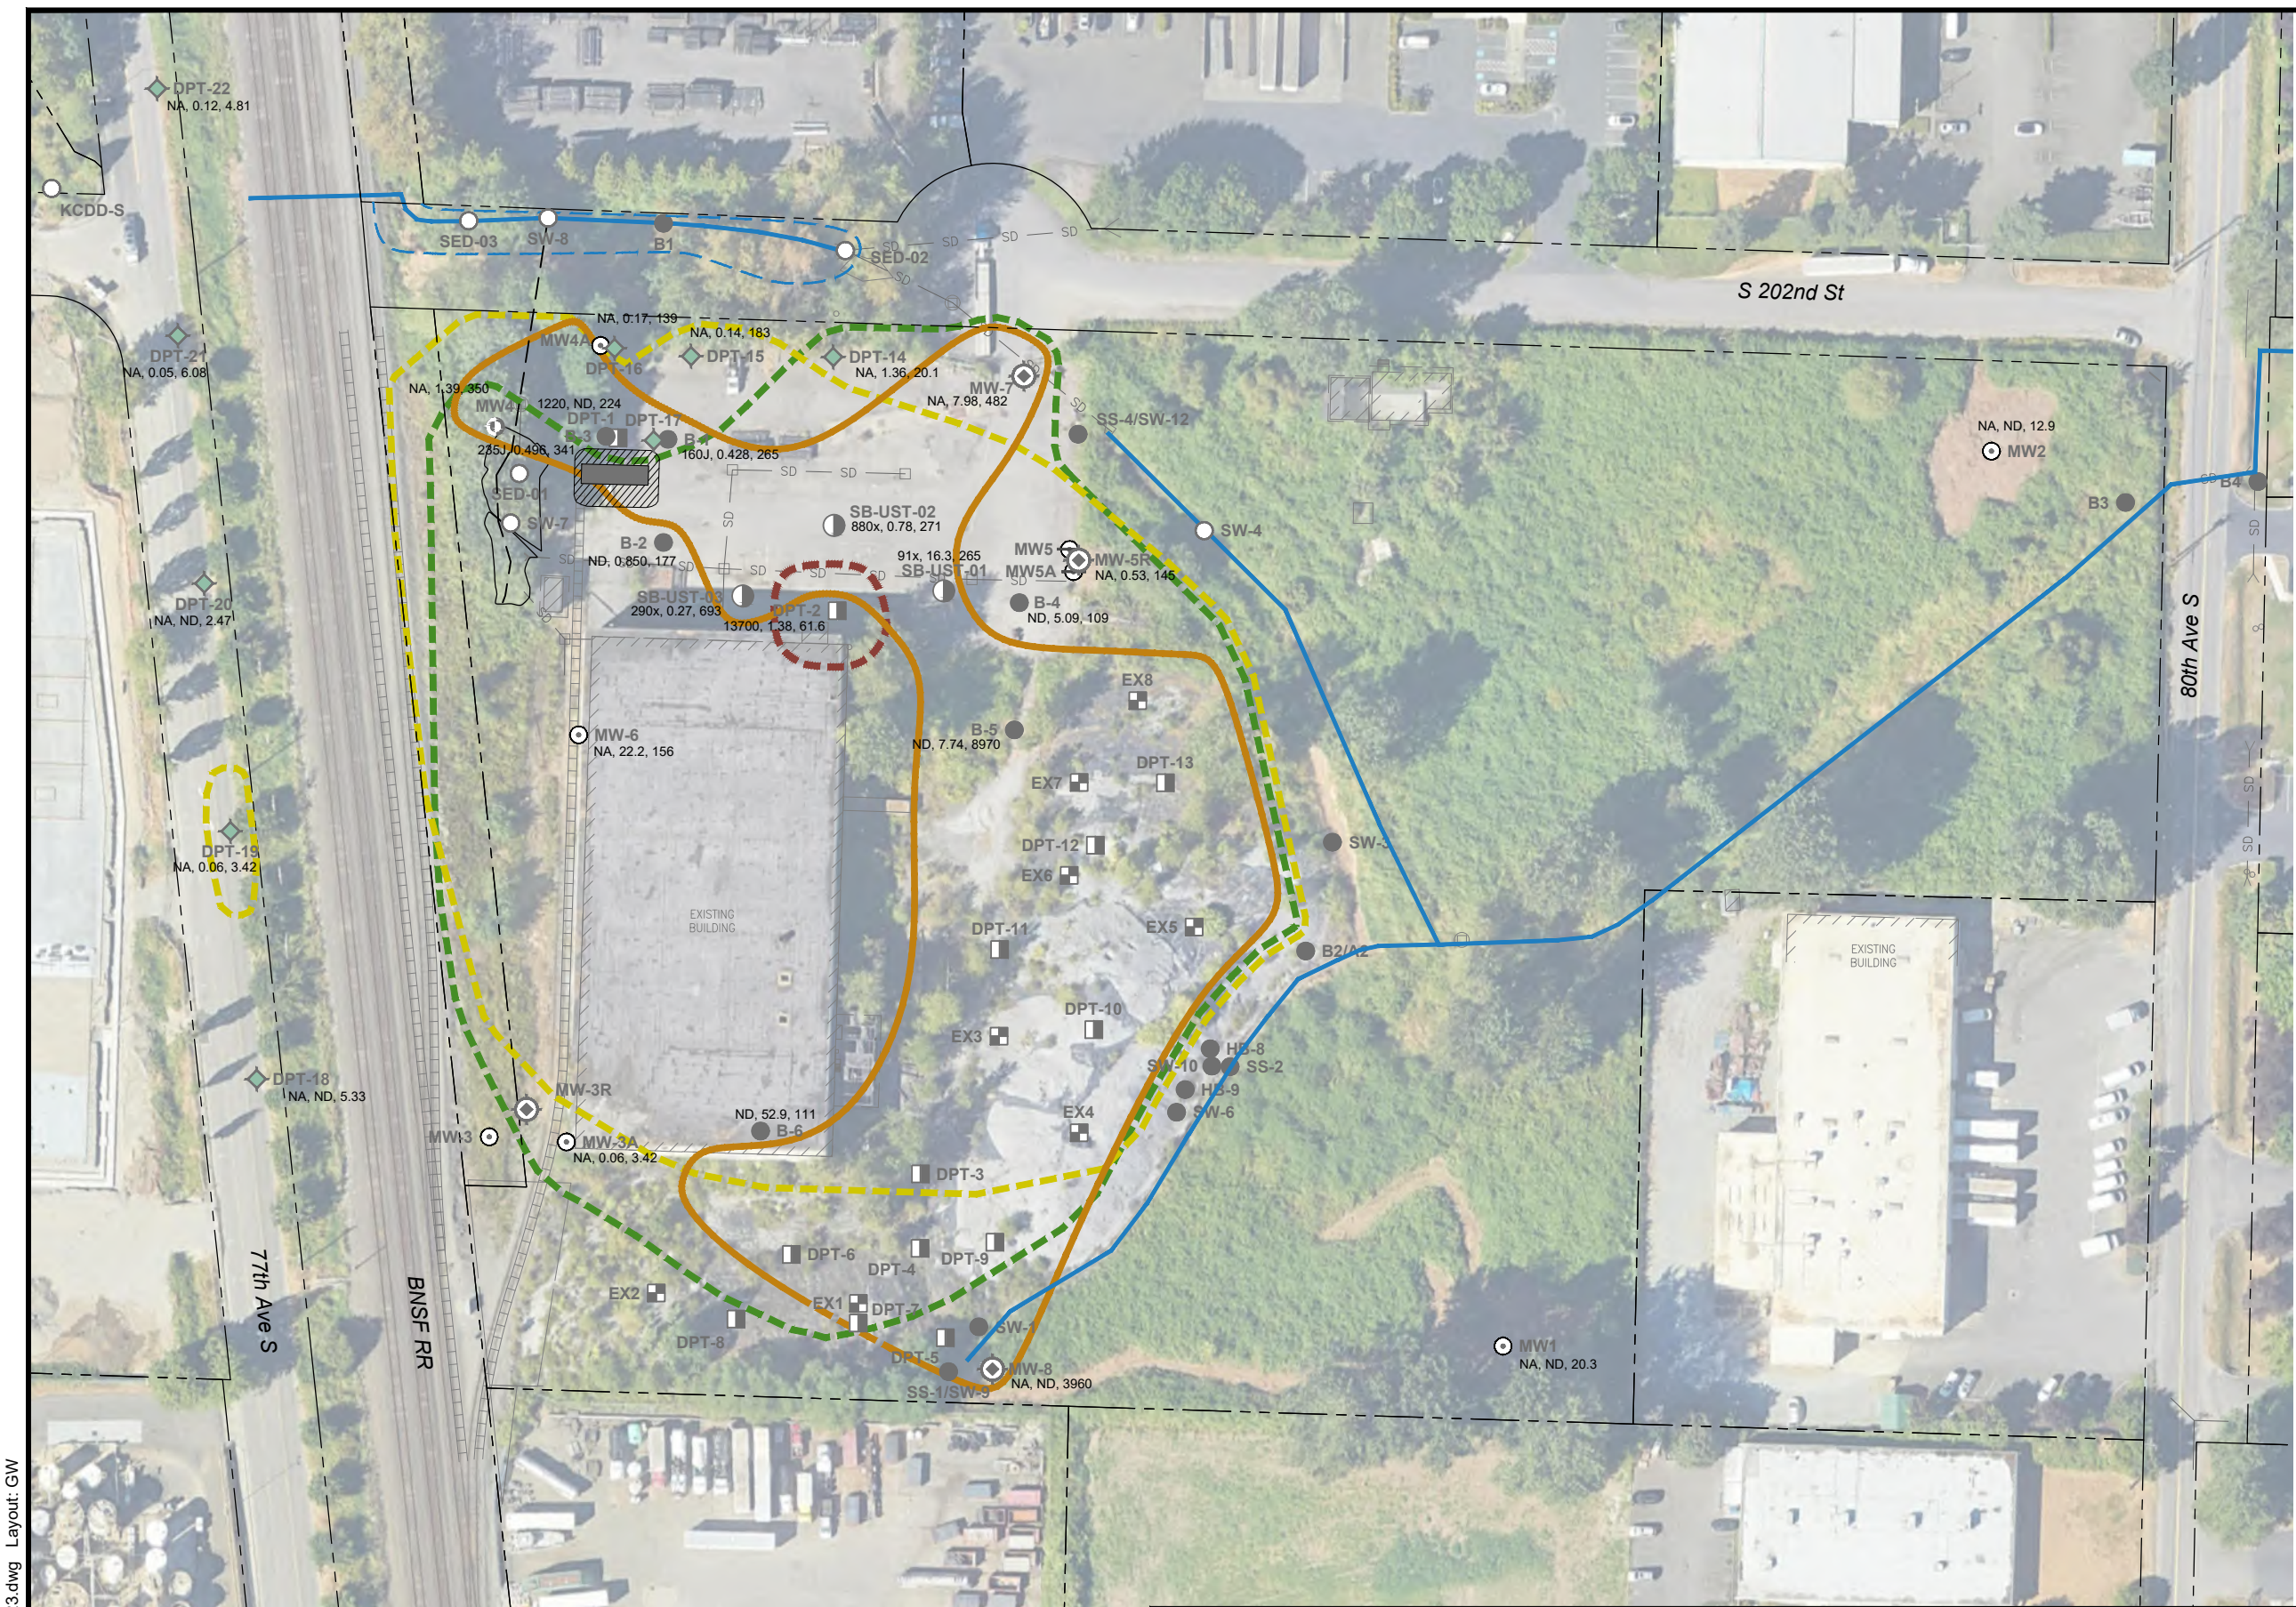
Figure 6
 Extent of Groundwater Impacts

Figure 6 illustrates the estimated extent of groundwater that exceeds screening levels based on 2022, 2021, and previously collected data. Fluoride exceeds screening levels throughout the property in areas downgradient (northwest) of the dross pile except for the far northwest corner (MW-4A and DPT-1). Fluoride may extend off the property to the west and the north in the vicinity of DPT-14 and MW-7. Chloride exceeds screening levels in areas limited to the northwest corner of the property. Chloride may extend off the property to the north near MW-4, MW-4A, and MW-7, and it is assumed these exceedances for chloride extend from under the black dross pile.

- - - Estimated Extent of Diesel in Groundwater
- - - Estimated Extent of Fluoride in Groundwater
- - - Estimated Extent of Chloride in Groundwater
- - - Estimated Extent of Dissolved As in Groundwater
- Approximate Ditch Location
- DPT Locations
- Sediment Sample (Crete, 2021)
- Test Pits (Aerotech, 2017)
- Monitoring Wells
- Former Monitoring Wells
- Historical Boring and Sediment Sample Locations
- Former UST
- Former Excavation Location
- - - Parcel Boundary
- 91x, 16.3, 265 TPH-Dx, FI-, CI- Concentrations in mg/kg

On August 28, 2022, groundwater samples were collected from direct push probe locations SB-UST-01, -02, and -03 to define the extent of TPH-Dx in groundwater. All samples were below screening levels, leaving DPT-2 as the only sample location with a TPH-Dx concentration that exceeds the screening level. Figure 6 provides the estimated extent of diesel in groundwater.

Groundwater contamination at the site is primarily due to the outdoor black dross stockpile. Groundwater is impacted by metals, fluoride, and chloride. A much smaller TPH-diesel plume is also present. As indicated on Figure 6, these impacts are primarily constrained to within the property boundary, indicating that current conditions may satisfy a conditional point of groundwater compliance at the property boundary. The one off-site exceedance of dissolved arsenic at DPT-19 is 8.93 µg/L, slightly exceeding the natural background level of 8.0 µg/L. Based on these data, following the excavation of the waste stockpiles, contaminated soil/sediment is proposed to be excavated to satisfy MTCA Method B Direct Contact criteria.
