## INDEPENDENT REMEDIAL ACTION REPORT

# Seward Park Estates Underground Storage Tank Removal

Lake Washington Limited Partnership

April 16, 1997

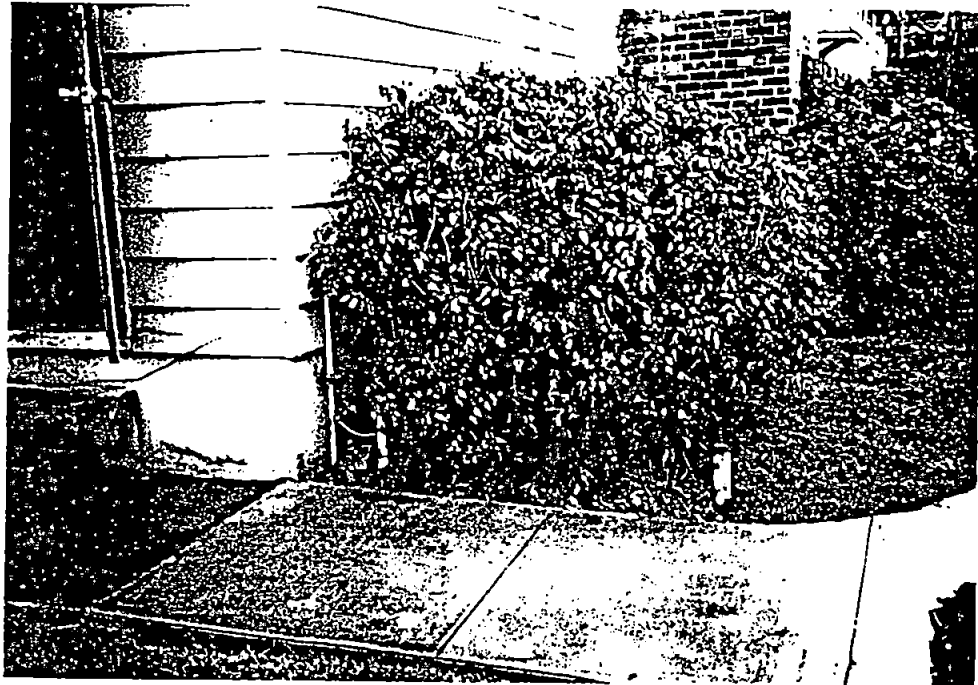
View of fuel oil fill pipes outside boiler room #2,  
Photo date 03/10/95.

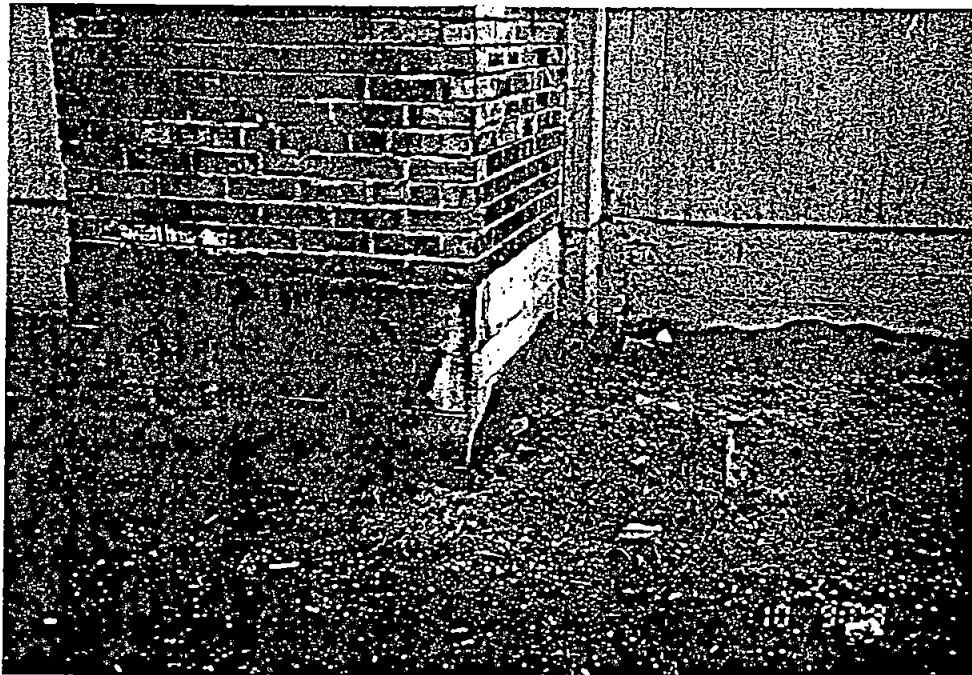
View of fuel oil fill pipe outside boiler room #8,  
photo date 03/10/95.

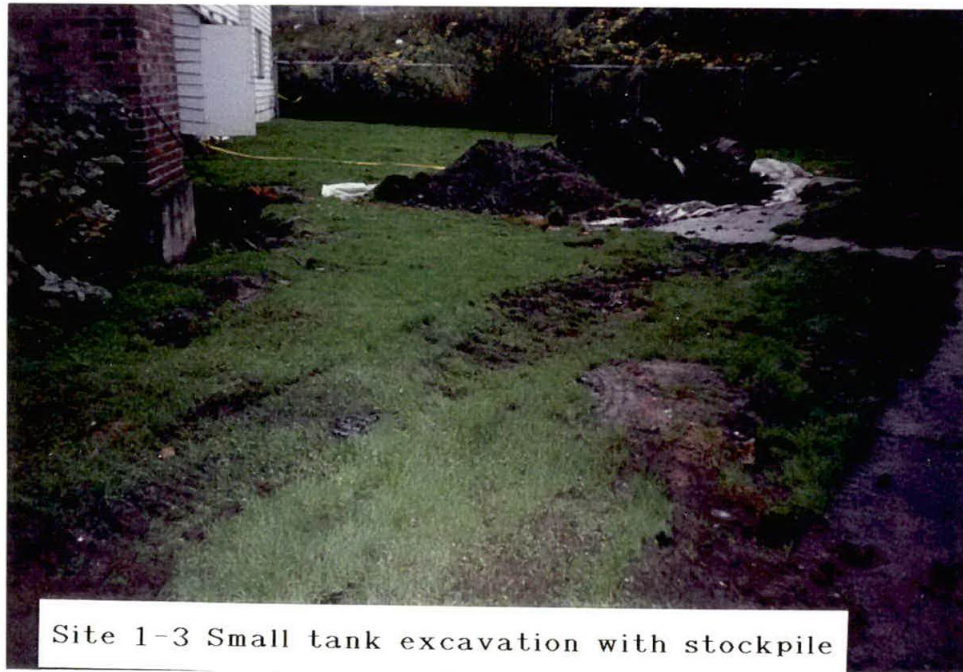
Site 1-3 Small tank excavation with stockpile

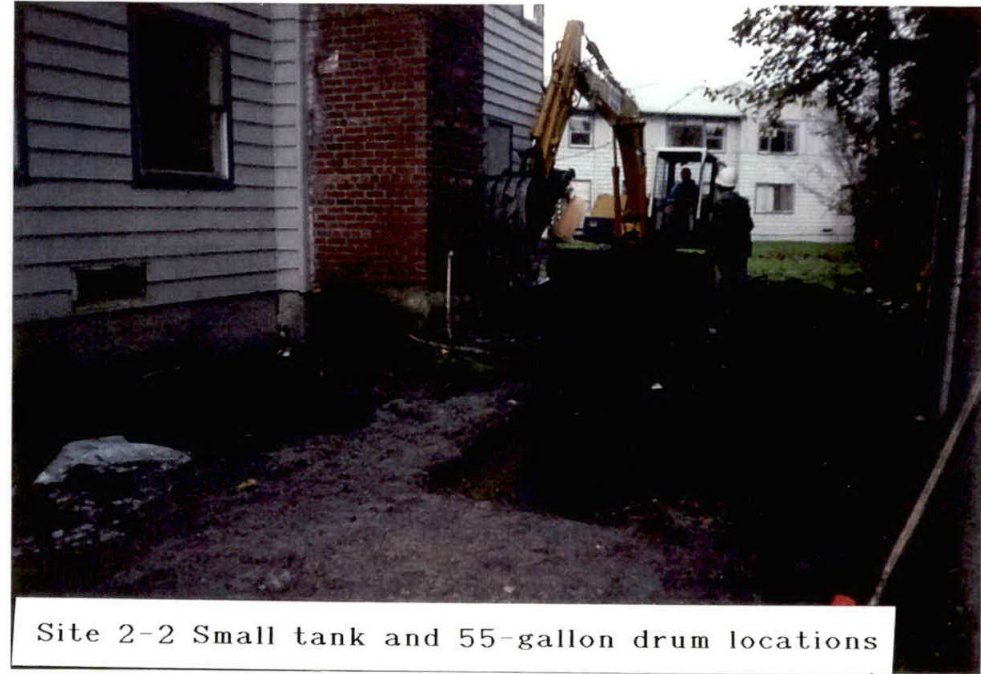
Site 2-2 Small tank and 55-gallon drum locations

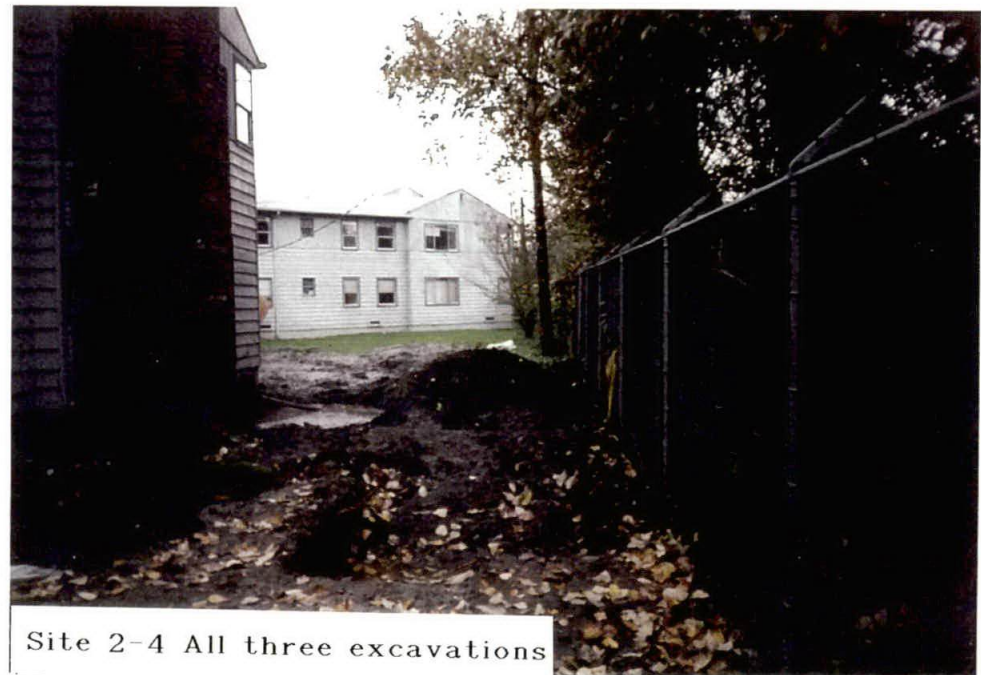
Site 2-4 All three excavations

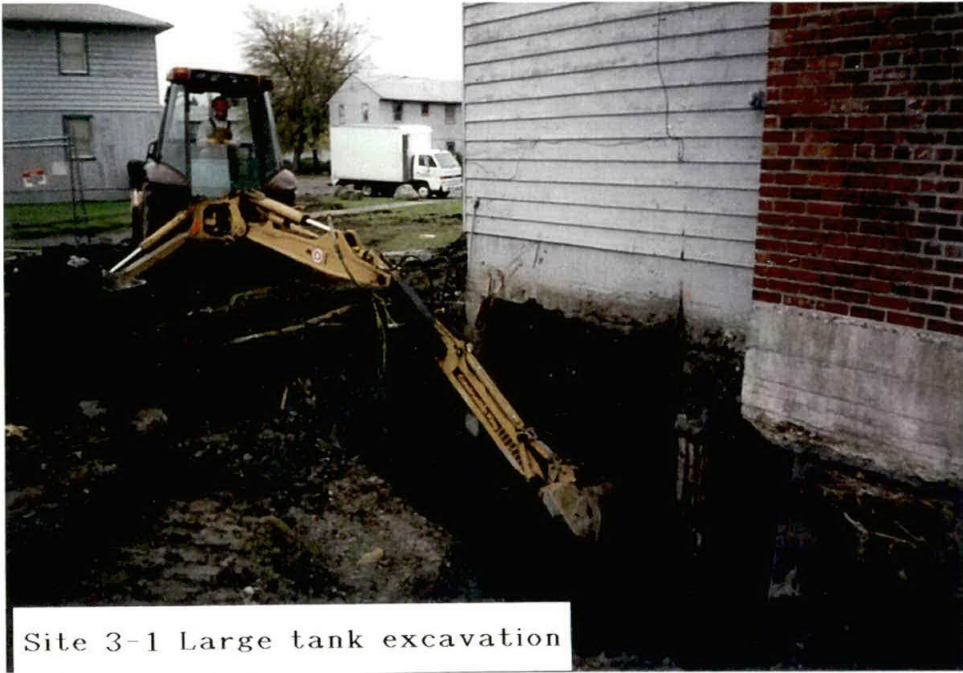
Site 3-1 Large tank excavation

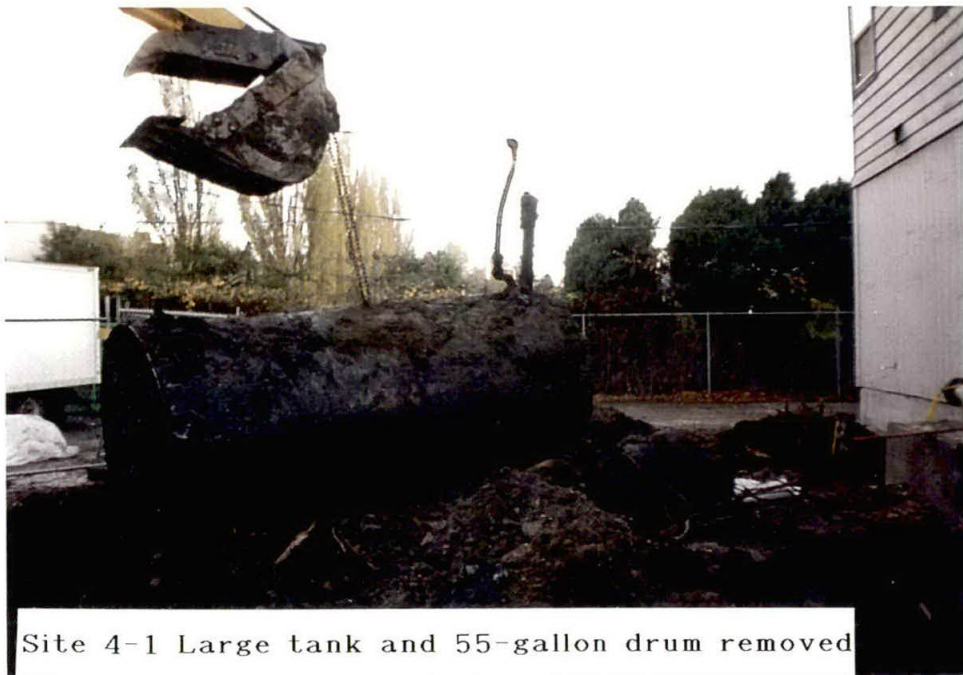
Site 4-1 Large tank and 55-gallon drum removed

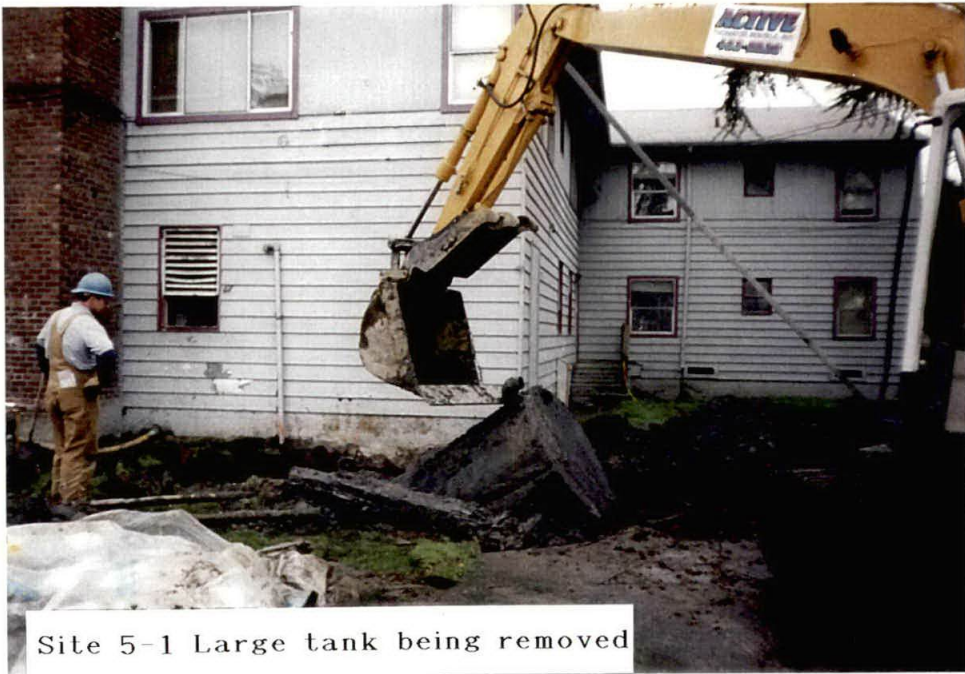
Site 5-1 Large tank being removed

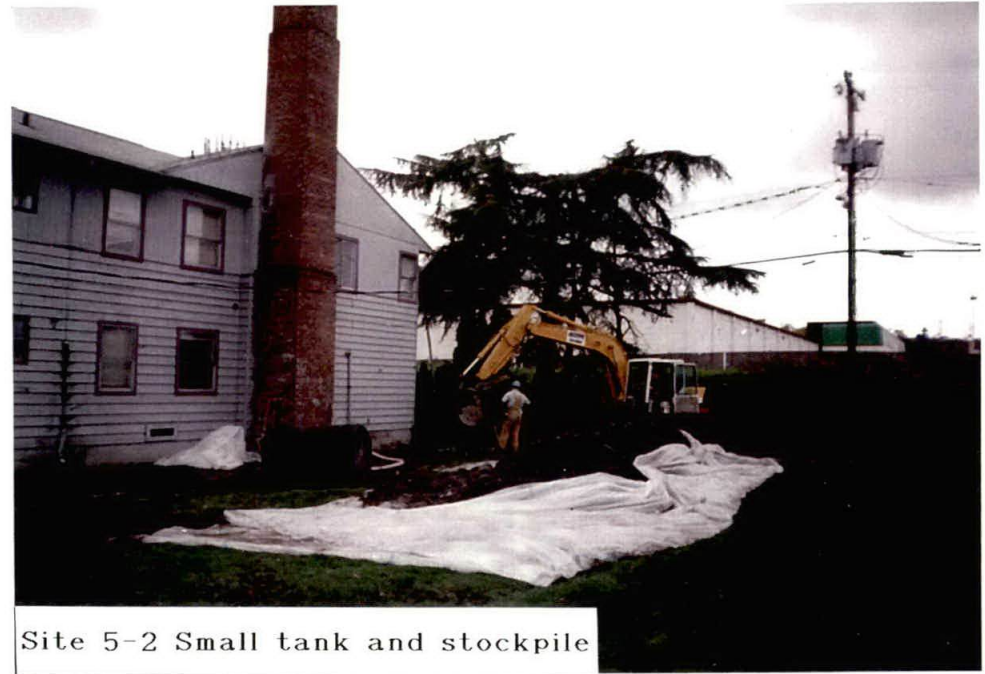
Site 5-2 Small tank and stockpile

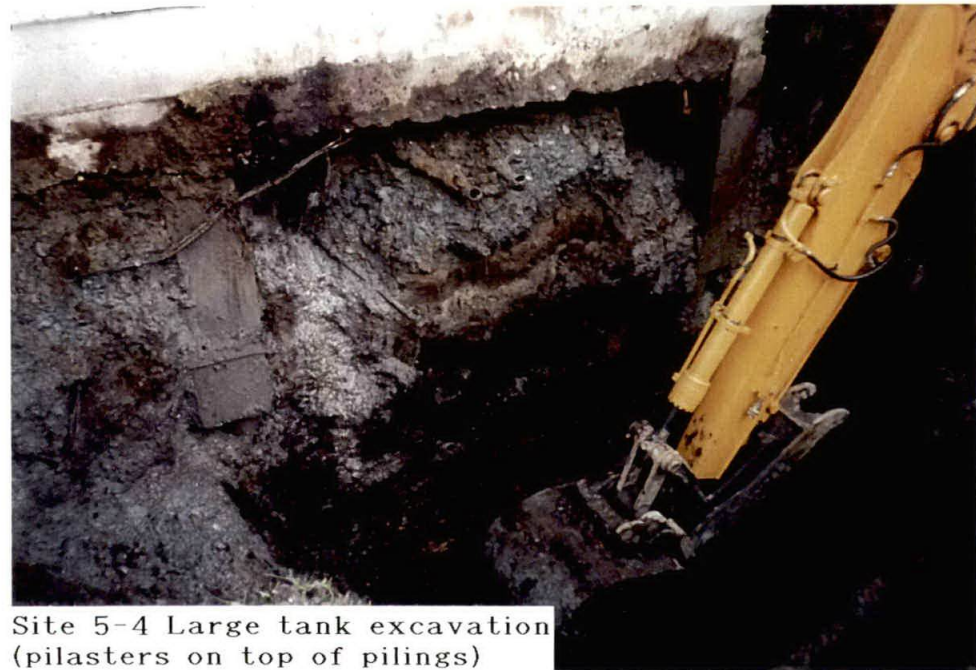
Site 5-4 Large tank excavation (pilasters on top of pilings)

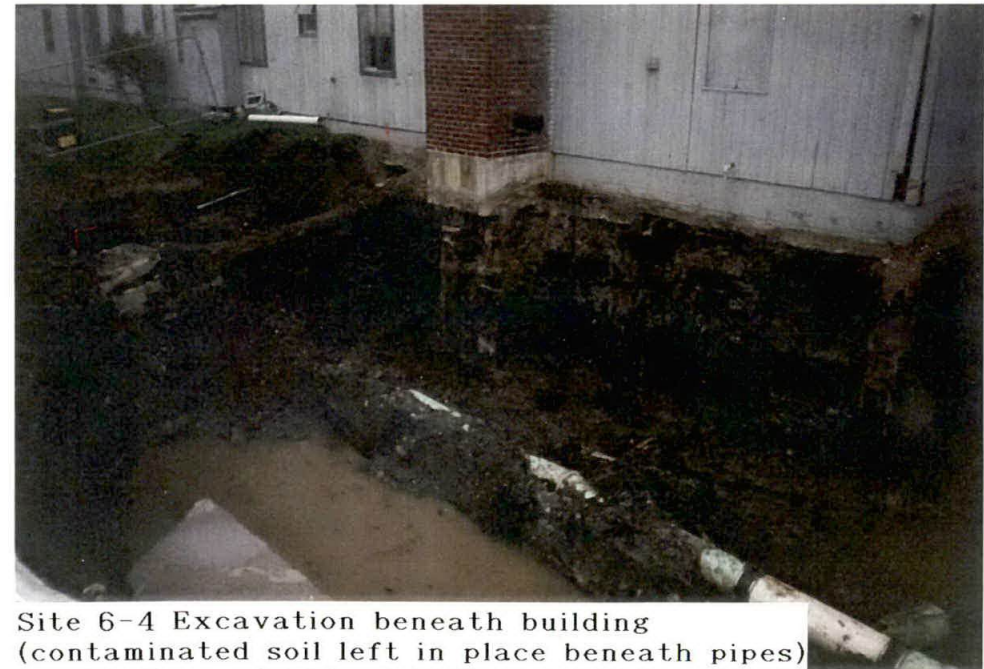
Site 6-4 Excavation beneath building  
(contaminated soil left in place beneath pipes)

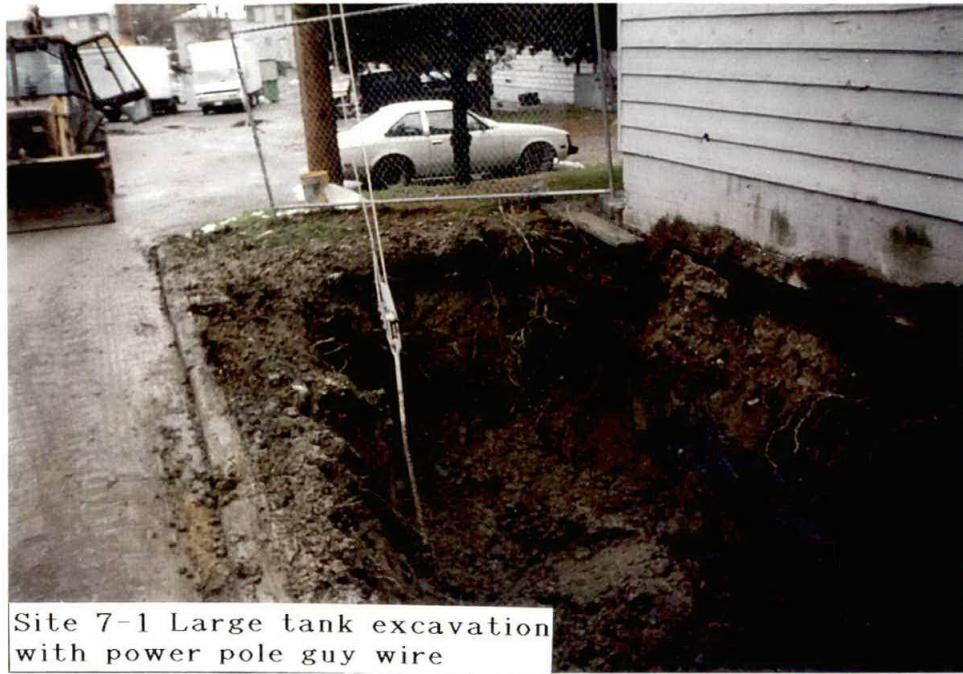
Site 7-1 Large tank excavation with power pole guy wire

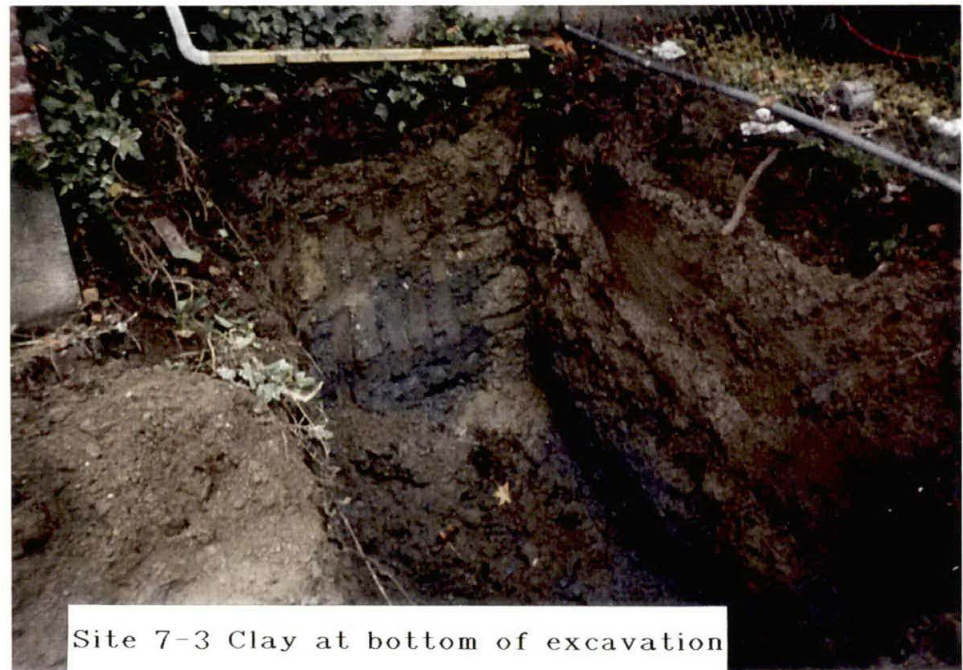
Site 7-3 Clay at bottom of excavation

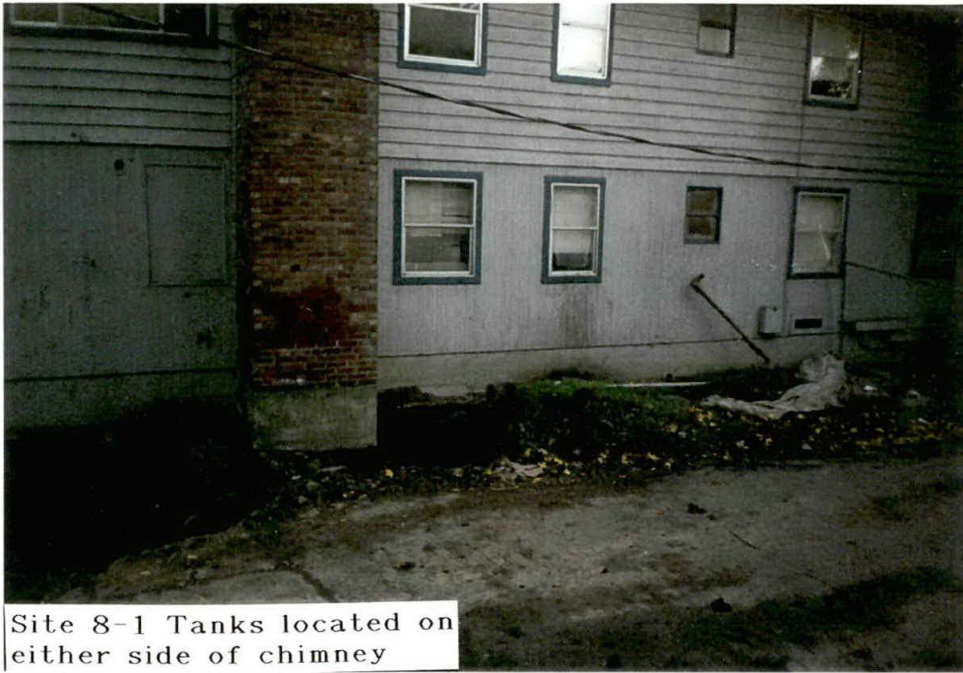
Site 8-1 Tanks located on either side of chimney

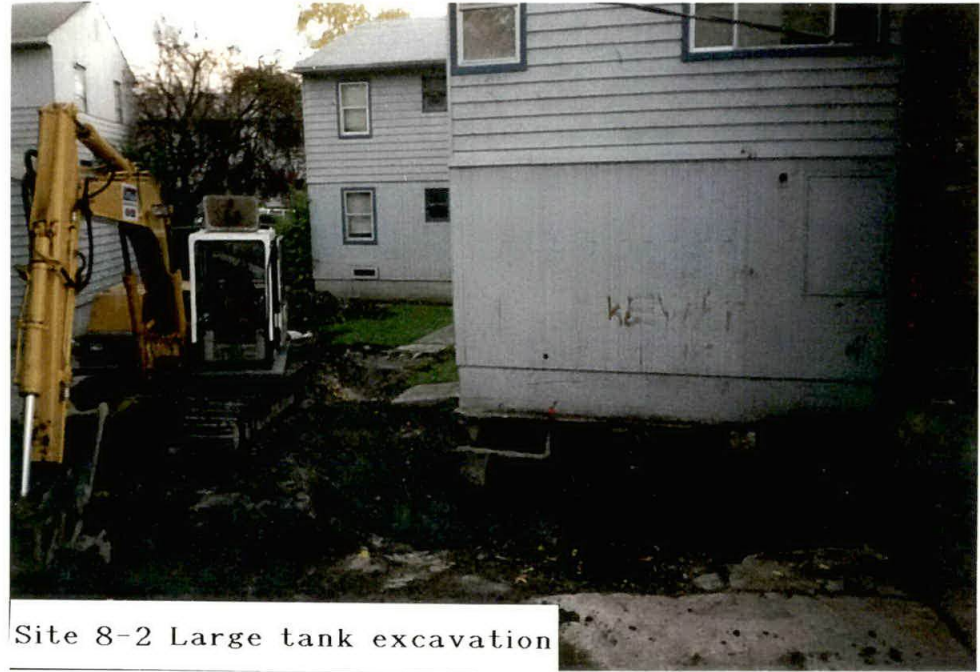
Site 8-2 Large tank excavation

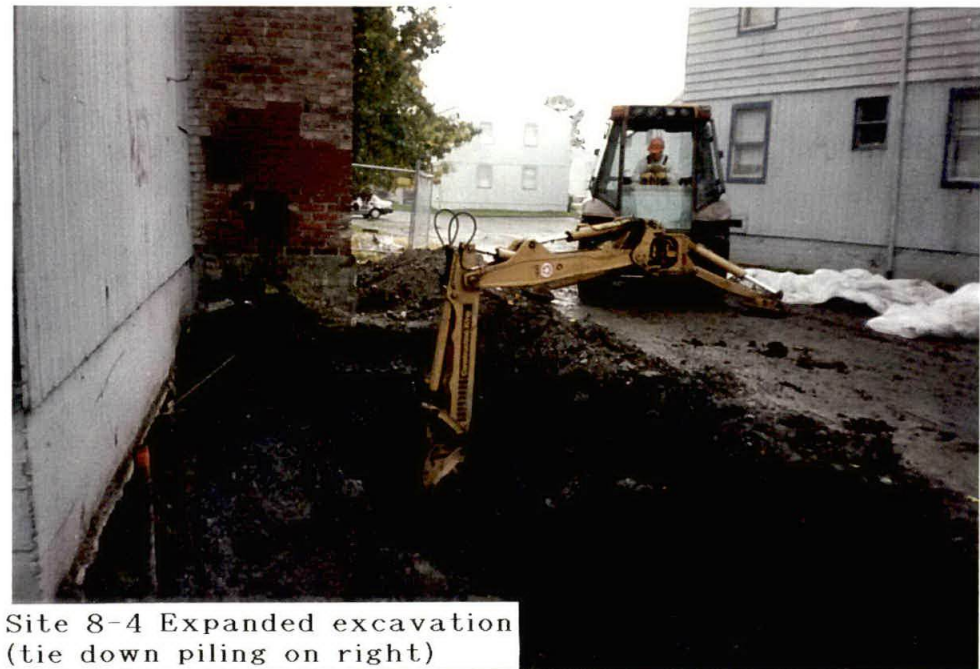
Site 8-4 Expanded excavation (tie down piling on right)

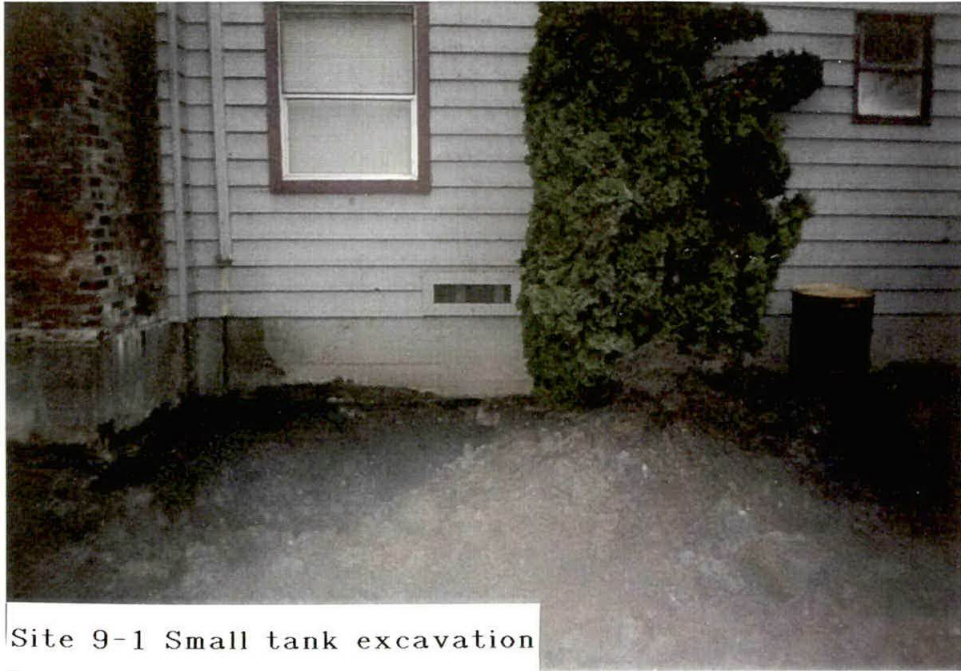
Site 9-1 Small tank excavation

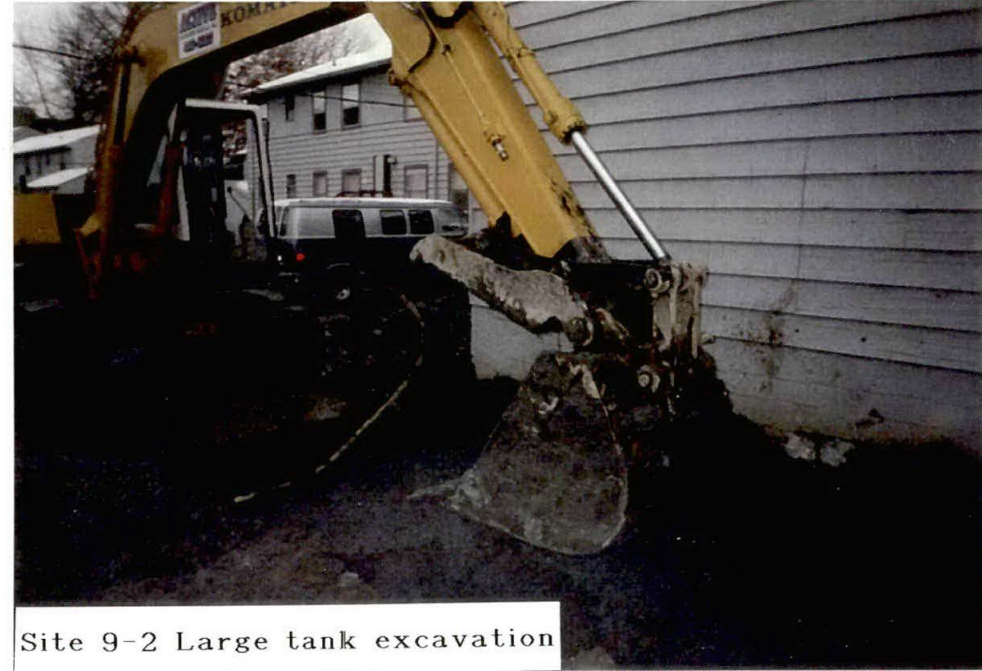
Site 9-2 Large tank excavation
