APPENDIX C
Standard Operating Procedures

GRAB VAPOR EXTRACTION SYSTEM AIR SAMPLING

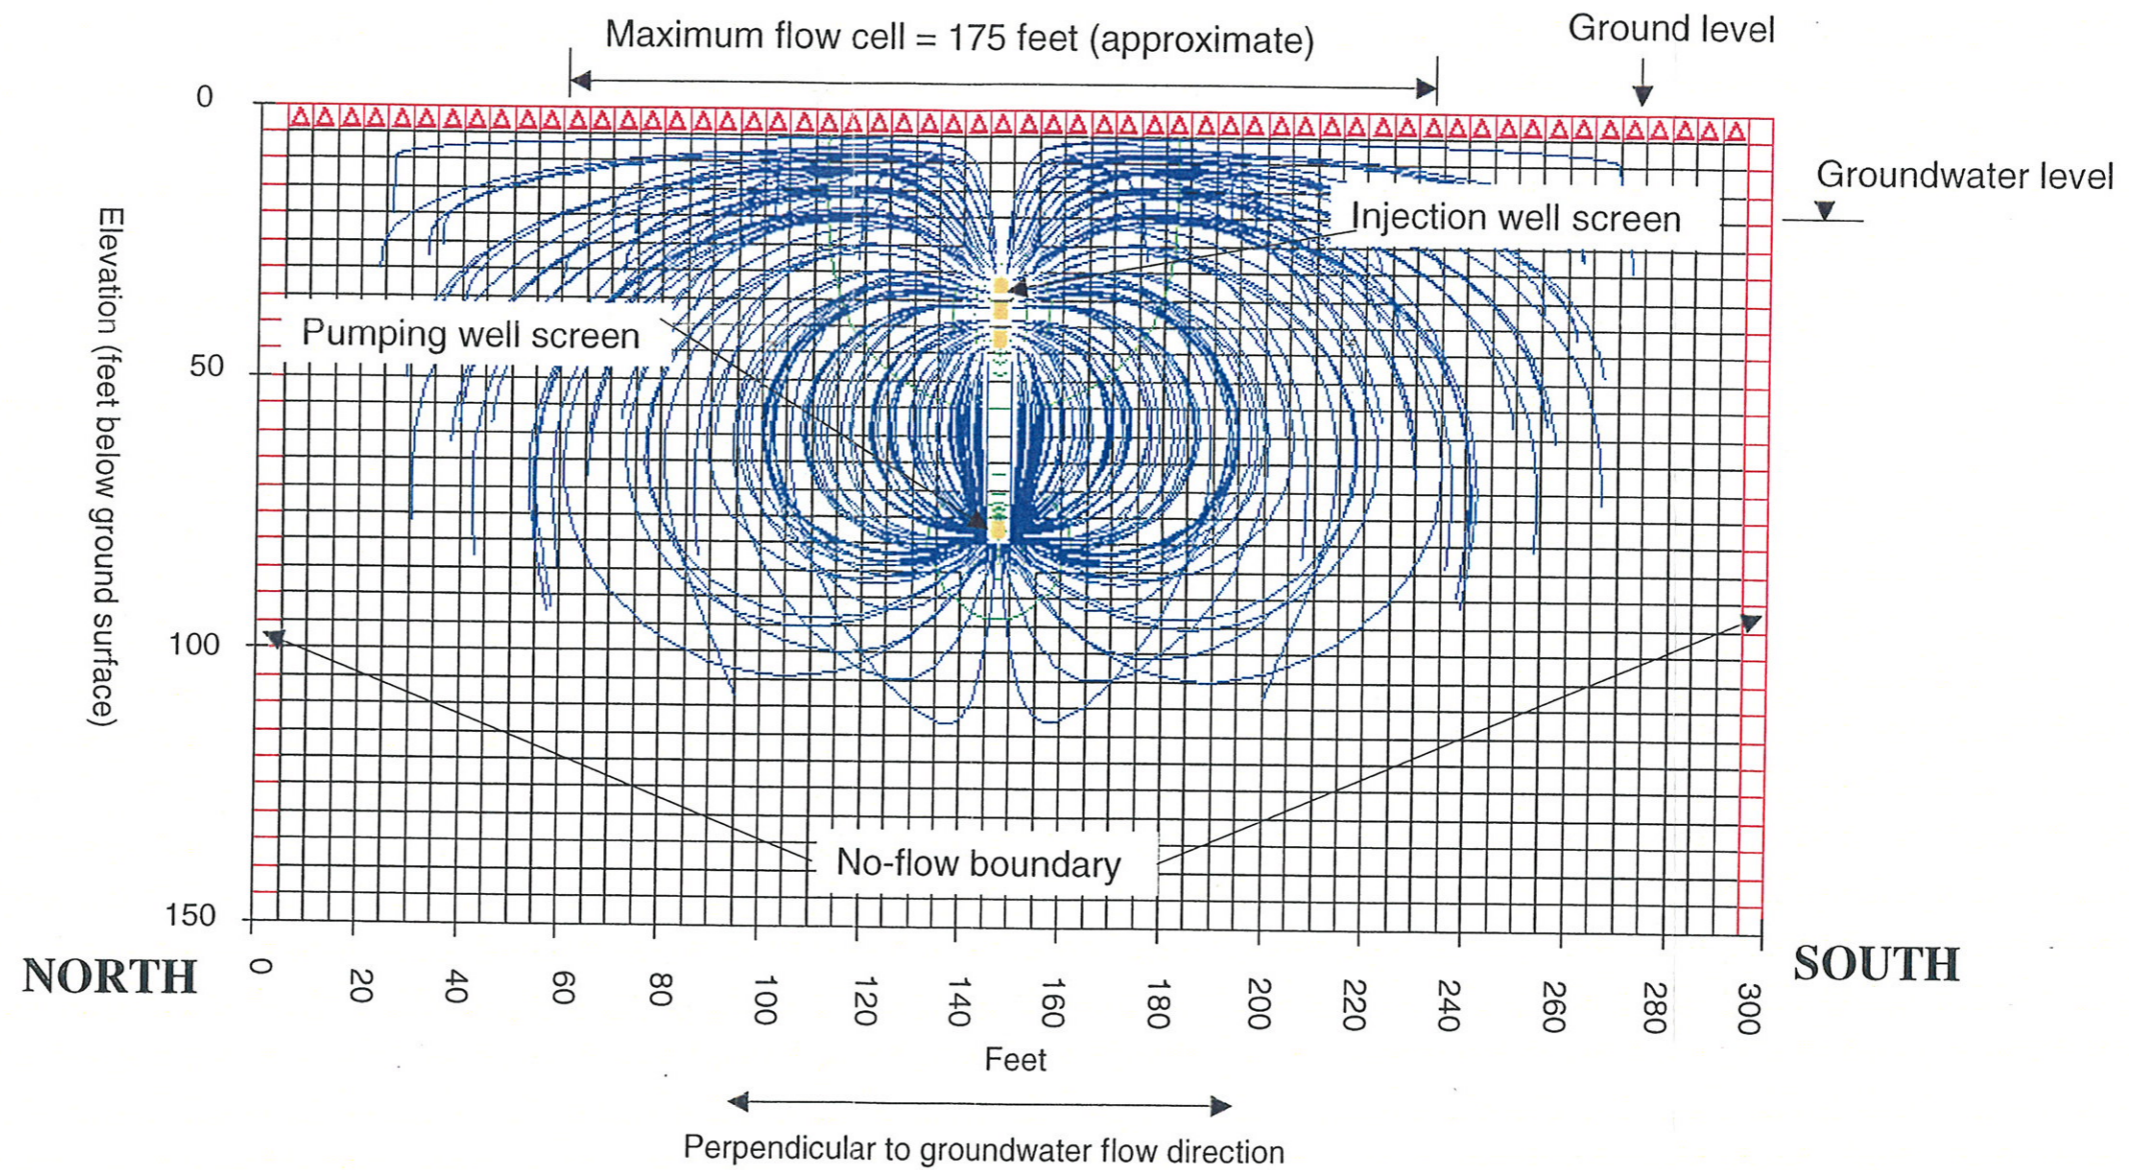
FIGURE 3

**Cadet Manufacturing Company
Model Cross Section Perpendicular to
Groundwater Flow Direction with Maximum
Radius of Influence in approximately 2 months
(Flowrate = 300 gpm)**

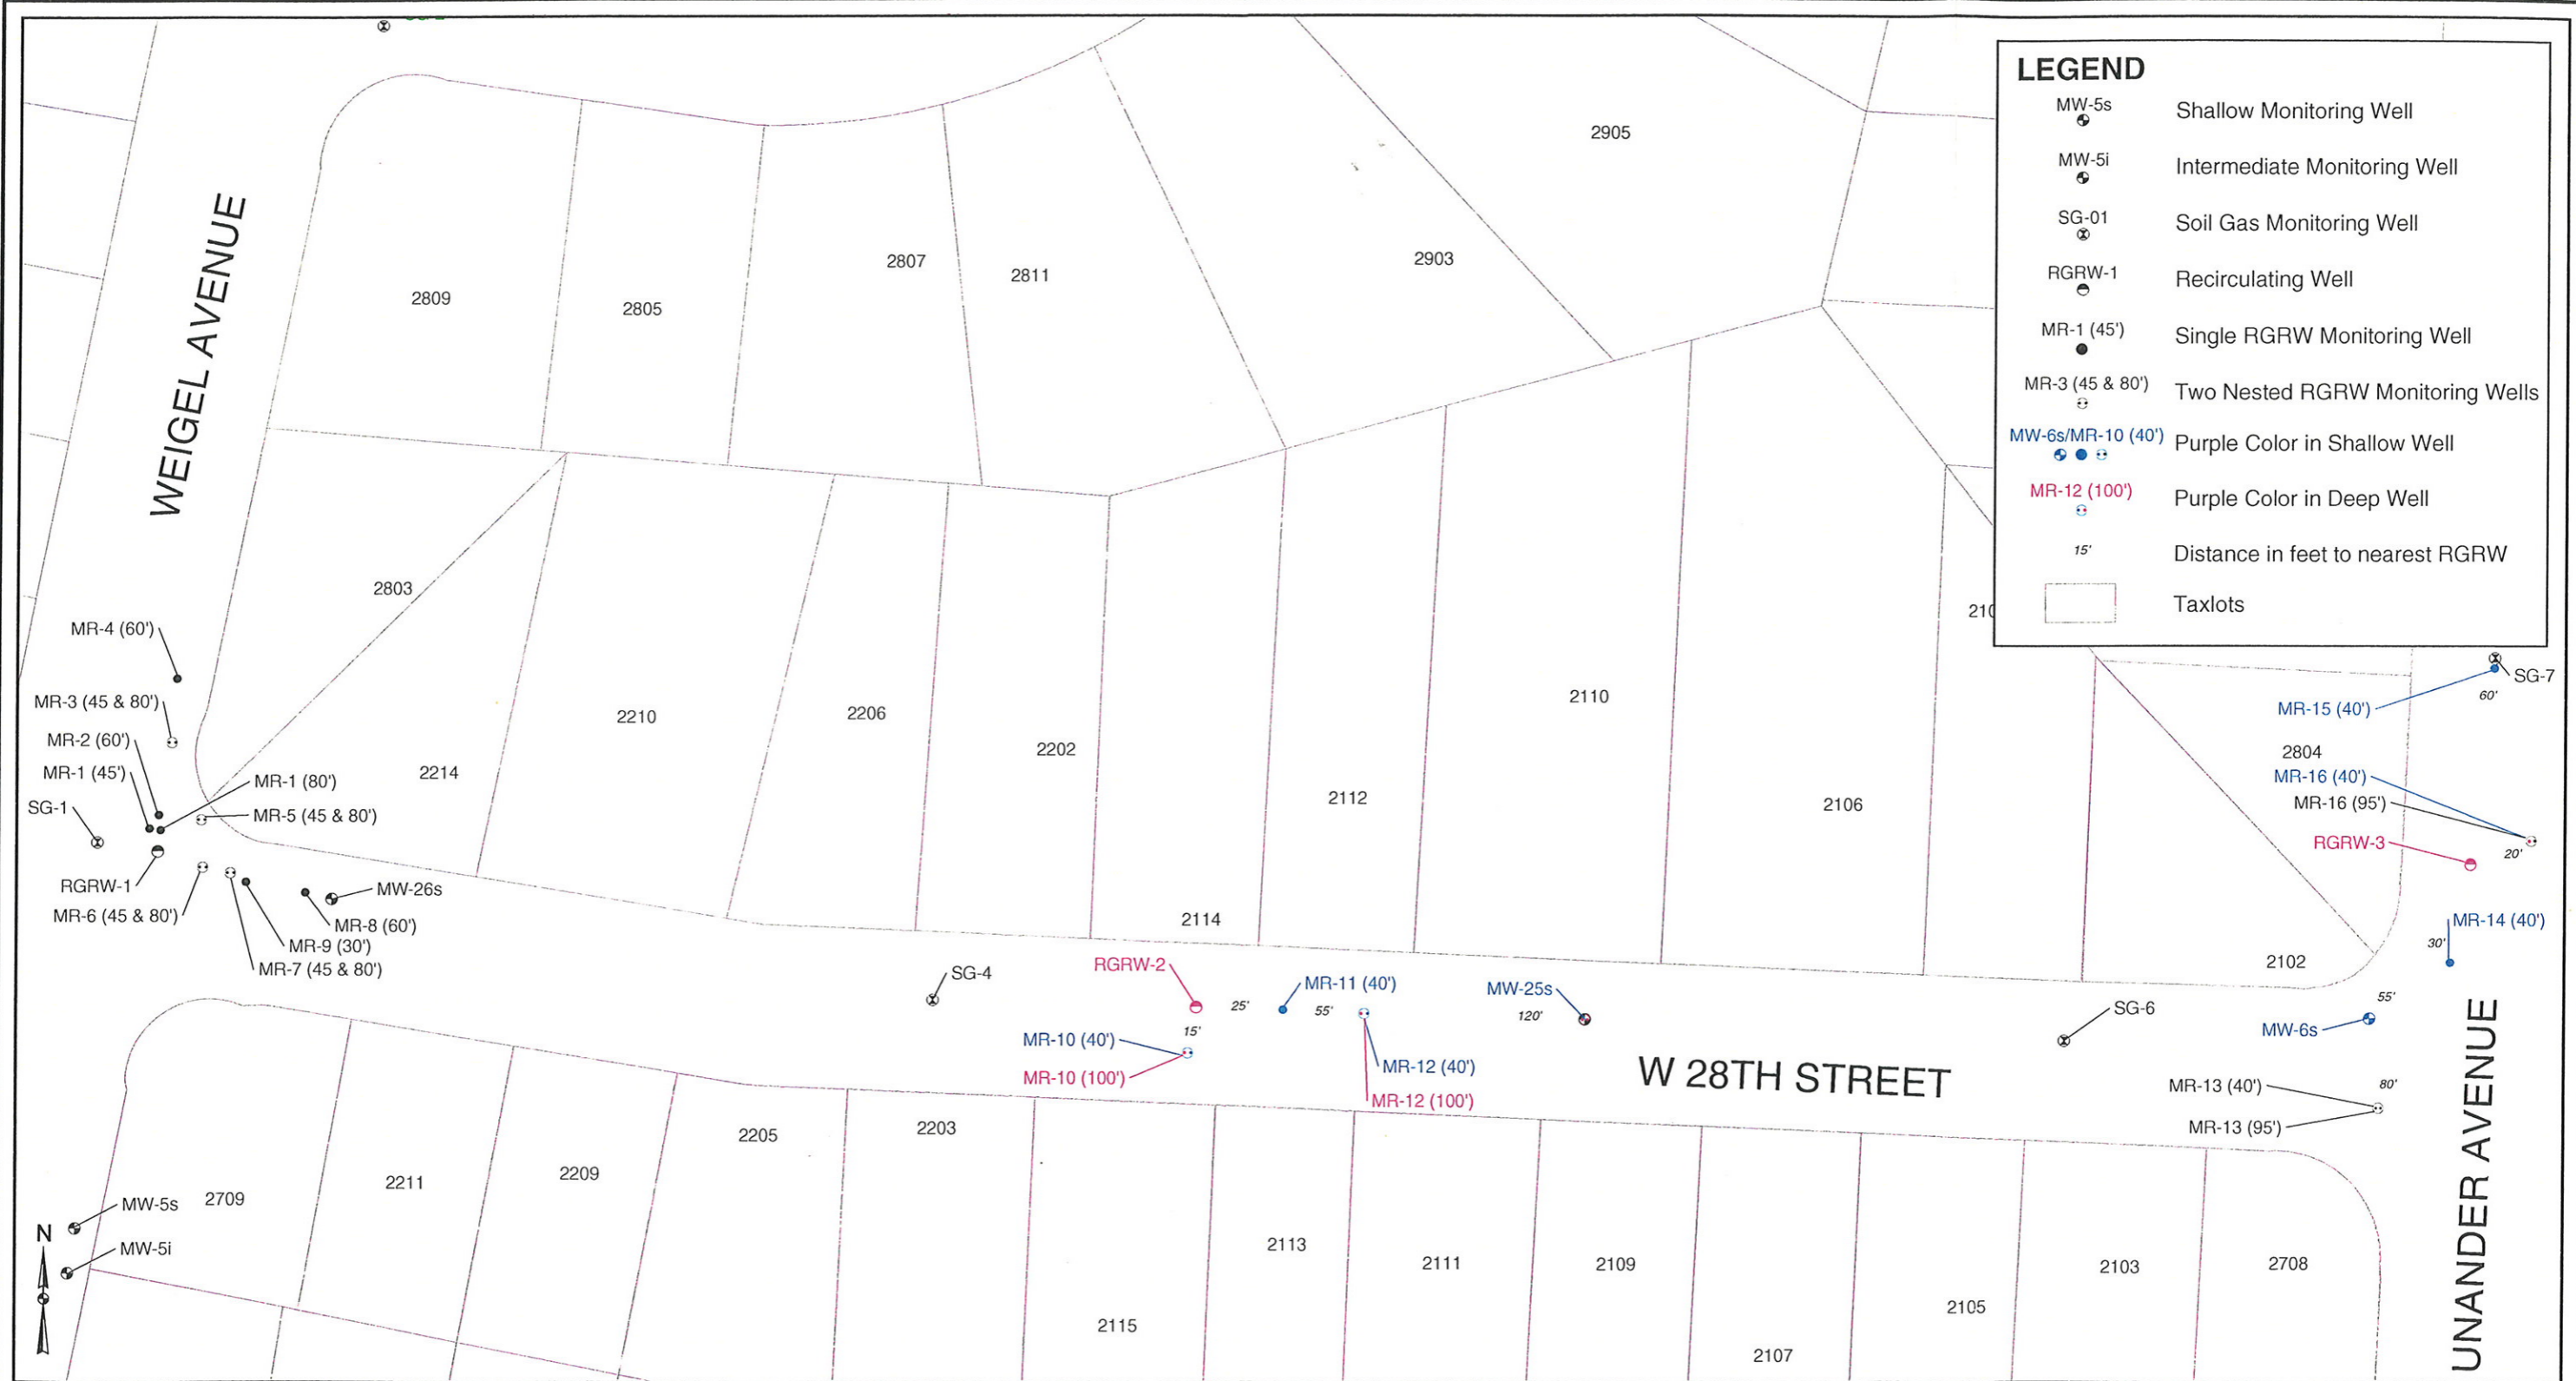
ACTUAL RADIUS OF INFLUENCE OF
RECIRCULATING WELL (RGRW-1) BASED
ON TRACER RESULTS
