#### **Environmental Covenant**

**b.** The Property that is the subject of this Covenant (hereafter "Property") is part of a site commonly known as Texaco 211544, 8701 Greenwood Ave N, Seattle, Washington, Facility Site ID 63538329. The Property is depicted on the sketch attached as Exhibit C. The Property is affected by releases from the SMI Inc. Trust site, 8733 Greenwood Avenue N, Seattle, Washington, Facility Site ID 74731271, Cleanup Site ID 4350 and is part of Grantor's real property legally described in Exhibit A, and illustrated in Exhibit B, both of which are attached. If there are differences between these two Exhibits, the legal description in Exhibit A shall prevail.

# SOIL CAP MANAGEMENT PLAN

8701 Greenwood Avenue N Seattle, Washington

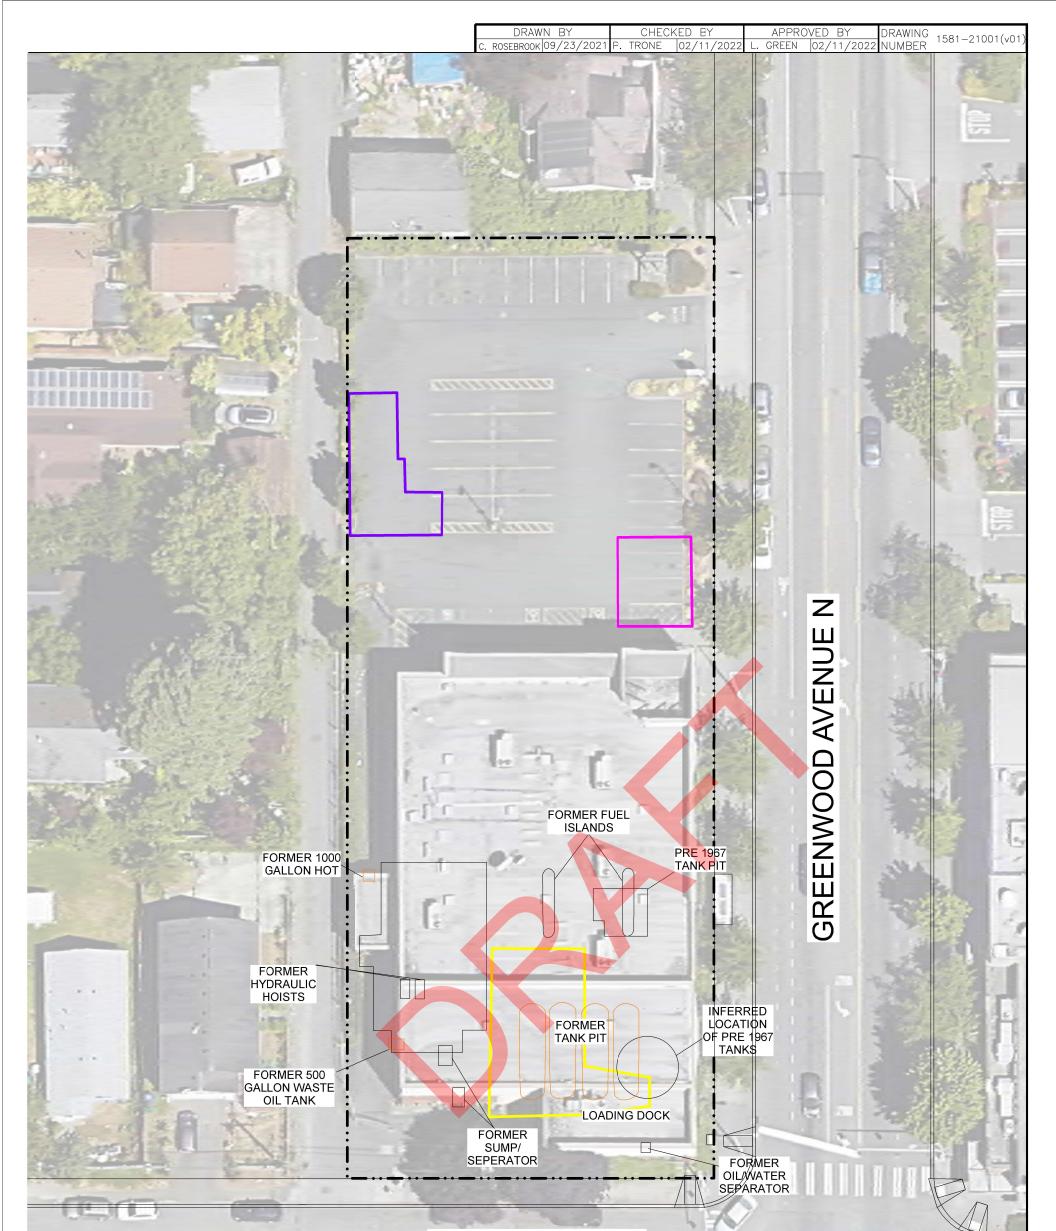
### PROPERTY MAP

LEGEND:	NOTES:	
SUBJECT BUILDINGS	<ol> <li>BASE MAP DEVELOPED FROM AN AERIAL PHOTOGRAPH MAP DATED 2019 AND ENW FIELD NOTES.</li> </ol>	
SUBJECT PROPERTY BOUNDARIES	2. ALL BUILDING, STREET, AND FEATURE	PO BOX 14488, PORTLAND, OREGON 97293
FORMER GAS STATION PER 1950 HISTORICAL SANBORN MAP	3. SYMBOLS REPRESENT LOCATION AND	P: (503)452-5561, E: ENW@EVREN-NW.COM
FORMER VANITY CLEANERS PER CITY DIRECTORY 1951–1955, LOCATION BASED ON 1950–1966 SANBORN MAP	DO NOT ALWAYS REPRESENT EXACT SHAPE, SIZE, OR ORIENTATION.	FIGURE 2 SITE PLAN WITH HISTORICAL
FORMER LAUNDRY PER 1930 HISTORICAL SANBORN MAP	APPROXIMATE SCALE	FEATURES OF INTEREST FORMER TEXACO 211544 FACILITY
* FORMER FEATURES PER 1994 EMCON NORTHWEST INC. AND TEXACO 1991 AND ENVIRO. RESOLUTION INC. 1994 AND 1996	0 30 60 FEET	8701 GREENWOOD AVENUE N SEATTLE, WASHINGTON

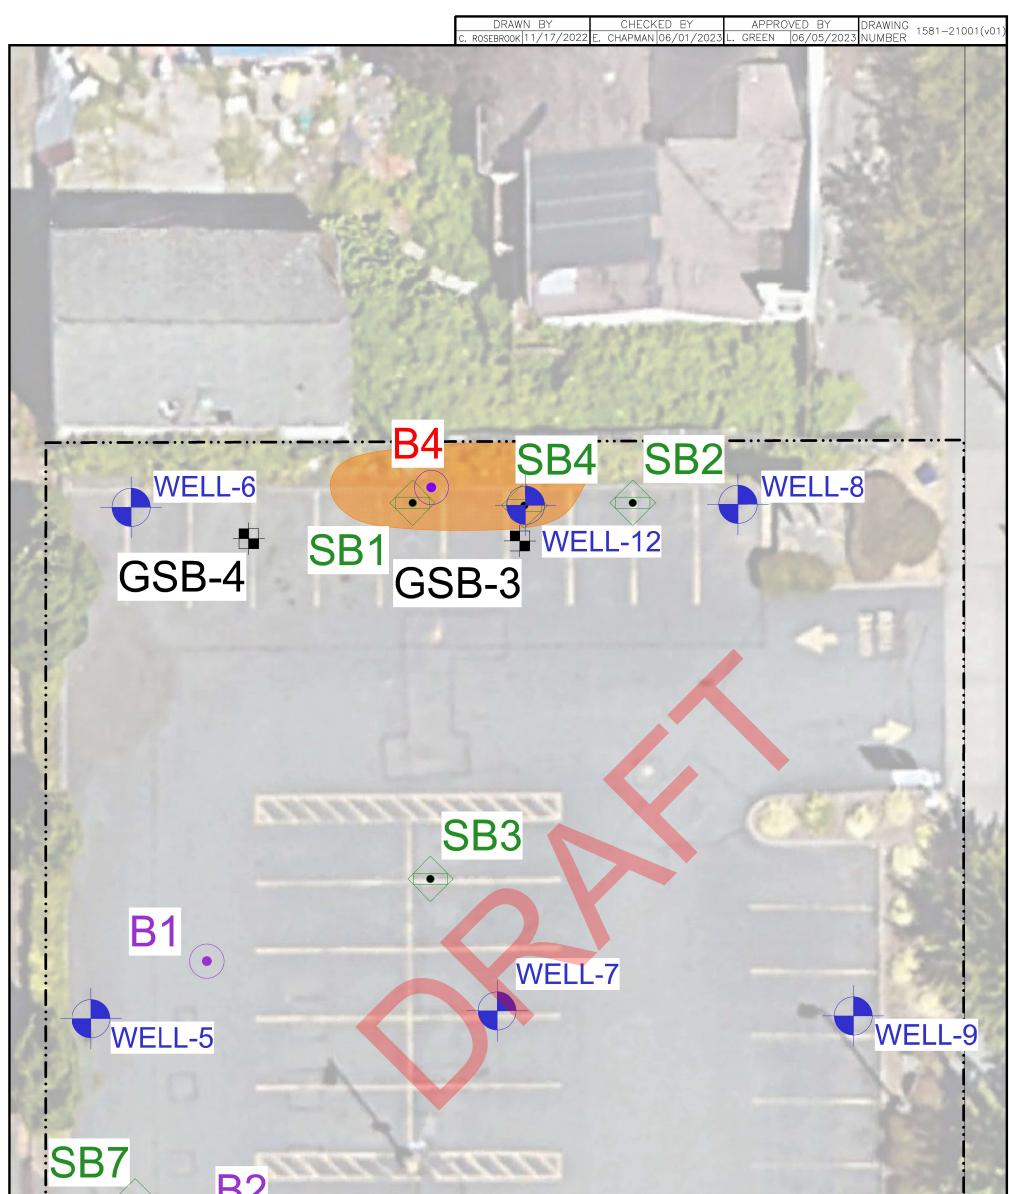
MAP ILLUSTRATING LOCATION OF RESTRICTIONS

- LEFT COAST SERVICES LLC SOIL BORING
- PARTNER SOIL BORING LOCATION MARCH 2021
- ${\sf B1} \textcircled{}{\textcircled{}}$  Environmental specialties soil boring location may 2021
  - MONITORING WELL LOCATION PER ENVIRONMENTAL SPECIALTIES MAY 2021

B4 LABELS IN RED EXCEED MTCA METHOD A CLEANUP LEVELS

a. Containment of soil. The remedial action for the Property is based on containing residual contaminated soil under a cap consisting of pavement and located as illustrated in Exhibit C. The primary purpose of this cap is to minimize the potential for contact with contaminated soil. As such, the following restrictions shall apply within the area illustrated in Exhibit C:

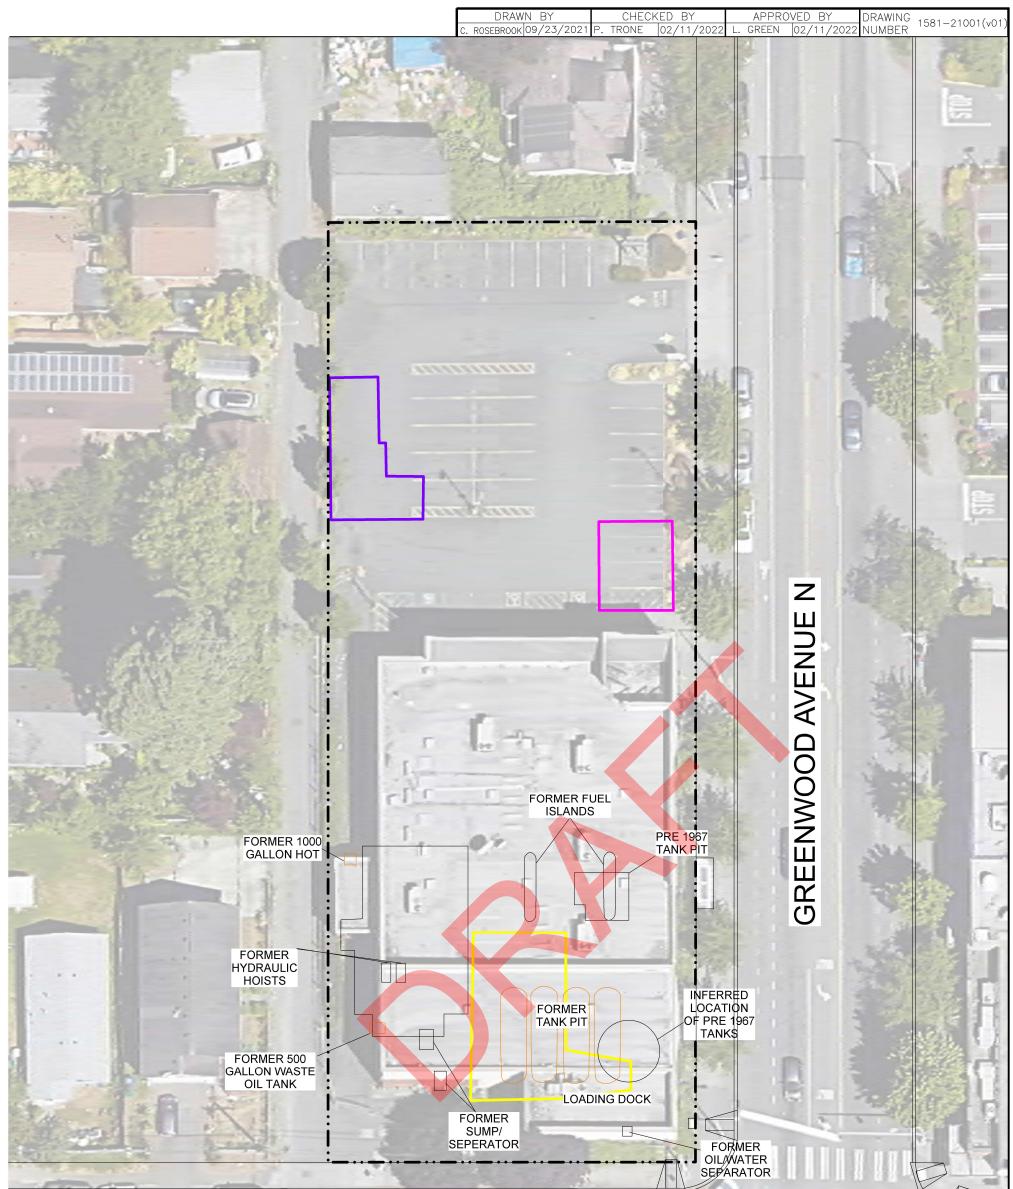
N 87TH	I STREET	JR
the state of the second		
LEGEND:	NOTES: 1. BASE MAP DEVELOPED FROM AN AERIAL PHOTOGRAPH MAP DATED 2019 AND ENW FIELD NOTES.	EVRENNOR HWEST
SUBJECT PROPERTY BOUNDARIES	2. ALL BUILDING, STREET, AND FEATURE LOCATIONS ARE APPROXIMATE.	PO BOX 14488, PORTLAND, OREGON 97293 P: (503)452-5561, E: ENW@EVREN-NW.COM
FORMER VANITY CLEANERS PER CITY DIRECTORY 1951-1955, LOCATION BASED ON 1950-1966 SANBORN MAP FORMER LAUNDRY PER 1930 HISTORICAL SANBORN MAP * FORMER FEATURES PER 1994 EMCON NORTHWEST INC. AND TEXACO 1991 AND ENVIRO. RESOLUTION INC. 1994 AND 1996	3. SYMBOLS REPRESENT LOCATION AND DO NOT ALWAYS REPRESENT EXACT SHAPE, SIZE, OR ORIENTATION. APPROXIMATE SCALE 0 30 60 FEET	FIGURE 2 SITE PLAN WITH HISTORICAL FEATURES OF INTEREST FORMER TEXACO 211544 FACILITY 8701 GREENWOOD AVENUE N SEATTLE, WASHINGTON

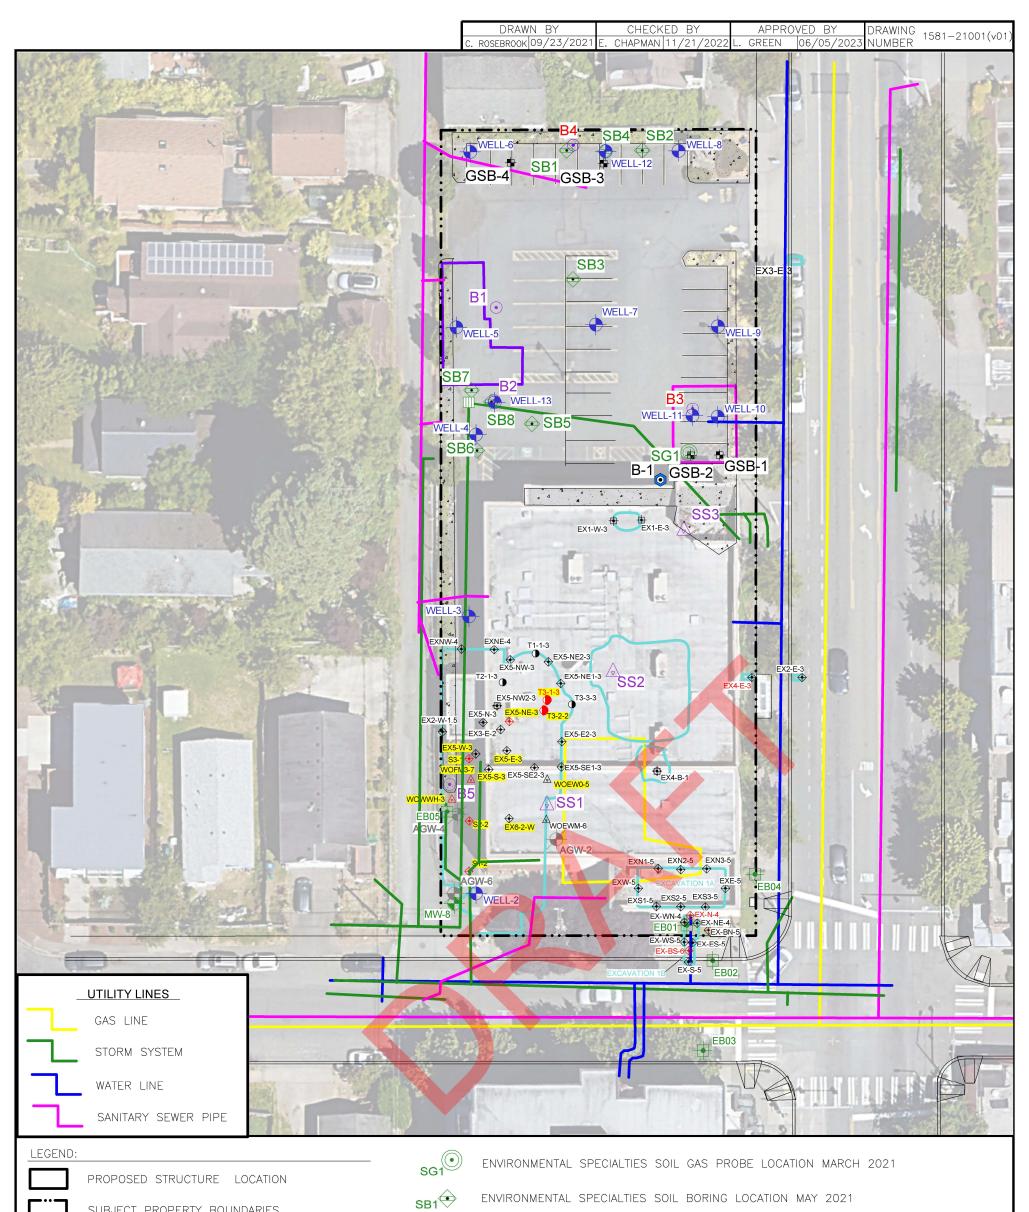
SAMPLE LOCATION DIAGRAM

FORMER TEXACO 211544 FACILITY 8701 GREENWOOD AVENUE N SEATTLE, WASHINGTON

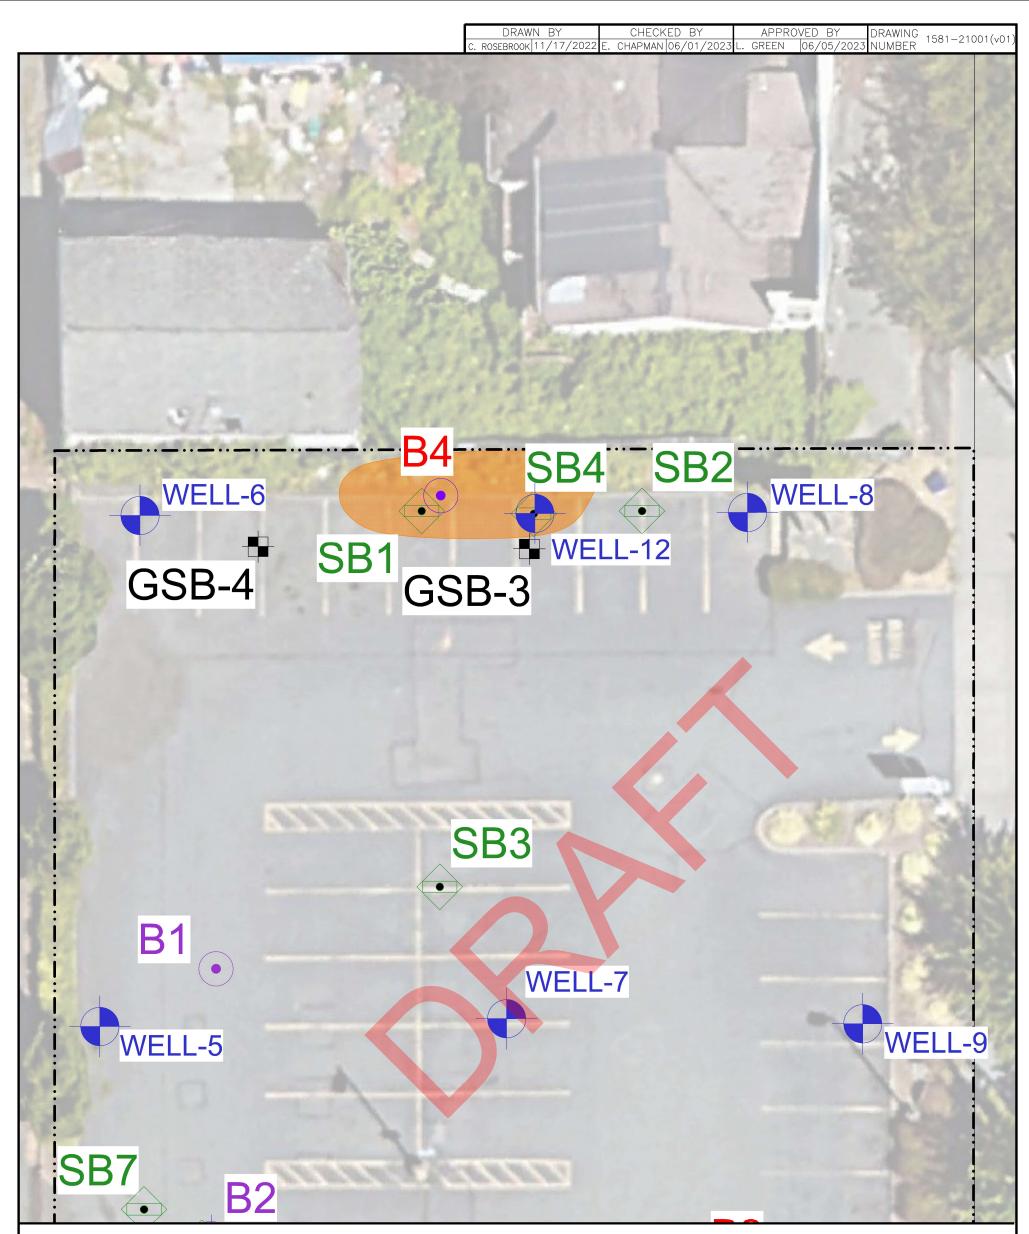
- LEFT COAST SERVICES LLC SOIL BORING LOCATION NOVEMBER 2020
- PARTNER SOIL BORING LOCATION MARCH 2021
- B1 ENVIRONMENTAL SPECIALTIES SOIL BORING LOCATION MAY 2021
  - MONITORING WELL LOCATION PER ENVIRONMENTAL SPECIALTIES MAY 2021

B4 LABELS IN RED EXCEED MTCA METHOD A CLEANUP LEVELS
