PHASE II ENVIRONMENTAL SITE ASSESSMENT:

SUBSURFACE INVESTIGATION REPORT

**King County Parcel #2826059046
11932 124th Avenue NE
Kirkland, WA 98034**

December 12, 2019

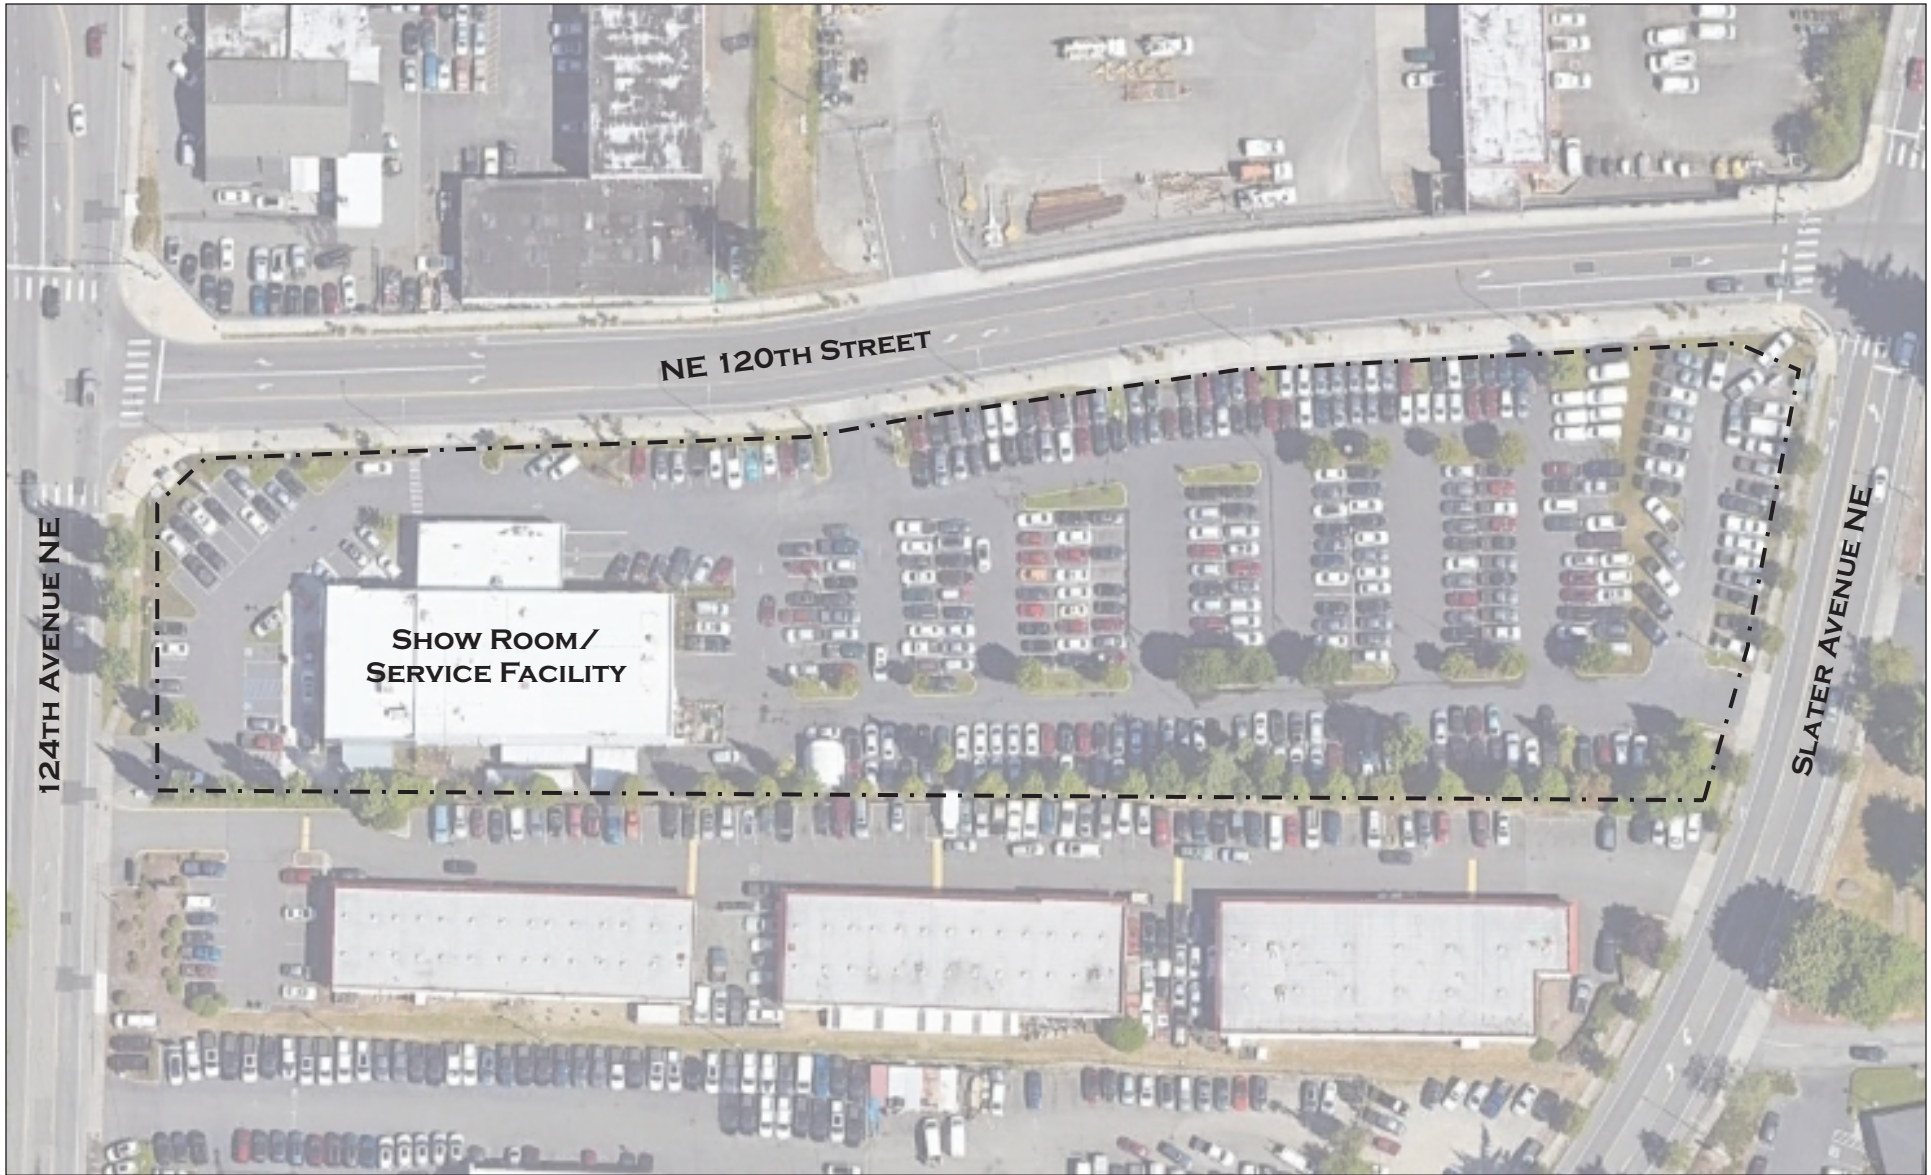
SITE PLAN

The Property is currently developed with a two-story, 13,801 square foot auto dealership. The building is separated into a show room, office space, service garage, and car wash bay. The tenant at the time of this Phase II ESA was Nissan of Kirkland.

The current Property layout is depicted on Figure 2 in Exhibit A.
