FINAL REPORT

ENVIRONMENTAL SITE ASSESSMENT

35TH STREET LANDFILL

APRIL 1992

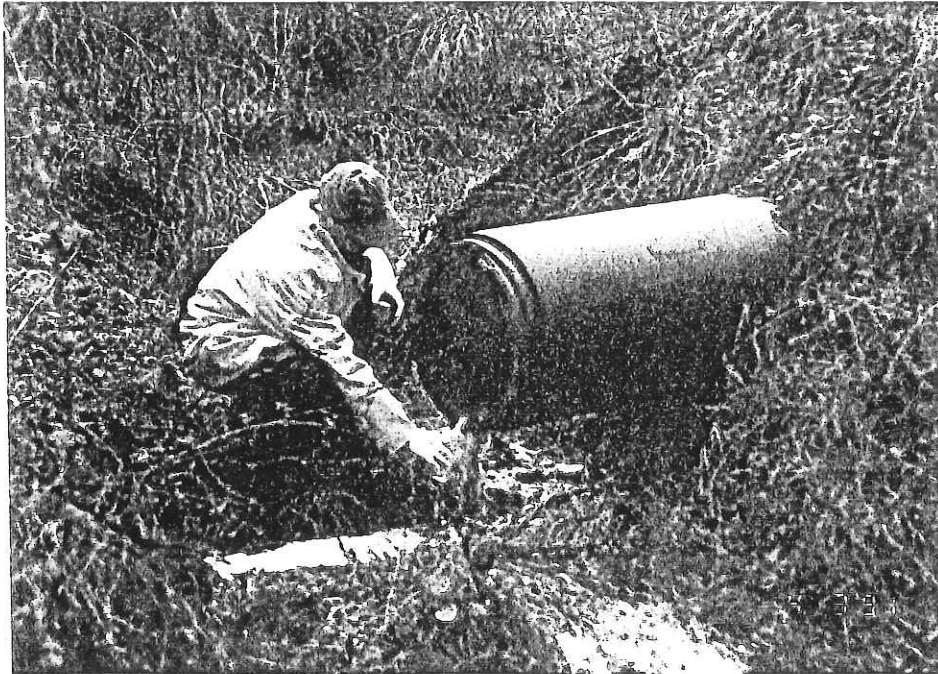
FIGURE 5 SW1 CULVERT PIPE WHICH RUNS NORTH & SOUTH  
BELOW THE FILL

Samples were collected following a period of at least 24 hours of continuous precipitation (Appendix B). Preliminary conductivity measurements were performed at four locations. Three conductivity measurements were taken from run-off streams at the base of the fill and one from an 18" culvert pipe on the lower bench near TP9. The flow rate of the water sampled from the culvert was 25 gallons per minute (gpm). Conductivity was measured with a HACH Model 44600 Conductivity/TSD Meter (calibrated prior to use). The run-off measurements were 0.057 millisemens (ms), 0.068 ms and 0.088 ms respectively. The conductivity of water flowing from the culvert pipe measured 0.184 ms (Table 2). Surface water grab samples were collected from areas with the two highest measurements: the culvert pipe (Figure 5) and the 0.088 ms run-off stream (Figure 6). These two locations are represented by SW1 and SW2 on Figure 7.

500 ml of surface water was collected at each location (SW1 and SW2). The samples were then analyzed for total petroleum hydrocarbons (TPH) using EPA Method 418.1. SW1 contained 25.6 mg/l TPH and SW2 contained 32.0 mg/l TPH (Table 3). A field blank, which was carried by person collecting samples, contained 3.1 mg/l TPH.

Sewer Utility indicated TPH levels in surface water samples taken from SW1 and SW2 are consistent with TPH levels from samples collected at or near street storm drains. The levels of petroleum hydrocarbons in surface water will decline as the soil naturally bioremediates itself.

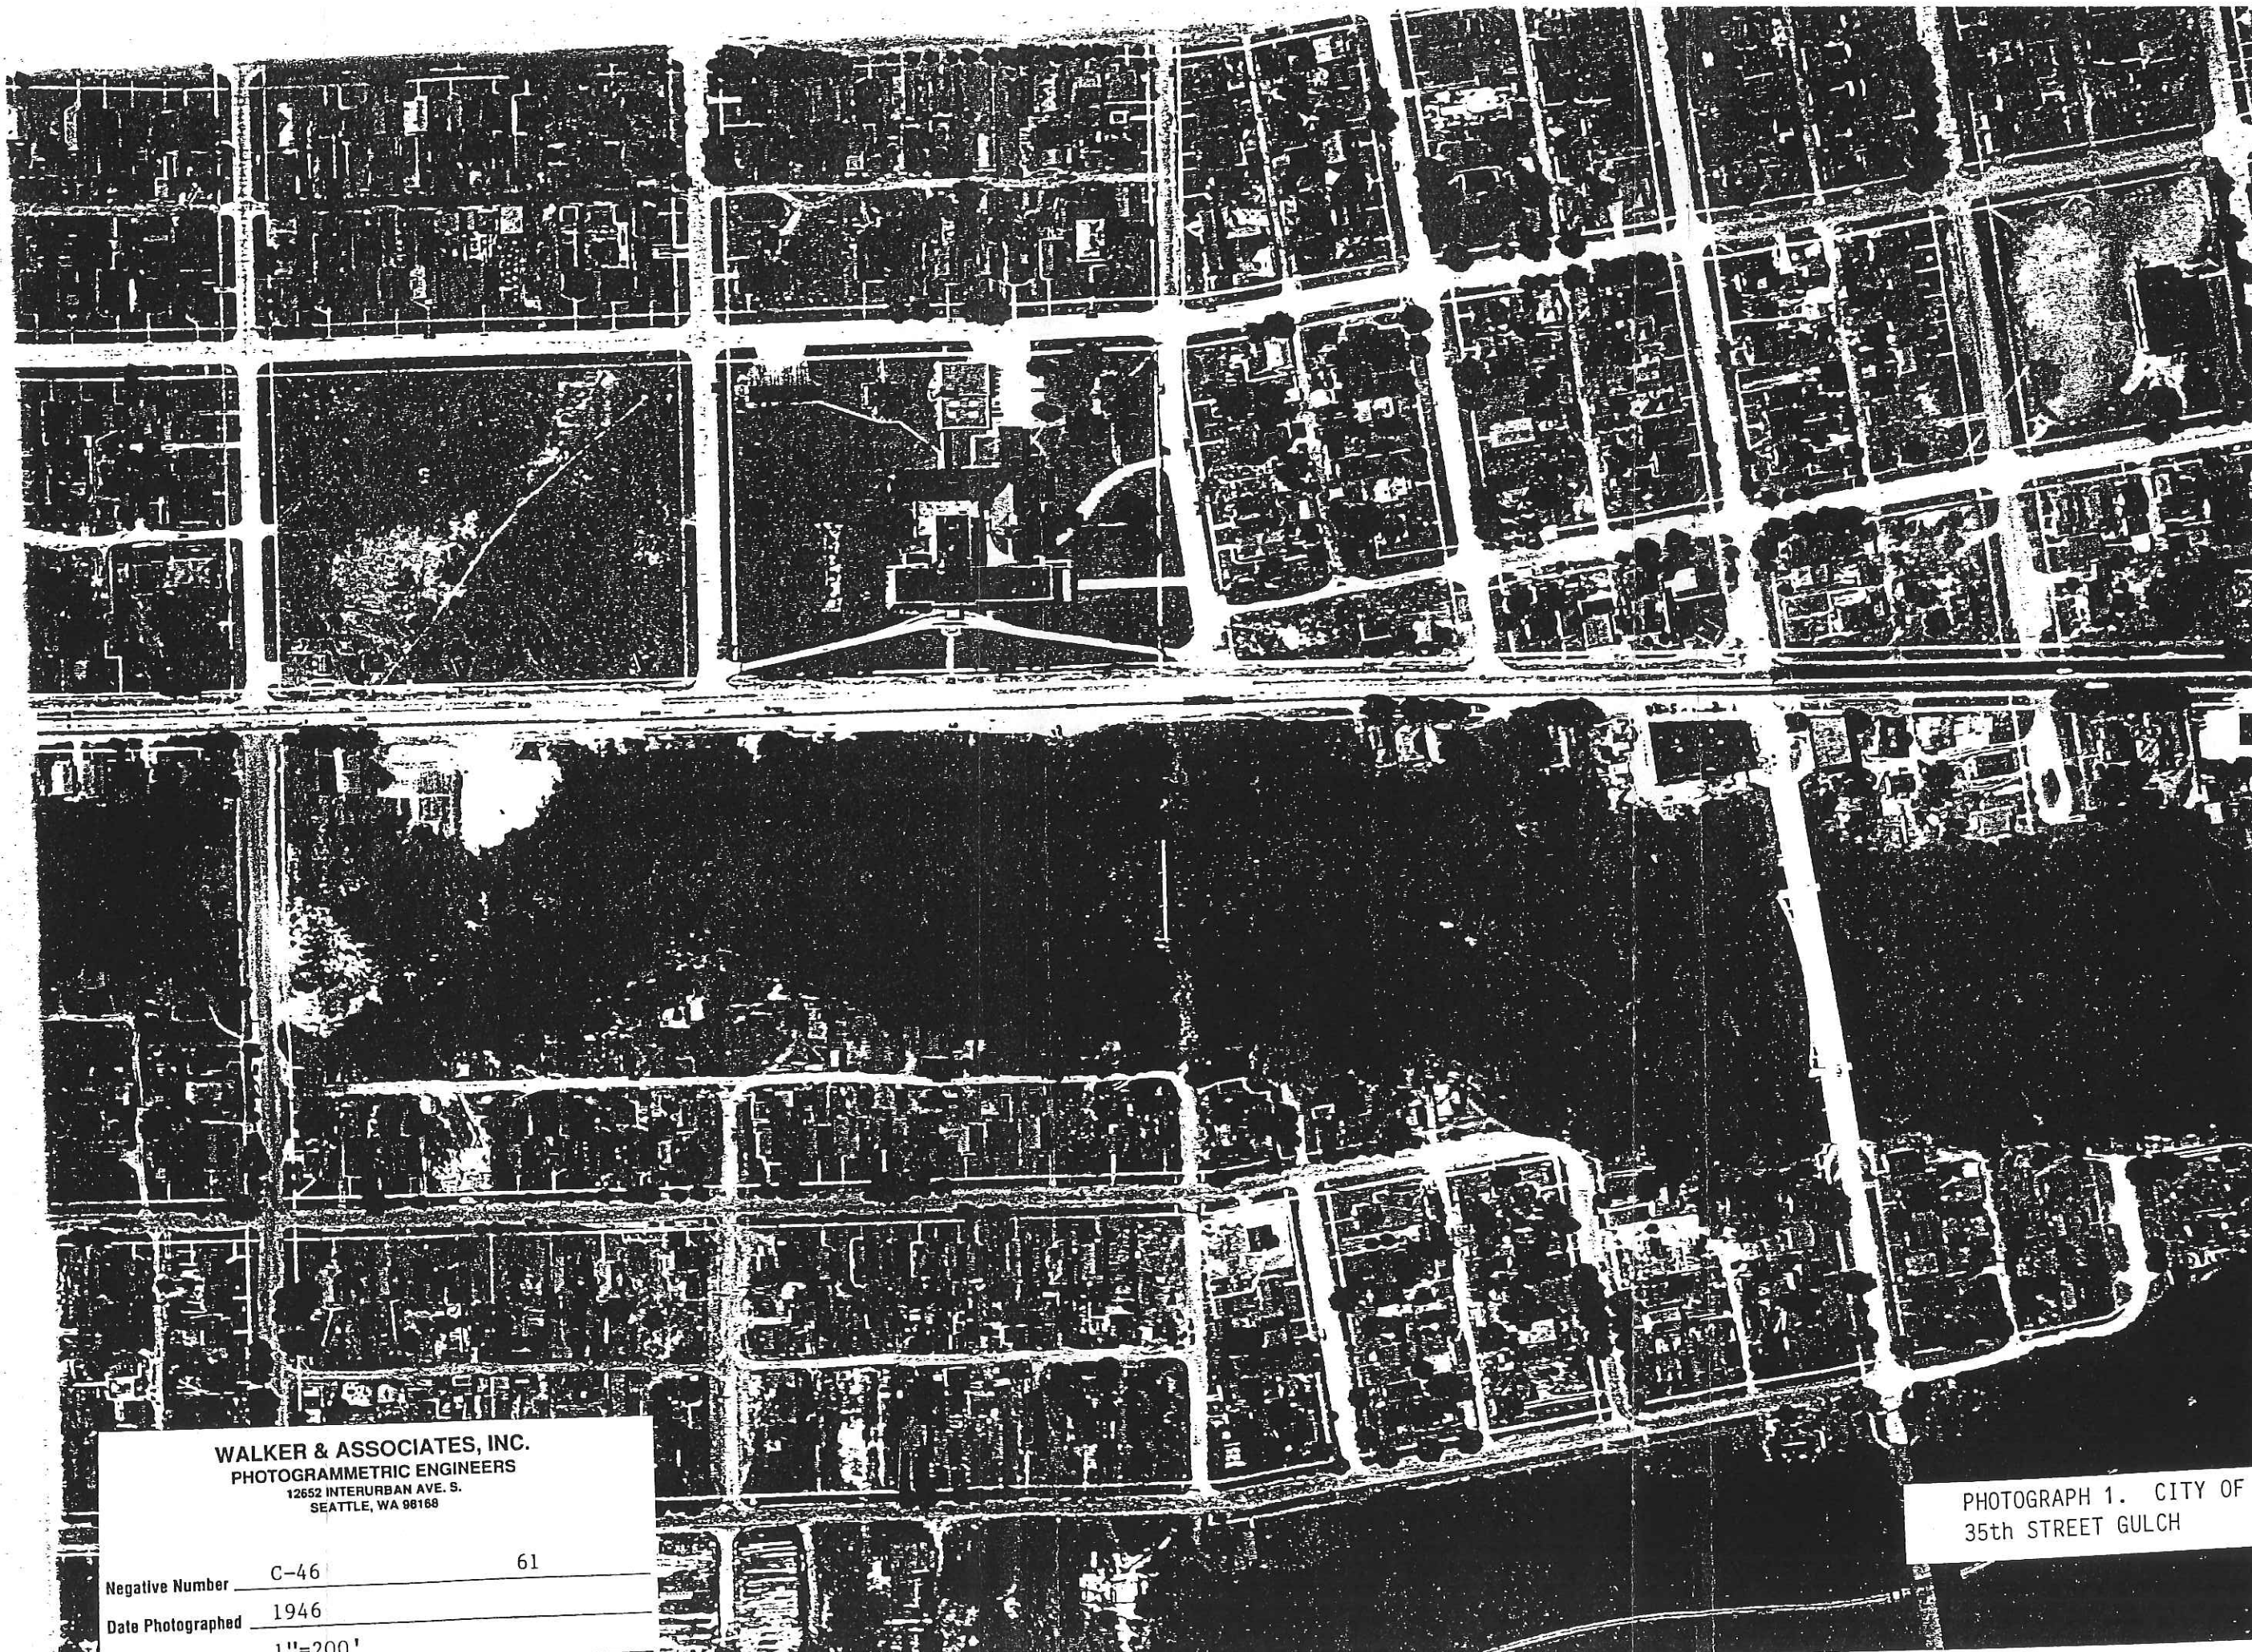
PHOTOGRAPH 1. CITY OF  
35th STREET GULCH

A photo taken of the site in 1946 (Photograph 1) depicts the ravine as it was prior to filling. The presence of trees demonstrates the absence of activity on the property prior to filling. Photograph 2, taken in 1969, shows the entire ravine cleared of its vegetation. Property south of Harrison Street is shown to be filled.

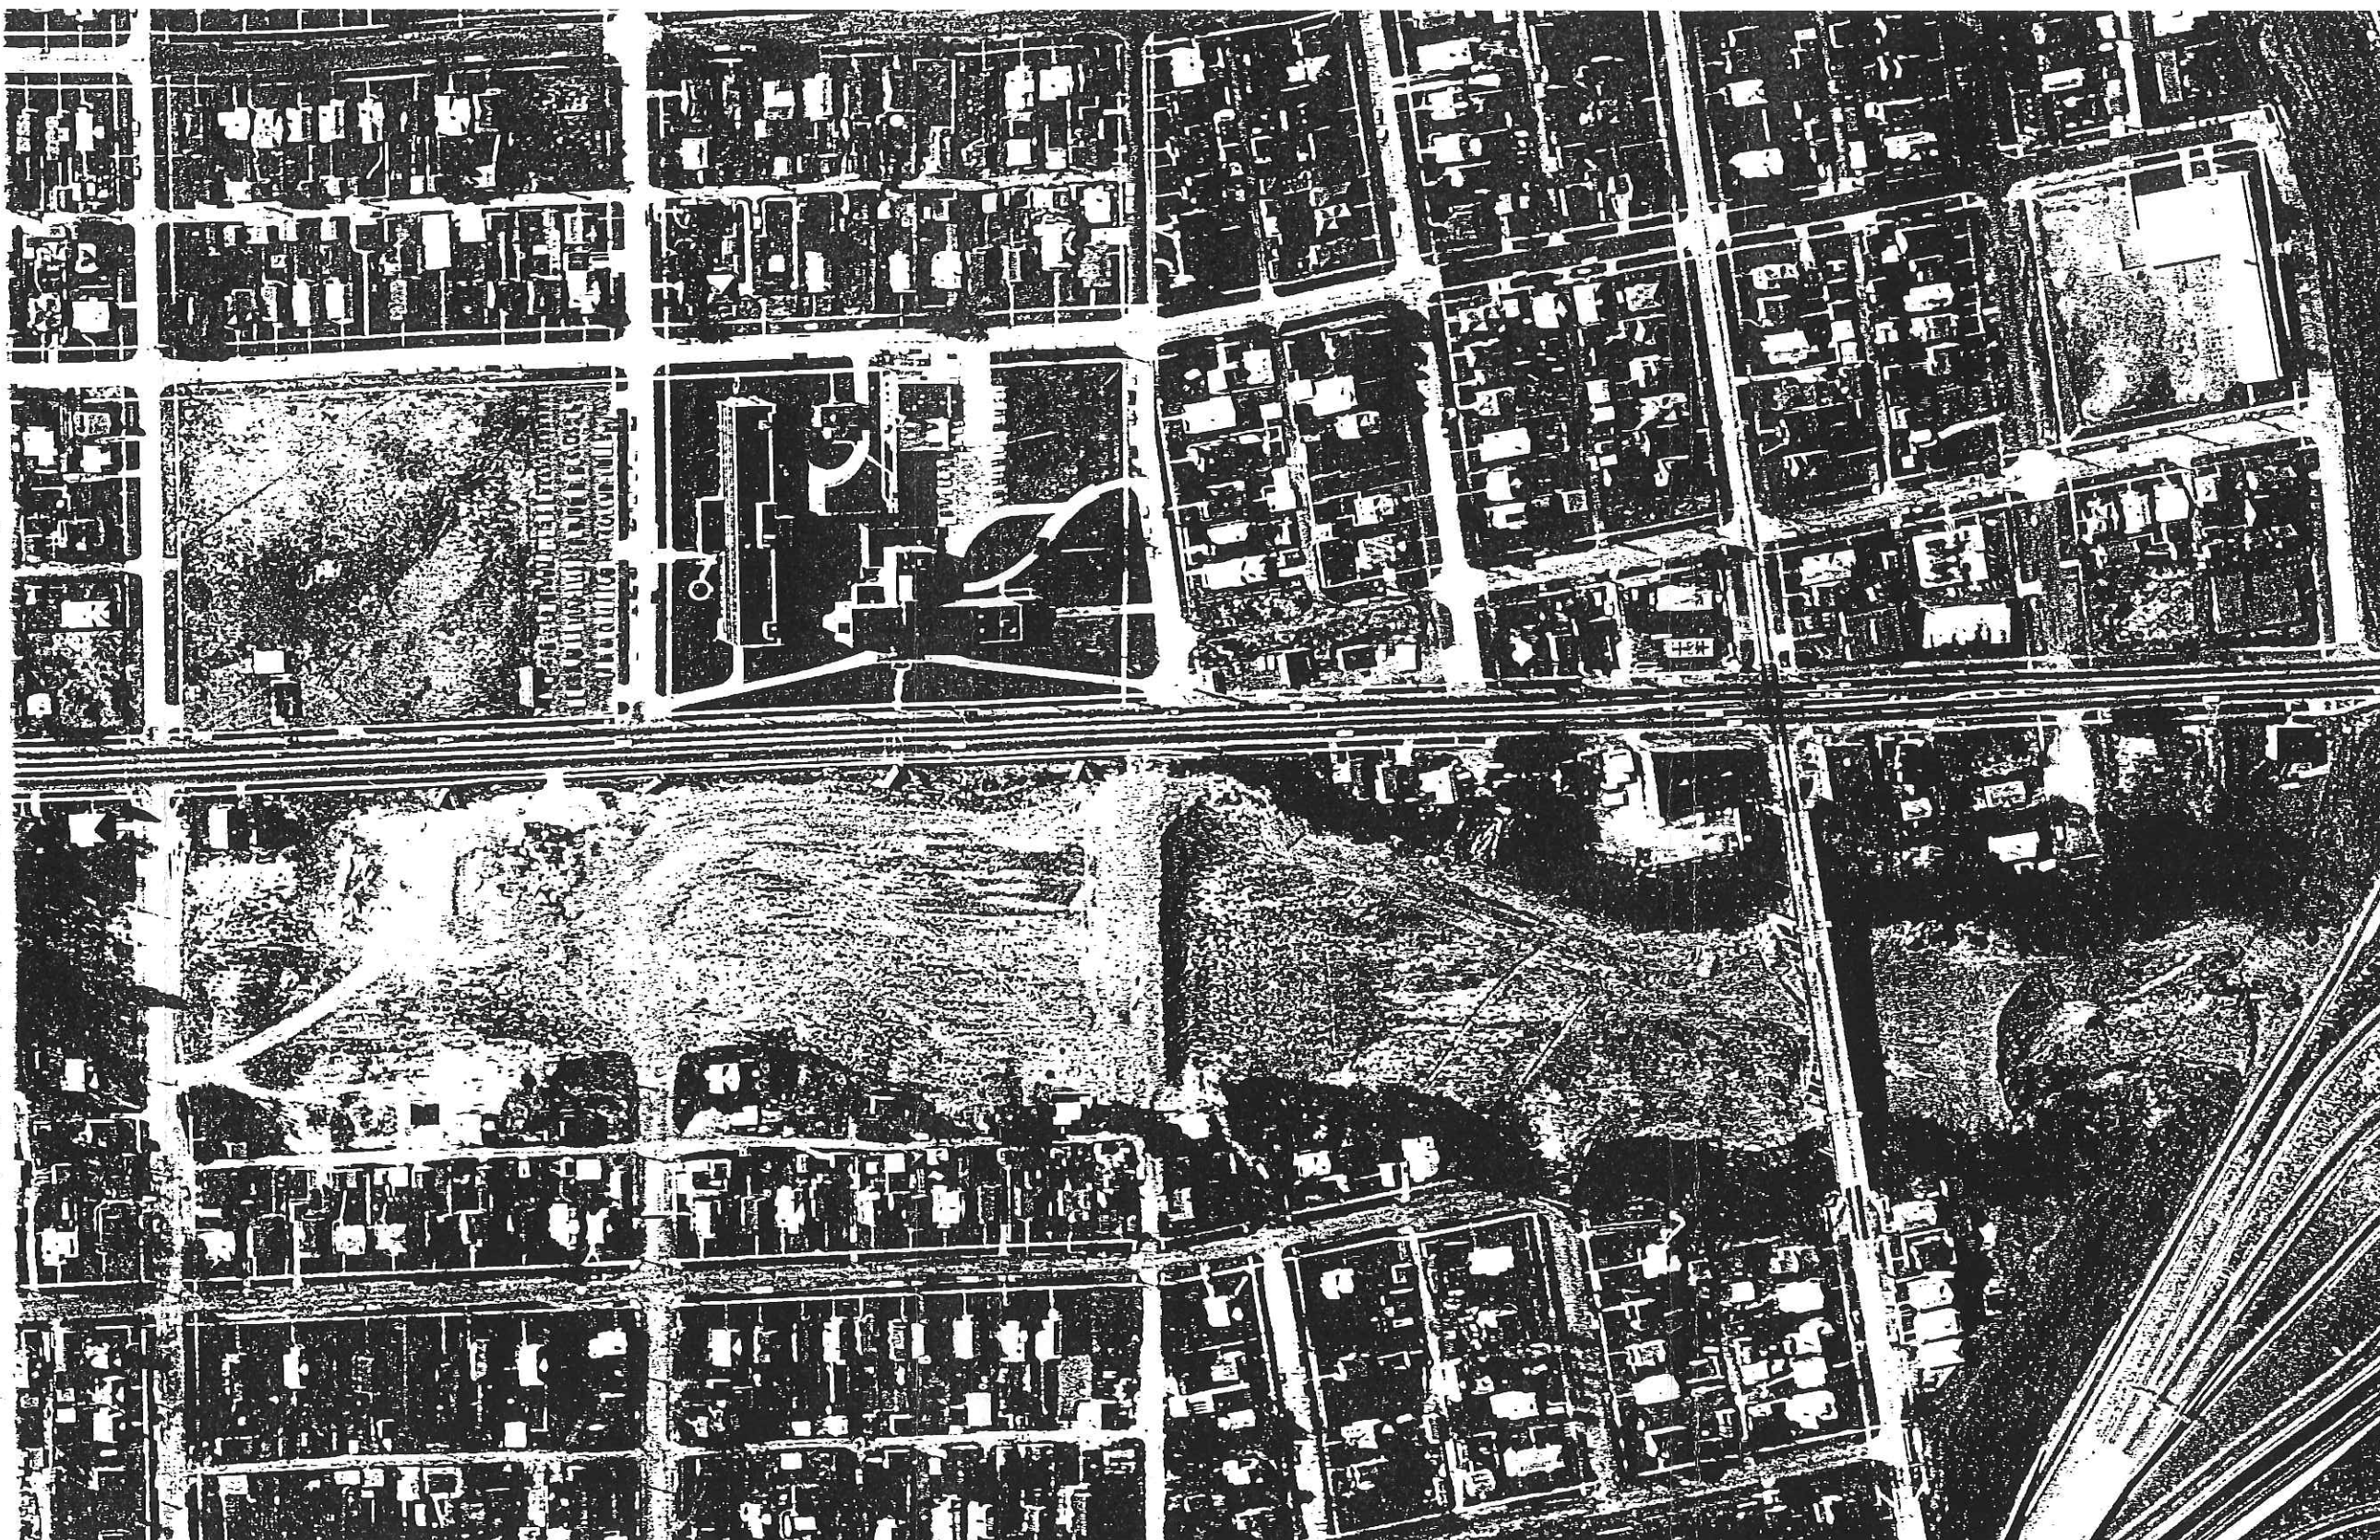
Negative Number C-46 61  
Date Photographed 1946  
Approx Scale of Print 1"=200'
