Underground Storage Tank Closure & Soil Remediation Report

Snohomish County Parcel: 00439147502900
2202 Broadway Avenue
Everett, Washington

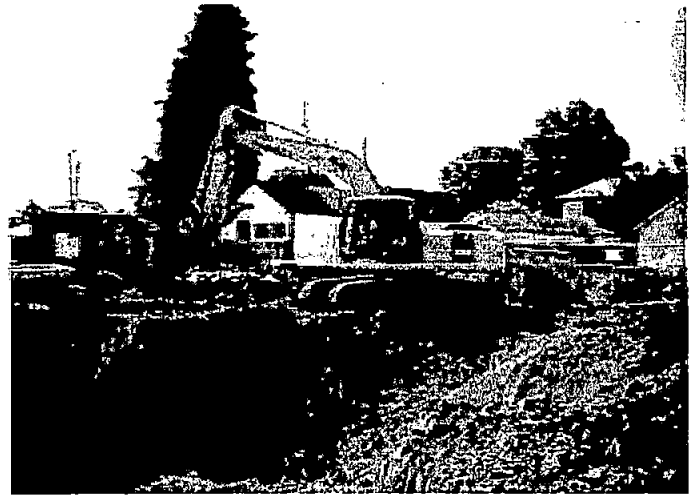
Photo 14 - Excavation area - View south

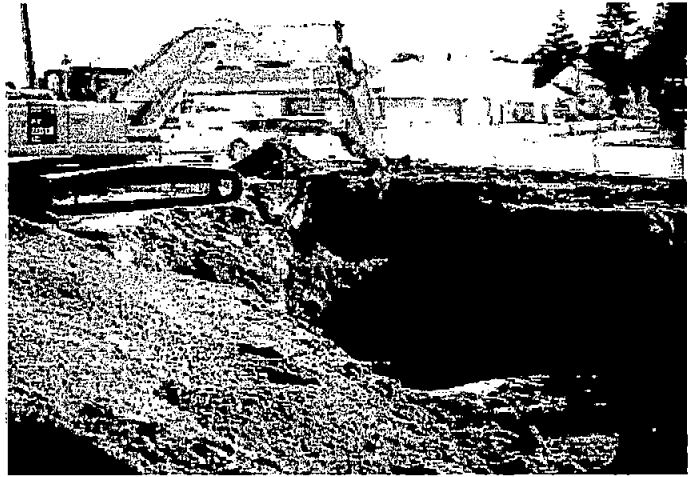
Photo 16 - Backfill placement - View northeast

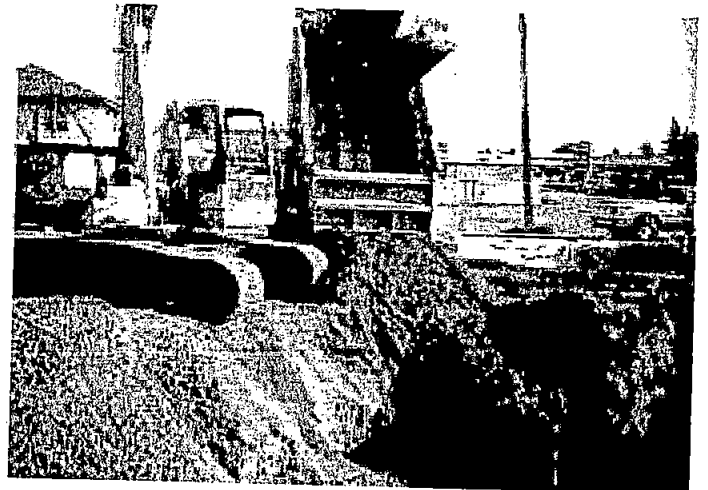
Photo 28 - Backfill placement - View north

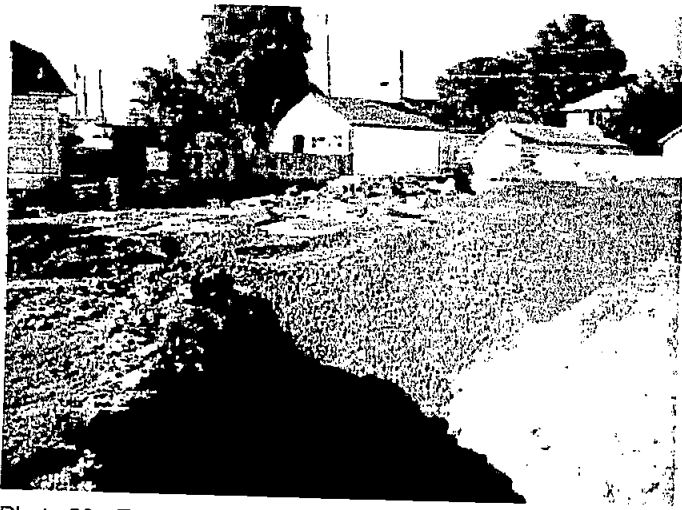
Photo 29 - Excavation during backfill placement - View southwest

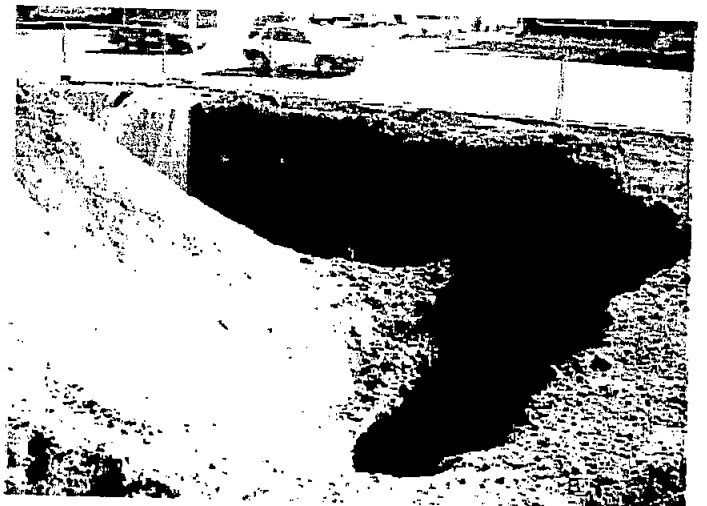
Photo 30 - Excavation North sidewall limits during backfill placement

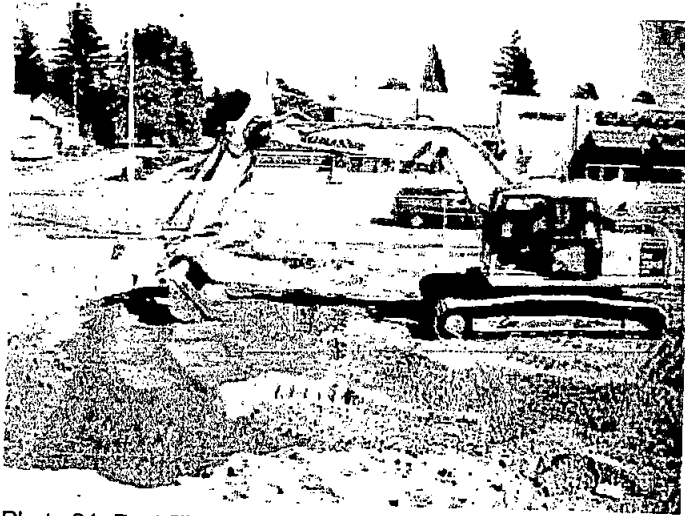
Photo 31 -Backfill compaction and grading

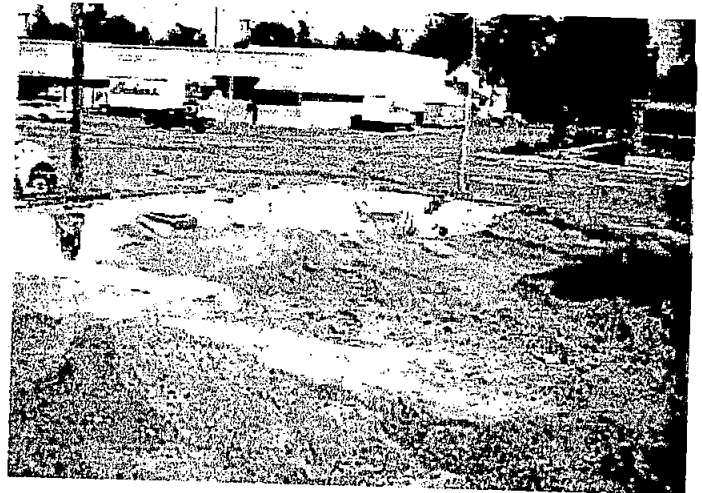
Photo 34 - Excavation north and east limits with plastic barrier

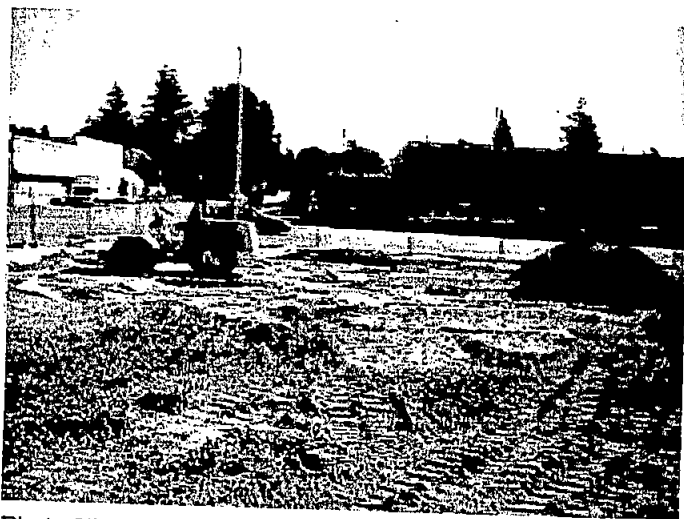
Photo 35- Excavation area following backfill and grading
