# REMEDIAL INVESTIGATION REPORT

Snopac Property

Facility Site ID #1523145

Project No. 150054 • December 21, 2023 FINAL

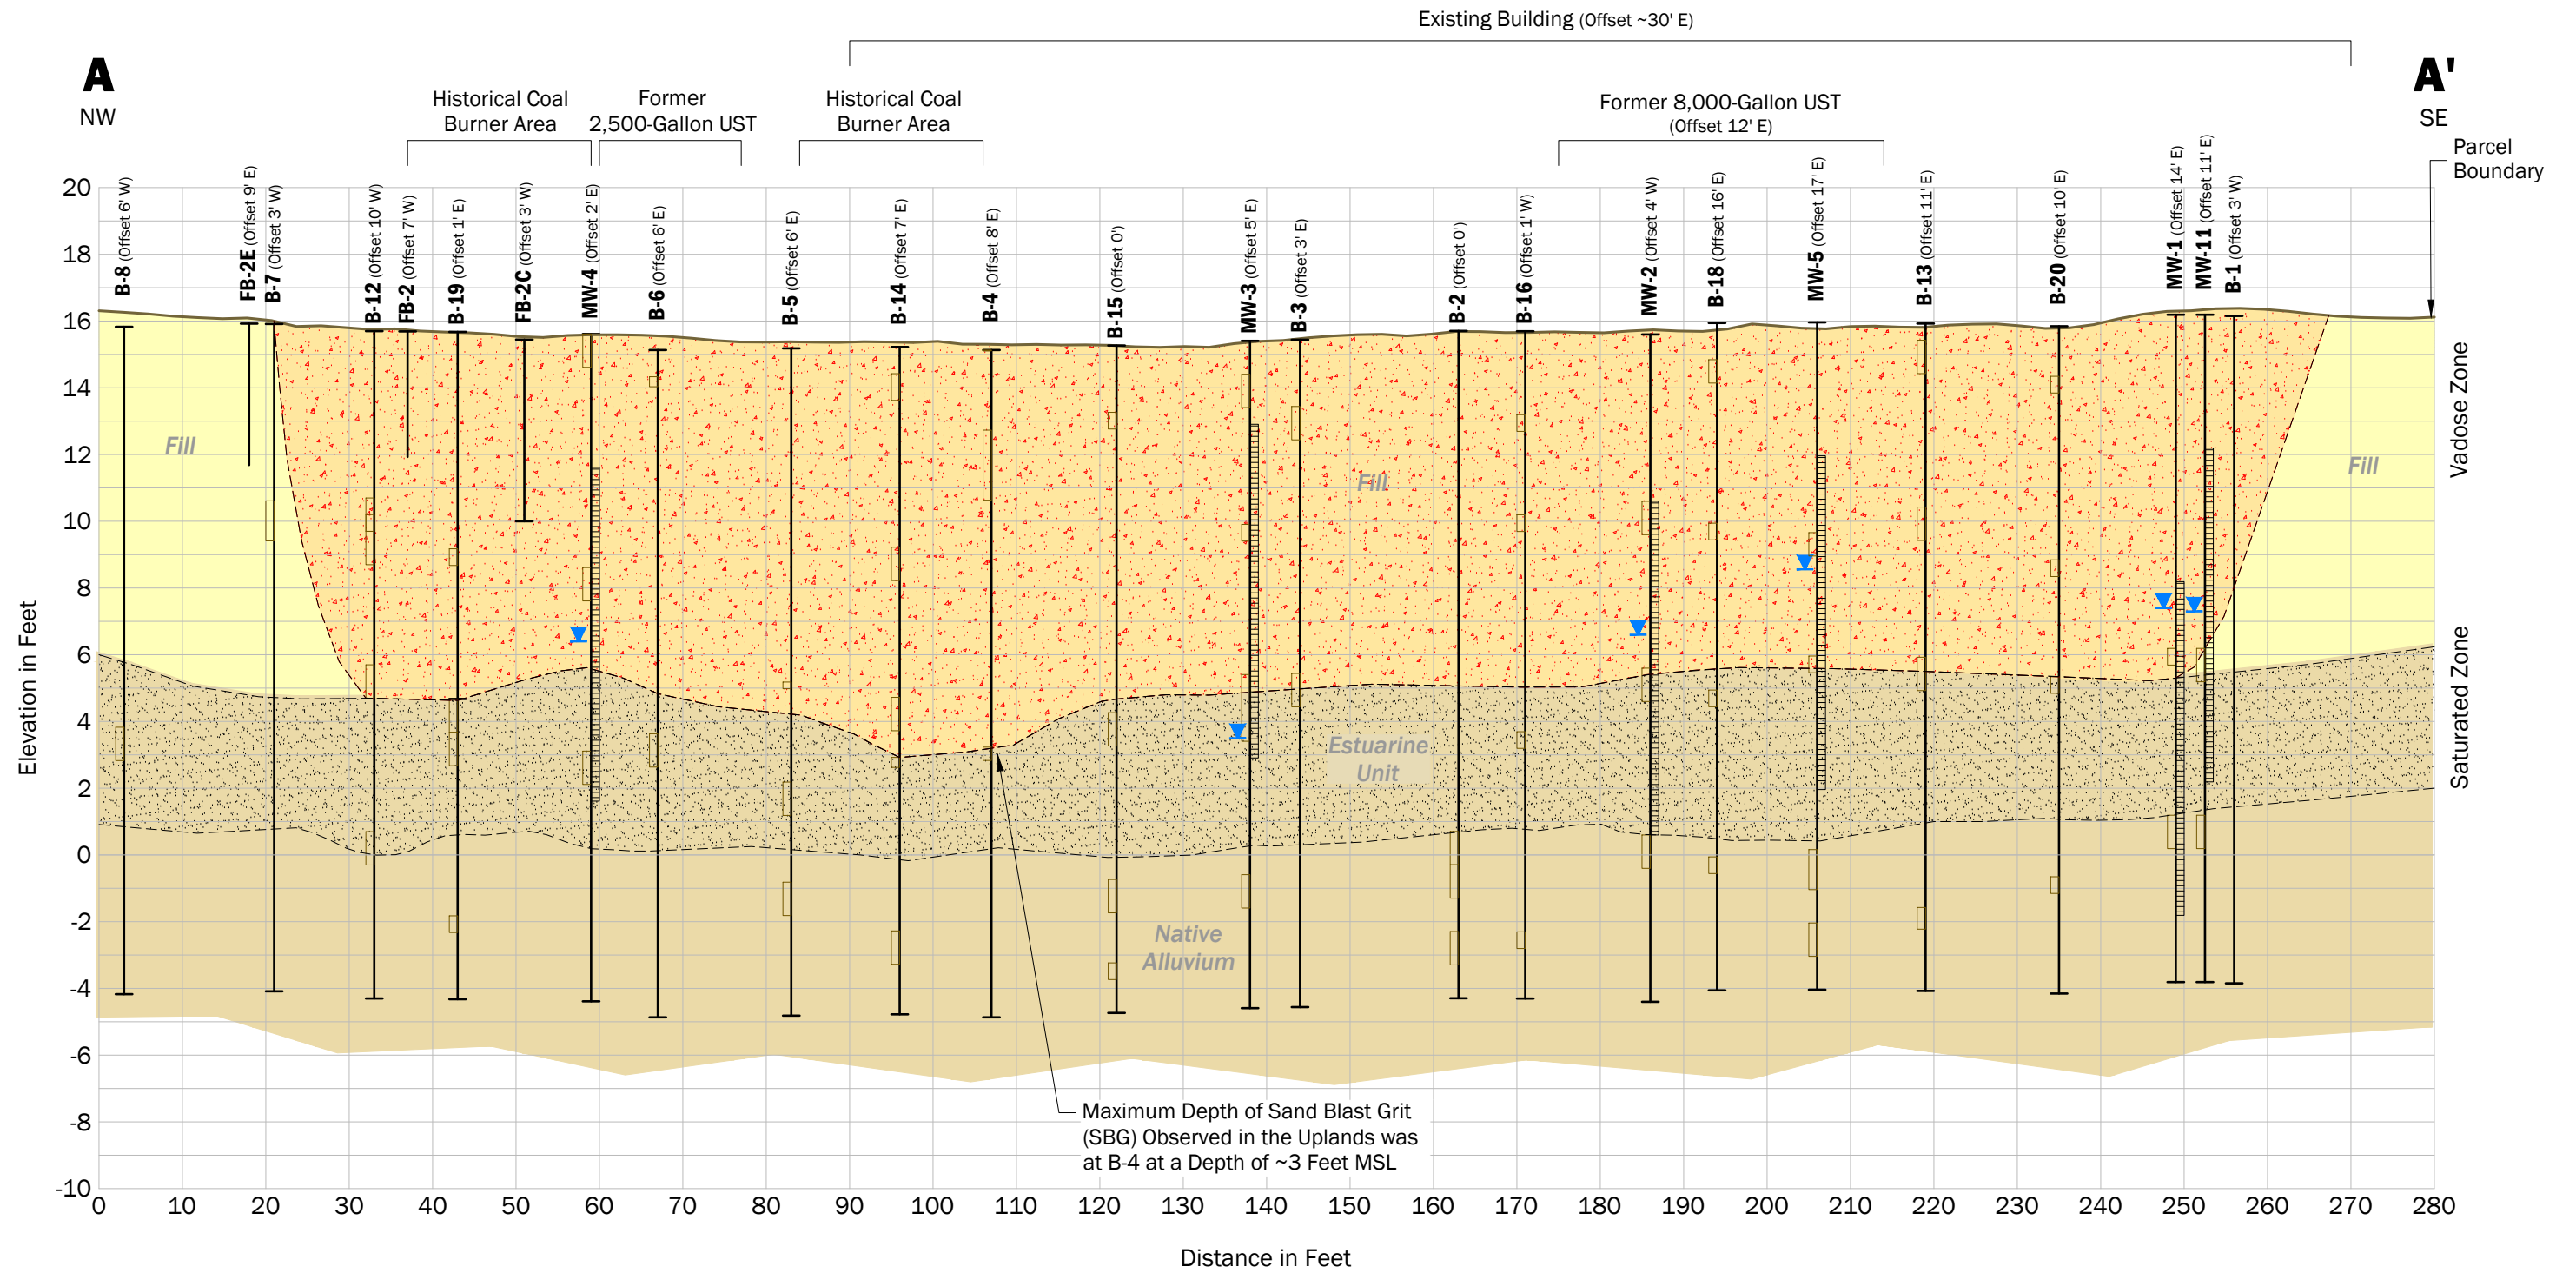
FIGURE NO.  
**3**

- Geologic Contact
- Existing Grade
- ▼ Groundwater Elevation (Feet NAVD88)

The fill present on the western portion of the Property is interpreted to be both hydraulic fill placed prior to 1919, and debris-containing fill placed post-1919. SBG-containing fill is thought to have been placed starting in 1970s as described in Section 2.2.2. The observed SBG consists of predominantly glassy, rounded to angular sand-sized grains, with admixtures of multi-colored paint chips. The observation of SBG was in the upper 3 to 5 feet of the Fill Unit, but was observed at depths up to 12 feet bgs at boring B-4 (Appendix B). The portions of the Fill Unit interpreted to contain SBG are depicted in cross section on Figures 3 through 6, and aerially on Figure 2.

Estuarine deposits (the Estuarine Unit) were observed to extend from the bottom of the Fill Unit to a depth of about 16 feet bgs and are generally 4 to 6 feet thick. The estuarine deposits consist of very soft/loose organic silt and clay, with shells, abundant organic debris, and a sulfur like odor. The Estuarine Unit is depicted overlying the Native Alluvium Unit on the cross-section figures.

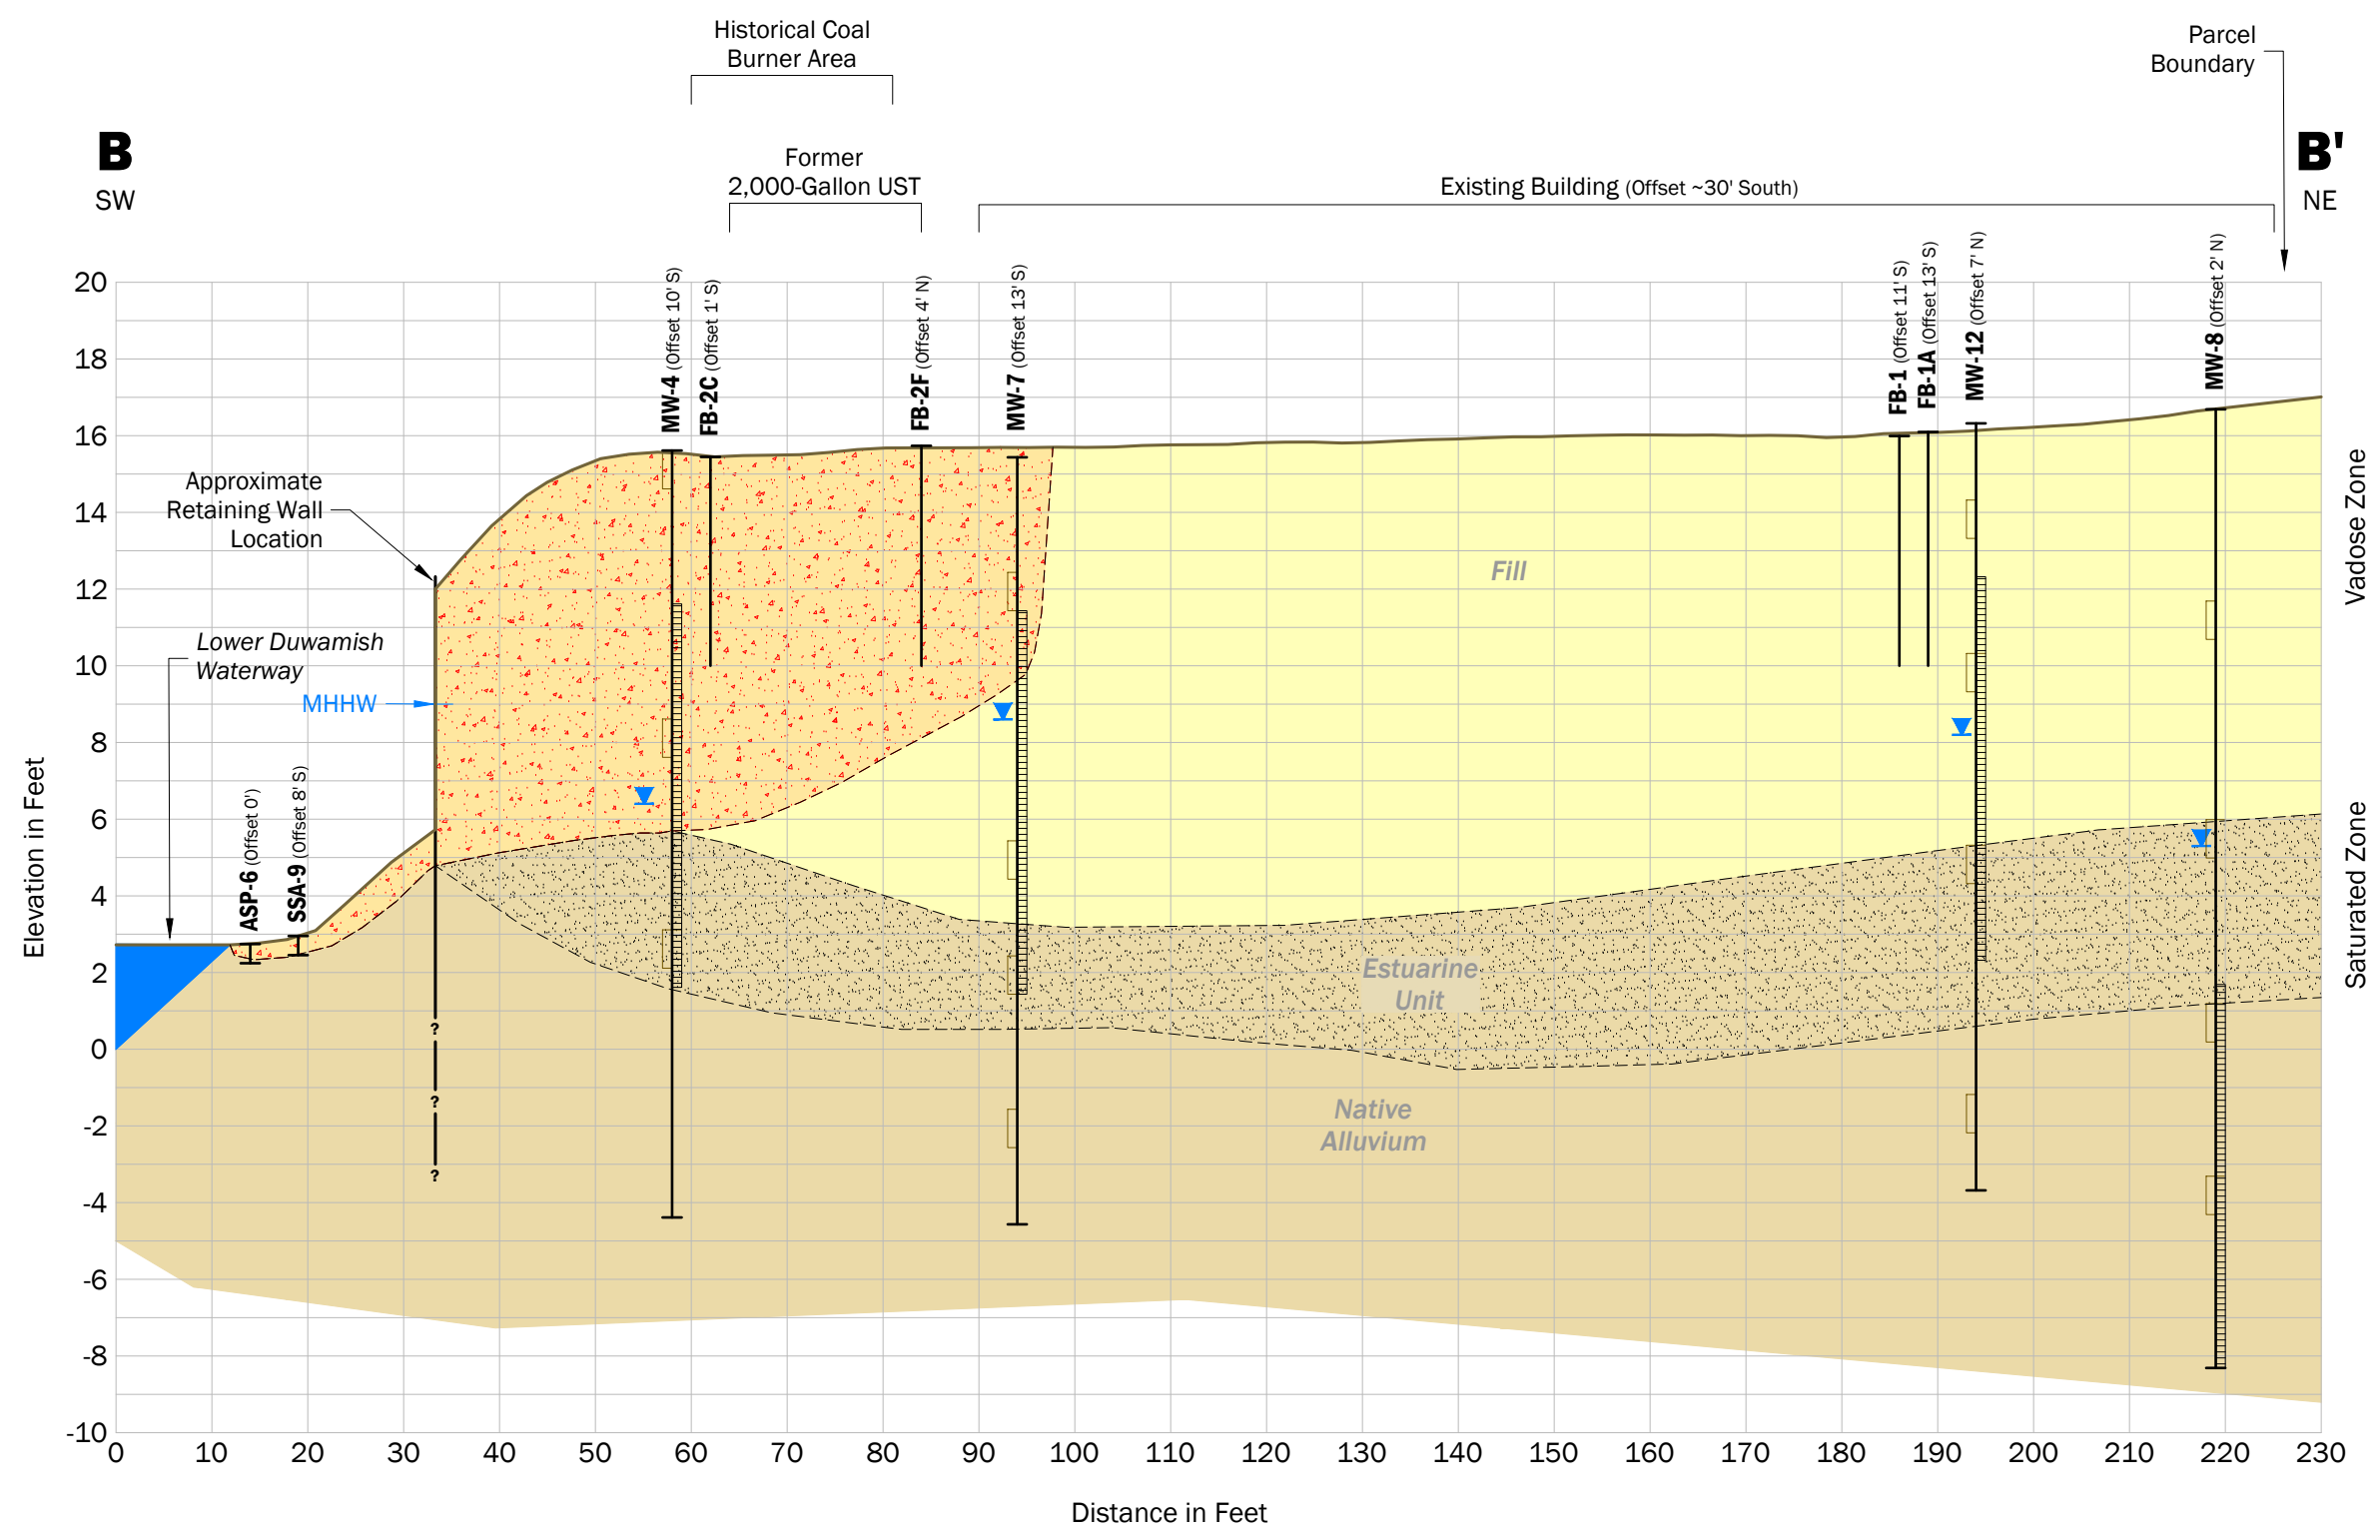
May-2020	BY: MLK/SCC	FIGURE NO. <b>4</b>
	PROJECT NO. 150054	REVISED BY: JCH/SCC

NOTE: DEPICTIONS OF LITHOLOGY AND EXTENT OF FILL AND FILL CONTAINING  
 SANDBLAST GRIT ARE BASED ON DATA FROM PREVIOUS SITE EVALUATIONS.

**Cross Section B-B'**  
 Snopac Property Site Remedial Investigation  
 Seattle, Washington
