February 2, 2023  
Project No. M1472.02.002

Re: Site Assessment for Permanent Closure of a 1,200-Gallon Underground Storage Tank  
Mount Vernon Library Commons  
208 West Kincaid Street, Mount Vernon, Washington

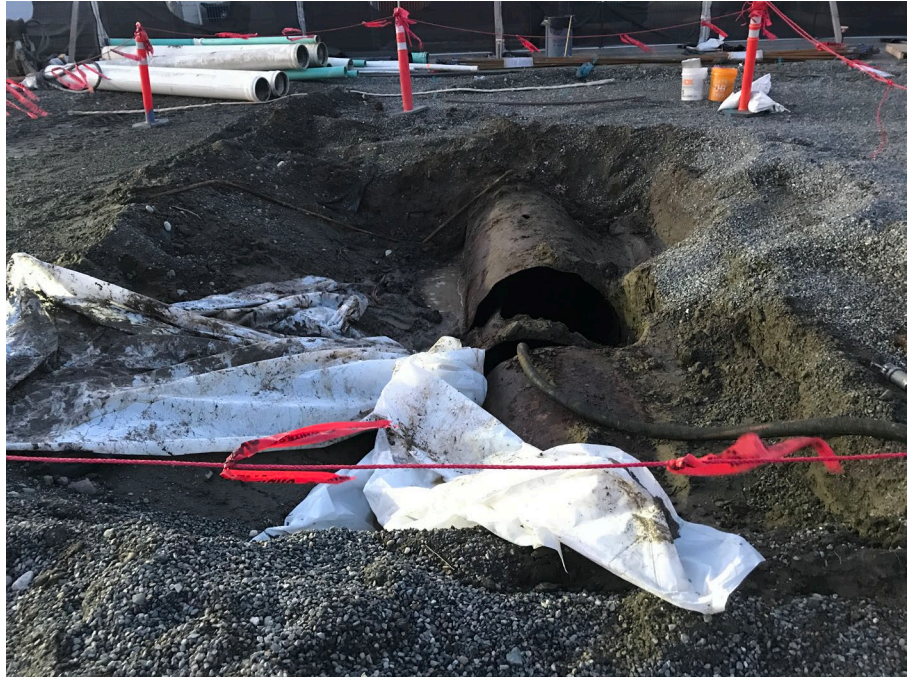
1,200-gallon underground storage tank (UST). Photograph taken on January 4, 2023, looking south.

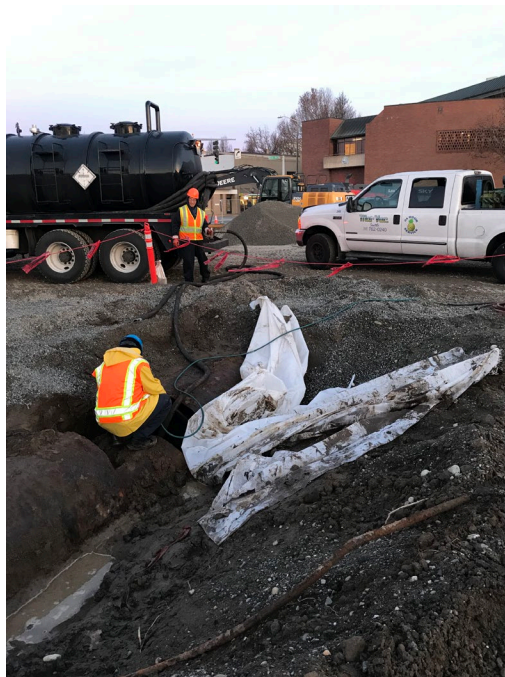
### **Photo No. 2.**

Marine Vacuum emptying and triple-rinsing the UST. Photograph taken on January 4, 2023, looking northwest.

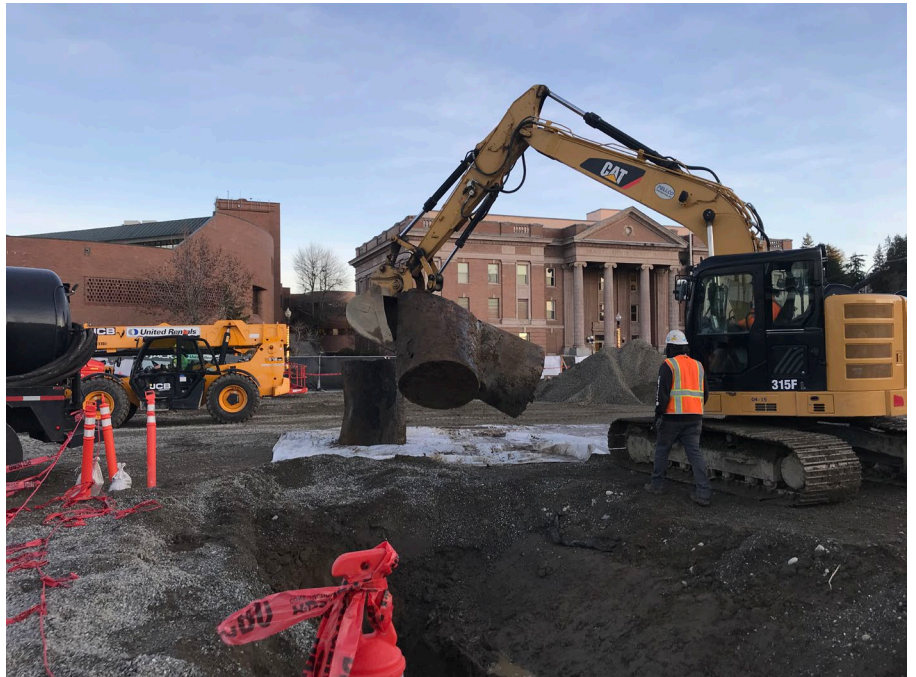
Earthwork contractor removing the inerted UST. Photograph taken on January 4, 2023, looking north.

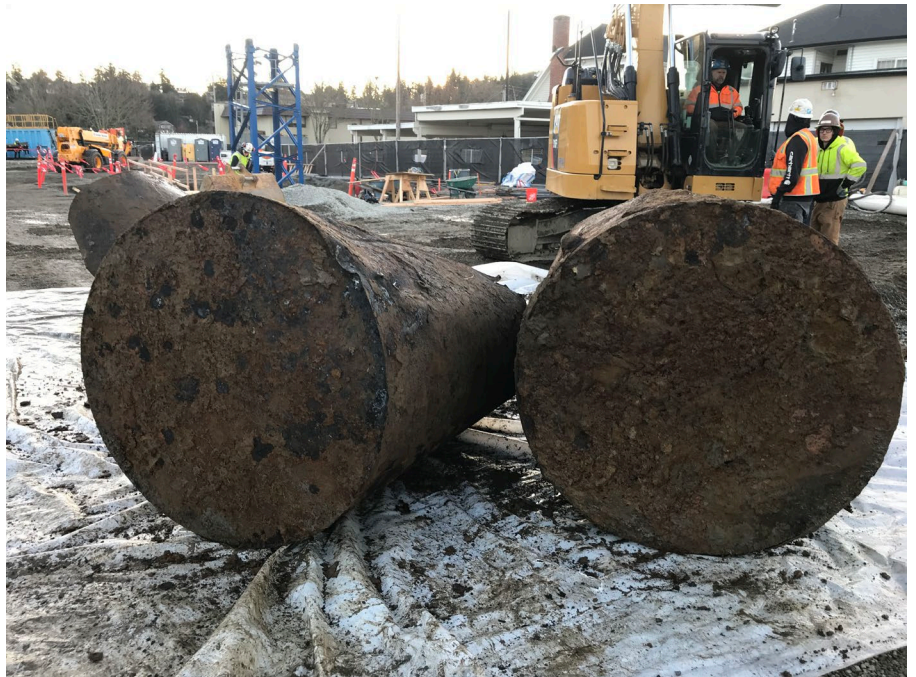
### Photo No. 4.

On January 4, 2023, Marine Vacuum Services, Inc. (Marvac) of Seattle, Washington removed approximately 5 gallons of residual product from the bottom of the UST. The UST was then triple rinsed. Approximately 45 gallons of rinse water was removed from the UST; all liquids were transported to Marvac's facility in Seattle, Washington for treatment and disposal. Disposal manifests are included as Attachment D. Pellco Construction, Inc. then removed the UST. No holes were observed in the UST upon removal; however, significant rust was observed on the steel walls.

No holes were observed in the 1,200-gallon UST; however, significant rust was observed on the steel walls. Photograph taken on January 4, 2023, looking southeast.

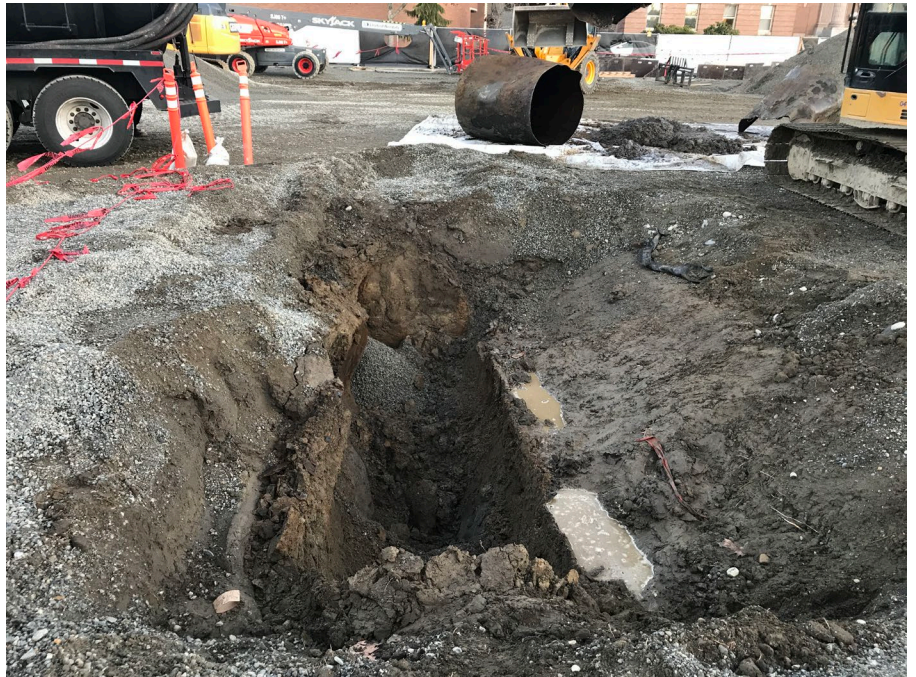
1,200-gallon UST pit post-removal. Rinse water is visible in the base of the pit.  
Photograph taken on January 4, 2023, looking north.

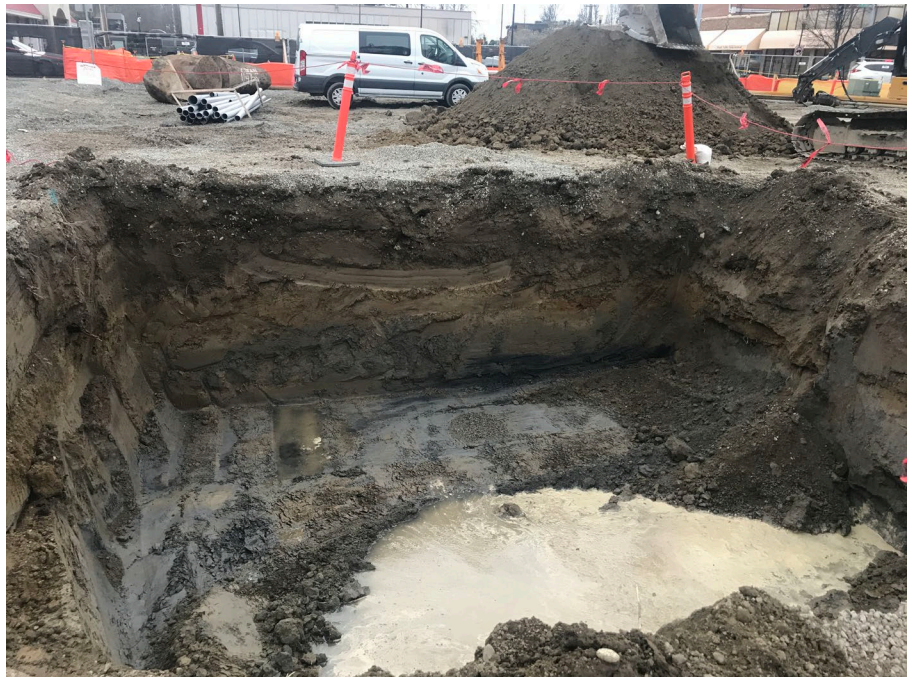
### **Photo No. 6.**

Groundwater in the excavation at approximately 9.0 feet below ground surface (bgs). Bluish gray staining visible indicative of petroleum contaminated soil (PCS) in the excavation base below the former UST.  
Photograph taken on January 4, 2023, looking west.

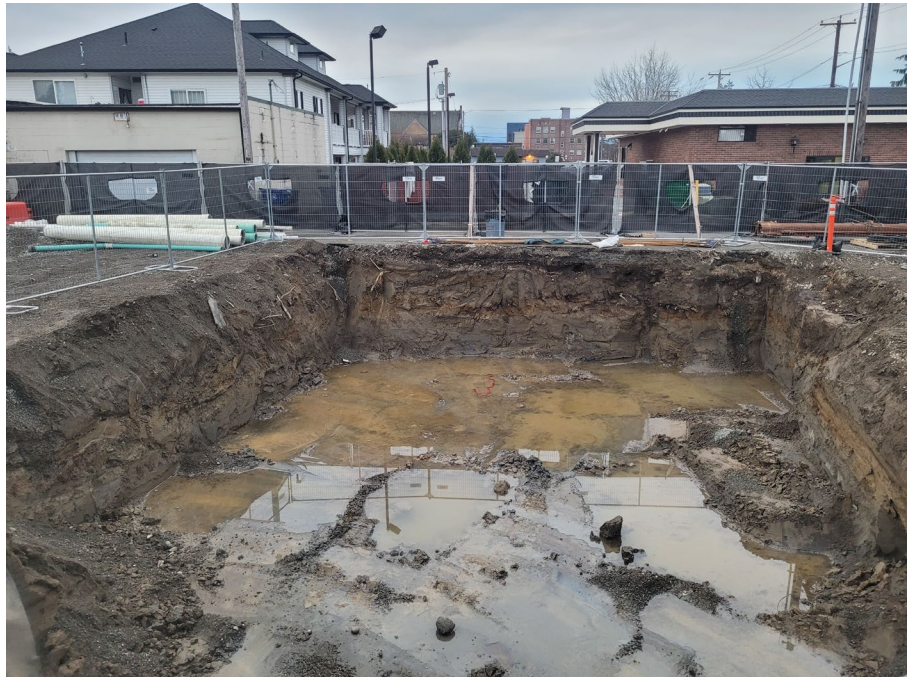
Overexcavation continued laterally until PCS impacts ceased. Final excavation extent was approximately 68 feet long by 36 feet wide, as shown on this photograph. Photograph taken on January 9, 2023, looking south.

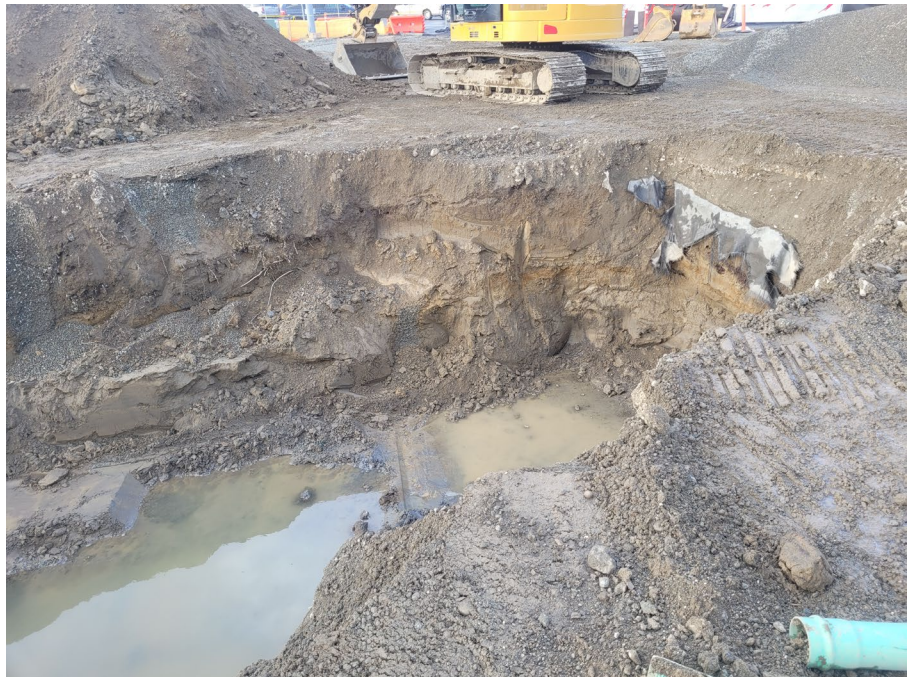
### **Photo No. 8.**

Northern final extent of excavation. Photograph taken on January 10, 2023, looking west.

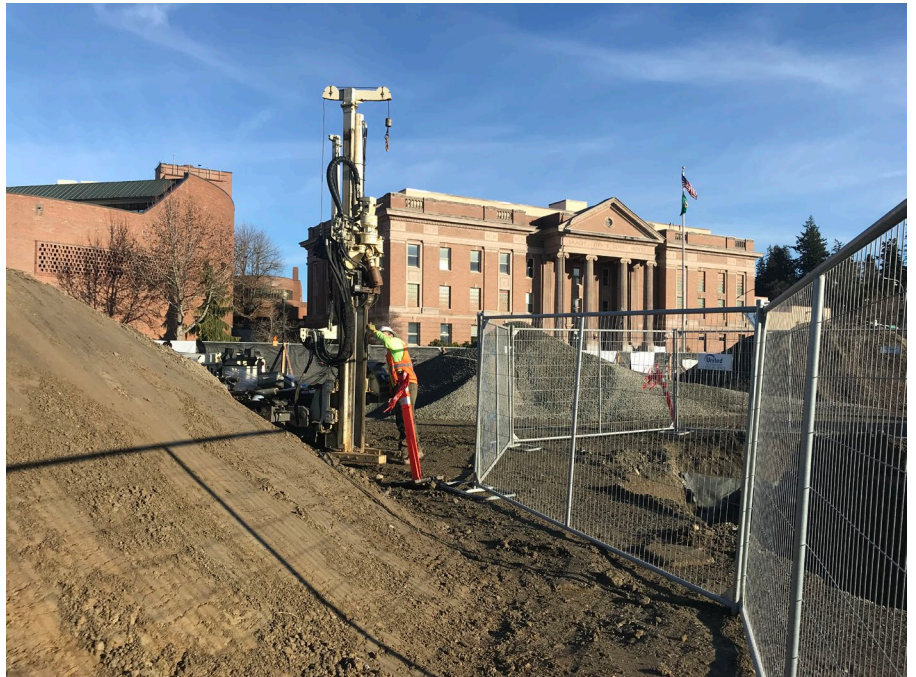
Driller installing temporary well screen at boring location B01 for reconnaissance groundwater sample collection. Photograph taken on January 10, 2023, looking north.

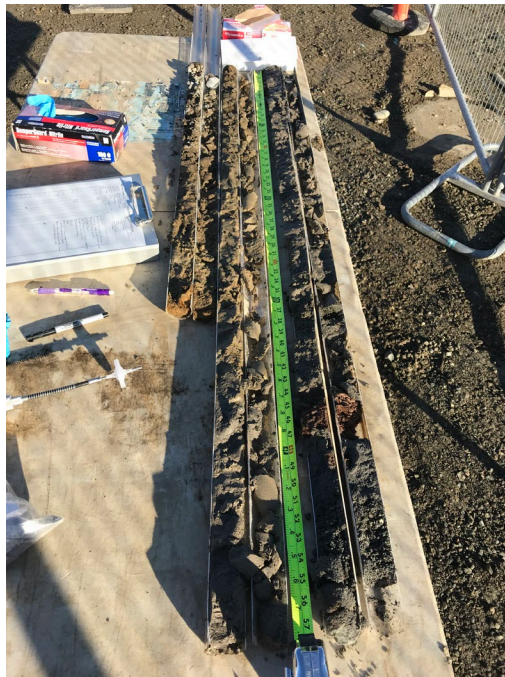
### **Photo No. 10.**

Soil core (0 to 15.0 feet bgs) from boring location B01, northwest of the excavation.

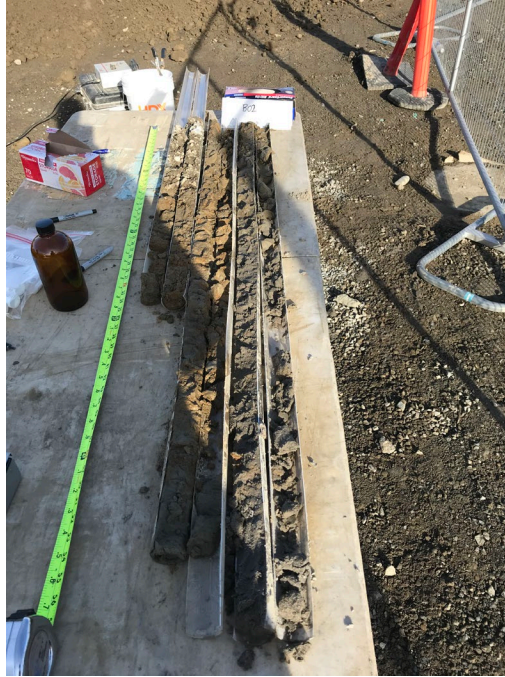
Soil core (0 to 15.0 feet bgs) from boring location B02, west of the excavation.

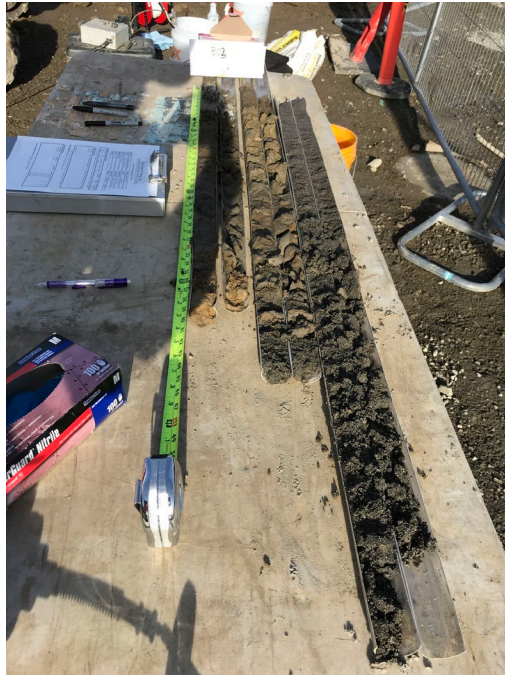
### **Photo No. 12.**

Soil core (0 to 15.0 feet bgs) from boring location B03, east-southeast of the excavation.

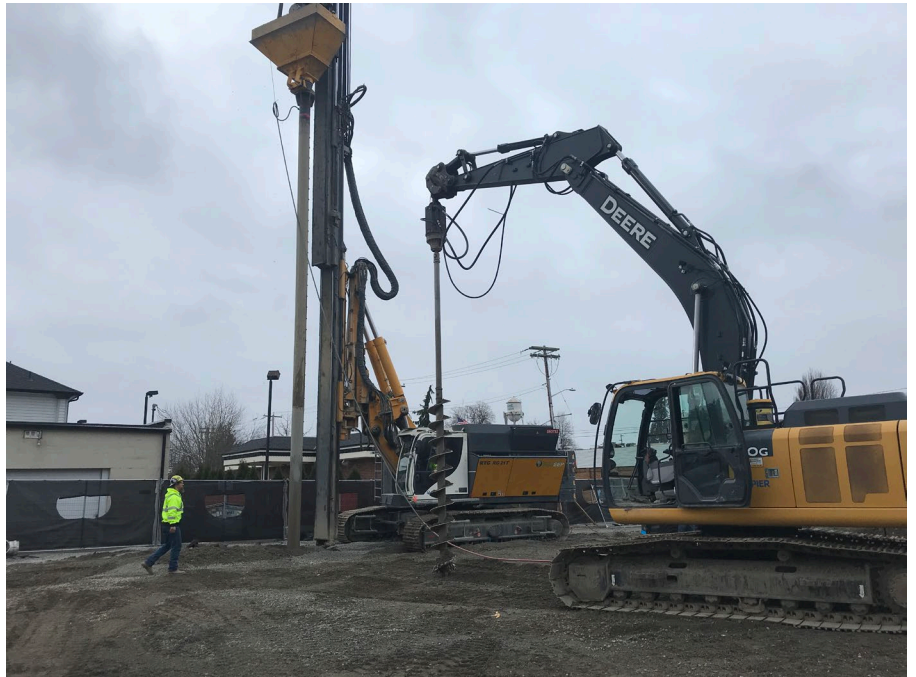
Contractor installing geo-piles in the vicinity of the former excavation area, post-backfill. The contractor plans to place a deep footing in south portion of the former excavation area. Photograph taken on January 17, 2023, looking southwest.

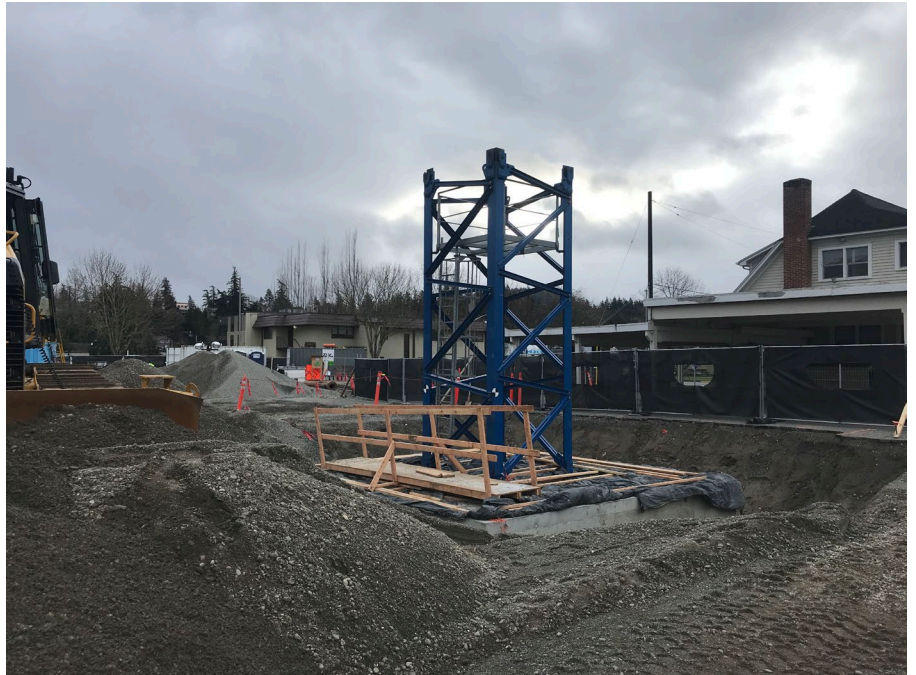
### **Photo No. 14.**

Deep footing adjacent east of the former excavation area. Deep footings are installed to approximately 9.0 feet bgs. Photograph taken on January 17, 2023, looking southeast.
