March 16, 2023
Project No. M1472.02.002

Re: Site Assessment for Permanent Closure of a 440-Gallon Underground Storage Tank
Mount Vernon Library Commons
208 West Kincaid Street, Mount Vernon, Washington

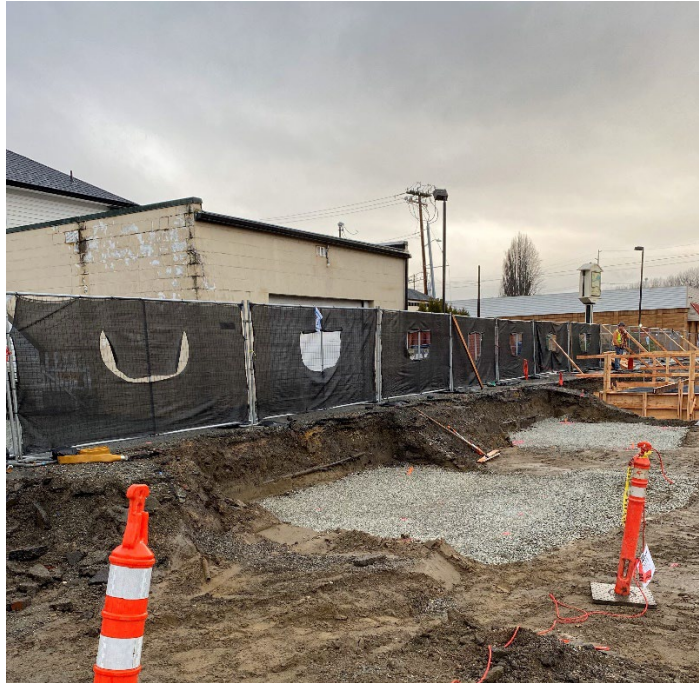
Photo No. 1.

Property grade approximately 2 feet below the surrounding grade, looking southwest. Photo taken on February 17, 2023.

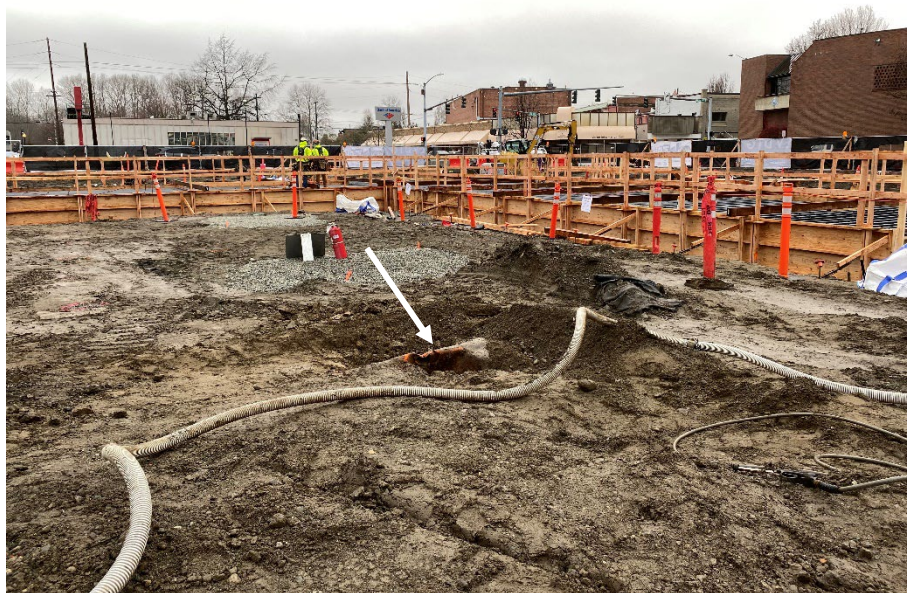
Photo No. 2.

Location of 440-gallon underground storage tank (UST) indicated by white arrow, looking west-northwest. Photo taken on February 17, 2023.

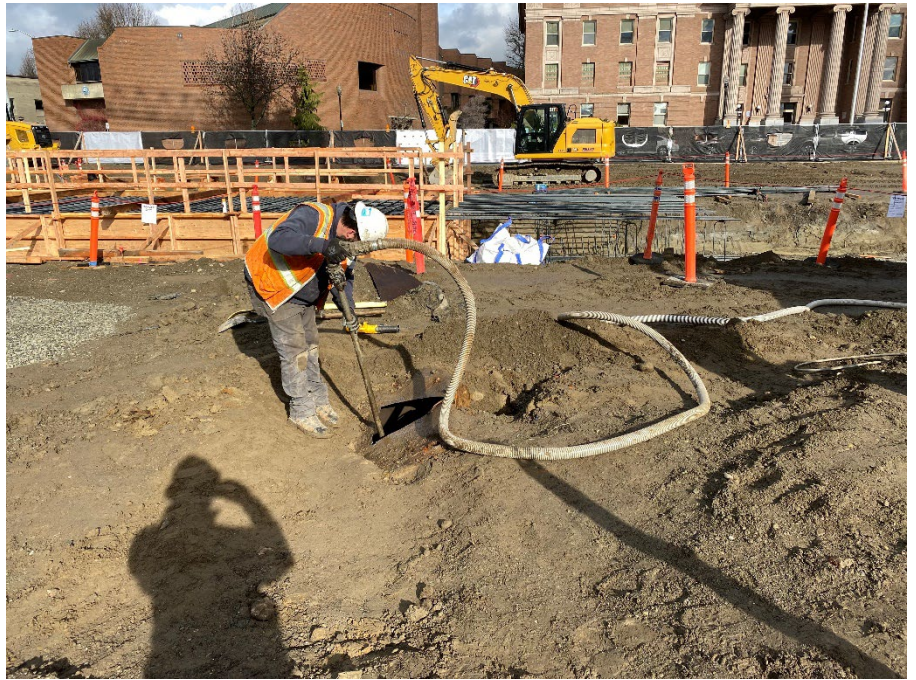
Photo No. 3.

ClearCreek Contractors pumping out the contents of the 440-gallon UST, looking west-northwest. Photo taken on February 17, 2023.

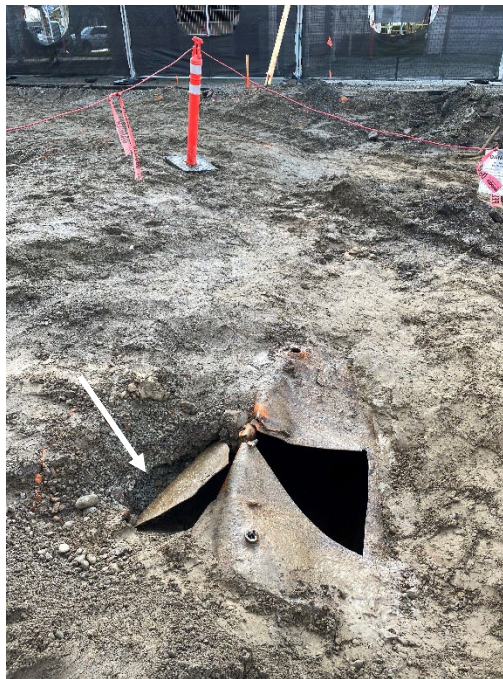
Photo No. 4.

Triple-rinsed and inerted 440-gallon UST with geopier material visible to the west indicated by white arrow, looking south. Photo taken on February 17, 2023.

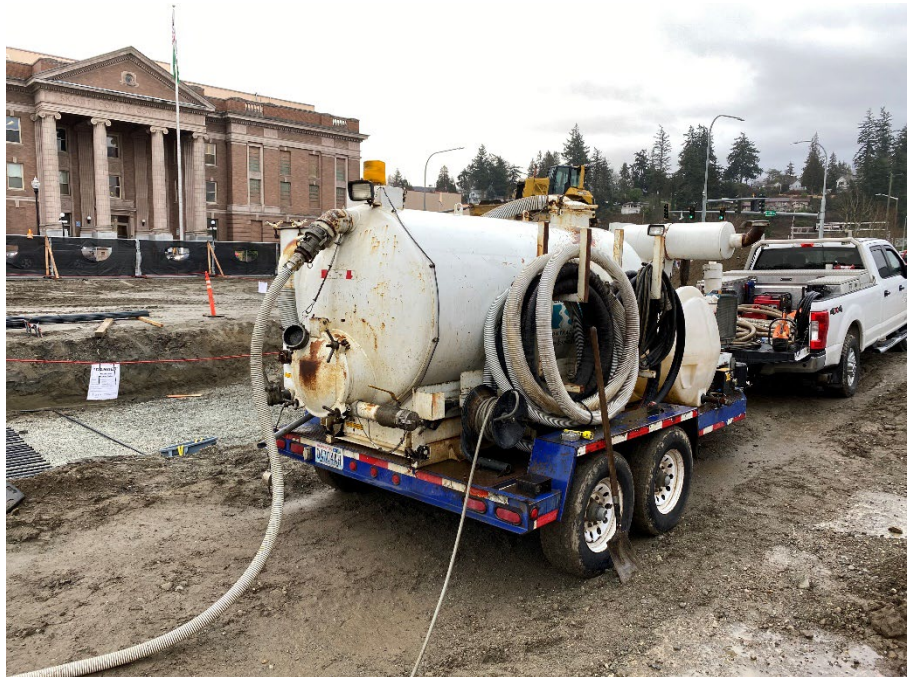
Photo No. 5.

Tank used to transport the contents of the 440-gallon UST for off-site disposal, looking northeast. Photo taken on February 17, 2023.

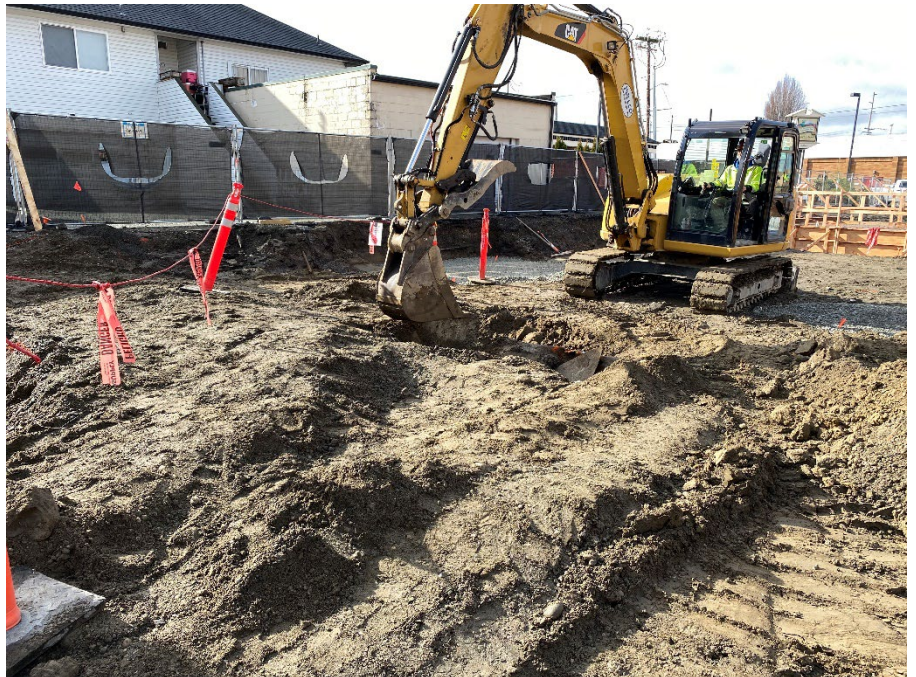
Photo No. 6.

Uncovering the 440-gallon UST, looking southwest. Photo taken on February 17, 2023.

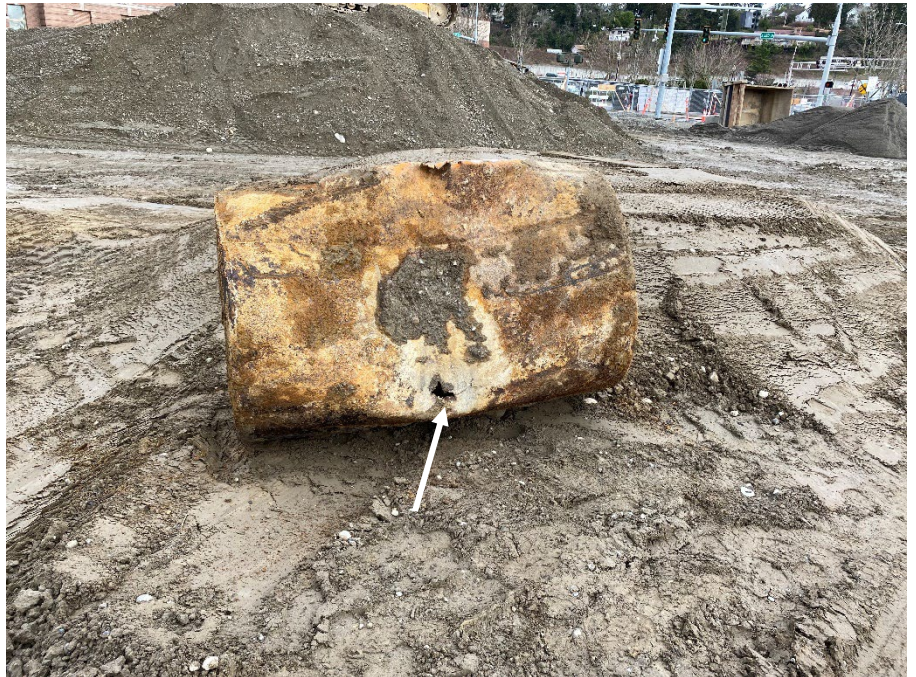
Photo No. 7.

ClearCreek removed approximately 15 gallons of residual product from the bottom of the UST. The UST was then triple rinsed. Approximately 25 gallons of rinse water was removed from the UST; all liquids were transported to ClearCreek's facility in Puyallup, Washington for treatment and disposal. Disposal manifests are included as Attachment D. Pellco then removed the UST. One hole was observed in the side of the UST upon removal immediately adjacent to a geopier. Geopiers are a ground improvement feature consisting of a column of very dense, stiff, gravel. Based on visual observations of the hole, including punctured metal into the UST, it is likely the hole was created during installation of a geopier, adjacent to the UST. The hole did not appear to be caused by rust or tank degradation.

Side of 440-gallon UST, with hole indicated by white arrow. Photo taken on February 17, 2023.

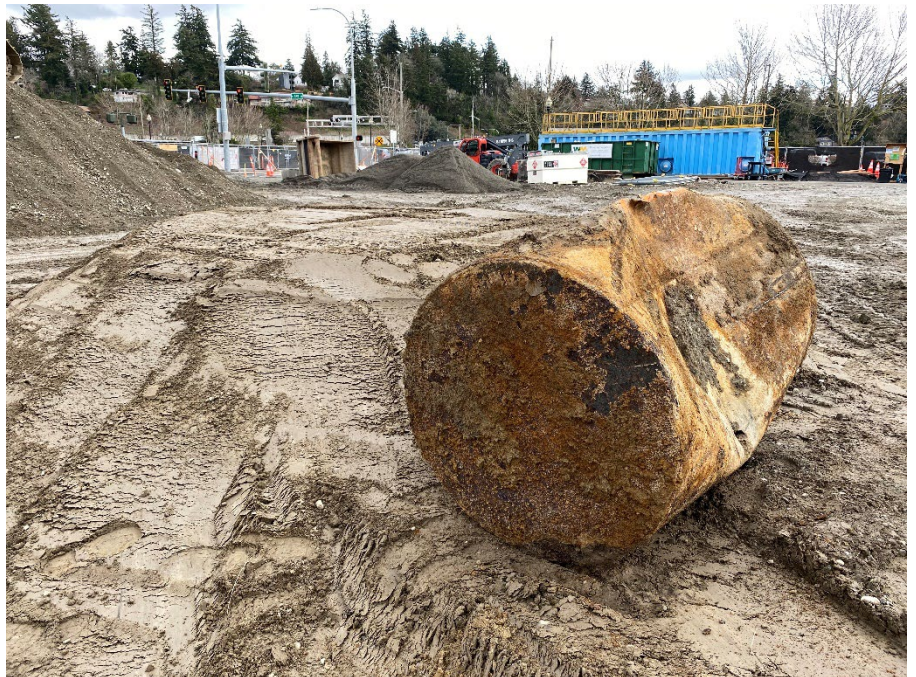
Photo No. 8.

End of 440-gallon UST, in good condition. Photo taken on February 17, 2023.

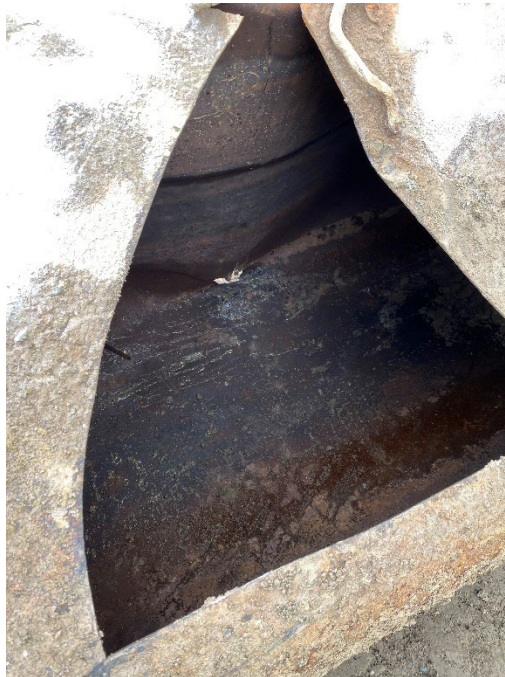
Photo No. 9.

Hole in 440-gallon UST,
viewed from the inside.
Photo taken on
February 17, 2023.

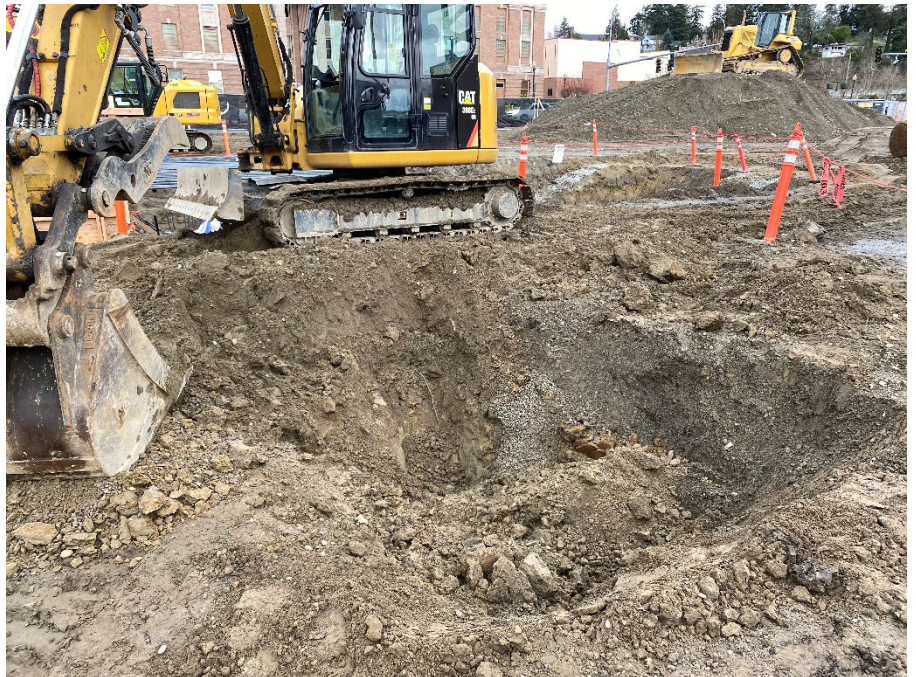
Photo No. 10.

440-gallon UST pit, with
minor staining, looking
northeast. Photo taken
on February 17, 2023.

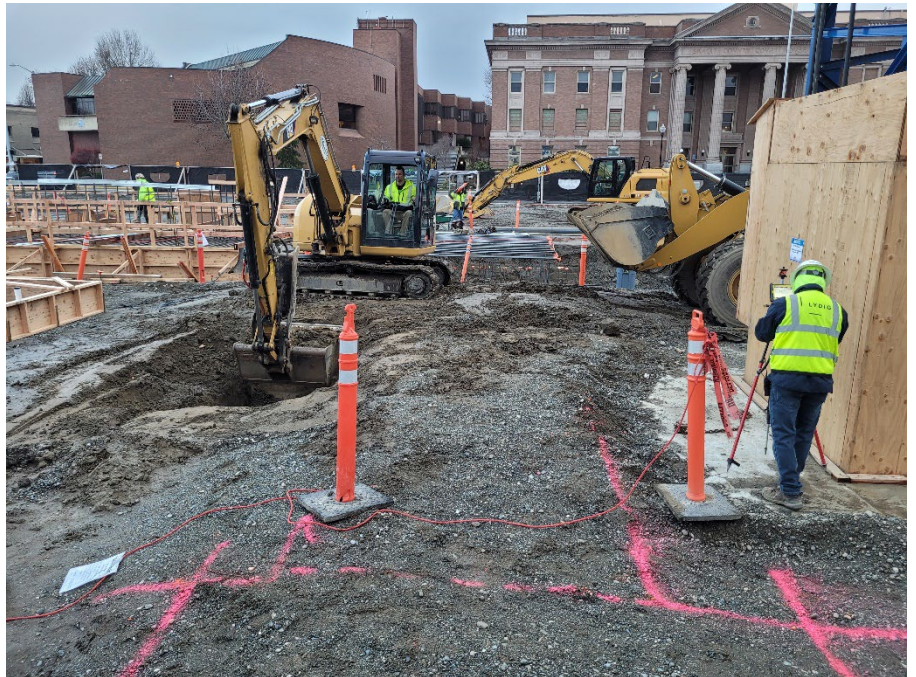
Photo No. 11.

Over-excavation of 440-gallon UST pit, looking north. Photo taken on February 21, 2023.

Approximately 12 cubic yards of PCS were excavated and disposed of off-site. The final excavation extent was 7 feet below Property grade (9 feet below ground surface), 10 feet long (north-south), and 6 feet wide (east-west).

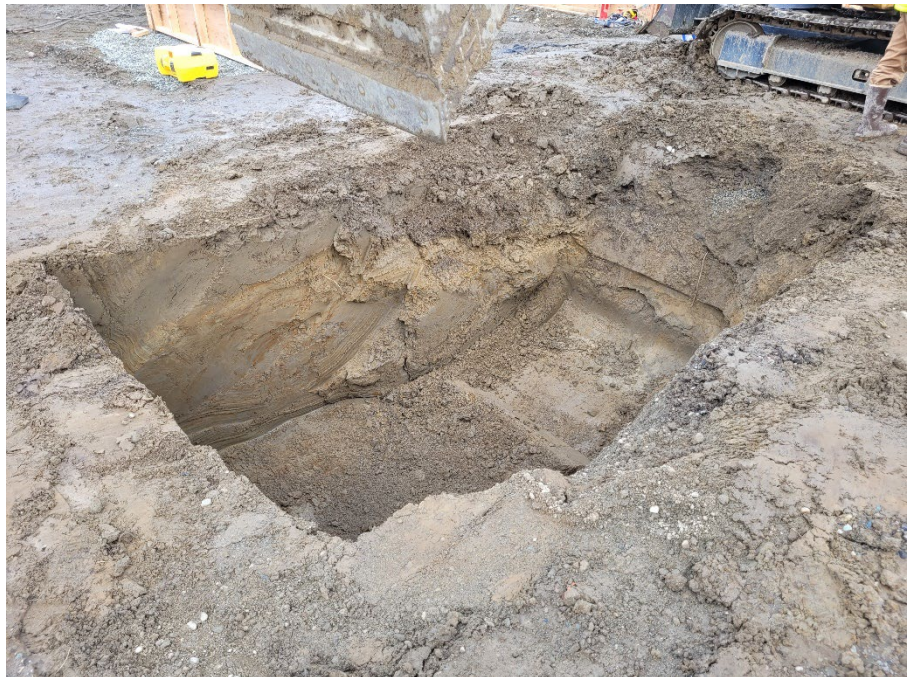
Photo No. 12.

Final excavation extent, looking northwest. Photo taken on February 21, 2023.

Confirmation soil samples collected from all four sidewalls and the base of the excavation were non-detect for all analytes. Therefore, no additional remediation is recommended associated with the closure of this UST.

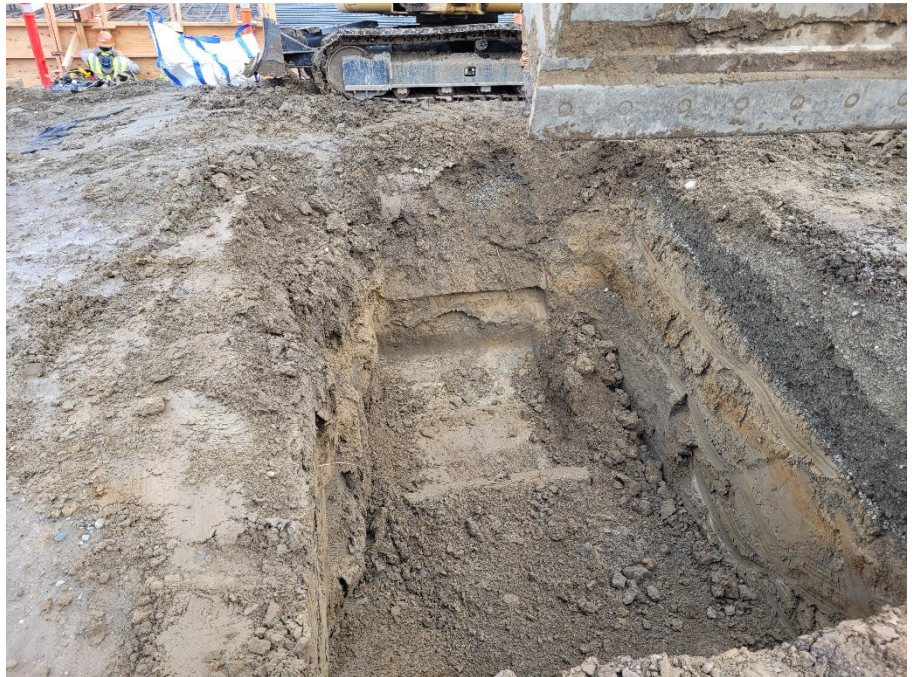
Photo No. 13.

Final excavation extent,
looking north-northeast.
Photo taken on
February 21, 2023.
