VENTILATION WORK PLAN Texaco Strickland Site

Prepared for: Strickland Real Estate Holdings, LLC

Project No. 180357 • January 6, 2023 • DRAFT

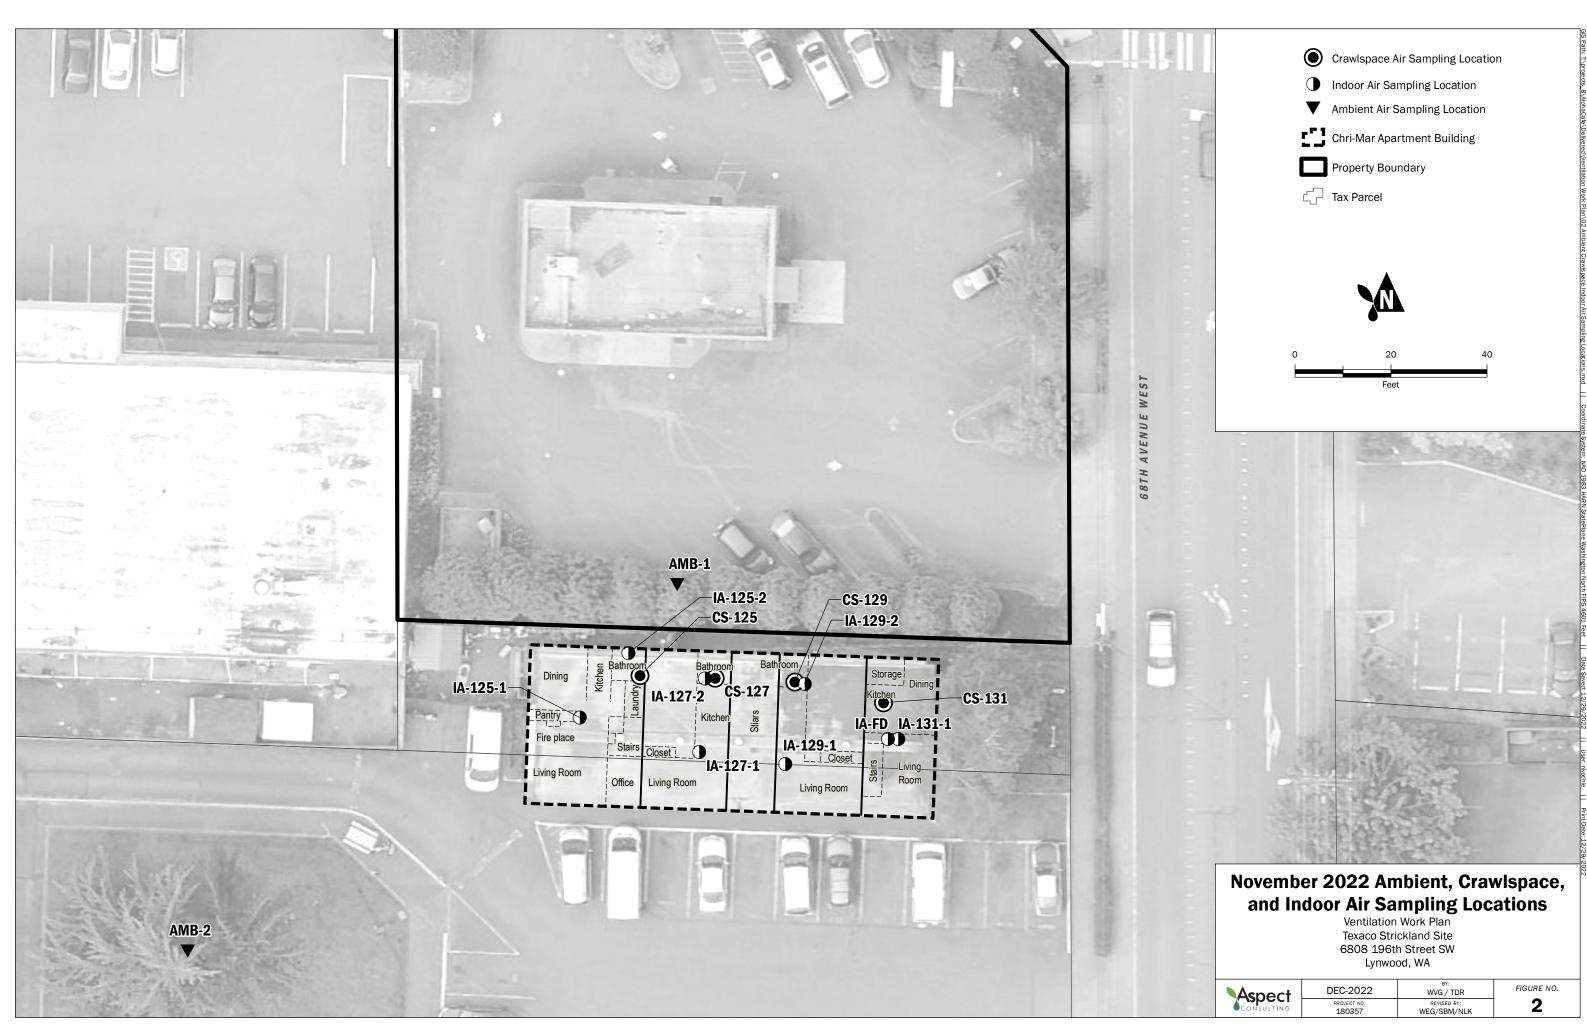
DEC-2022	^{ву:} WVG / TDR	FIGURE NO.
CONSULTING	PROJECT NO. 180357	REVISED BY: WEG/SBM/NLK	2

The purpose of ambient air sampling during a VI assessment is to estimate how much ambient air is contributing to the measured indoor air concentrations. Two ambient air samples were collected during the November 2022 sampling event as shown on Figure 2:

- AMB-1 was collected on the north side of the Building
- AMB-2 was collected to the southwest of the Building

Crawlspace air samples beneath each Building apartment unit were obtained concurrently with indoor air samples. The tubing intake for the crawlspace air samples was placed at approximately the mid-height of the crawlspace and where the plumbing penetrations entered the bathroom for the western three units (Units #125, #127, and #129) and the kitchen for the easternmost unit (Unit #131) as shown on Figure 2.

The laboratory analytical report is included as Appendix A and the tabulated analytical results are in Table 1. All sample locations are shown in Figure 2. It should be noted that the analytical report is still undergoing third party data validation in accordance with the AO and therefore the results in Appendix A and Table 1 are subject to change as a result of data validation.

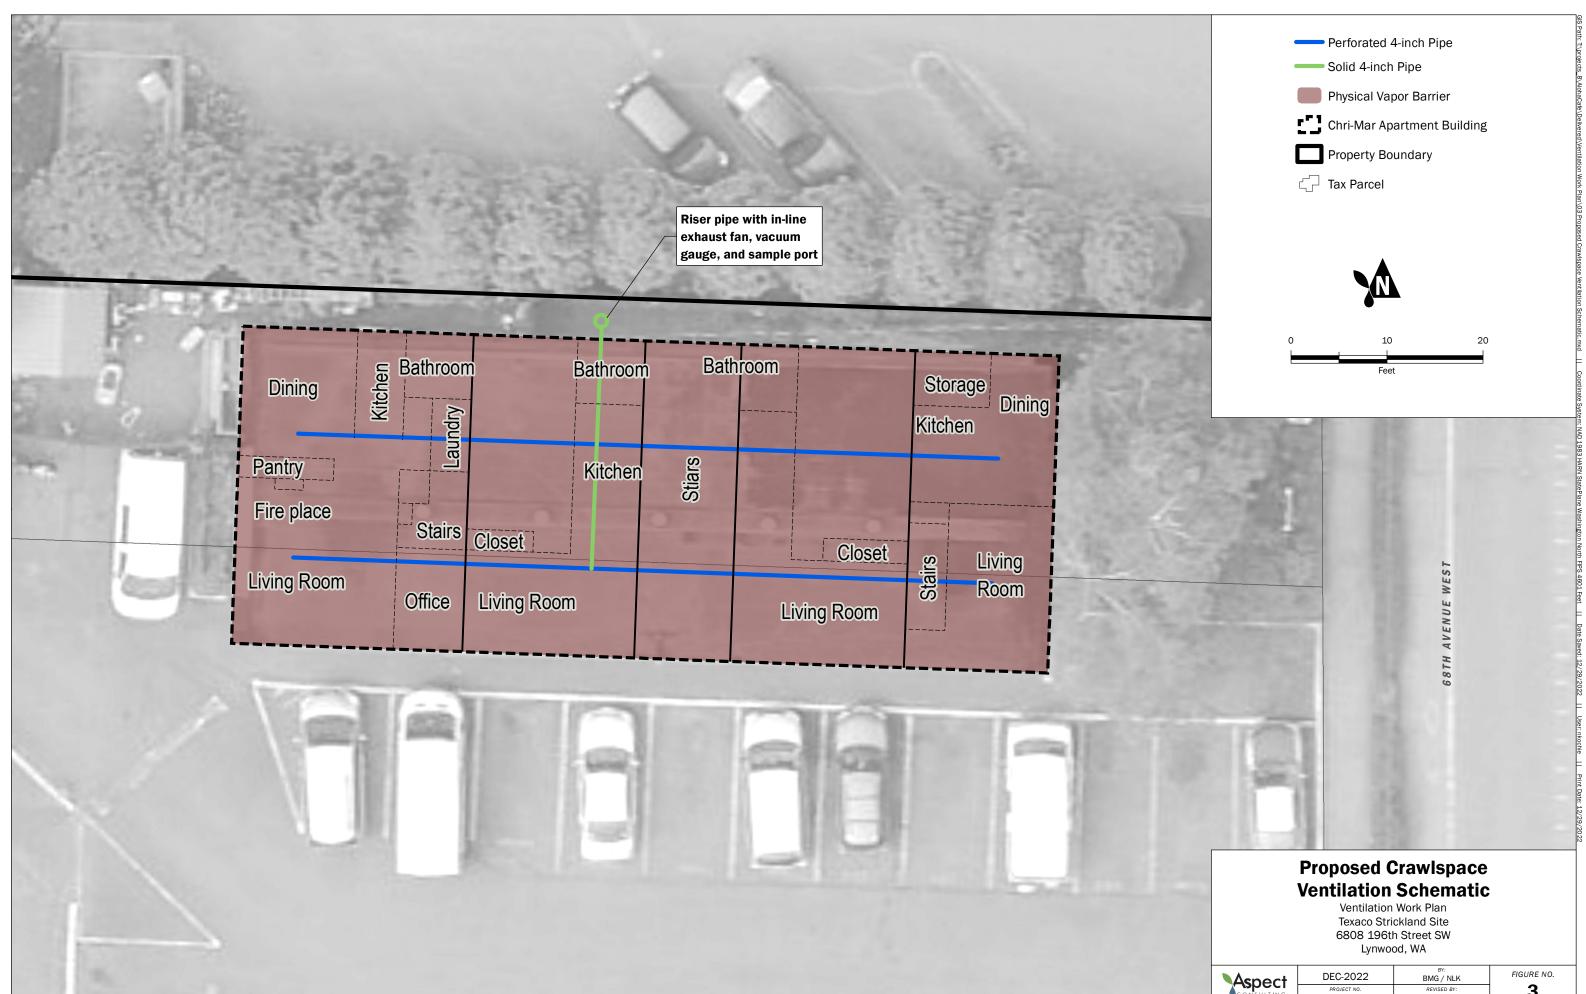
DEC-2022	BY: BMG / NLK	FIGURE NO.
CONSULTING	PROJECT NO. 180357	REVISED BY:	3

A diagram of the proposed crawlspace ventilation system is included as Figure 3. The crawlspace ventilation system will consist of two hand-perforated, four-inch, high density polyethylene (HDPE) piping laterals that join at a central location to a 4-inch 3034 polyvinyl chloride (PVC) or acrylonitrile-butadiene-styrene (ABS) main. Perforated laterals are placed on bare ground in the crawlspace and covered with 6-millimeter low density polyethylene plastic sheeting cut to 2-feet larger than the crawlspace and installed and sealed to the foundation walls and footings per established American National Standards Institute (ANSI) and American Association of Radon Scientists and Technologists (AARST) protocols (ANSI/AARST, 2017). The main pipe connects to a four-inch PVC or ABS vertical riser pipe equipped with an electric exhaust fan. The exhaust fan operates continuously, creating a negative pressure from beneath the crawlspace and venting to the atmosphere 14-inches above the roof of the Building via the riser pipe.

Exhaust fans are in-line fans that induce up to 5.0 inches of water vacuum with sufficient flow rate to induce a vacuum beneath the membrane throughout the crawlspace. Example exhaust fans that are expected to meet these requirements is the AMG Legend or AMG Legend Extreme by Festa Radon Technologies Company (Appendix B). Fan curves for both models can be found in Table A, below. The exact fan will be selected in the field based on the results of the installer's patented diagnostic vacuum tester.

- Aboveground perforated piping will be laid on bare soil in the crawl space.
- Physical vapor barrier membrane (6-mil low density polyethylene LDPE) will be placed above the perforated piping and sealed to the foundation walls.
- Fan and riser to the roofline will be installed on the building's north facing exterior wall.
- Electrical service to the fan will be connected. The fans will require single-phase, 110-volt service. Electrical hookups will be coordinated with the Building owner and a subcontracted licensed electrician.
- Vacuum gauge and sample port will be installed in the riser piping, upstream of the fan inlet to monitor performance.

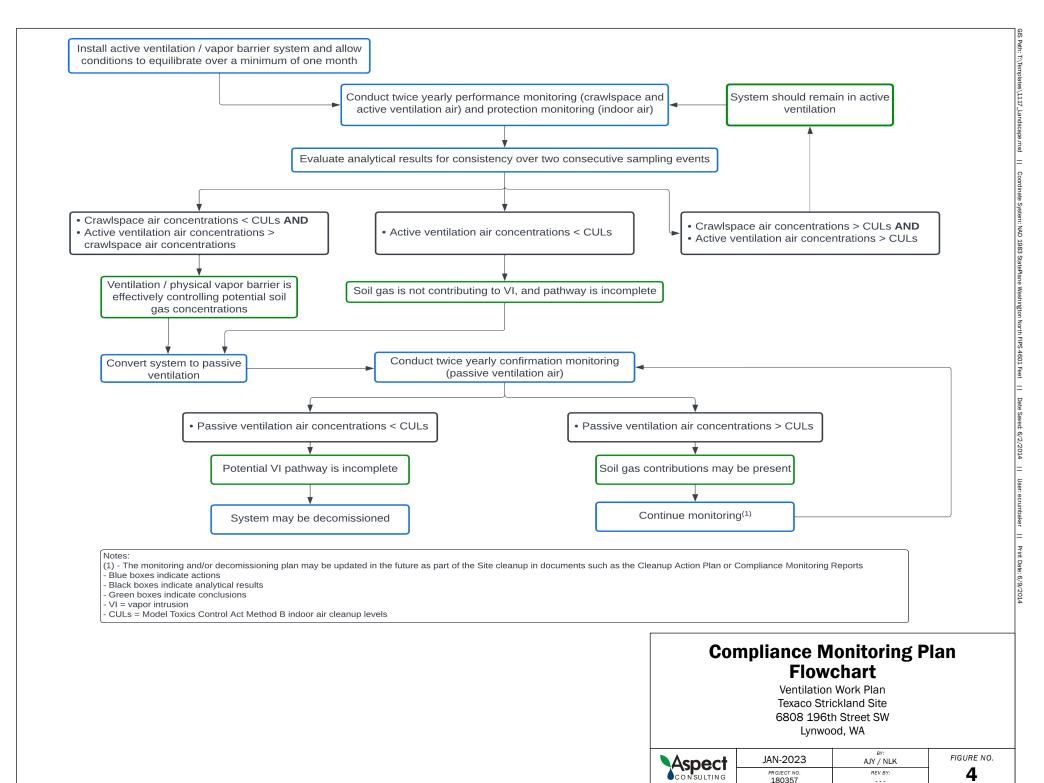
All compliance monitoring air samples will be collected in accordance with the procedures established for the Site as detailed in the VIAR (Aspect, 2022). A flowchart summarizing the process described below can be found in Figure 4.

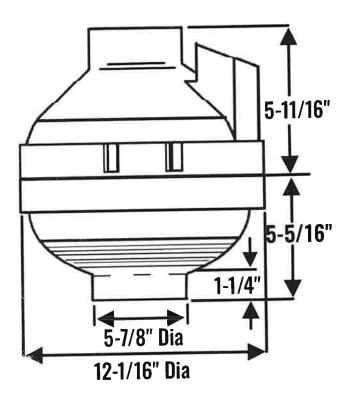
LEGEND EXTREME TECH SPECS

Structures varying from 1,500 to 4,000 sq. ft. Extremely compact or moist subslab, such as clay. Great for most large footprint homes or buildings, multiple suction points, and double stacking.

Fits to 6" Fernco Couplers Available in white only Weight: 9.2 lbs Festa Radon Technology 47A Progress Ave Cranberry Township PA 16066 1-800-806-7866
