INTERIM ACTION REPORT

Texaco Strickland Site

Prepared for: Strickland Real Estate Holdings, LLC and
Chevron Environmental Management Company

PROJECT NO. 180357 • APRIL 26, 2023 FINAL

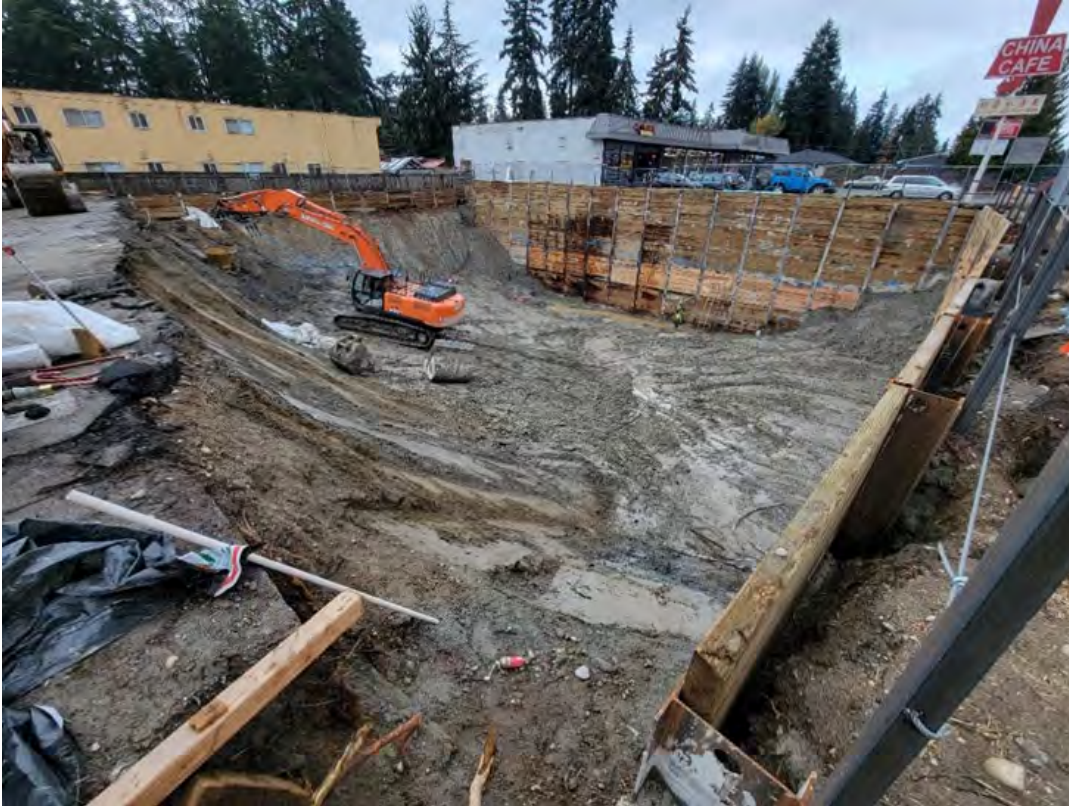
Photograph 1. Final IA excavation extents as photographed prior to initiating backfill, looking southwest.

During the IA, a total of 14,437 tons of contaminated soil and 3,034 tons of clean soil was excavated and removed from the Property.
