**PHASE II  
SITE CHARACTERIZATION**

**Reid Auto**  
3512 South 84<sup>th</sup> Street  
Lakewood, Washington 98499

**June 23, 2003**

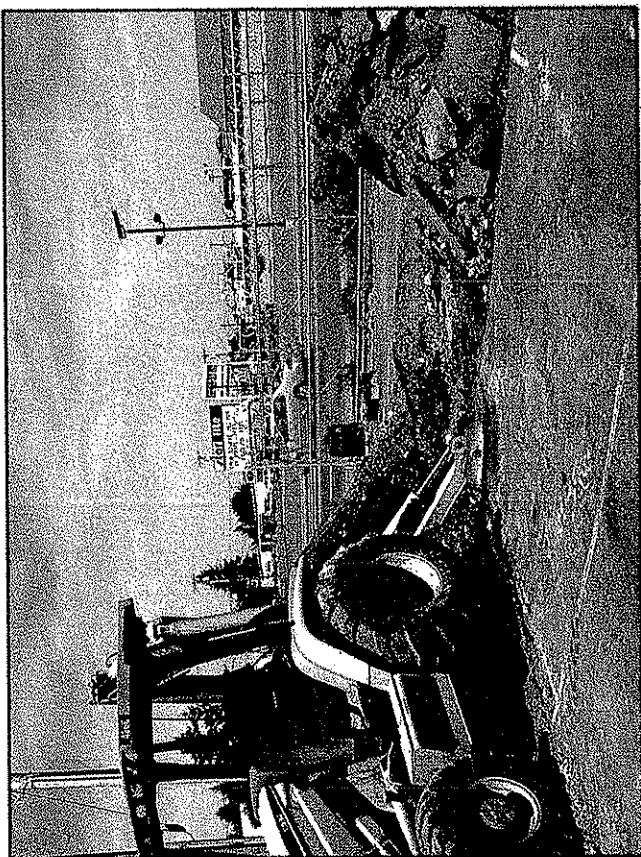
On June 5, 2003, AEG and subcontractor Canon Construction returned to the site to further delineate the extent of contamination and the pathway of the four inch perforated pipe. Subsurface activities were conducted immediately south of the northern property boundary, parallel to South 84<sup>th</sup> Street. The pit was excavated 10 feet running east and west and 16 feet running north and south and approximately 11 feet bgs. The four inch perforated pipe was exposed along the south wall of the excavation approximately 20 south of the north property boundary and approximately 6 feet bgs. Free product was encountered surrounding the pipe, 3-4 feet on east and west sides of the pipe and extended slightly beyond nine feet bgs.

Excavation parallel to 84<sup>th</sup> Street (North Excavation)

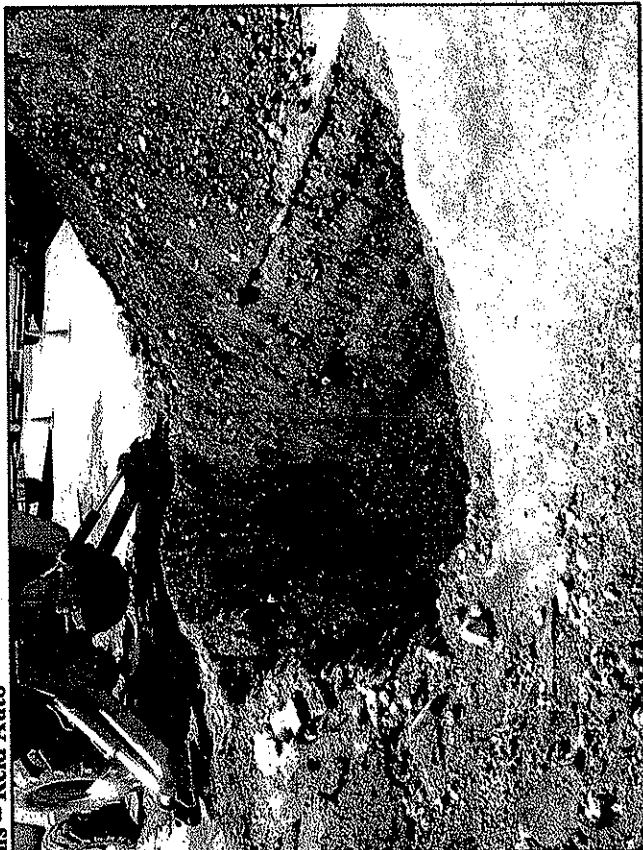
North excavation looking south

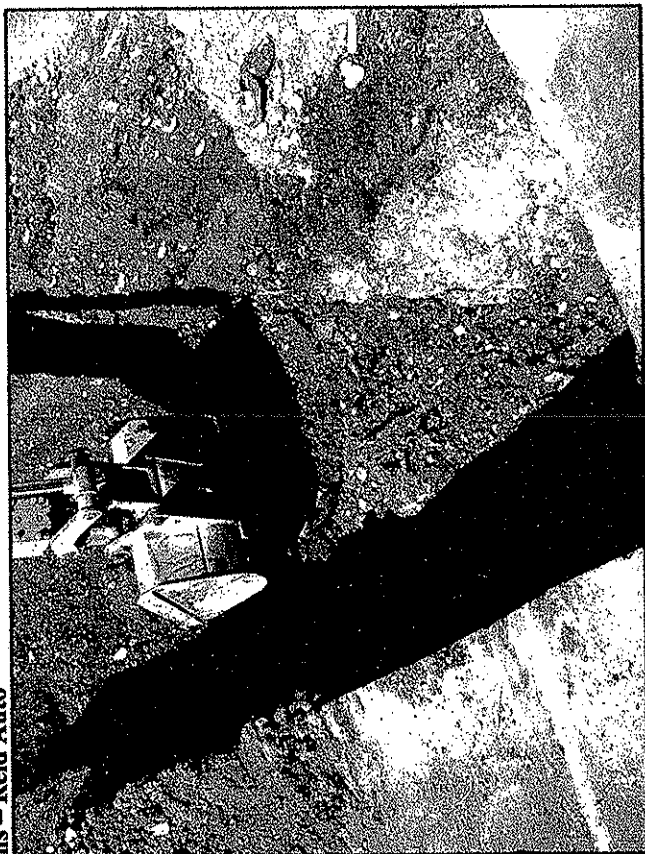
South excavation

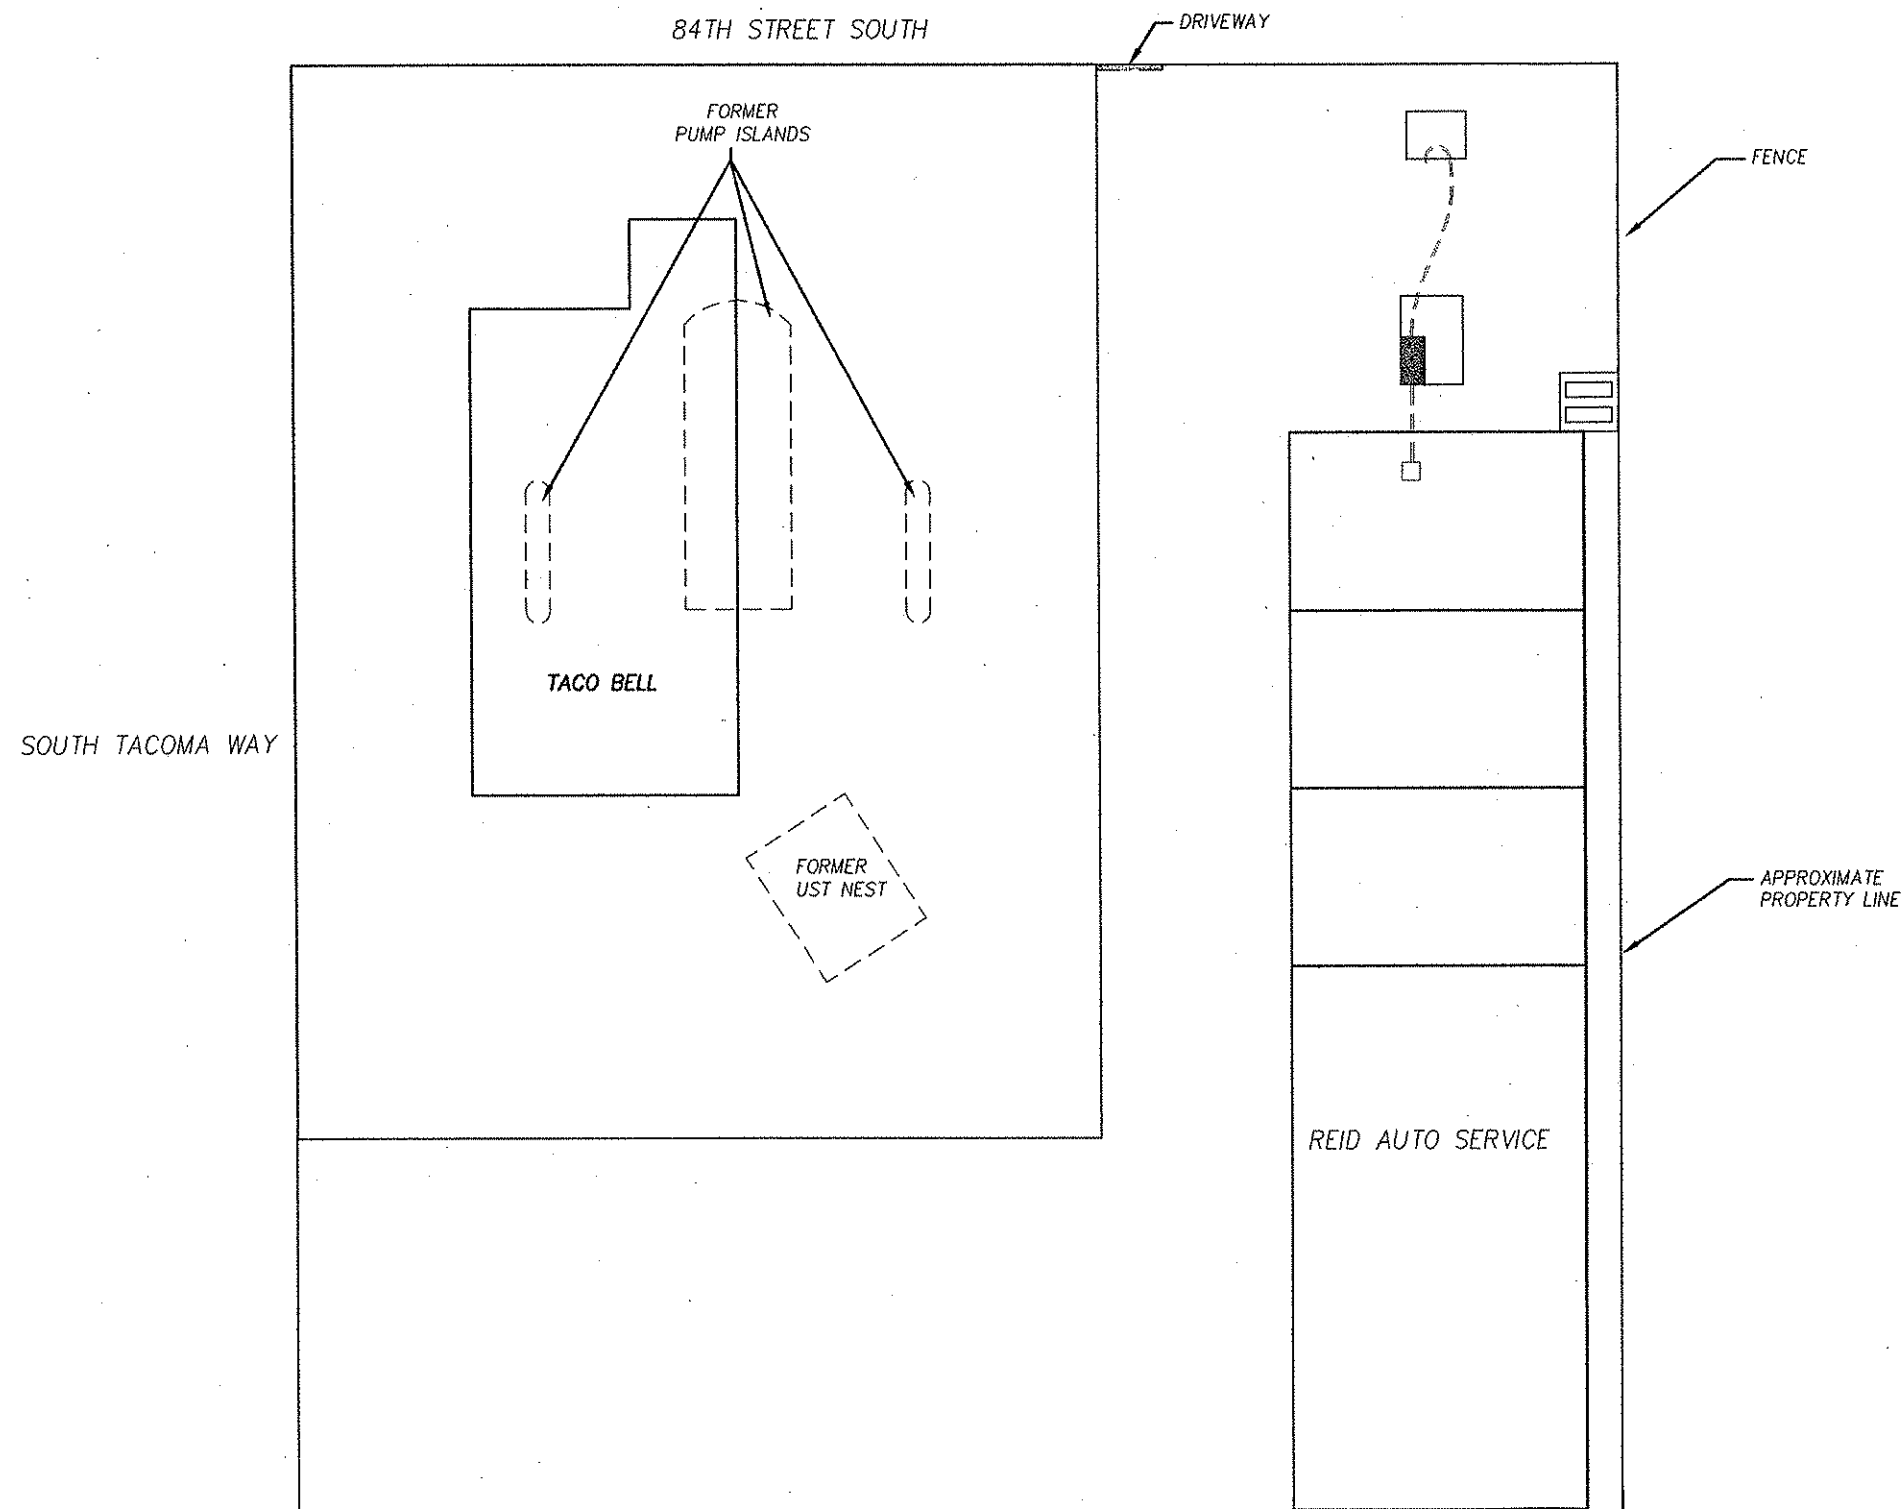
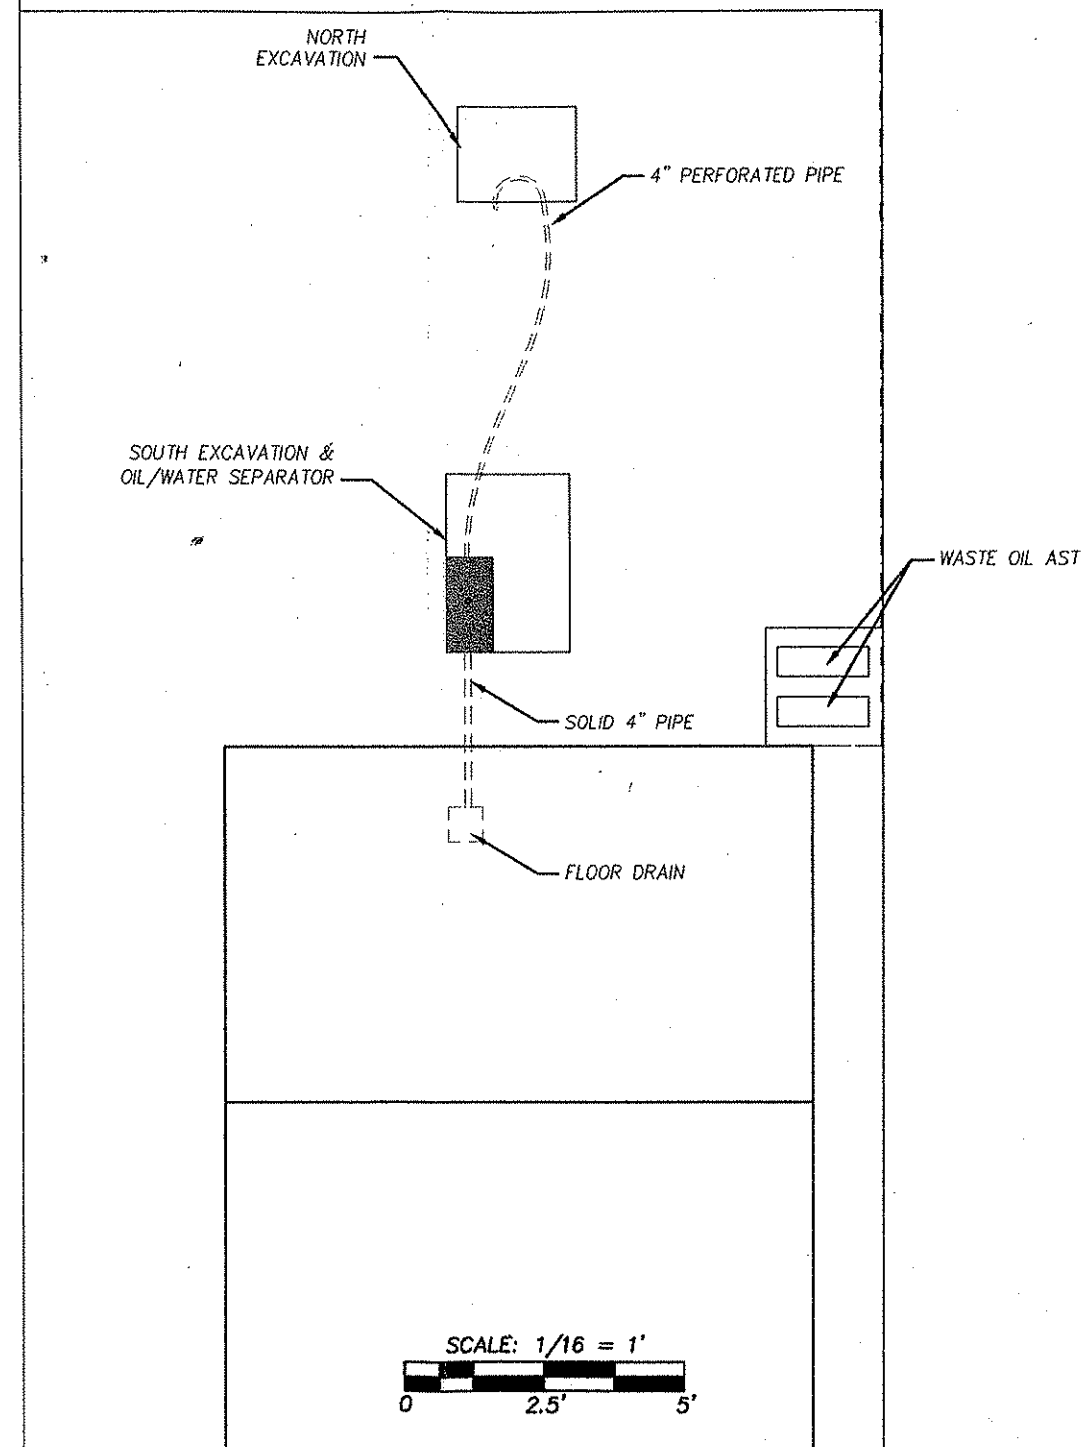
### EXCAVATION DETAIL

Refer to Appendix A: Site Detail for the site layout and excavation details and Appendix C: Site Photographs for photo documentation of the site activities.

Based on the field observations, AEG collected soil samples from the north excavation pit from the north, east and west walls and from the base of the excavation. One representative sample was collected from the contaminated material from the south excavation on the east side of the UST. Refer to Appendix A: Site Detail for the locations of the samples.
