SITE REMEDIATION

Reid Auto

3512 South 84th Street

AEG Project #: 22-234-01

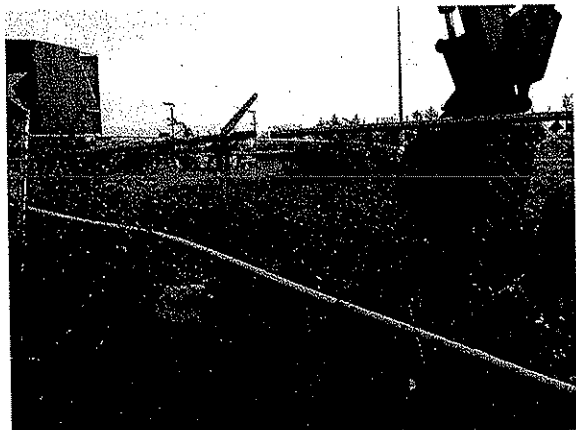
Photo #1: Fence along east edge of subject site being taken down.

The site was prepared by taking down the fencing along the eastern edge of the site to offer access for the vacant adjoining property; also owned by Mr. Reid, to be used for stockpiling of PCS. Plastic sheeting was placed on the ground, and the area to be used was surrounded by bales of hay to contain the PCS.

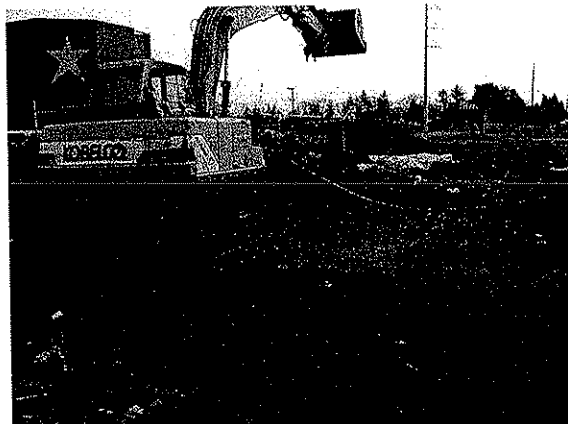
Photo #2: The excavation begins just north of the repair shop.

The excavation began in the area just north of the automotive shop where the tank was located. Since much of the overburden had already been excavated and mixed with PCS, much of the overburden was treated as PCS. The excavation continued downward until the tank was found, approximately four feet bgs where it was discovered that the tank was full of oily water. ProVac was retained to pump the liquid from the tank.

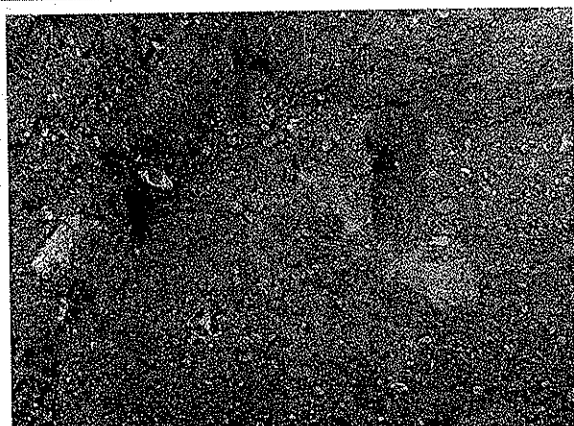
Photo #3: Tank exposed with drain line from building.

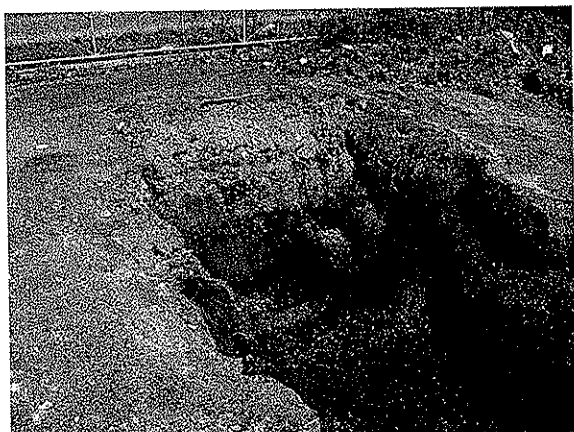
Photo #5: Northern edge of the excavation.

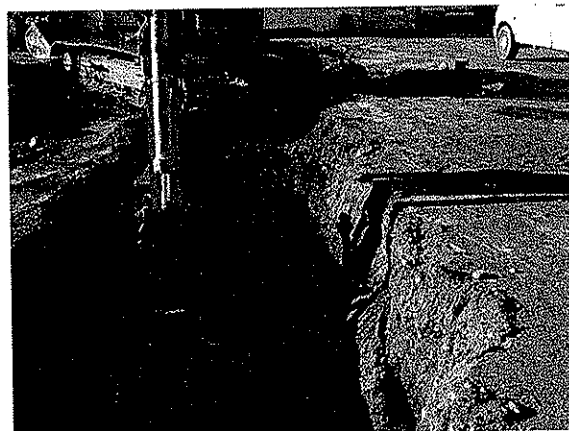
Photo #6: The excavation proceeds to the south towards tank area.

While waiting for the tank to be pumped, the excavation was continued from the north end of the property with the intent of working towards the building and eventually combining the north and south portions of the excavation. The tank was removed from the pit and removed from the property for recycling.

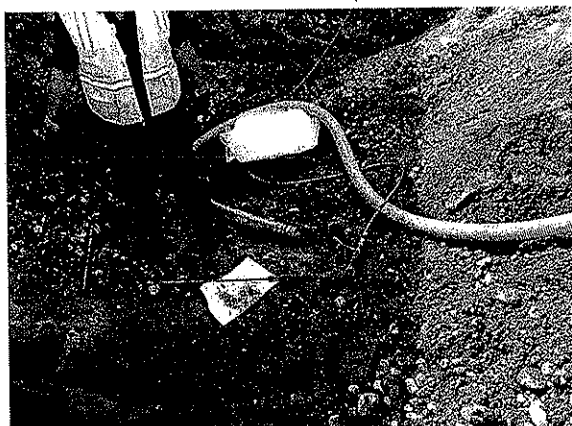
Photo #9: ProVac on site to remove tank contents.

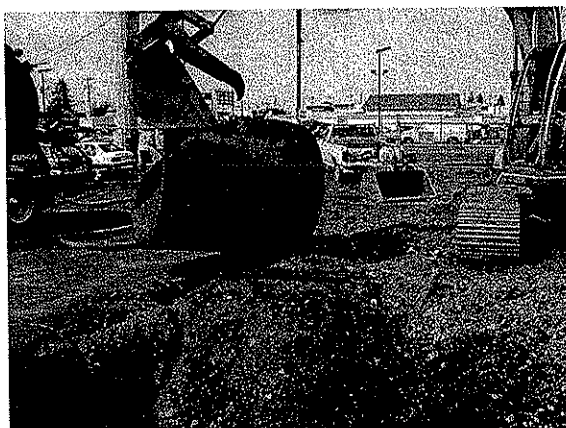
Photo #10: Removing tank from the pit.

- The 1,300-gallon tank utilized as an oil/water separator at the subject site was removed and disposed of offsite. The tank appeared intact but contained manufactured openings on the top that were not capped. The tank appeared full during excavation activities so Pro-Vac was retained to vacuum out the tank.
