FINAL COMPLIANCE MONITORING REPORT  
**AS/SVE System Extension and  
Modification**

8801 EAST MARGINAL WAY S., TUKWILA, WASHINGTON  
AGREED ORDER NO. 6069

Subject: FINAL COMPLIANCE MONITORING REPORT, AS/SVE SYSTEM  
EXTENSION AND MODIFICATION, 8801 EAST MARGINAL WAY S.,  
TUKWILA, WASHINGTON  
AGREED ORDER NO. 6069

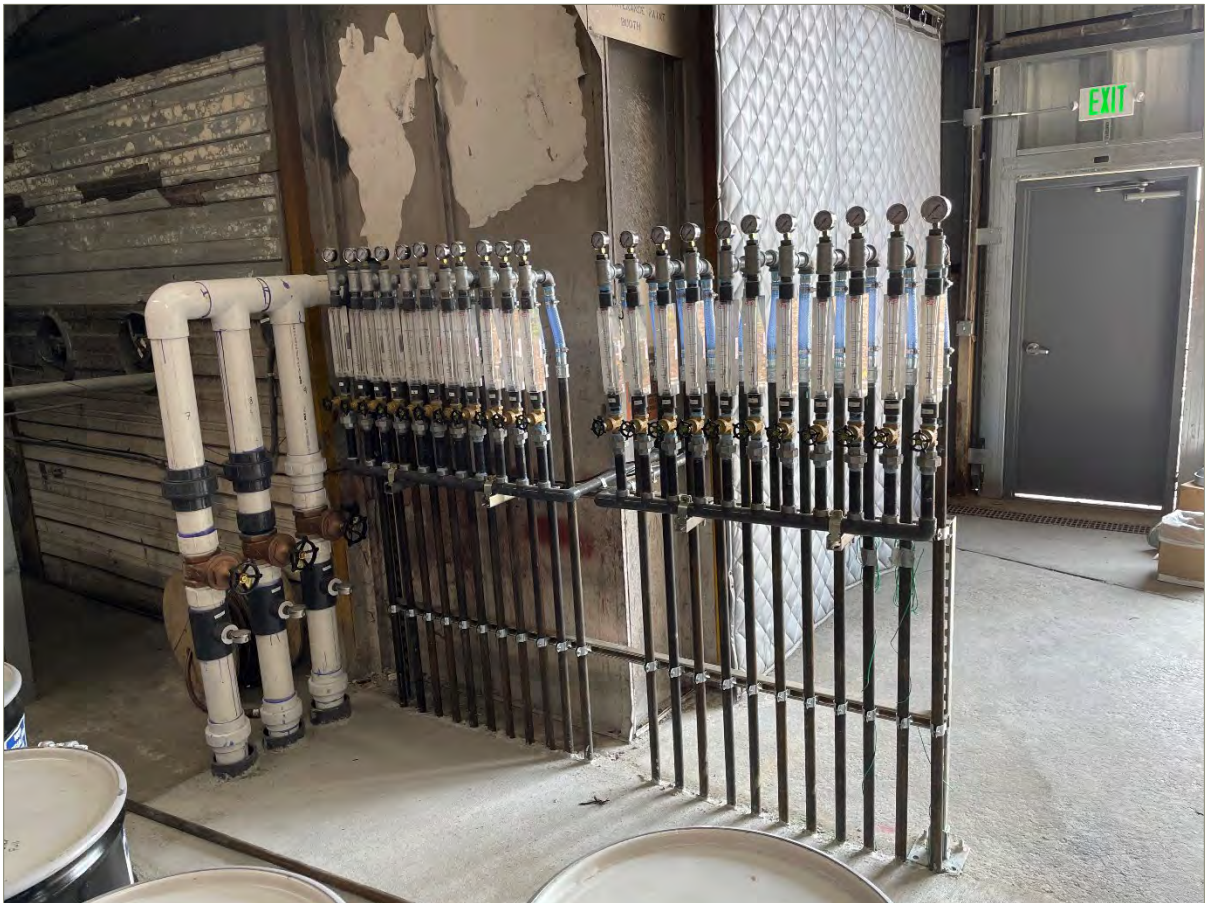
Exhibit 5-1: View of the 22 AS Extension Lines Inside of the AS/SVE Building, Looking Southeast

The existing AS compressors direct pressurized air to the new AS wells. The AS wells are screened in the shallow perched aquifer. The injected air percolates through the groundwater and saturated soil creating aerobic conditions and volatilizing chemicals. The locations of the 22 new AS wells are shown in Figure 3 and connections to the existing system are shown in Figures 6 and 7. A photo of the aboveground components of the AS extension is shown in Exhibit 5-1 below.

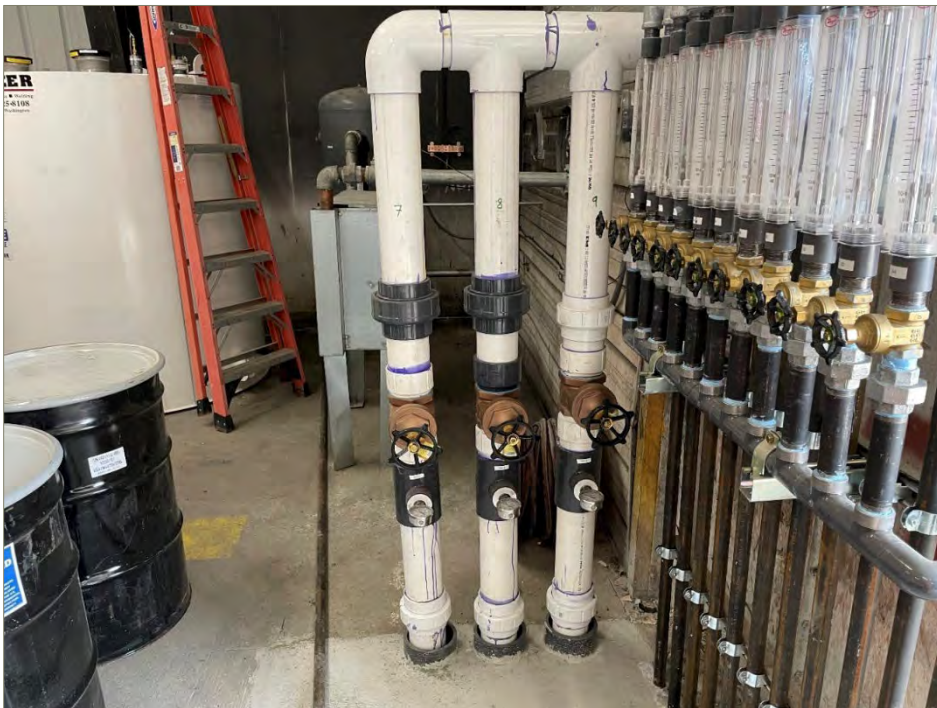
Exhibit 5-2: View of the Three SVE Extension Pipes Inside of the AS/SVE Building, Looking East

A photo of the point where the SVE screens are routed above the surface is provided as Exhibit 5-2 below.

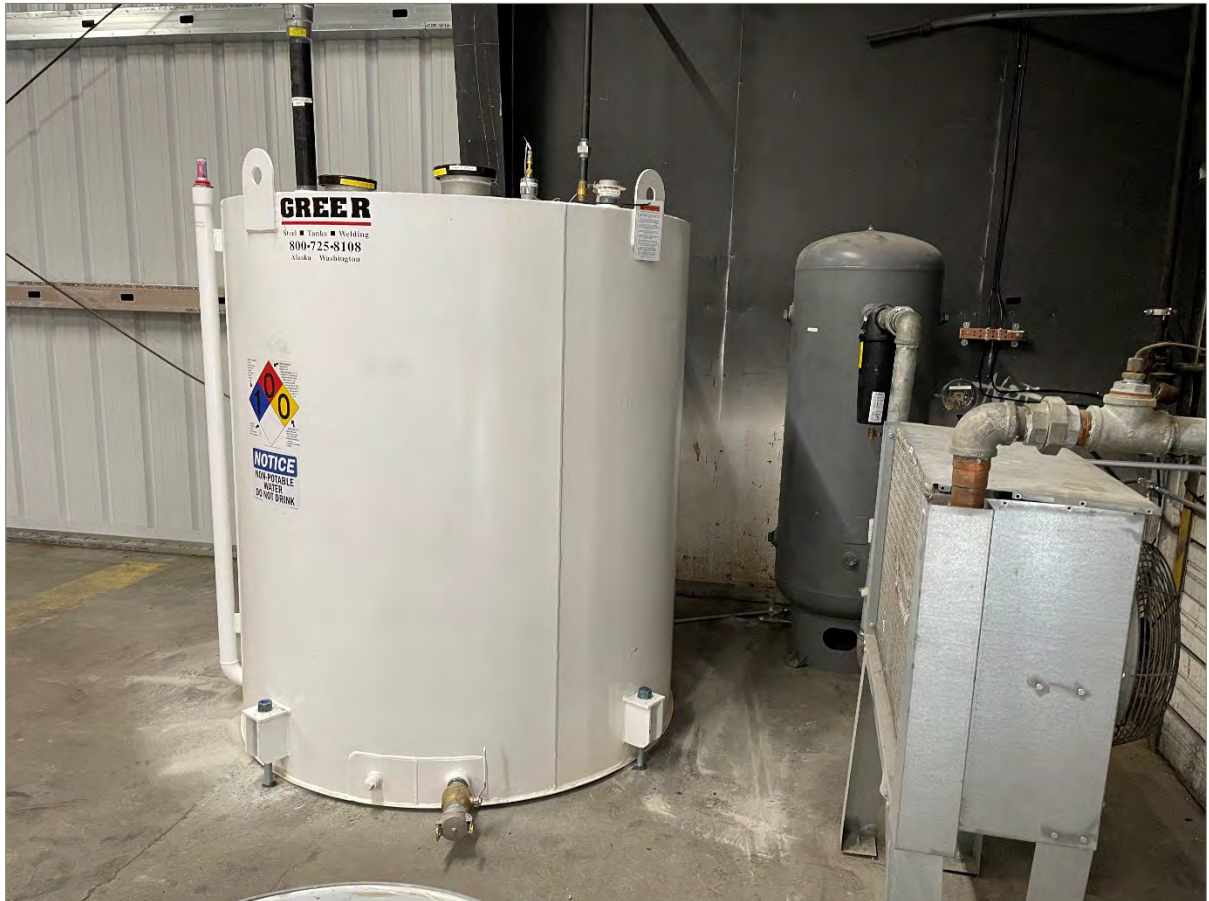
Exhibit 5-4: View of the Storage Tank Inside of the AS/SVE Building, Looking East

The existing 1,000-gallon aboveground storage tank used to store water extracted by the AS/SVE system was damaged during CenterPoint's redevelopment activities in approximately October 2021. The operational availability of the AS/SVE system was not impacted because the AS/SVE system was already offline due to the redevelopment activities.

The storage tank was replaced with materials and equipment to have equivalent functionality of the original tank. A photo of the new storage tank is provided below as Exhibit 5-4. A description of the installed components is provided in Appendix A. Product data sheets are provided in Appendix F.

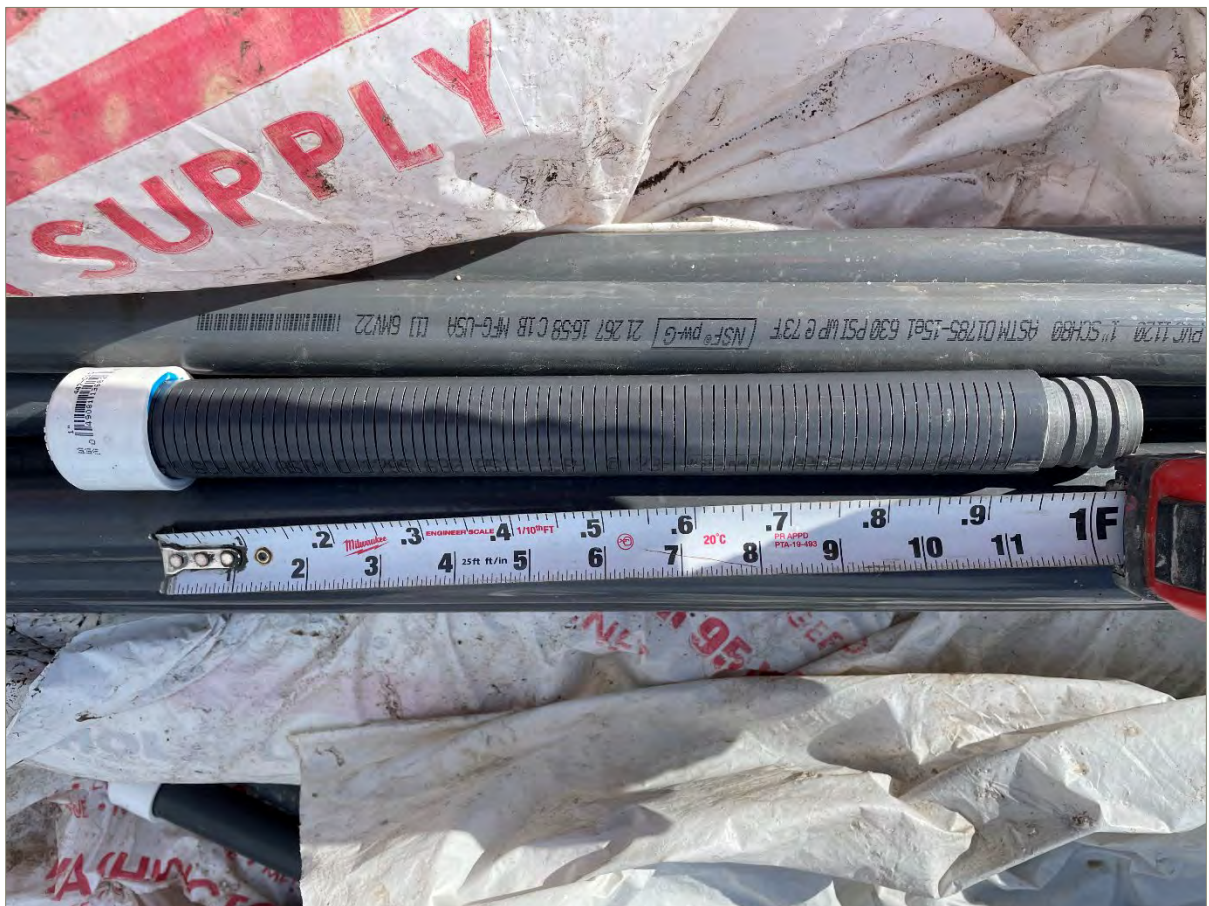
Exhibit A-1: Photo of an Air Sparging Well Screen

The wells consisted of 1-inch schedule 80 polyvinyl chloride (PVC) with a 1-foot-length 0.020-inch slotted screen. No. 2x12 sand was used for the filter pack. A photo of a well screen is provided below.

The wells were screened in the shallow perched aquifer above the apparent transition from Poorly Graded Sand to Silty Sand, which was observed at approximately 29 to 33 feet bgs. The well casing was sealed using hydrated bentonite ship, including the portion of the casing that penetrated the geosynthetic clay liner (GCL). The screen depths and other well

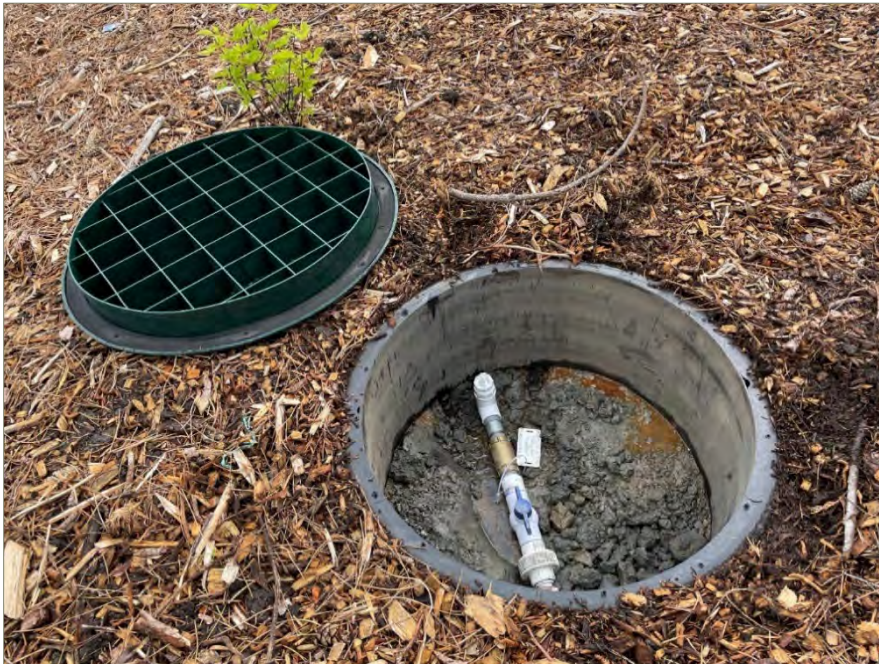
Exhibit A-2: Photo of an AS Well Monument in the Landscaped Berm

At each AS wellhead, the well casing was connected to a tee-fitting, check valve, and union. The wellhead was placed inside of the 24-inch double-wall corrugated high-density polyethylene (HDPE) collar with a green HDPE lid, except wells ASW 42 through ASW-45. Wells ASW-42 and ASW-45 were inside of the AS/SVE building and in the adjacent driveway and were placed in concrete vaults with metal lids to protect components from vehicle traffic. Photos of the well monuments are provided as Exhibits A-2 and A-3 below.

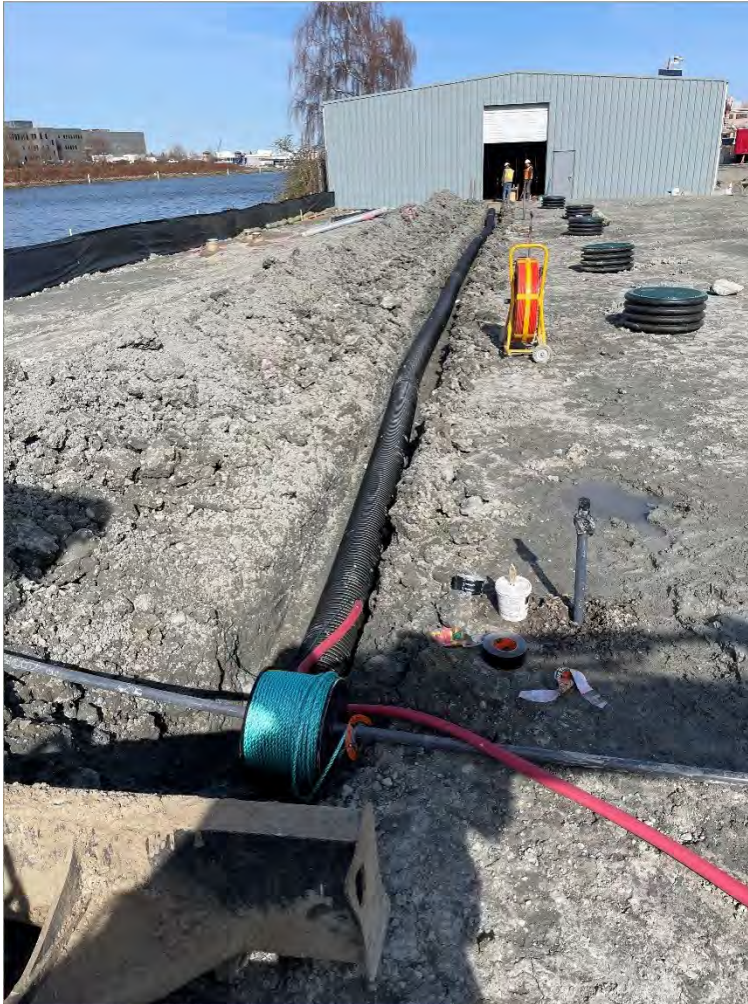
Exhibit A-4: Photo of the AS Conduit to the South of the AS/SVE Building, Looking North

The AS wells were connected to the existing AS infrastructure in the AS/SVE building using 1-inch pneumatic hoses placed in an 8-inch double-walled HDPE conduit. The conduit was placed in a trench adjacent to the AS wells. Trenched soil was used as backfill around the AS conduit. A photo of the conduit in the trench is provided as Exhibit A-4.

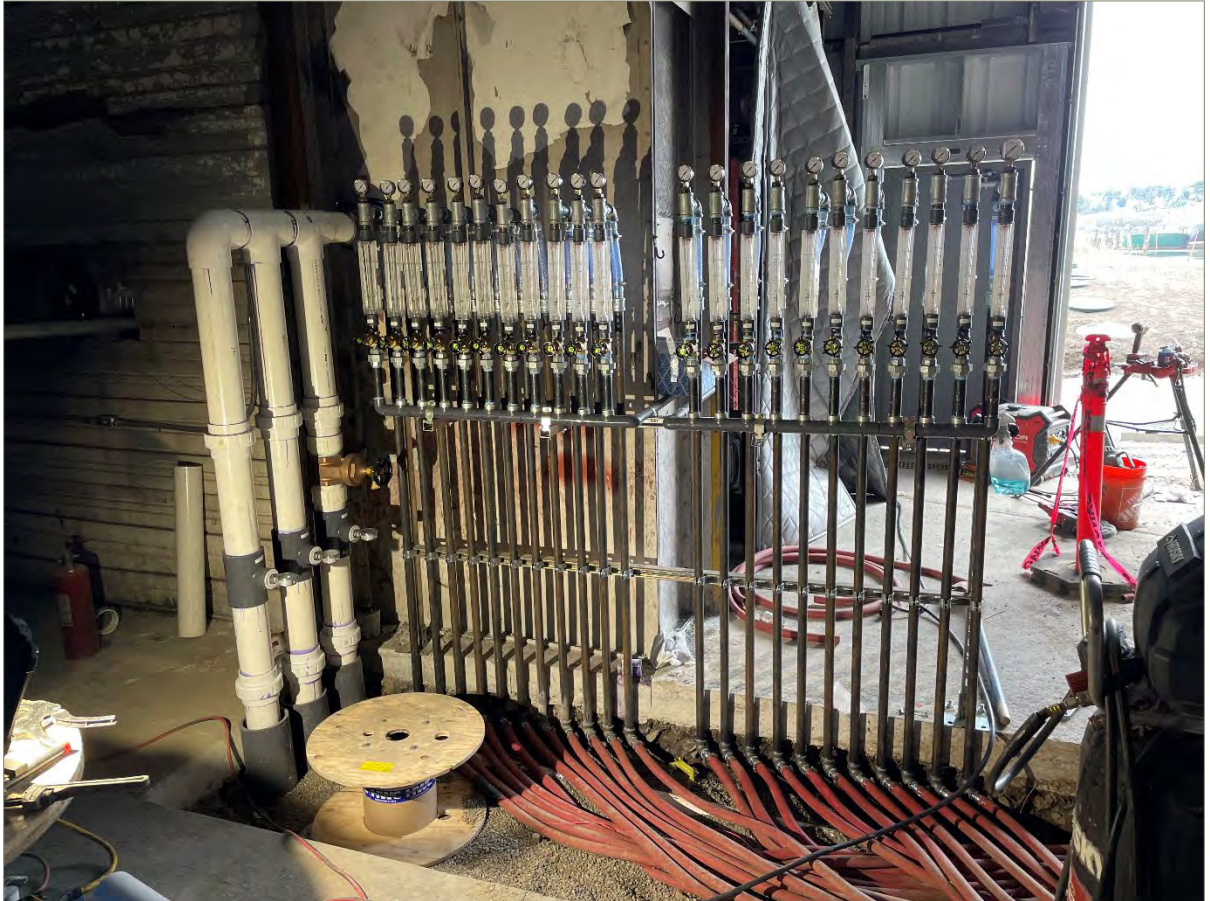
Exhibit A-5: View of the Aboveground AS Extension Components Inside of the AS/SVE Building

In the AS/SVE building, the 1-inch rubber hoses transitioned to 1-inch metal pipes and surfaced through the concrete floor. A photo of the aboveground AS extension components is provided as Exhibit A-5.

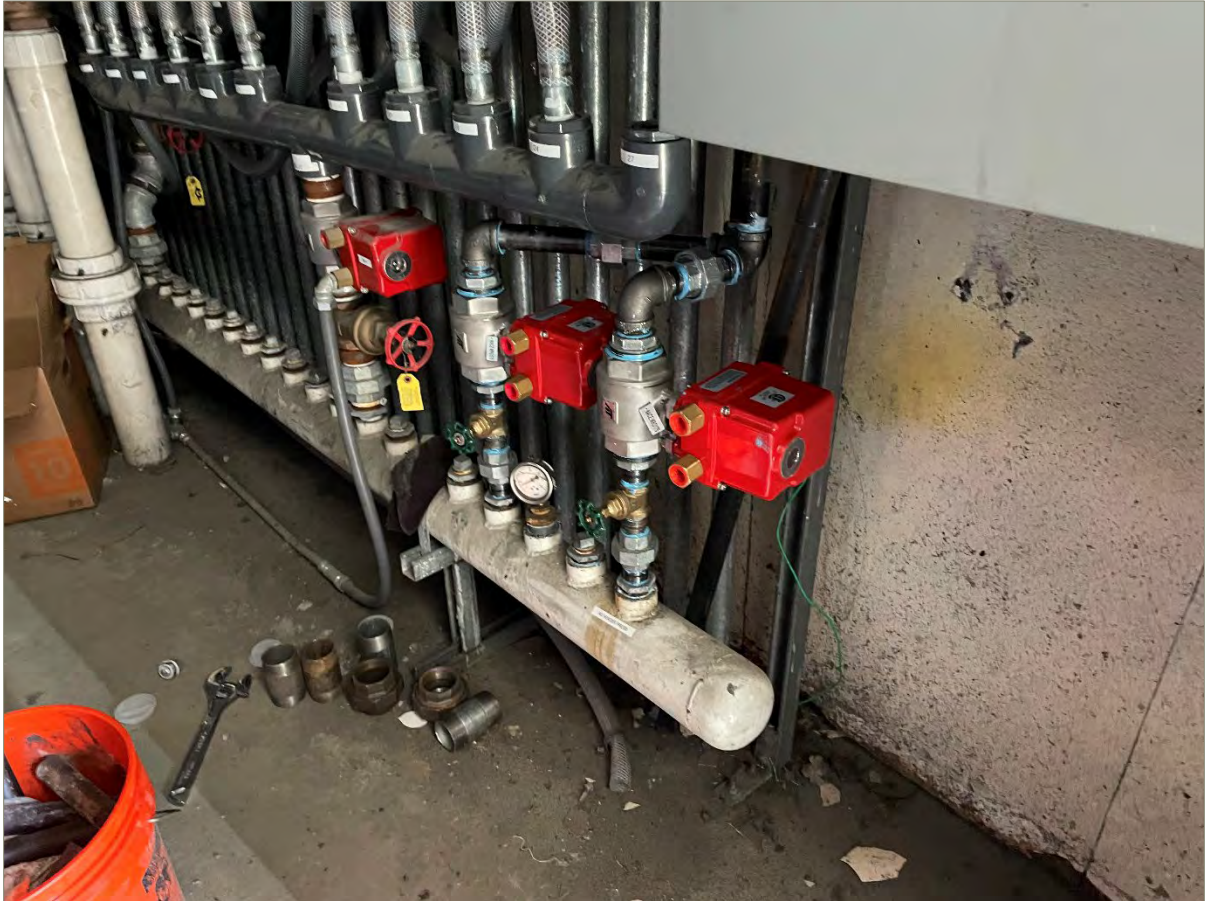
Exhibit A-6: View of Ball Valves BV-4 and BV-5 Connected to the Main AS Header

Above the concrete floor, the AS pipes were connected to gate valves, pressure gauges, and flowmeters. Thereafter, 11 of the AS lines were connected to one manifold and the other 11 AS lines were connected to a second manifold. The manifolds were separately connected to electrical-operated ball valves (BV-4 and BV-5) that were connected to the main pressurized air header (Exhibit A-6). A line diagram showing AS components and connections to the existing AS system is provided in Figure 6 with further detail in Figure 7.

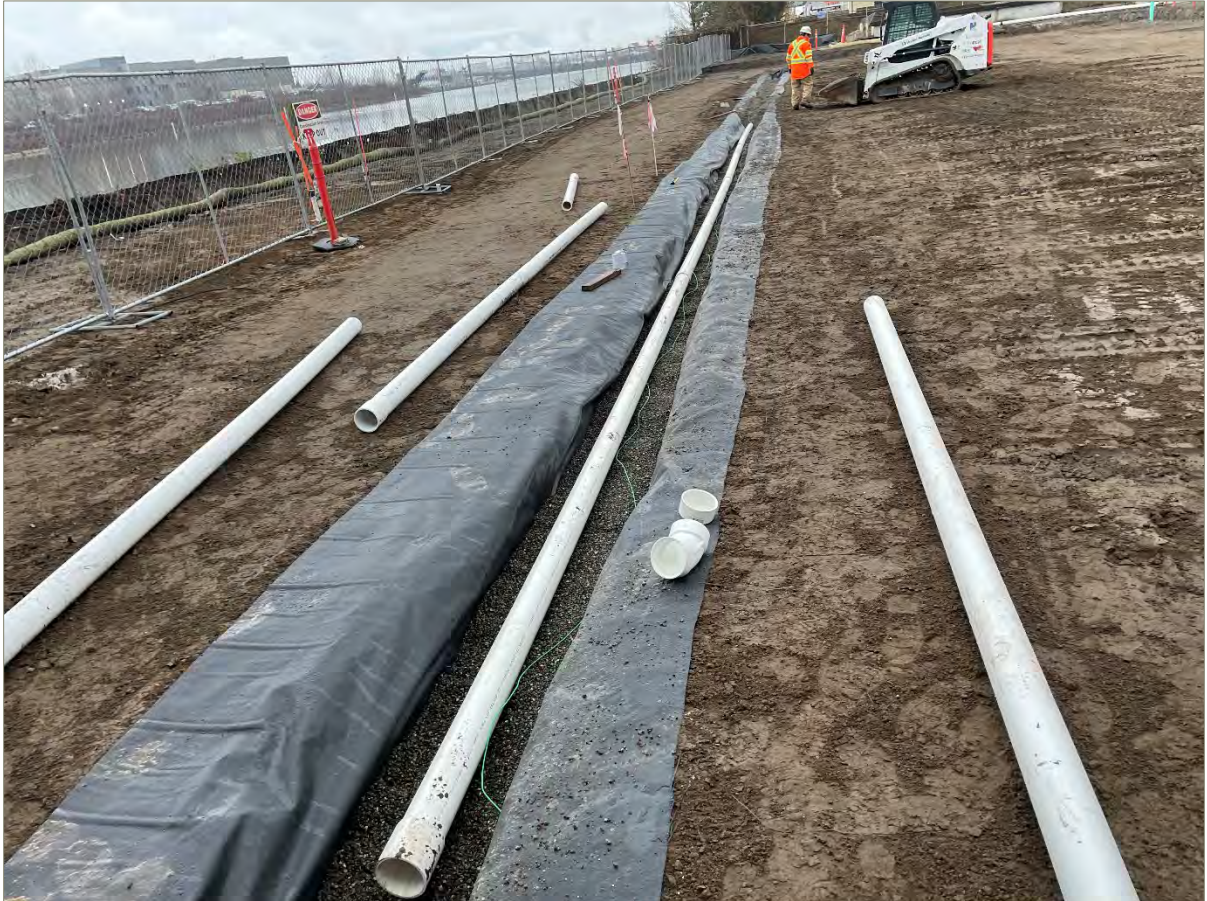
Exhibit A-8: Photo of Construction of the SVE Extension Located North of the AS/SVE Building, Looking North

The extension to the SVE system consisted of three horizontal screens, each approximately 110 feet long. The SVE screens are composed of 4-inch schedule 40 PVC with 0.020-inch slotted horizontal screens. The screens were placed in a single trench within 1 foot under the clay liner. The screens were bedded in pea gravel and wrapped in a geotextile to prevent the introduction of fines into the SVE system.

The screens (SVE-7, -8, and -9) were installed in a single trench extending in an approximate north/south alignment (Exhibit A-8). The screened sections of the SVE pipe were offset, such that SVE-7 was farthest north in the trench, SVE-8 was in the middle, and SVE-9 was farthest south. Figure 3 shows the approximate location of each screen.

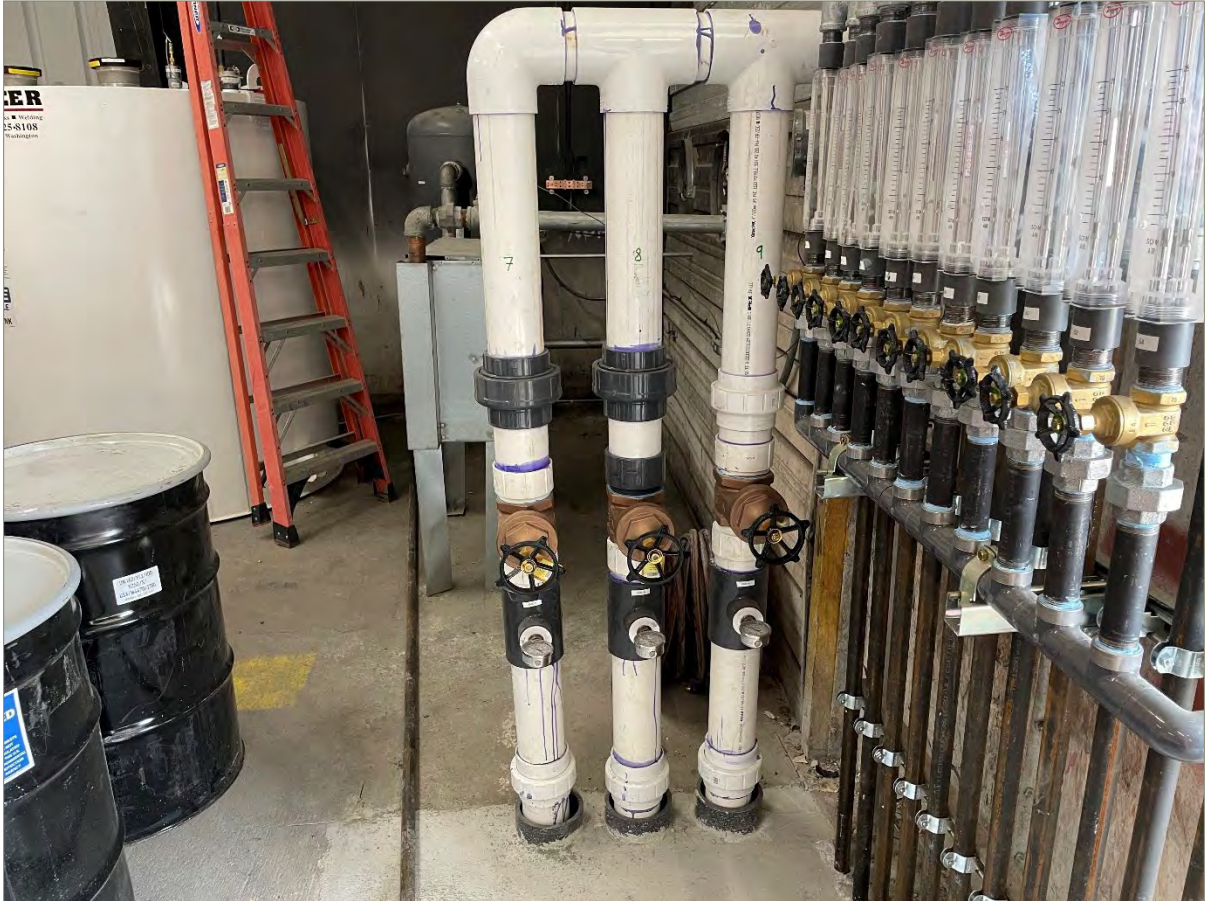
Exhibit A-9: View of the Three SVE Extension Pipes Inside of the AS/SVE Building, Looking East

The new SVE lines were routed aboveground inside of the AS/SVE building and connected to a gate valve, vacuum gauge, and union. Then the SVE lines were connected the existing SVE vacuum header. A photo of the aboveground SVE extension components is provided as Exhibit A-9. A line diagram showing SVE components and connections to the existing SVE system is provided as Figure 6 and further detail is shown in Figure 8.

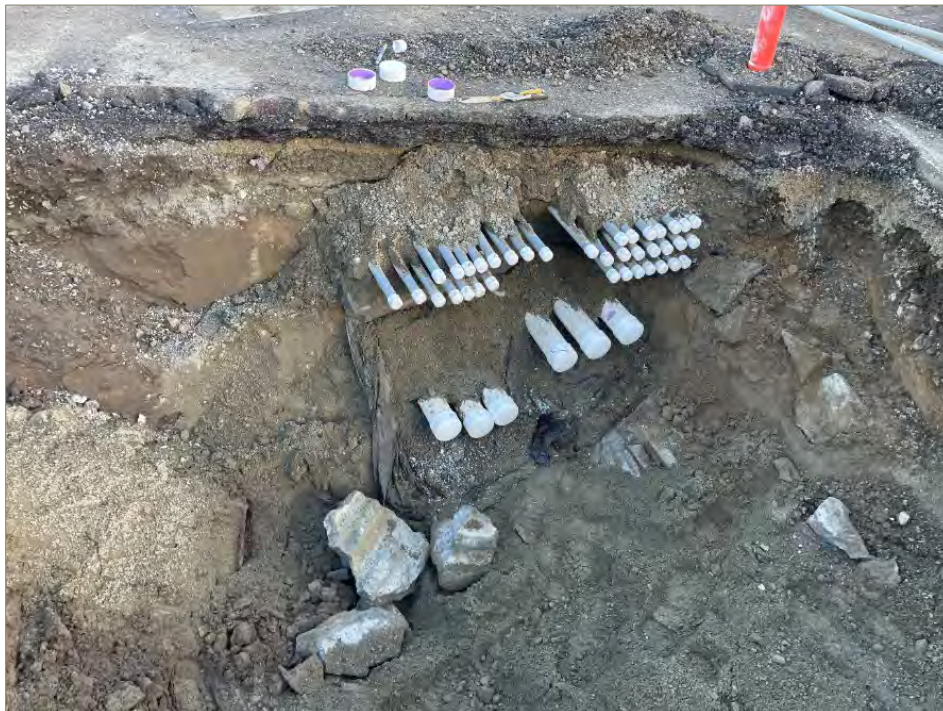
Exhibit A-11: View of the East Terminus of the Disconnected and Capped AS/SVE Pipes, Looking East

Photos of the capped pipe ends are provided as Exhibits A-11 and A-12 below.

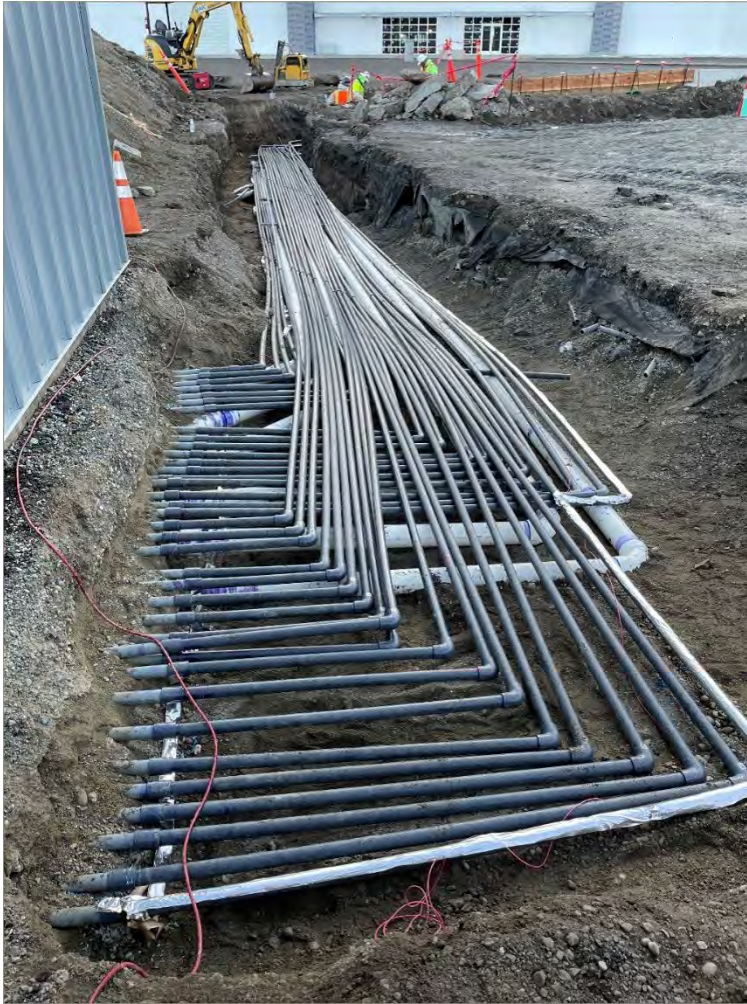
Exhibit A-13: New Replumbed AS/SVE Lines, Looking East

The new AS lines consisted of 1-inch schedule 80 PVC and the new SVE lines consisted of 4-inch schedule 40 PVC as shown in Exhibit A-13 below. The new AS/SVE lines were tested for proper sealing as described in Section A.3.8.

Excavation spoils from the trench were used as backfill around the new AS/SVE pipes. Approximately 8-inch-thick lifts were compacted with a walk-behind vibrating plate compactor until the soil was firm and unyielding. The area was then paved with asphalt for a driveway.

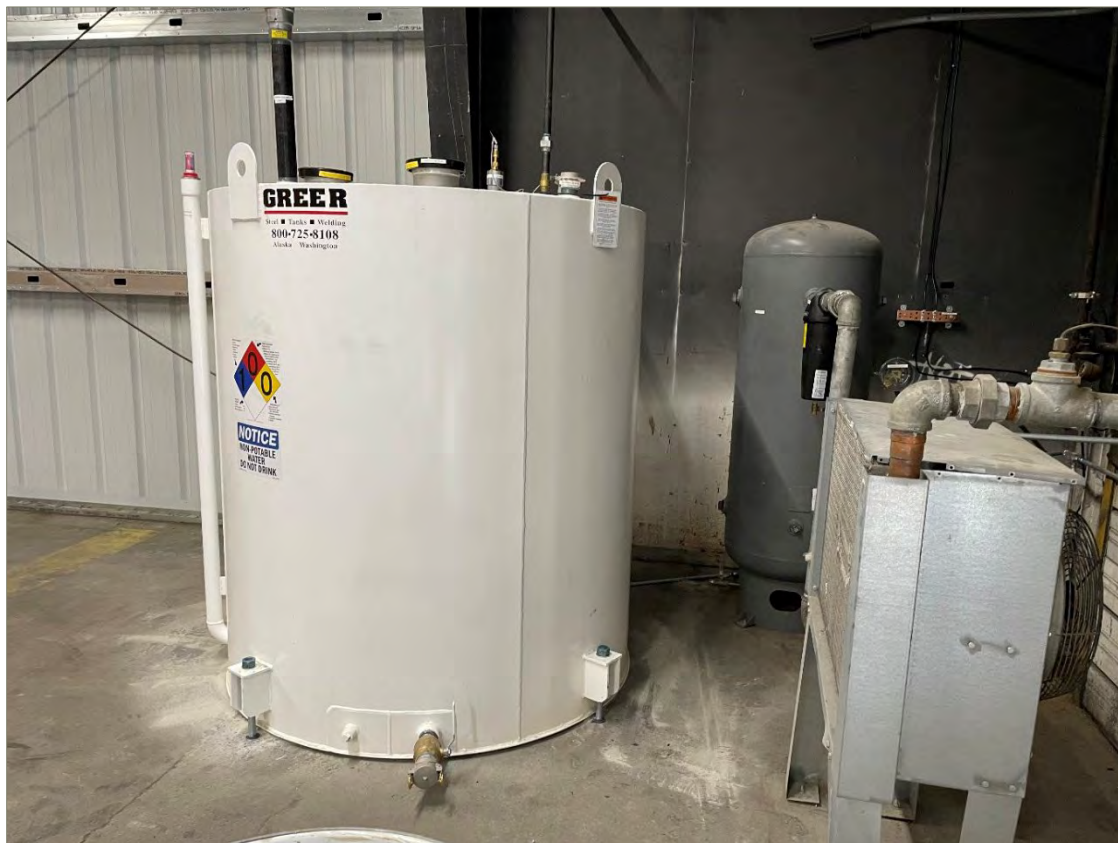
Exhibit A-14: View of the Storage Tank Inside of the AS/SVE Building, Looking East

The storage tank was replaced with materials and equipment to have equivalent functionality of the original tank. A line diagram showing the connections of the AS/SVE system to the storage tank is provided in Figure 6. Sideview and top-view photos of the storage tank are provided as Exhibits A-14 and A-15 below.

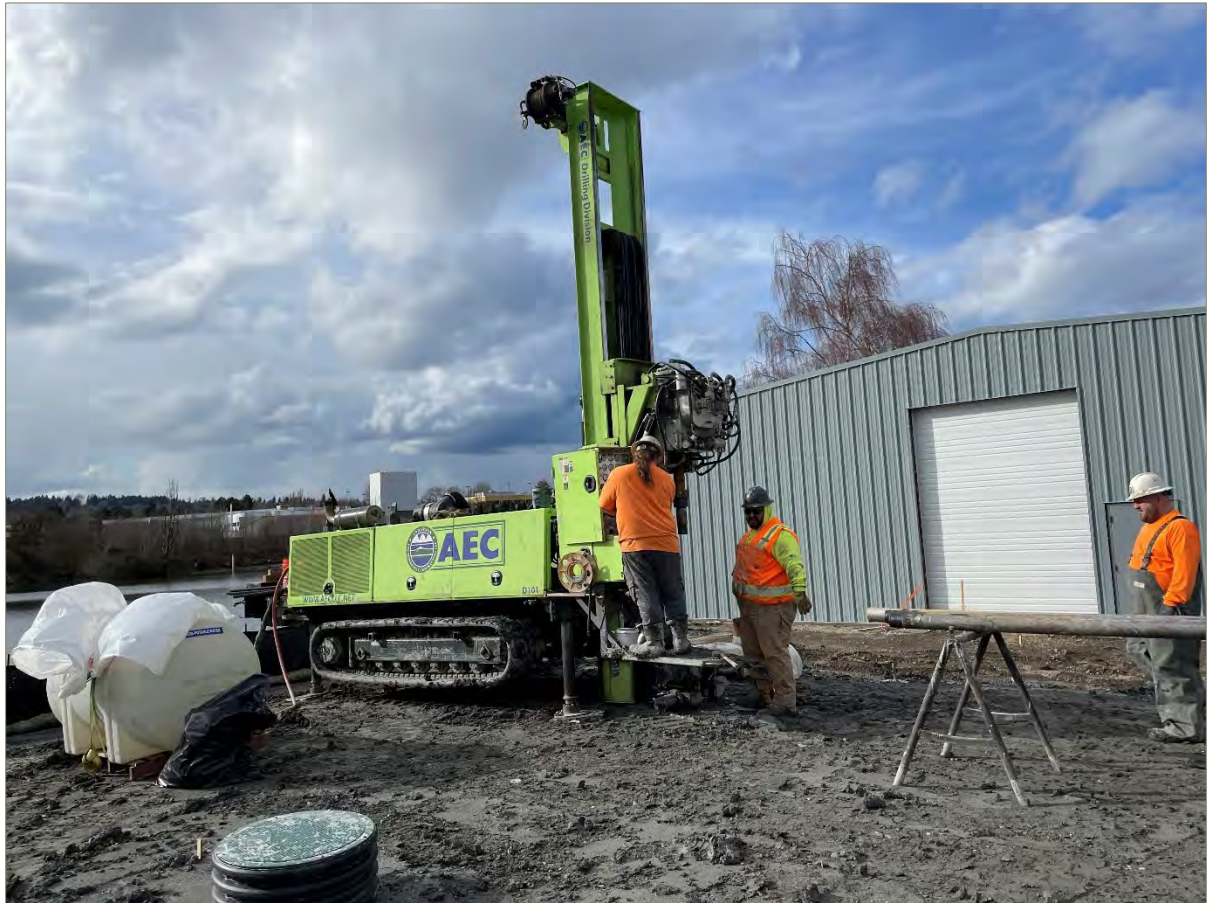
Exhibit A-16: Photo of the Sonic Drill Rig to the South of the AS/SVE Building, Looking Northwest

Sonic drilling methods utilize a hollow metal tube with a cutting head. The metal tube is connected to oscillators at the drill rig. The oscillators transmit high-frequency, resonant sonic energy through the drill string, which causes the surrounding material to fluidize and reduces friction. Once the cutting head is advanced for an interval (typically 5 feet), a larger diameter hollow metal casing is advanced around the cutting head. Then the cutting head and 5 feet of soil core are retrieved from the borehole. The soil core is vibrated from the metal tube into a cylindrical PVC bag. The cutting head is then advanced further in the borehole to the next deeper interval. The process repeats until the total depth of the borehole is achieved.

Soil from the PVC core bags were cut open and the soil was logged. A photo of the sonic drill rig is provided in Exhibit A-16 below.

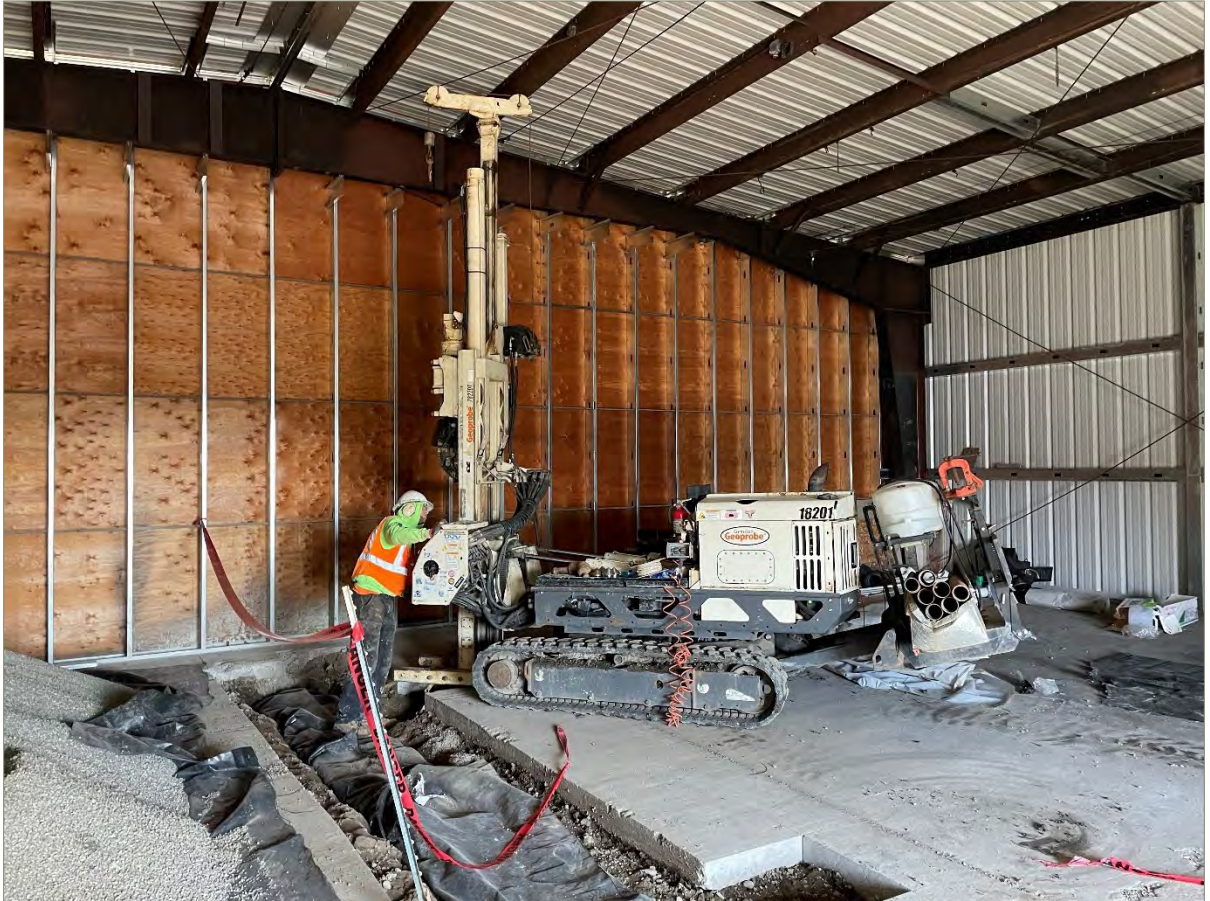
Exhibit A-17: Photo of the Direct-Push Drill Rig Inside of the AS/SVE Building, Looking Northeast

At direct-push locations, the static weight of the hydraulic probe rig combined with percussive energy were used to advance a series of hollow metal rods. To collect soil from the borehole, a 2-inch-diameter, 5-foot-long hollow metal rod fitted with a removable PVC liner was driven into undisturbed soil continuously from the ground surface to the desired depth of the boring.

Upon retrieval of the metal probe, the PVC liner and entrained soil were extruded from the metal tube, the PVC liner was then sliced open, and the soil was logged. A photo of the direct-push drill rig is provided in Exhibit A-17 below.

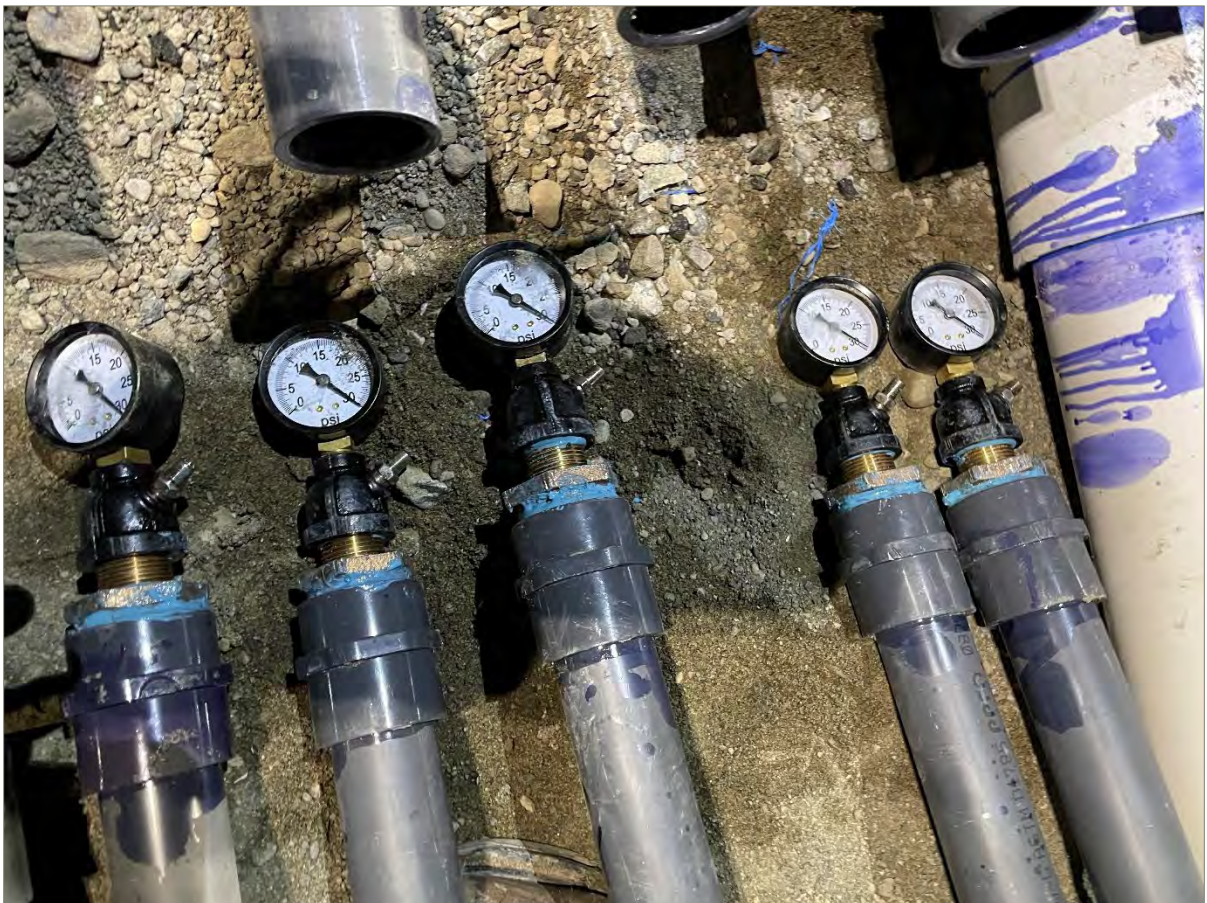
Exhibit A-18: Photo of Test Gauges Attached to AS Lines in the Replumbed AS/SVE Trench

The new AS and SVE lines were pneumatically tested for indications of leaks. The passing criteria for AS lines was 30 pounds per square inch gauge (psig) for 15 minutes. The passing criteria for SVE lines was 5 psig for 15 minutes.

To perform the tests, the tested section of the pipes was isolated using valves and/or temporary plugs. A test pressure gauge was attached to the section or pipe, then compressed air was injected into the pipes until the test pressure was achieved. Photos of the testing apparatus are provided below as Exhibits A-18 through A-20.

Several leaks were encountered at the connection to the test gauge. The connections were tightened and the tests reperfomed until the passing criteria were achieved. Logs of the tests are provided in Appendix G.

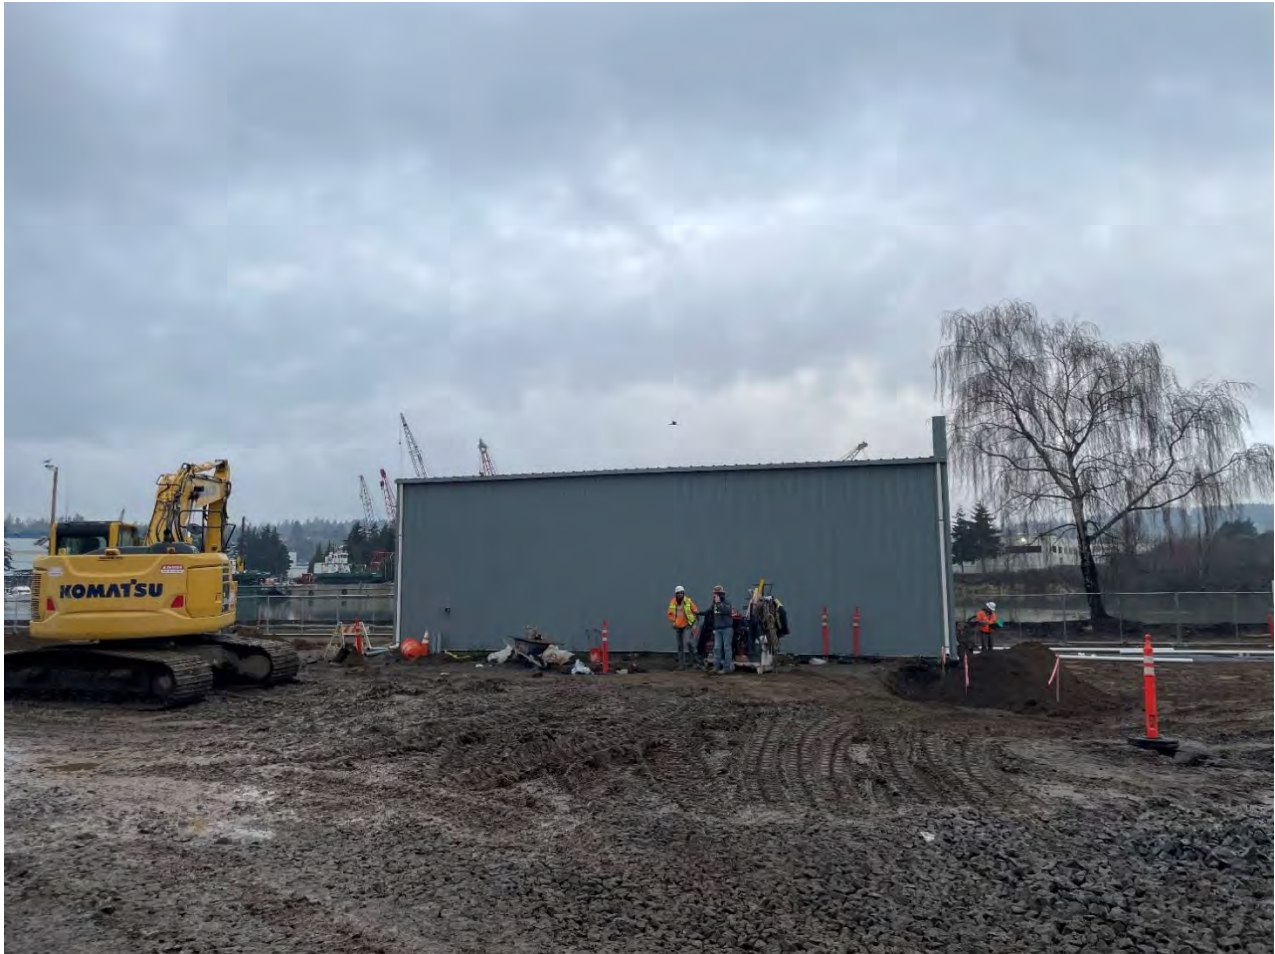
**Figure 1: Overview of AS/SVE Building that separates the southern and northern trenches, facing West. Trenches are approximately 10 feet east of Duwamish River**

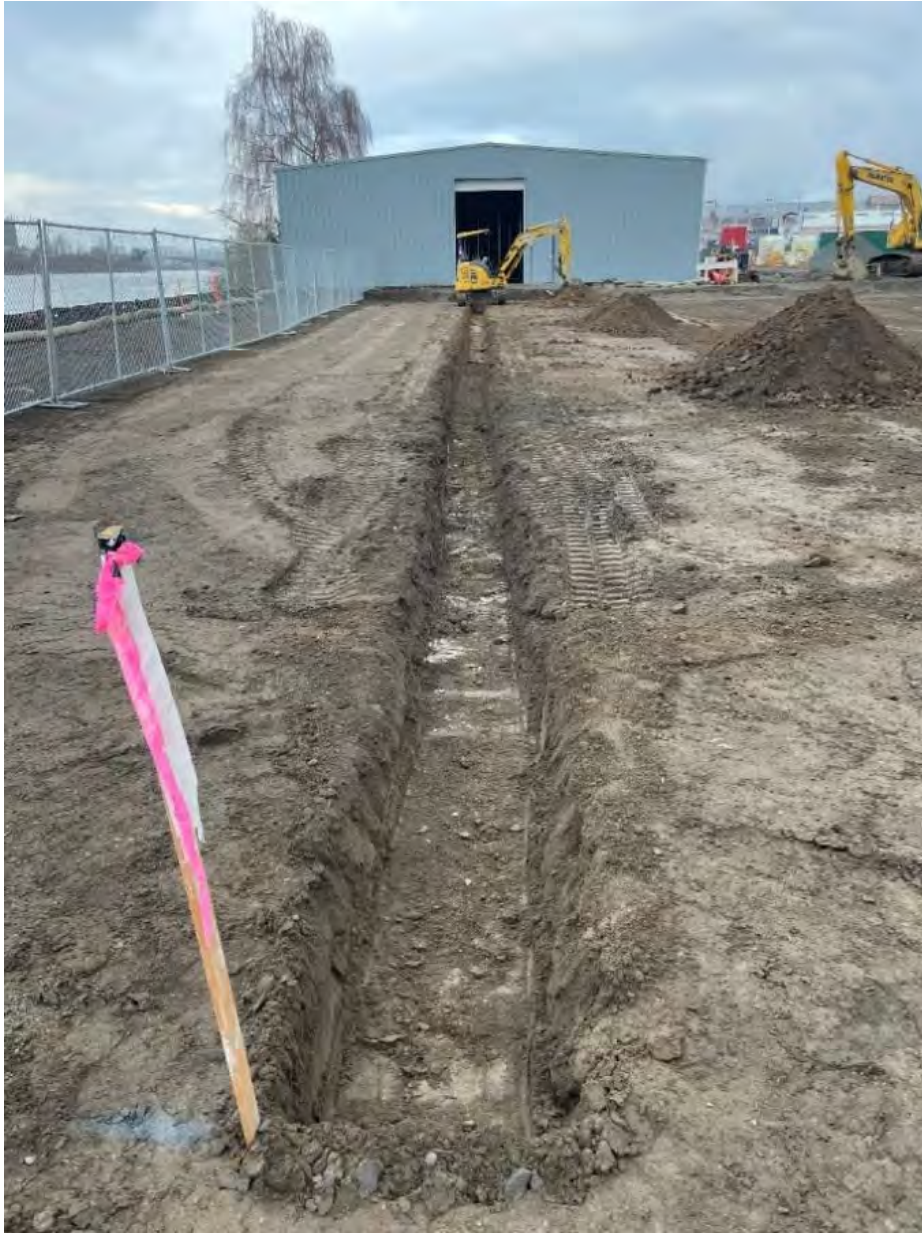
**Figure 6: Overview of southern trench at end of excavation, facing North**

Nichole Padovano monitored the SVE of the southern trench of planned excavation located along the NW corner of 8801 E Marginal Way South, Tukwila WA. Trench was 100 ft in length, 2 ft in width, and 1 ft in depth, with the northern end terminating at the southside building wall (see figure 6). Trench was approximately  $\frac{3}{4}$  completed when monitor arrived on site. On the southern side, sediment removed was an oily-black/brown compacted silty clay with many clay clumps and  $<$  20% gravels. On the northern side, sediment removed was brown/orange-gray loose silty sand with some clay clumps. Cultural material extracted from trench included both colorless and amber glass shards, many terracotta fragments, 3 rusty metal pipe segments, and 1 old brick fragment. No source for terracotta fragments was discovered, but shards existed on the southern end of trench, both on the surface and subsurface. The largest metal pipe to be excavated (20 in x 5 in; piping was hollow but filled with compressed soil) was located from the south end of trench while the other two pipes (19 in x 1 in; 6 in x 1 in) were excavated from in the middle of the trench.

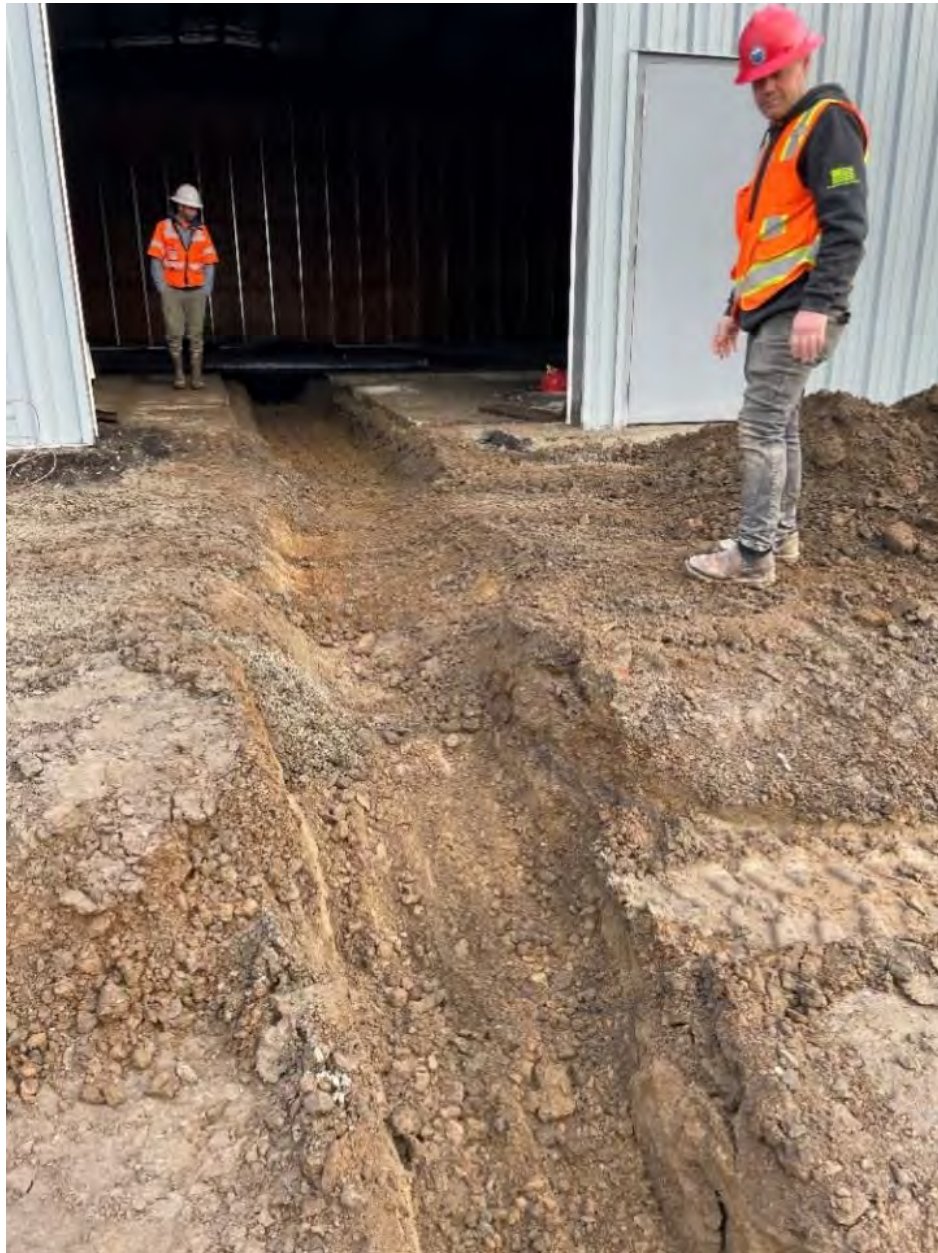
**Figure 10: Overview of AS/SVE Building trench connecting to southern trench, facing North**

Nichole Padovano monitored the completion of the SVE trench along the NW corner of 8801 E Marginal Way South, Tukwila WA. The southern point of the AS/SVE Building trench was connected to the northern point of the southern trench, completing this project component (see Figure 10). Sediment excavated was a fine, poorly sorted, brown silty sand that was loose and dry and contained 50% sub-angular/sub-rounded gravels and medium cobbles. Cultural materials extracted included asbestos fragments and many red bricks fragments ranging from small shard to whole brick.
