FINAL COMPLIANCE MONITORING REPORT  
**AS/SVE System Extension and  
Modification**

8801 EAST MARGINAL WAY S., TUKWILA, WASHINGTON  
AGREED ORDER NO. 6069

Subject: FINAL COMPLIANCE MONITORING REPORT, AS/SVE SYSTEM  
EXTENSION AND MODIFICATION, 8801 EAST MARGINAL WAY S.,  
TUKWILA, WASHINGTON  
AGREED ORDER NO. 6069

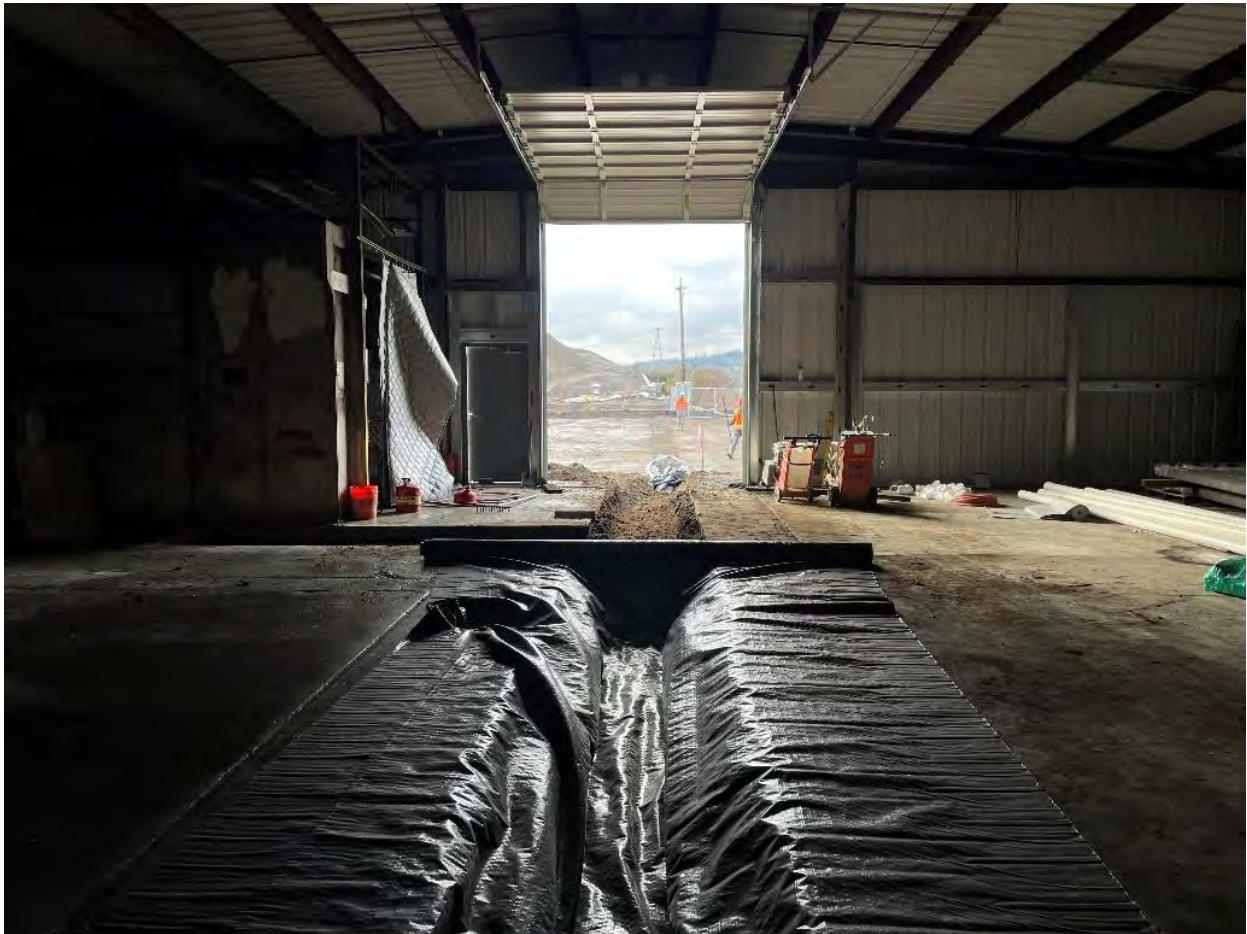
**Figure 11: Overview of AS/SVE Building trench at completion of excavation, facing South**

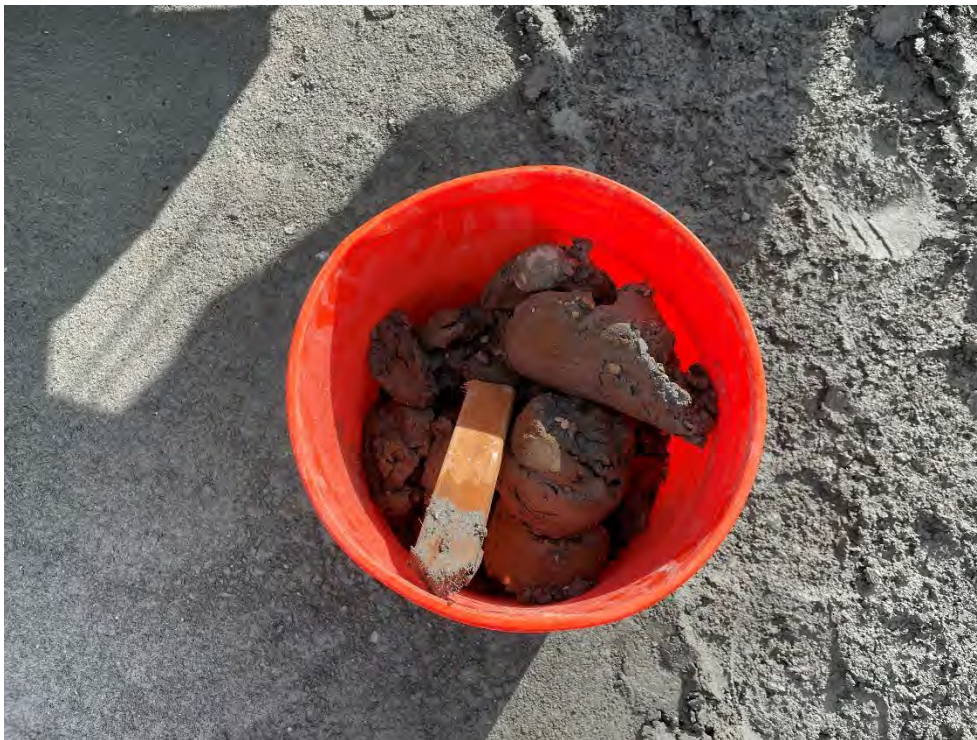
**Figure 2: ASW-55 Soil Extraction 0-10 ft bgs**

<b>Depth of SPT</b>	<b>Cultural Materials</b>	<b>Soil Description</b>	<b>Photo Log</b>
0-10 ft bgs	Negative	Brown Silty Sand, Loose, Dry on top; Brown-Gray Wet, Cemented Sandy Loam with depth	Figure 2
10-20 ft bgs	Negative	Gray Clayey Loam, Wet, Very Cemented, Very Fine, Very Well Sorted on top. With depth, Black, Angular Sand, Fine-Medium, Poorly Sorted, Wet	Figure 3
20-25 ft bgs	Negative	Black, Angular Sand, Fine-Medium, Very Poorly Sorted. Gray Sandy Loam, Very Wet, Very Cemented, Poorly Sorted	Figure 4
25-30 ft bgs	Negative	Black Angular Sand, Fine-Medium, Very Poorly Sorted Sand, Very Wet	Figure 5
30-35 ft bgs	Negative	Black Angular Sand, Fine-Medium, Very Poorly Sorted Sand, Very Wet. Very Dark Gray Silty Sand, Finer, More Well Sorted, Wet, Very Cemented	Figure 6
35-40 ft bgs	Negative	Very Dark Gray/Black Silty Sand, Poorly Sorted, Slightly Cemented, Very Wet, Some Fine Gravels. Terminated at 40 ft bgs.	Figure 7

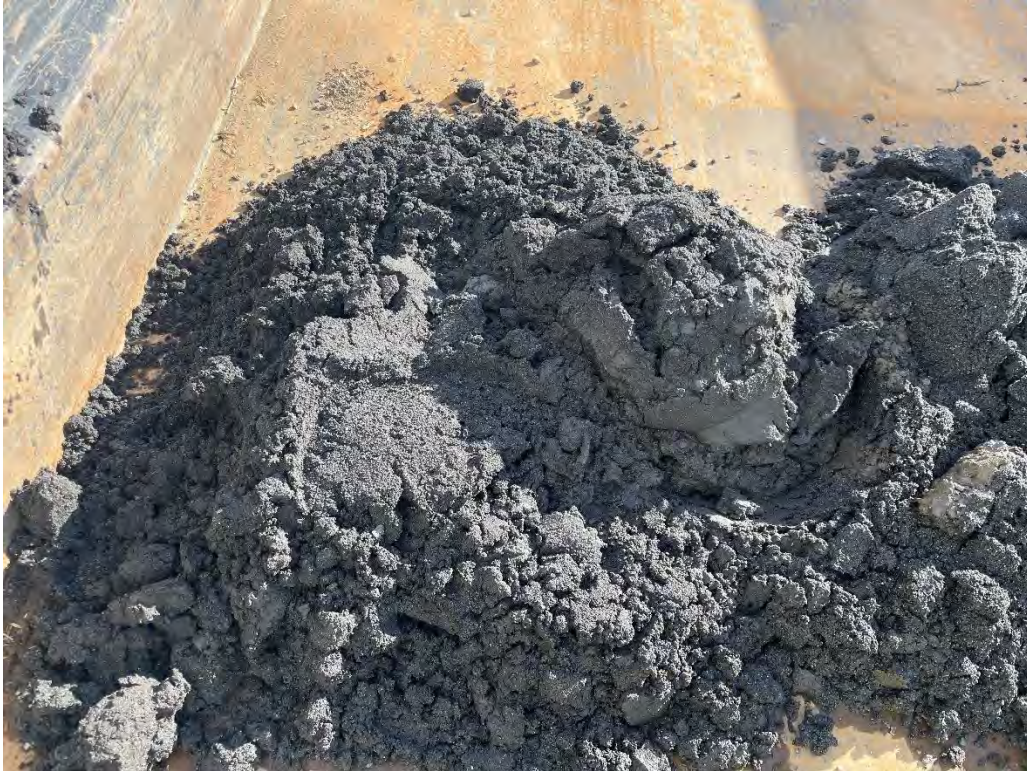
**Figure 7: ASW-55 Soil Extraction 35-40 ft bgs**

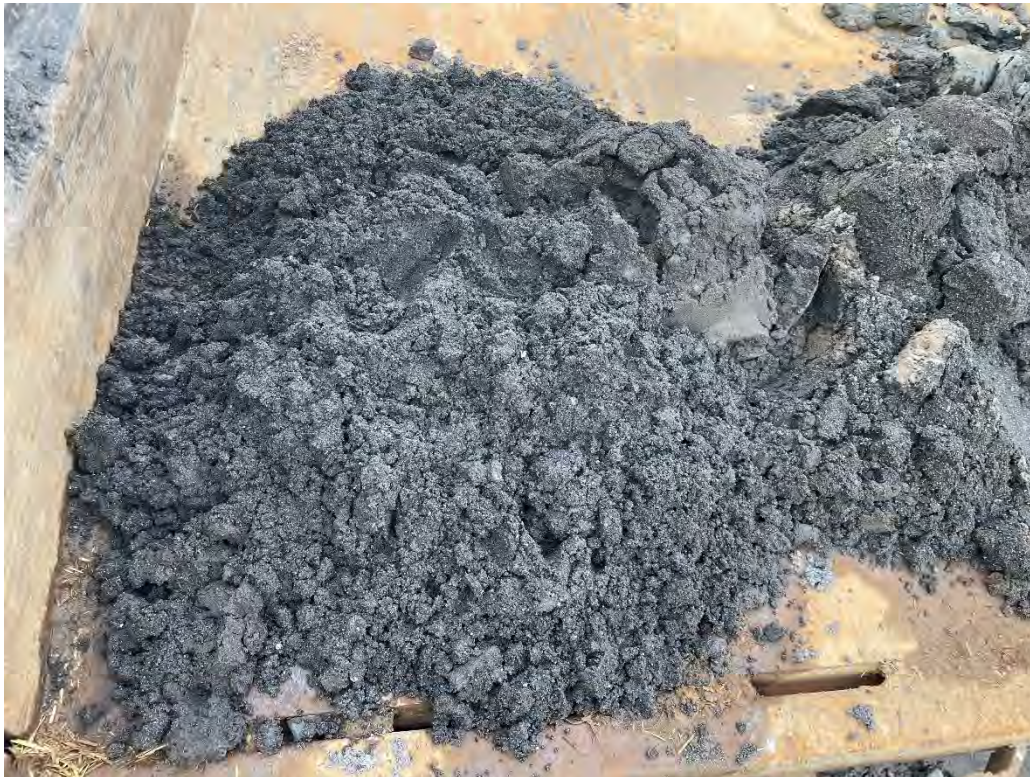
**Figure 10: ASW-54 Soil Extraction 30-35 ft bgs**

<b>Depth of SPT</b>	<b>Cultural Materials</b>	<b>Soil Description</b>	<b>Photo Log</b>
0-30 ft bgs	Negative	Brown Silty Sand, Some Nodules, Slightly Cemented but Fairly Loose. Gray Clay, Very Fine, Very Well Sorted, Very Cemented, Wet. Gray-Brown Sandy Loam, Wet, Poorly Sorted. Black Angular Sand, Very Poorly Sorted, Very Wet, Some Medium Gravels. Started looking wet around 10 ft bgs	Figure 9
30-35 ft bgs	Negative	Black Angular Sand, Very Poorly Sorted, Very Wet, Some Silty Loamy Sand in mix. Terminated at 35 ft bgs.	Figure 10

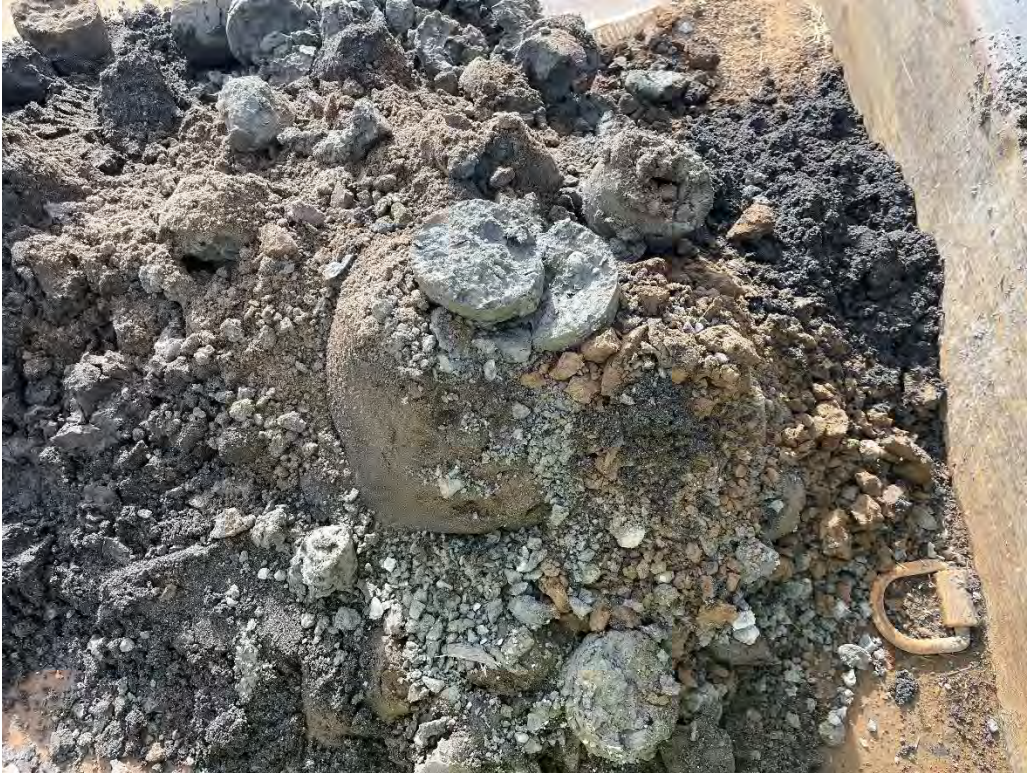
**Figure 13: ASW-53 Soil Extraction 0-10 ft bgs**

<b>Depth of SPT</b>	<b>Cultural Materials</b>	<b>Soil Description</b>	<b>Photo Log</b>
0-10 ft bgs	Negative	Grayish, Orangish Brown San, Dry(ish), Loose, Very Poorly Sorted, Fine, Angular. Gray Clay, Very Fine, Very Well Sorted, Very Cemented, Wet	Figure 13
30-35 ft bgs	Negative	Black Angular Sand, Very Poorly Sorted, Wet, Some Silty Loamy Sand in Mix. Terminated at 35 ft bgs.	Figure 14

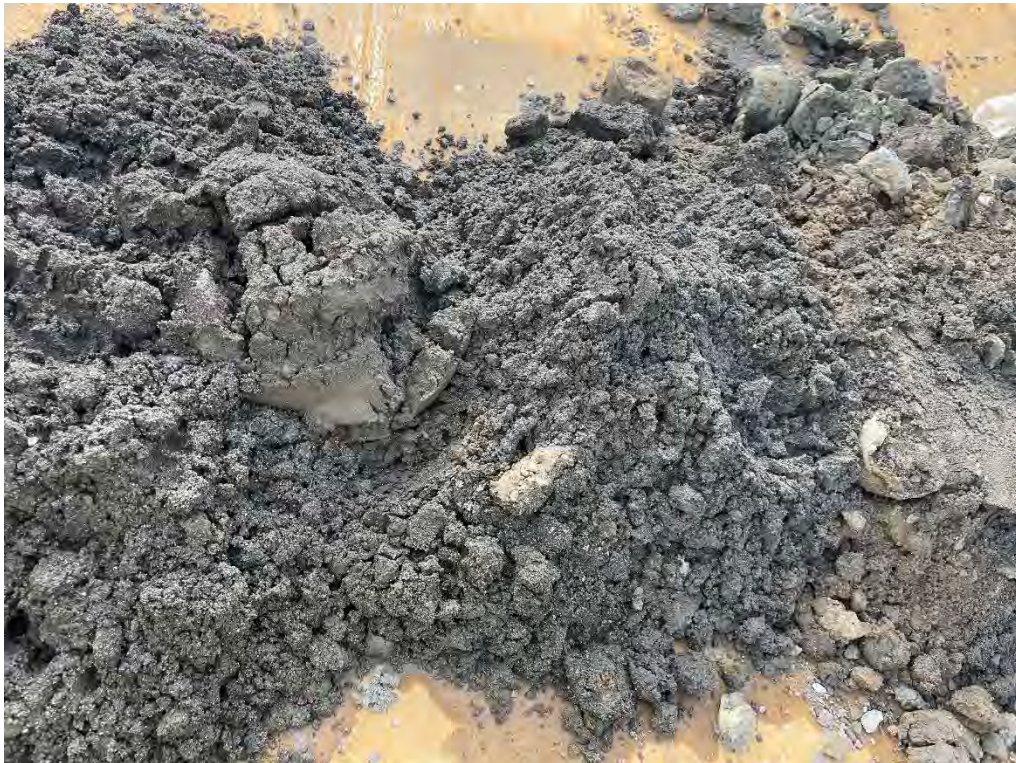
**Figure 14: ASW-53 Soil Extraction 30-35 ft bgs**

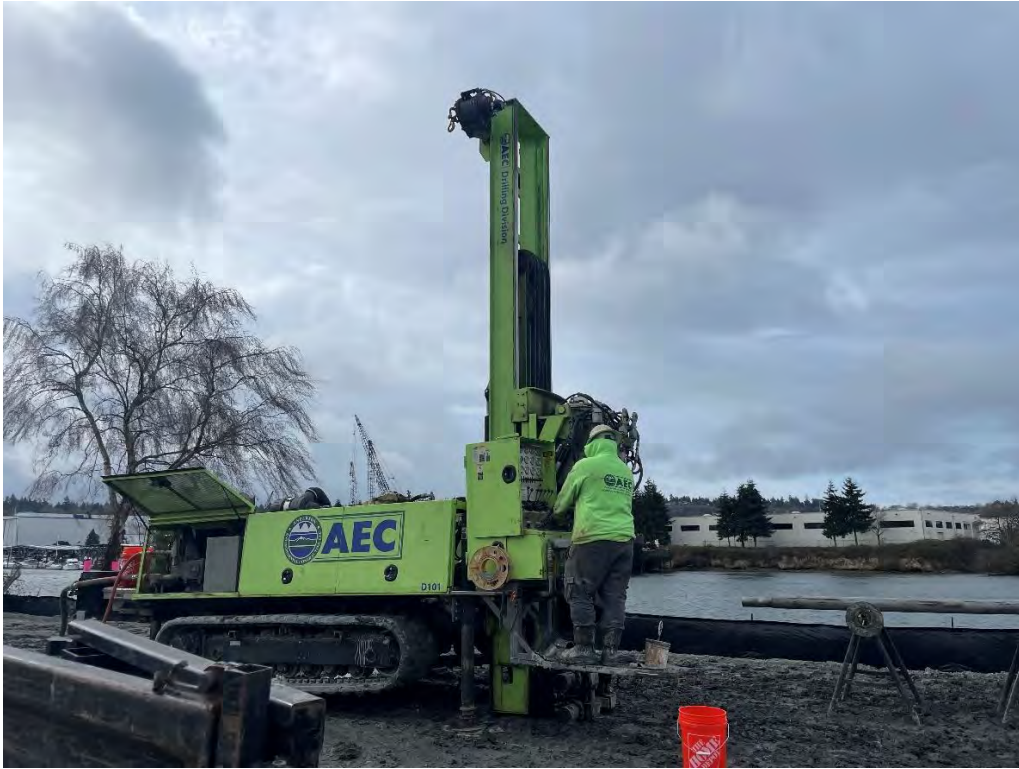
**Figure 17: ASW-52 Soil Extraction 0-10 ft bgs**

<b>Depth of SPT</b>	<b>Cultural Materials</b>	<b>Soil Description</b>	<b>Photo Log</b>
0-10 ft bgs	Negative	Black Angular Sand, Very Poorly Sorted, Wet, No Silt, Some Sub-Rounded Fine-Medium Gravels	Figure 17
30-35 ft bgs	Negative	Black Angular Sand, Very Poorly Sorted, Wet, Some Silty Loamy Sand in Mix. Terminated at 35 ft bgs.	Figure 18

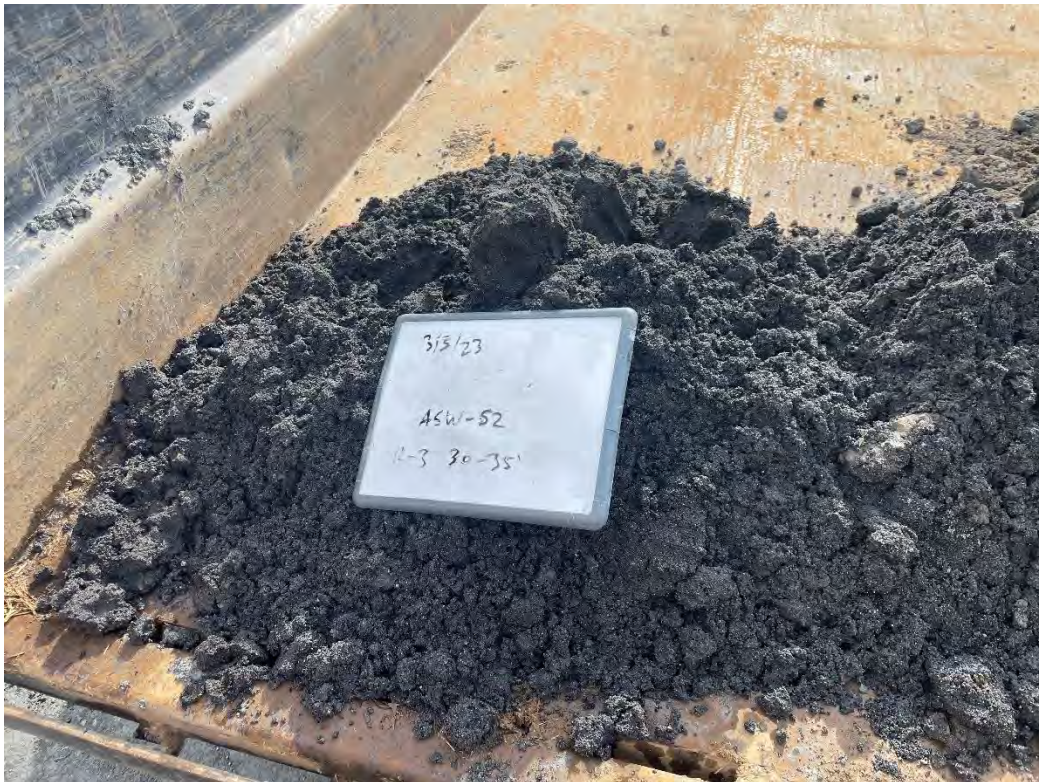
**Figure 18: ASW-52 Soil Extraction 30-35 ft bgs**

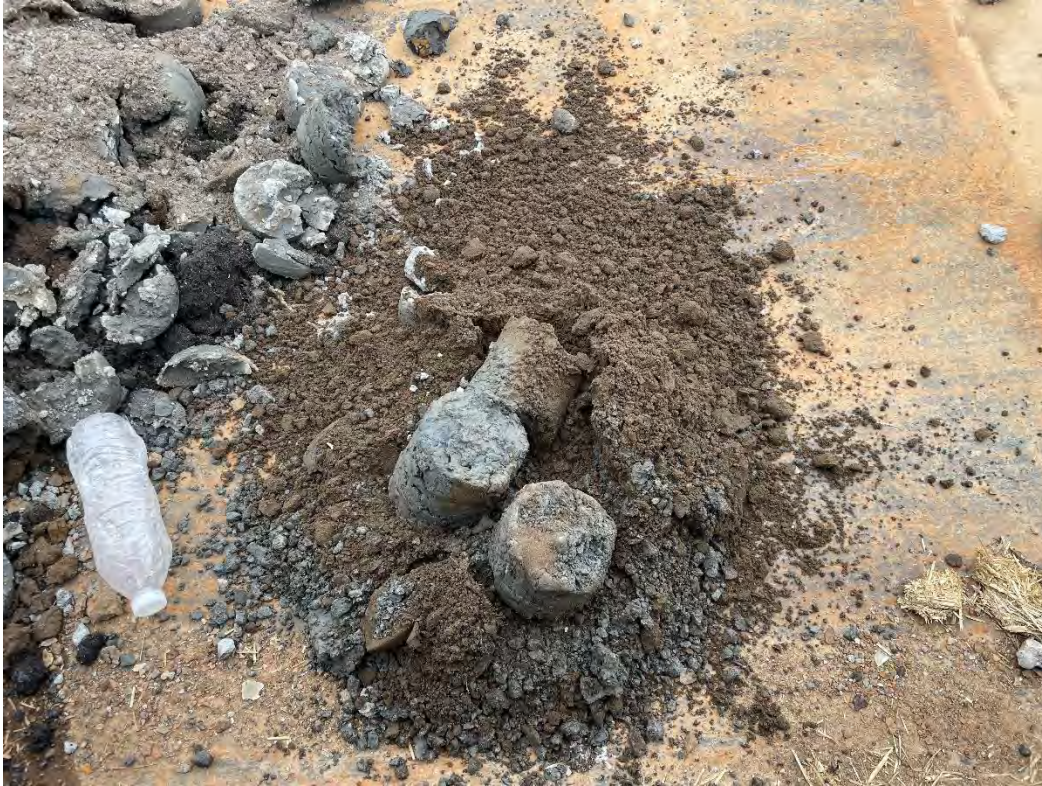
**Figure 21: ASW-51 Soil Extraction 0-10 ft bgs**

<b>Depth of SPT</b>	<b>Cultural Materials</b>	<b>Soil Description</b>	<b>Photo Log</b>
0-10 ft bgs	Negative	Brown Silty Sand, Dry, Loose, Poorly Sorted, Many Nodules. Dark Gray Silty Clay, Very Fine, Very Well Sorted, Very Cemented, Wet, Some Sub-Angular Gravels	Figure 21
30-35 ft bgs	Negative	Black Angular Sand, Poorly Sorted, Wet, Some Silty Loamy Sand in Mix. Terminated at 35 ft bgs.	Figure 22

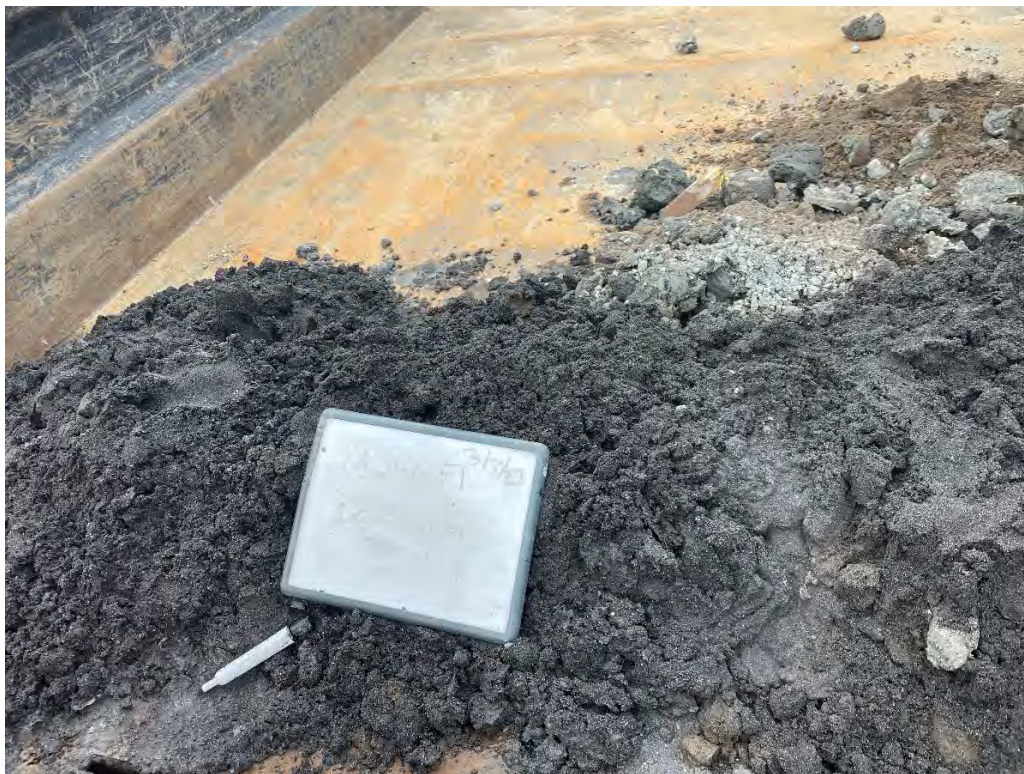
**Figure 22: ASW-51 Soil Extraction 30-35 ft bgs**

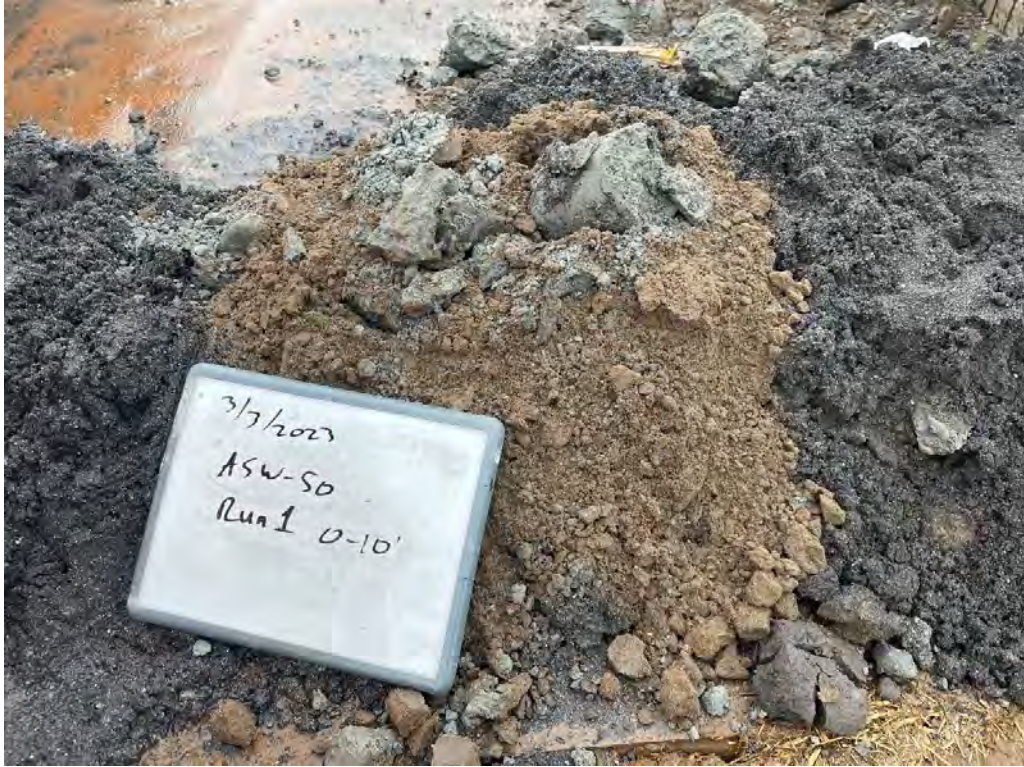
Figure 25: ASW-50 Soil Extraction 0-10 ft bgs

<b>Depth of SPT</b>	<b>Cultural Materials</b>	<b>Soil Description</b>	<b>Photo Log</b>
0-10 ft bgs	Negative	Orangish Brown Silty Sand, Dry, Loose, Poorly Sorted, Some Nodules. Gray Silty Clay, Very Fine, Very Well Sorted, Very Cemented, Wet	Figure 25

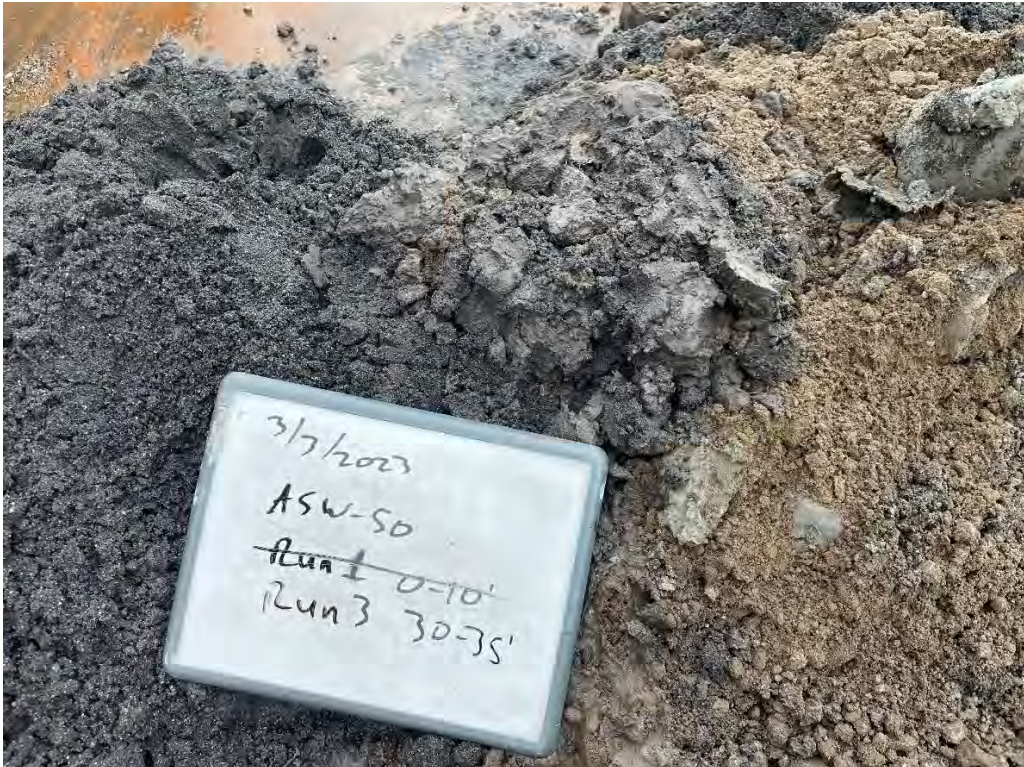
Figure 26: ASW-50 Soil Extraction 30-35 ft bgs

Depth of SPT	Cultural Materials	Soil Description	Photo Log
30-35 ft bgs	Negative	Black Angular Sand, Poorly Sorted, Wet. Very Dark Gray Sandy Loam, Slightly Cemented, Very Wet. Terminated at 35 ft bgs.	Figure 26

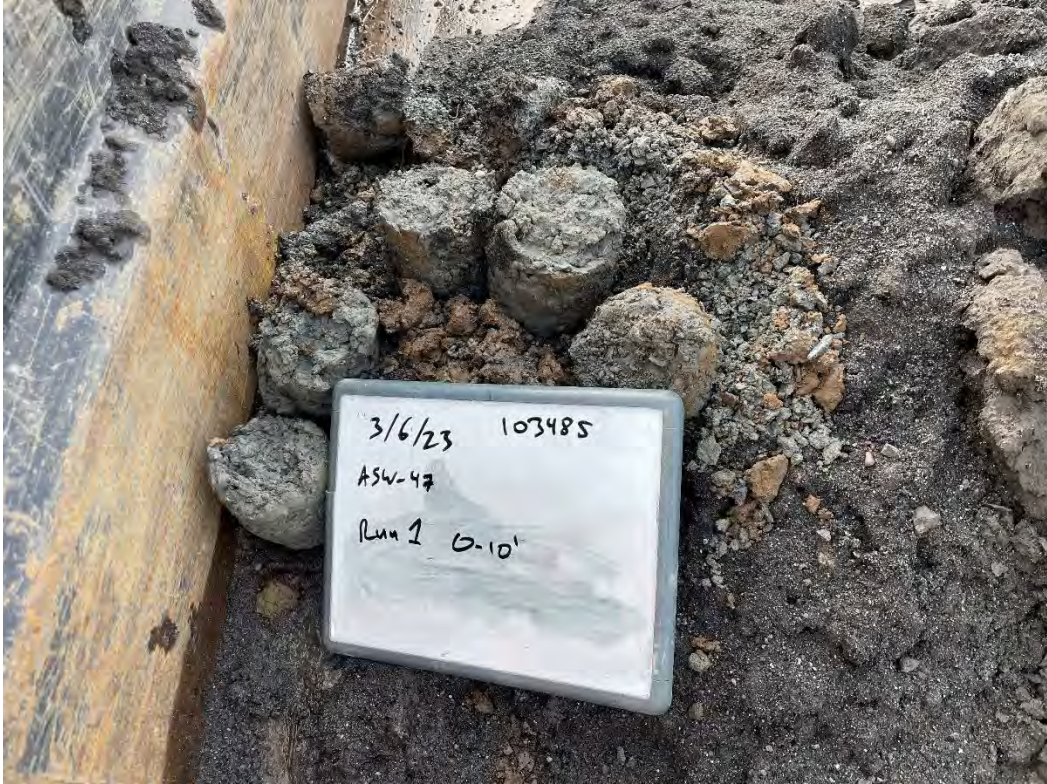
**Figure 37: ASW-47 Soil Extraction 0-10 ft bgs**

Depth of SPT	Cultural Materials	Soil Description	Photo Log
0-10 ft bgs	Negative	Orangish Brown Silty Sand, Very Fine, Well Sorted, Slightly Cemented (More Cemented than Loose), Slightly Wet, Some Fine Gravels. Light Gray Silty Clay, Very Cemented, Wet, Well Sorted, Many Fine-Medium Sub-Rounded Gravels	Figure 37

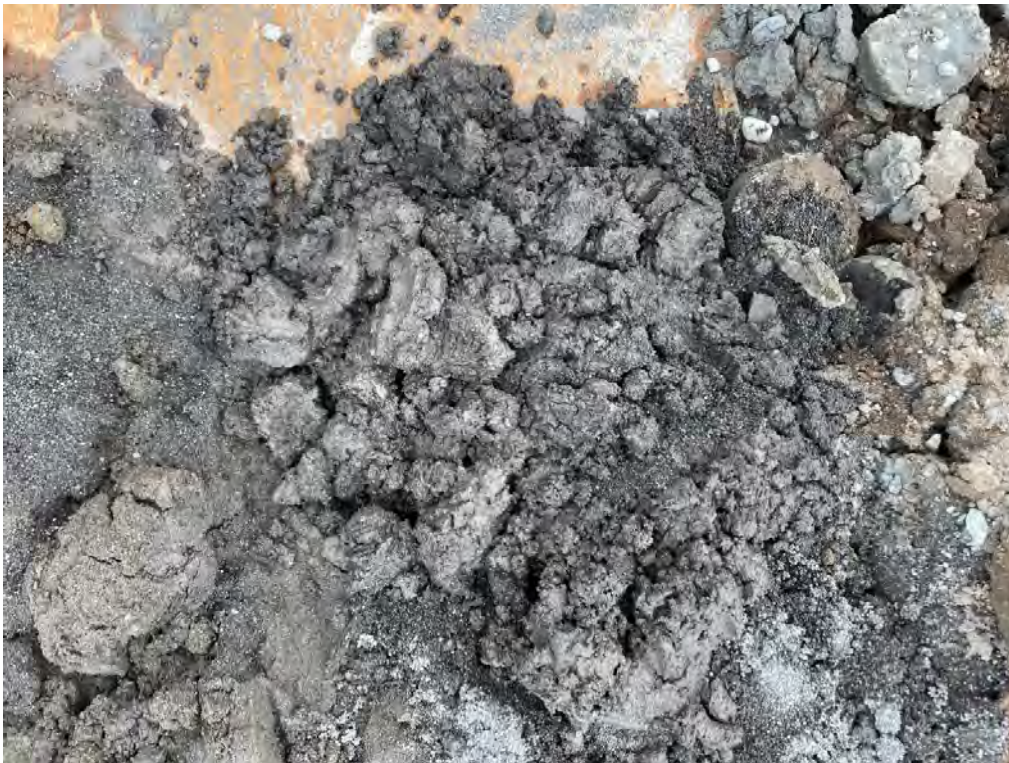
**Figure 46: ASW-41 Soil Extraction 30-35 ft bgs**

Depth of SPT	Cultural Materials	Soil Description	Photo Log
0-10 ft bgs	Negative	Orangish Brown Silty Sand, Poorly Sorted, Loose, Dry. Light Gray Silty Clay, Slightly Wet, Compact, Poorly Sorted, Many Fine-Medium Sub-Rounded Gravels. Dark Gray Silty Sand, Very Dry, Very Loose, Very Poorly Sorted, Many Fine Angular/Sub-Angular Gravels.	Figure 45
30-35 ft bgs	Negative	Dark Brownish Gray, Very Silty Sand, Fine, Very Poorly Sorted, Very Wet, Slightly Compact, Some Fine Gravels. Terminated at 35 ft bgs.	Figure 46

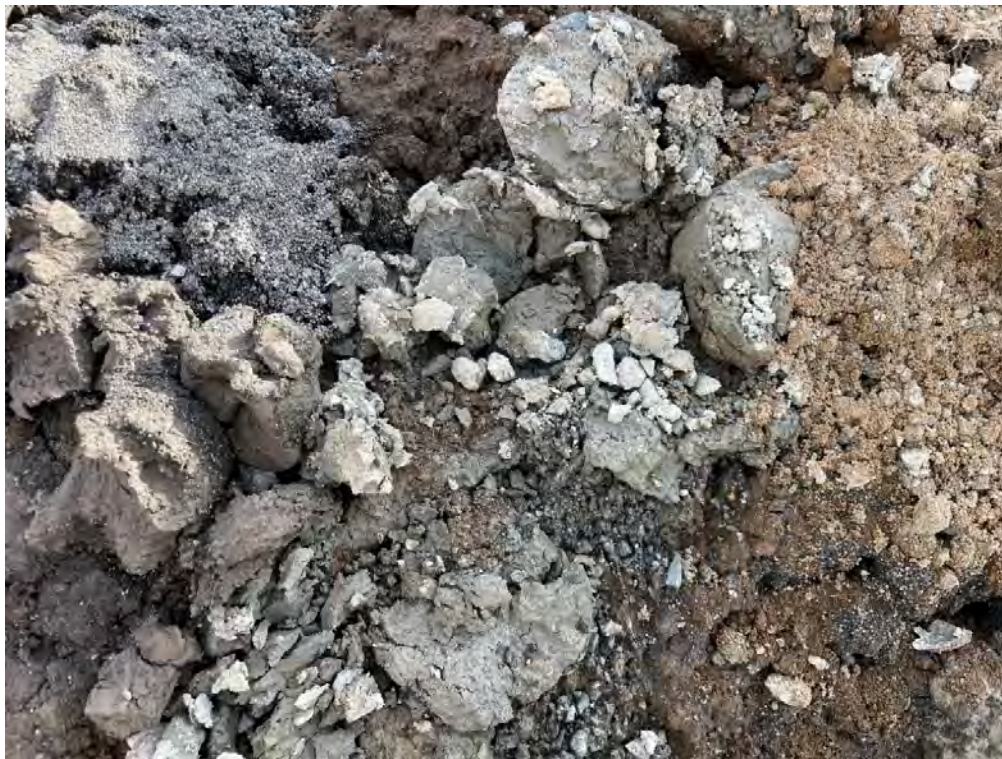
**Figure 52: ASW-39 Soil Extraction 0-10 ft bgs**

<b>Depth of SPT</b>	<b>Cultural Materials</b>	<b>Soil Description</b>	<b>Photo Log</b>
0-10 ft bgs	Negative	Dark Gray Silty Clay, Compact, Wet and Light Gray Silty Clay, Loose, Dry; Both Very Poorly Sorted, with Many Fine Sub-Rounded/Sub-Angular Gravels.	Figure 52
30-35 ft bgs	Negative	Black Sand, Angular, Loose, Wet, Very Poorly Sorted. Terminated at 35 ft bgs.	Figure 53

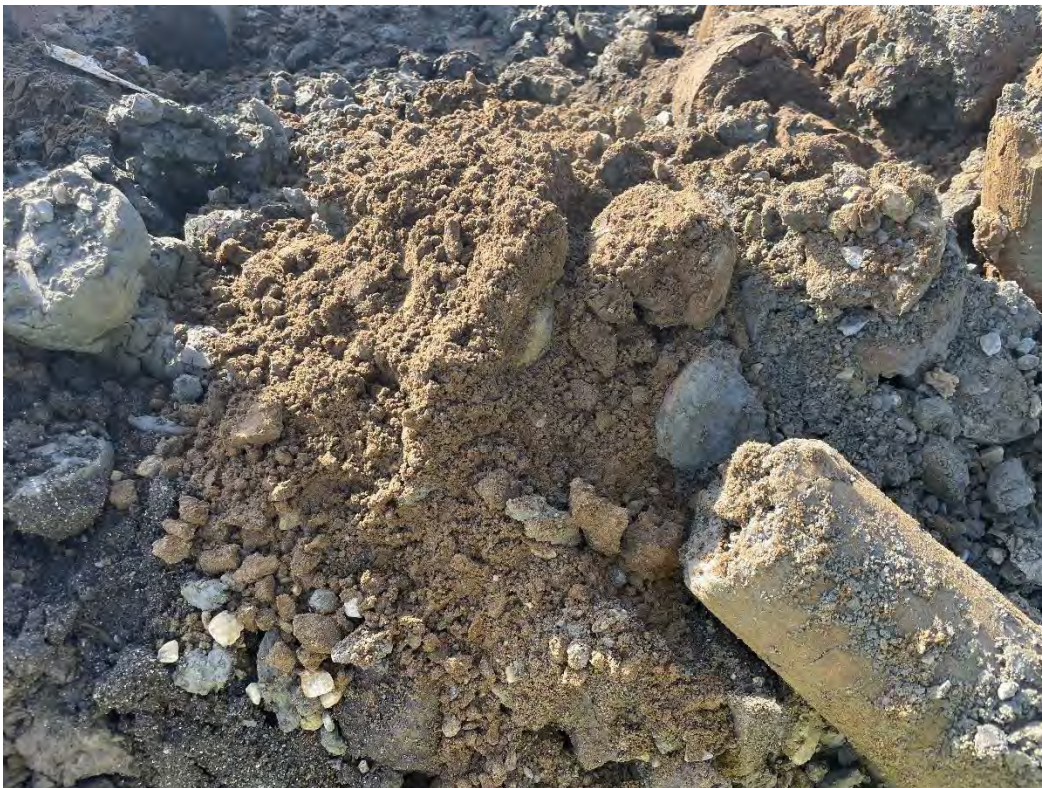
**Figure 56: ASW-38 Soil Extraction 0-10 ft bgs**

<b>Depth of SPT</b>	<b>Cultural Materials</b>	<b>Soil Description</b>	<b>Photo Log</b>
0-10 ft bgs	Negative	Orangish Brown Silty Sand, Slightly Wet but Mostly Dry, Loose, Poorly Sorted	Figure 56
30-35 ft bgs	Negative	Black Sand, Angular, Wet, Lose, Very Poorly Sorted. Very Dark Gray, Very Fine Sandy Silt, Very Wet, Cemented. Terminated at 35 ft bgs.	Figure 57

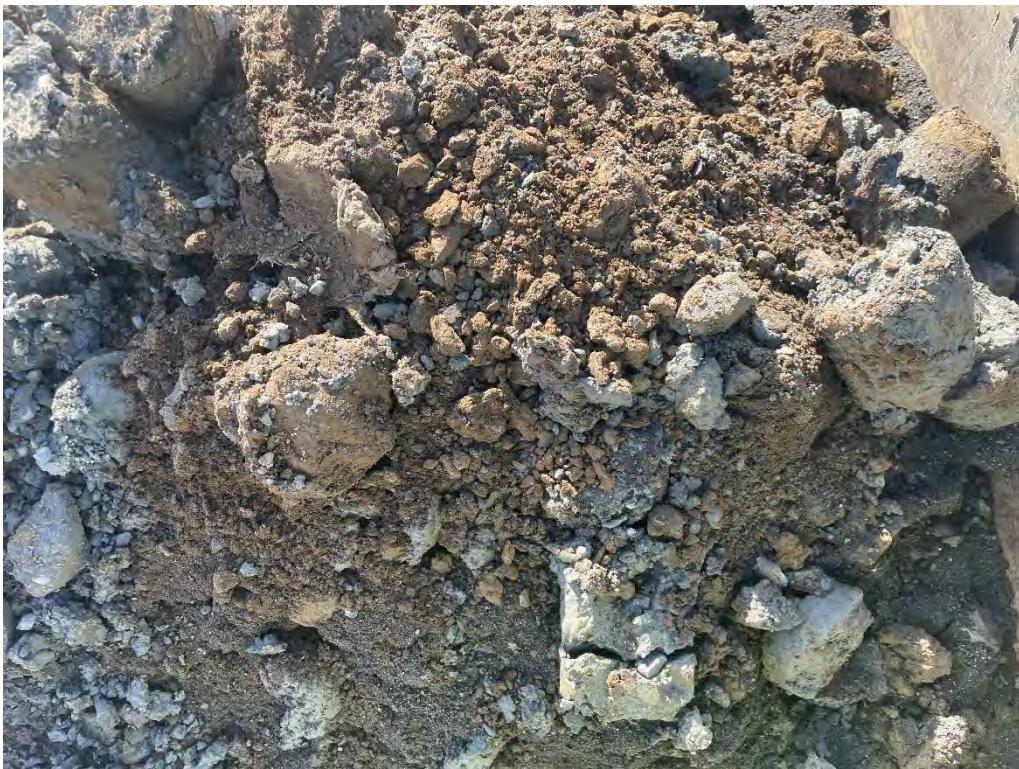
**Figure 62: ASW-37 Soil Extraction 0-10 ft bgs**

Depth of SPT	Cultural Materials	Soil Description	Photo Log
0-10 ft bgs	Negative	Brown Silty Sand, Dry, Loose, Many Nodules. Dark Gray Clay, Dry, Cemented.	Figure 62
30-35 ft bgs	Negative	Black Silty Sand, Very Angular, Very Poorly Sorted, Wet, Slightly Compact (Still Fairly Loose). Terminated at 35 ft bgs.	Figure 65

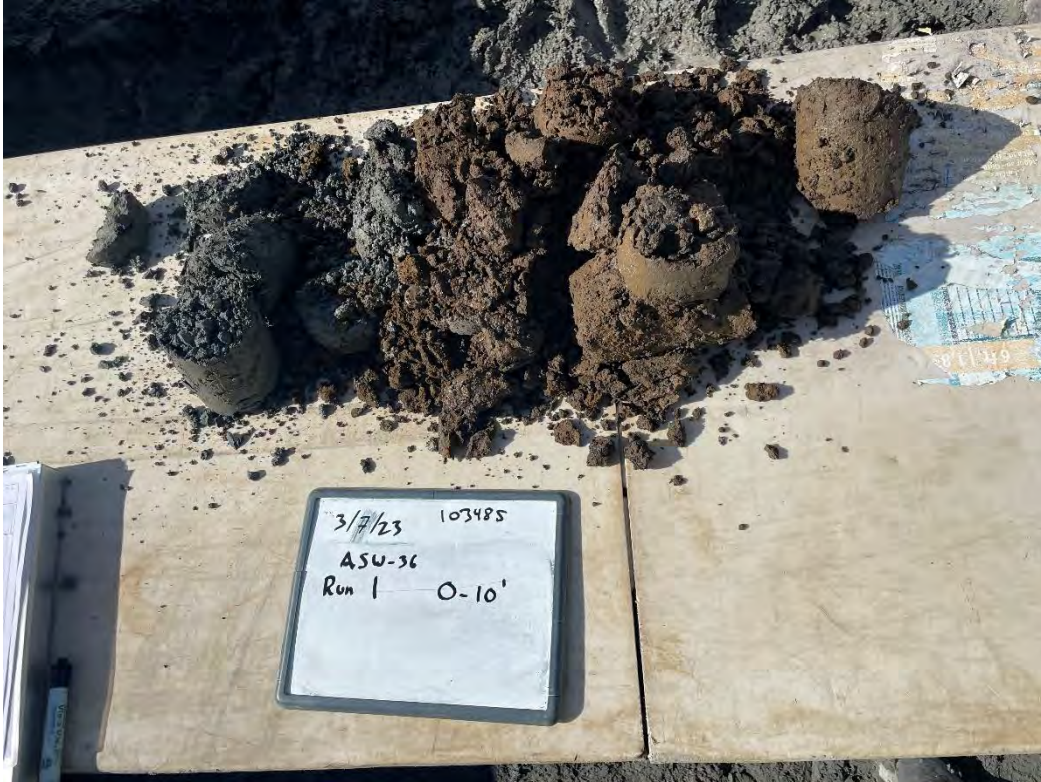
**Figure 67: ASW-36 Soil Extraction 0-10 ft bgs**

Depth of SPT	Cultural Materials	Soil Description	Photo Log
0-10 ft bgs	Negative	Brown Silty Sand, Very Fine, Wet, Cemented, Many Fine-Medium Sub-Angular Gravels. Gray Clay, Poorly Sorted, Slightly Wet, Very Cemented	Figure 67
30-35 ft bgs	Negative	Very Dark Gray/Black Silty Sand, Both Part Very Cemented, And More Loose/Less Cemented, Poorly Sorted, Very Wet. Terminated at 35 ft bgs.	Figure 69

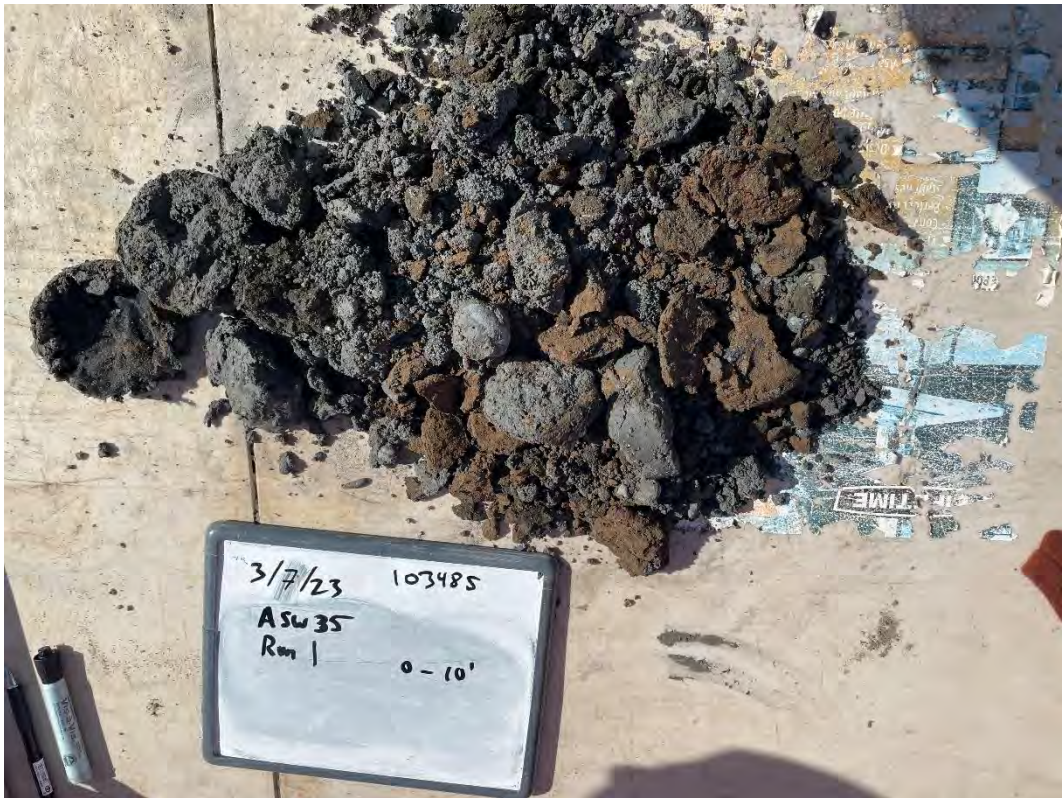
Figure 74: ASW-35 Soil Extraction 0-10 ft bgs

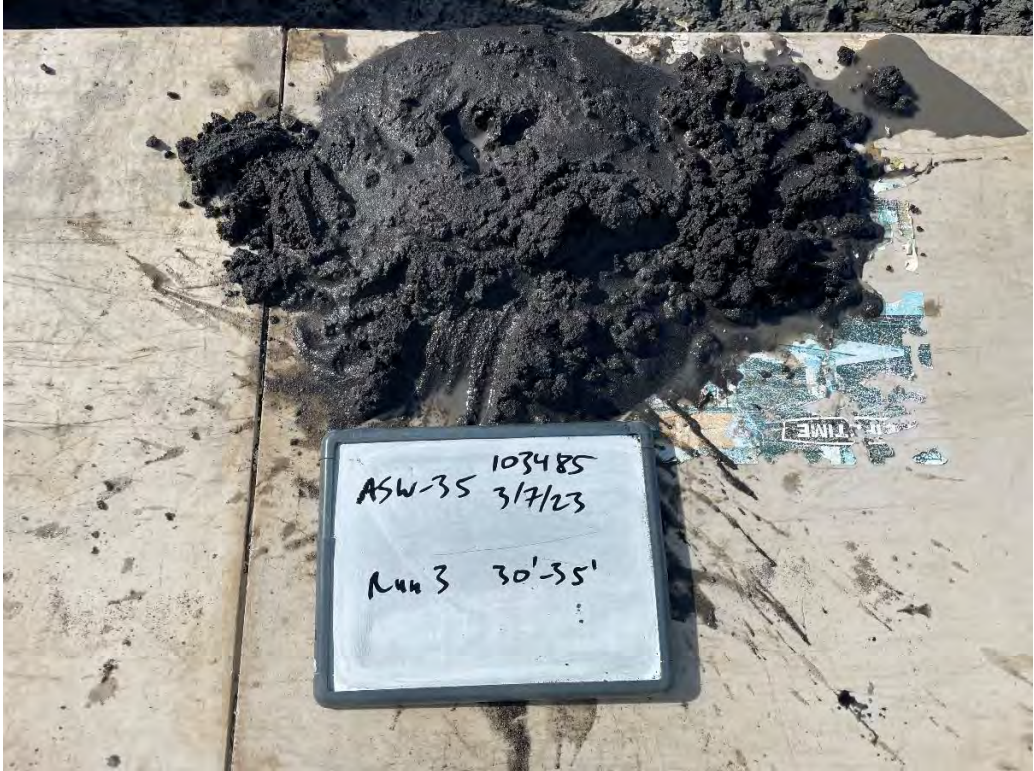
**Figure 75: ASW-35 Soil Extraction 30-35 ft bgs**

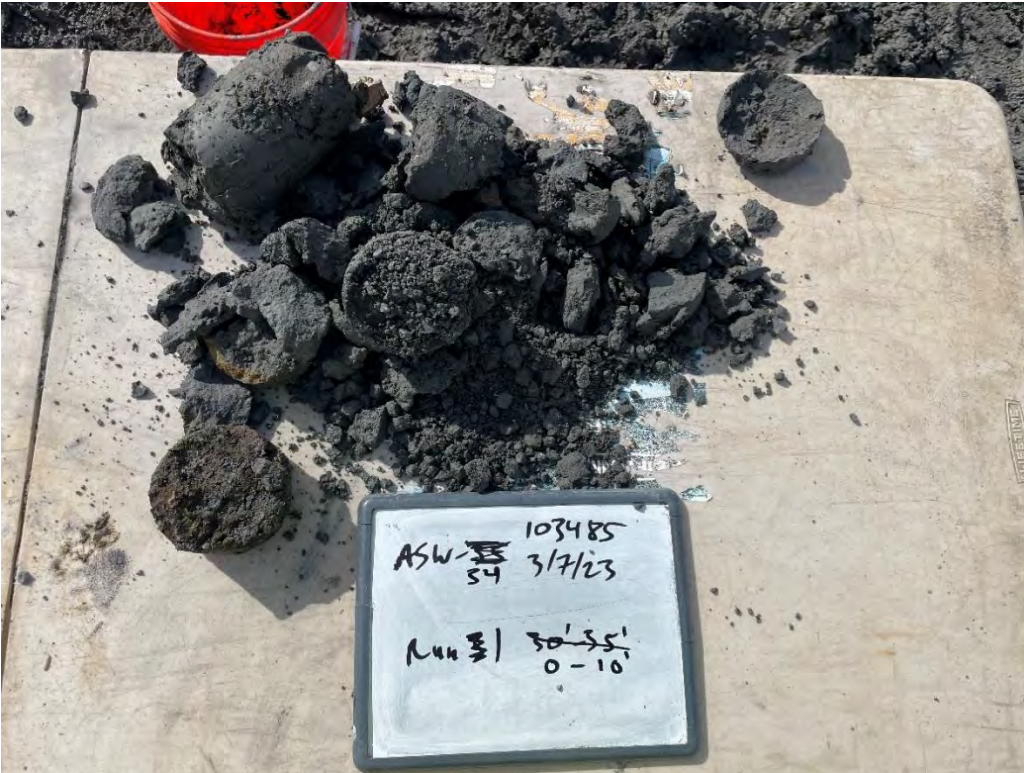
Depth of SPT	Cultural Materials	Soil Description	Photo Log
0-10 ft bgs	Negative	Dark Gray Clay, Mostly Very Dry, Some Slightly Wet, Very Cemented, Very Poorly Sorted, Many Fine-Medium Angular/Sub-Angular/Sub-Rounded Gravels	Figure 80

Figure 80: ASW-34 Soil Extraction 0-10 ft bgs

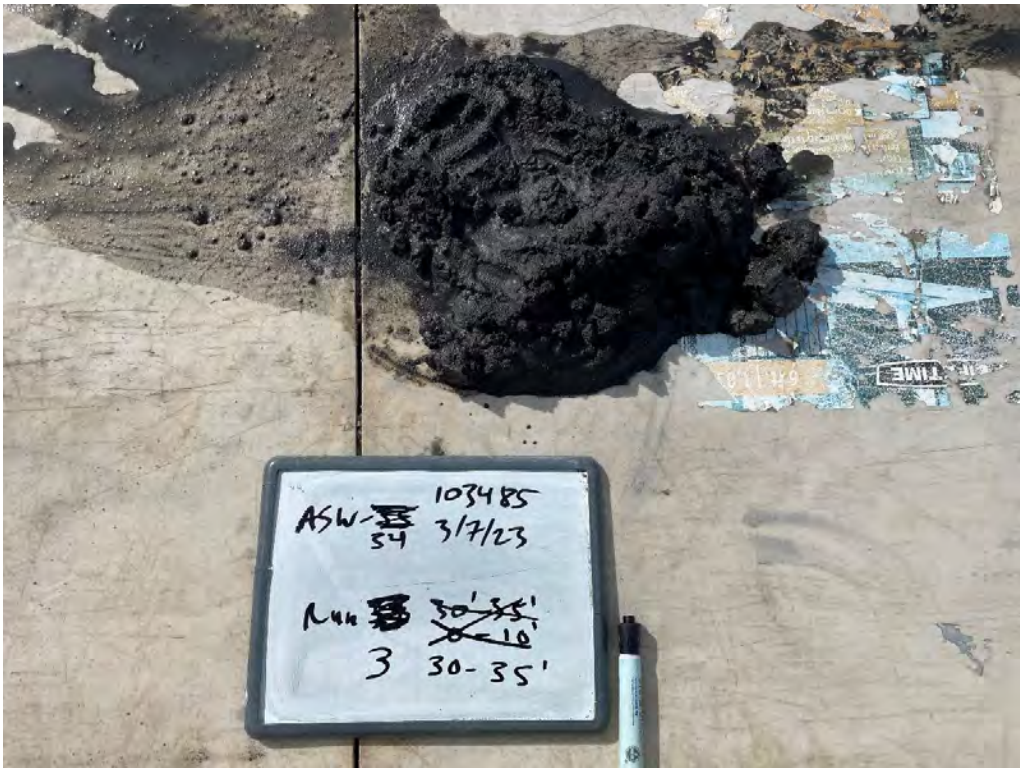
Depth of SPT	Cultural Materials	Soil Description	Photo Log
30-35 ft bgs	Negative	Very Dark Gray/Black Silty Sand with Trace Fine Angular Sand, Both Part Very Cemented, And More Loose/Less Cemented, Poorly Sorted, Very Wet. Terminated at 35 ft bgs.	Figure 82

Figure 82: ASW-34 Soil Extraction 30-35 ft bgs

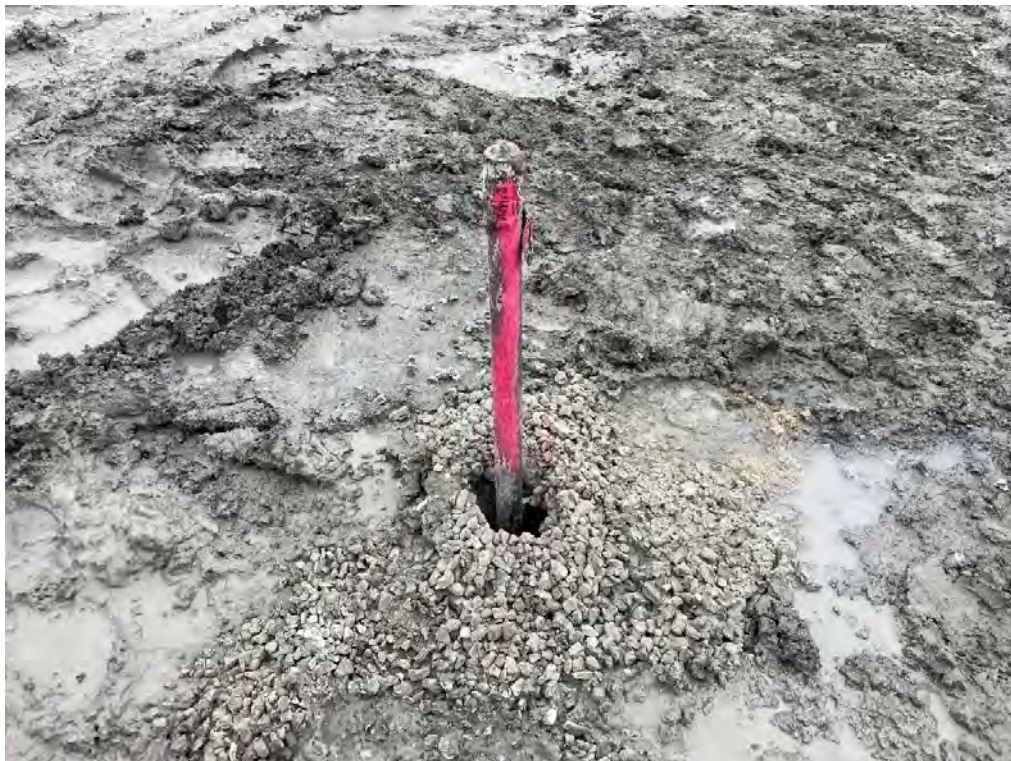
**Figure 84: Example of Well Screen after it is inserted into ground/boring hole**

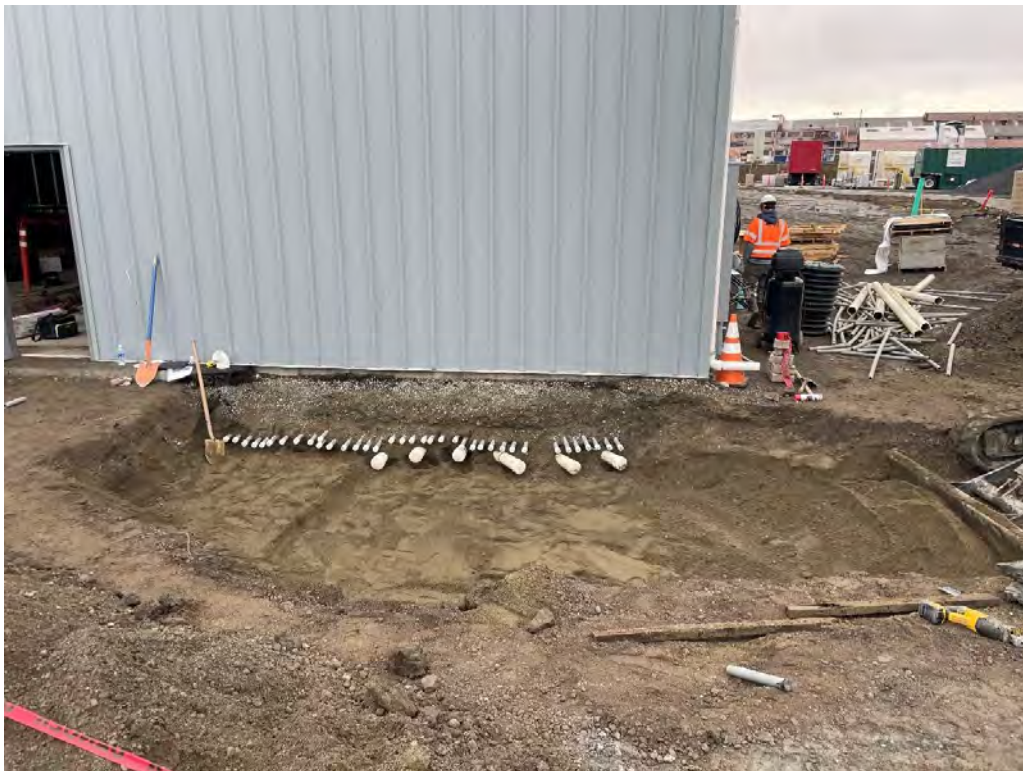
**Figure 88: Overview of Pipes Exposed Under S Side of AS/SVE Building**

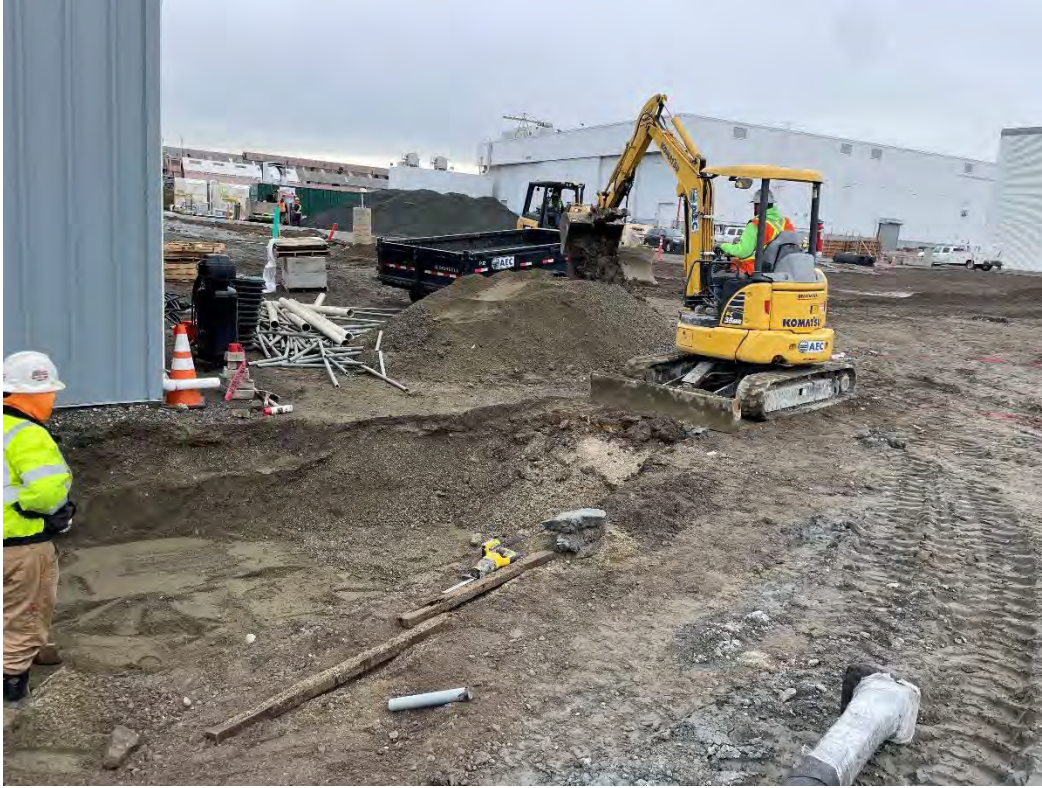
**Figure 89: Soil Change – Gravels**

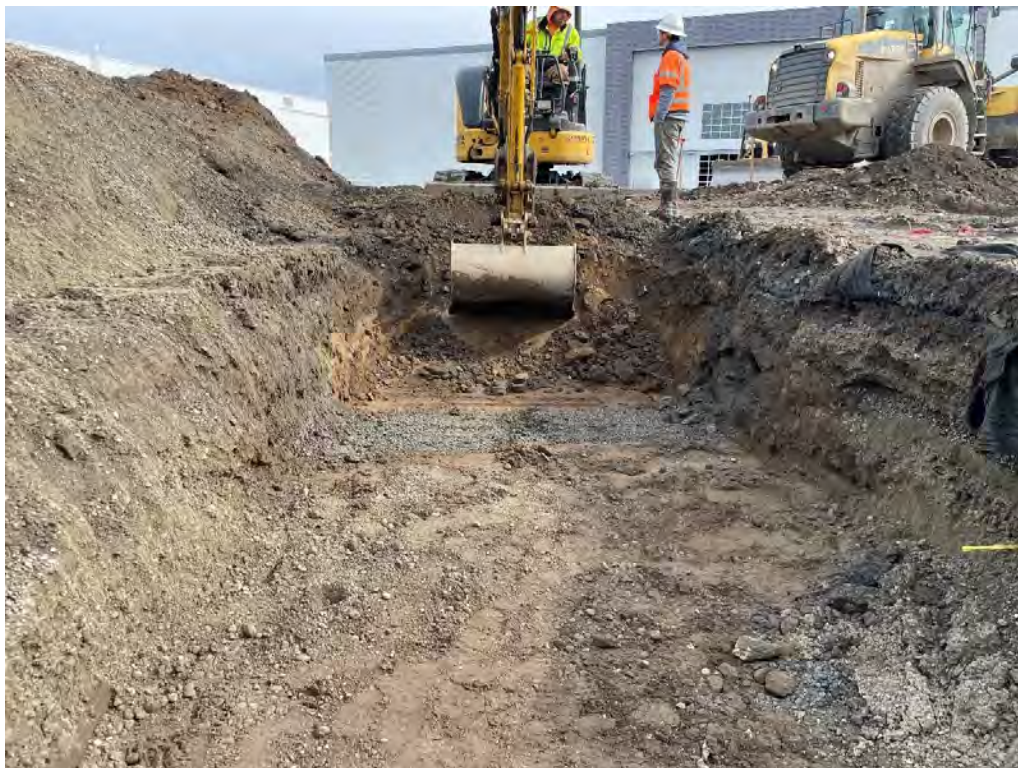
**Figure 90: Soil Change - Brown Sandy Silt**
