FINAL COMPLIANCE MONITORING REPORT  
**AS/SVE System Extension and  
Modification**

8801 EAST MARGINAL WAY S., TUKWILA, WASHINGTON  
AGREED ORDER NO. 6069

Subject: FINAL COMPLIANCE MONITORING REPORT, AS/SVE SYSTEM  
EXTENSION AND MODIFICATION, 8801 EAST MARGINAL WAY S.,  
TUKWILA, WASHINGTON  
AGREED ORDER NO. 6069

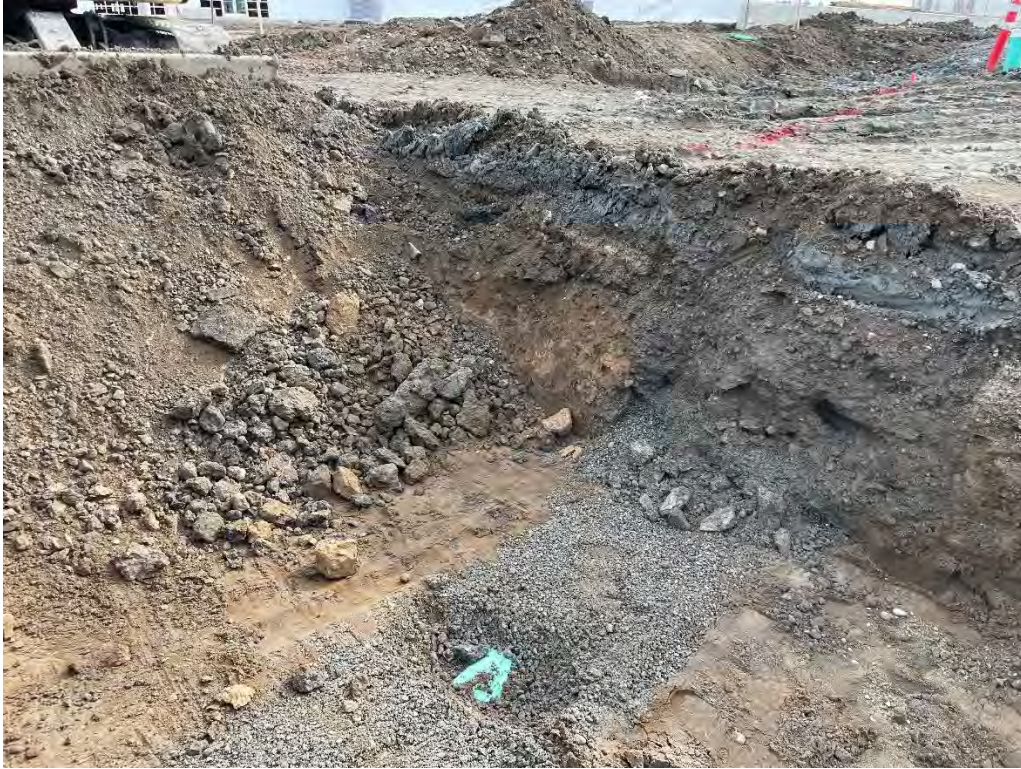
**Figure 91: Overview of Blue Unaffiliated Pipe/Abrupt Soil Disturbance Layers**

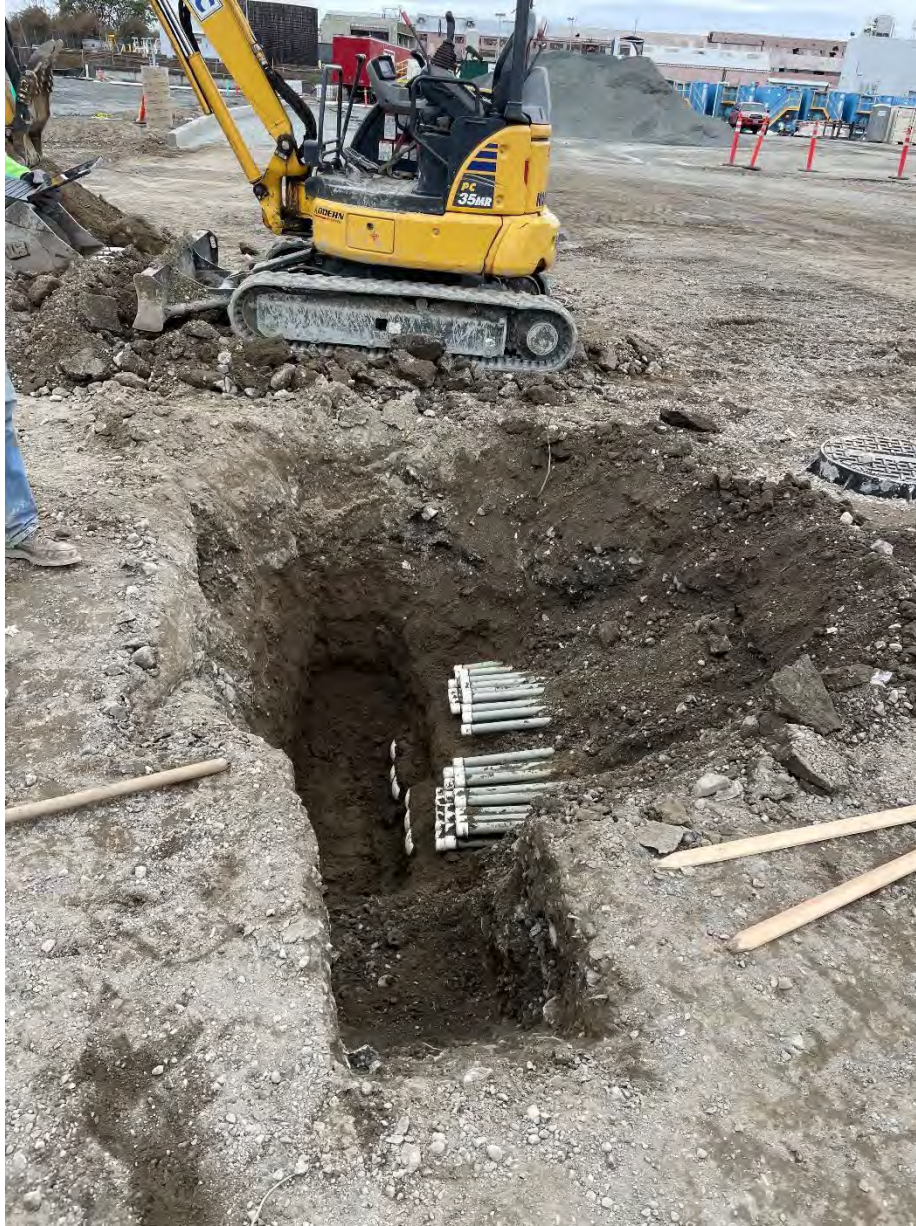
**Figure 93: Overview of Pipes Exposed on E Side**

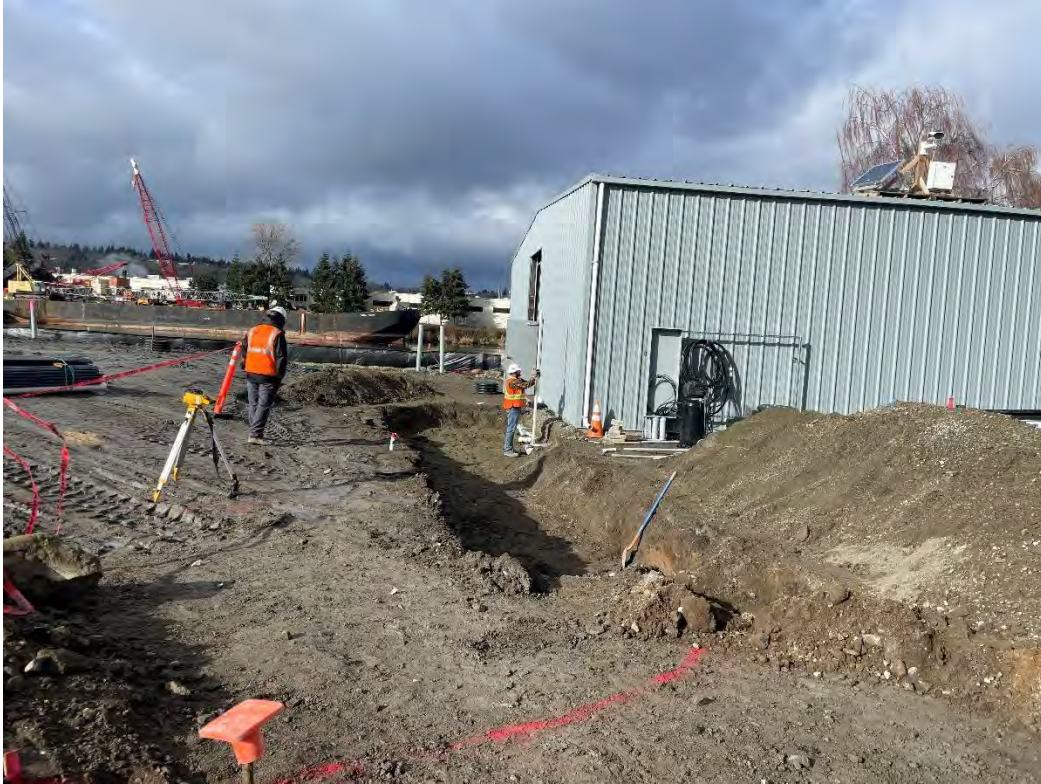
**Figure 96: Use of Laser to Measure Differing Pipe Depths**

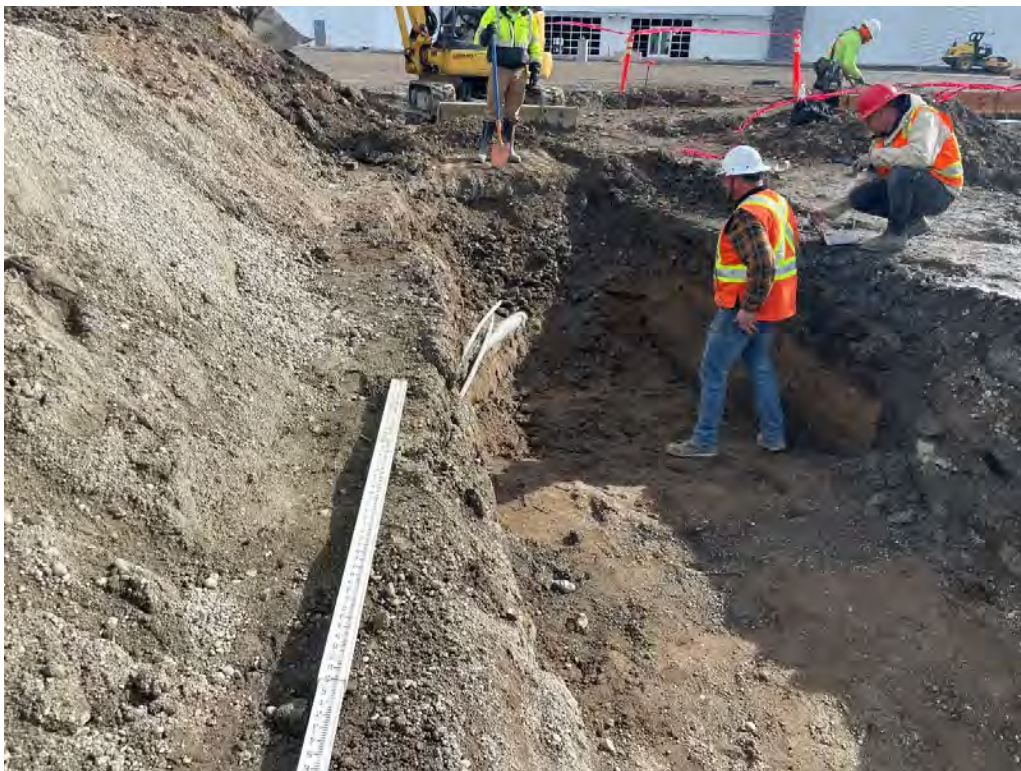
**Figure 97: Exposure of Set of Pipes Unaffiliated with this Project**

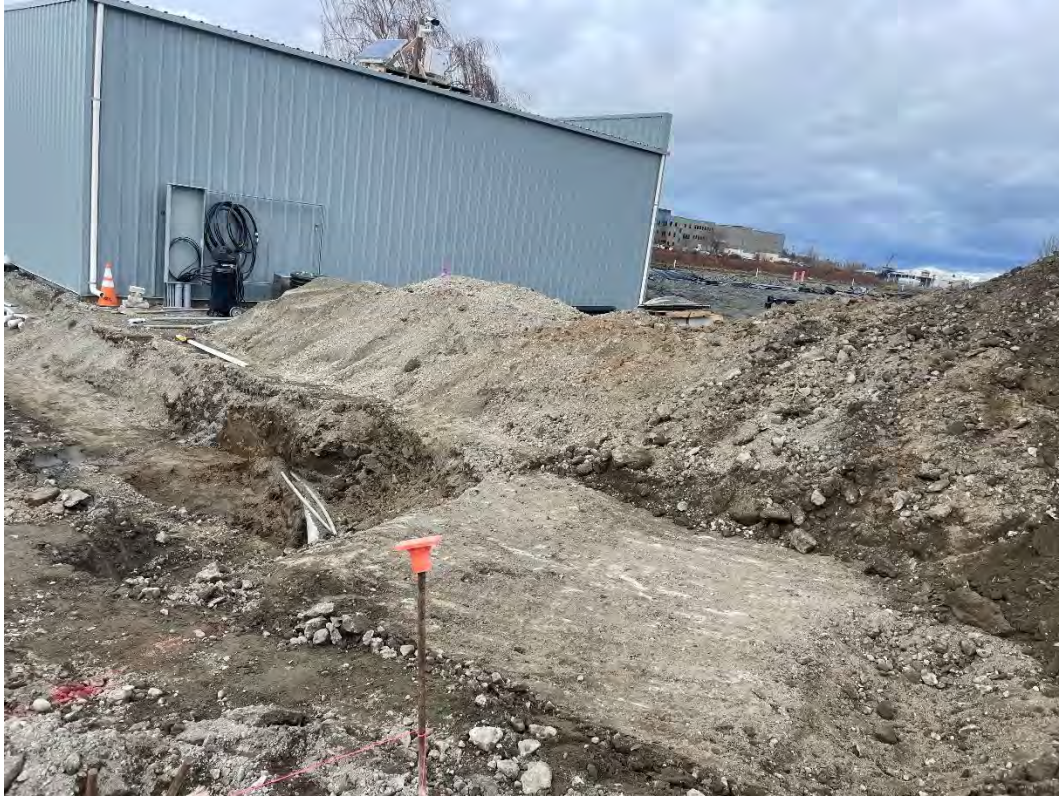
**Figure 98: Concrete Layer and Unaffiliated Pipes, Briefly Paused Excavation**

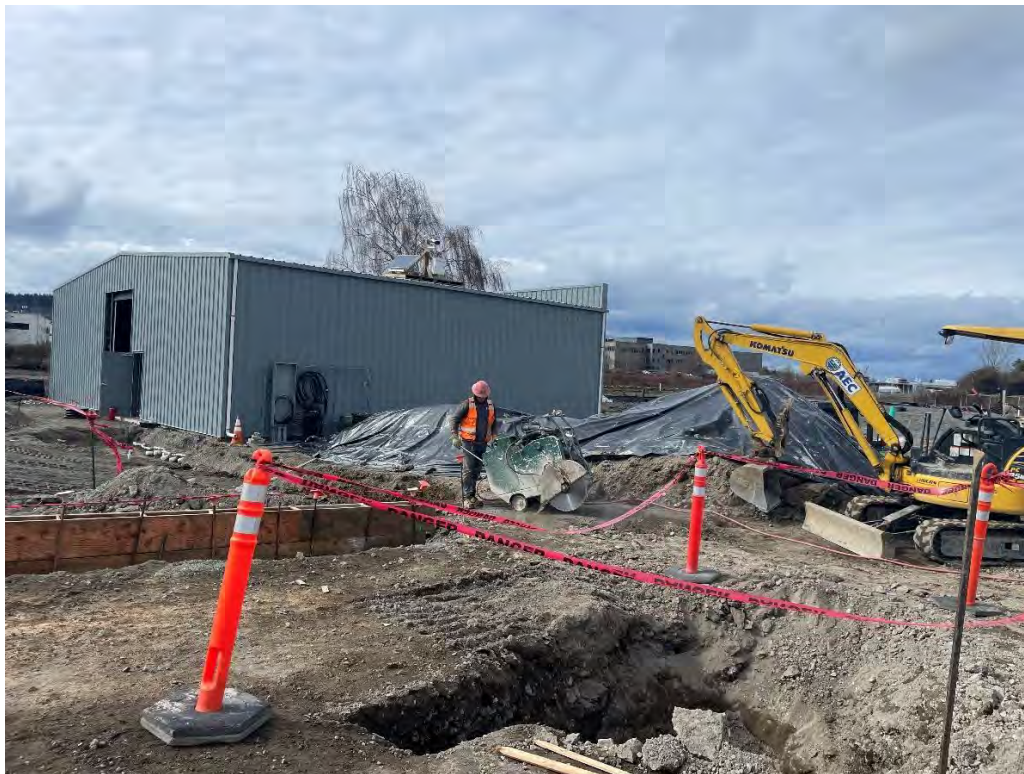
**Figure 99: Saw Used to Cut Concrete Layer**

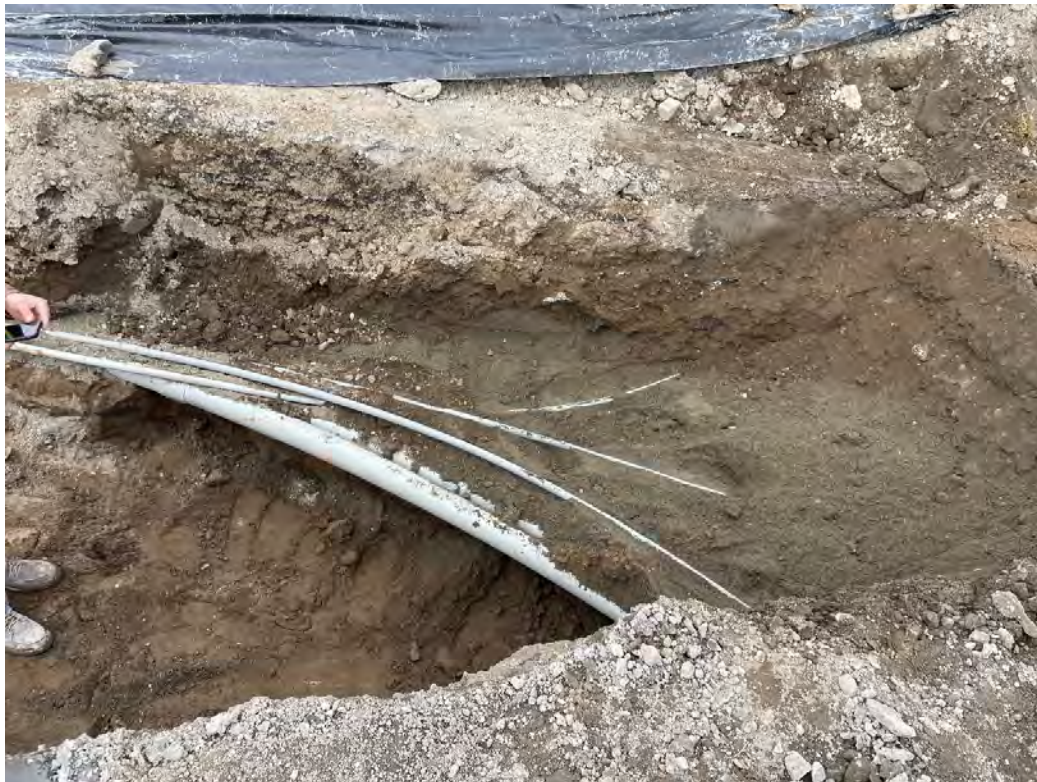
**Figure 101: Unaffiliated Pipes Exposed After Concrete Layer is Removed**

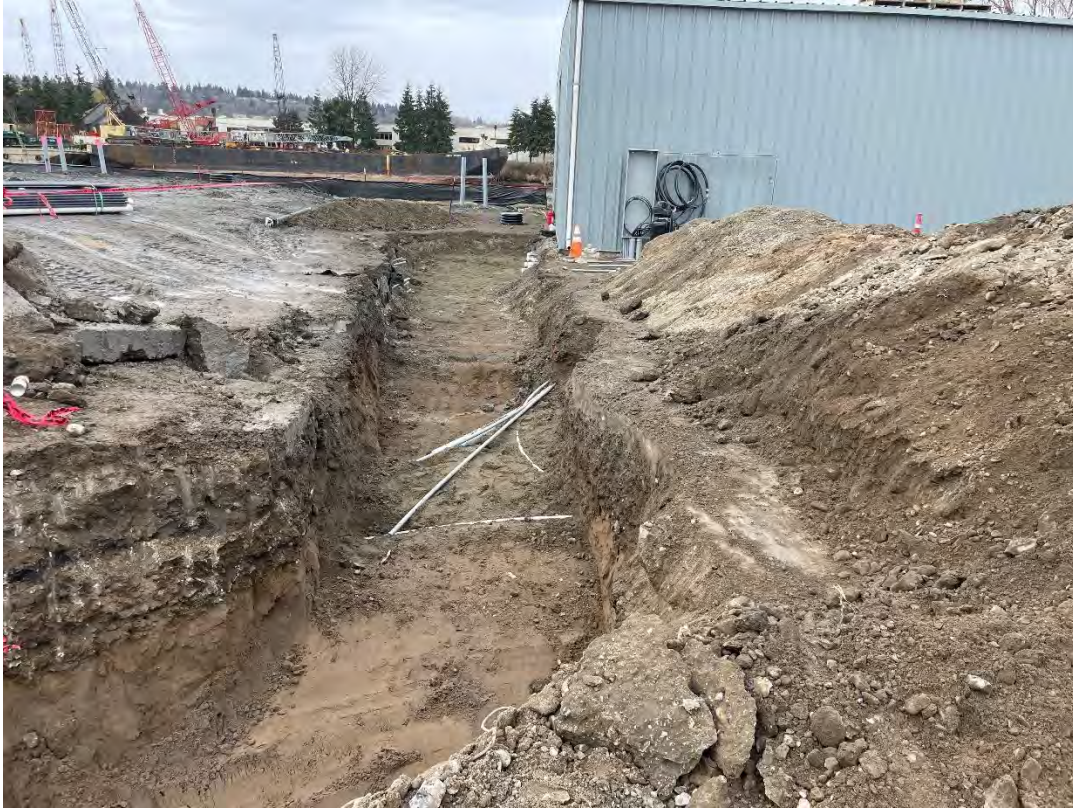
**Figure 108: E and W Trenches Merge**

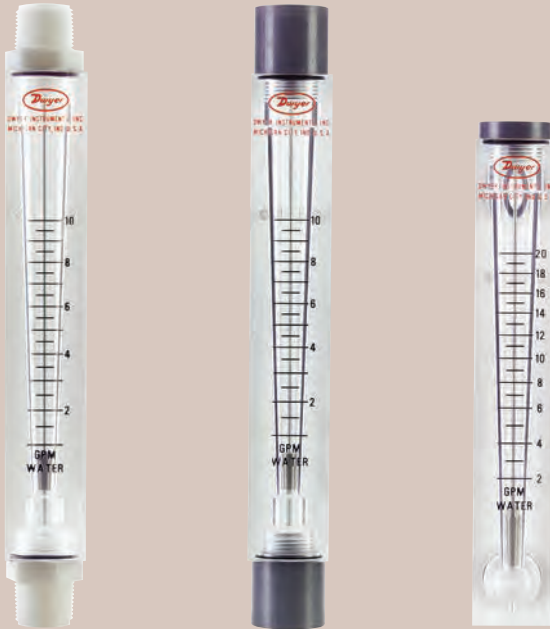
VFCII with 1" MNPT  
End Connections

VFC with 1" FNPT  
End Connections

The accurate and durable VFC Visi-Float® flowmeter contains a stainless steel guide rod and large diameter float for excellent stability and visibility in high flow rates. The large 5" scale provides a ±2% full-scale accuracy for precision measurement required in medical or laboratory applications. The VFC models have PVC 1" female NPT connections. VFC II units are equipped with acetal thermoplastic 1" male NPT fittings. VFC II fittings also include hex wrench flats to prevent stripped threads. All models have metal mounting inserts on the back for panel mounting. Units may also be supported directly by system piping.

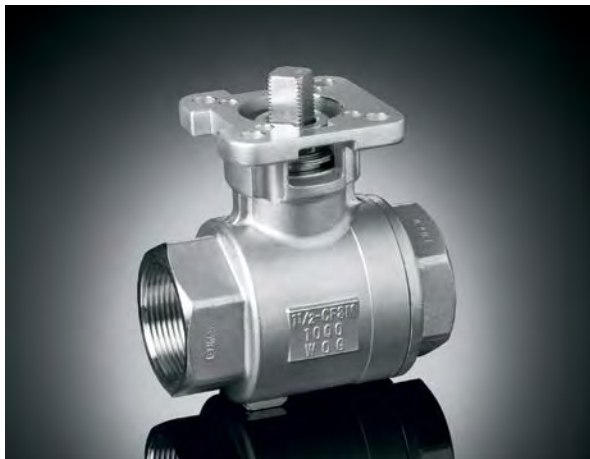
Triac Series 22 Ball Valves feature a high quality investment cast body and end. They are available in sizes from 1/4" to 3". Superior leak protection is accomplished by using our patented "Pyramidal" stem seal system shown in the graphic below. This advanced system protects against wear and leakage experienced by other ordinary ball valves.

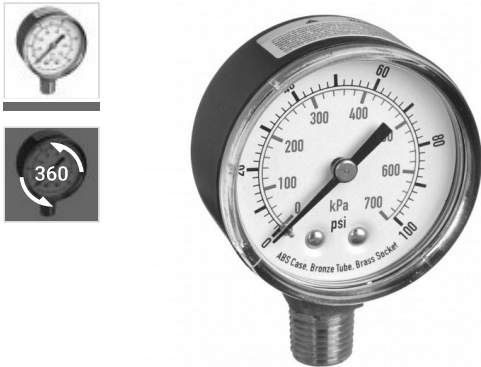
**GRAINGER APPROVED Commercial Pressure Gauge: 0 to 100 psi, 2 in Dial, 1/4 in NPT Male, Bottom, Dual**

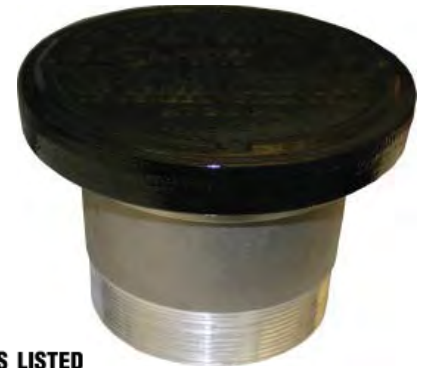
**CHART KEY:**

- A**—Size: 6"
- B**—Venting Capacity/CFH
- C**—Mounting Connection: Female N.P.T. (BLANK); Male N.P.T.(M); Flanged (F); BSP (B)
- D**—Pressure Settings: 8 or 16 oz/in<sup>2</sup>. Pressure Required to Open Vent.
- E**—Cover: Cast Iron (I); Powder Coated
- F**—Seat Material: O-Ring Viton A (A) or Viton B (B)
- G**—Body Material: Aluminum (AL) or Iron (I)
- Diameter**—Dimension Across Vent
- Height**—Dimension from Base to Top When Closed
- Weight**—Shipping Weight
- Screen**—3 Mesh Stainless Steel
- Bolt**—Zinc plated steel

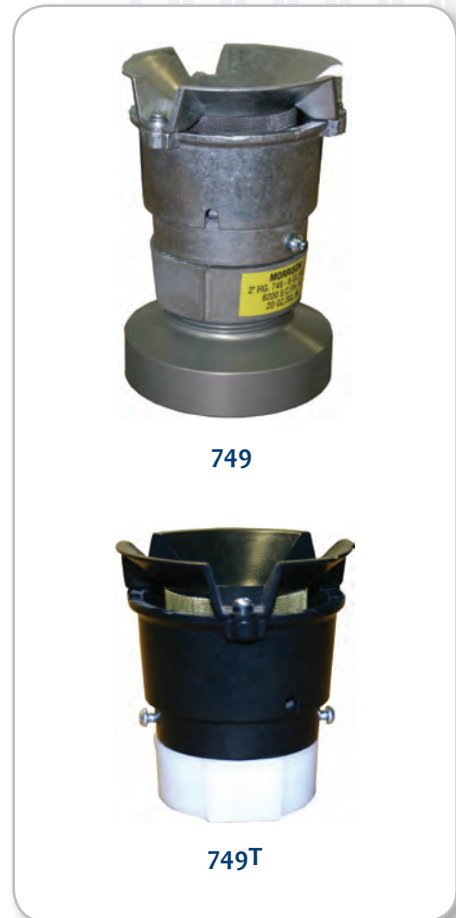
Fig. 749 P/V vent must only be used in conjunction with motor fueling. Fluid handling in lines larger than that used for retail service stations can cause tank to rupture or implode.
