INITIAL INVESTIGATION FIELD REPORT

<u>Site Name (Name over door):</u> Auburn VW	<u>Site Address (including City, State and Zip):</u> 3109 Auburn Way N Auburn, WA 98002	<u>Phone</u> <u>Email</u>
<u>Site Contact, Title, Business:</u> Dan Hatch Bluestone Environmental, NW	<u>Site Contact Address (including City, State and Zip):</u>	<u>Phone</u> <u>Email</u> danh@bluestonenw.com
<u>Site Owner, Title, Business:</u> Bryce Clary Clary Auburn RE, LLC	<u>Site Owner Address (including City, State and Zip):</u> P.O. Box 127 Longview, WA 98632	<u>Phone</u> (360) 423-1700 <u>Email</u> bryce.clary@budclary.com
<u>Site Owner Contact, Title, Business:</u>	<u>Site Owner Contact Address (including City, State and Zip):</u>	<u>Phone</u> <u>Email</u>
<u>Previous Site Owner(s):</u> Conducere Investments, LLC	<u>Additional Info (for any Site Information Item):</u> A previous release (CSID 12228, Auburn Way Properties) associated with this FSID is on the lot line between this parcel (0004000041 at 3109 Auburn Way N) and the south-adjacent parcel (0004000039 at 3025 Auburn Way N). PLIA issued an NFA on 5/6/19. This IIFR is for a separate release.

Site Diagram, Features, and Exploration Locations

Auburn

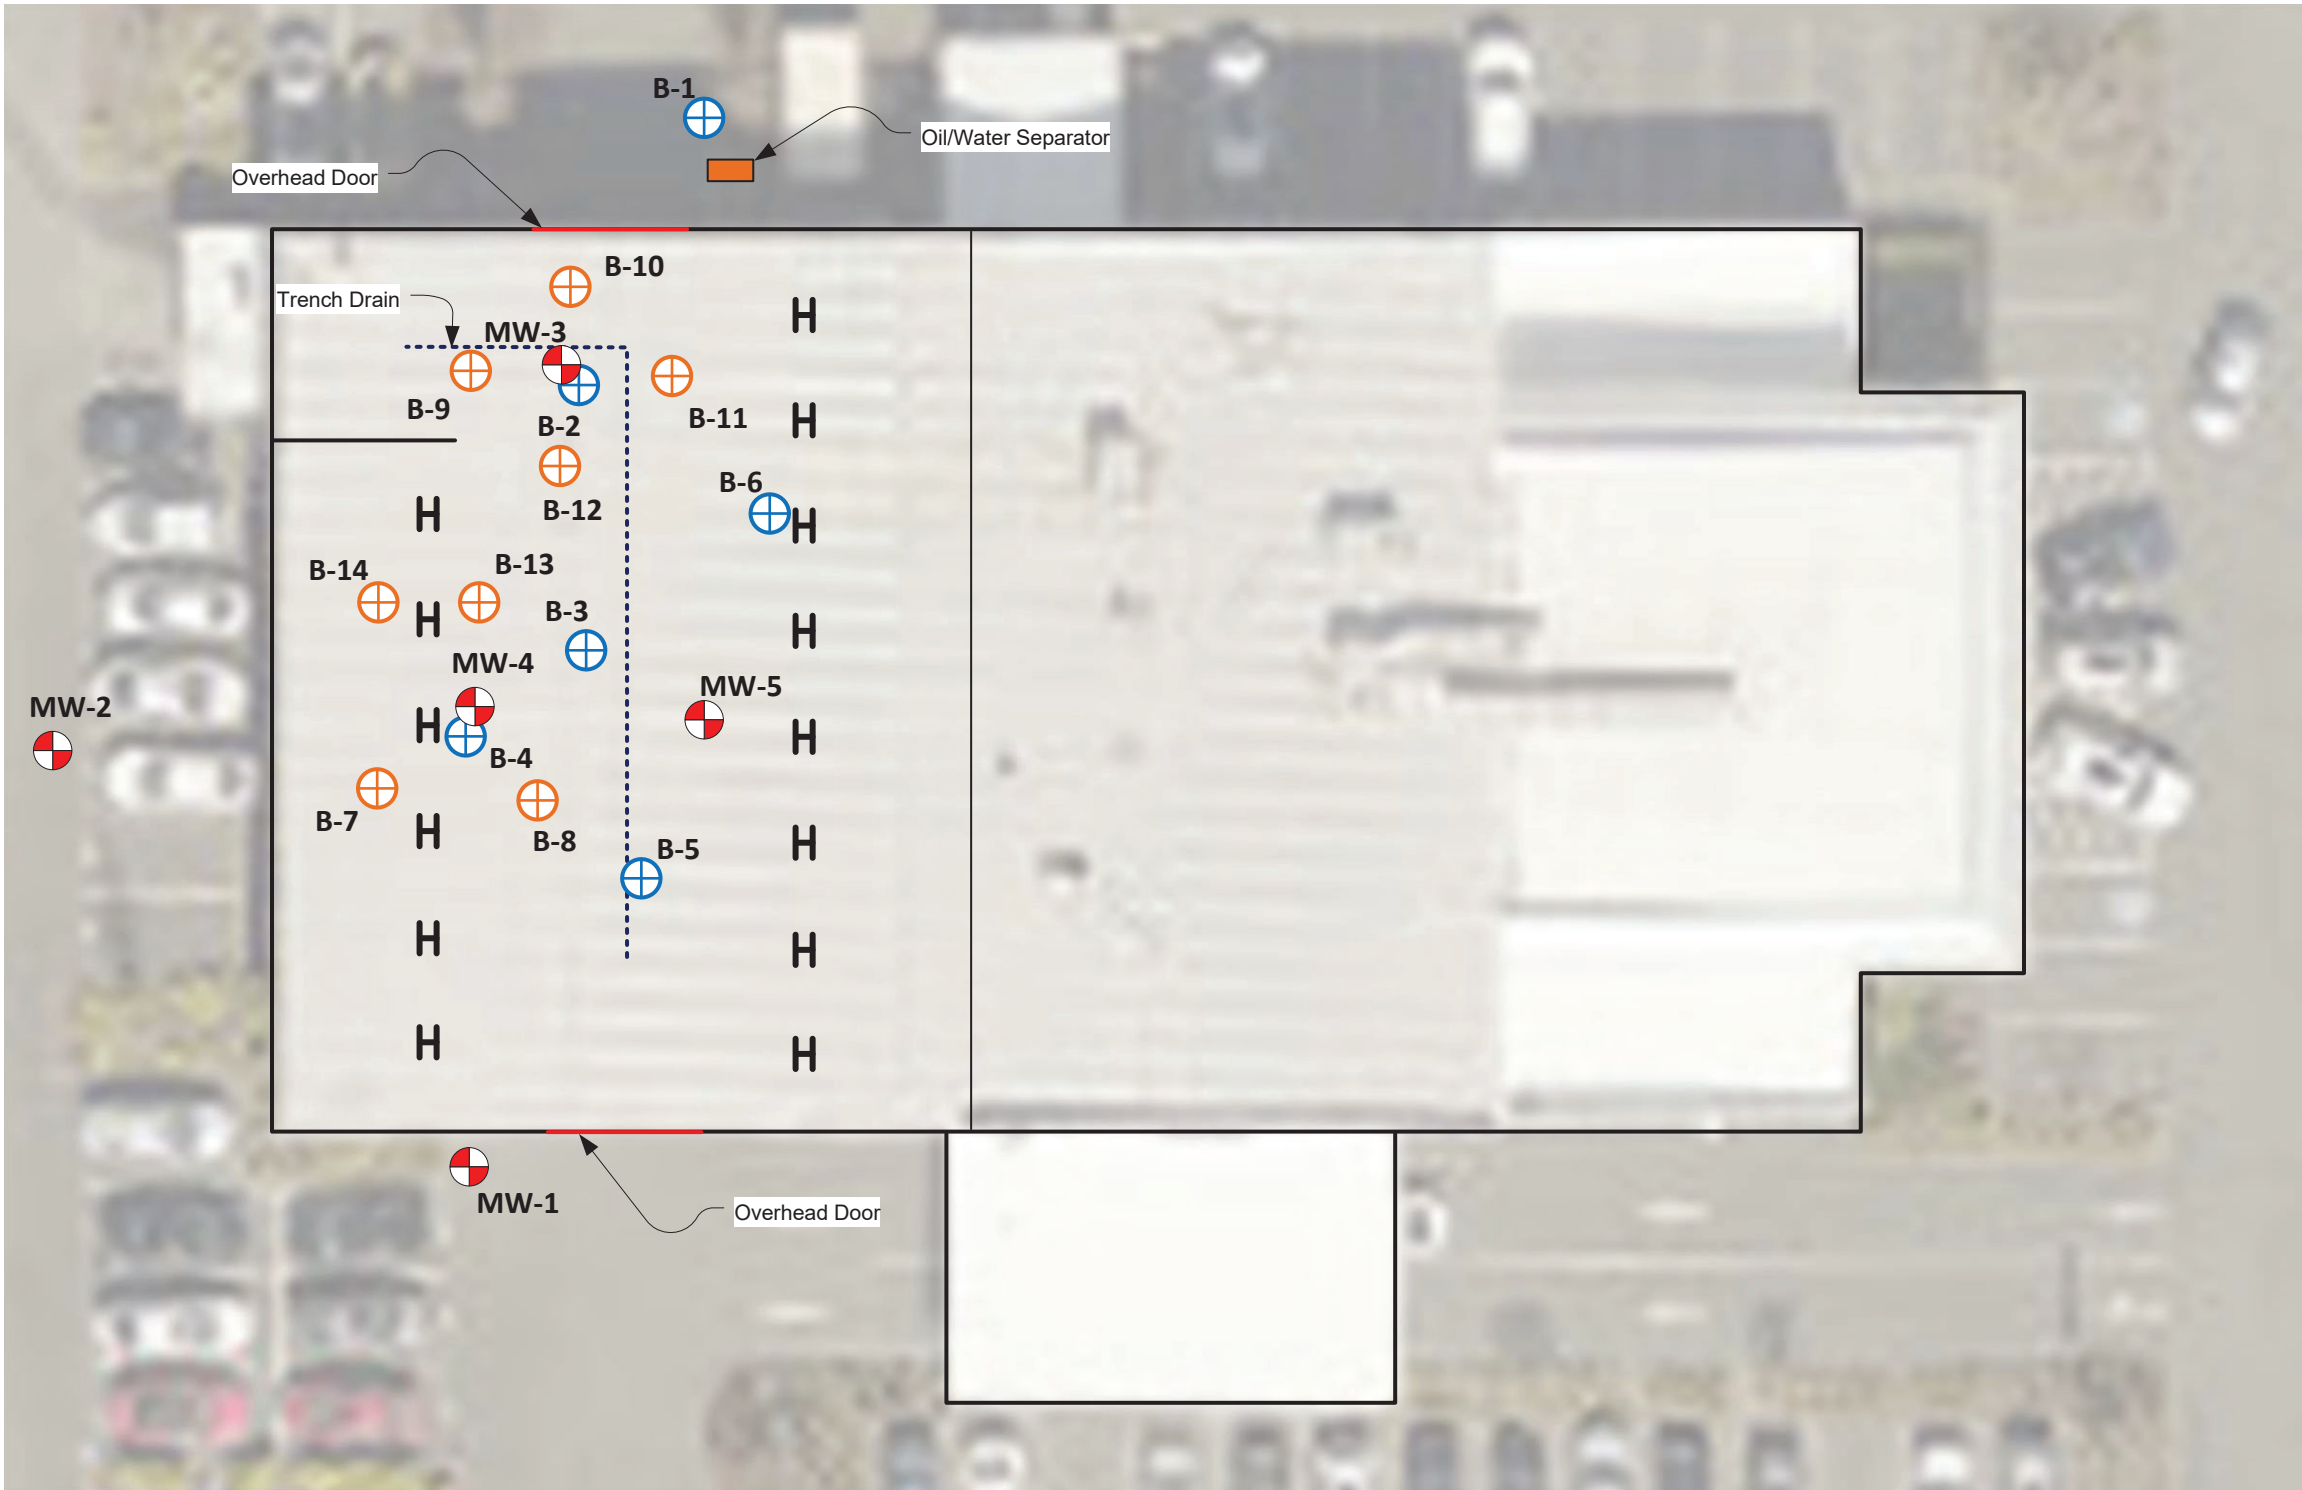
**Figure
2**

| Building Outline | Groundwater Monitoring Well Location (May 23, 2022) | Trench Drain in Shop Floor |
| July 20, 2022 Soil Boring Location | April 24, 2022 Soil Boring Location | Underground Hoist Location |

Subsequent soil borings were completed around the two borings with cPAH and petroleum exceedances to better delineate the contamination, and four monitoring wells were installed at the Site parcel. Two wells were installed at the approximate locations of the two borings with the cPAH and petroleum exceedances, and one well each was installed to the west and east of the two wells, in assumed upgradient and downgradient directions, respectively. An additional well was installed to the south of the service building.

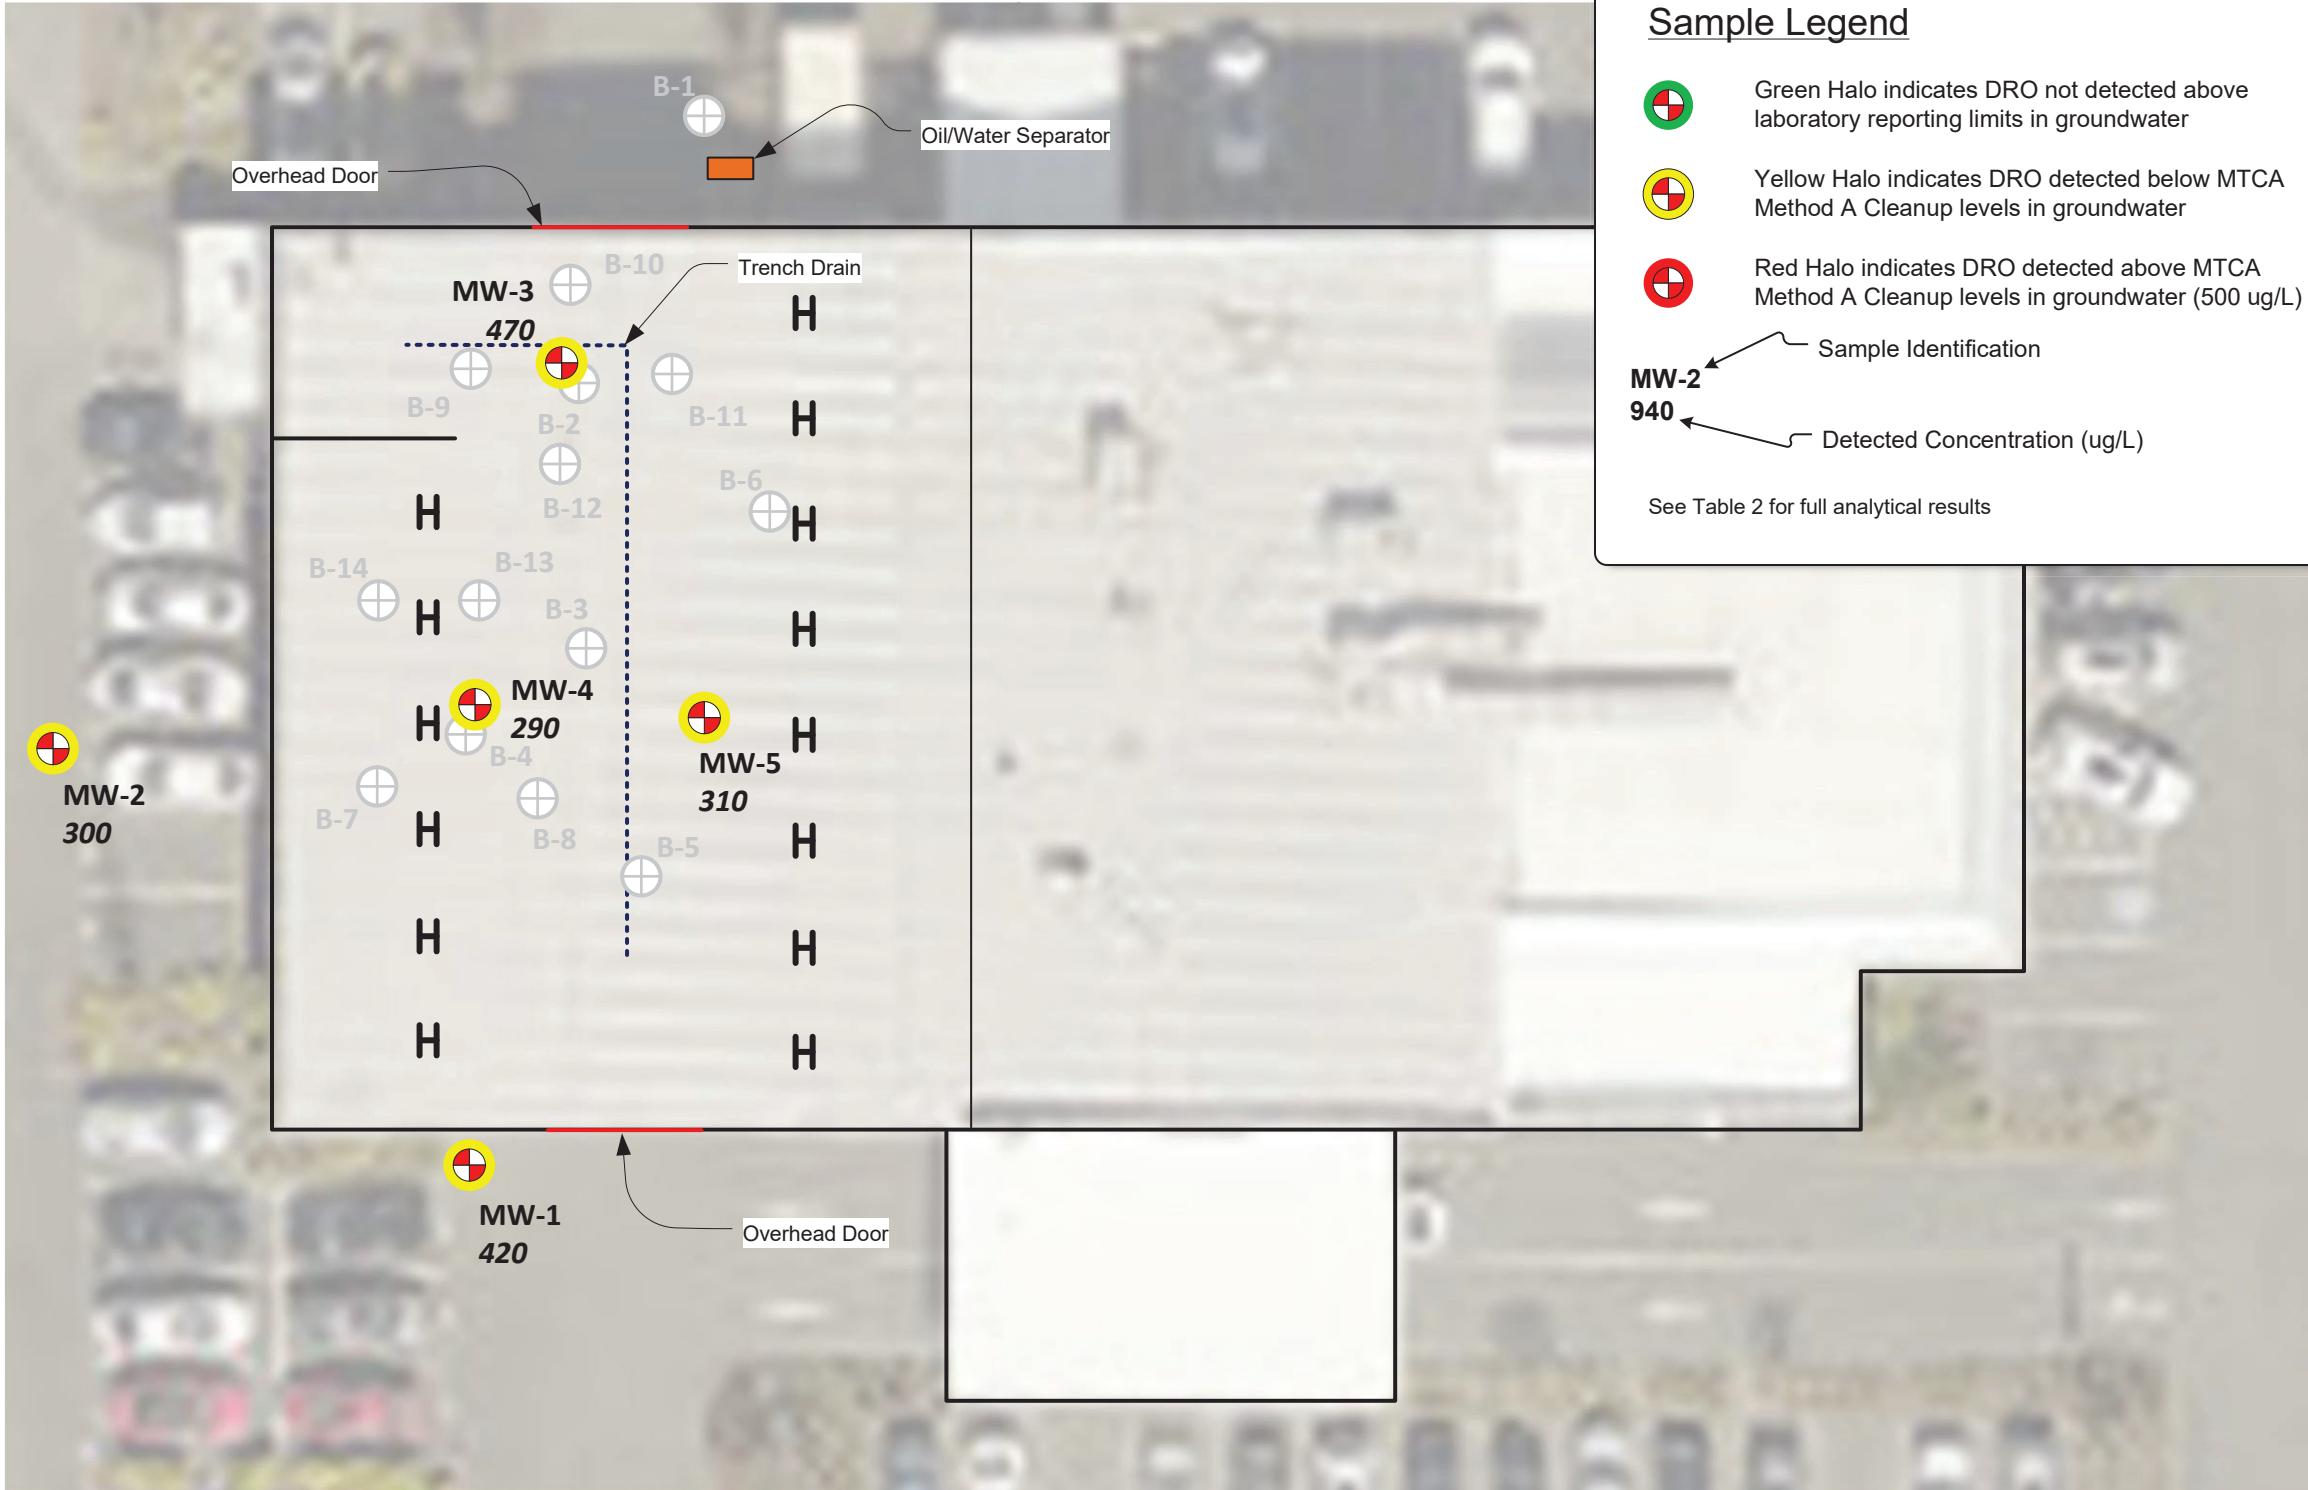
Figure
3a

DRO Concentrations in Groundwater
(May 26, 2022)

Diesel and oil-range petroleum hydrocarbons exceeding the MTCA Method A groundwater cleanup level were identified in groundwater underlying and to the west of the Site service building. The source of the petroleum was not identified, and additional investigation was recommended.

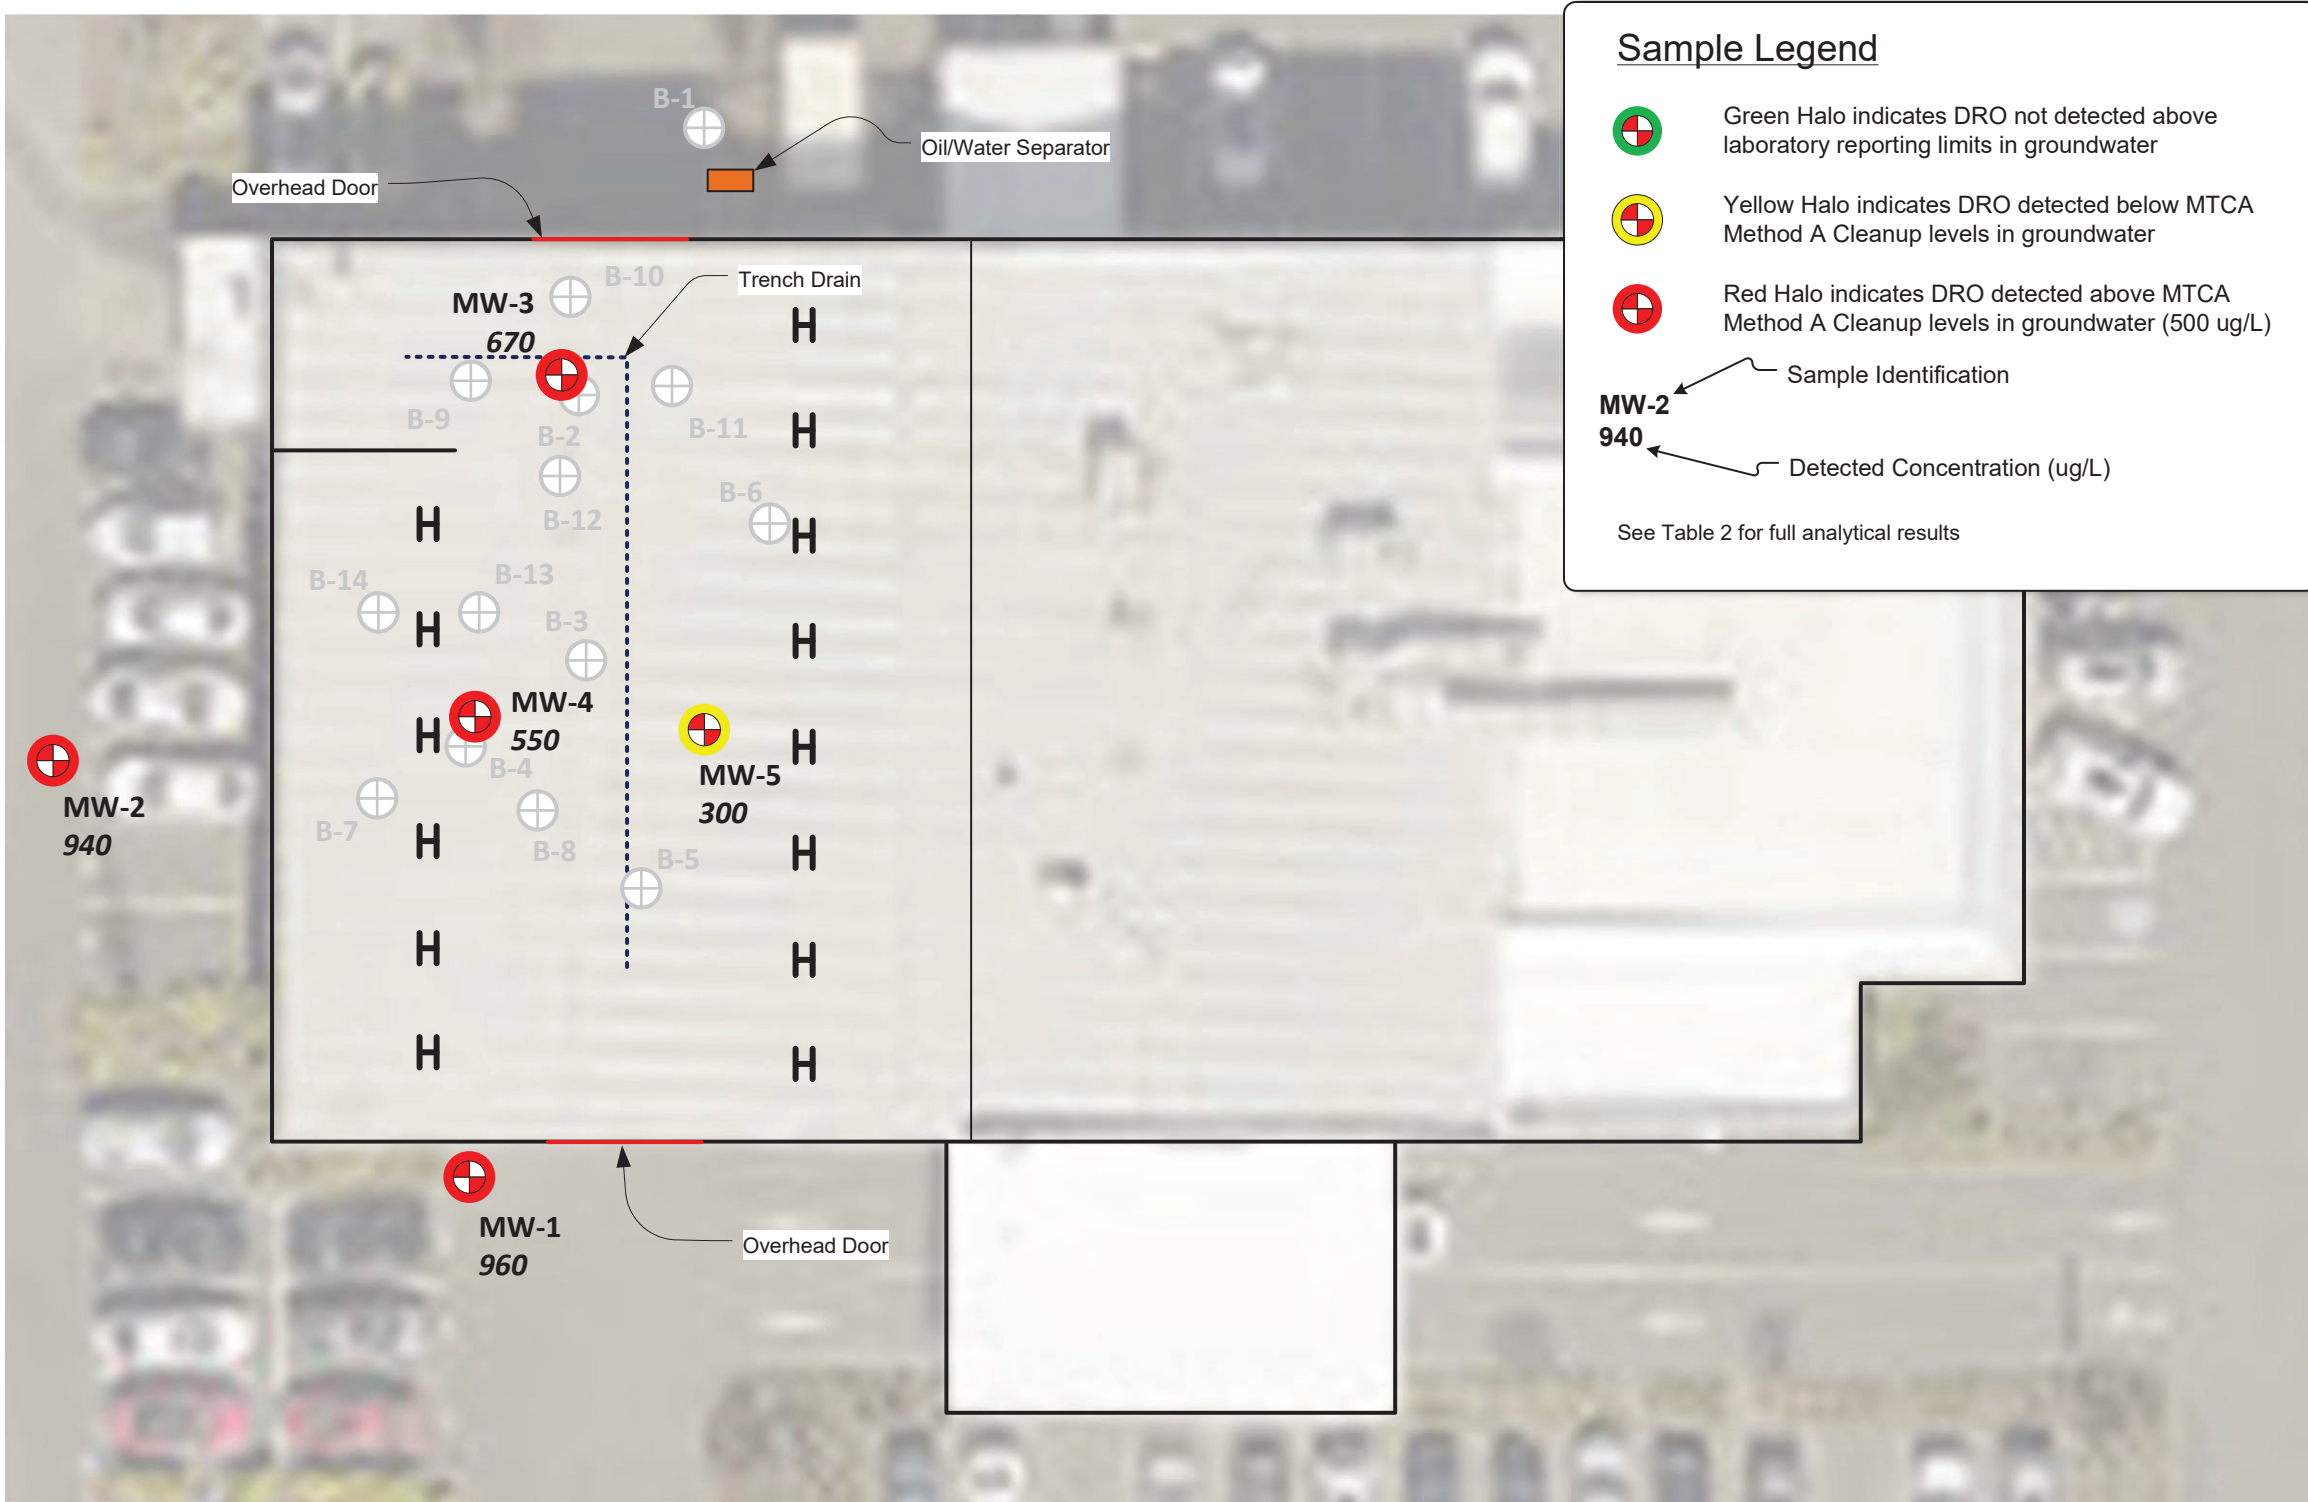
Figure
3b

DRO Concentrations in Groundwater
(July 26, 2022)

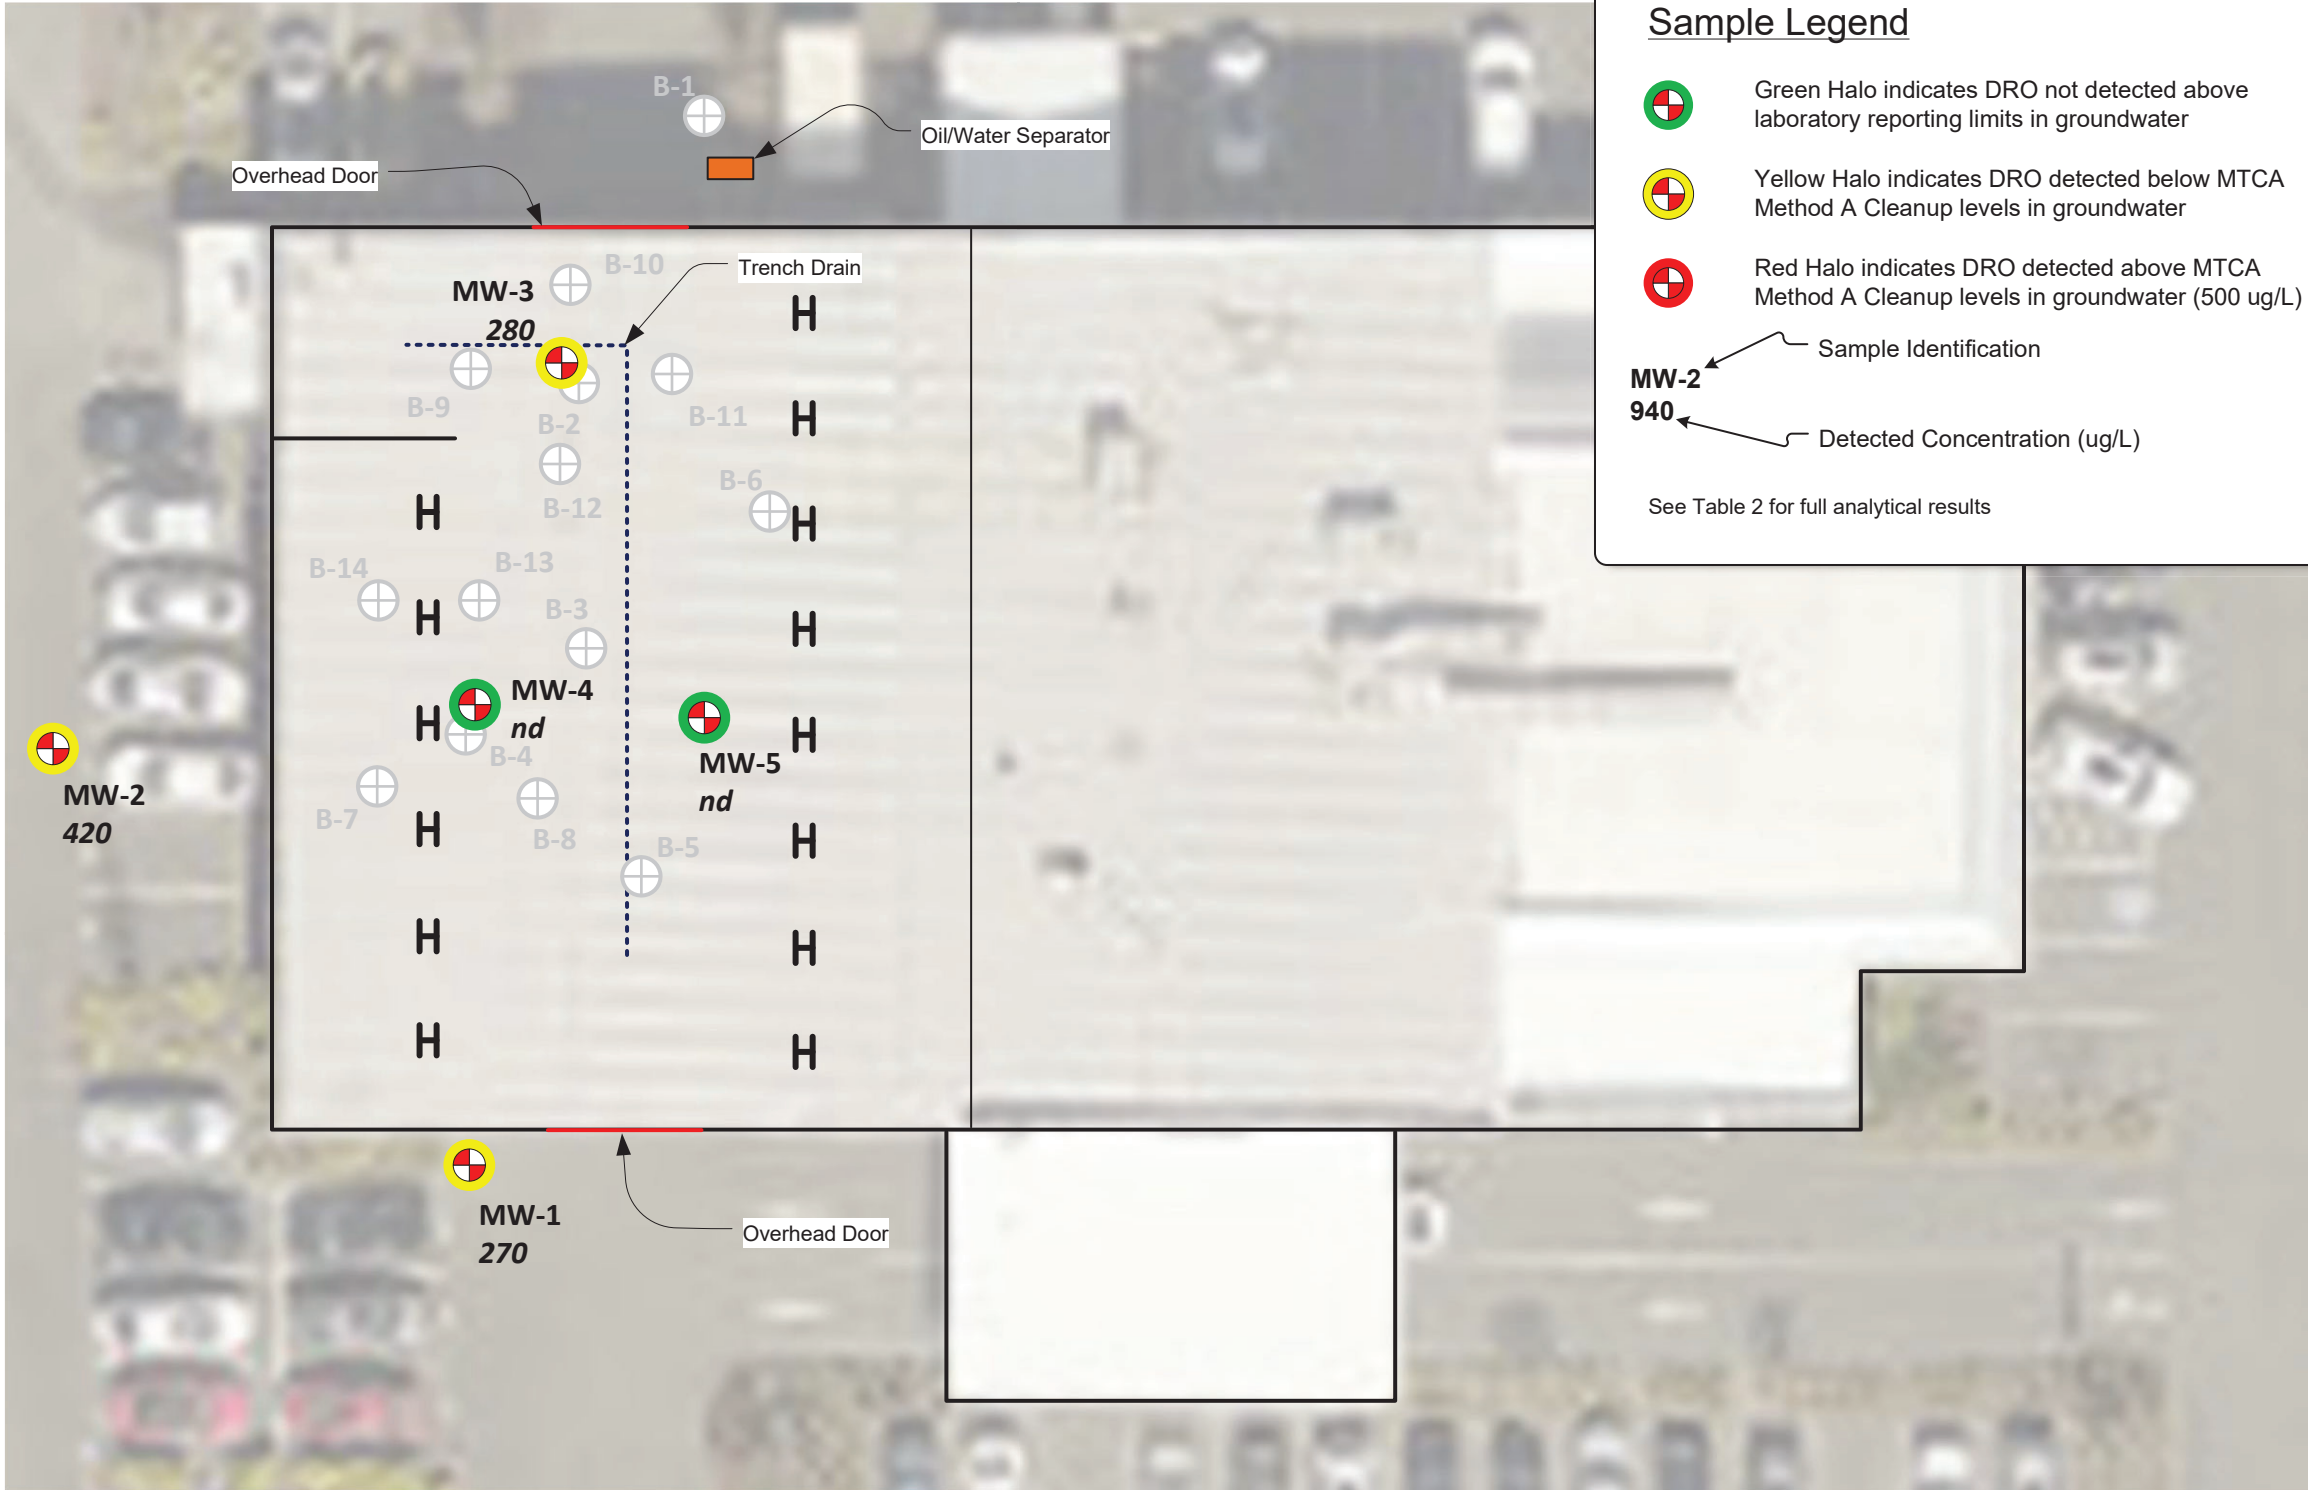
Figure
3c

Red Halo indicates DRO detected above MTCA Method A Cleanup levels in groundwater (500 ug/L)

DRO Concentrations in Groundwater
(January 10, 2023)

A supplemental groundwater sampling event was conducted in January 2023. Petroleum hydrocarbons either did not exceed groundwater cleanup levels, or were not detected at laboratory reporting limits. Arsenic concentrations were similar to previous detections, and dissolved and total arsenic concentrations were similar.

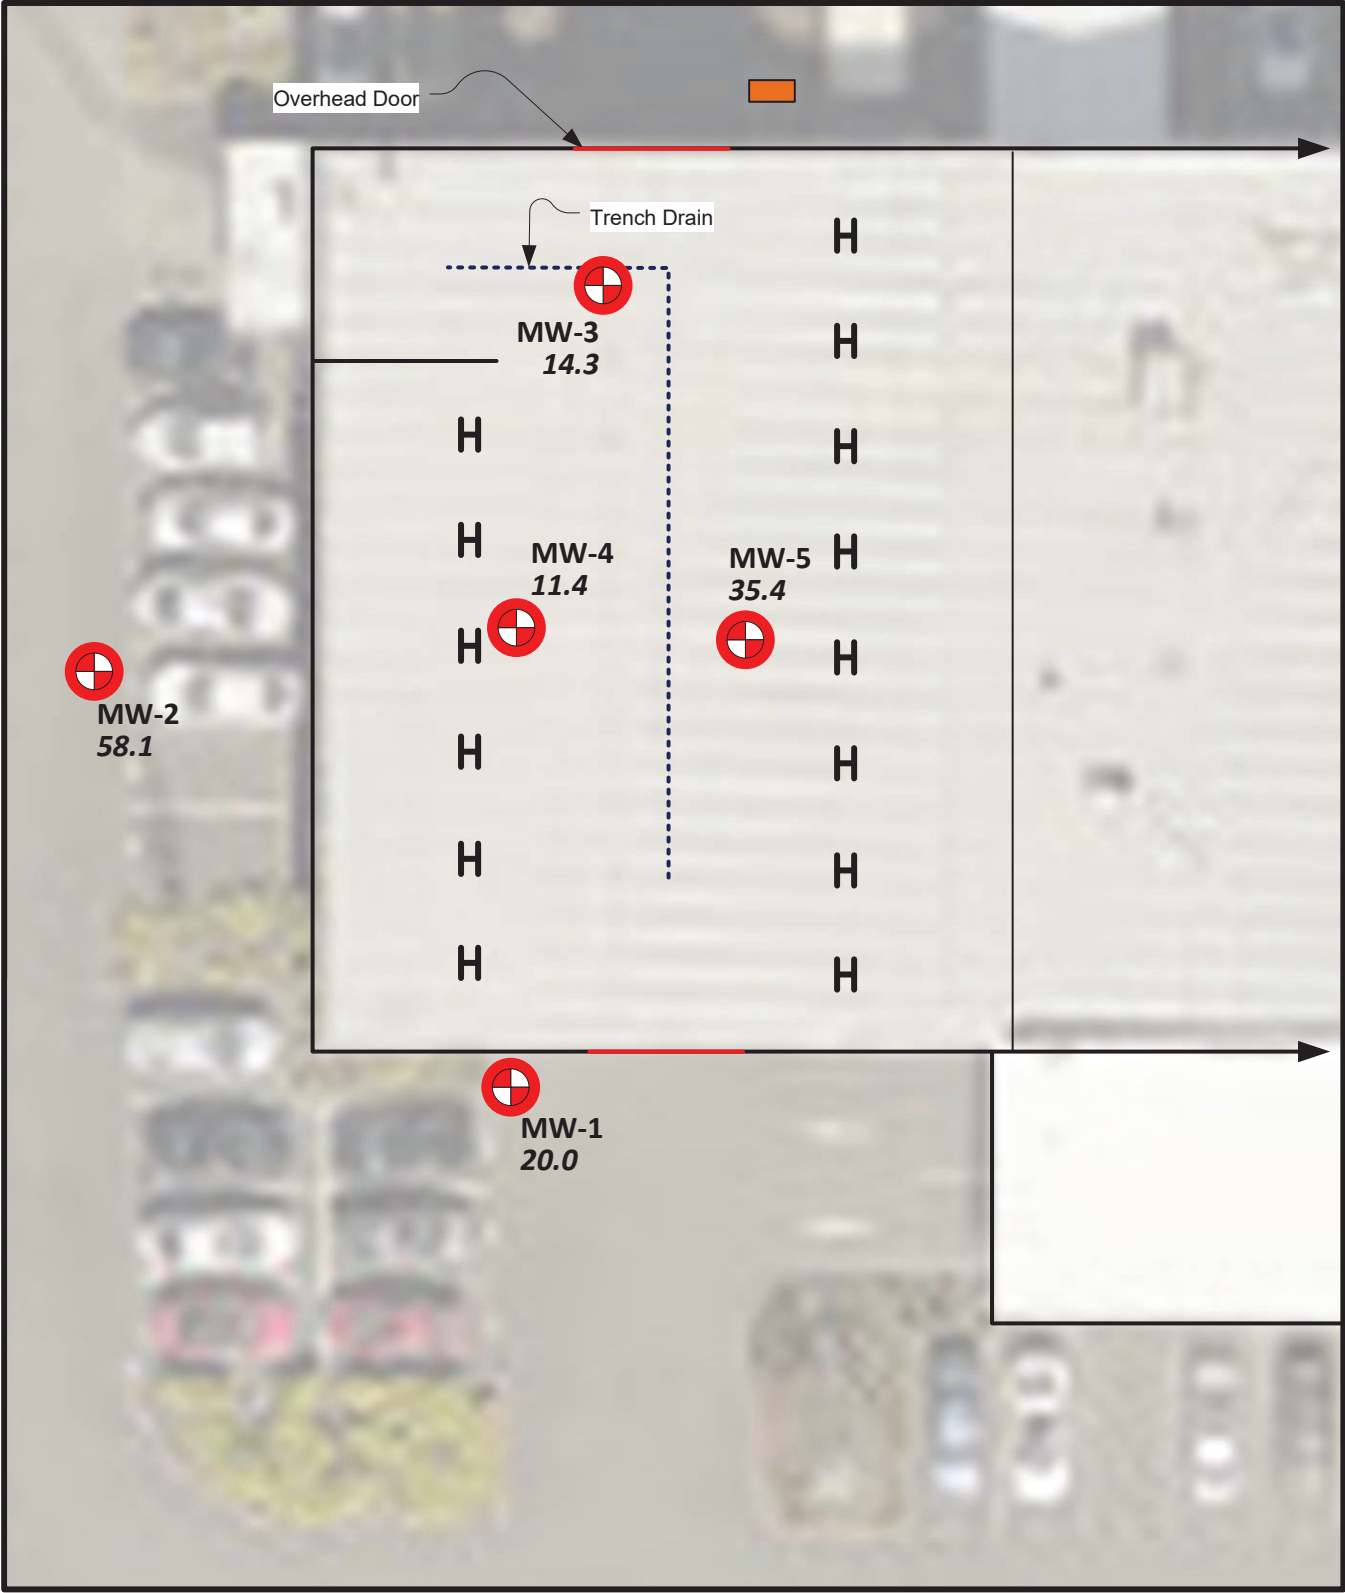
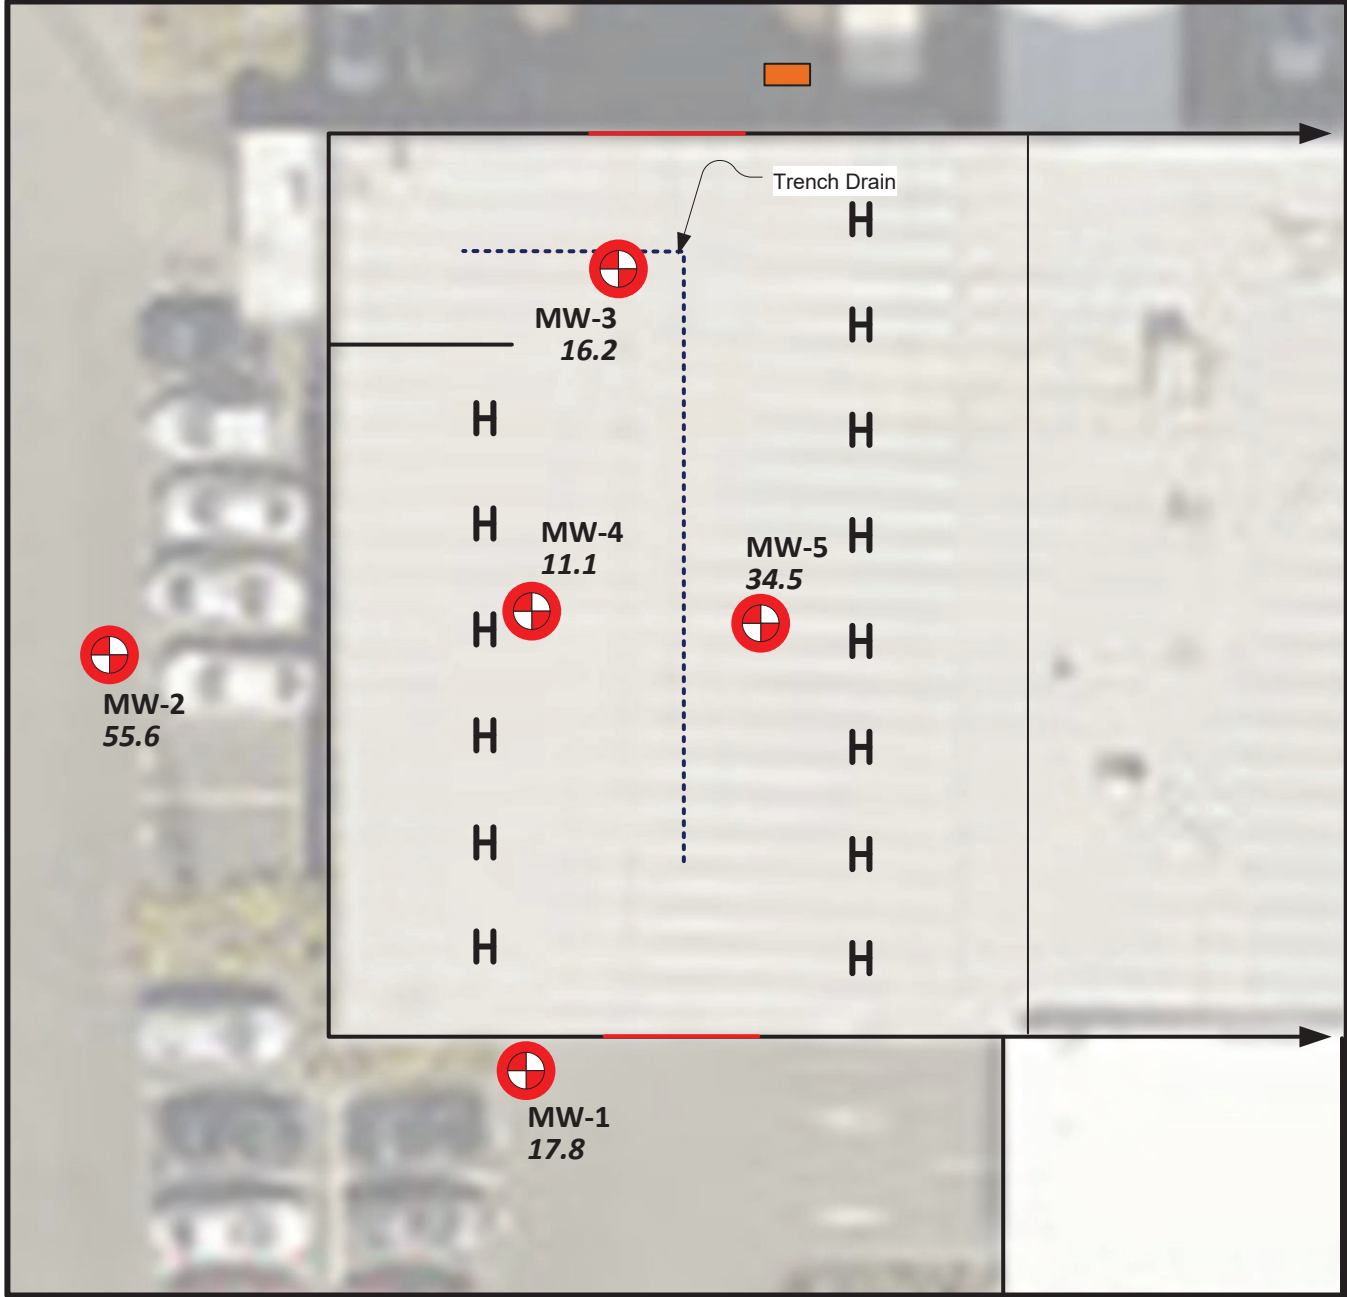
Figure
4b

Total Arsenic

Dissolved Arsenic

Red Halo indicates total/dissolved arsenic detected above MTCA Method A Cleanup levels in groundwater (5 ug/L)

Total and Dissolved Arsenic Concentrations
in Groundwater (July 26, 2022)

Elevated arsenic detected in soil and groundwater was evaluated with respect to published background arsenic studies and prior remedial actions at the Site parcel (CSID 12228). Elevated arsenic had been detected in native soils at the Site, indicating non-anthropogenic sources.

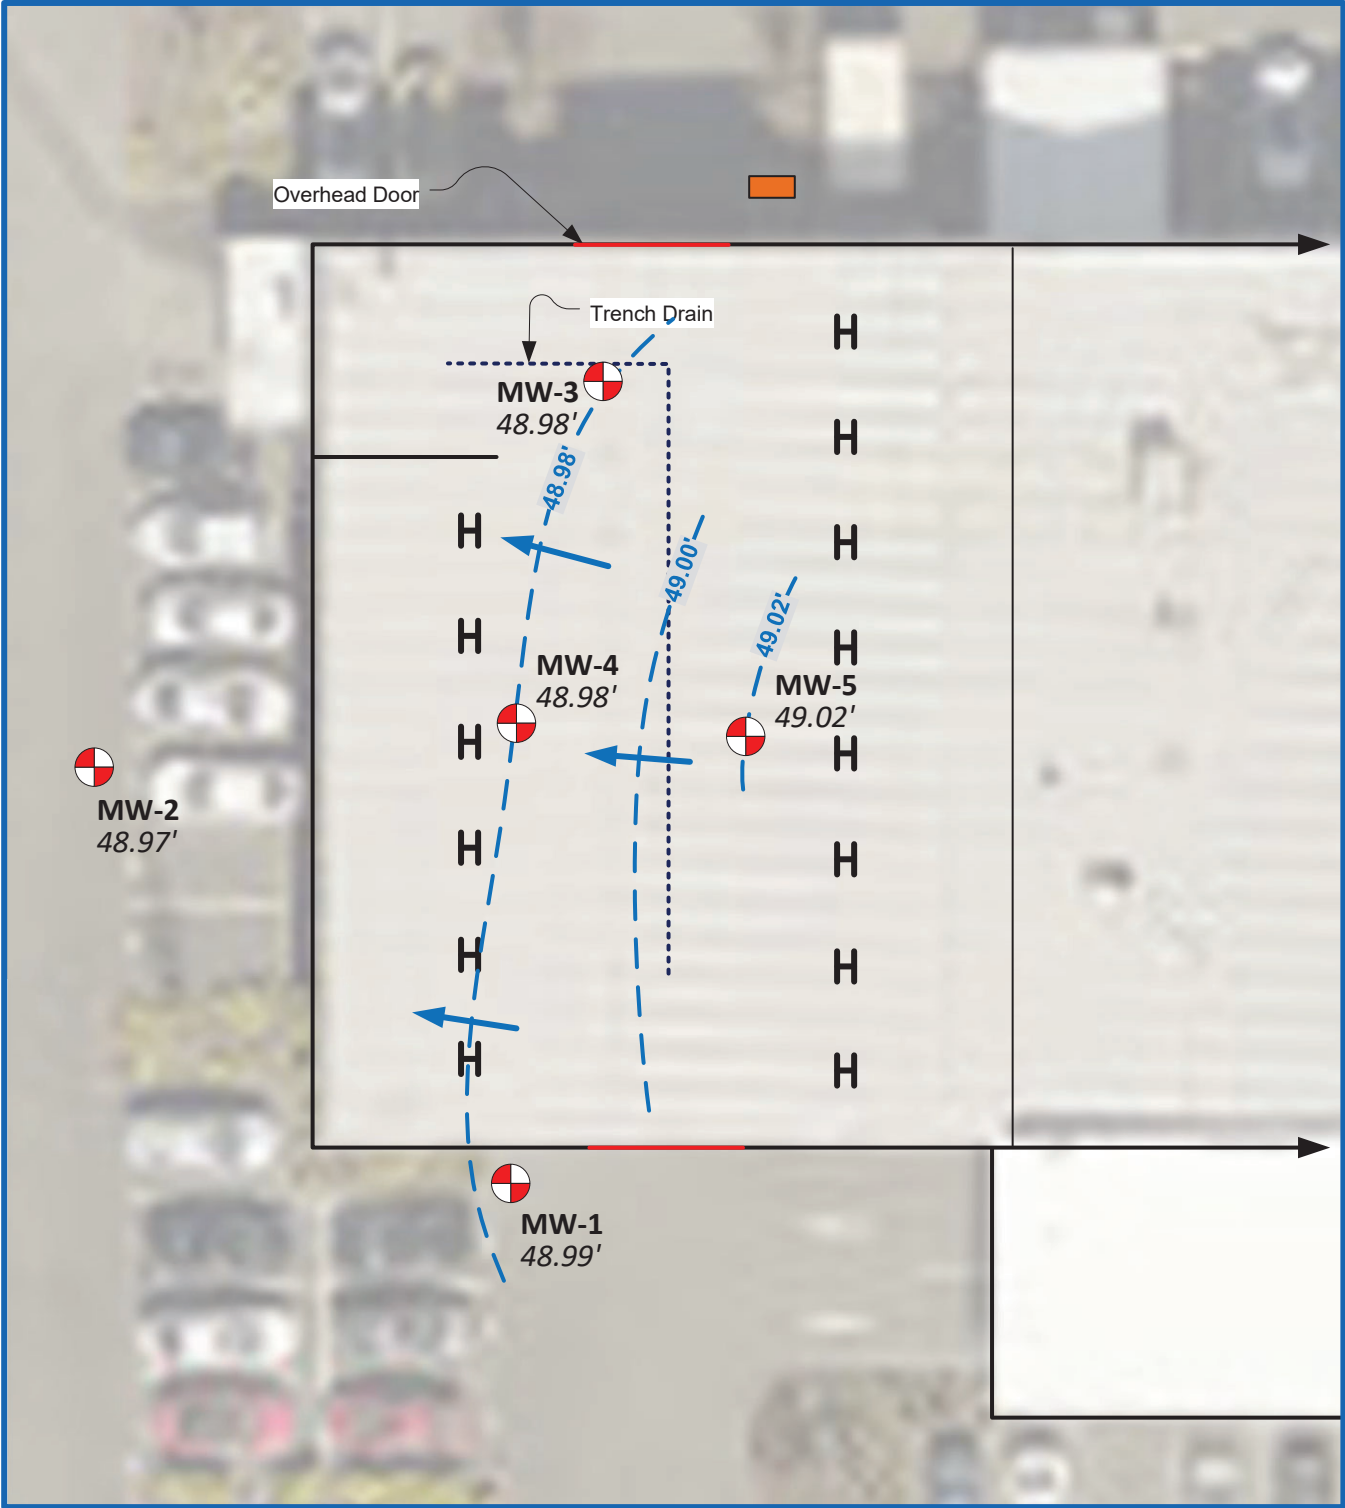
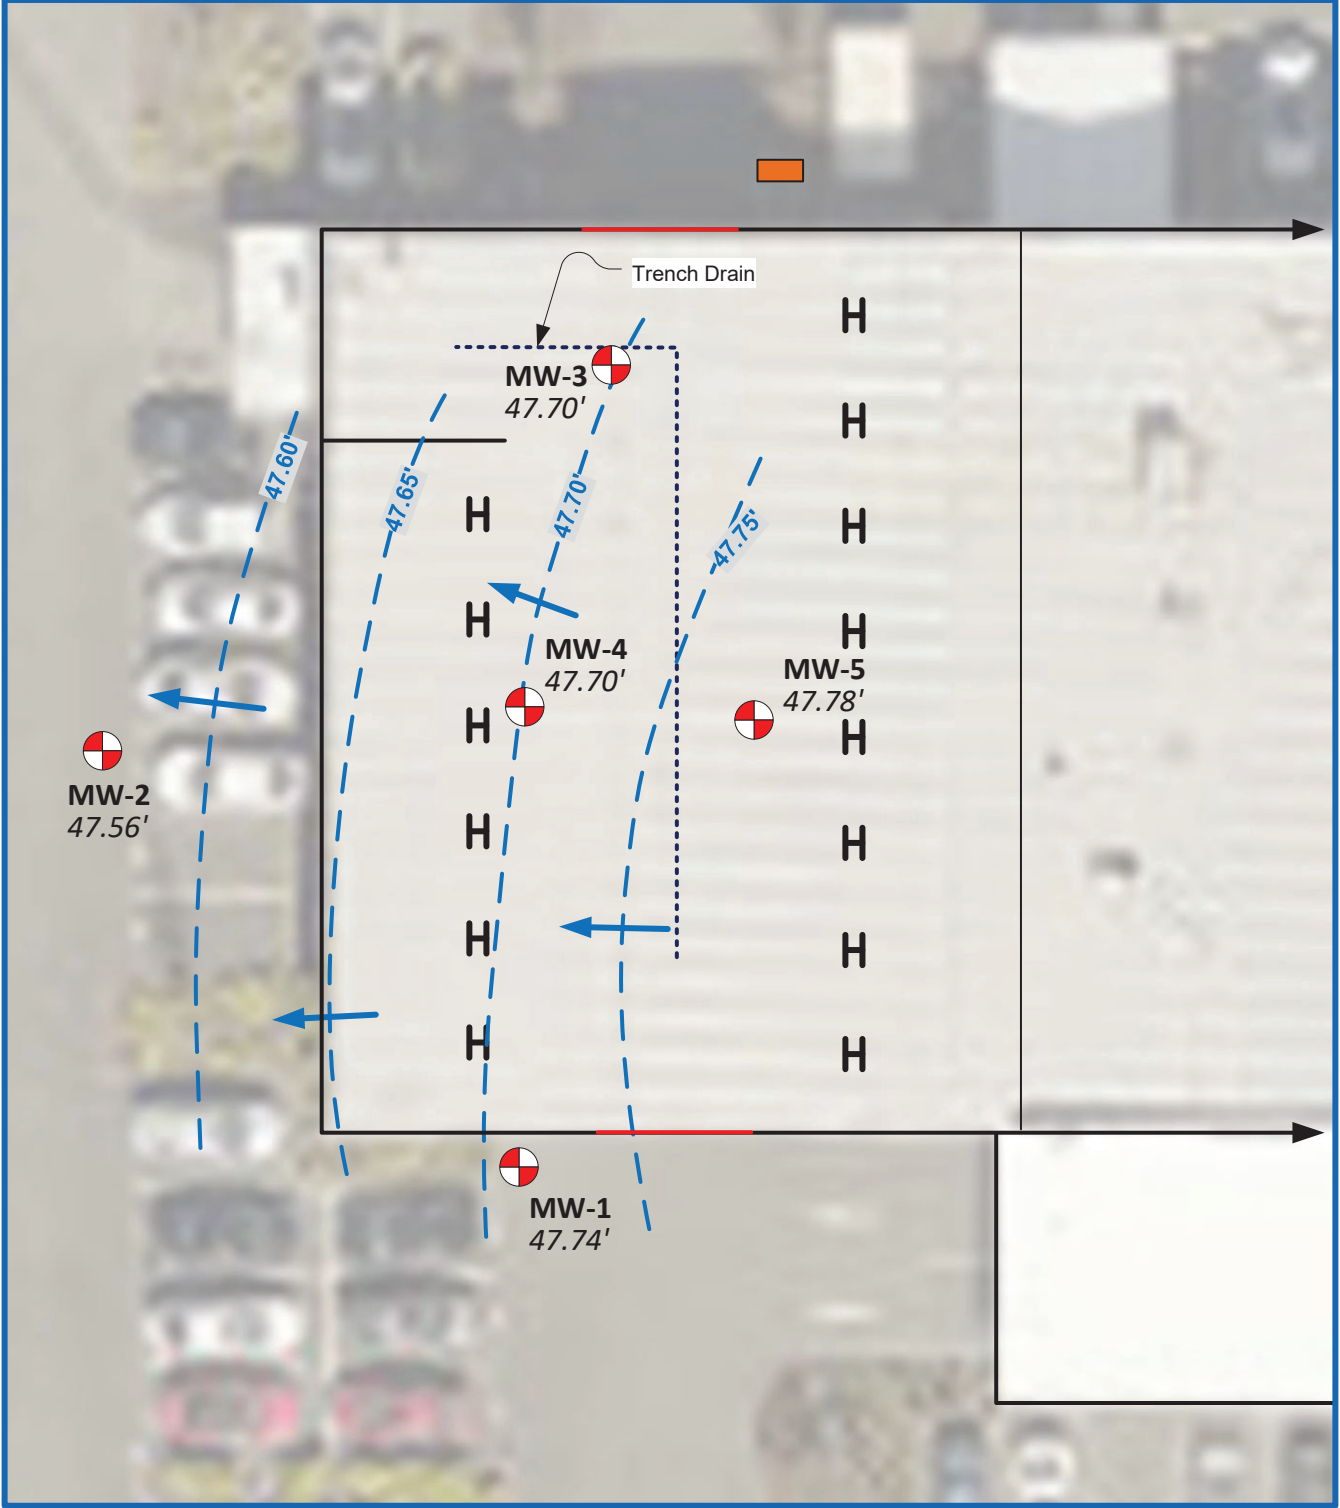
Figure
5a

May 26, 2022

July 26, 2022

The contours represent an interpretation of available data, for the indicated date. Site groundwater contours may change with additional measurements and/or data points, weather changes, construction activities, and/or other influences.

Groundwater Elevations & Interpreted Gradient, May 2022 & July 2022

Groundwater was measured at approximately 7.5 to 10 feet below ground surface over three sampling events between May and August 2022, demonstrating seasonal elevation changes. Groundwater flow direction was consistently to the west and north.
