INITIAL INVESTIGATION FIELD REPORT

<u>Site Name (Name over door):</u> Auburn VW	<u>Site Address (including City, State and Zip):</u> 3109 Auburn Way N Auburn, WA 98002	<u>Phone</u> <u>Email</u>
<u>Site Contact, Title, Business:</u> Dan Hatch Bluestone Environmental, NW	<u>Site Contact Address (including City, State and Zip):</u>	<u>Phone</u> <u>Email</u> danh@bluestonenw.com
<u>Site Owner, Title, Business:</u> Bryce Clary Clary Auburn RE, LLC	<u>Site Owner Address (including City, State and Zip):</u> P.O. Box 127 Longview, WA 98632	<u>Phone</u> (360) 423-1700 <u>Email</u> bryce.clary@budclary.com
<u>Site Owner Contact, Title, Business:</u>	<u>Site Owner Contact Address (including City, State and Zip):</u>	<u>Phone</u> <u>Email</u>
<u>Previous Site Owner(s):</u> Conducere Investments, LLC	<u>Additional Info (for any Site Information Item):</u> A previous release (CSID 12228, Auburn Way Properties) associated with this FSID is on the lot line between this parcel (0004000041 at 3109 Auburn Way N) and the south-adjacent parcel (0004000039 at 3025 Auburn Way N). PLIA issued an NFA on 5/6/19. This IIFR is for a separate release.

Site Diagram, Features, and Exploration Locations

Auburn

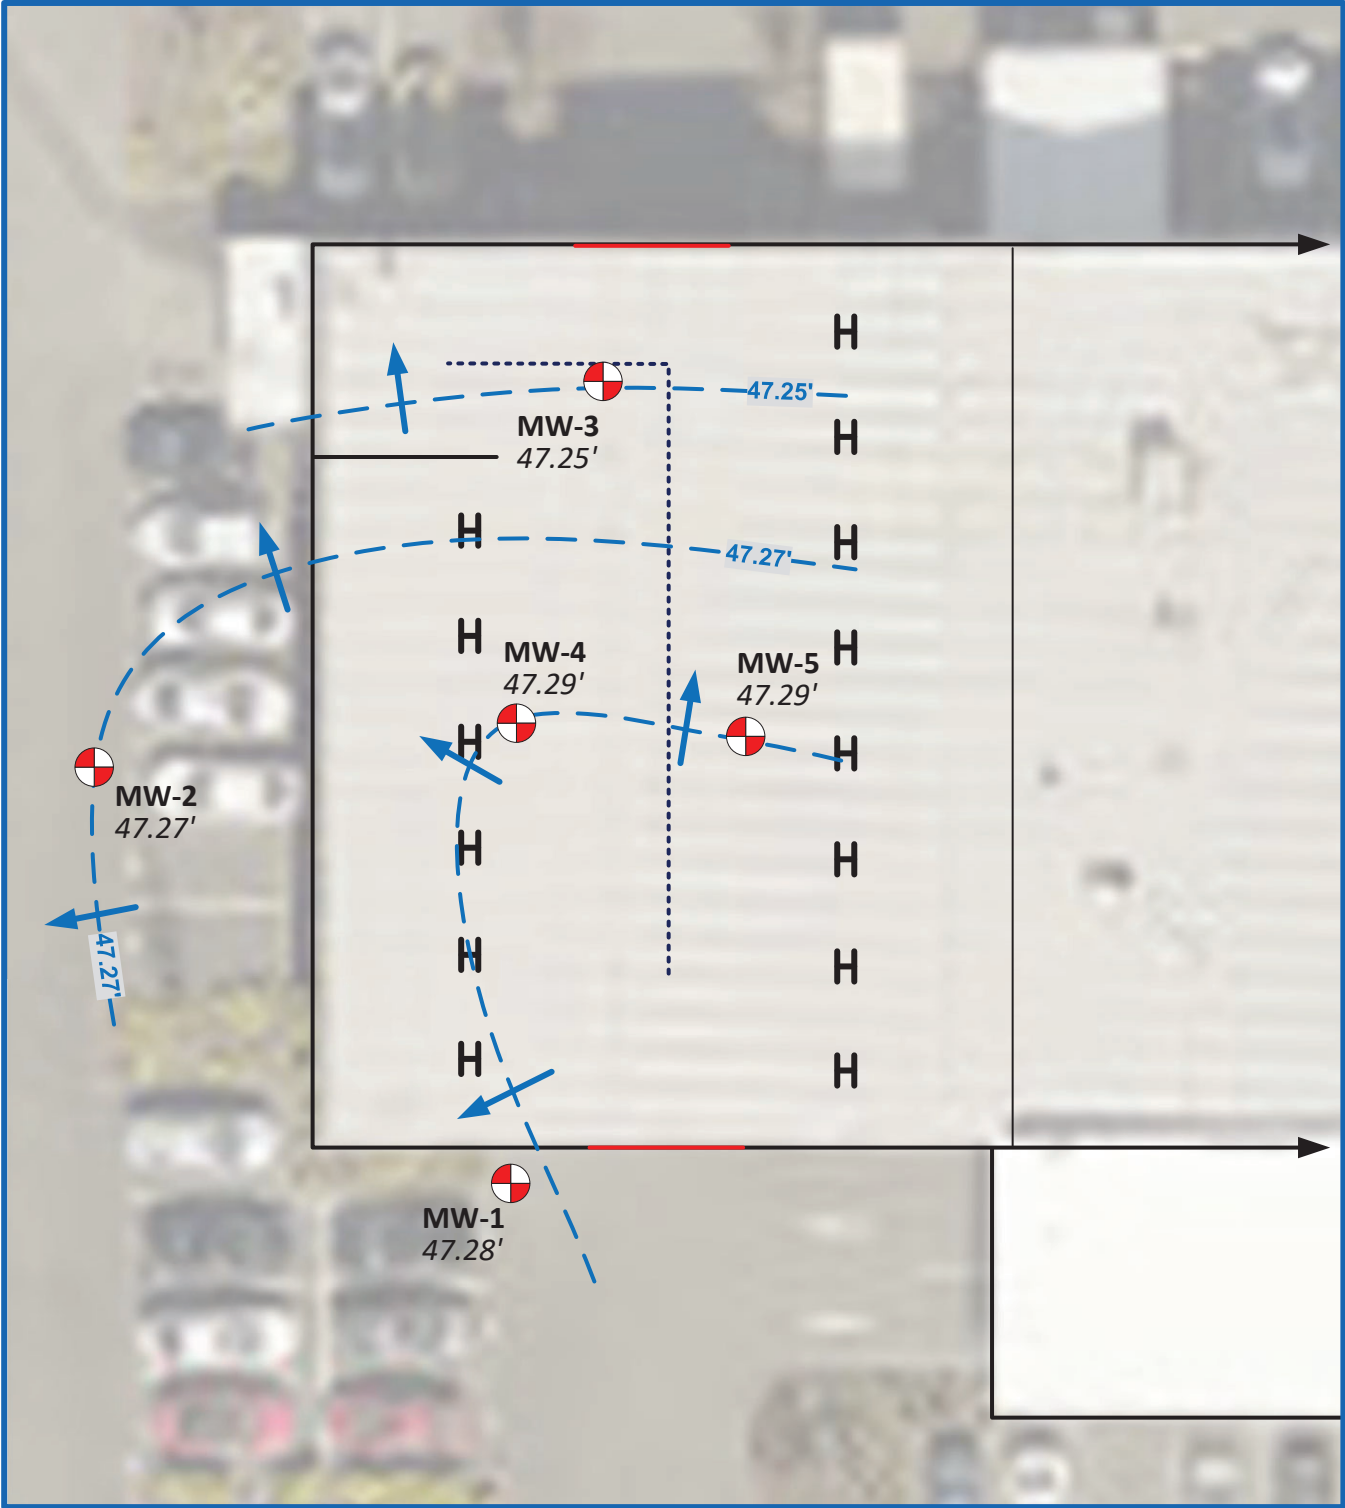
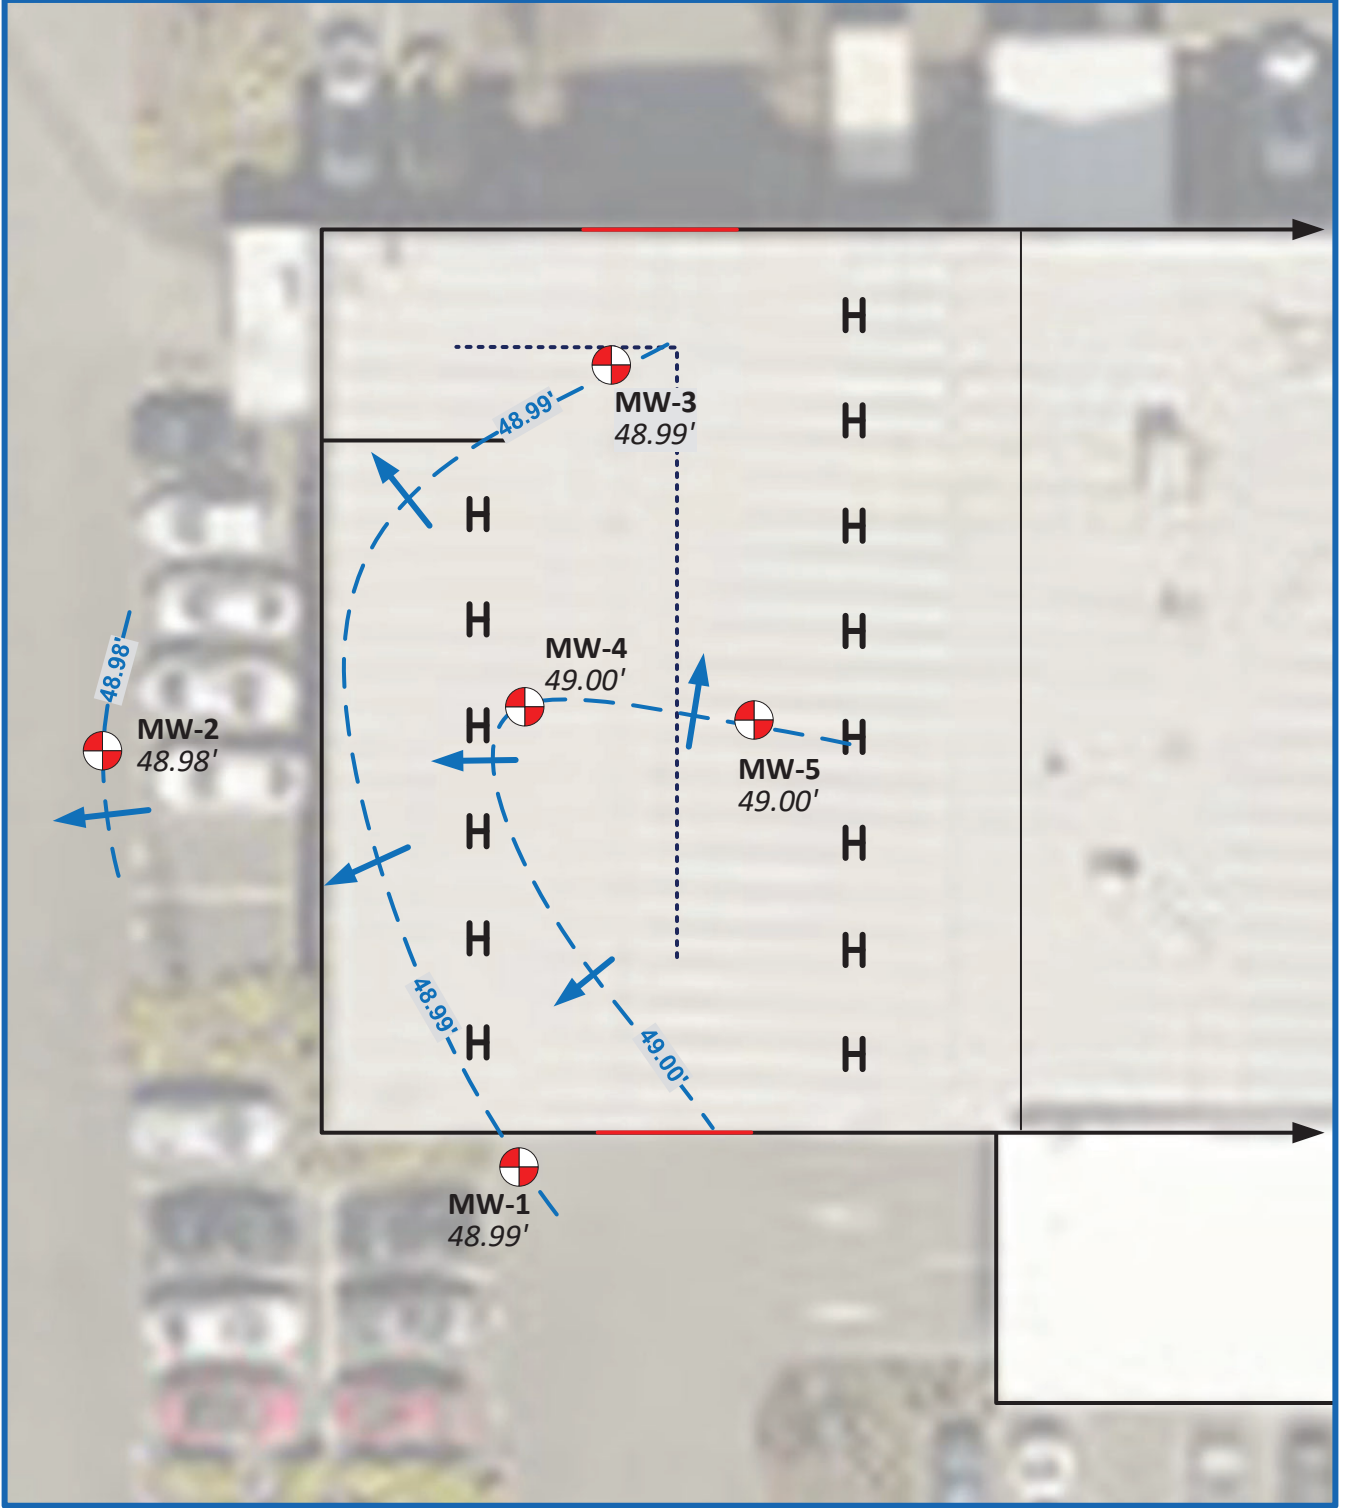
Figure 5b

August 11, 2022

January 10, 2023

The contours represent an interpretation of available data, for the indicated date. Site groundwater contours may change with additional measurements and/or data points, weather changes, construction activities, and/or other influences.

Groundwater Elevations & Interpreted Gradient, August 2022 & January 2023

Groundwater was measured at approximately 7.5 to 10 feet below ground surface over three sampling events between May and August 2022, demonstrating seasonal elevation changes. Groundwater flow direction was consistently to the west and north.
