Subject: Updated Groundwater Data, ERTS 719681
Auburn Volkswagen
Bluestone Project Number BE-0107-E
3109 Auburn Way N.
Auburn, WA 98002

Attachments January 10, 2023, Updated Tables and Figures

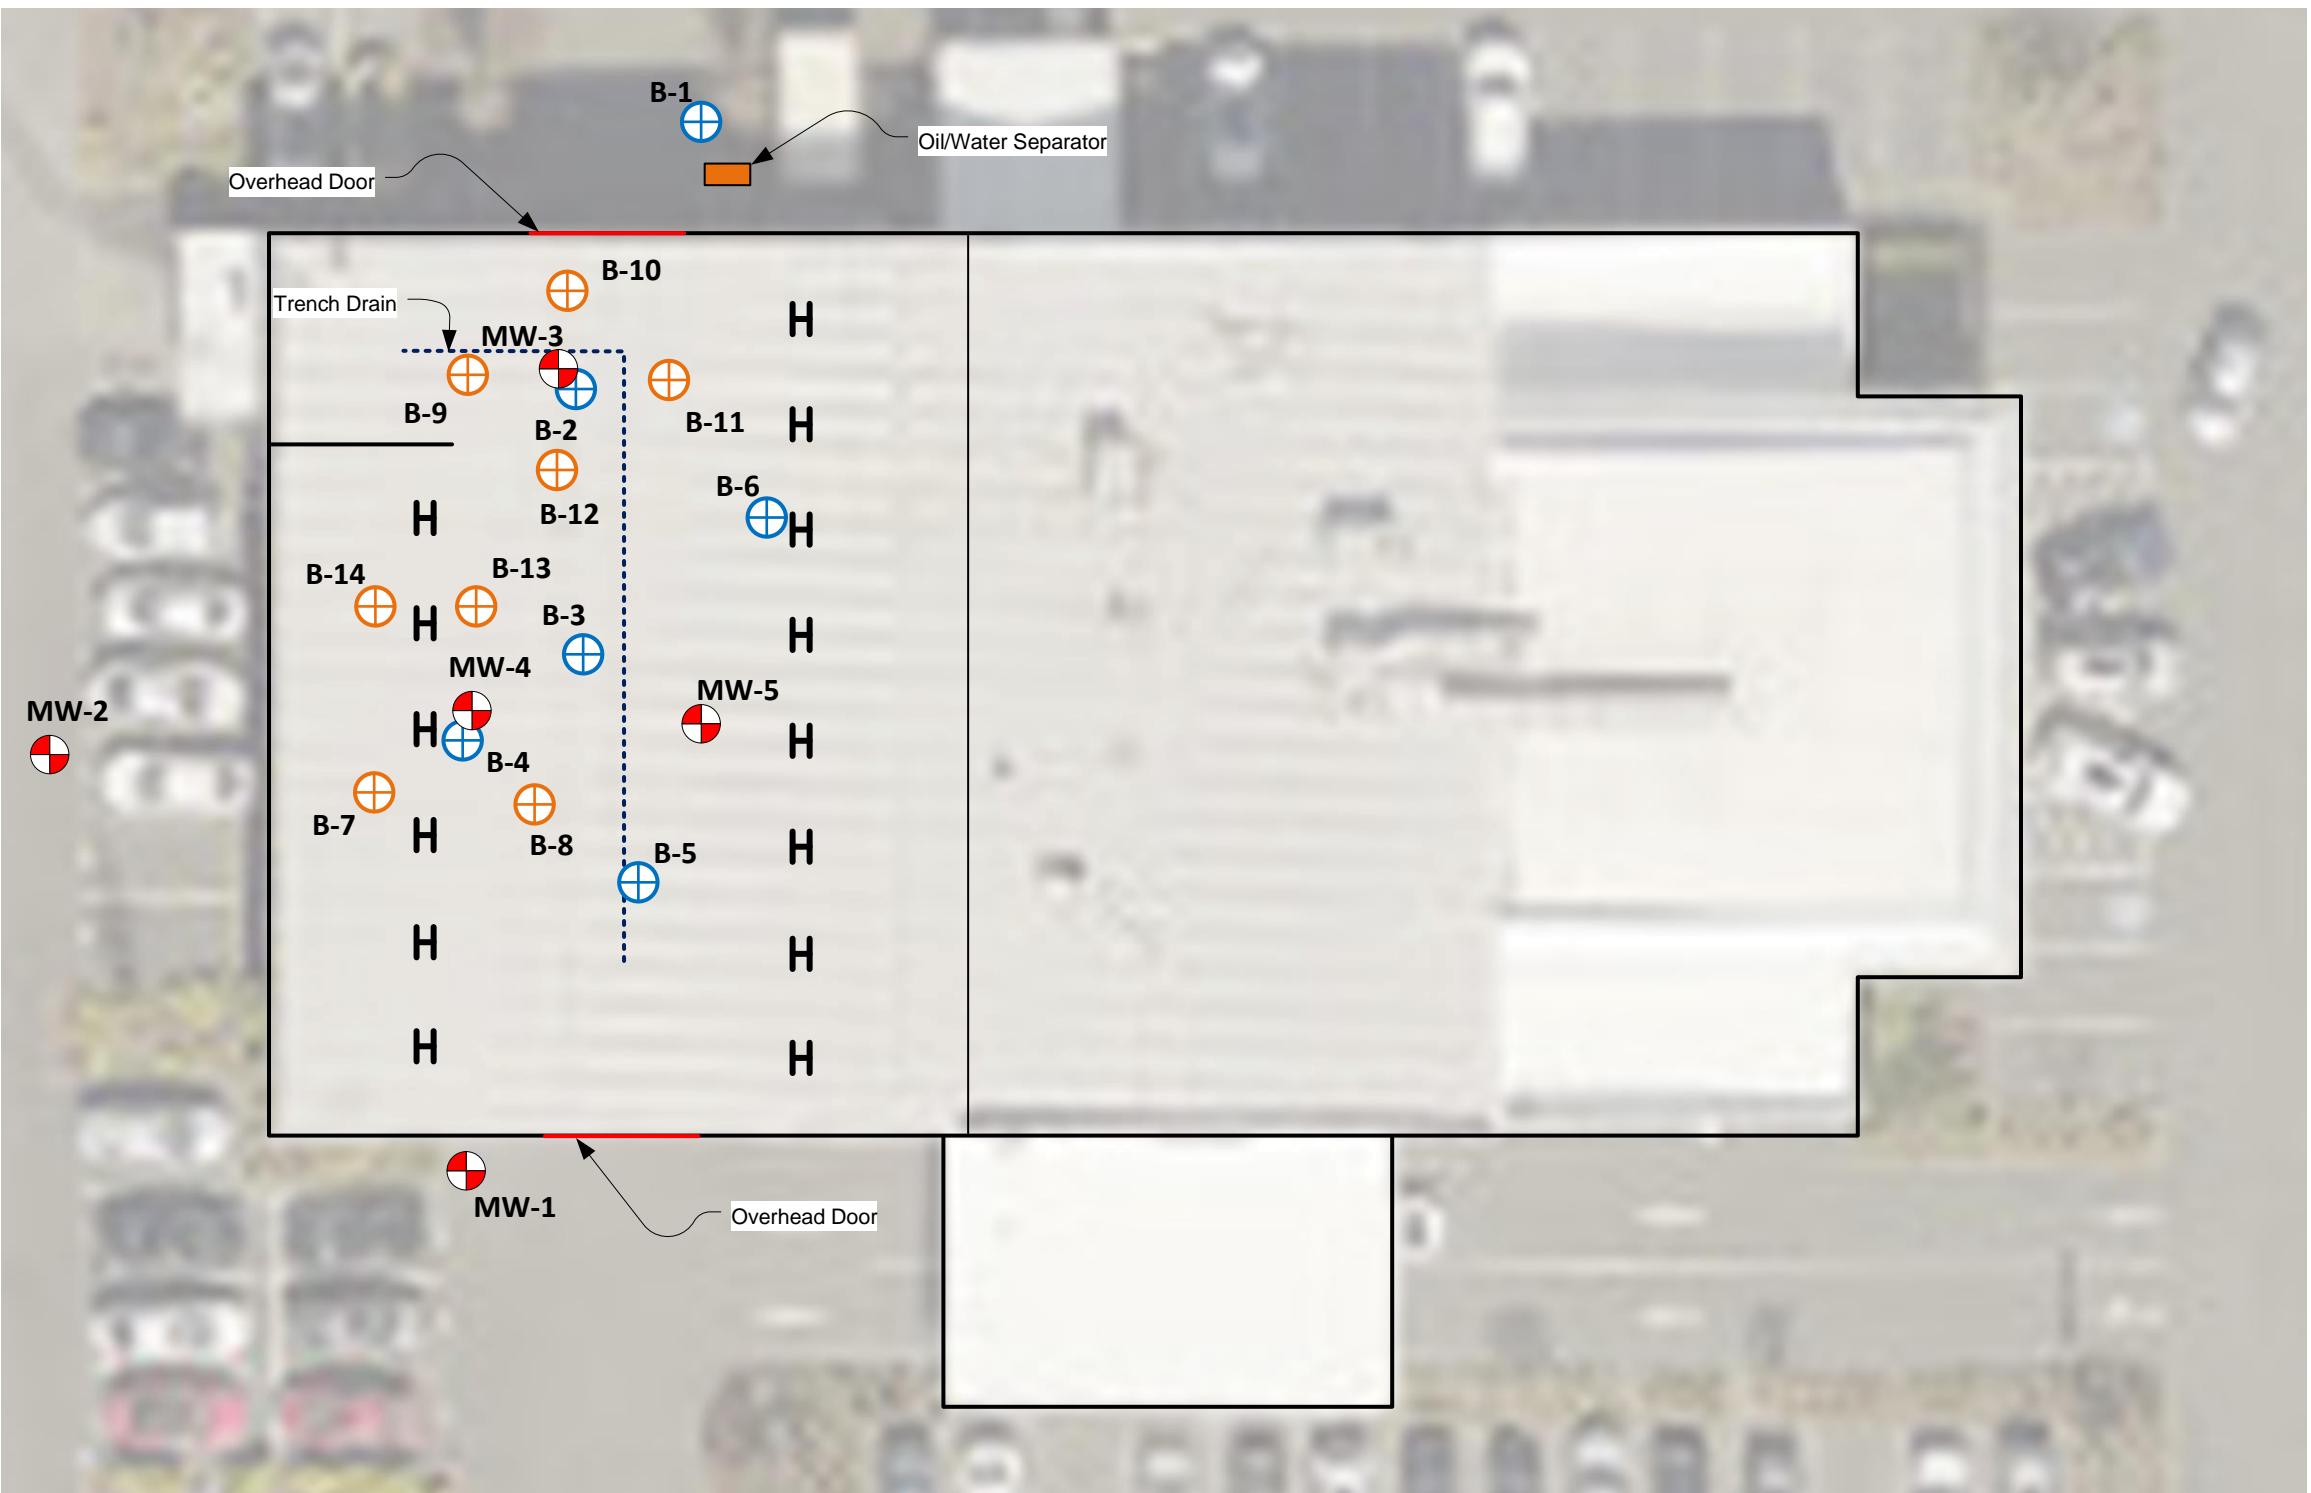
Figure 2

Site Diagram, Features, and Exploration Locations

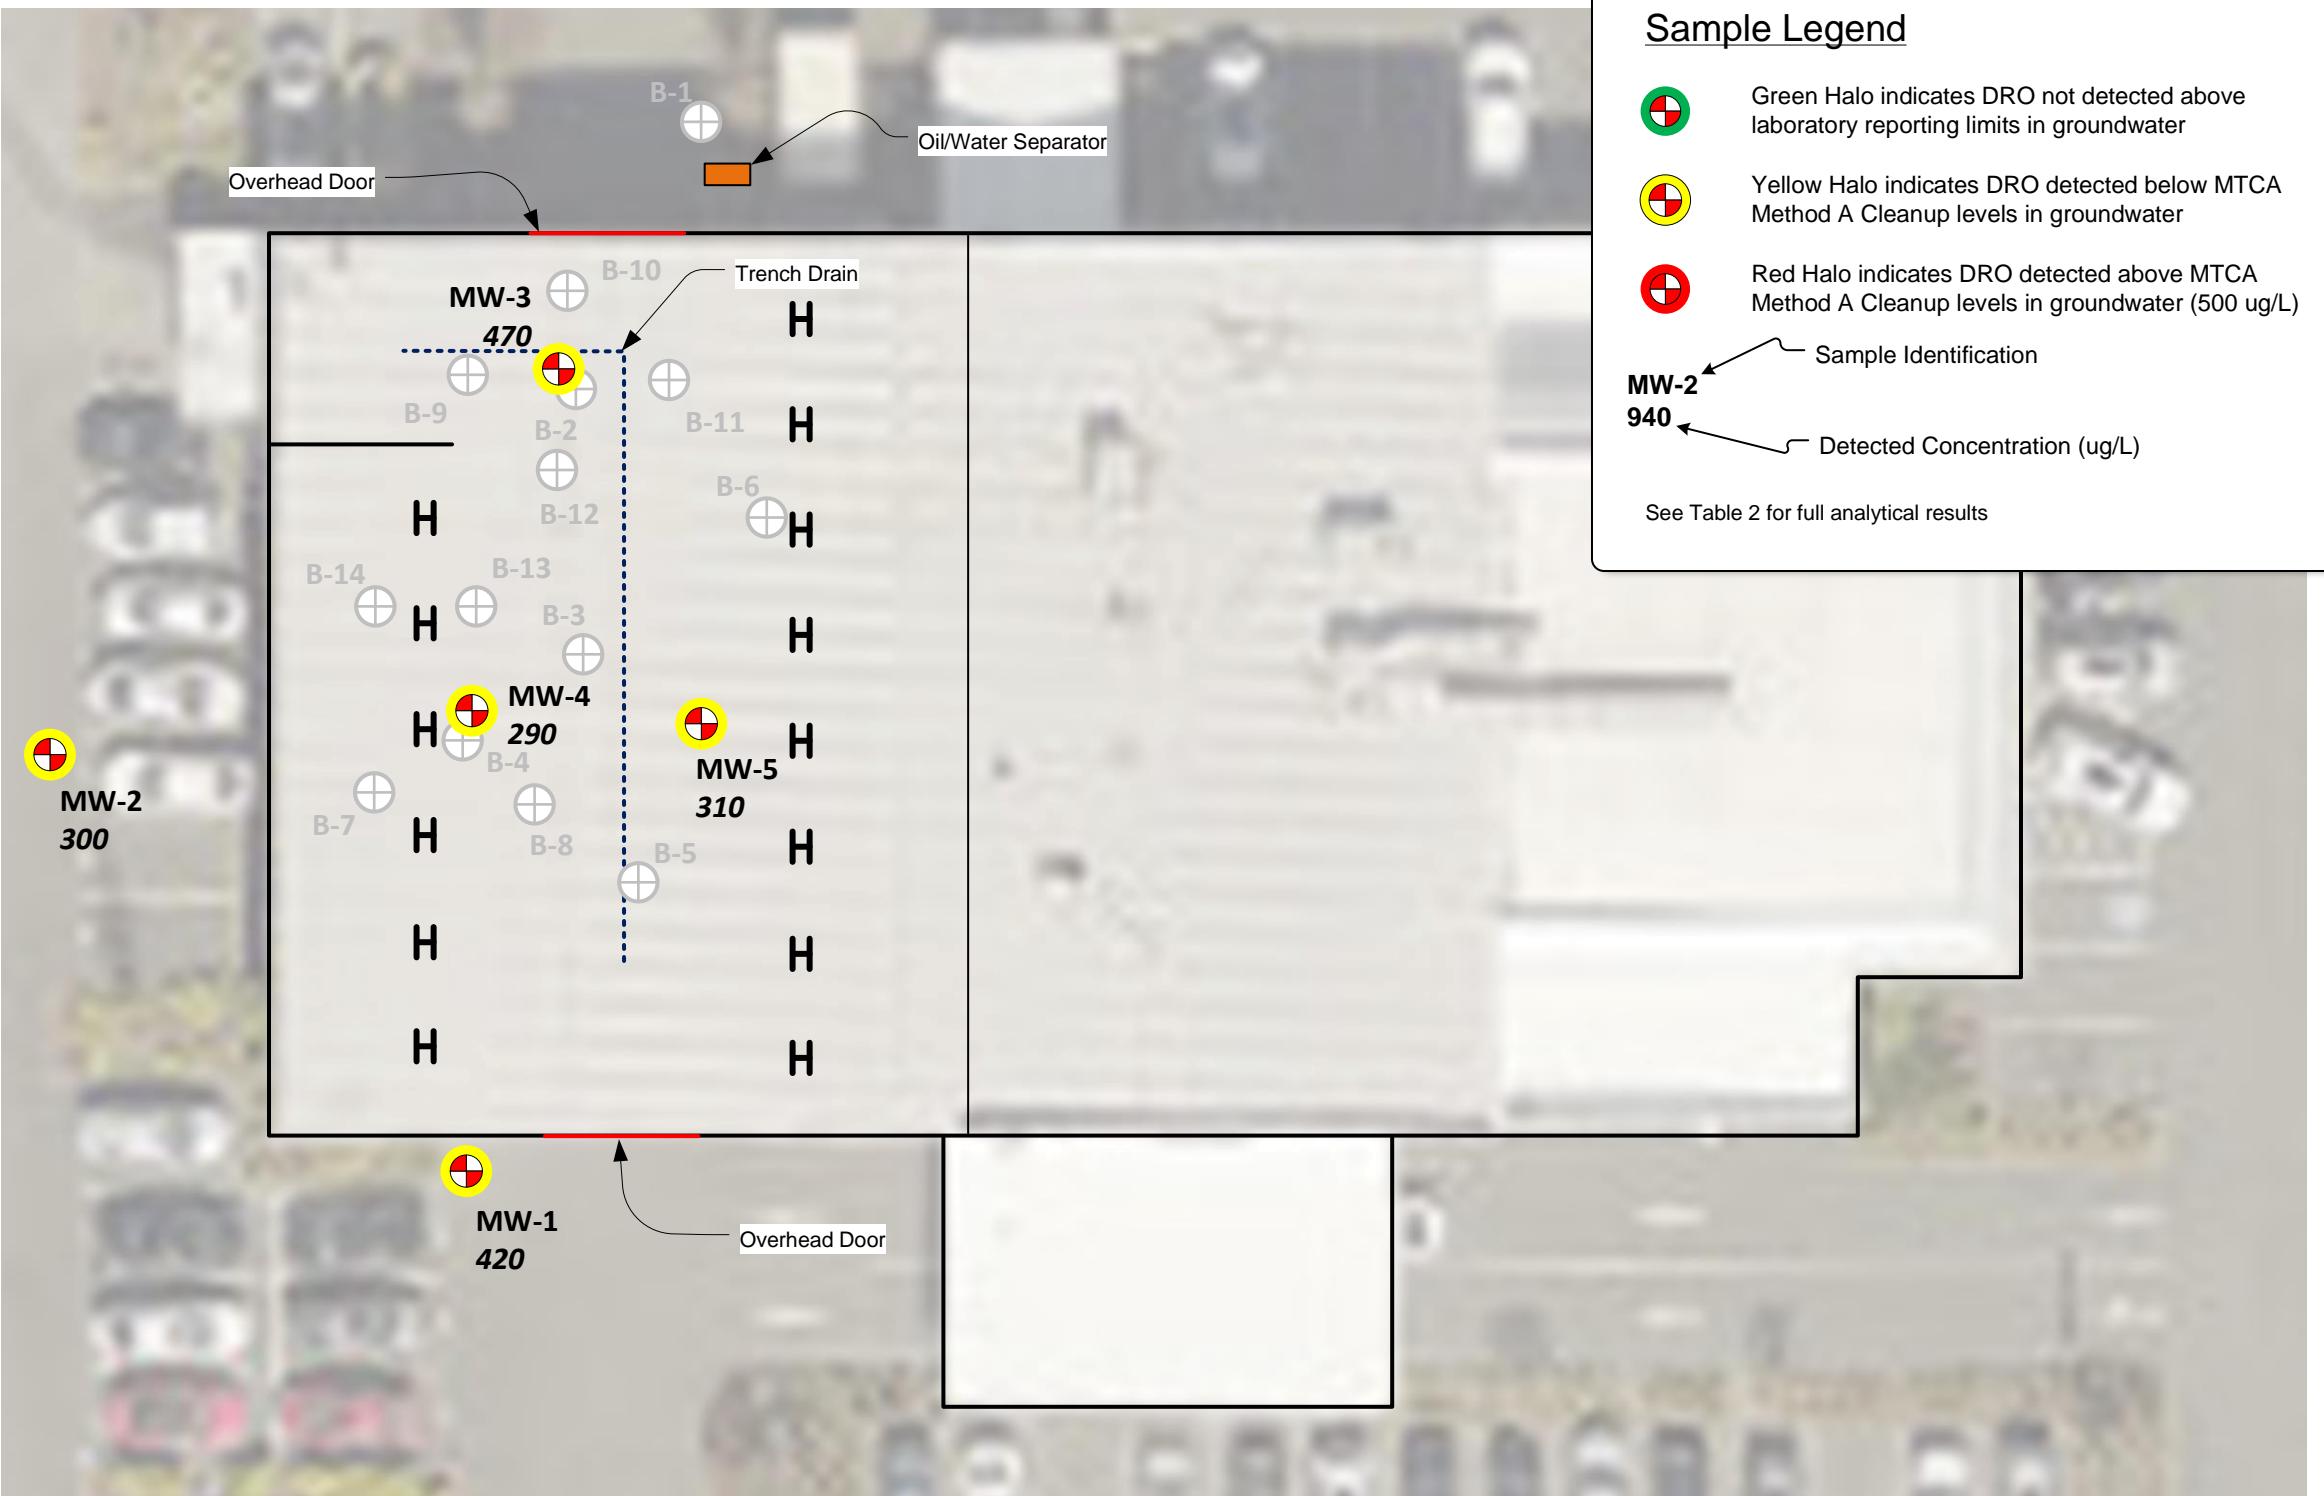
**Figure
3a**

DRO Concentrations in Groundwater
(May 26, 2022)

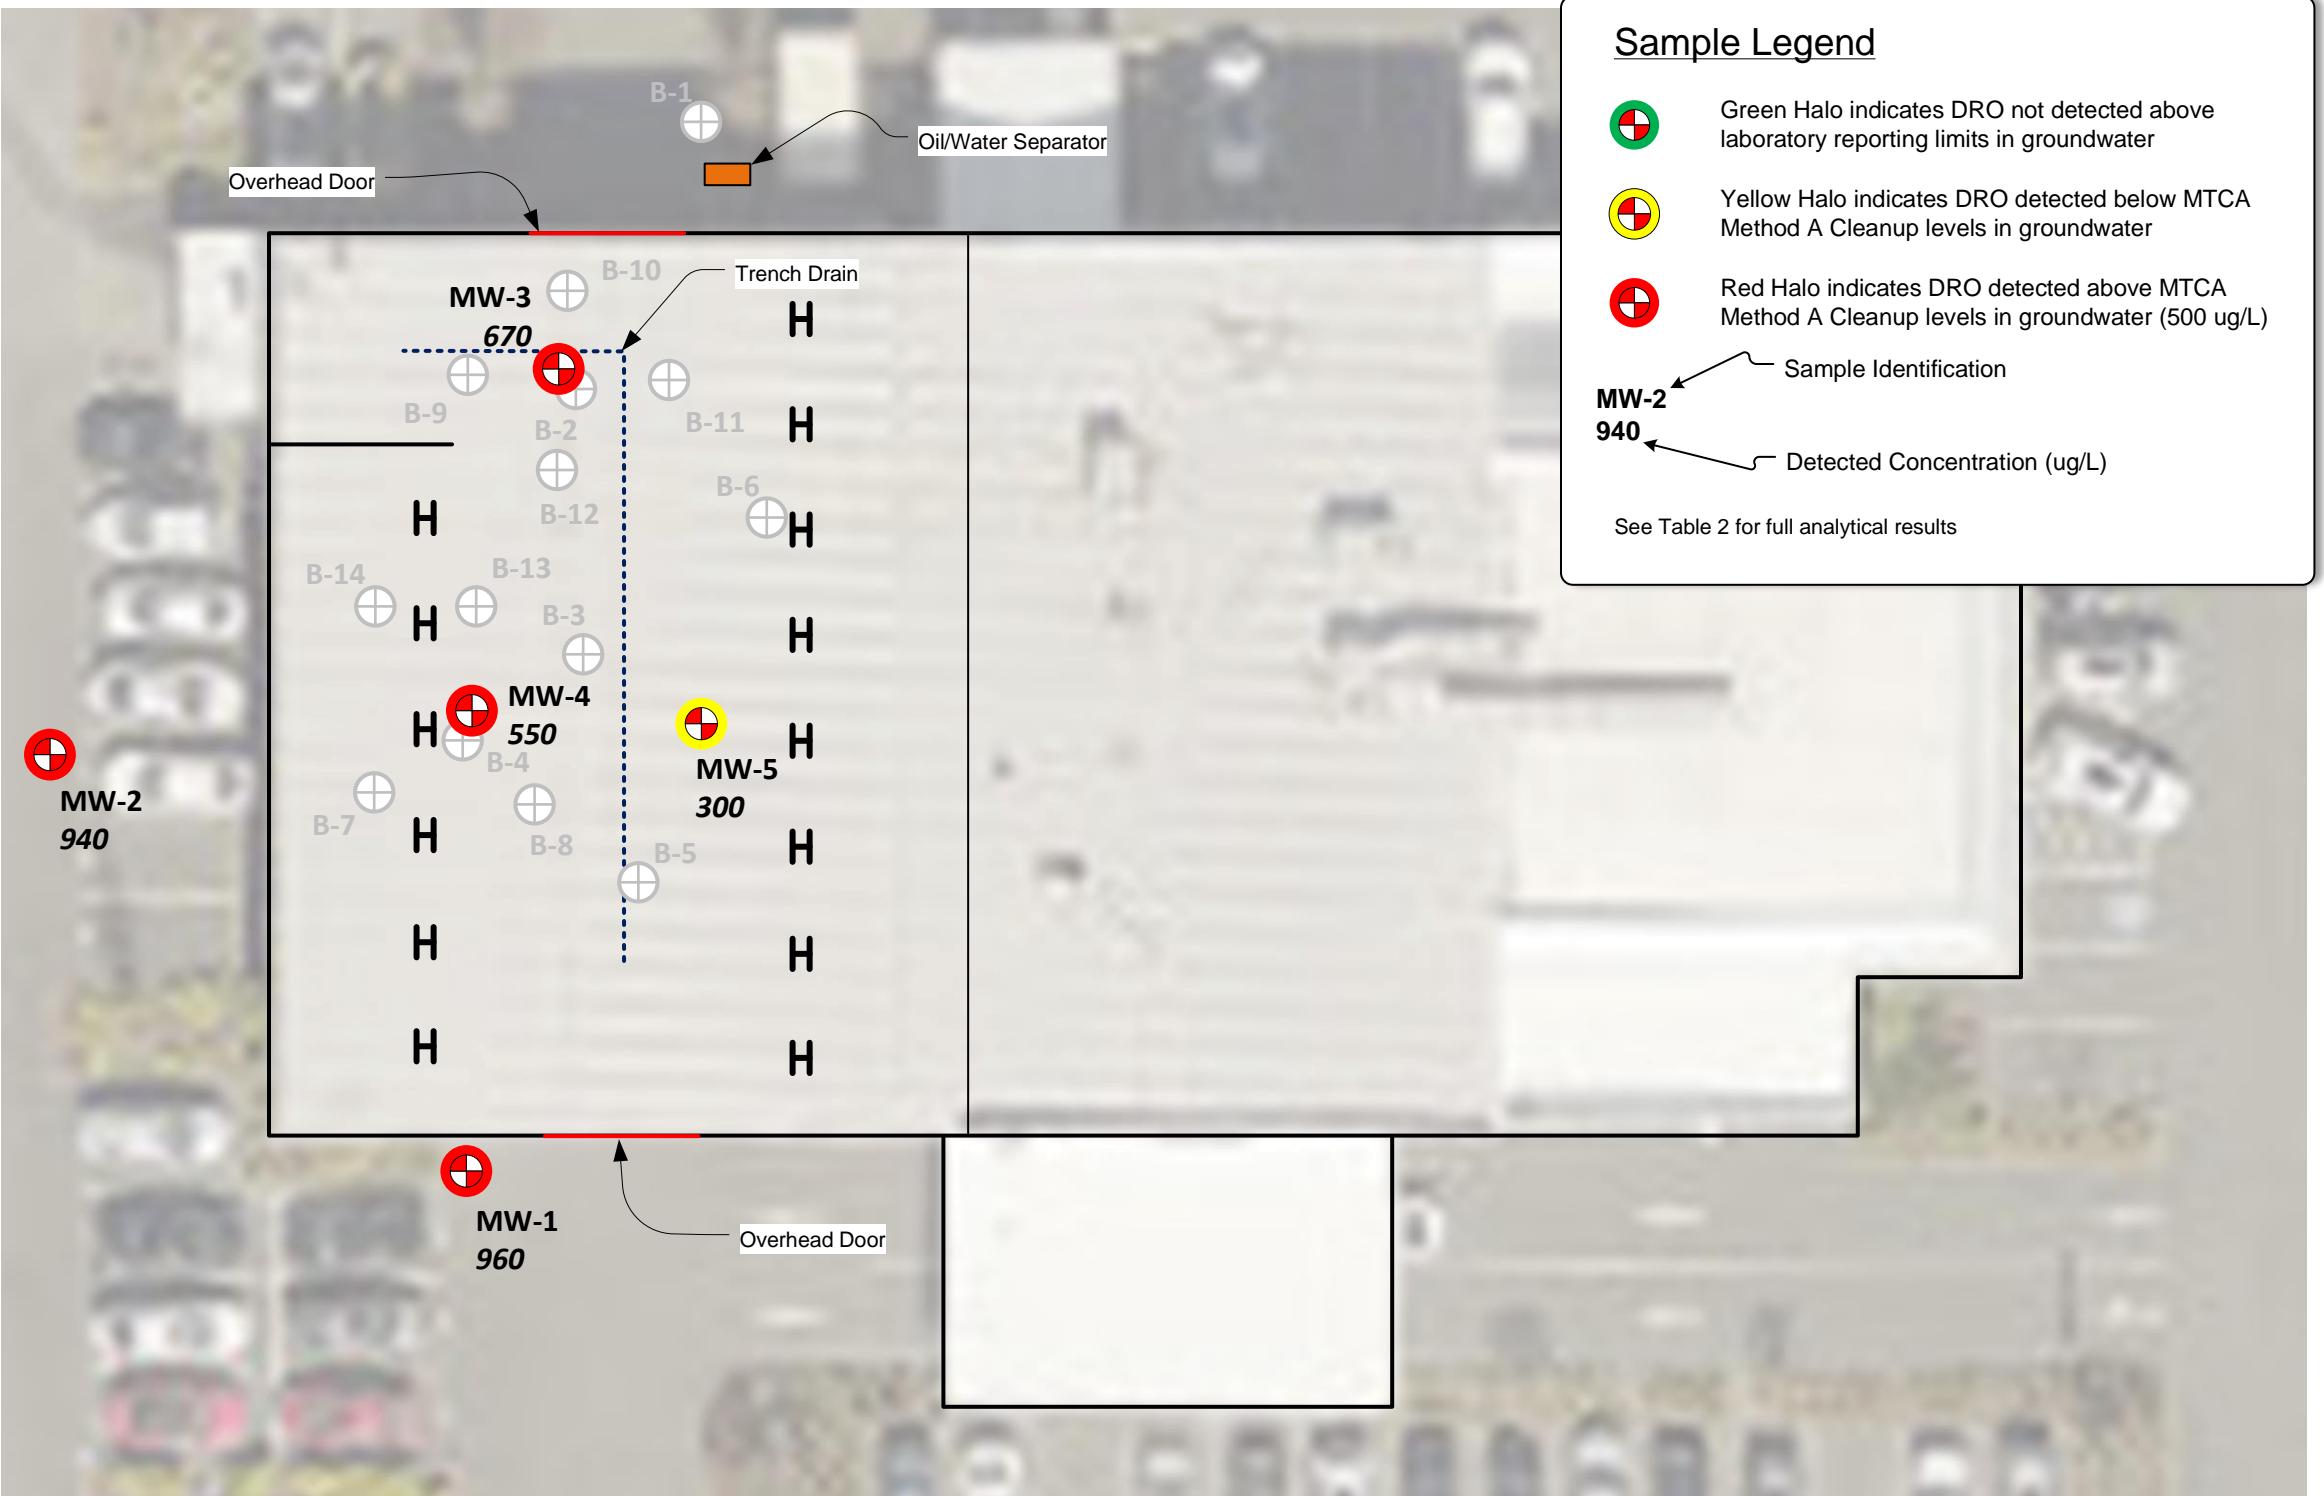
**Figure
3b**

DRO Concentrations in Groundwater
(July 26, 2022)

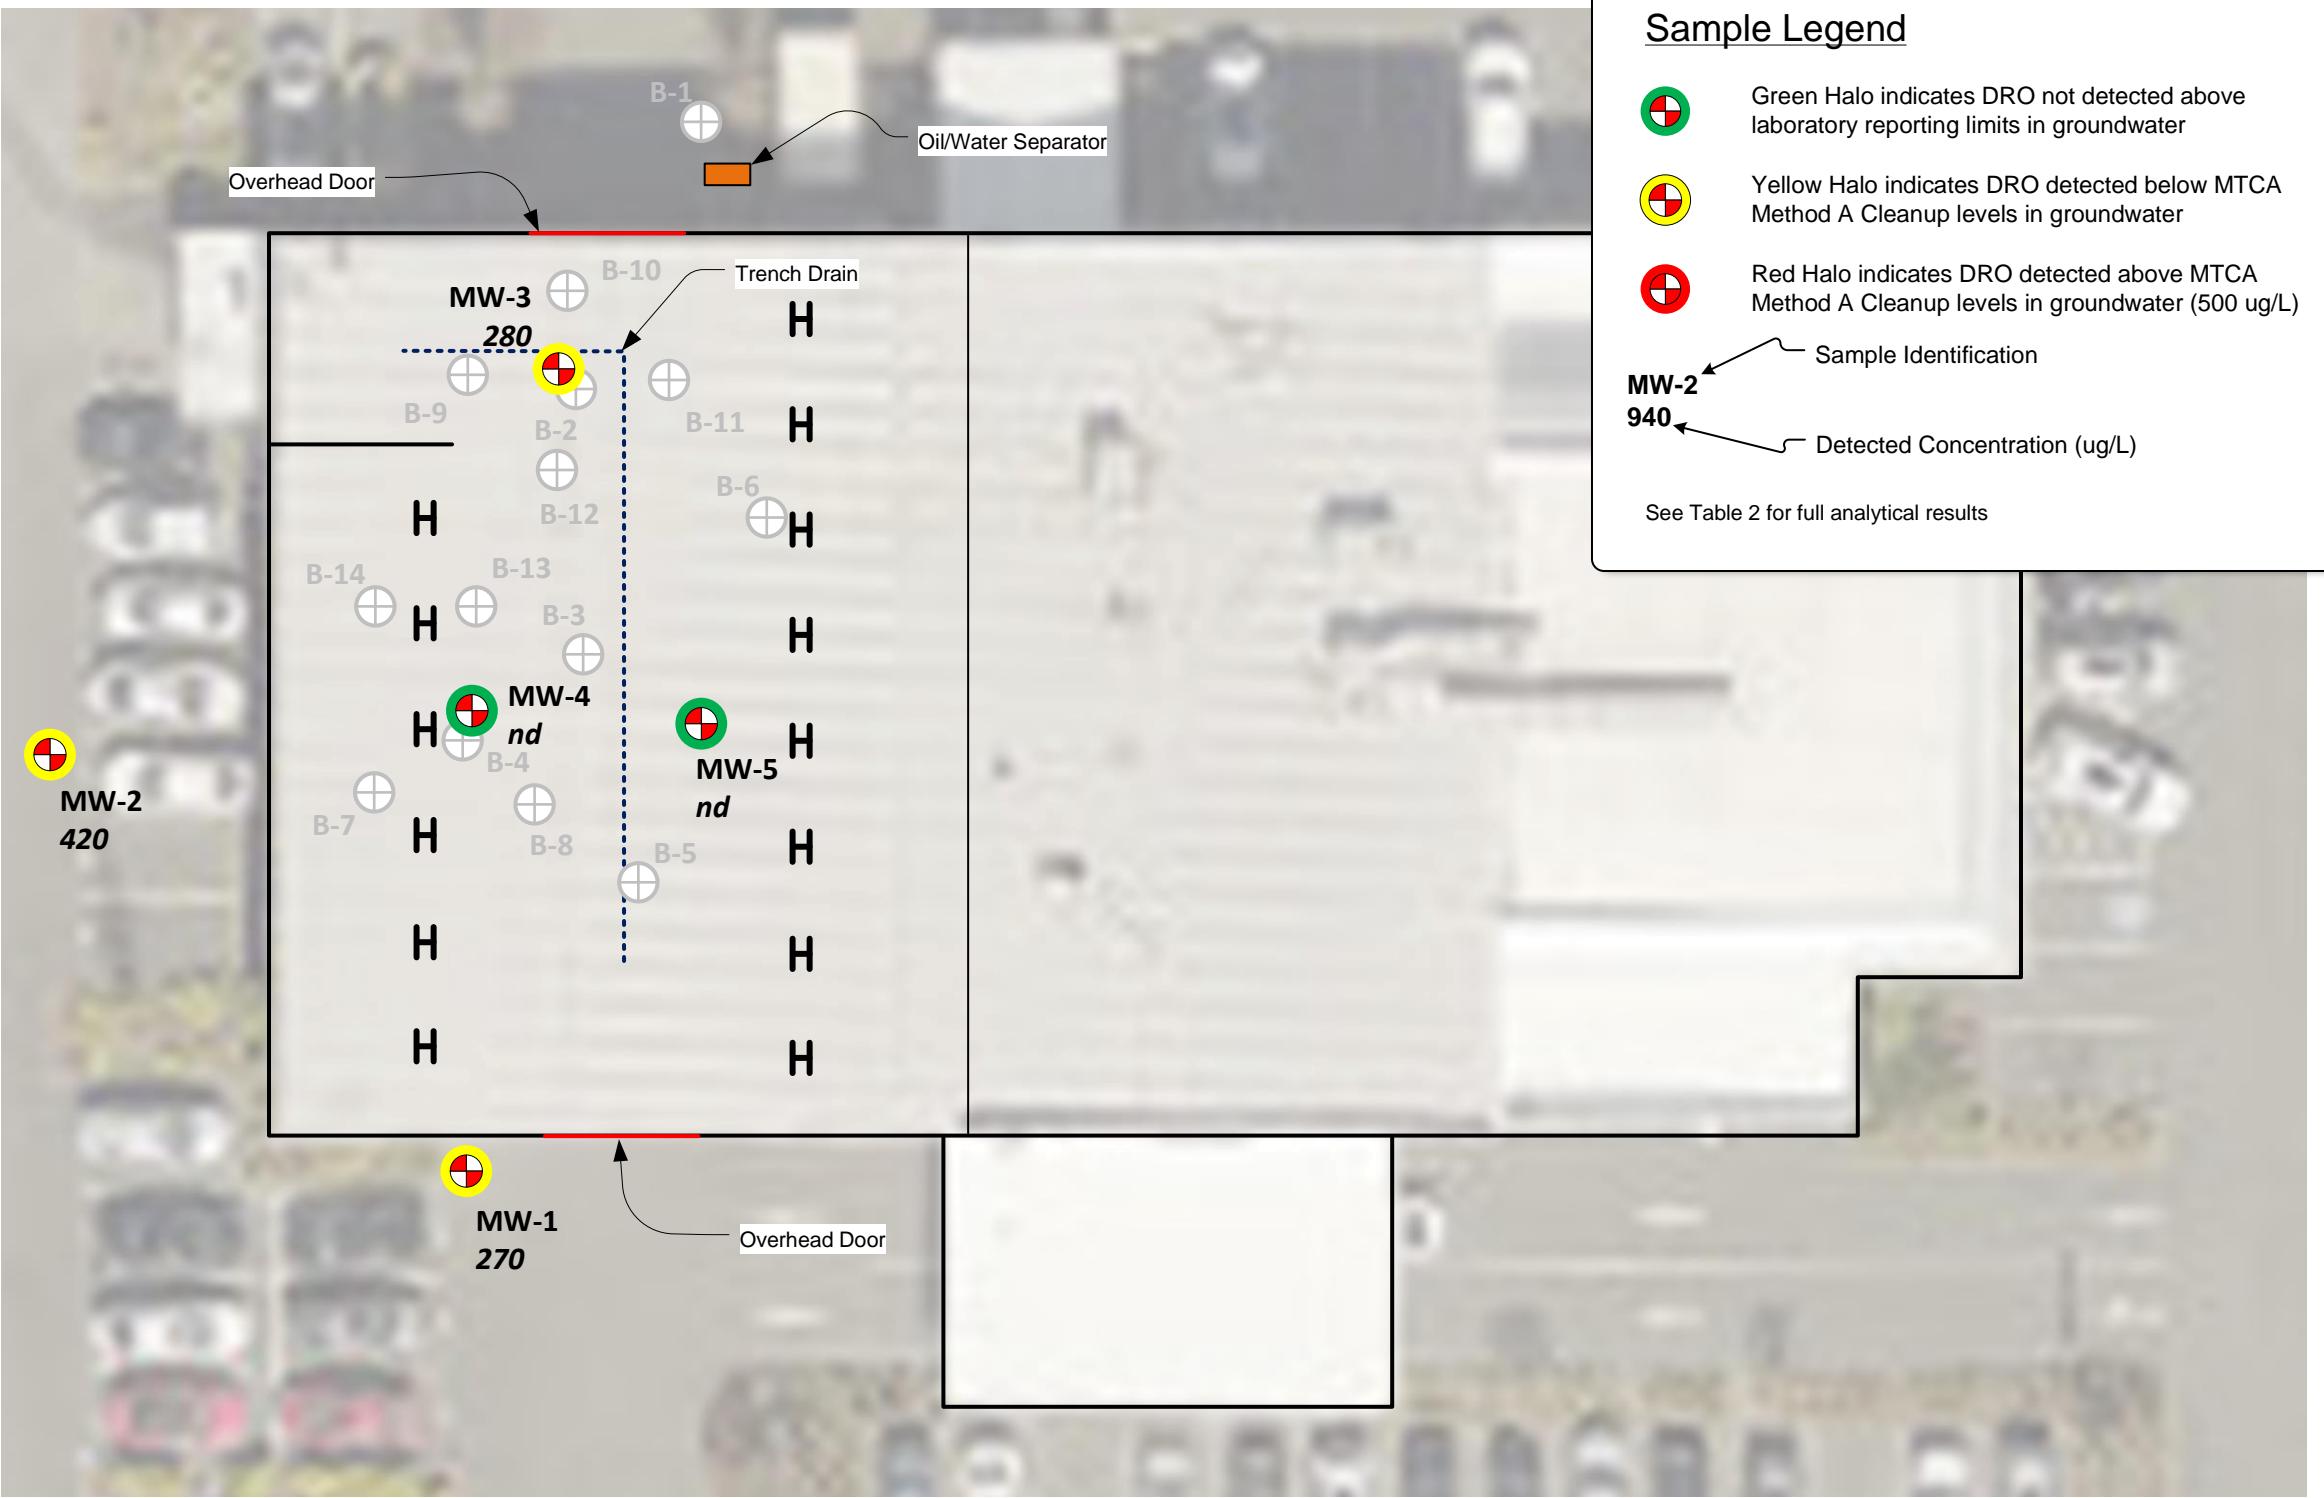
**Figure
3c**

DRO Concentrations in Groundwater
(January 10, 2023)

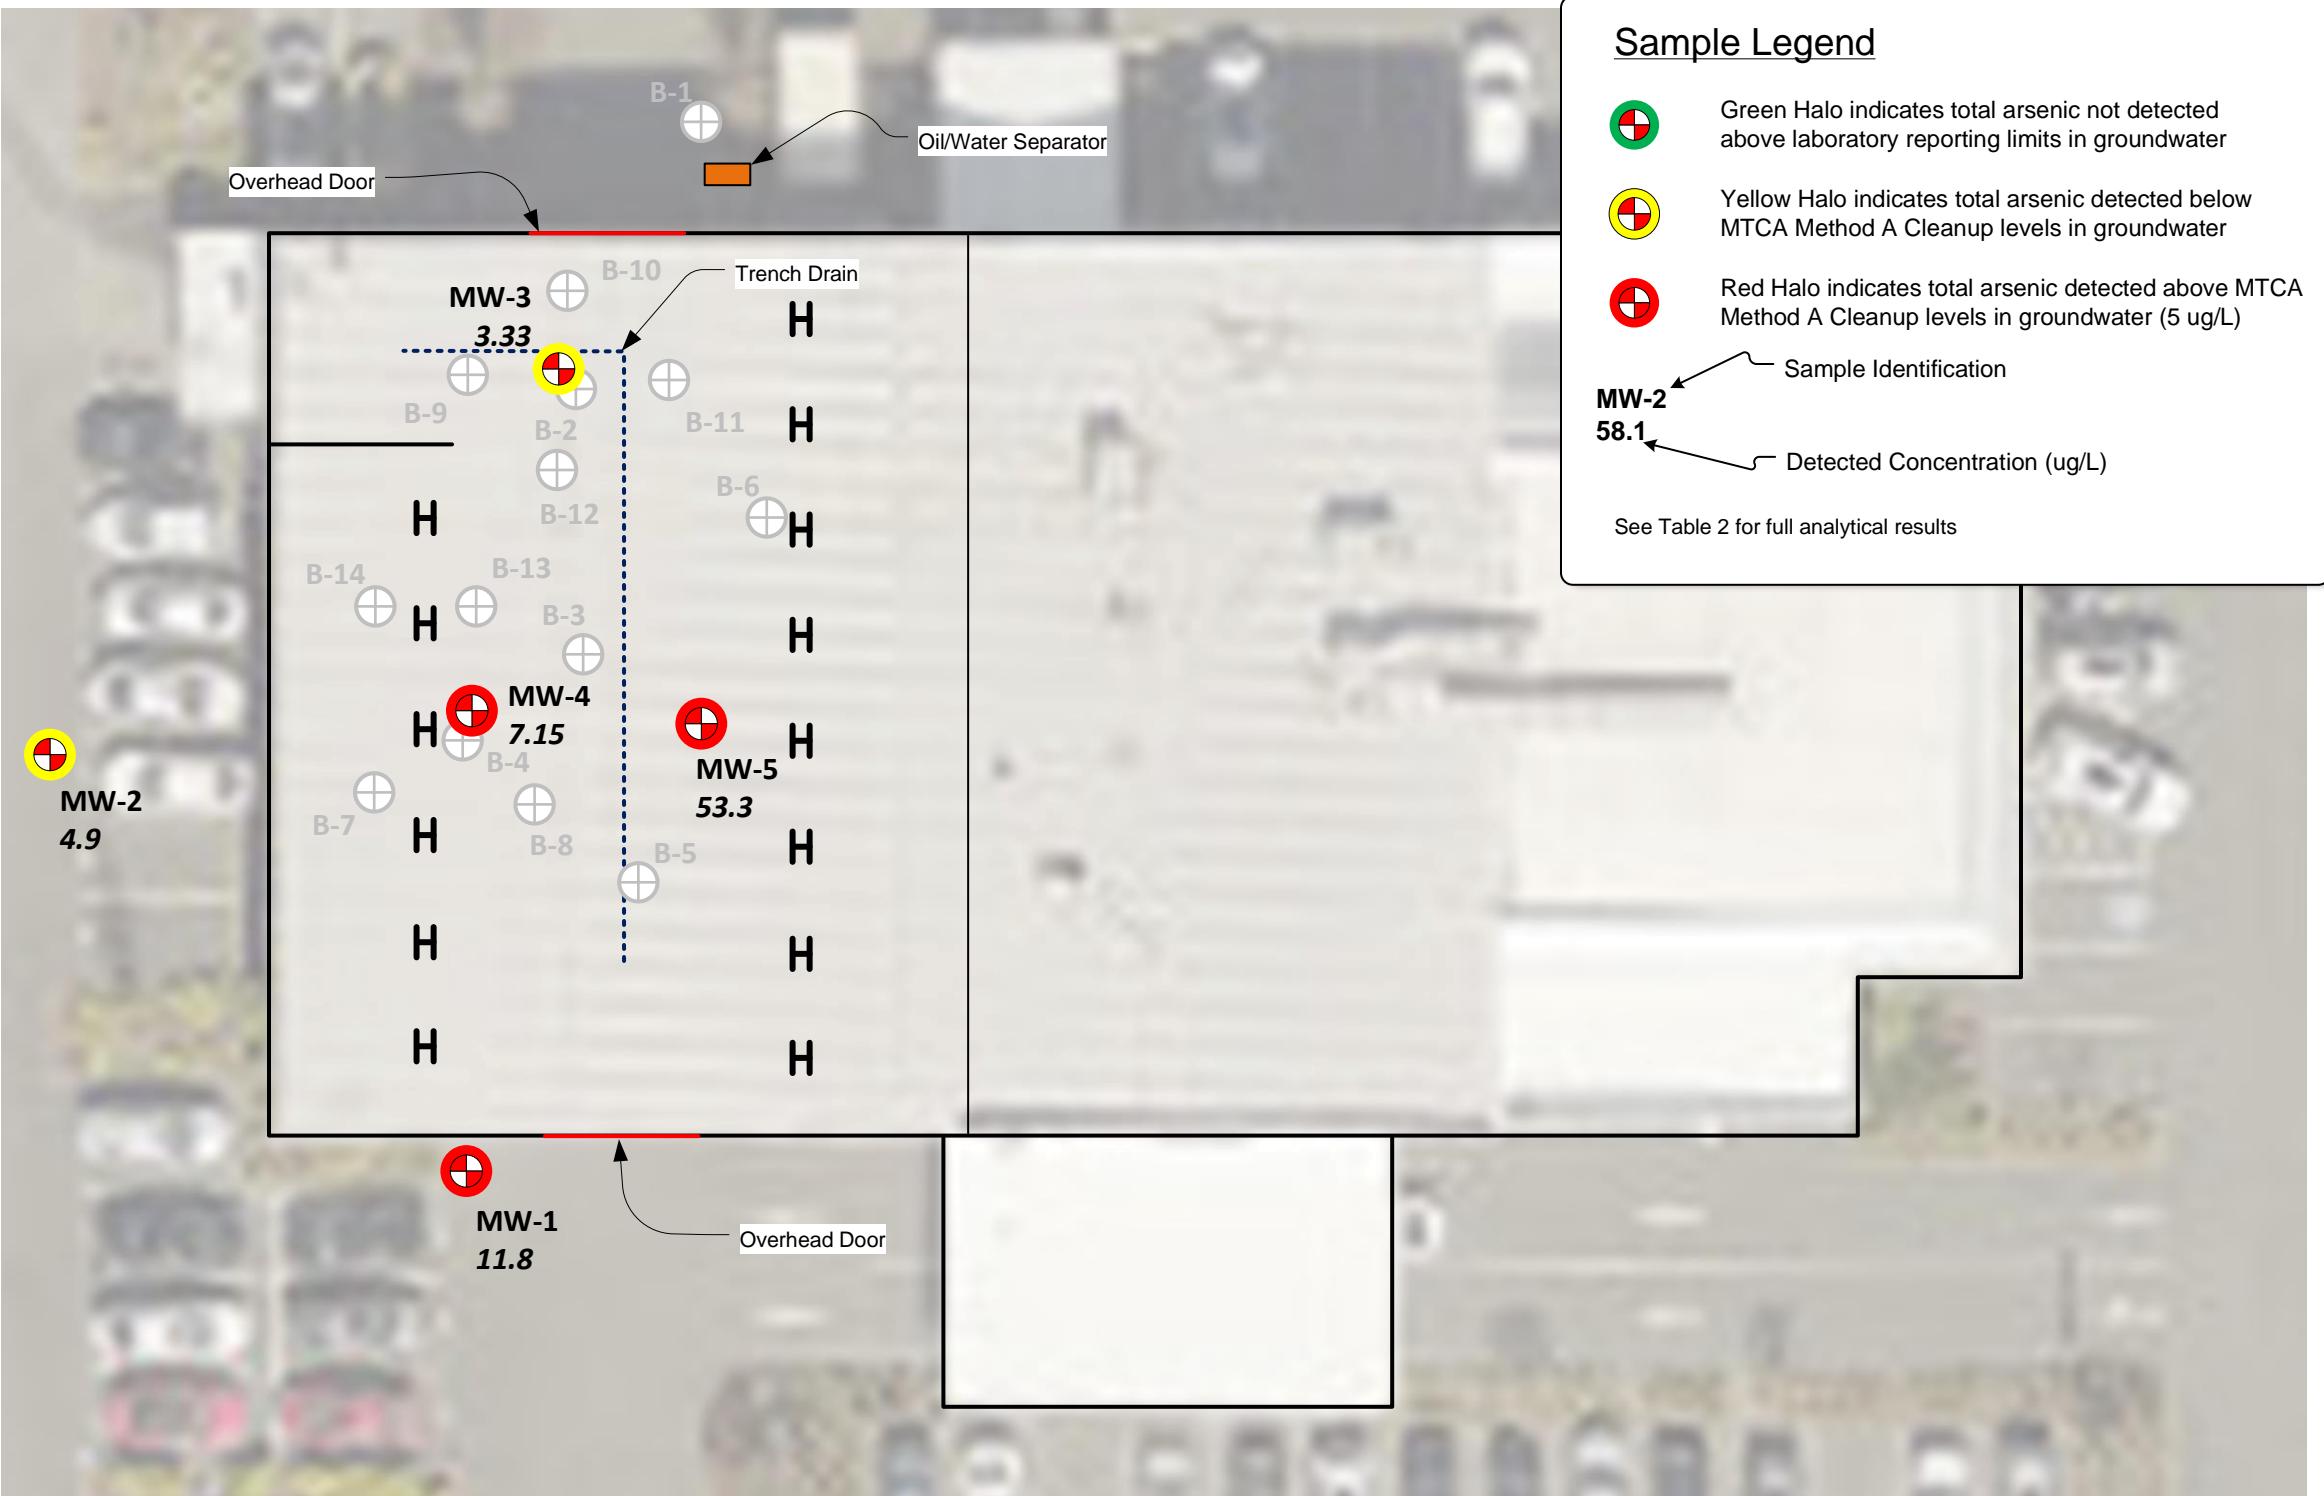
**Figure
4a**

Total Arsenic Concentrations in Groundwater
(May 26, 2022)

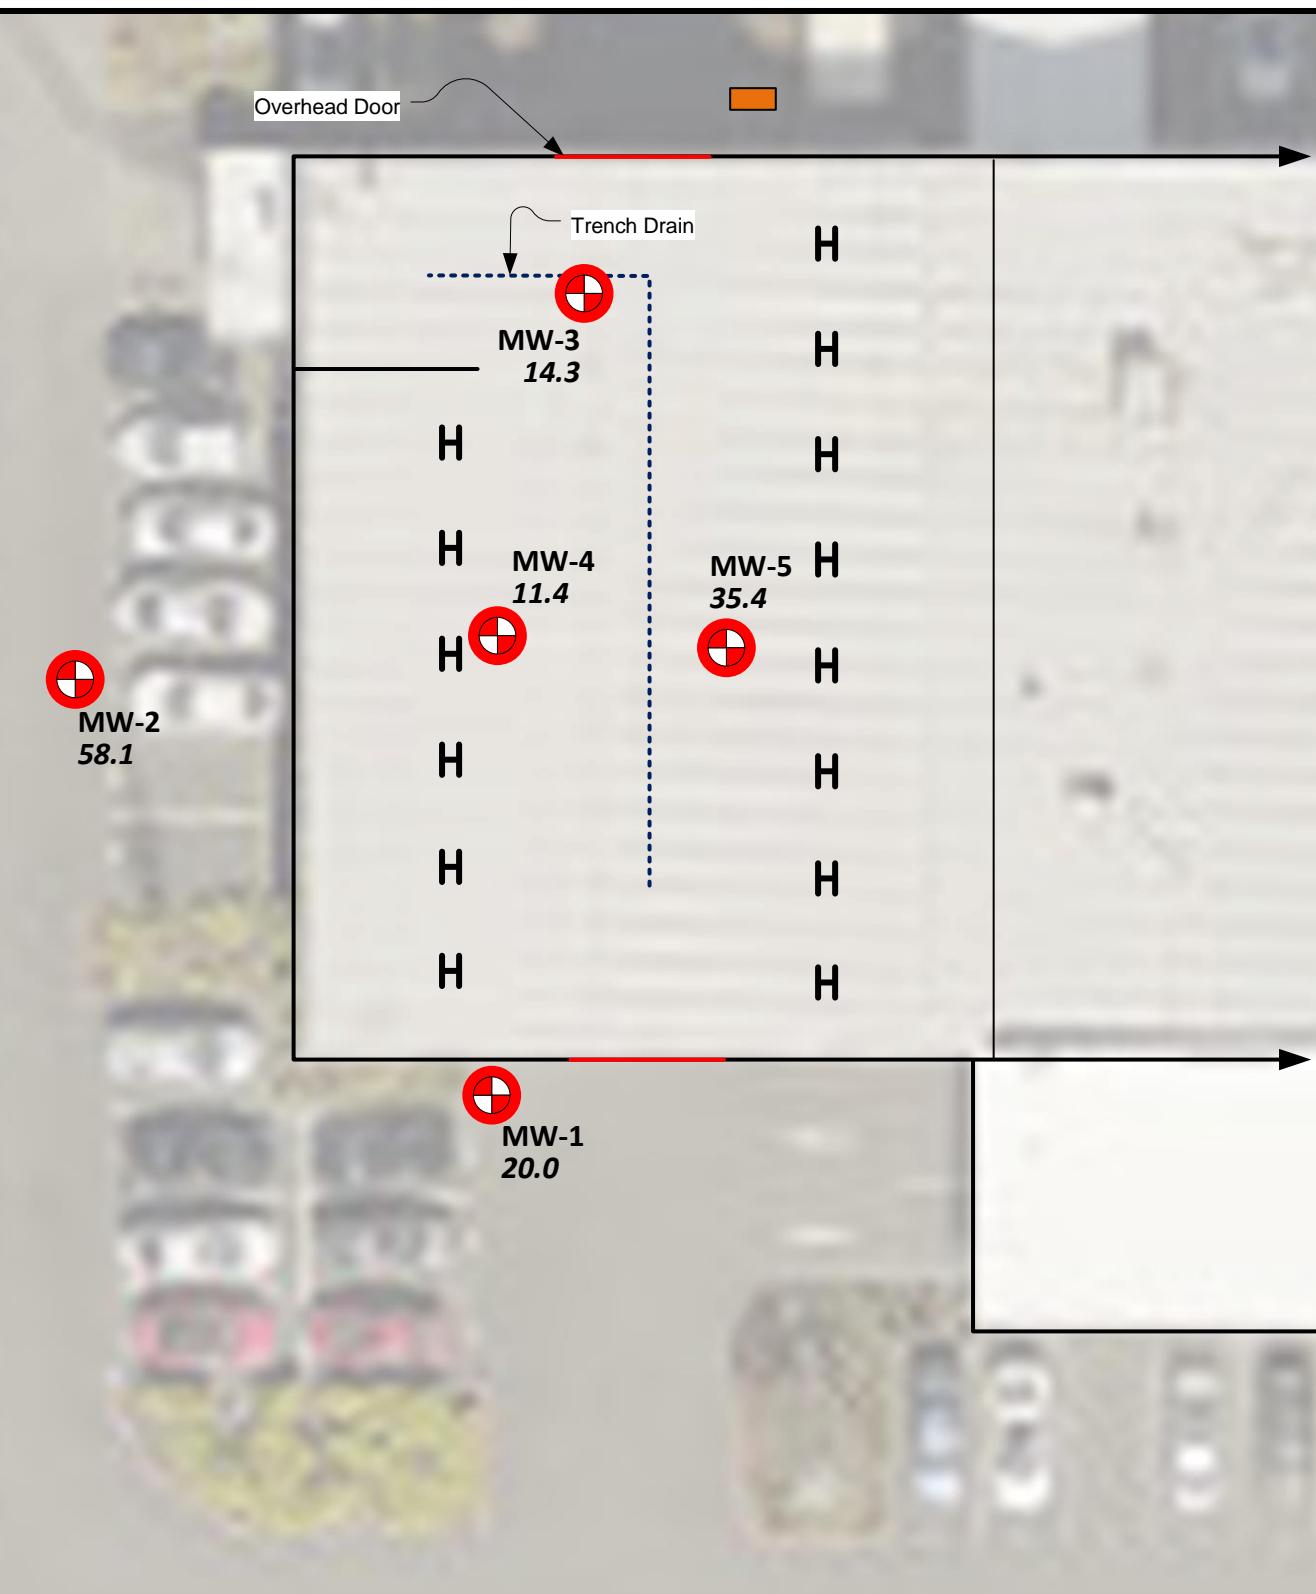
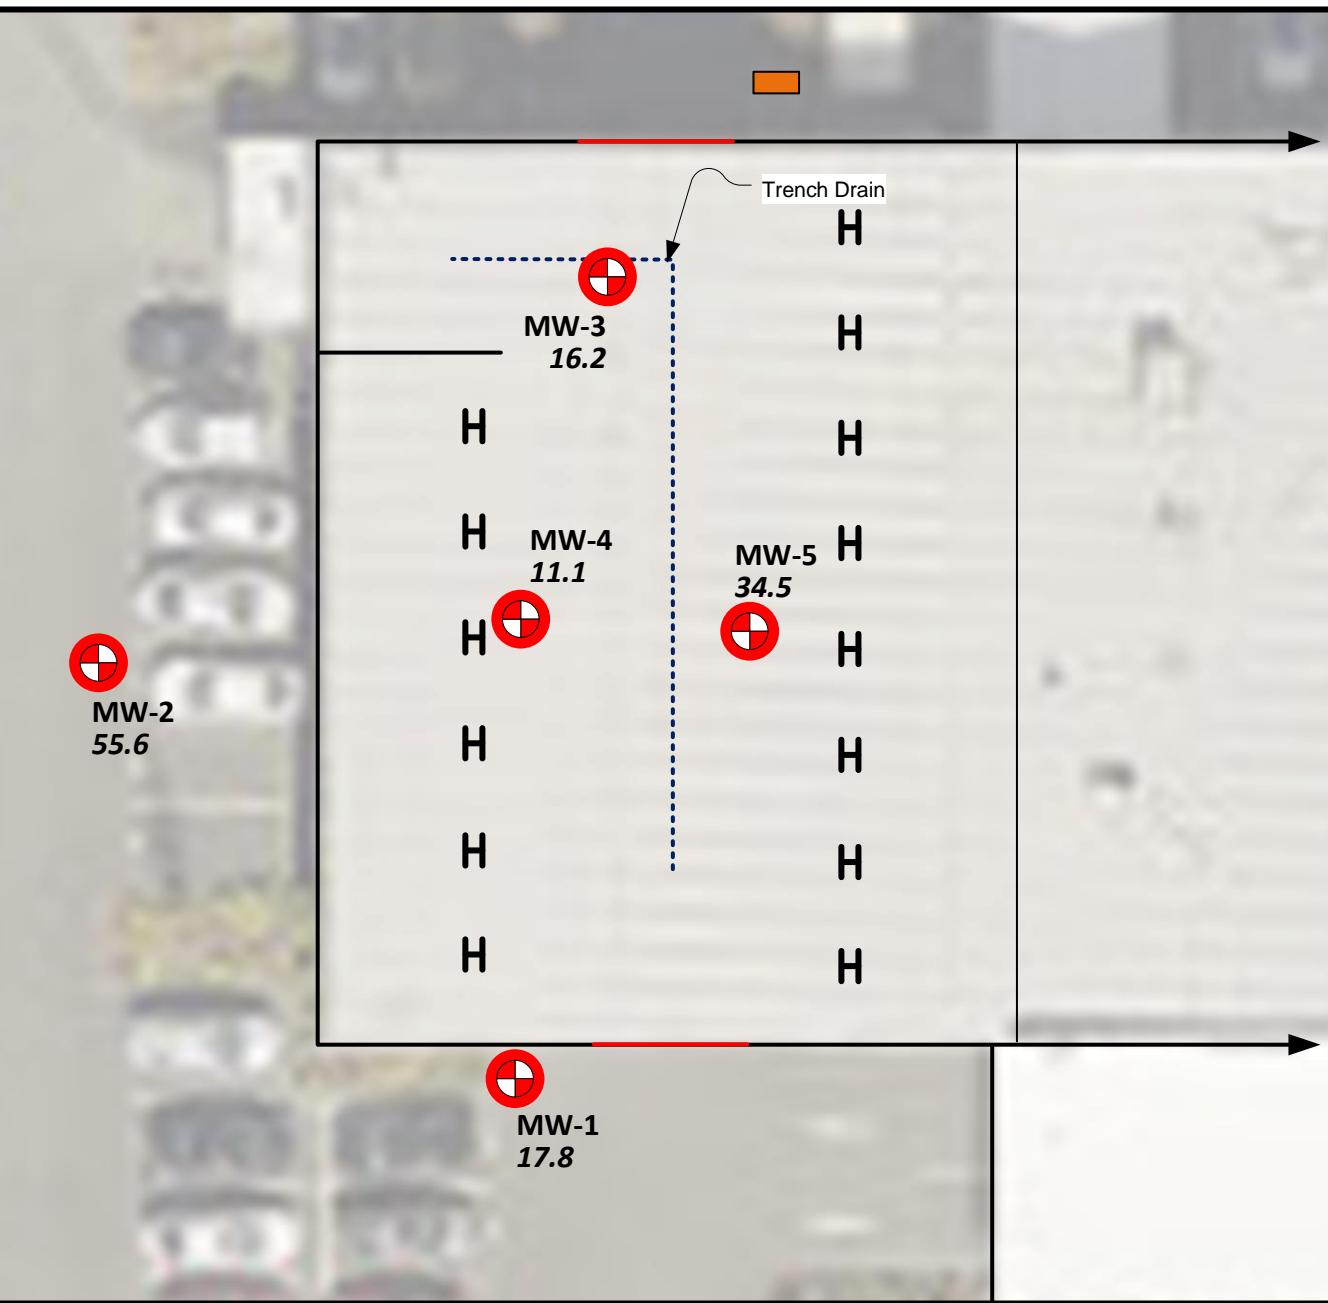
Figure
4b

- Red Halo indicates total/dissolved arsenic detected above MTCA Method A Cleanup levels in groundwater (5 ug/L)
- Green Halo indicates total/dissolved arsenic not detected above laboratory reporting limits in groundwater
- Yellow Halo indicates total/dissolved arsenic detected below MTCA Method A Cleanup levels in groundwater

Total and Dissolved Arsenic Concentrations in Groundwater (July 26, 2022)
