Subject: Updated Groundwater Data, ERTS 719681
Auburn Volkswagen
Bluestone Project Number BE-0107-E
3109 Auburn Way N.
Auburn, WA 98002

Attachments January 10, 2023, Updated Tables and Figures

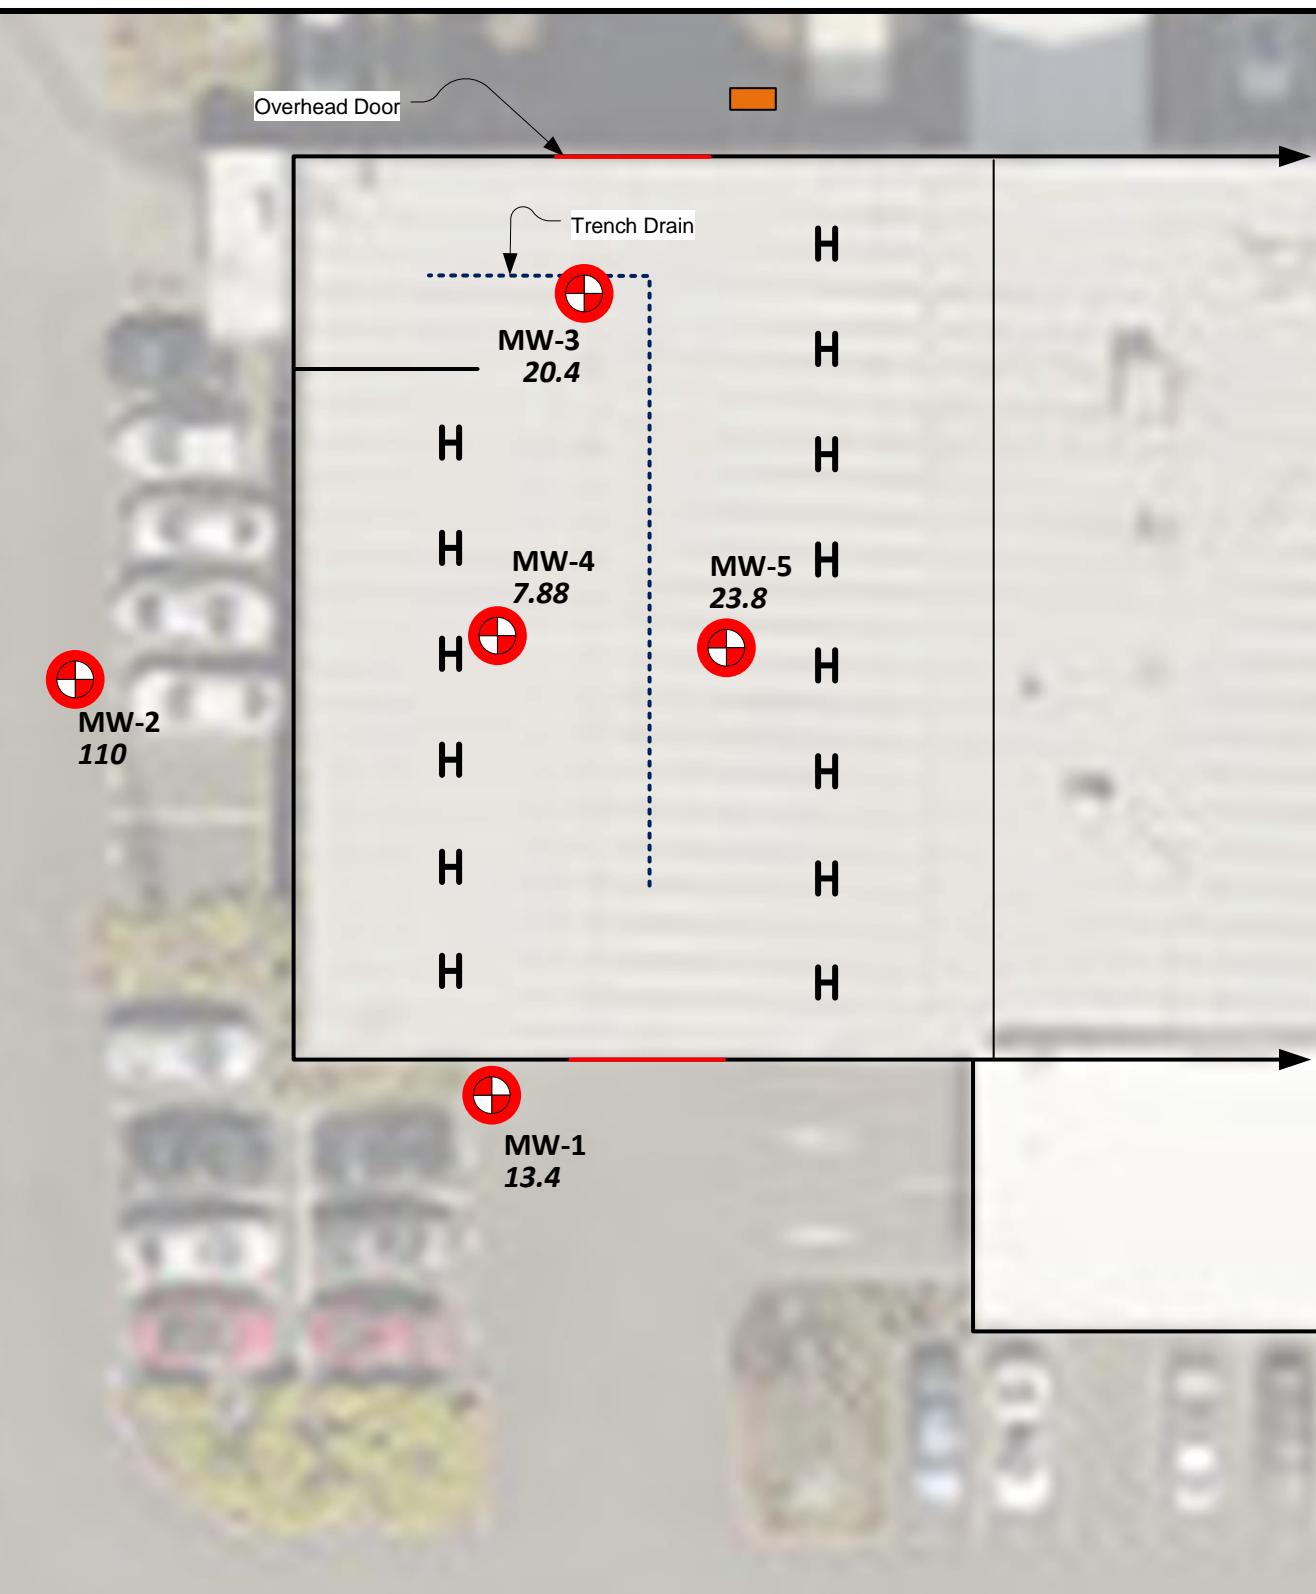
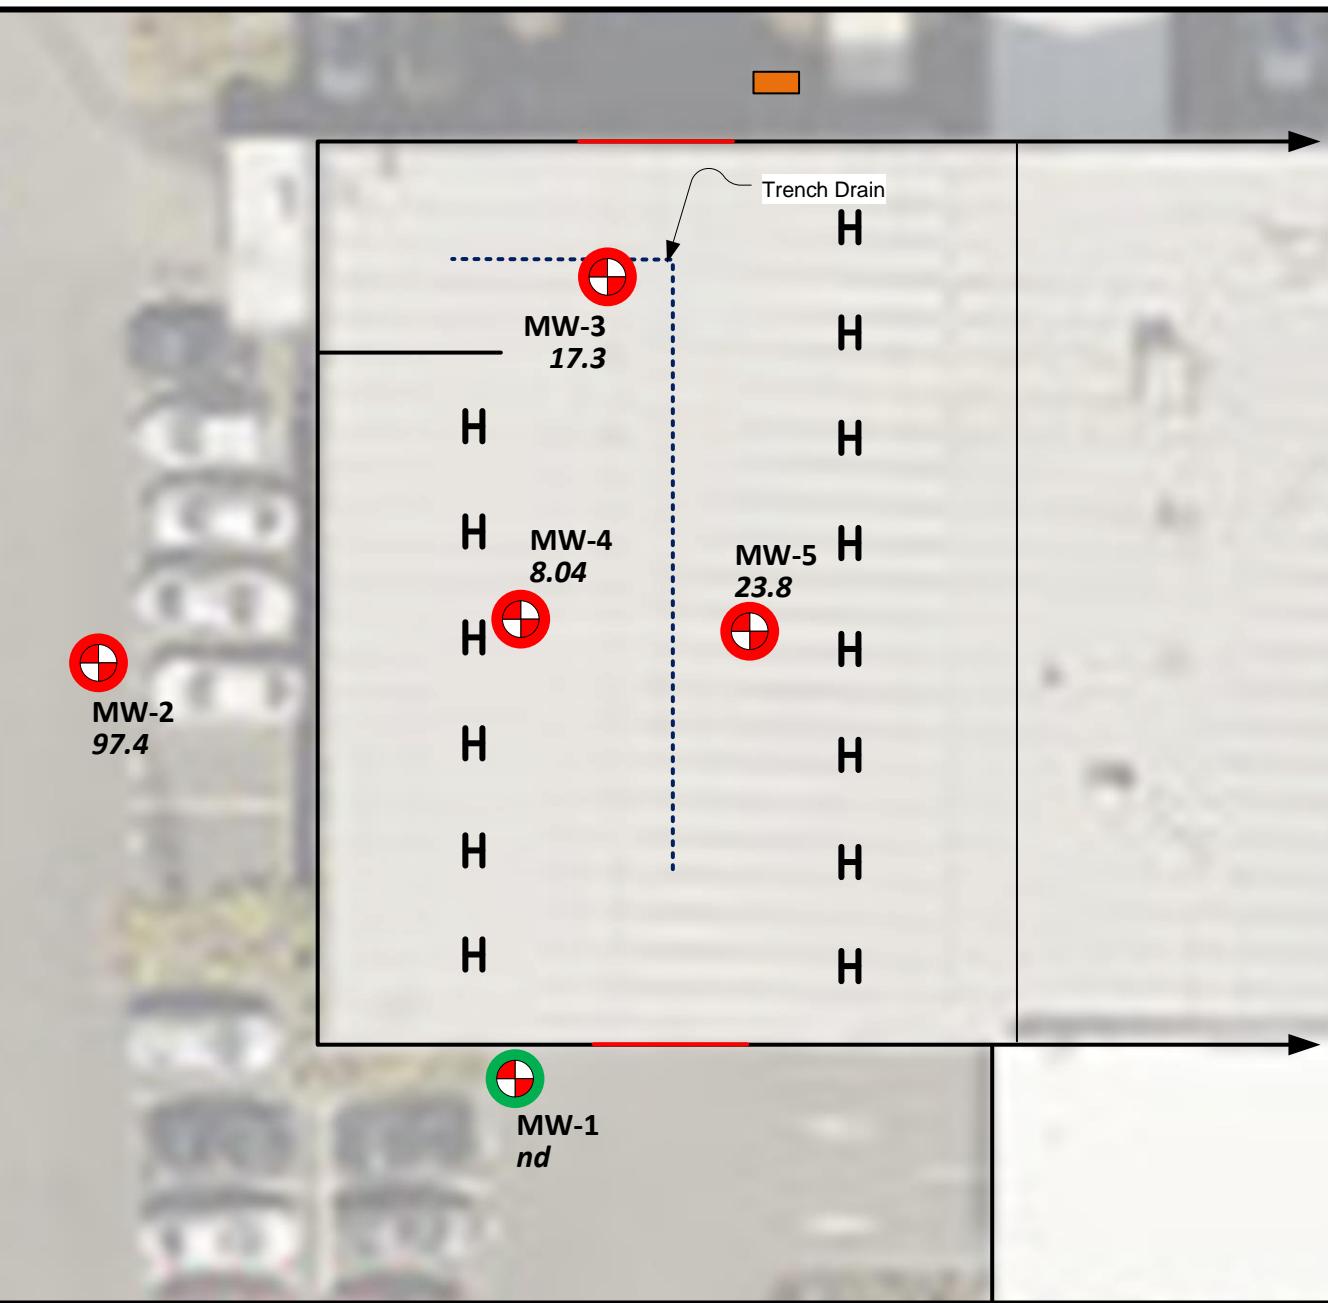
Figure
4C

Total and Dissolved Arsenic Concentrations in Groundwater (January 10, 2023)

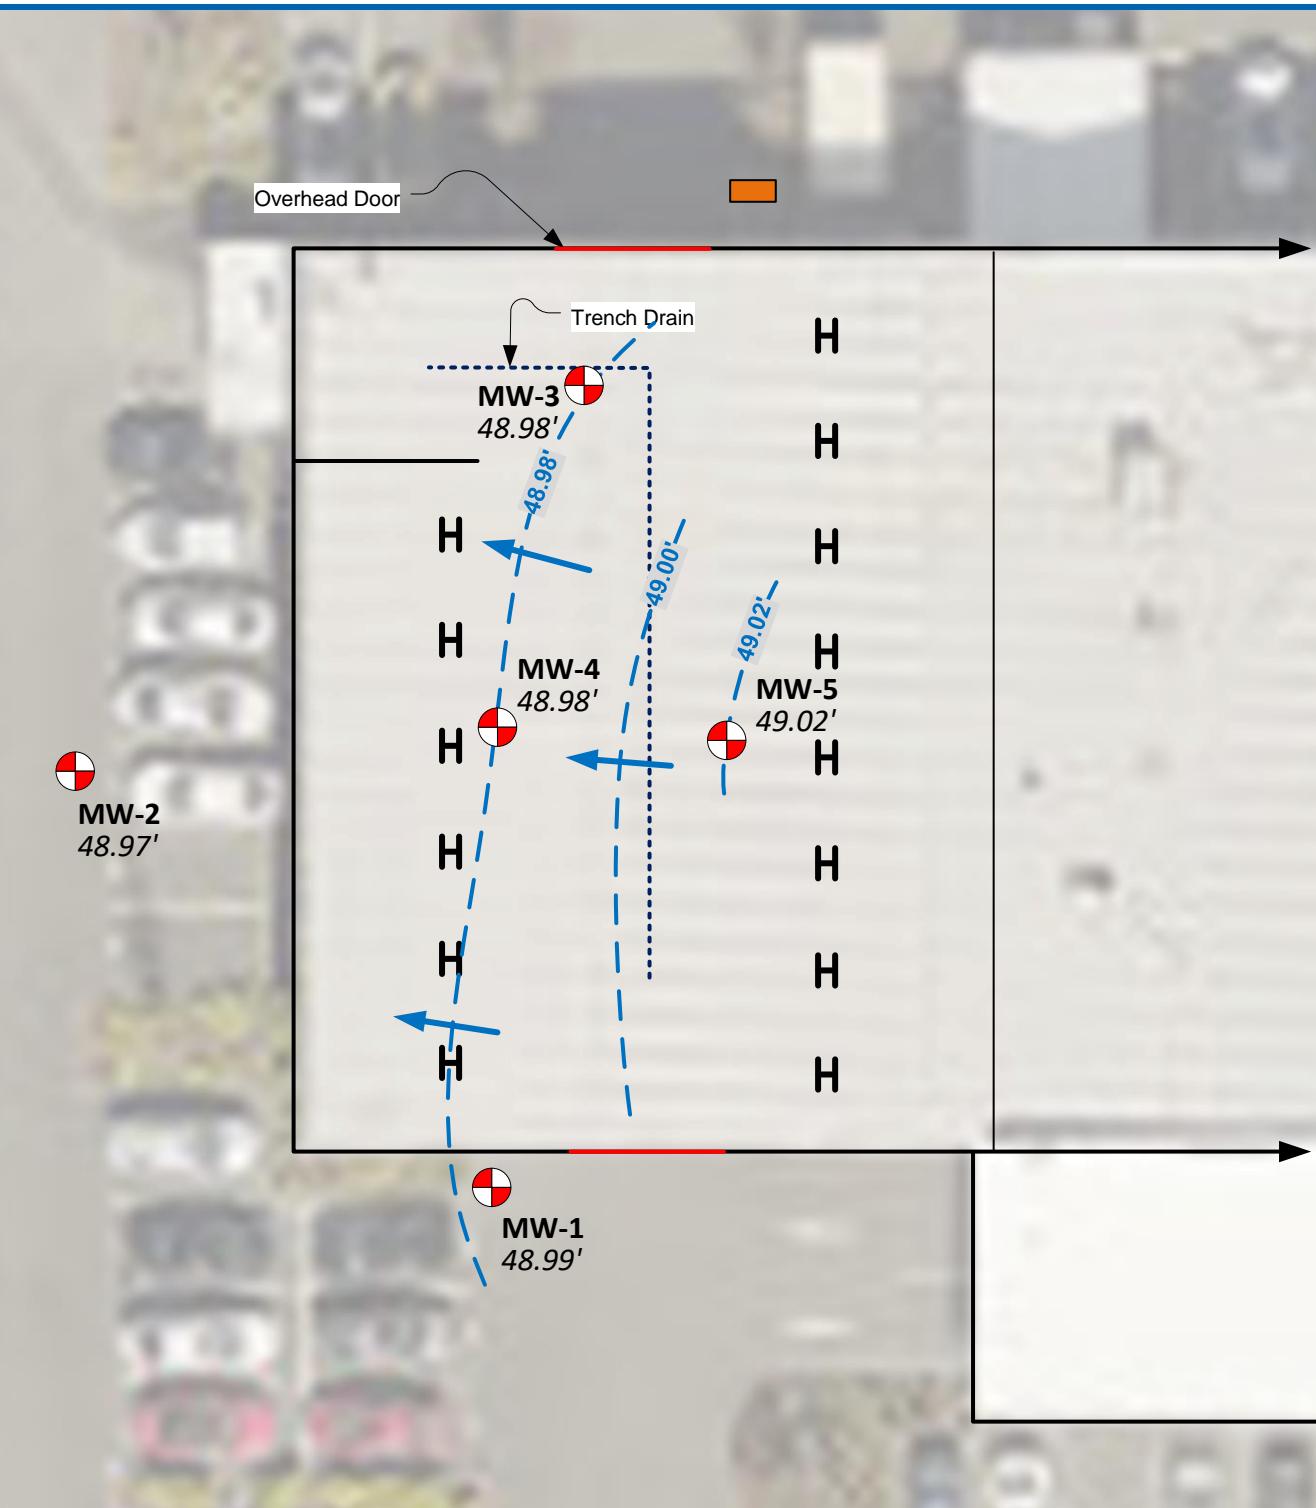
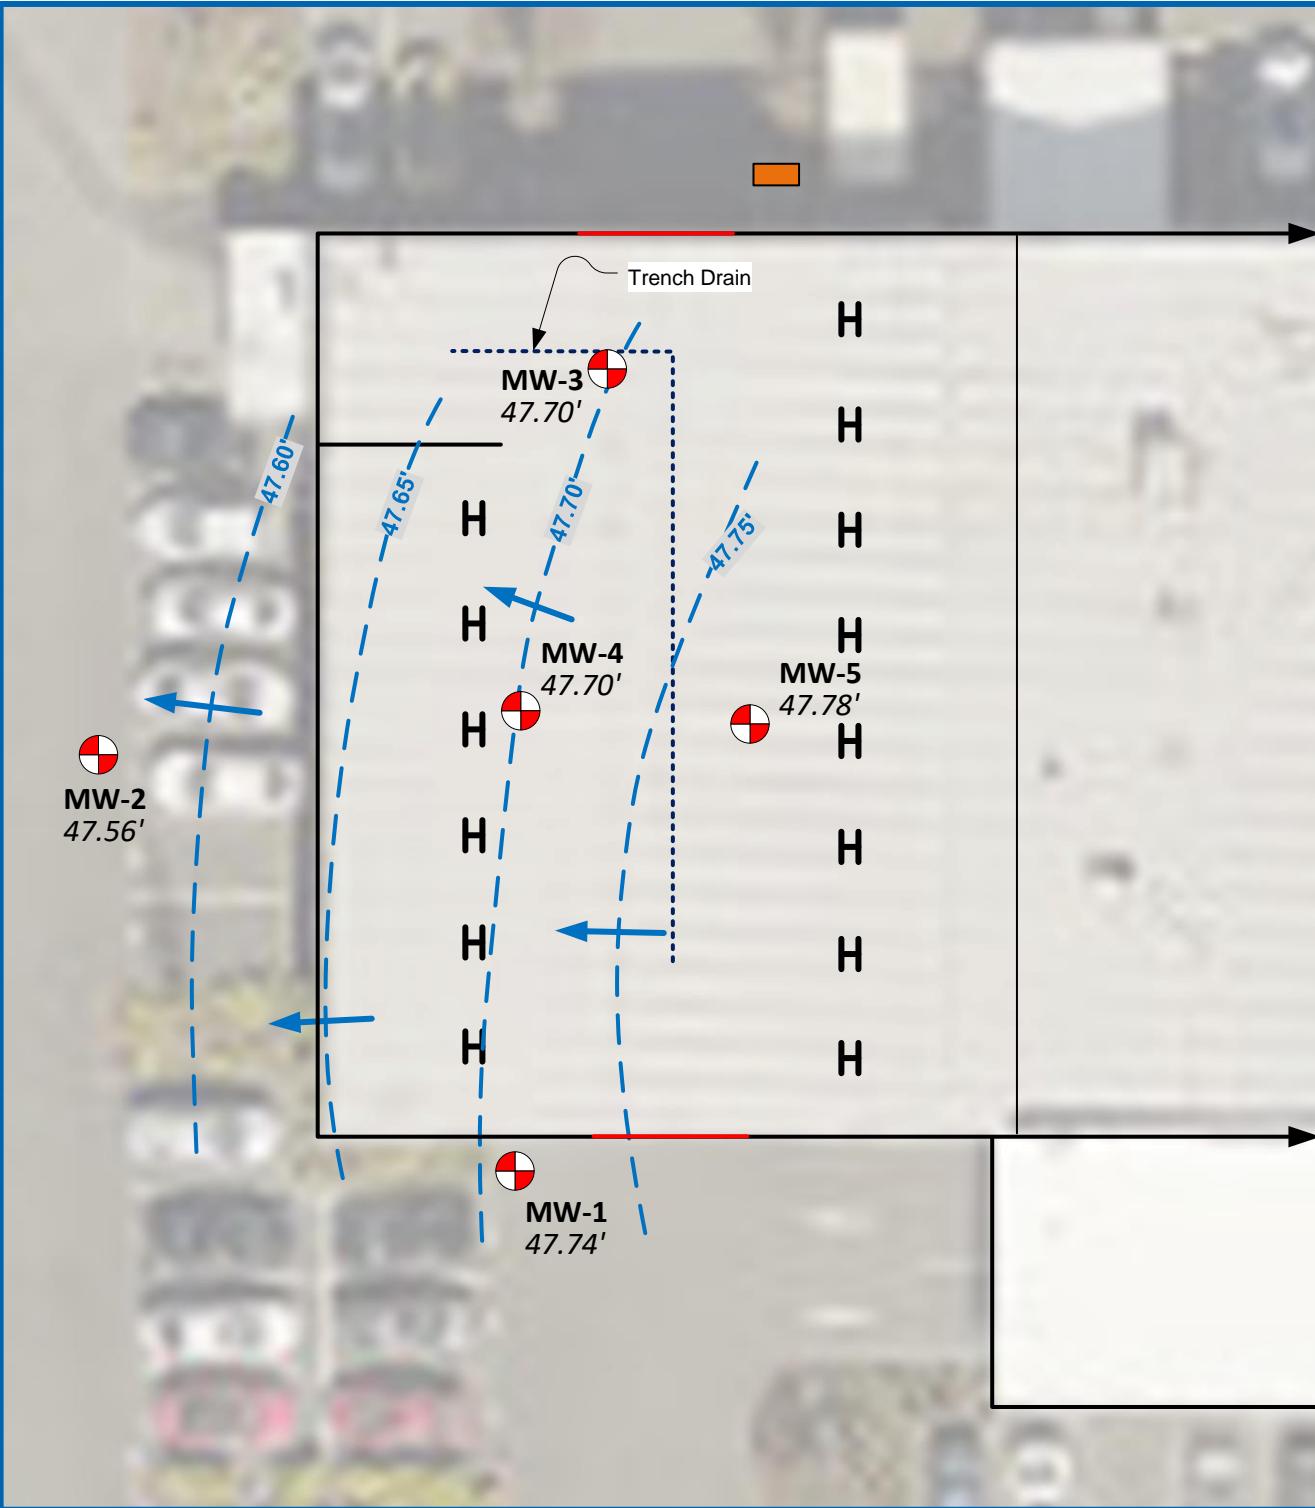
Figure
5a

The contours represent an interpretation of available data, for the indicated date. Site groundwater contours may change with additional measurements and/or data points, weather changes, construction activities, and/or other influences.

Groundwater Elevations & Interpreted Gradient, May 2022 & July 2022

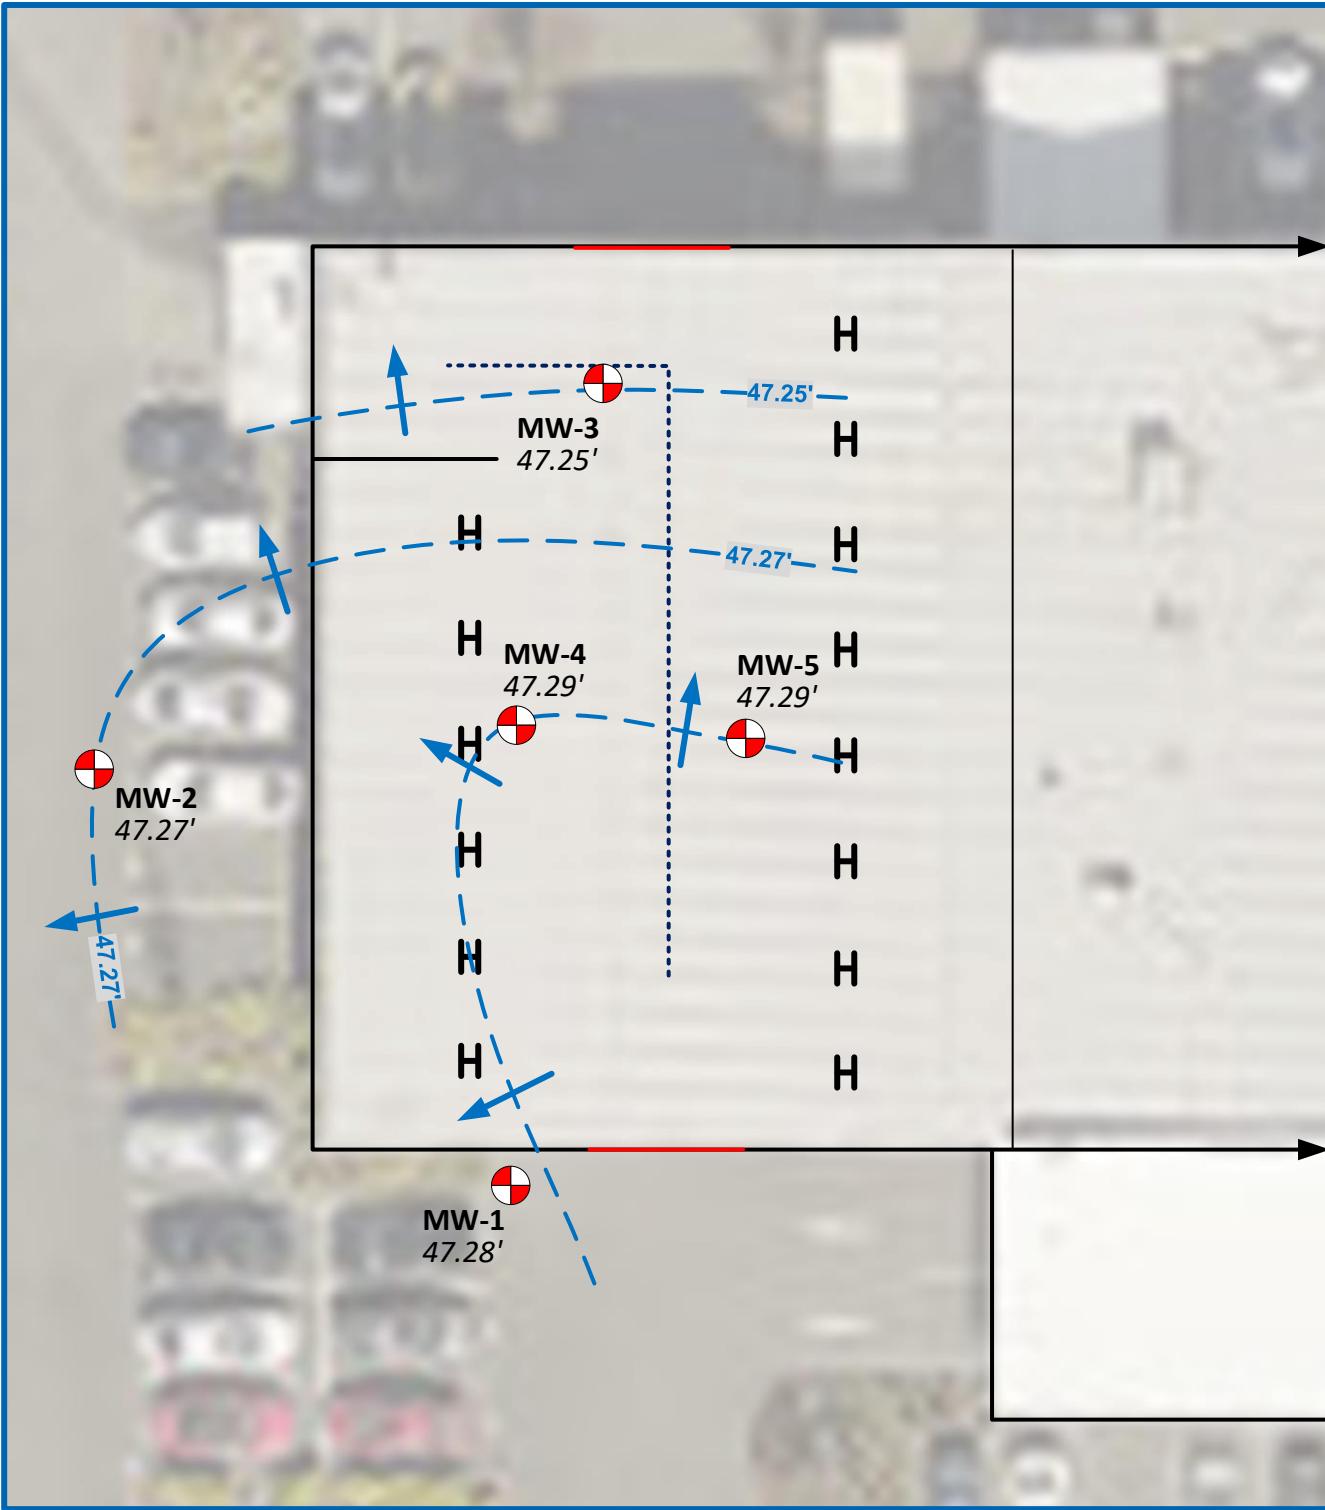
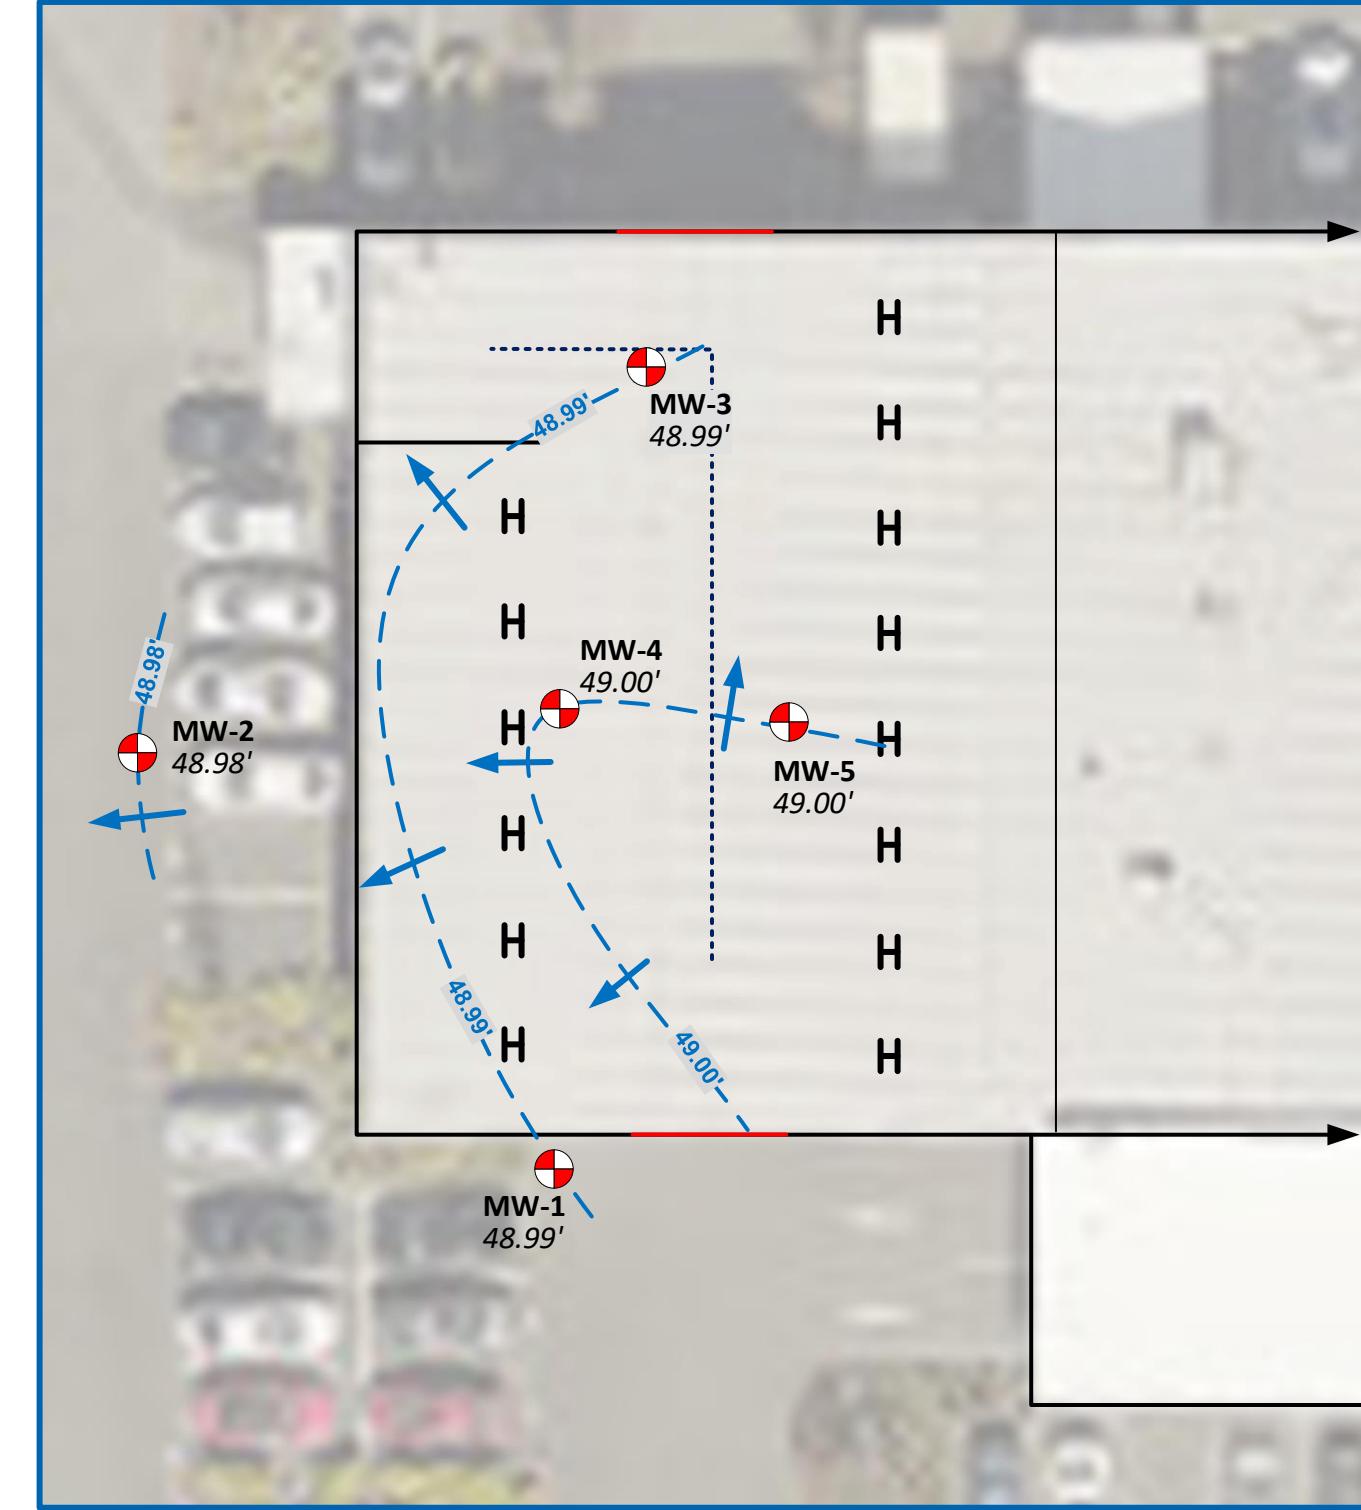
The contours represent an interpretation of available data, for the indicated date. Site groundwater contours may change with additional measurements and/or data points, weather changes, construction activities, and/or other influences.

Groundwater Elevations & Interpreted
Gradient, August 2022 & January 2023Auburn VW
3109 Auburn Way North, Auburn, WAFigure and notations are in color. Black and white
copies may not be suitable for use.Figure
5b
