LUST # 554478
Cowman Campbell Paints
NOWICKI ~~Seattle~~
& ASSOCIATES
ENERGY & ENVIRONMENTAL MANAGEMENT

RE: 300-Gallon Diesel Heating Oil UST Closure Site Assessment Report
C & C Paint

~~5121 Ballard Avenue NW~~ 5232 SHILSHOLE AVE NW 11/8/2001 AH
Seattle, Washington

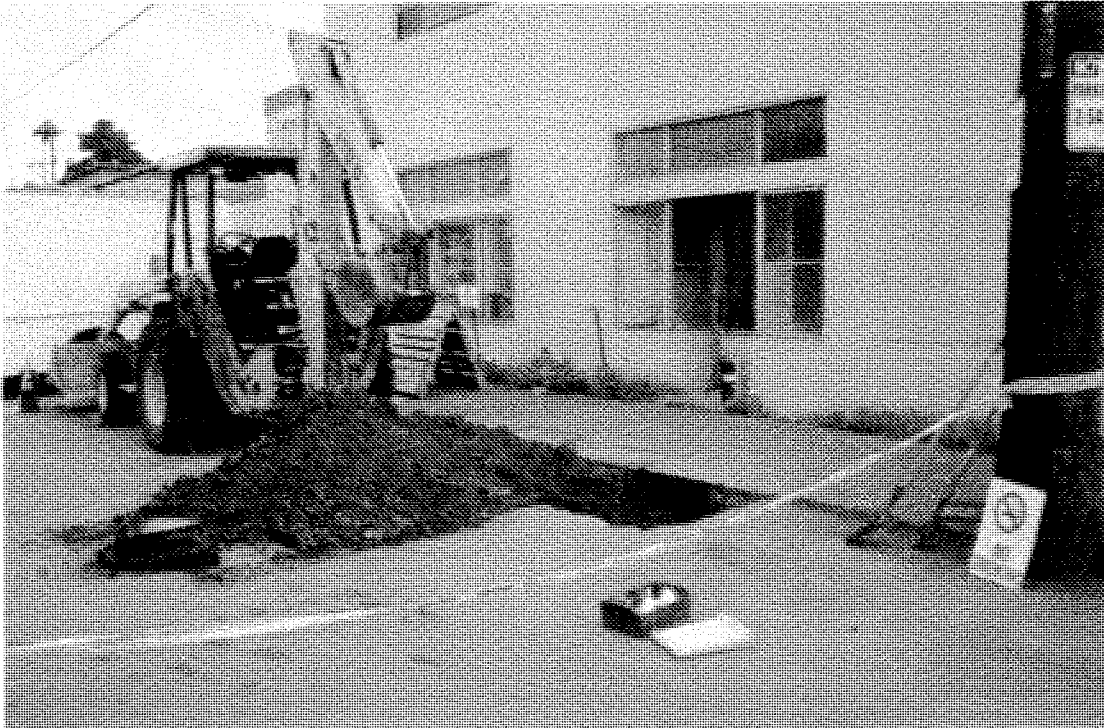
Diesel UST location, west of sidewalk.

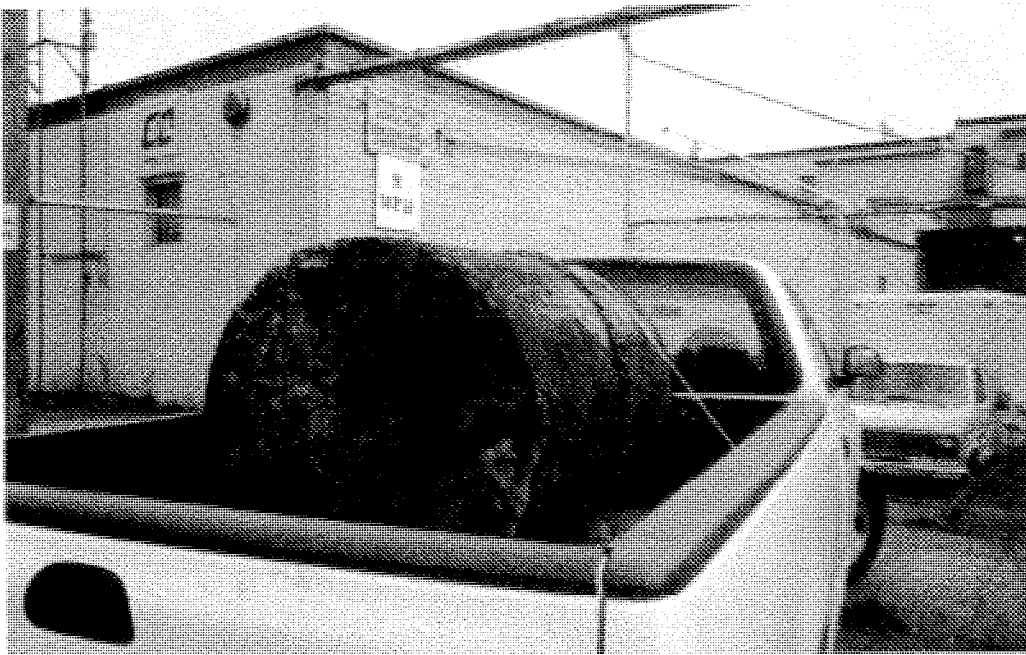
diesel below MTCA Method A level. The removed tank was measured at 38" in diameter and 5' in length and had several dime-size holes. The tank was transported to Seattle Metal & Iron for recycle disposal.

Removed diesel UST with heavy corrosion and several holes.

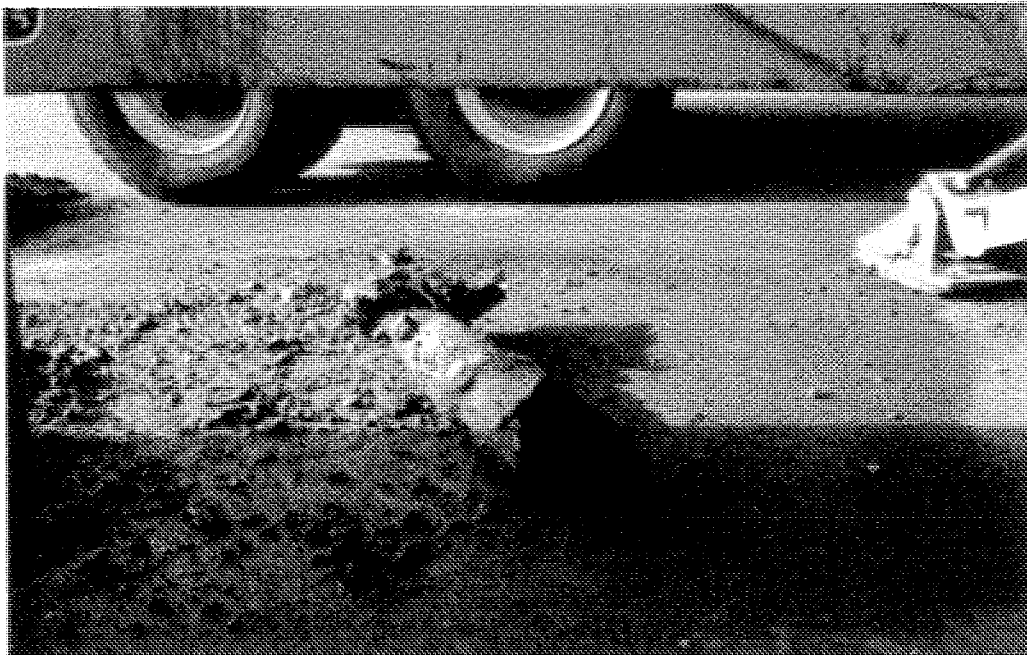
At the bottom of the excavation, a metal object was encountered at approximately 6' bgs. Further exploration revealed a metal pipe with numerous holes, through which water was observed to bubble up from. A minimal amount of soil was excavated from the excavation bottom and a soil sample was then collected at 6.5' bgs. Laboratory results indicate non-detect for diesel and oil.

Discovered metal object with rusted holes.
