Subject: **JARPA Application Package Components  
Whitmarsh Landfill Site, Skagit County**

## Joint Aquatic Resources Permit Application (JARPA) Form<sup>1,2</sup> [\[help\]](#)

March Point Landfill Site Cleanup Action

# Whitmarsh Landfill

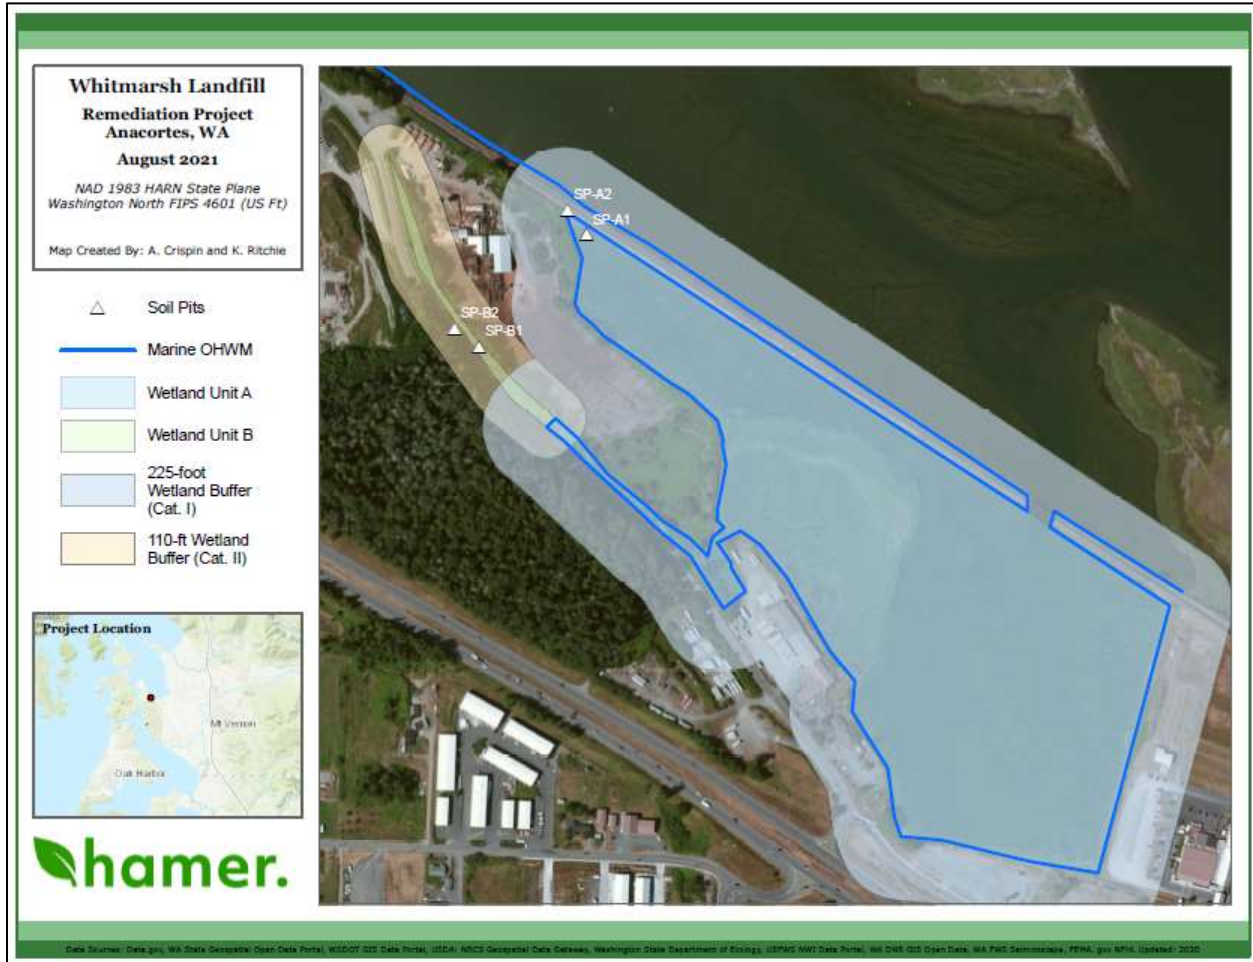
Figure 3. Study Area Existing Conditions overview (see also Appendix B).

Hamer scientists conducted a site assessment of the study area on May 3, 2021. During the site visit one wetland, with two wetland units, was assessed outside of the study area boundaries. Figure 3 is an overview of the study area existing conditions (Appendix B). Site wetlands were delineated per USACE methodologies.

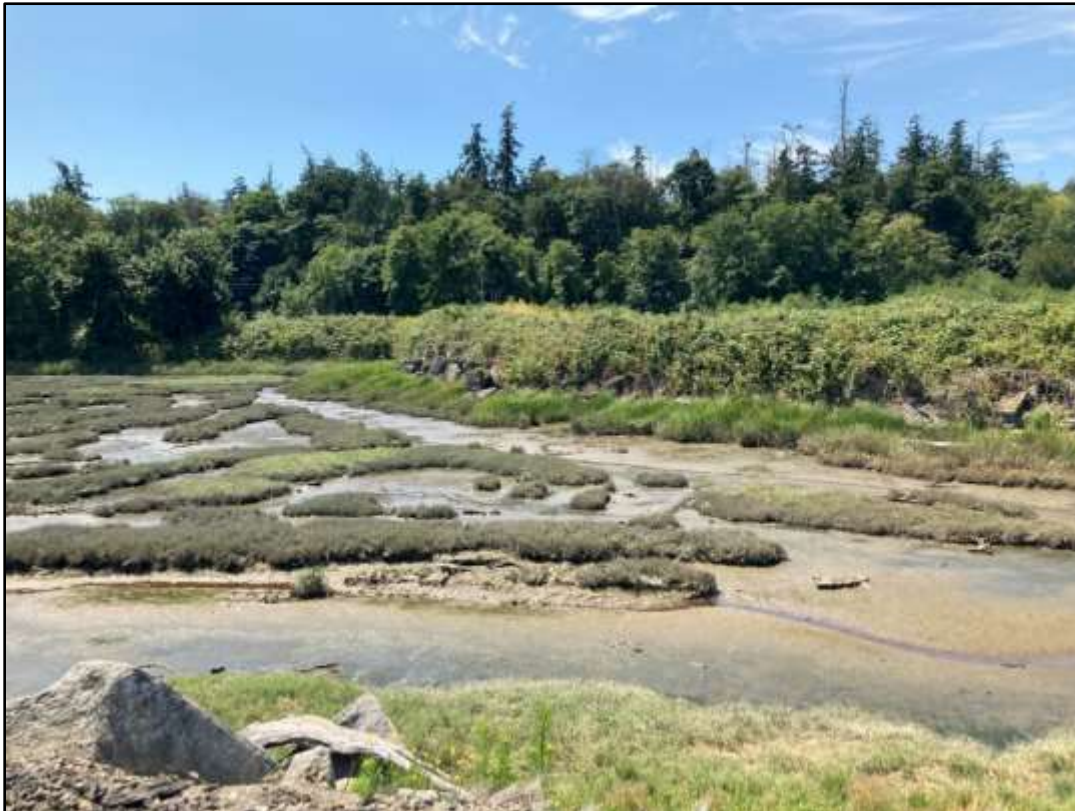
**Figure 4.** Overview of existing conditions of Wetland Unit A.

Wetland Unit A is estuarine and receives surface water from Padilla Bay and upslope freshwater areas, including stormwater from South March Point Road (Figure 4).

Vegetation within Wetland Unit A is dominated by herbaceous saltmarsh species such as saltmarsh bulrush (*Schoenoplectus maritimus*) and seaside arrowgrass (*Triglochin maritima*) and there are large mudflat areas that contain no vegetation. Soils are highly organic and have a mucky consistency in upper layers. Stormwater from South March Point Road, culverts, and the linear ditch-wetland portion of Wetland Unit A (Figure 3, Table 5) each appear to convey surface water to the wetland during wet periods. The ditch-wetland portion of Wetland Unit A was largely unvegetated in lower sections (near the connection to the estuary).

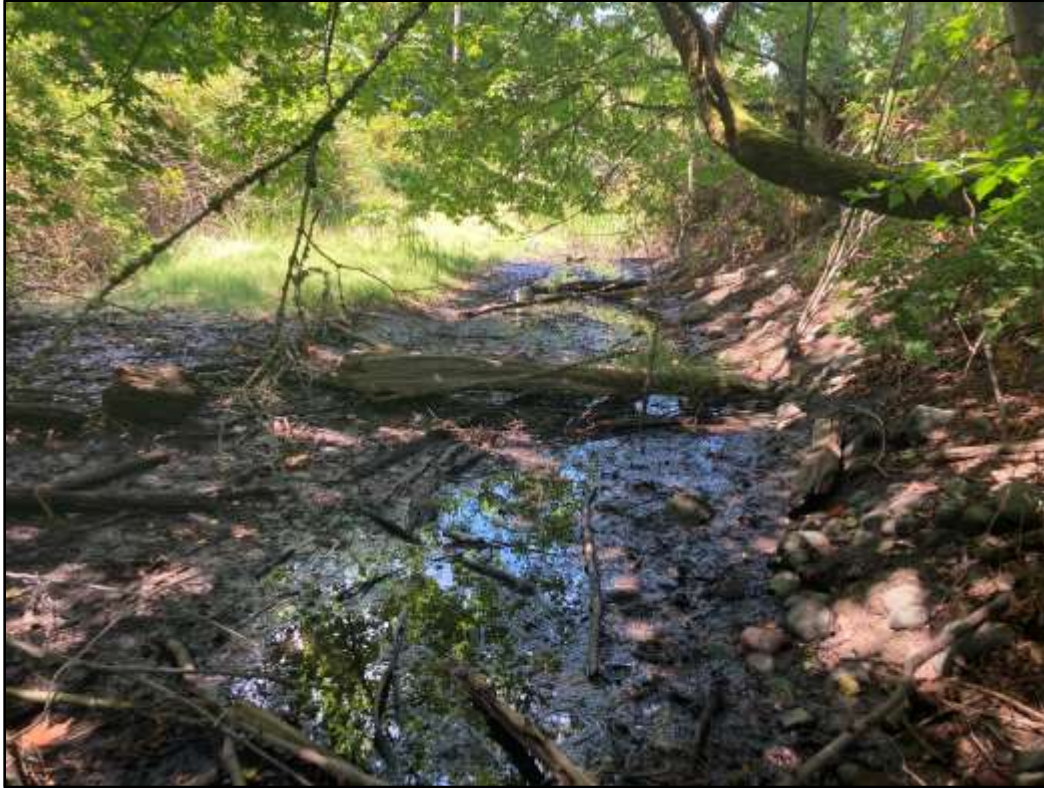
**Figure 5.** Overview of existing conditions of Wetland Unit B.

Wetland Unit B appears to be primarily influenced by freshwater inputs, as determined by observed freshwater vegetation, such as skunk cabbage (*Symplocarpus foetidus*), and historic salinity measurements (Appendix B). There was evidence of unidirectional flow in areas where surface water was observed (Figure 5). The unit was rated separately from Wetland Unit A given its different hydrologic regime and vegetation. Lower sections of the ditch did appear to be tidally influenced and contained salt-tolerant species; however, freshwater species gradually become dominant in the norther sections of the ditch. The unit “break” was determined where skunk cabbage was first observed.

Vegetation within Wetland Unit B is dominated by facultative and obligate species such as red alder (*Alnus rubra*), cattail (*Typha sp.*), and skunk cabbage, along the linear ditch-channel. Soils are organic in upper layers containing redox depletions below six inches. Stormwater from South March Point Road, culverts, and the landfill site, and each appear to convey surface water to the wetland during wet periods (Table 6).

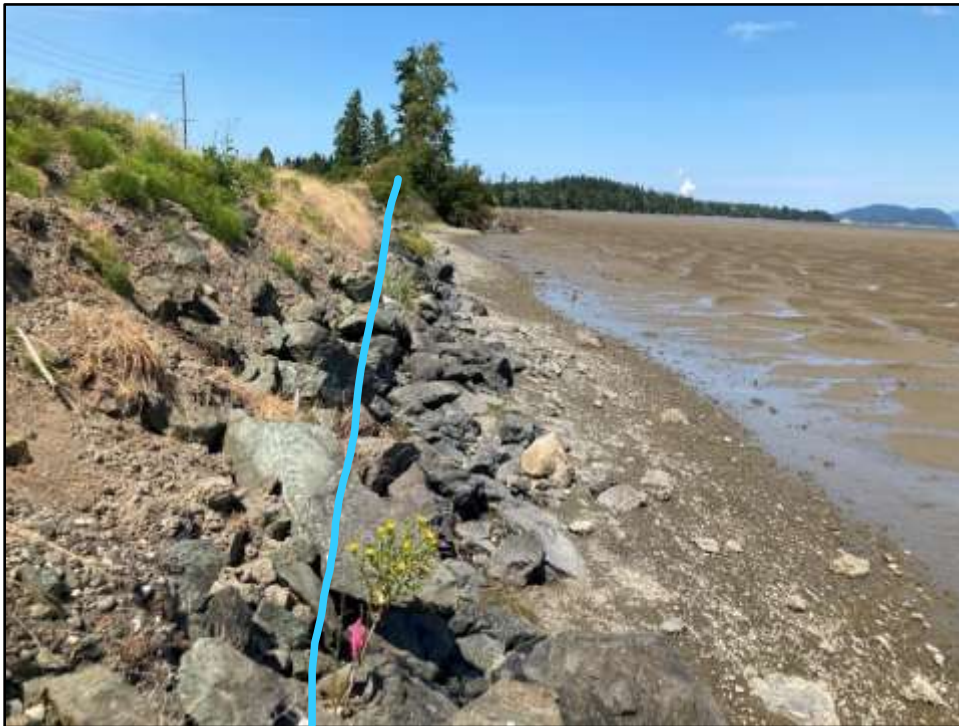
**Figure 6.** Overview of existing conditions of the Padilla Bay OHWM (east of railway).

The Padilla shoreline adjacent to the study area was evaluated onsite and the OHWM was determined in conjunction with available information (including LiDAR topographical images and WDNR shoreline data). The shoreline is armored and composed of large boulders that make up the BNSF railway, or is contiguous with the wetland boundary (Figure 3). Padilla Bay is a shoreline of the state, and the study area is within the 200-foot shoreline jurisdiction according to the delineated OHWM. Indicators of the OHWM were prevalent and obvious; they included water marks, persistent salt-tolerant vegetation, and presence of marine lichens (Figure 6).

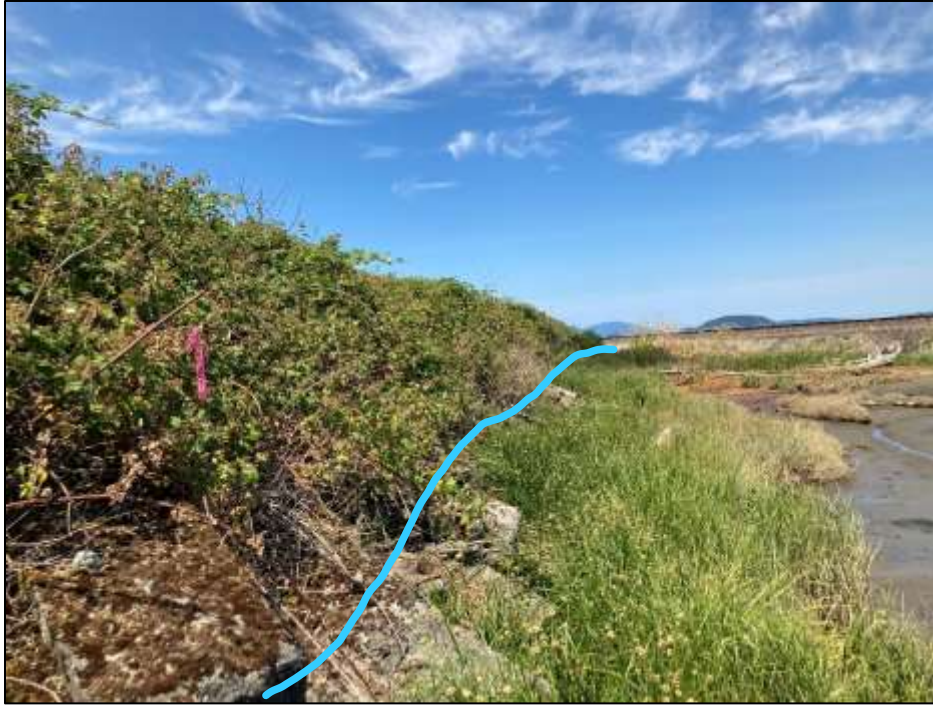
**Figure 7.** Overview of existing conditions of the Inner Lagoon OHWM.

Within the inner lagoon, indicators of the OHWM were consistent with the estuarine wetland they included water marks, persistent salt-tolerant vegetation, marine algae, and staining of iron rich sediment (Figure 7). The boundary of the marine OHWM was delineated east of the ditch-wetland area where marine waters were observed to be the dominant source of hydrology.

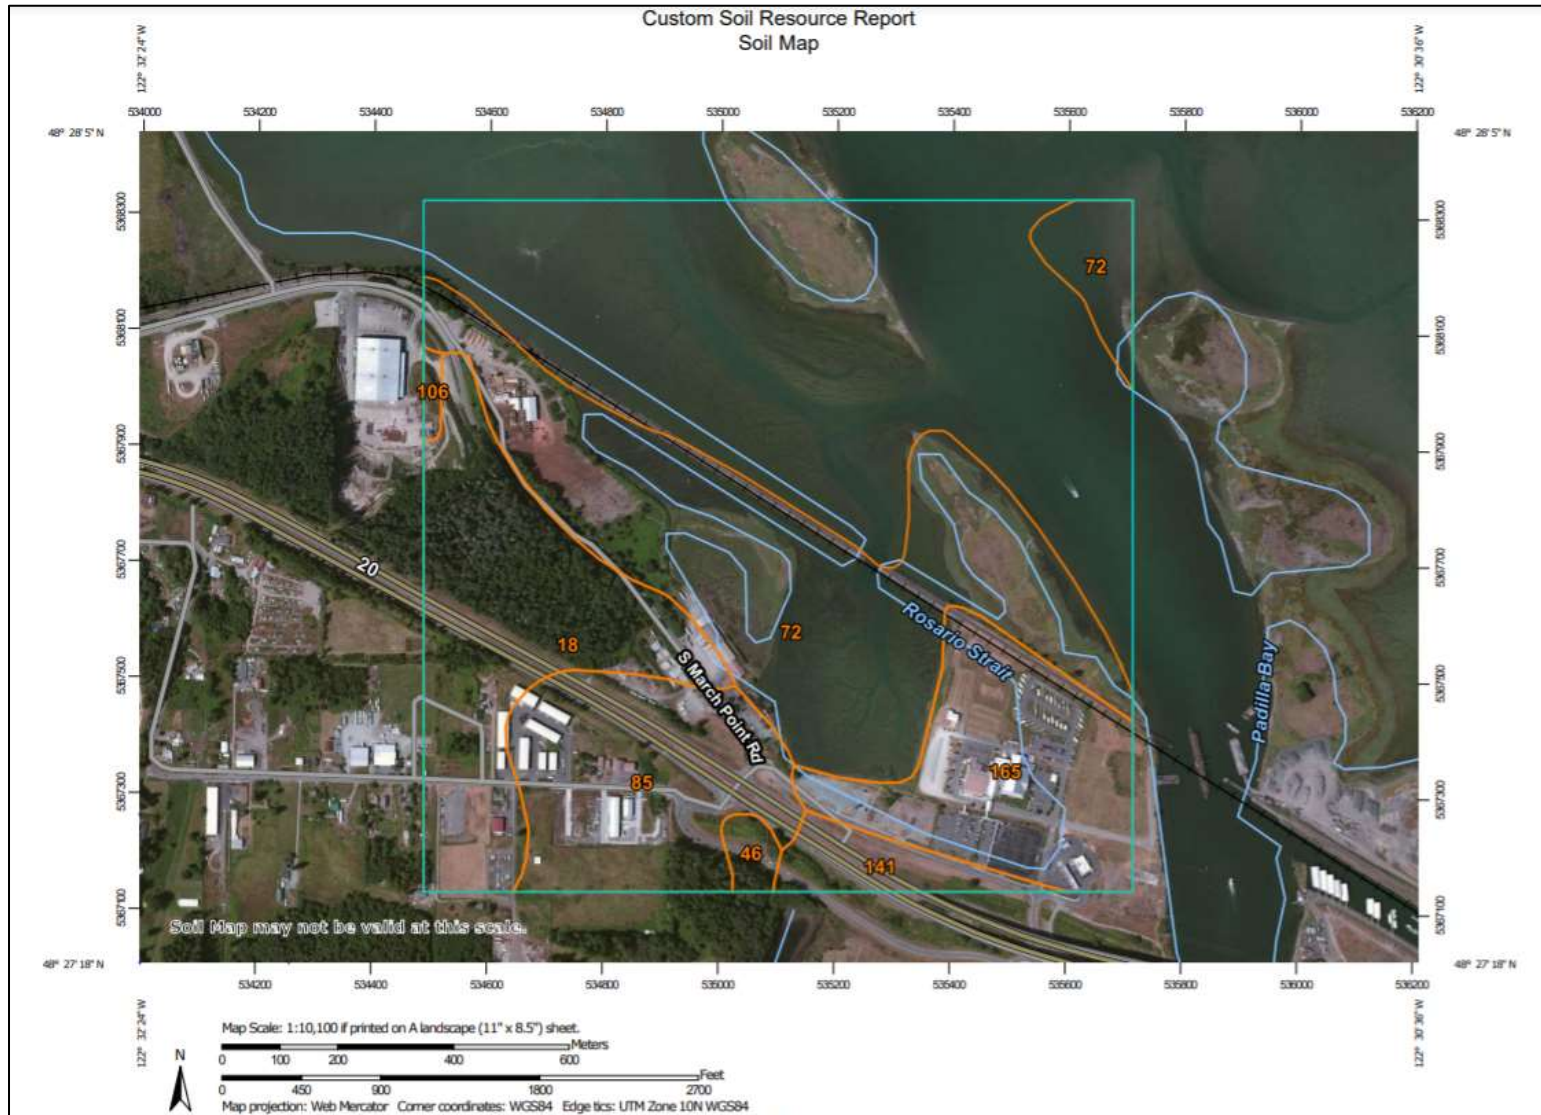
Figure B-2. Custom soil map of study area.

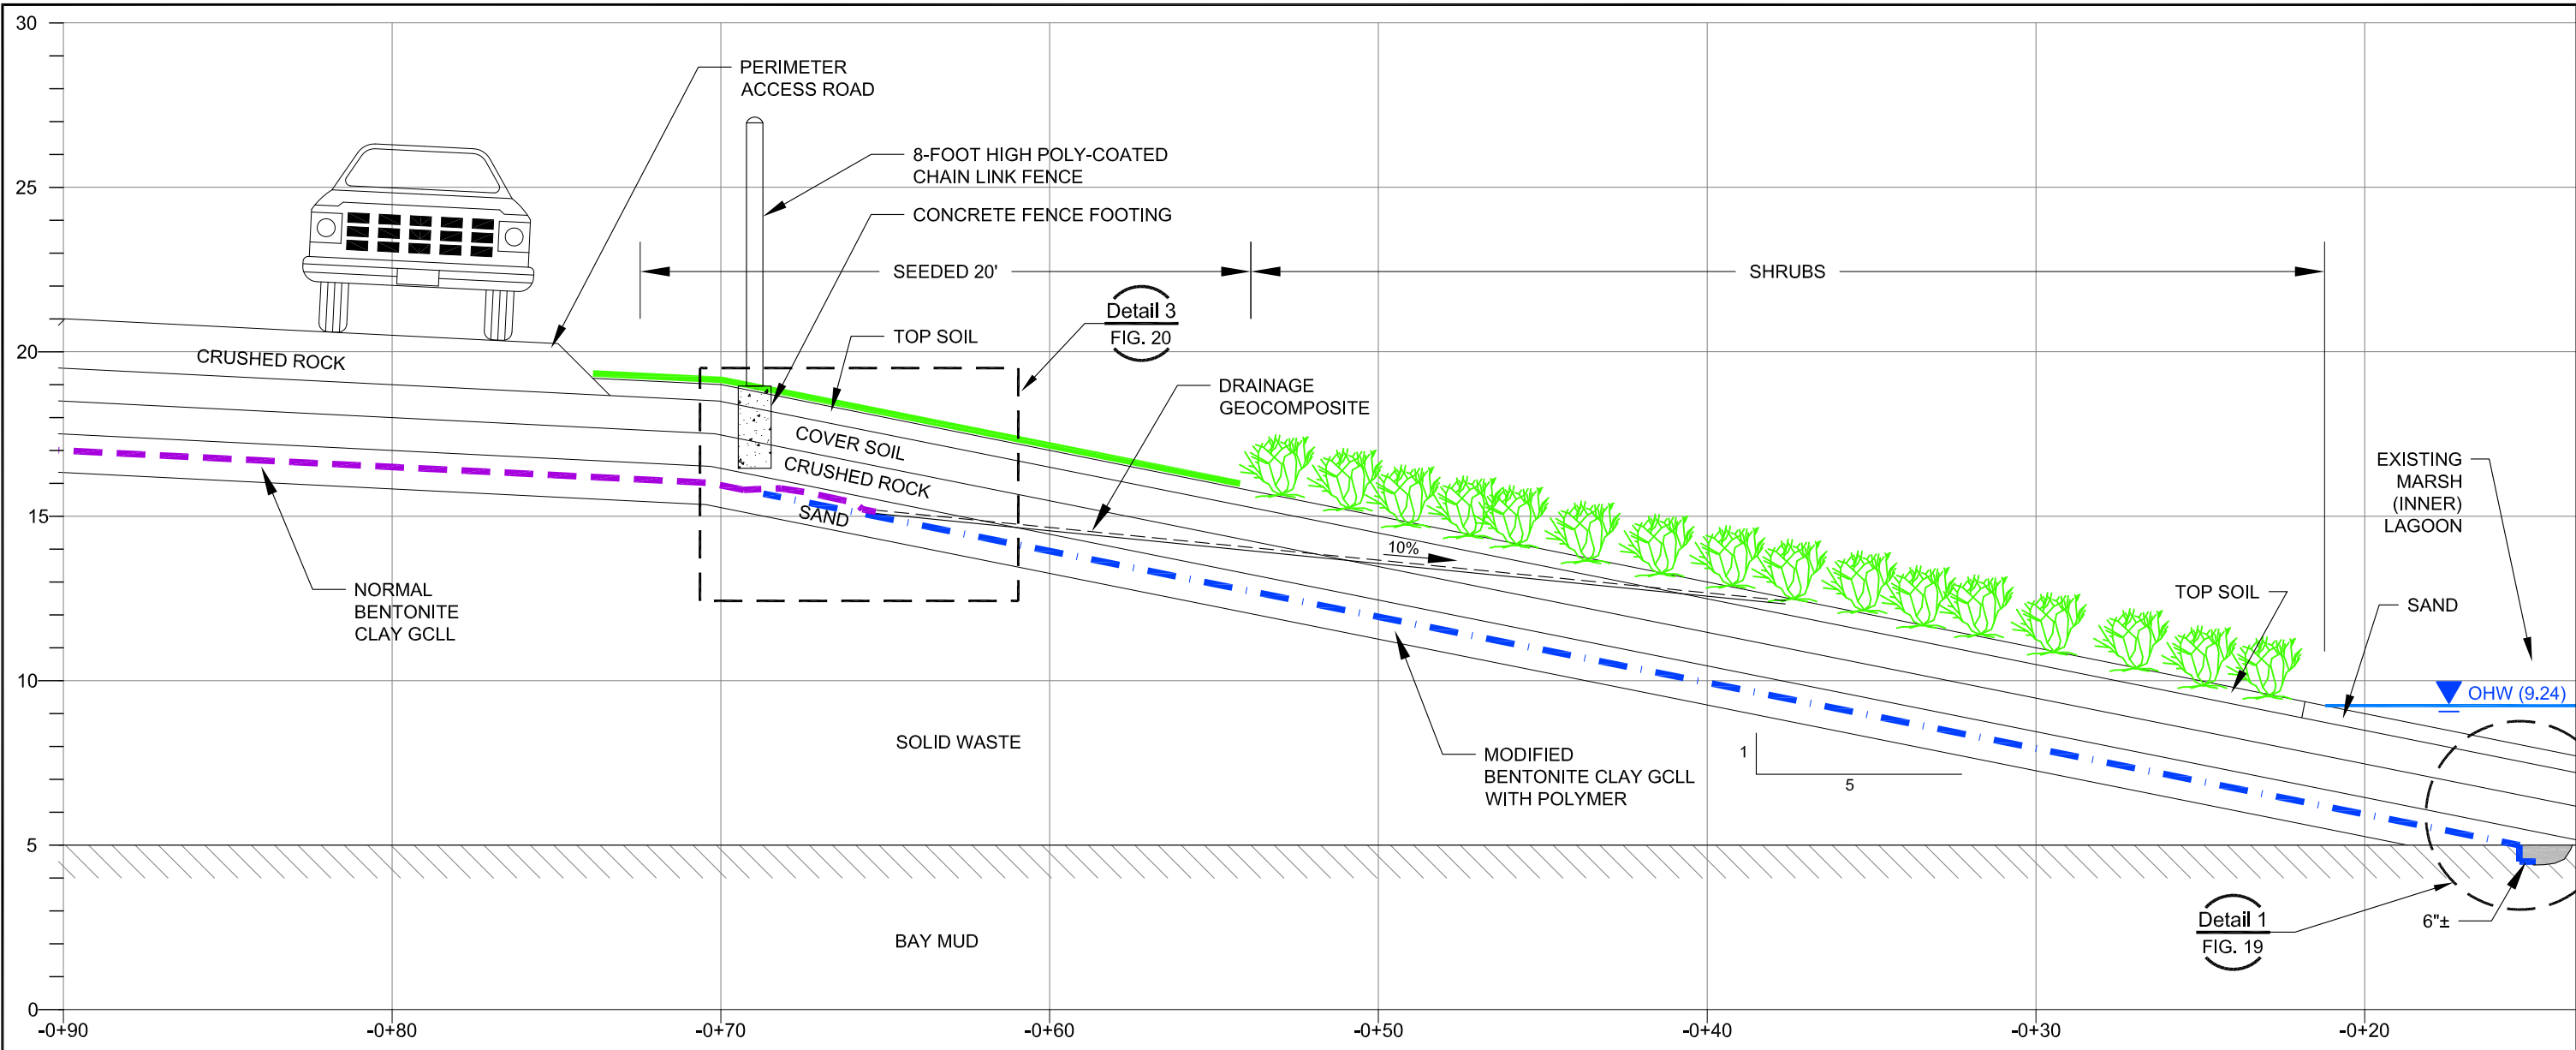
<b>SHORELINE CROSS SECTION</b> March Point (Whitmarsh) Landfill Skagit County, Washington		
By: APS	Date: 06/15/18	Project No. 14159
Amec Foster Wheeler Environment & Infrastructure, Inc.		Figure <b>3</b>

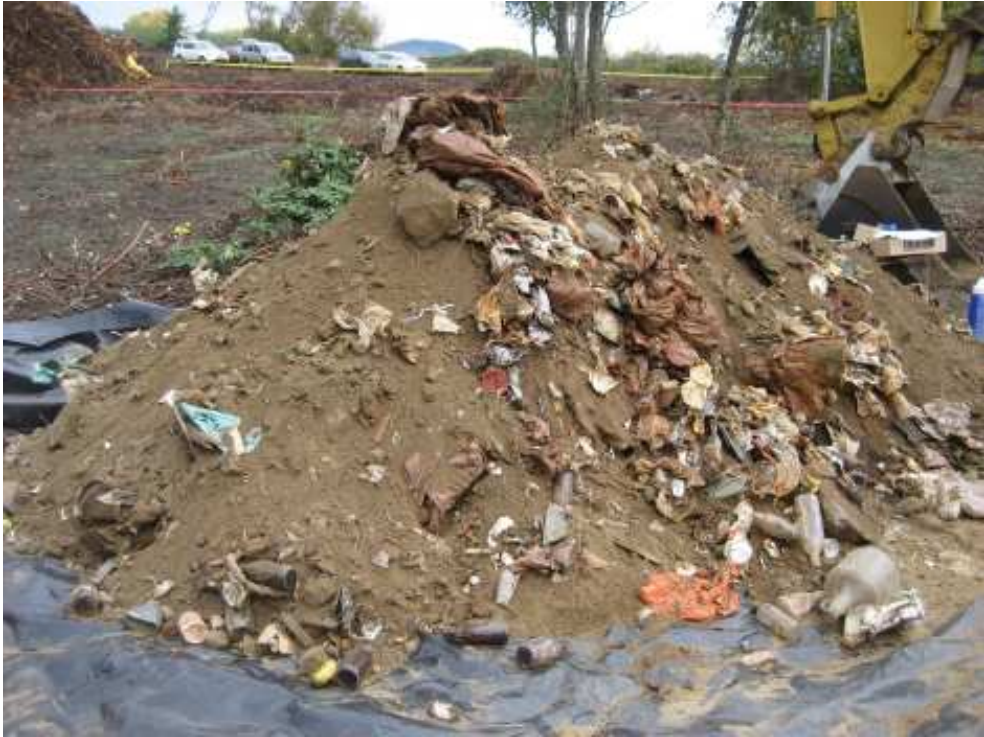
**Photo 1.** An example of landfill deposits excavated at Whitmarsh Landfill.

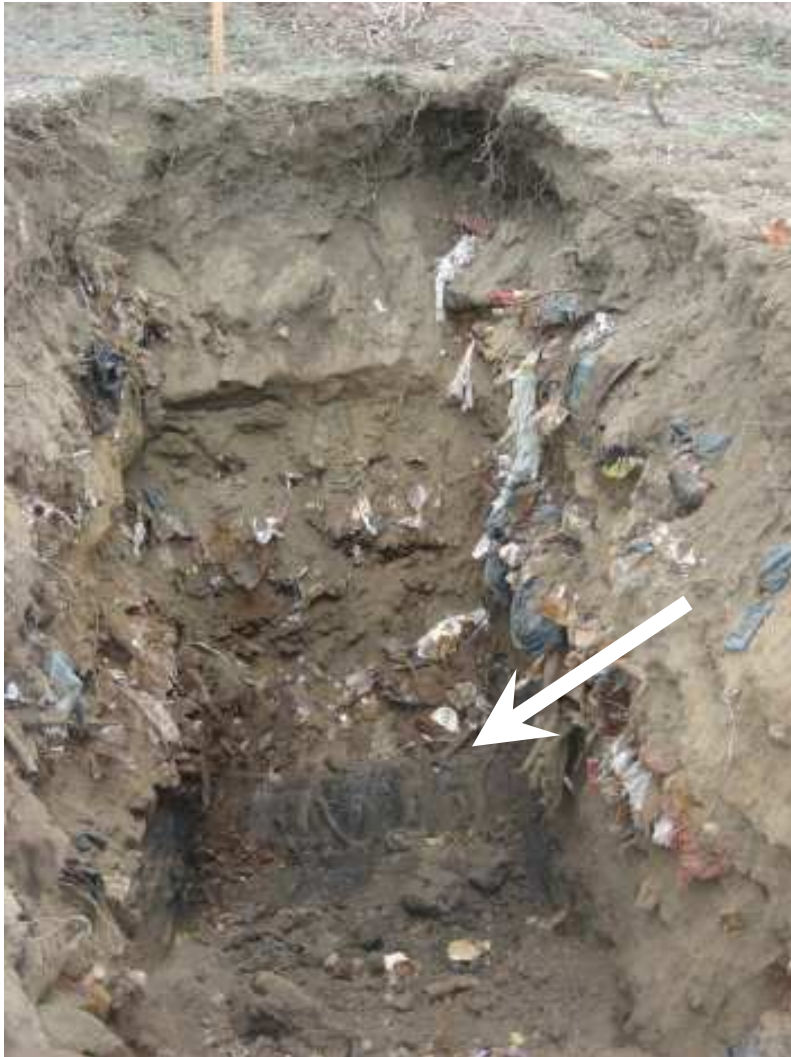
**Photo 2.** Native tide-flats exposed beneath landfill material in test pit G-7 (arrow).

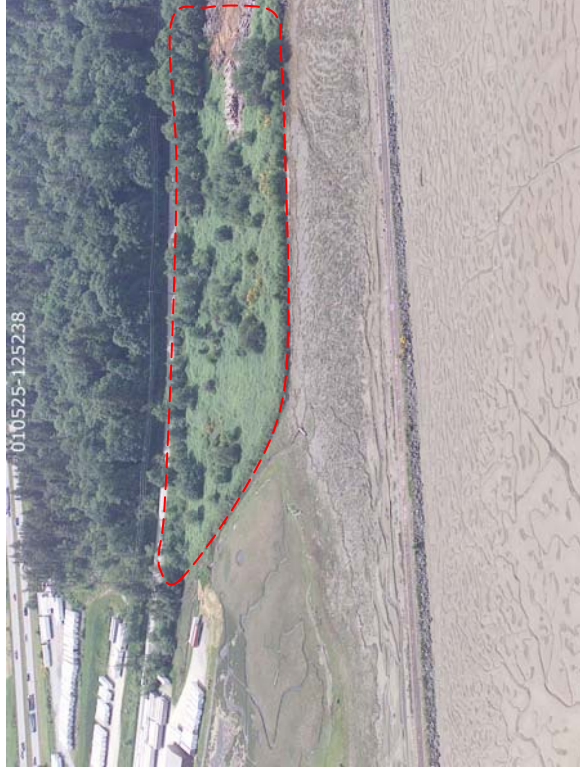
Photo 3. View looking down at Whitmarsh Landfill, circa 2009. The entire project area is not visible in this oblique aerial. This area was the focus of our field investigation.

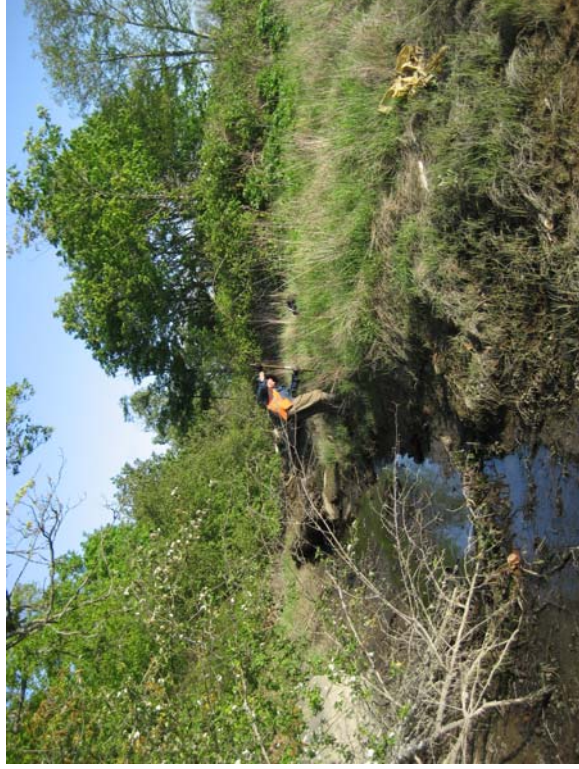
Photo 6. View looking north during shovel testing for the Whitmarsh Landfill Archaeological Survey near the southeastern corner of the APE.

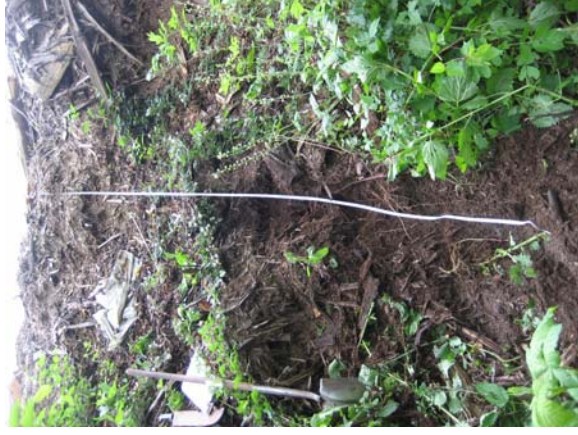
Photo 8. View looking northeast toward exposed bank above ditch that runs parallel to South March Point Road. Fieldwork was geared toward identifying native sediment vs. fill material within APE.

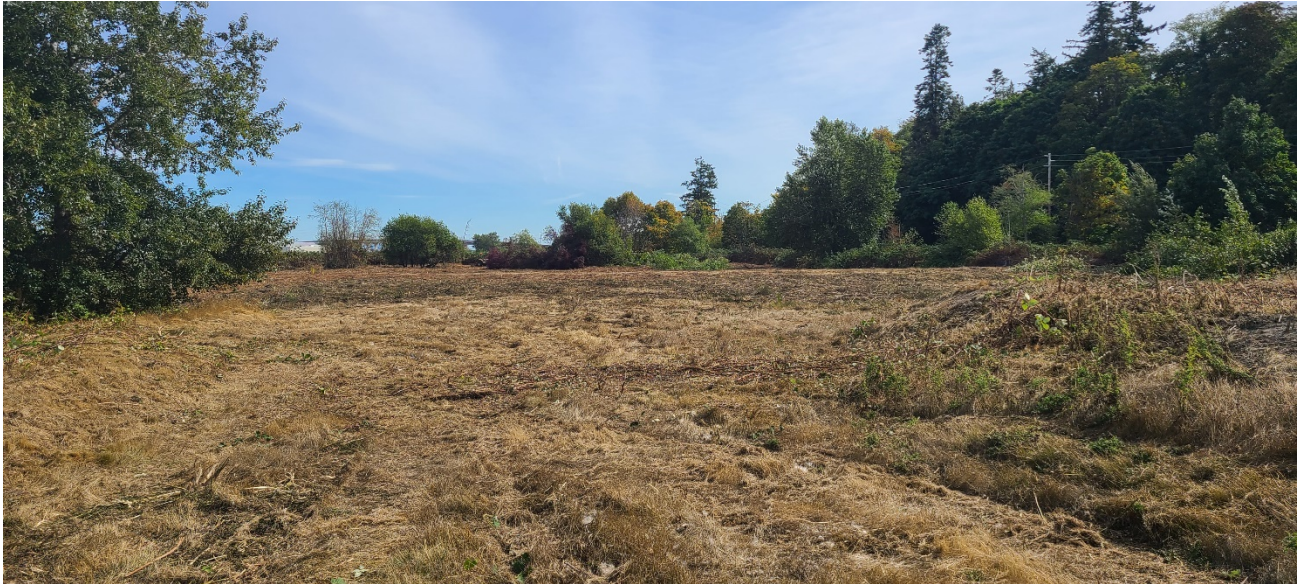
Photo 1 The project site following vegetation removal. View towards the eastern half of the project site.

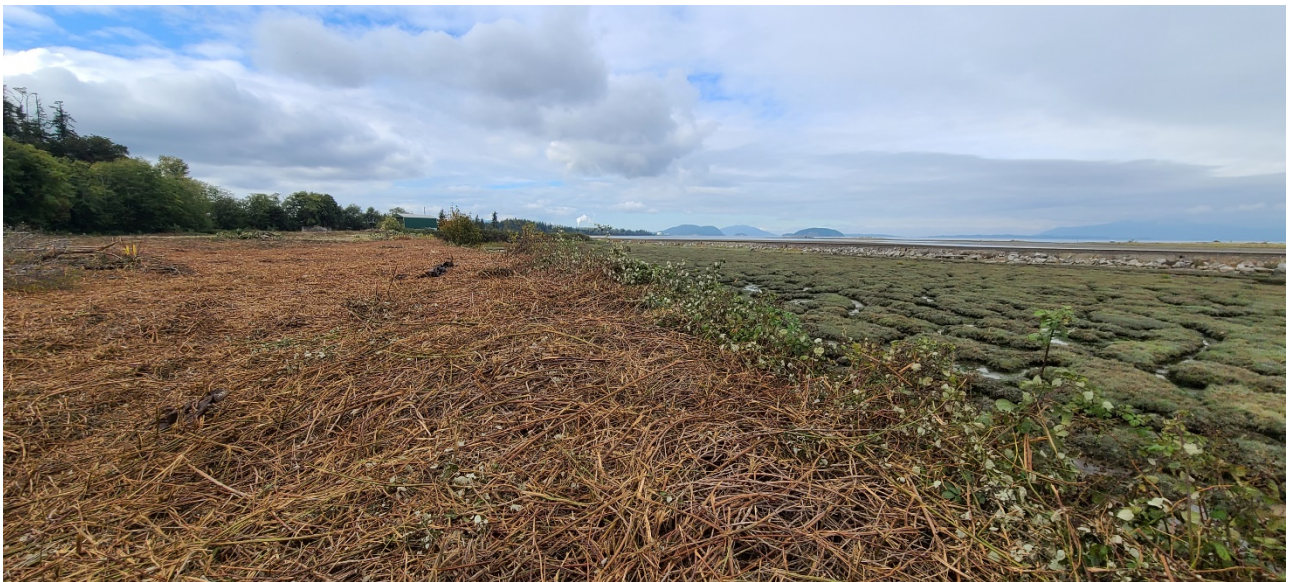
Photo 2 The project site following vegetation removal. View towards the western half of the project site. Adjacent to the project site is the Padilla Bay inner lagoon area.

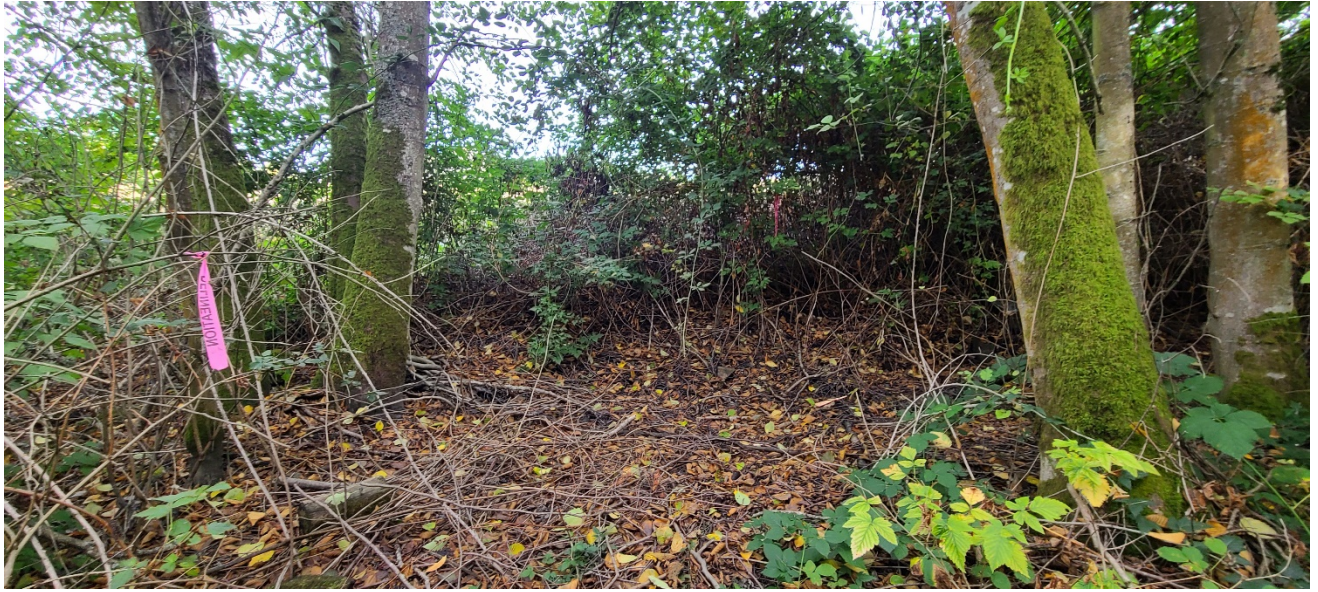
Photo 3 View of Wetland B (palustrine emergent) associated with ditch (western half) along the southern edge of the project site.

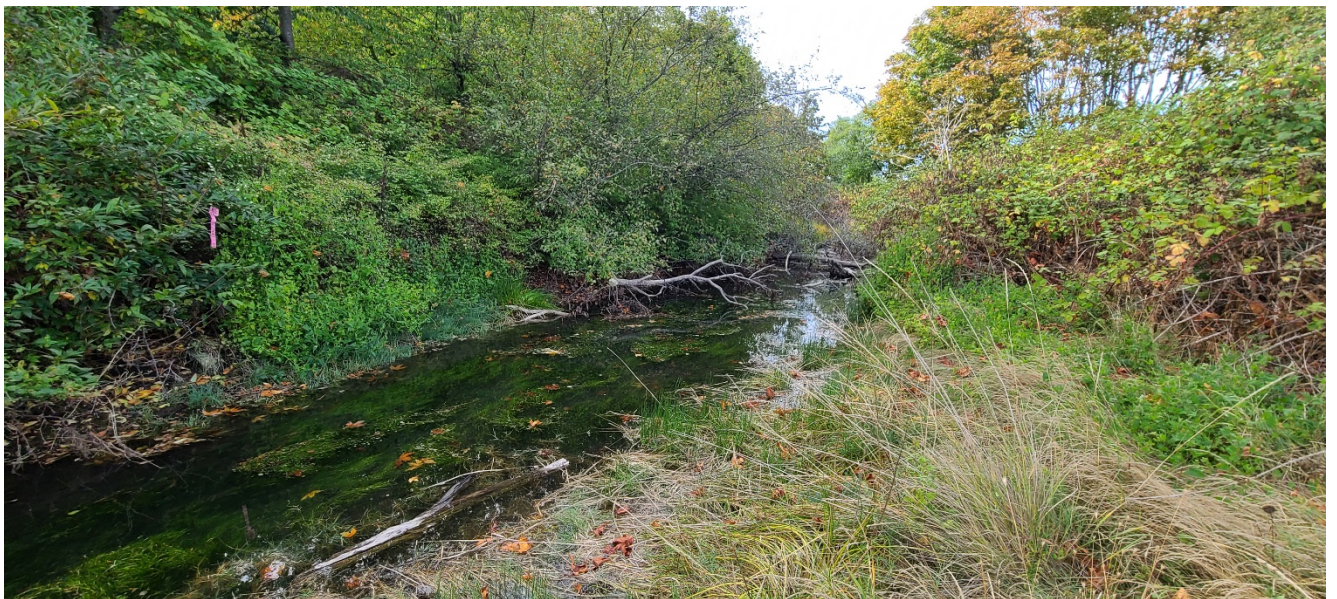
Photo 4 View of Wetland B (palustrine emergent) associated with ditch (eastern half) along the southern edge of the project site.

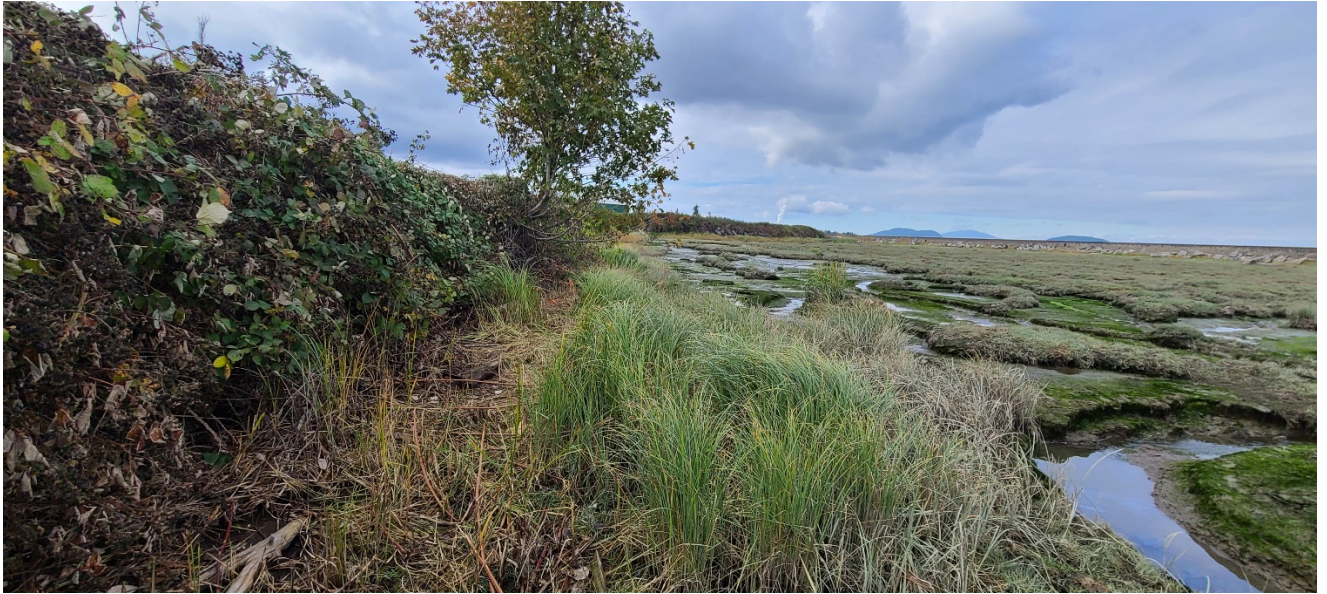
Photo 5 Looking towards the northwestern portion of Wetland A (estuarine marsh) of the project site along the Padilla Bay inner lagoon shoreline.

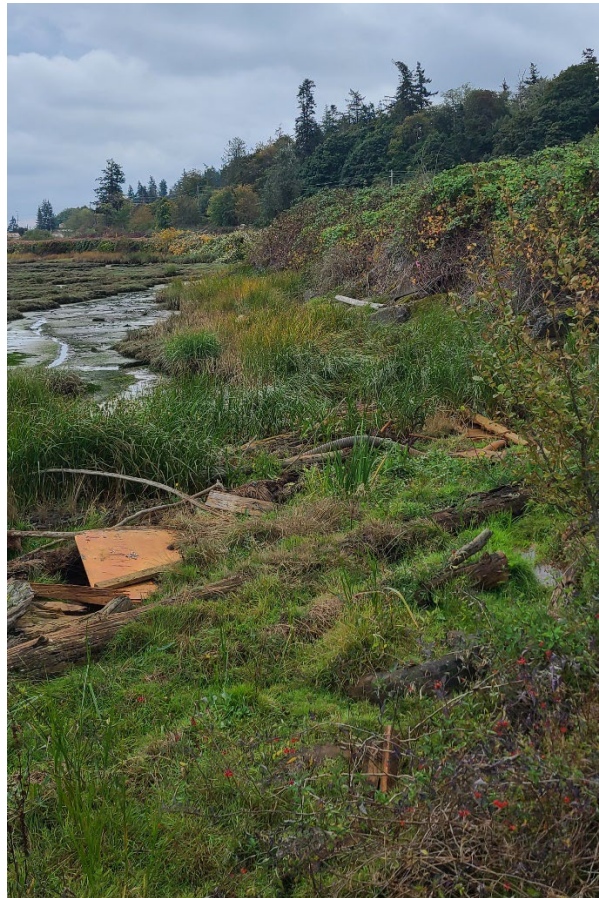
Photo 6 Looking towards the southeastern portion Wetland A (estuarine marsh) of the project site along the Padilla Bay inner lagoon shoreline.

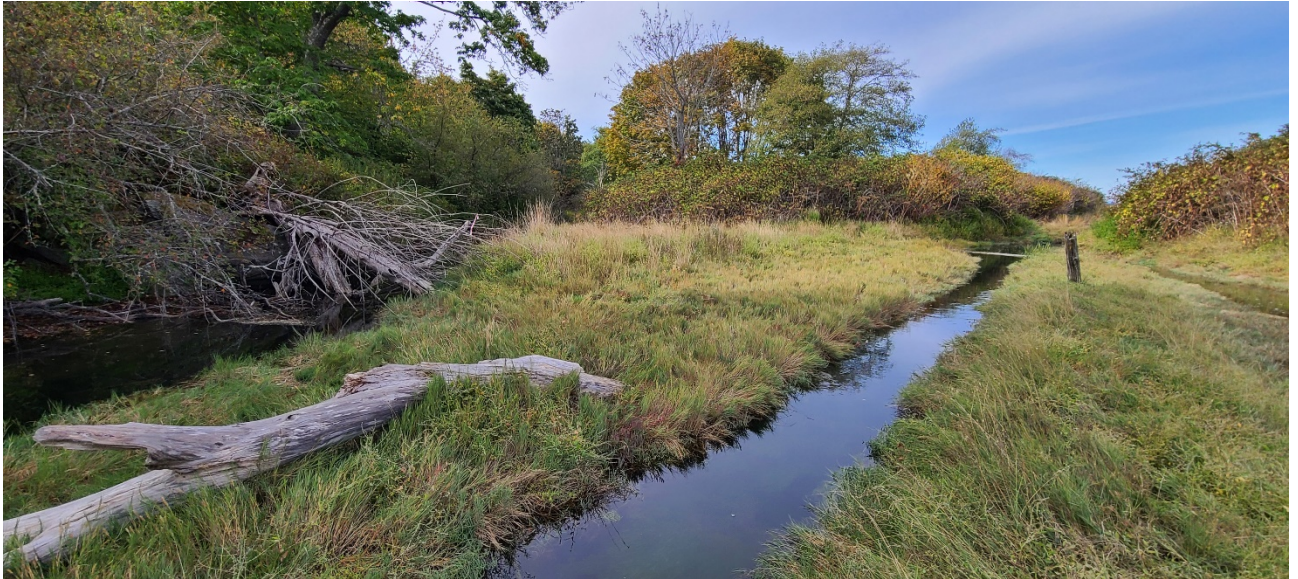
Photo 7 View of Wetland A (estuarine marsh) located at most eastern portion of the project site along the Padilla Bay inner lagoon.

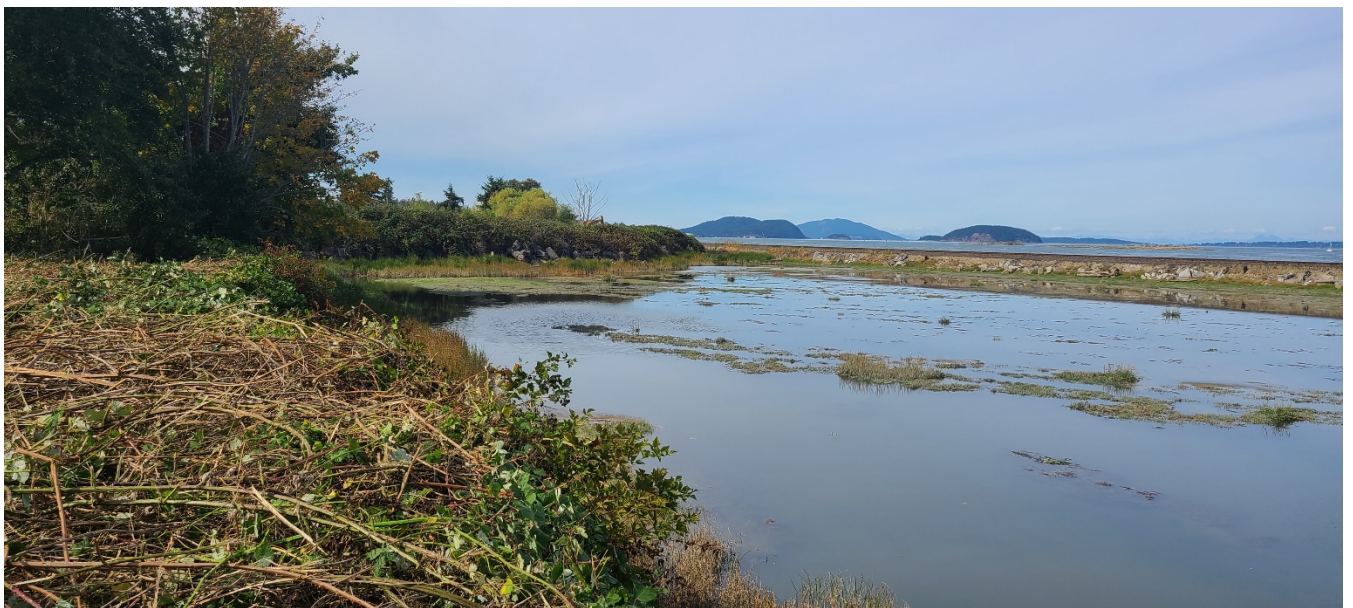
Photo 8 View of tidally influenced Wetland A (estuarine marsh) of the Padilla bay inner lagoon located along the eastern portion of the project site.
