Lake Goodwin Landfill 2010 1st Quarter Groundwater Monitoring Report

1.0 INTRODUCTION

The following report presents the first quarter ground water monitoring results for 2010 at the Lake Goodwin Landfill (*Lake Goodwin Landfill, Site*). The site is located immediately west of Frank Waters Road in northwestern Snohomish County, about one and one half (1.5) miles northwest of Lake Goodwin and about five-(5) miles south of Stanwood (*T31N, R4E, sections 17, 20 Willamette Meridian*). The landfill is located at 18520 Frank Waters Road, Stanwood, Washington, 98292. The location of the site relative to existing municipal improvements is shown on the **Vicinity Map** (*figure 1*).

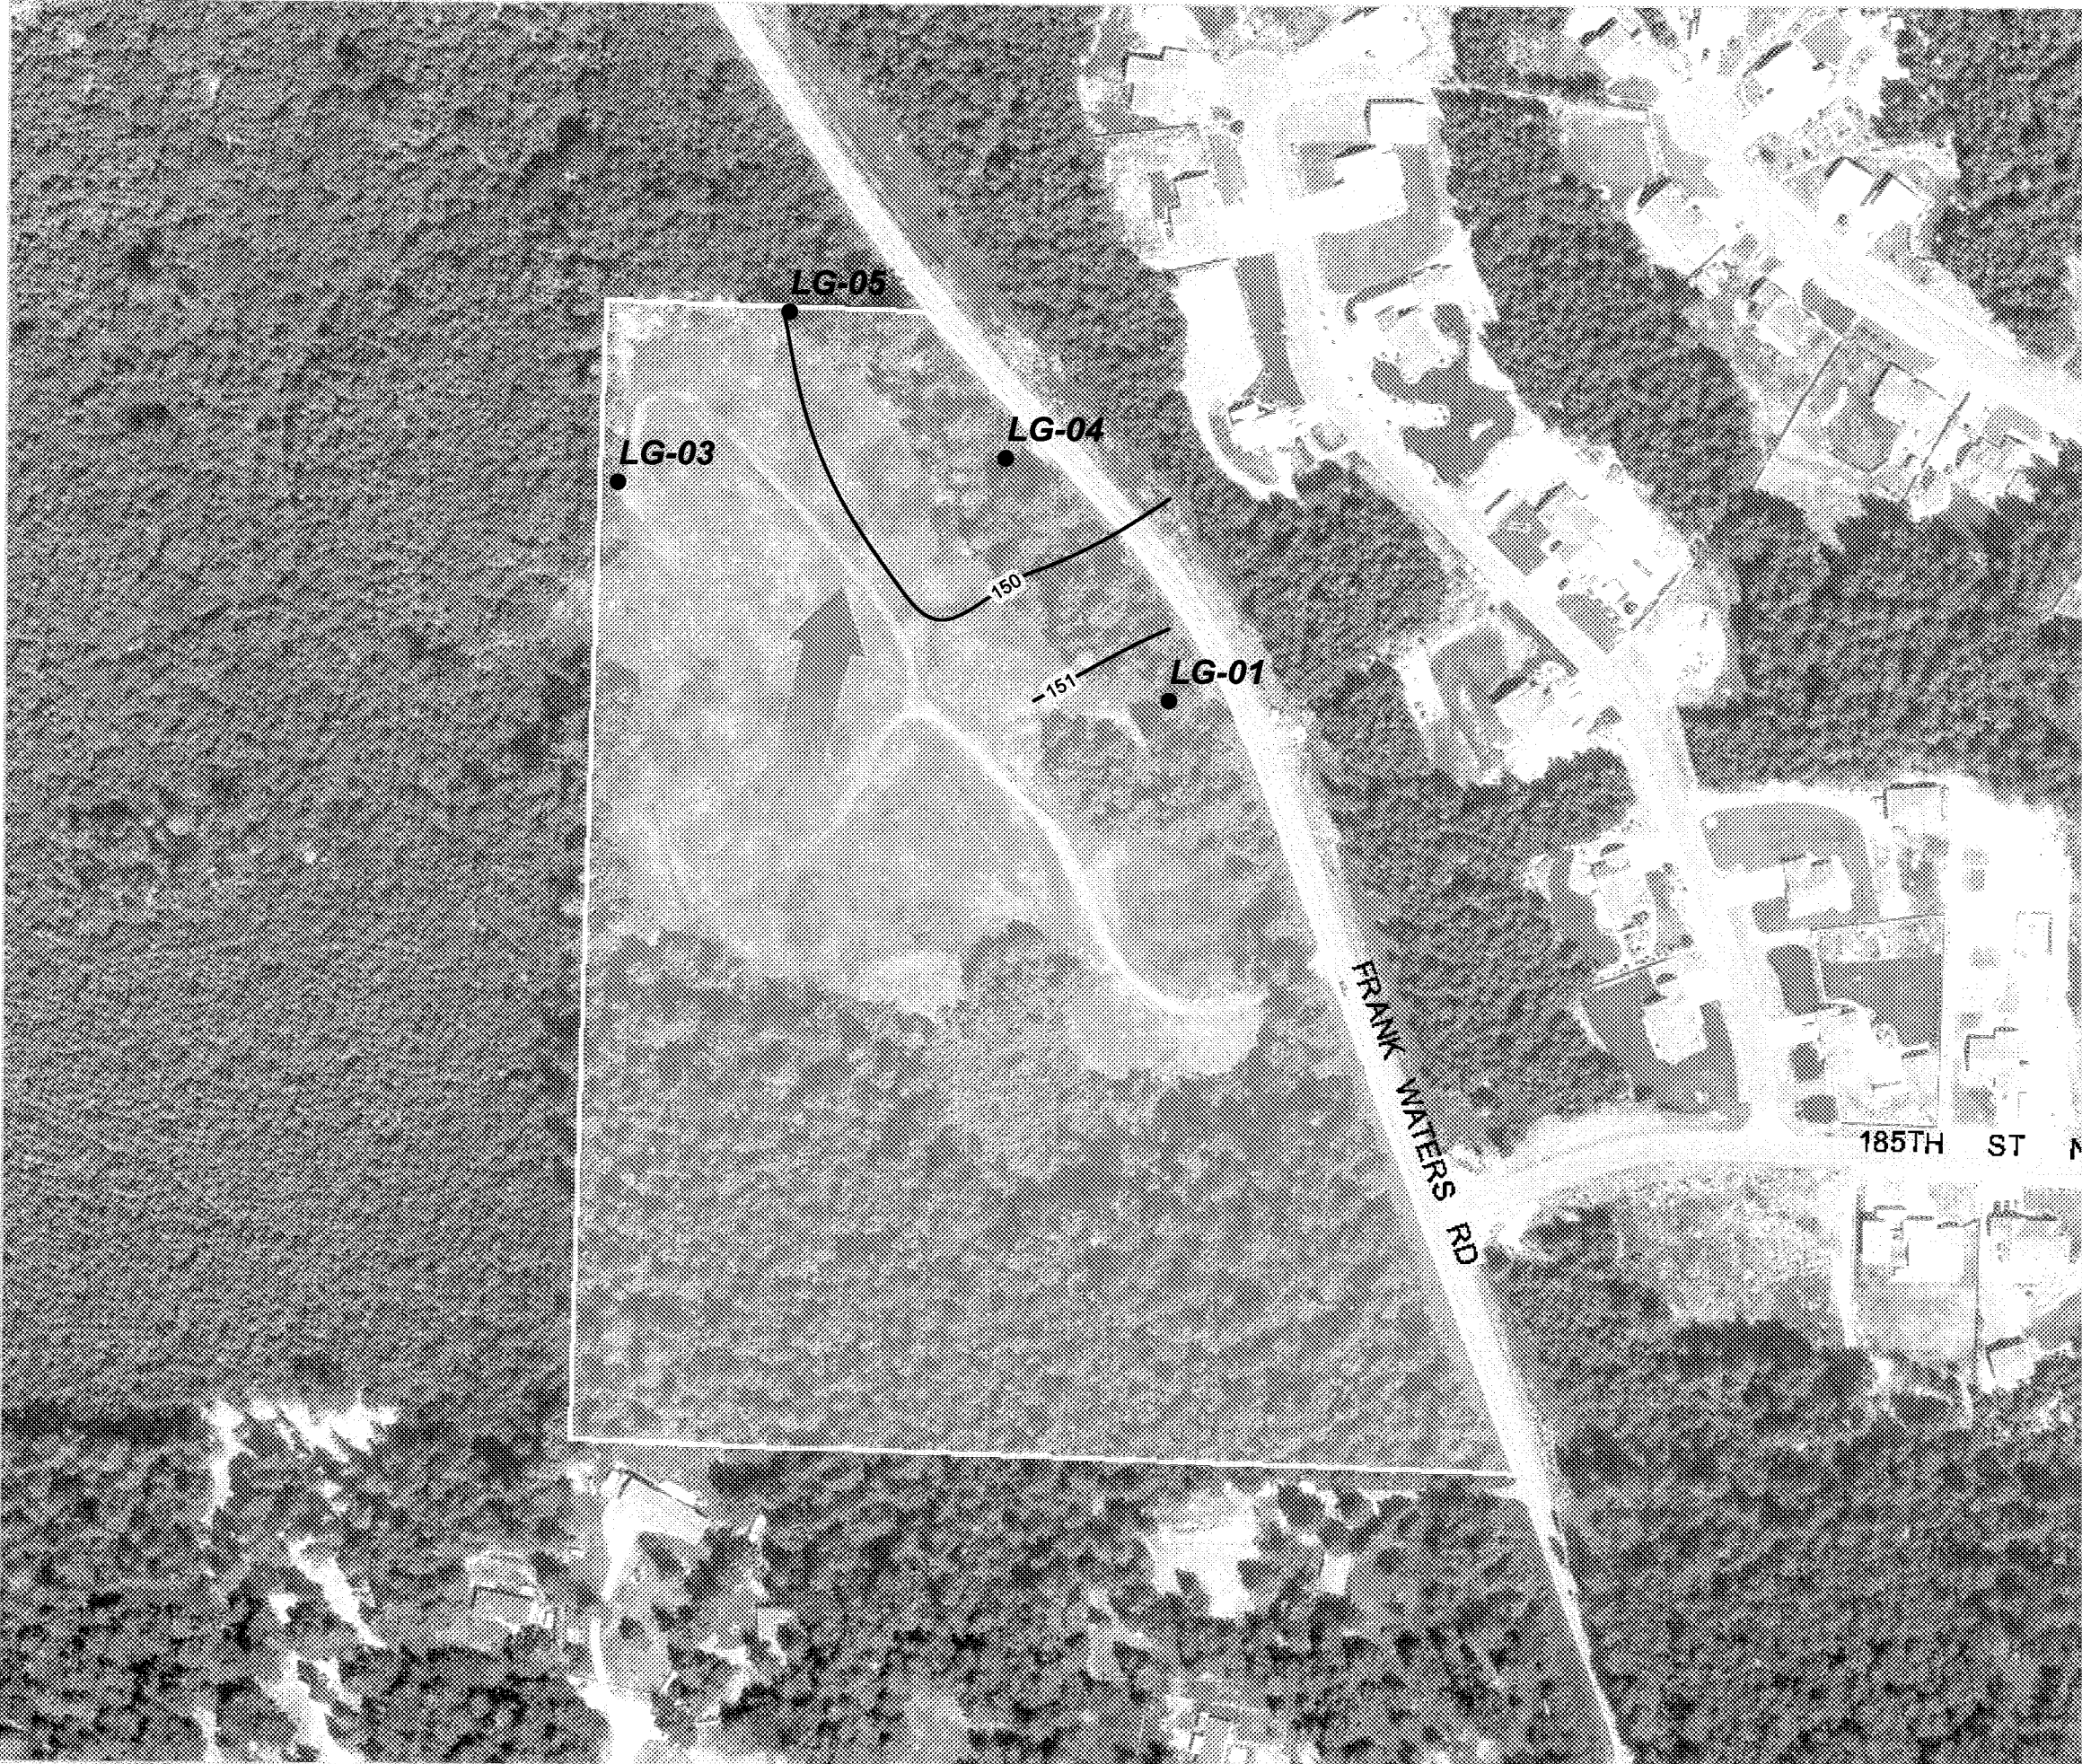
Figure 6

Water Elevation Contours
1st Quarter 2010

DIRECTION OF GROUNDWATER FLOW
2.31 ft/day
843 ft/year
75.27 degrees to the positive x-axis
-

WELL_ID	SAMP_DATE	MEAS_HEAD
LG-01	01/20/2010	151.56
LG-03	01/20/2010	150.59
LG-04	01/20/2010	149.22
LG-05	01/20/2010	149.98

First Quarter Ground Water Measurements are shown in *Table 1* below. **Hydrographs** of the first quarter 2010 monitoring well readings are contained in *Appendix A* of this report. Based on the ground water readings, small fluctuations in the ground water gradient below the site were observed. Overall ground water elevations remained fairly constant between the monitoring events. Readings suggest that the aquifer is unconfined in the immediate vicinity of the site. The **First Quarter Ground Water Contour Map** developed from the field data is shown in *Figure 6* of this report.
