Lake Goodwin Landfill 2010 3rd Quarter Groundwater Monitoring Report

The following report presents the third quarter ground water monitoring results for 2010 at the Lake Goodwin Landfill (*Lake Goodwin Landfill, Site*). The site is located immediately west of Frank Waters Road in northwestern Snohomish County, about one and one half (1.5) miles northwest of Lake Goodwin and about five-(5) miles south of Stanwood (*T31N, R4E, sections 17, 20 Willamette Meridian*). The landfill is located at 18520 Frank Waters Road, Stanwood, Washington, 98292. The location of the site relative to existing municipal improvements is shown on the **Vicinity Map** (*figure 1*).

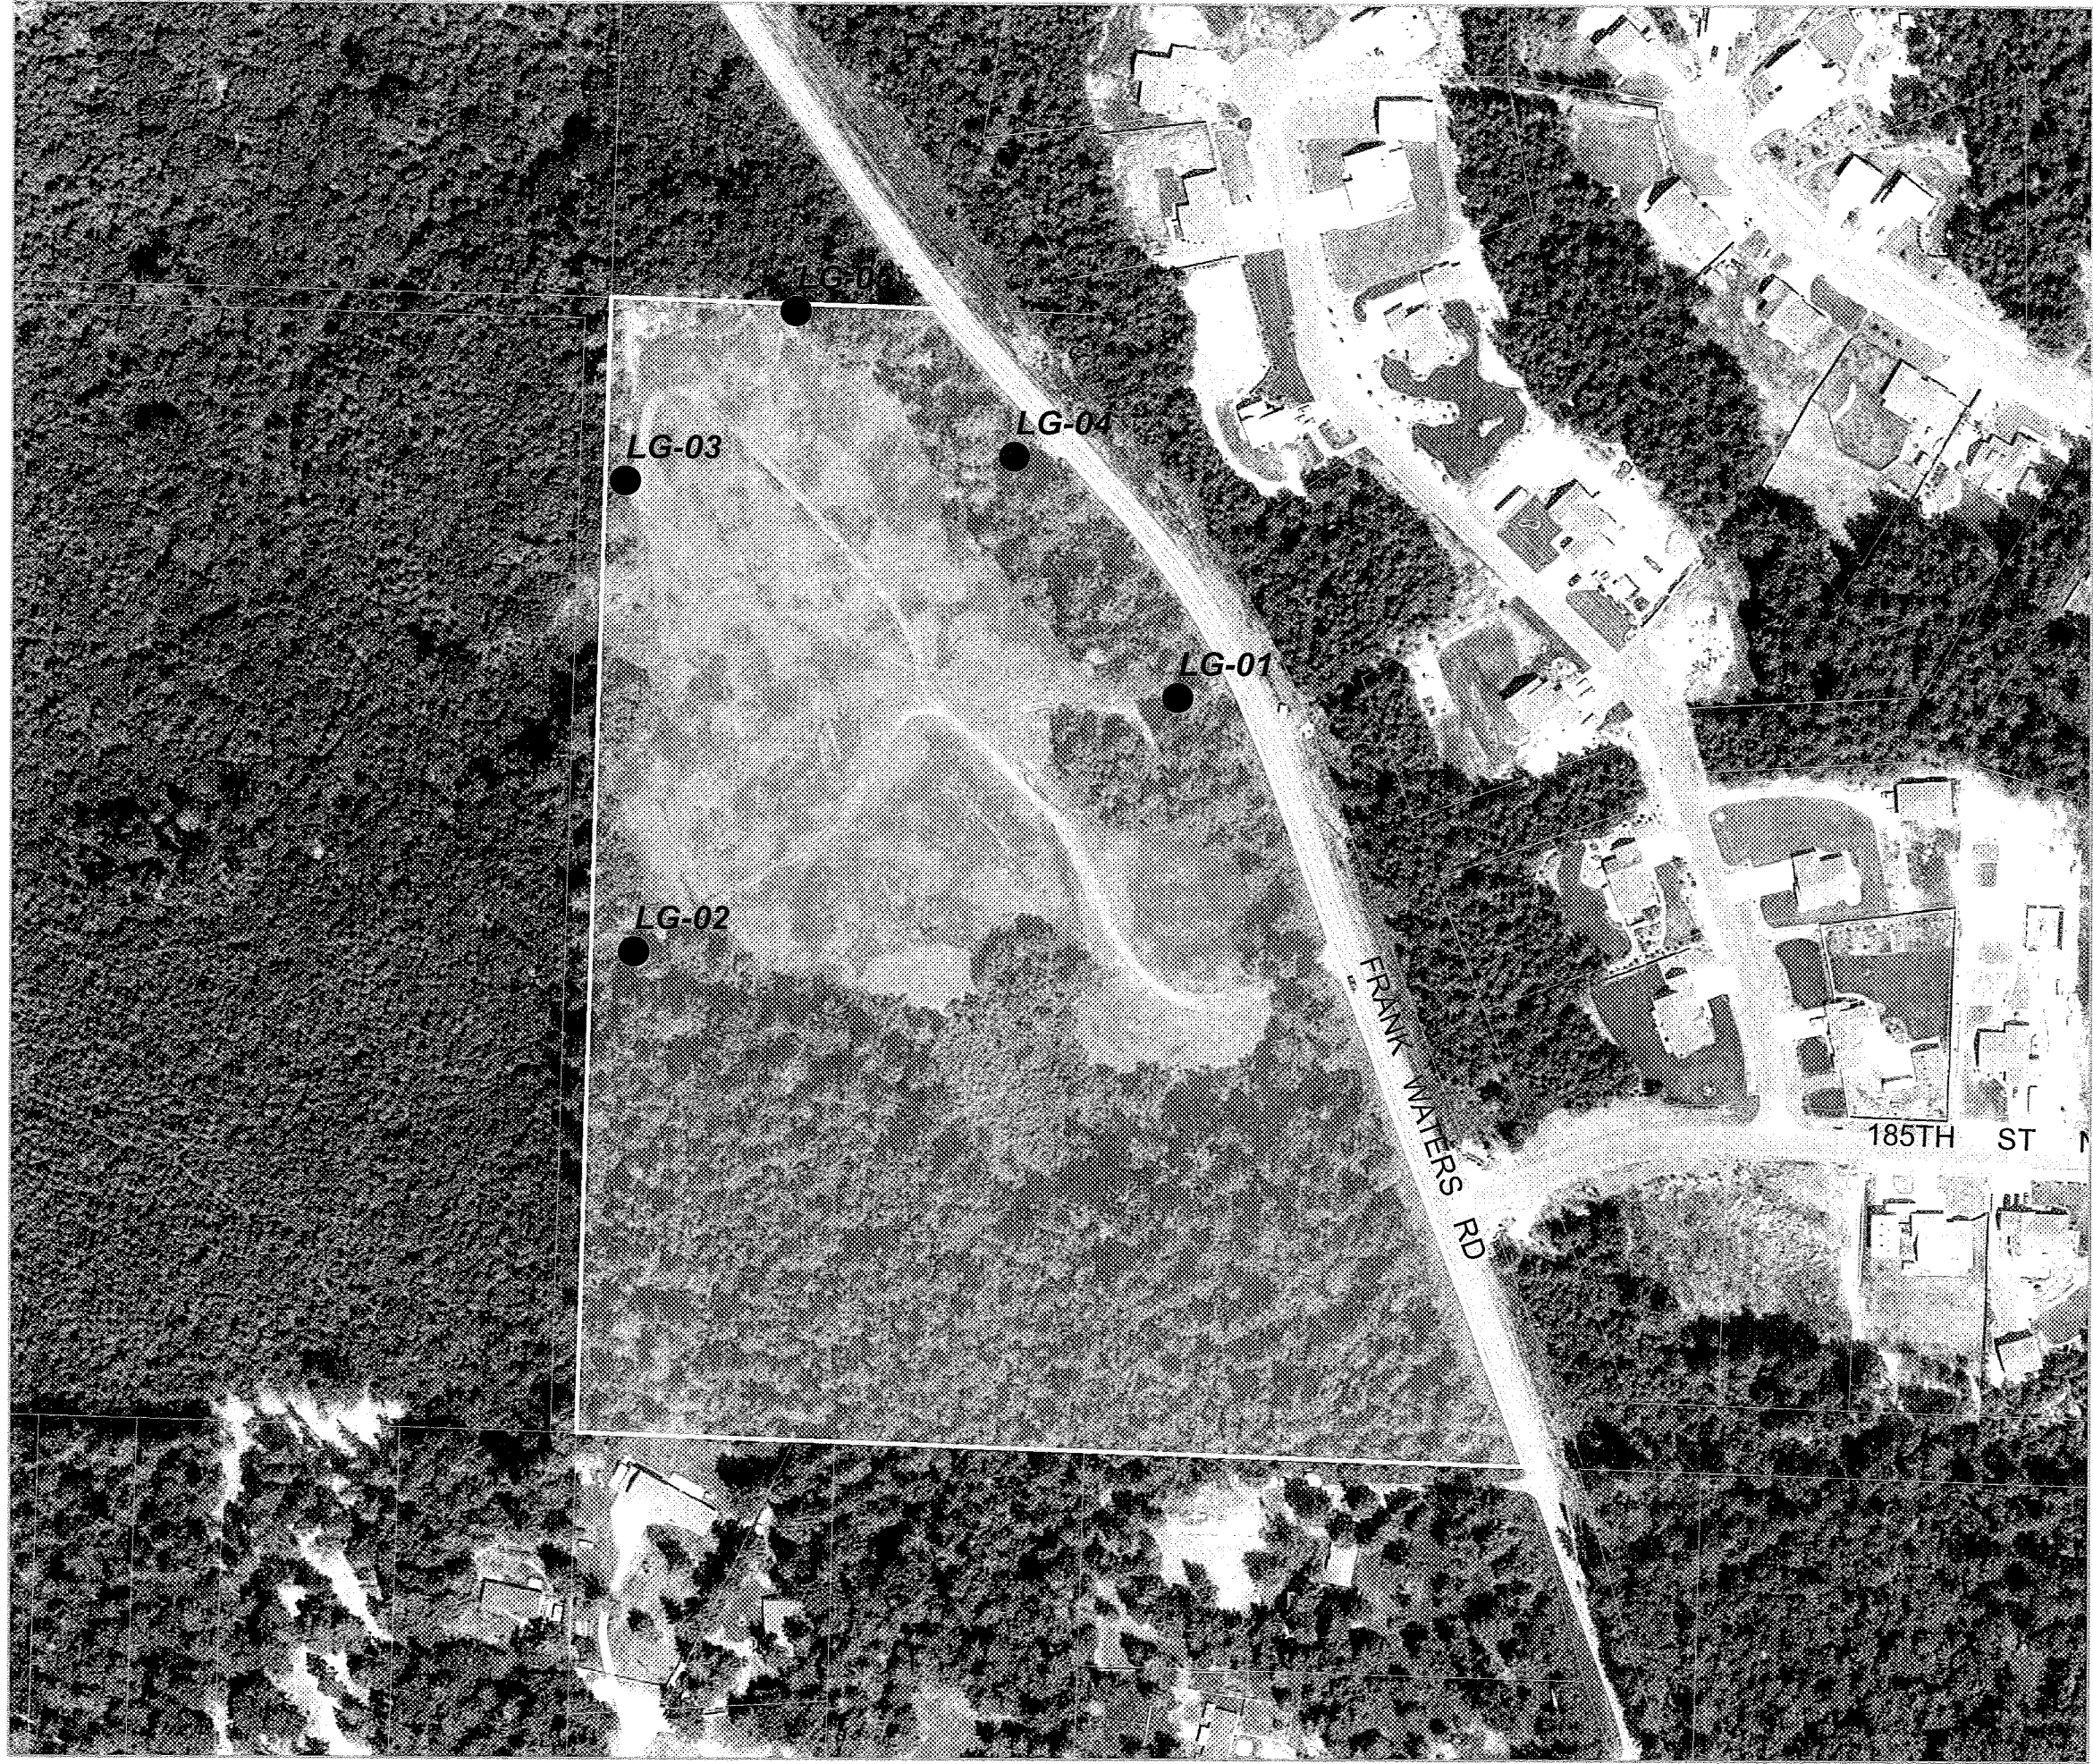
Figure 6

Water Elevation Contours
3rd Quarter 2010

DIRECTION OF GROUNDWATER FLOW
.609 ft/day
222 ft/year
26.56 degrees to the positive x-axis
-

WELL_ID	SAMP_DATE	MEAS_HEAD
LG-01	7/13/2010	151.05
LG-02	7/13/2010	150.86
LG-03	7/13/2010	151.59
LG-04	7/16/2010	149.73
LG-05	7/13/2010	150.62

the site. The **Third Quarter Ground Water Contour Map** developed from the field data is shown in *Figure 6* of this report.
