Lake Goodwin Landfill 2010 4th Quarter Groundwater Monitoring Report

The following report presents the fourth quarter ground water monitoring results for 2010 at the Lake Goodwin Landfill (*Lake Goodwin Landfill, Site*). The site is located immediately west of Frank Waters Road in northwestern Snohomish County, about one and one half (1.5) miles northwest of Lake Goodwin and about five-(5) miles south of Stanwood (*T31N, R4E, sections 17, 20 Willamette Meridian*). The landfill is located at 18520 Frank Waters Road, Stanwood, Washington, 98292. The location of the site relative to existing municipal improvements is shown on the **Vicinity Map** (*figure 1*).

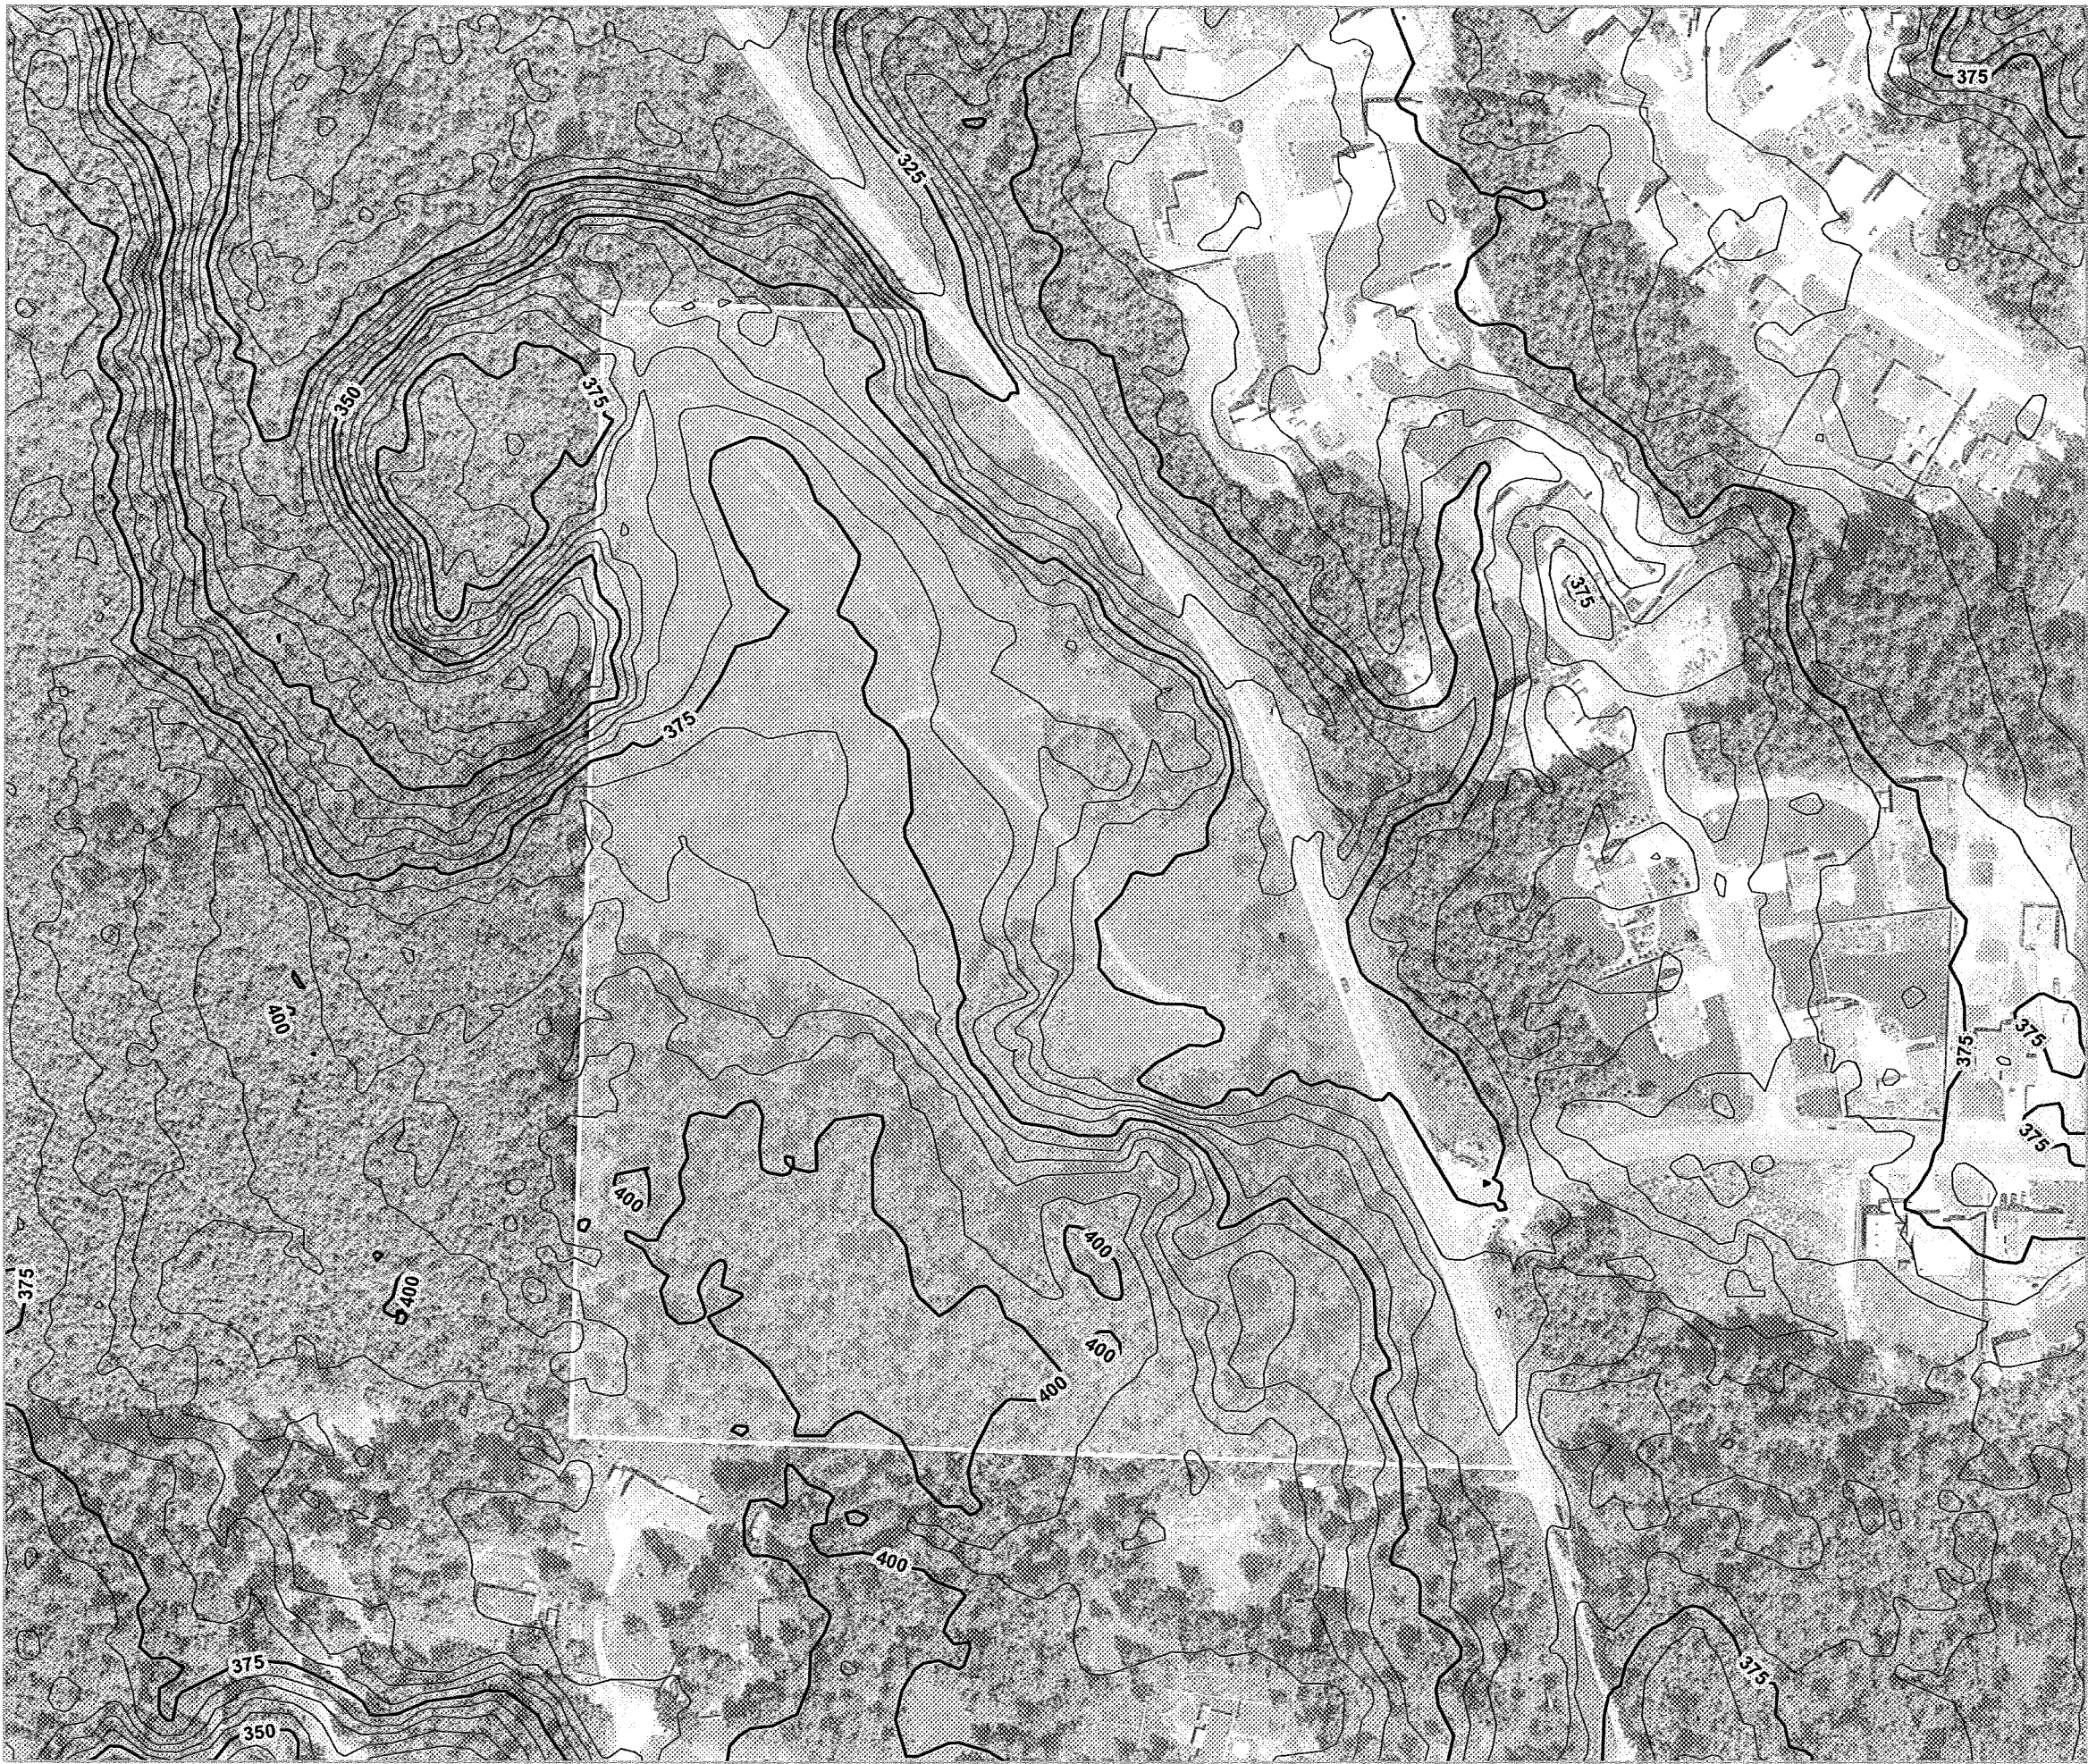
Figure 3

Lake Goodwin Landfill Topography

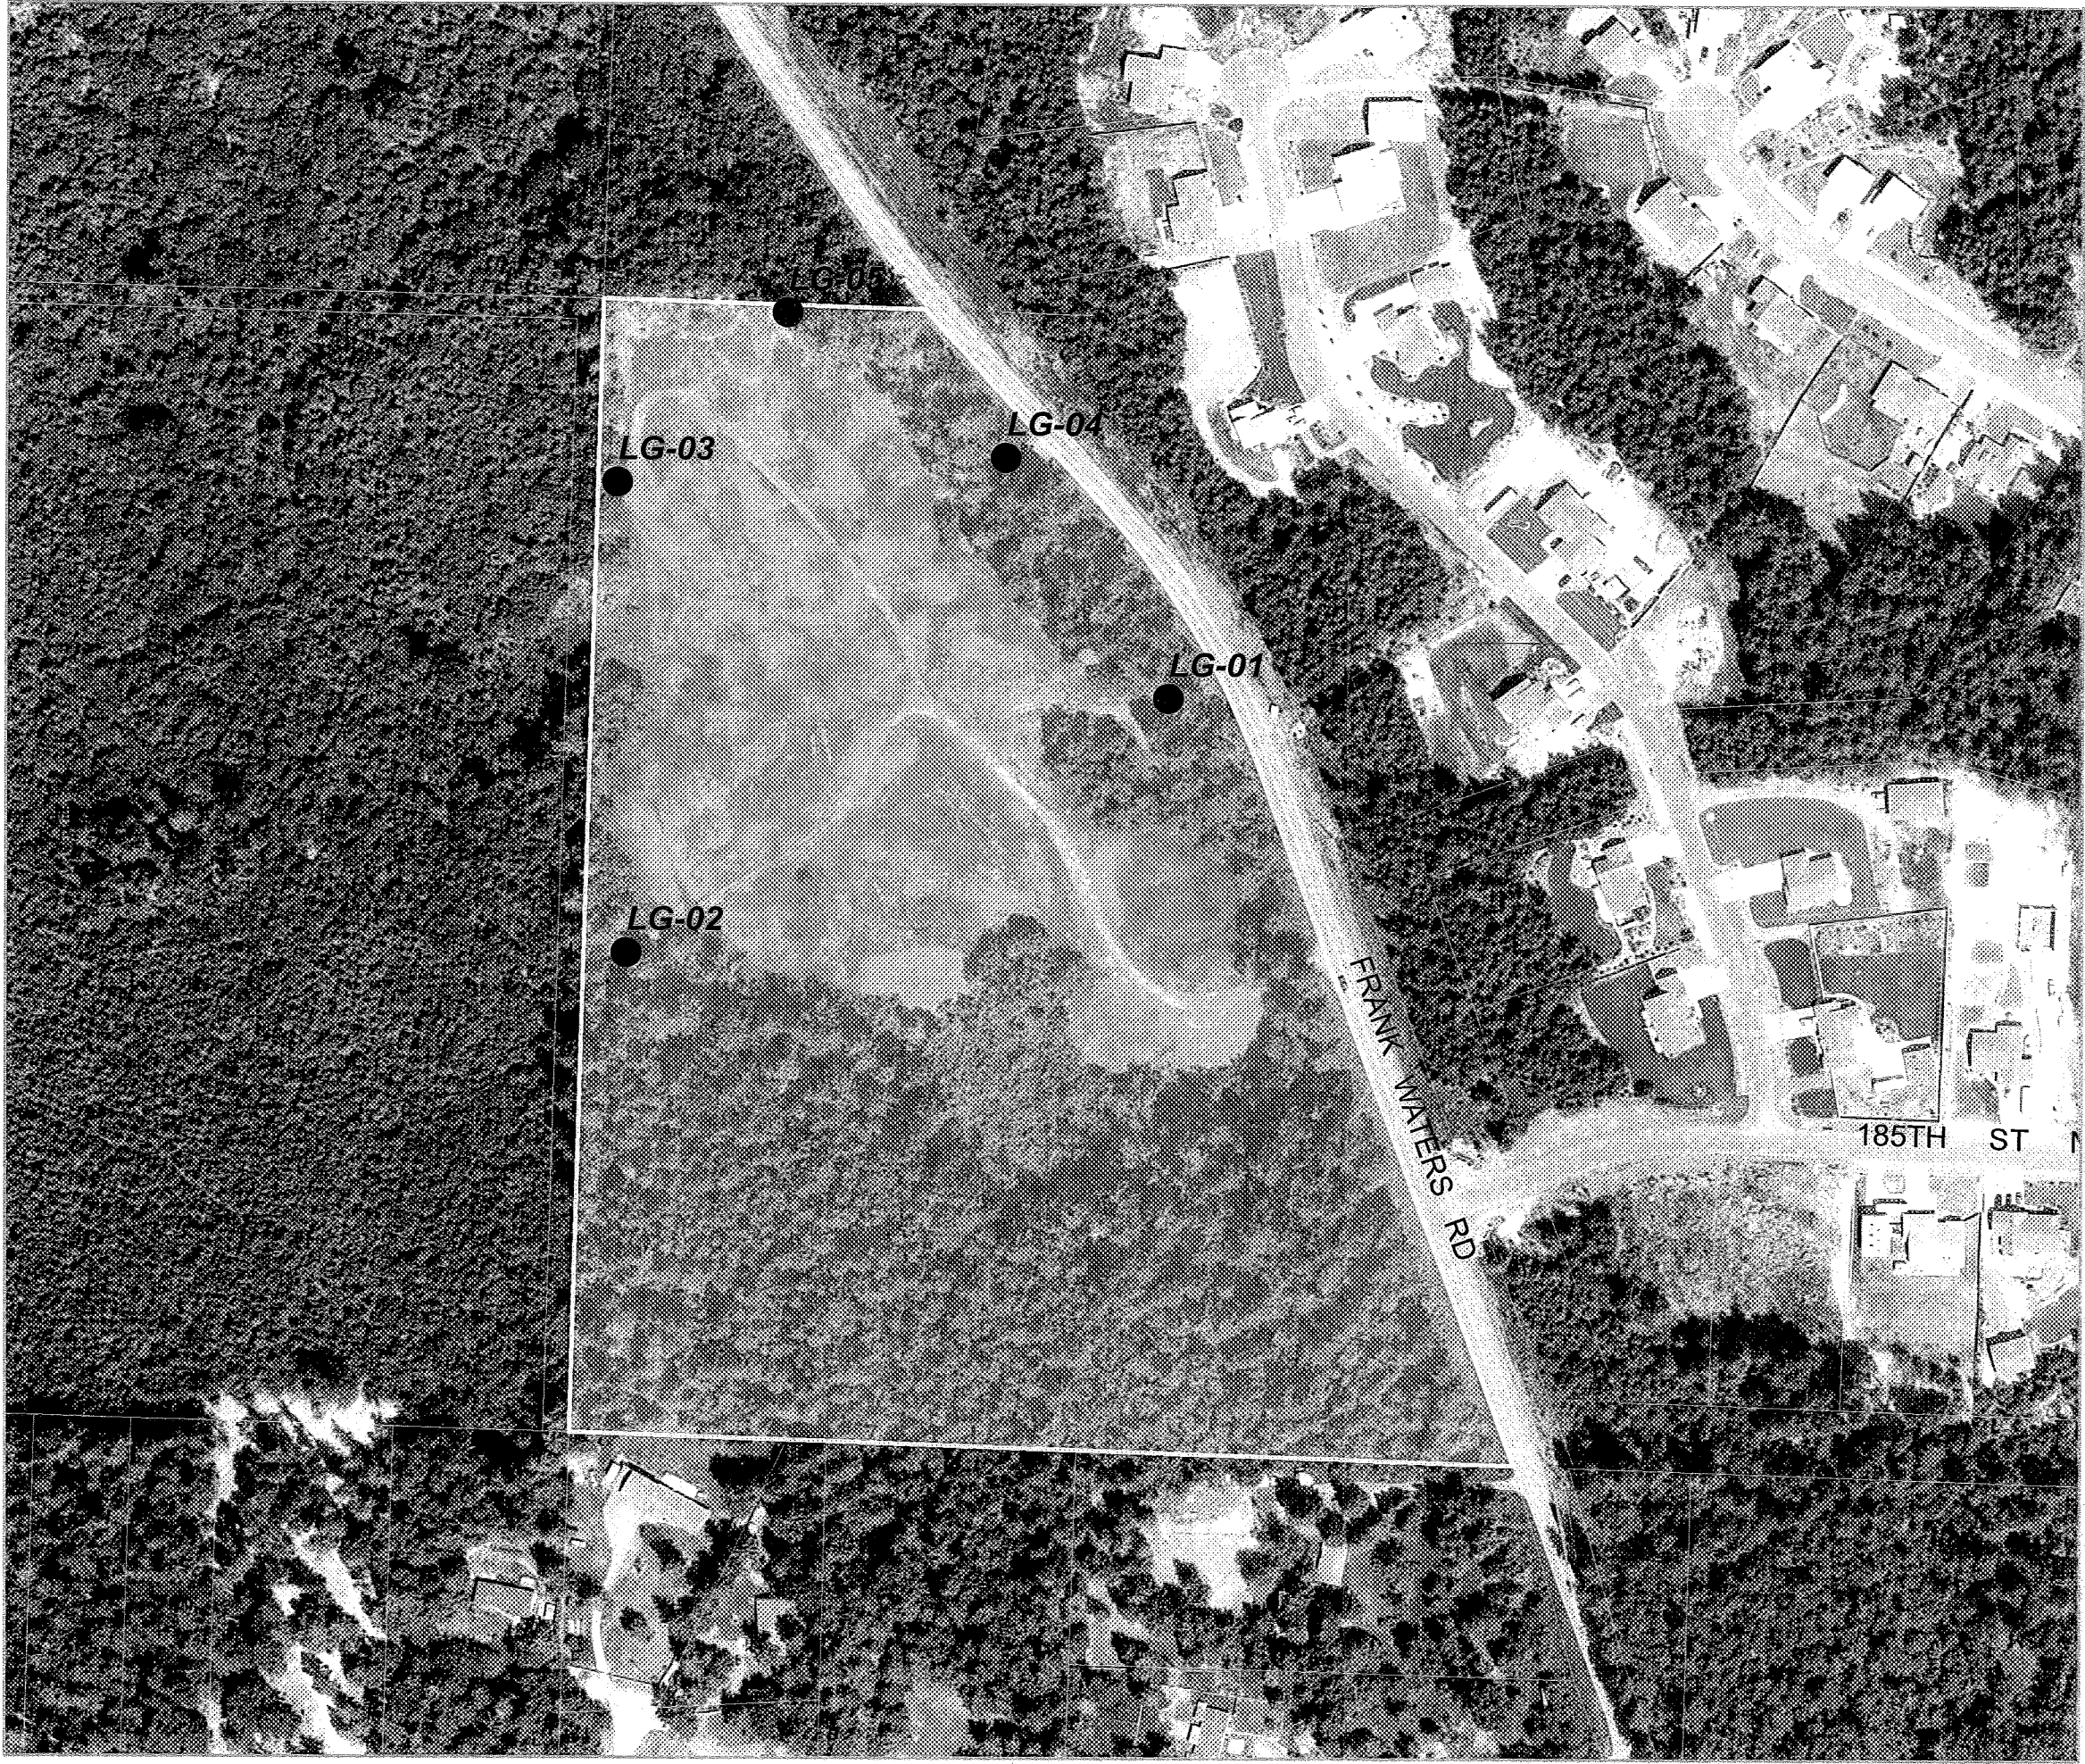
Figure 5

Groundwater Monitoring Network

As outlined in the Solid Waste Facility Permit SW-085, quarterly monitoring of ground water is required at the Lake Goodwin Landfill. There are currently five-(5) ground water monitoring wells (LG-01 thru LG-05) at the Lake Goodwin Landfill site that are read on a quarterly basis. Well locations are shown on the **Network Monitoring Map** (figure 5). Of these wells, one-(1) is considered to be an up-gradient well monitoring background ground water conditions in the immediate vicinity of the site (LG-02). The remaining four-(4) wells are located in and/or down gradient of the landfill (LG-01, and LG-03 thru LG-05) and monitor ground water conditions that may be impacted from the site. Fourth quarter monitoring results are discussed in section 2.0 below.

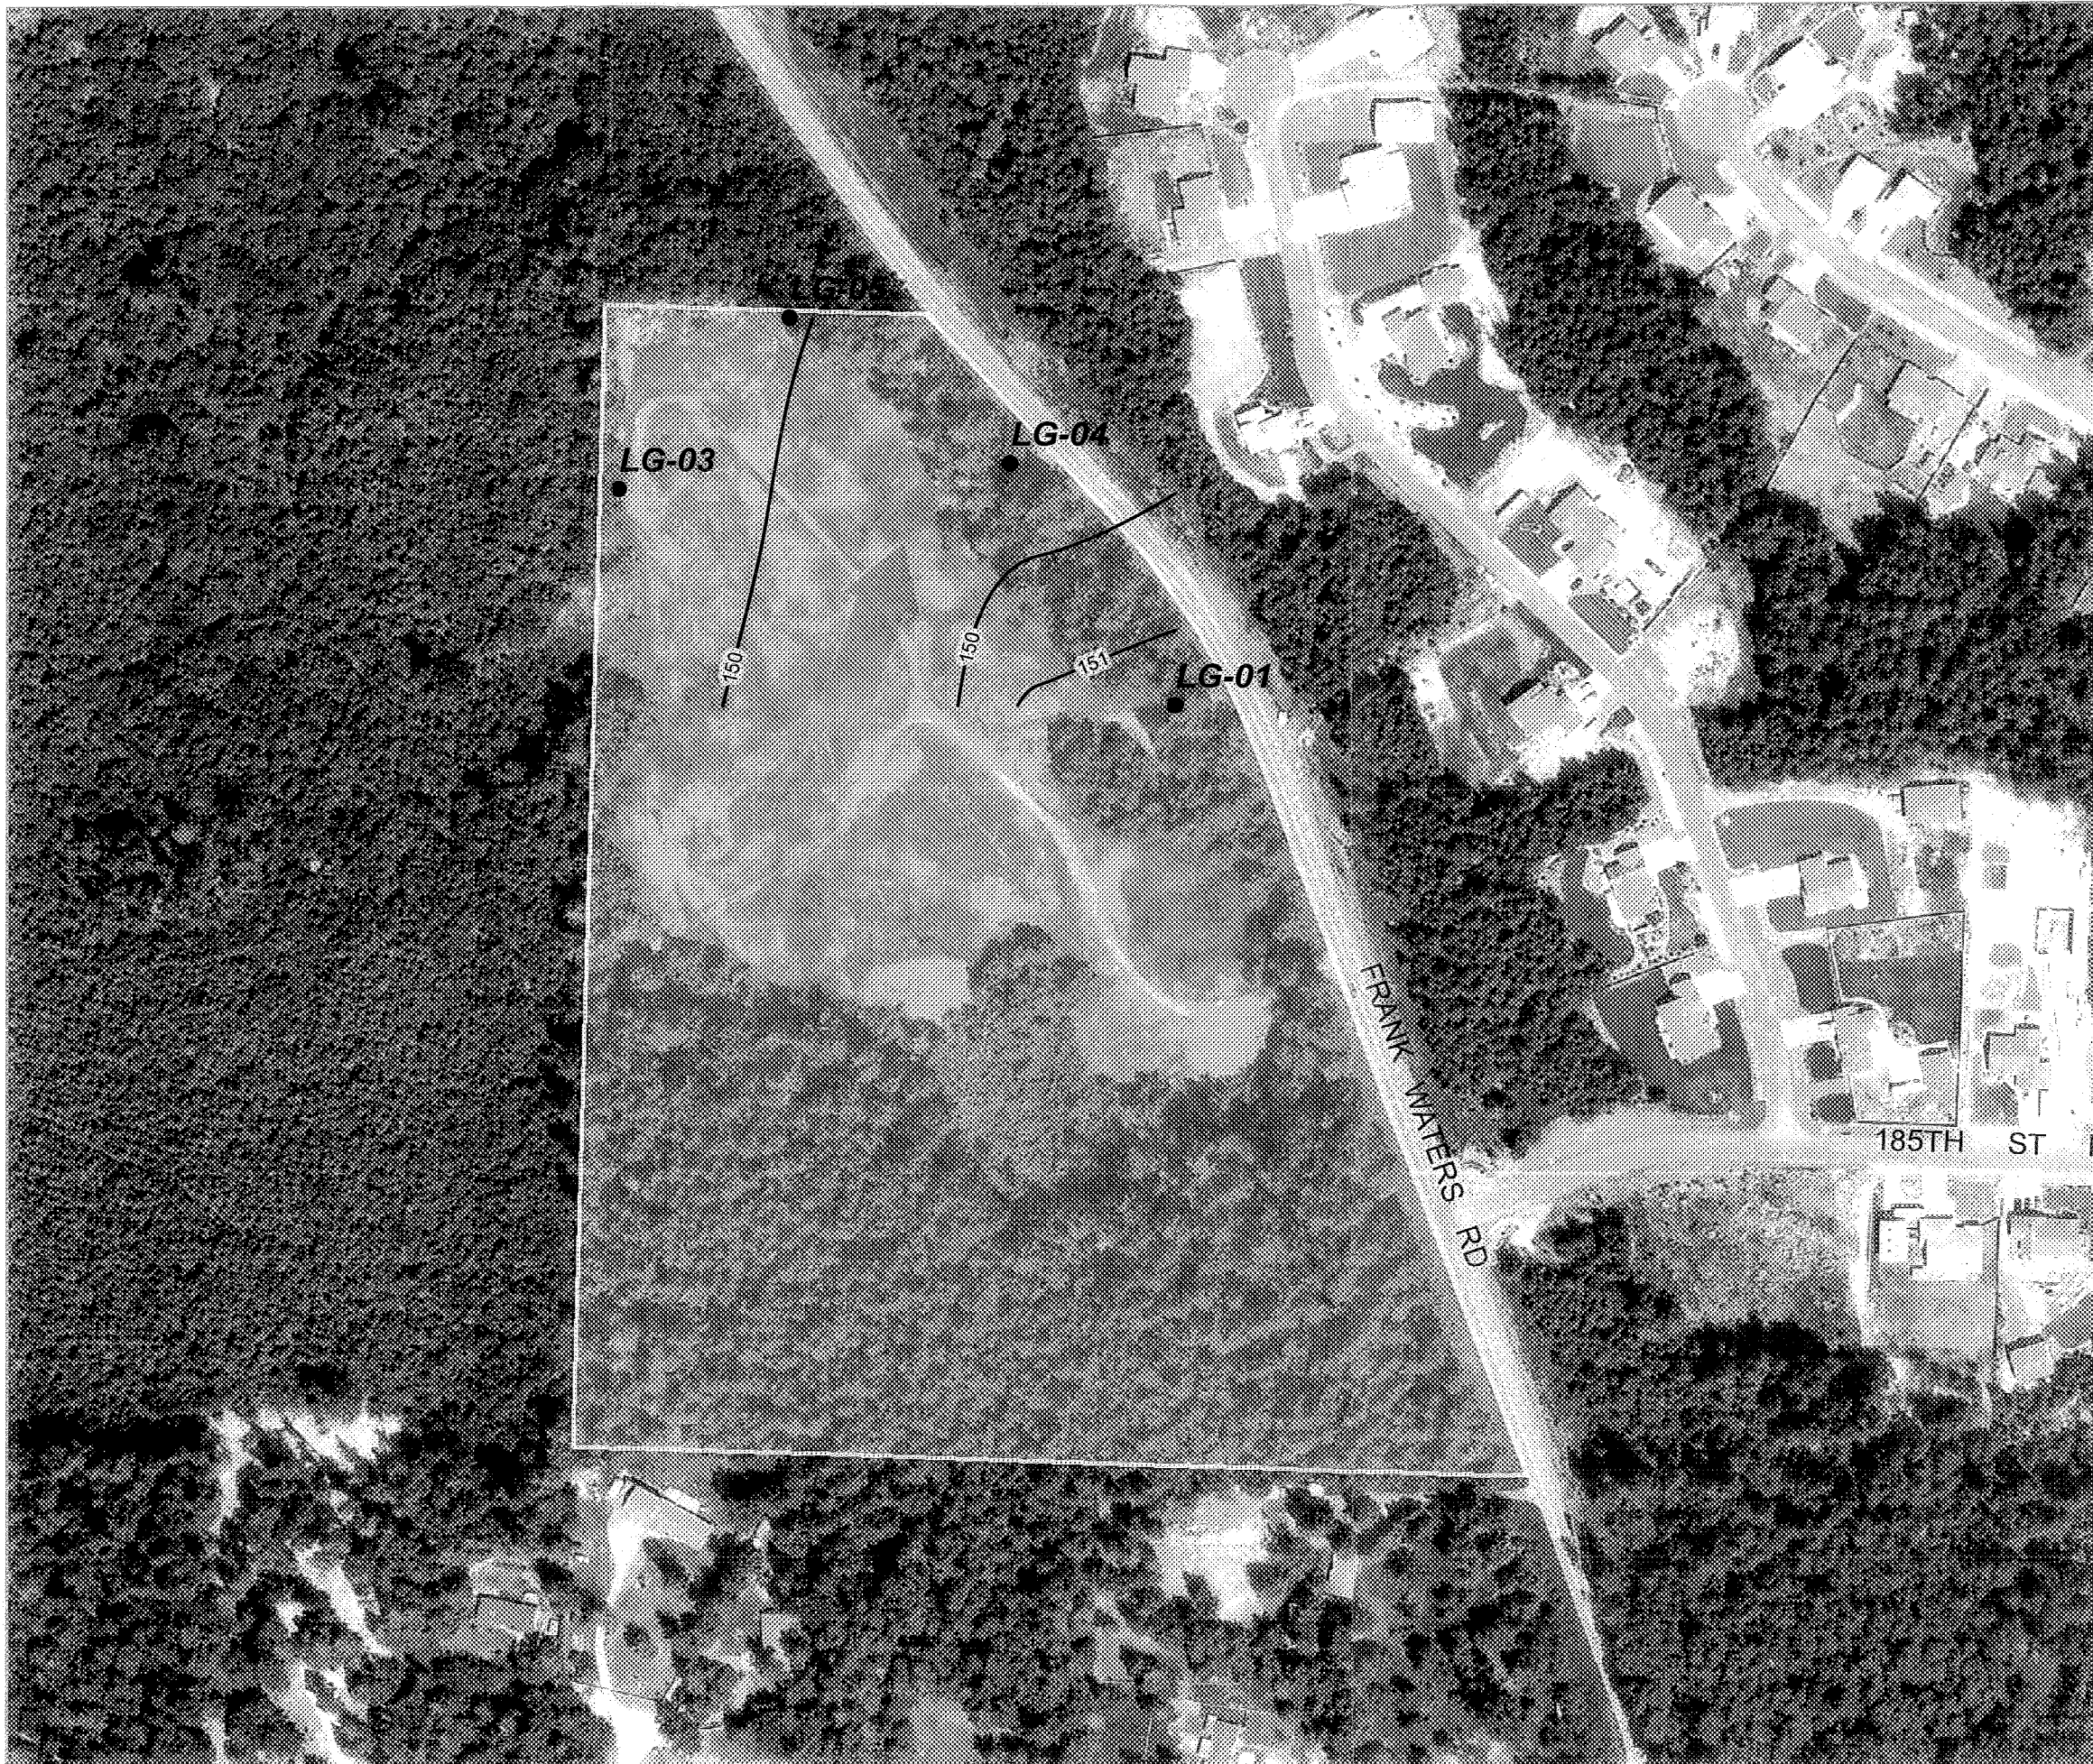
Figure 6

Water Elevation Contours 4th Quarter 2010

DIRECTION OF GROUNDWATER FLOW
3.97 ft/day
1450 ft/year
70.87 degrees to the positive x-axis
-

WELL_ID	SAMP_DATE	MEAS_HEAD
LG-01	10/19/2010	151.56
LG-03	10/19/2010	150.35
LG-04	10/19/2010	149.39
LG-05	10/19/2010	150.05

ground water elevation is not consistent with other readings or with previously observed aquifer behavior. Readings suggest that the aquifer is unconfined in the immediate vicinity of the site. The **Fourth Quarter Ground Water Contour Map** developed from the field data is shown in *Figure 6* of this report.
