Lake Goodwin Landfill

2011 1st Quarter Groundwater

Monitoring Report

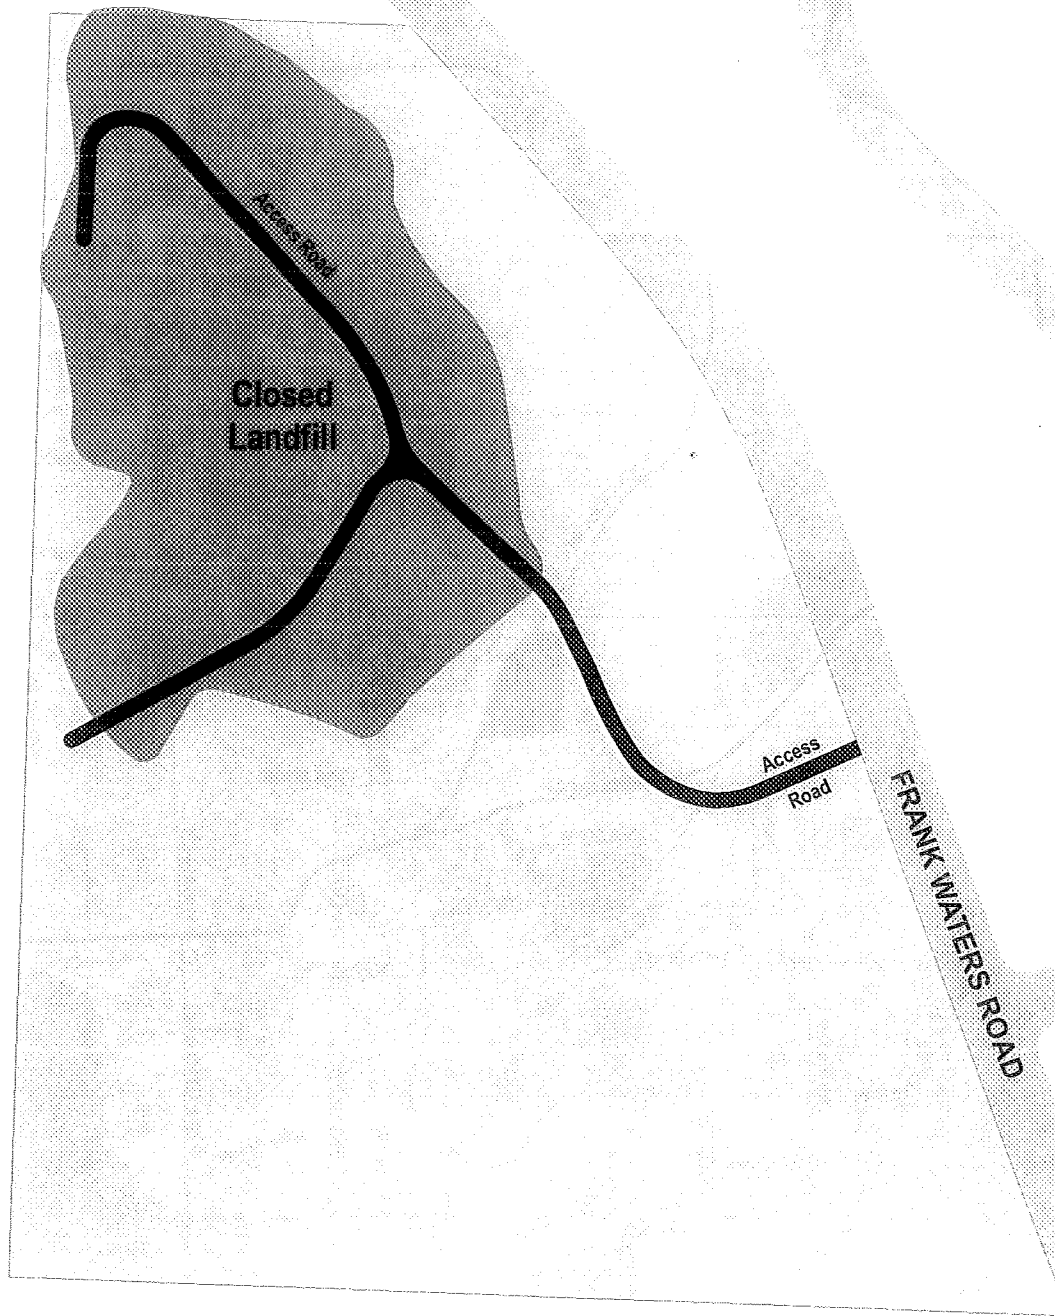
Figure 2

Lake Goodwin Landfill Site Map

The closed landfill is approximately 11.5 acres in size and is part of a larger County owned parcel of land. The Lake Goodwin Landfill is bounded by private residential property or commercial forest to the south, west and north. The Frank Waters Road is located along the eastern side of the site. Access into the site is from a partially paved and partially graveled driveway off of the Frank Waters Road. Existing site improvements are shown on the **Site Map** (*figure 2*).

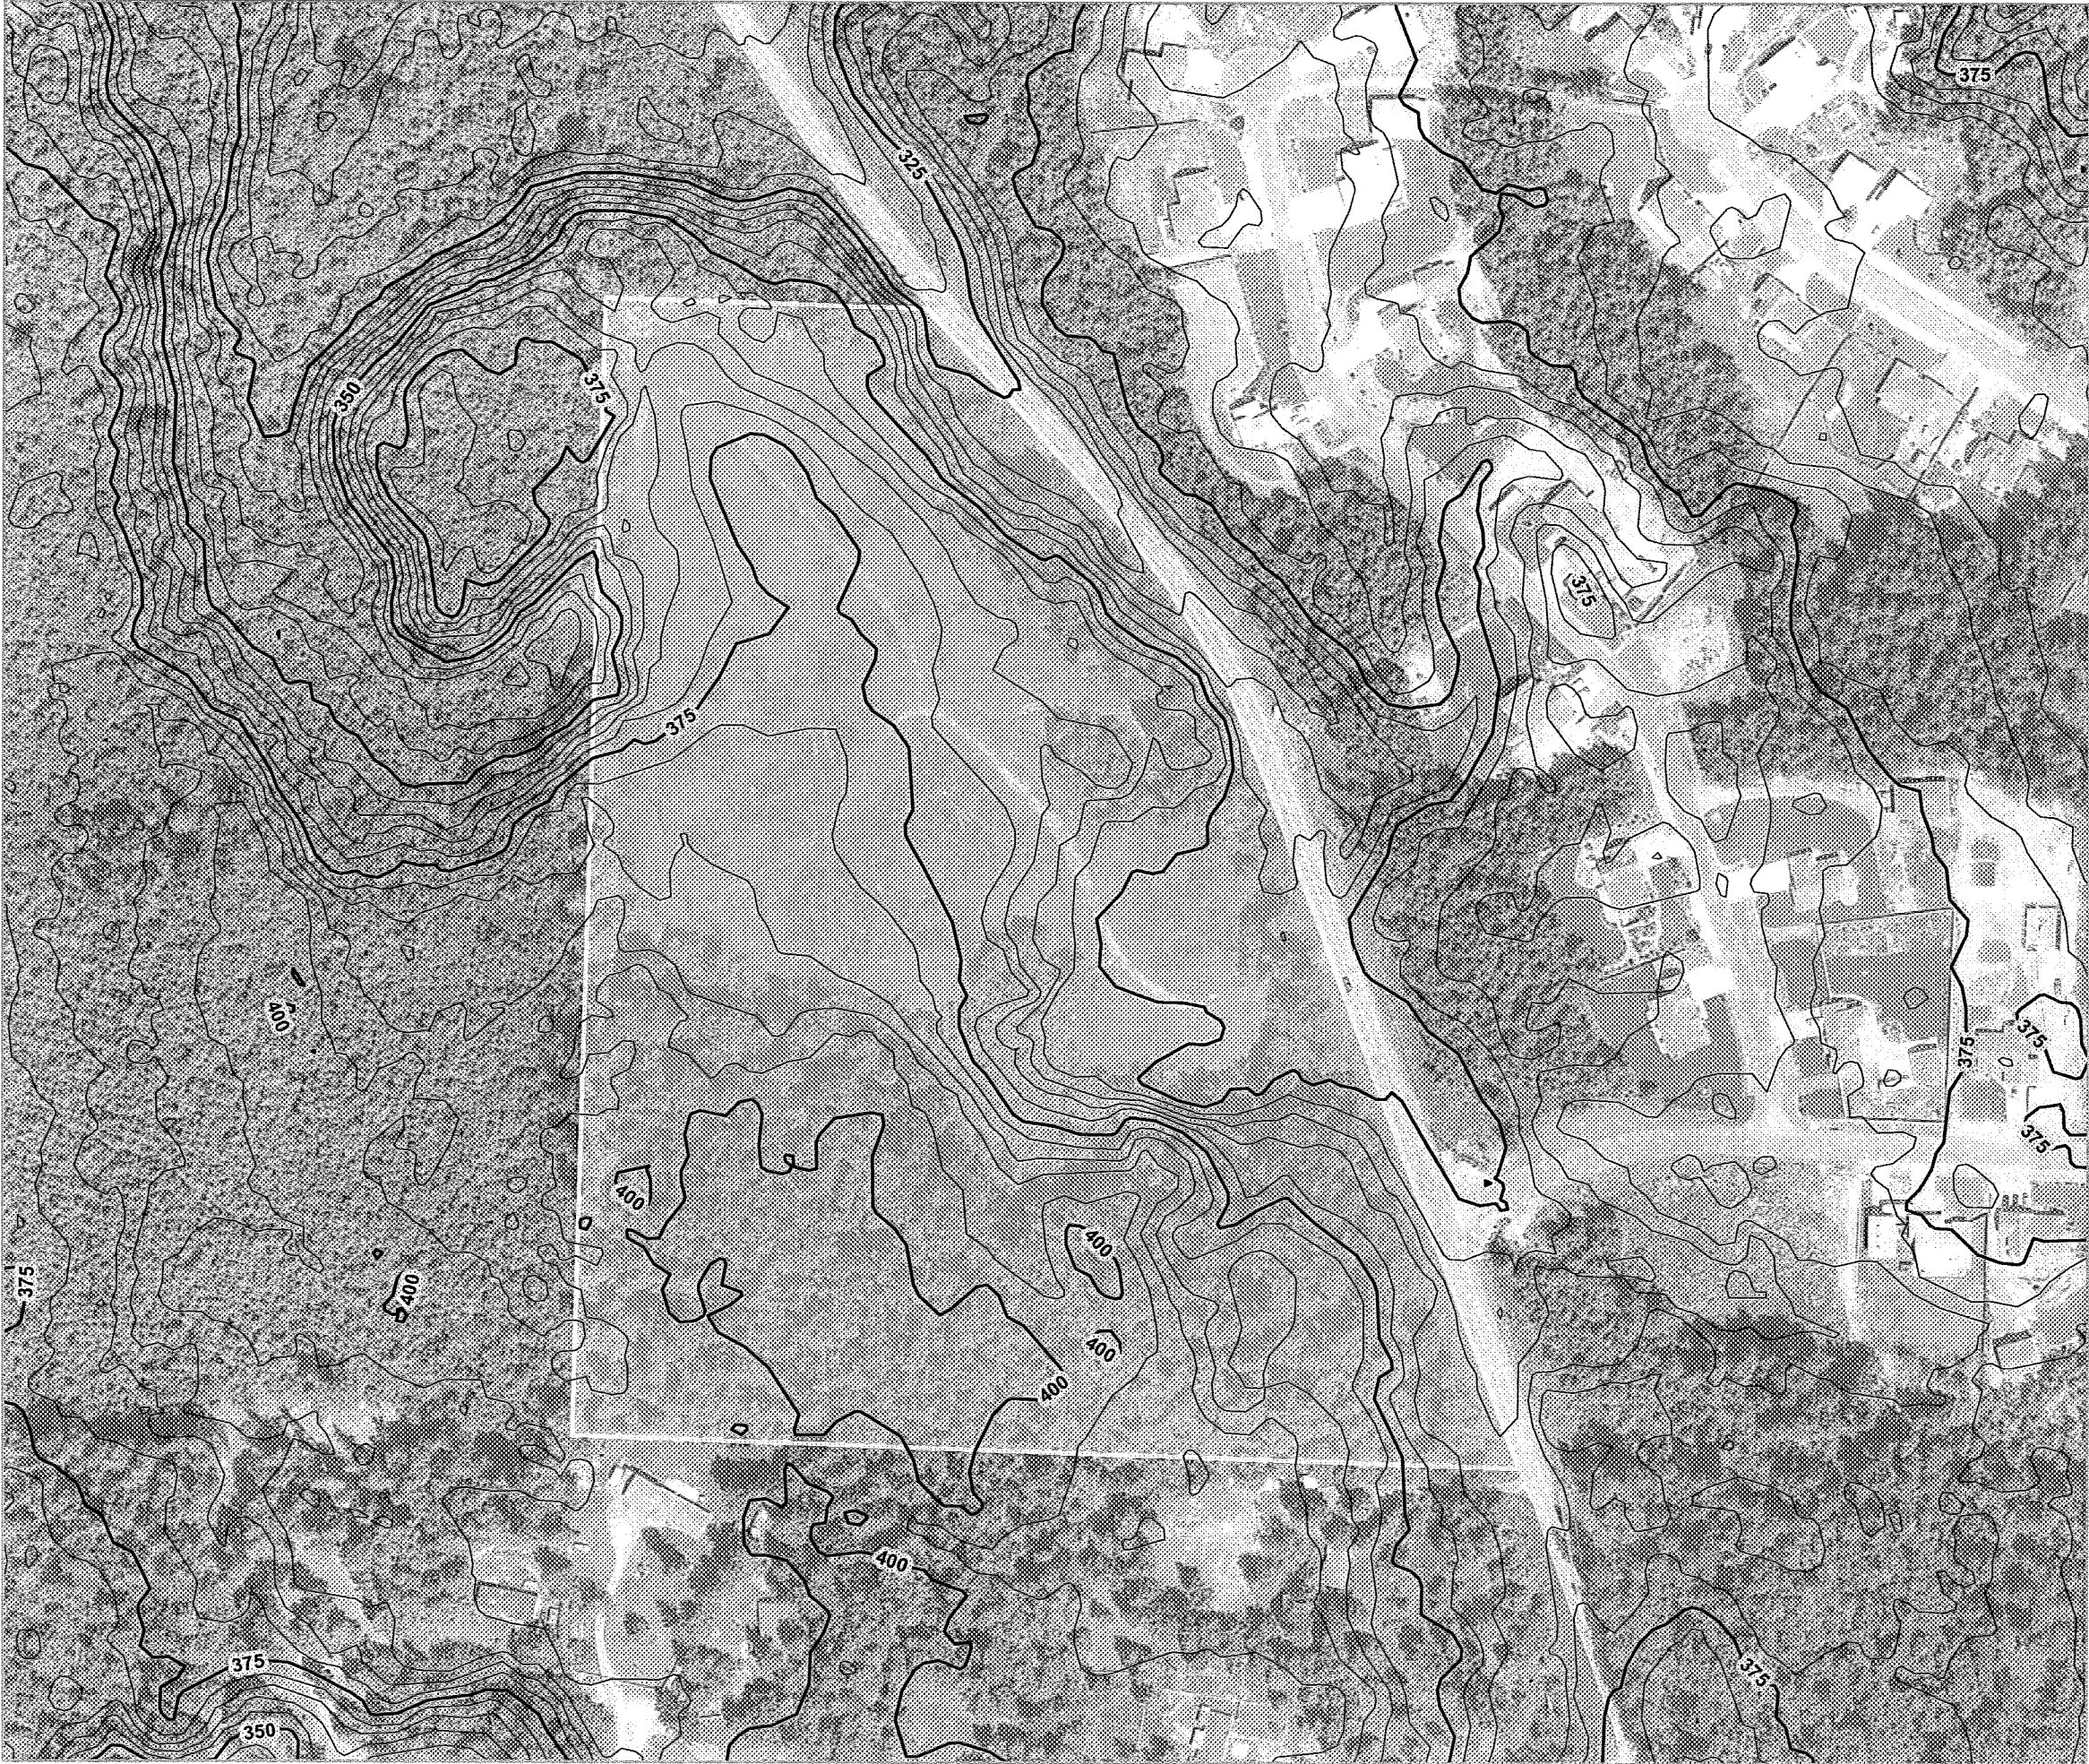
Figure 3

Lake Goodwin Landfill Topography

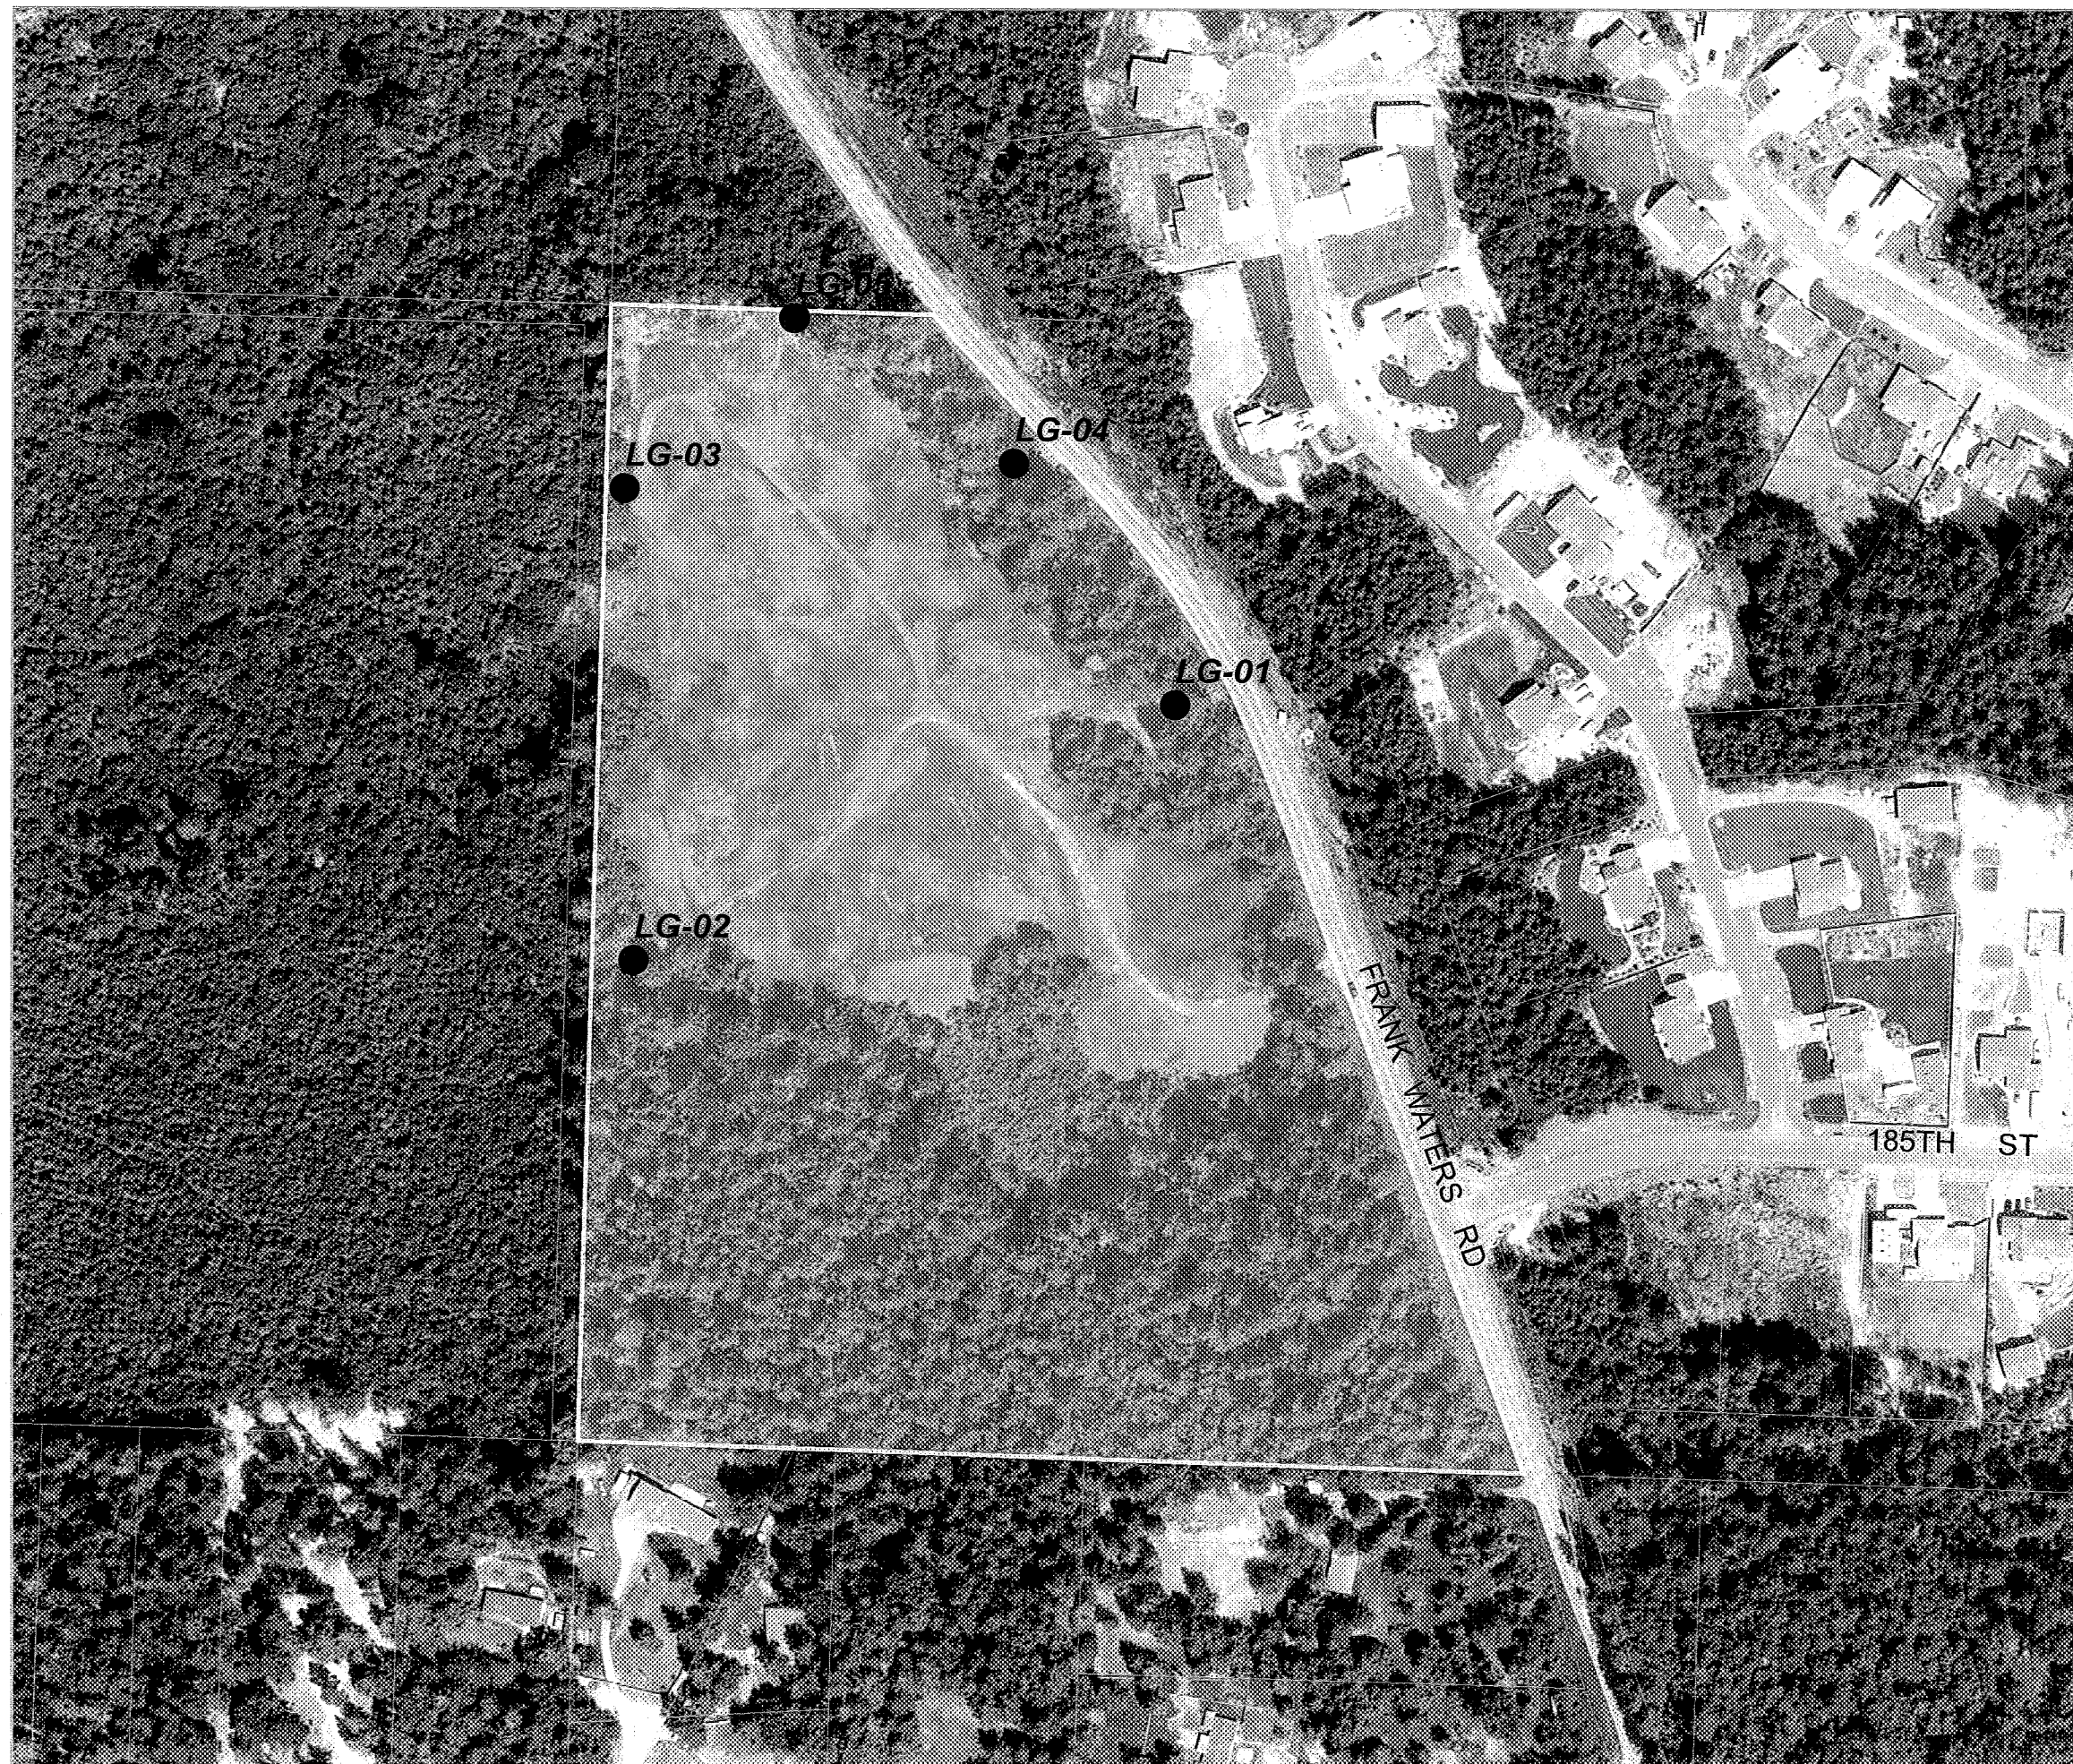
Figure 5

Groundwater Monitoring Network

Aquifer Unit (Active Wells)

- Deep Aquifer

As outlined in the Solid Waste Facility Permit SW-085, quarterly monitoring of ground water is required at the Lake Goodwin Landfill. There are currently five-(5) ground water monitoring wells (LG-01 thru LG-05) at the Lake Goodwin Landfill site that are read on a quarterly basis. Well locations are shown on the **Network Monitoring Map** (figure 5). Of these wells, one-(1) is considered to be an up-gradient well monitoring background ground water conditions in the immediate vicinity of the site (LG-02). The remaining four-(4) wells are located in and/or down gradient of the landfill (LG-01, and LG-03 thru LG-05) and monitor ground water conditions that may be impacted from the site. First quarter monitoring results are discussed in section 2.0 below.

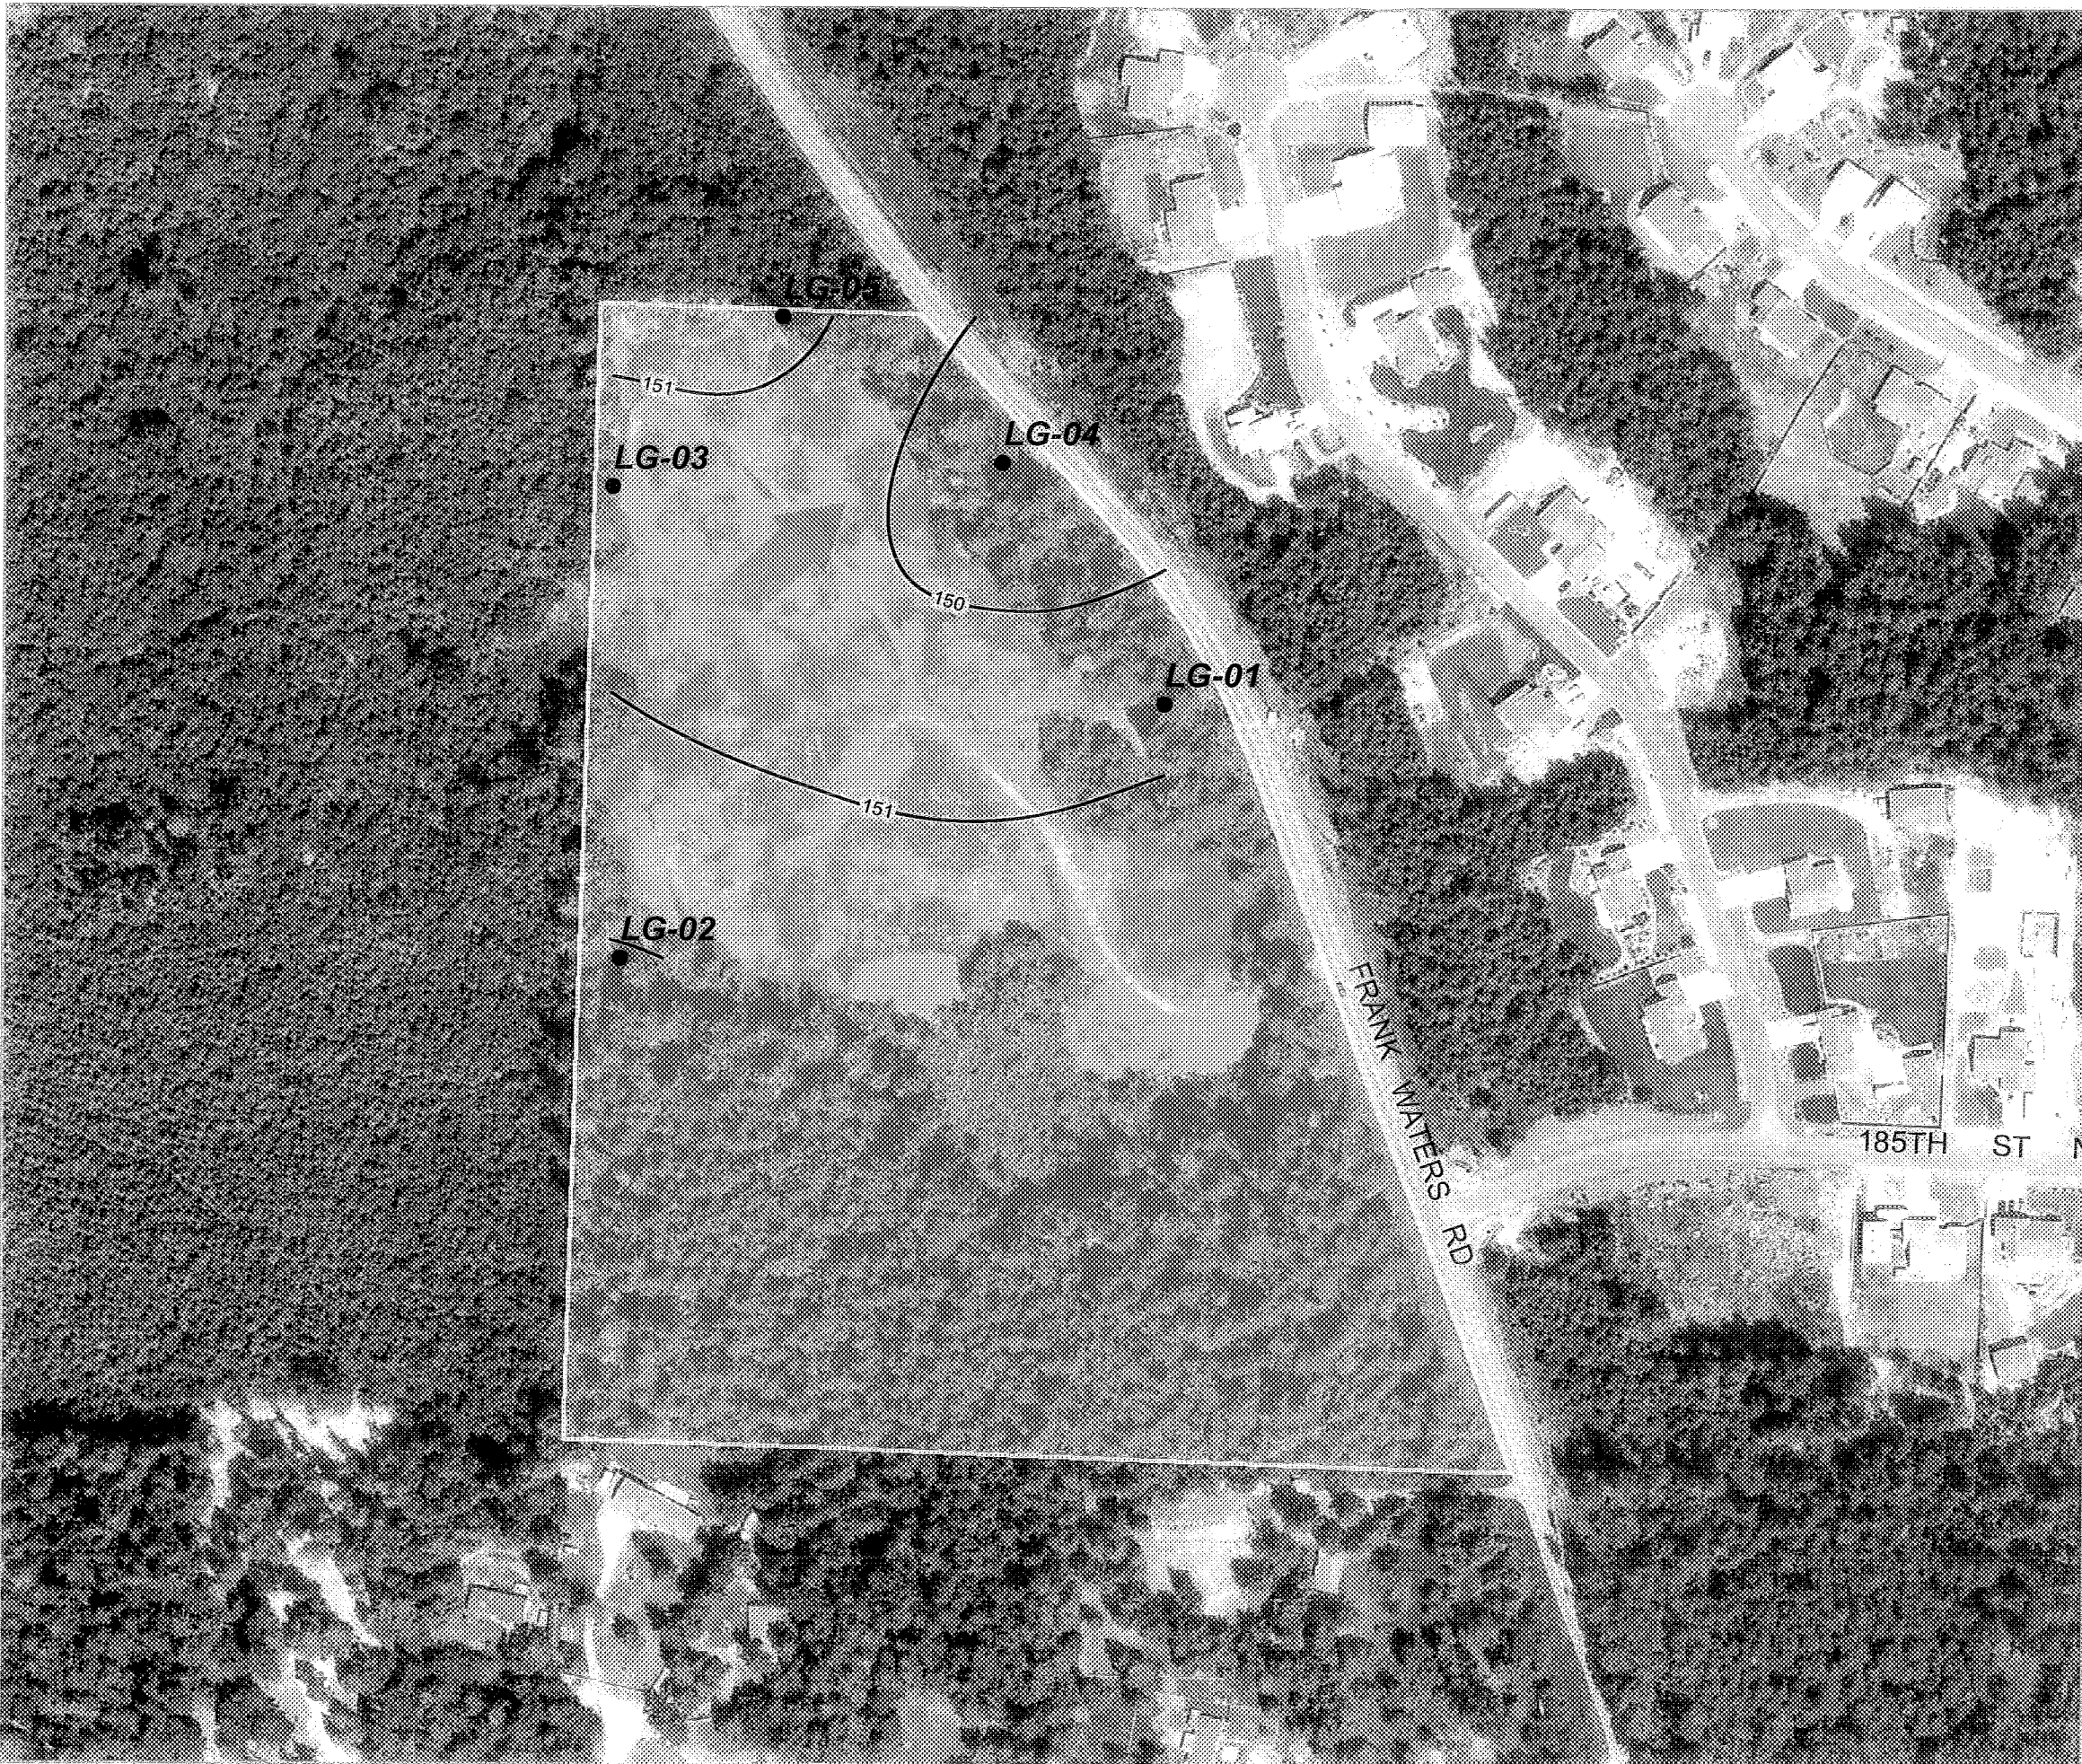
Figure 6

Water Elevation Contours 1st Quarter 2011

- DIRECTION OF GROUNDWATER FLOW
.993 ft/day
362 ft/year
42.58 degrees to the positive x-axis
- PARCEL BOUNDARY
- SUBJECT PROPERTY BOUNDARY
- 1 FT CONTOUR
- WELL LOCATION

WELL_ID	SAMP_DATE	MEAS_HEAD
LG-01	1/18/2011	150.71
LG-02	1/19/2011	152.06
LG-03	1/19/2011	150.64
LG-04	1/18/2011	149.40
LG-05	1/18/2011	151.28

rapid change in the ground water elevation is not consistent with other readings or with previously observed aquifer behavior. Readings suggest that the aquifer is unconfined in the immediate vicinity of the site. The **First Quarter Ground Water Contour Map** developed from the field data is shown in *Figure 6* of this report.

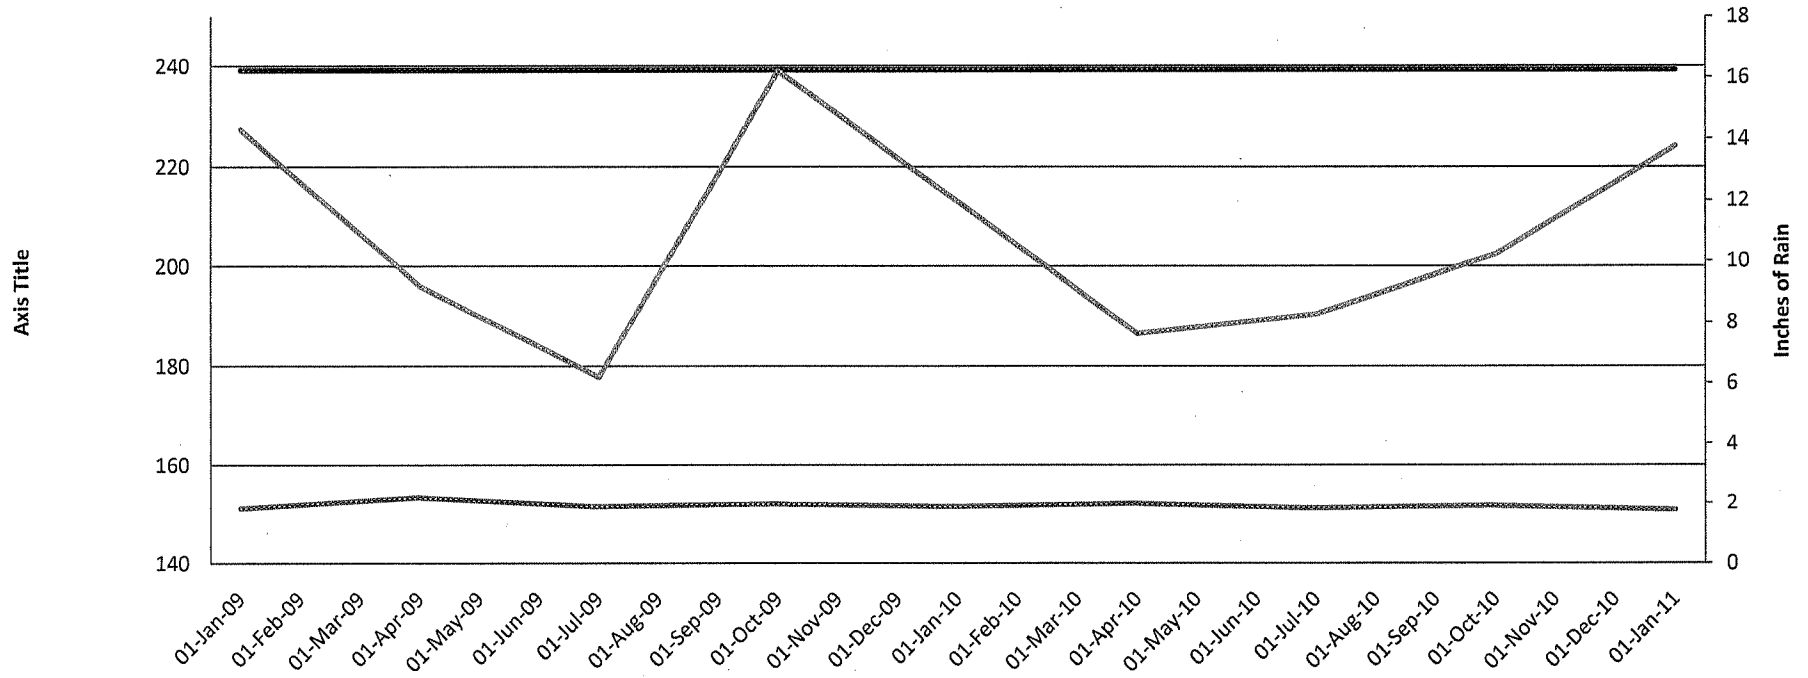
Lake Goodwin Well LG-01

27-Jan-09	21-Apr-09	29-Jul-09	08-Oct-09	20-Jan-10	20-Apr-10	7/13/2010	10/19/2010	1/8/2011
Depth to Water	151.06	153.43	151.48	152.04	151.46	152.09	151.05	151.56	150.71
Well Casing	239.18	239.18	239.18	239.18	239.18	239.18	239.18	239.18	239.18
Precipitation	14.3	9.2	6.2	16.2	11.96	7.62	8.26	10.2	13.75

First Quarter Ground Water Measurements are shown in *Table 1* below. **Hydrographs** of the first quarter 2011 monitoring well readings are contained in *Appendix A* of this report. Based on the ground water readings for all wells except LG-02, small fluctuations in the ground water gradient below the site were observed. Up-gradient well LG-02 showed over a four and one-half (4-1/2) foot drop in ground water elevation over the 4th quarter reading. This fairly

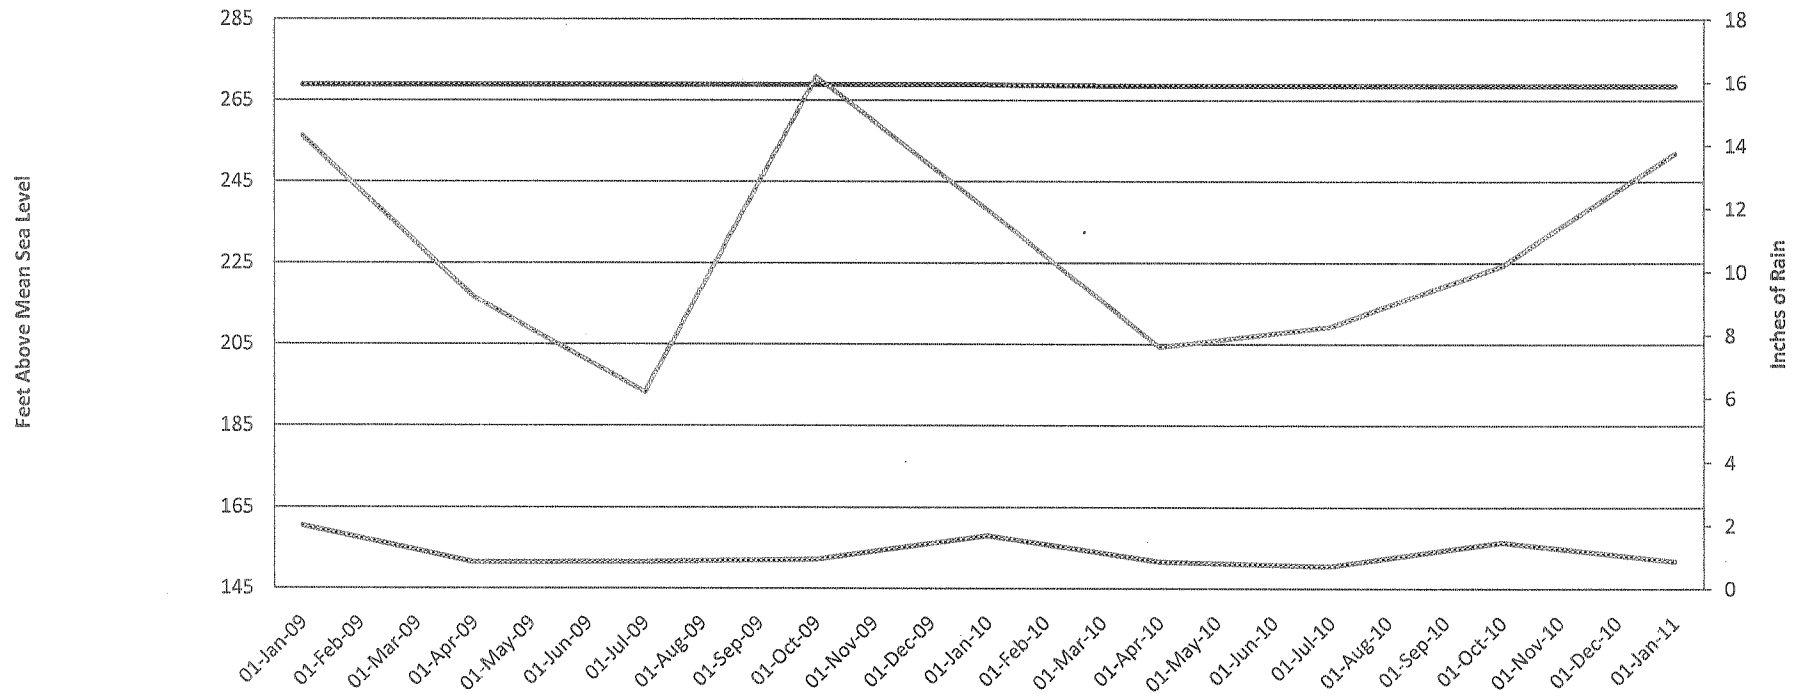
Lake Goodwin Well LG-02

27-Jan-09	21-Apr-09	29-Jul-09	08-Oct-09	20-Jan-10	4/20/2010	7/13/2010	10/19/2010	1/18/2011
Groundwater Elevation	160.57	151.56	151.59	152.25	158.1	151.67	150.54	156.37	151.74
Well Casing	268.99	268.99	268.99	268.99	268.99	268.67	268.67	268.67	268.67
Precipitation	14.3	9.2	6.2	16.2	11.96	7.62	8.26	10.2	13.75

- The water level variability in *LG-02* is probably caused by the cable wrapping around the dedicator column in the well. ESS is investigating a new water level monitor with a tape instead of a cable.

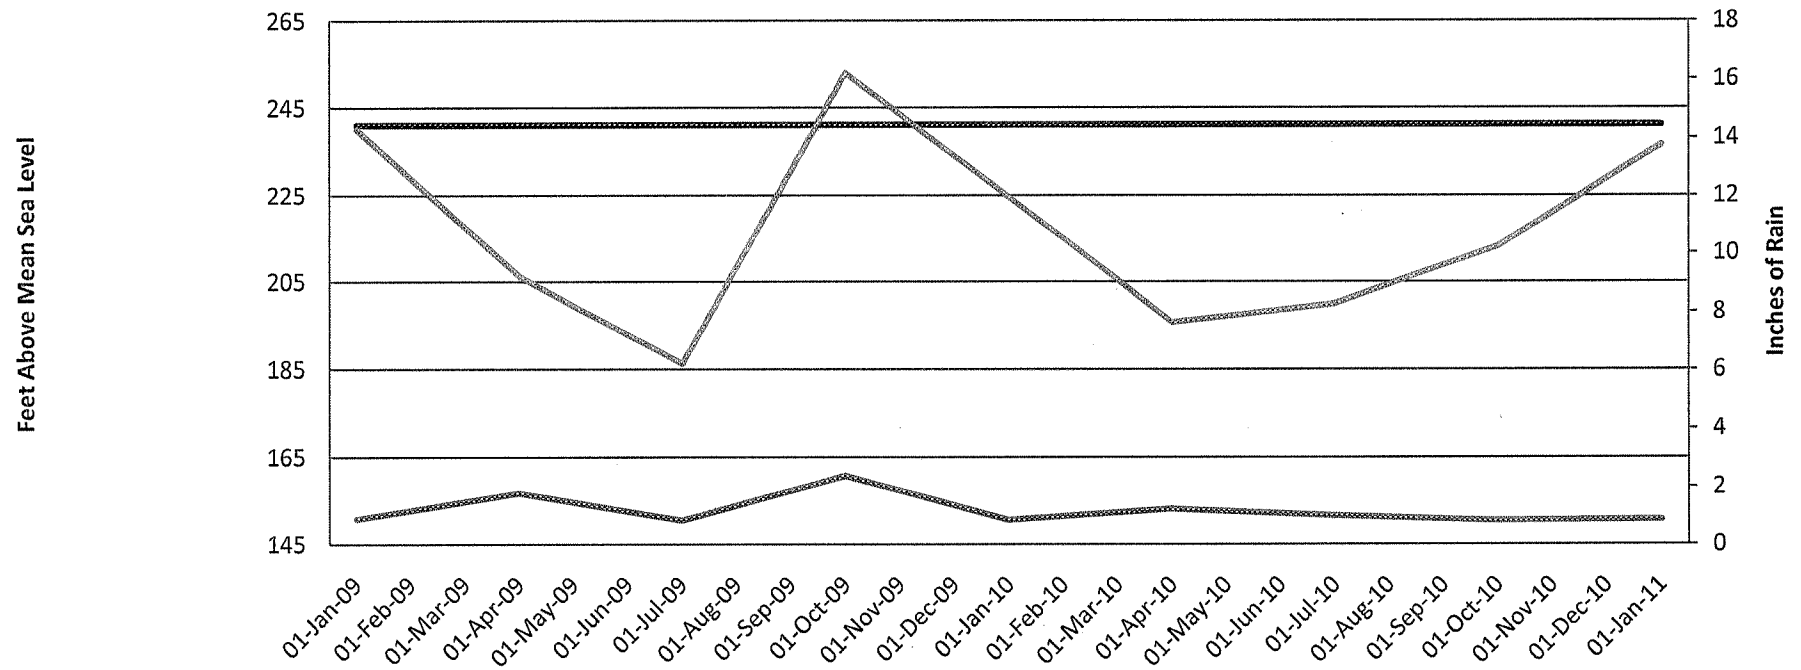
Lake Goodwin Well LG-03

27-Jan-09	21-Apr-09	29-Jul-09	08-Oct-09	20-Jan-10	4/20/2010	7/13/2010	10/19/2010	1/19/2011
Groundwater Elevations	150.86	156.82	150.51	160.84	150.59	153.1	151.59	150.35	150.64
Well Casing	241.2	241.2	241.2	241.2	241.2	241.2	241.2	241.2	241.2
Precipitation	14.3	9.2	6.2	16.2	11.96	7.62	8.26	10.2	13.75

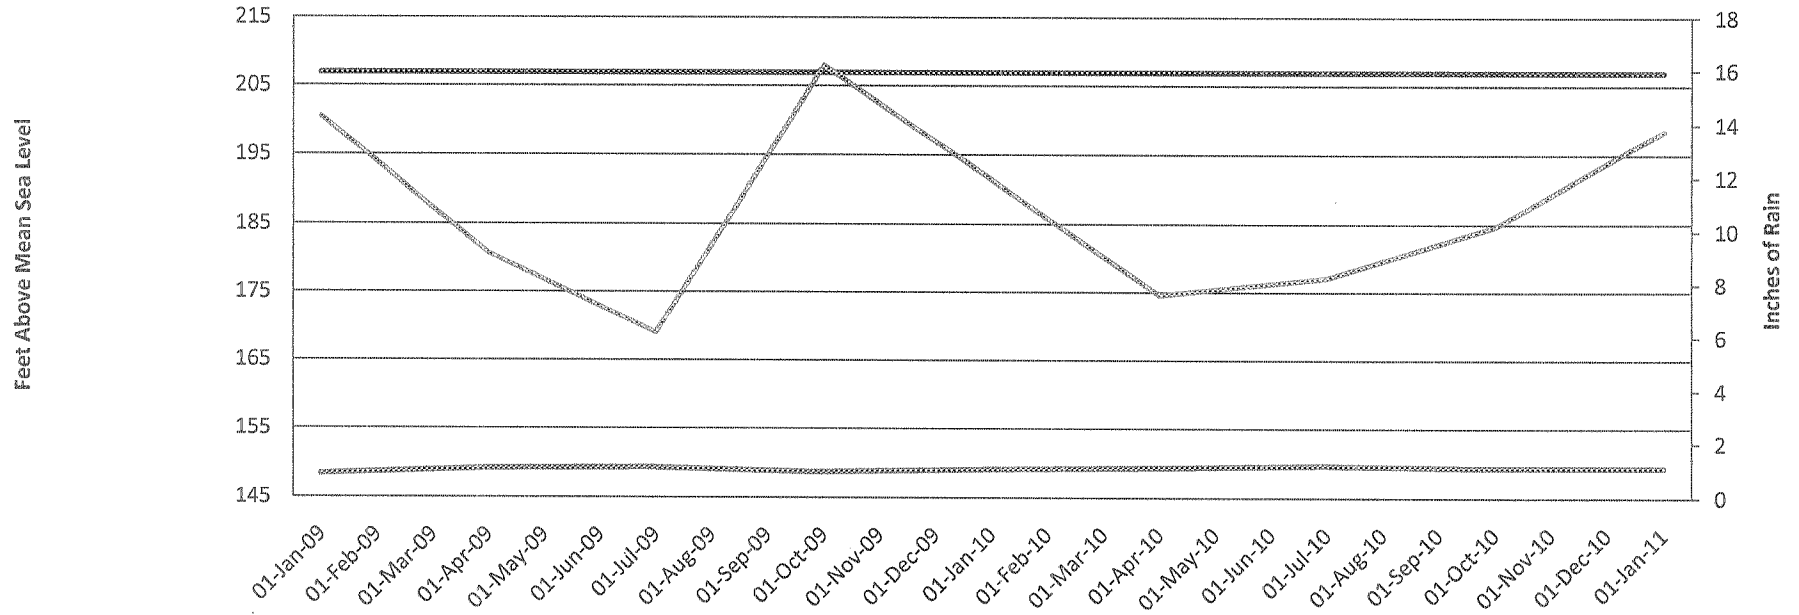
Lake Goodwin Well LG-04

27-Jan-09	21-Apr-09	31-Jul-09	08-Oct-09	20-Jan-10	4/20/2010	7/13/2010	10/19/2010	1/19/2011
Groundwater Elevation	148.5	149.34	149.46	148.84	149.22	149.42	149.72	149.39	149.4
Well Casing	206.93	206.93	206.93	206.93	206.93	206.93	206.93	206.93	206.93
Precipitation	14.3	9.2	6.2	16.2	11.96	7.62	8.26	10.2	13.75

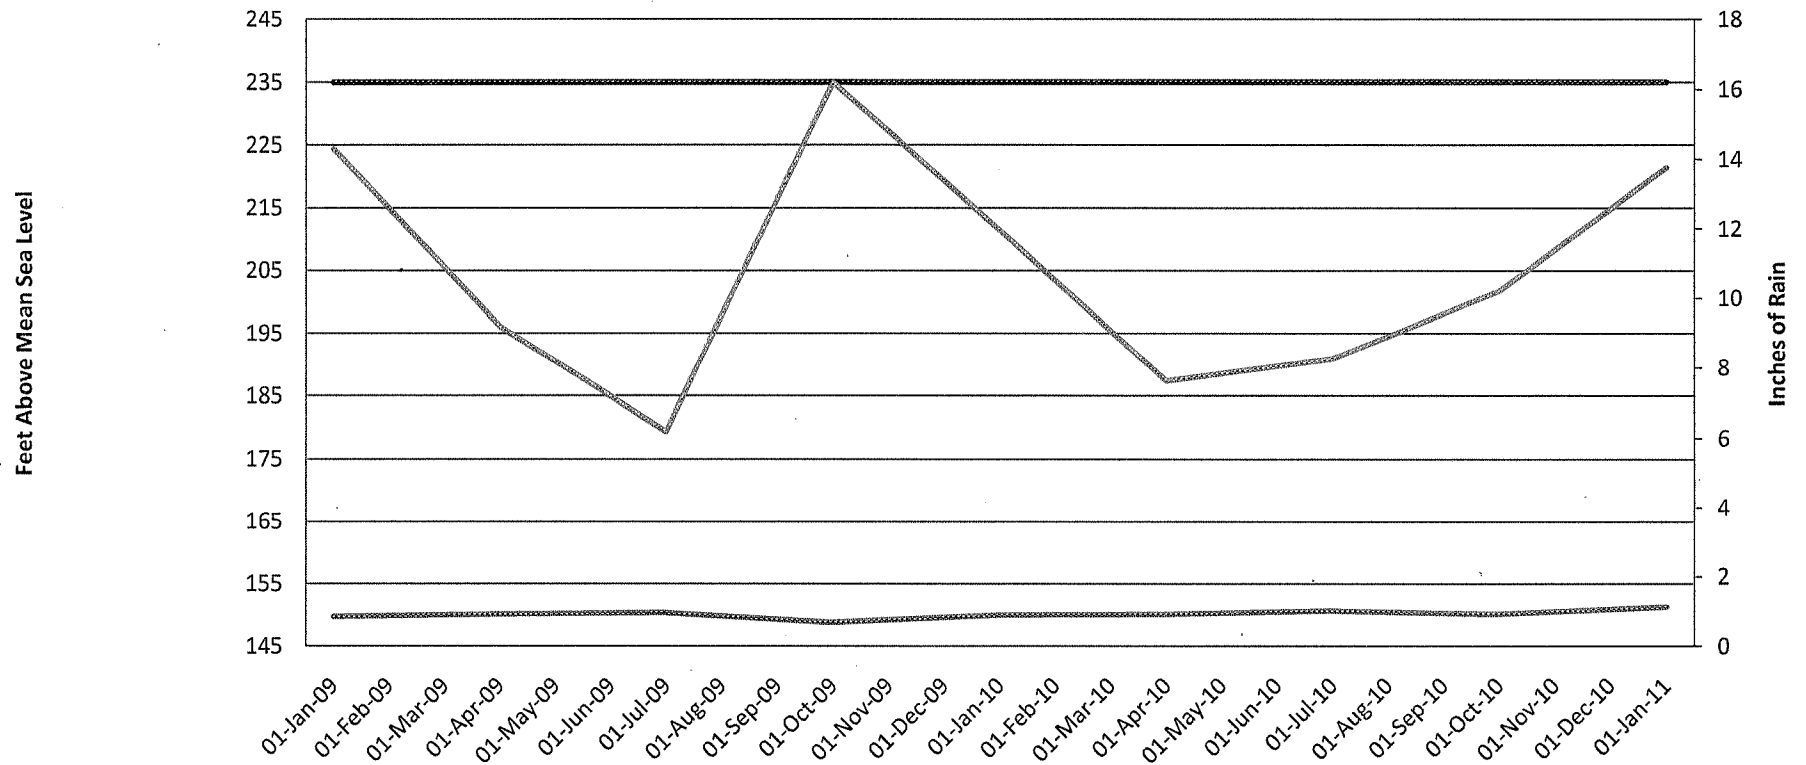
Lake Goodwin Well LG-05

27-Jan-09	21-Apr-09	29-Jul-09	08-Oct-09	20-Jan-10	4/20/2010	7/13/2010	10/19/2010	1/18/2011
Groundwater Elevation	149.71	150.11	150.39	148.79	149.98	150.09	150.62	150.05	151.28
Well Casing	235	235	235	235	235	235	235	235	235
Precipitation	14.3	9.2	6.2	16.2	11.96	7.62	8.26	10.2	13.75

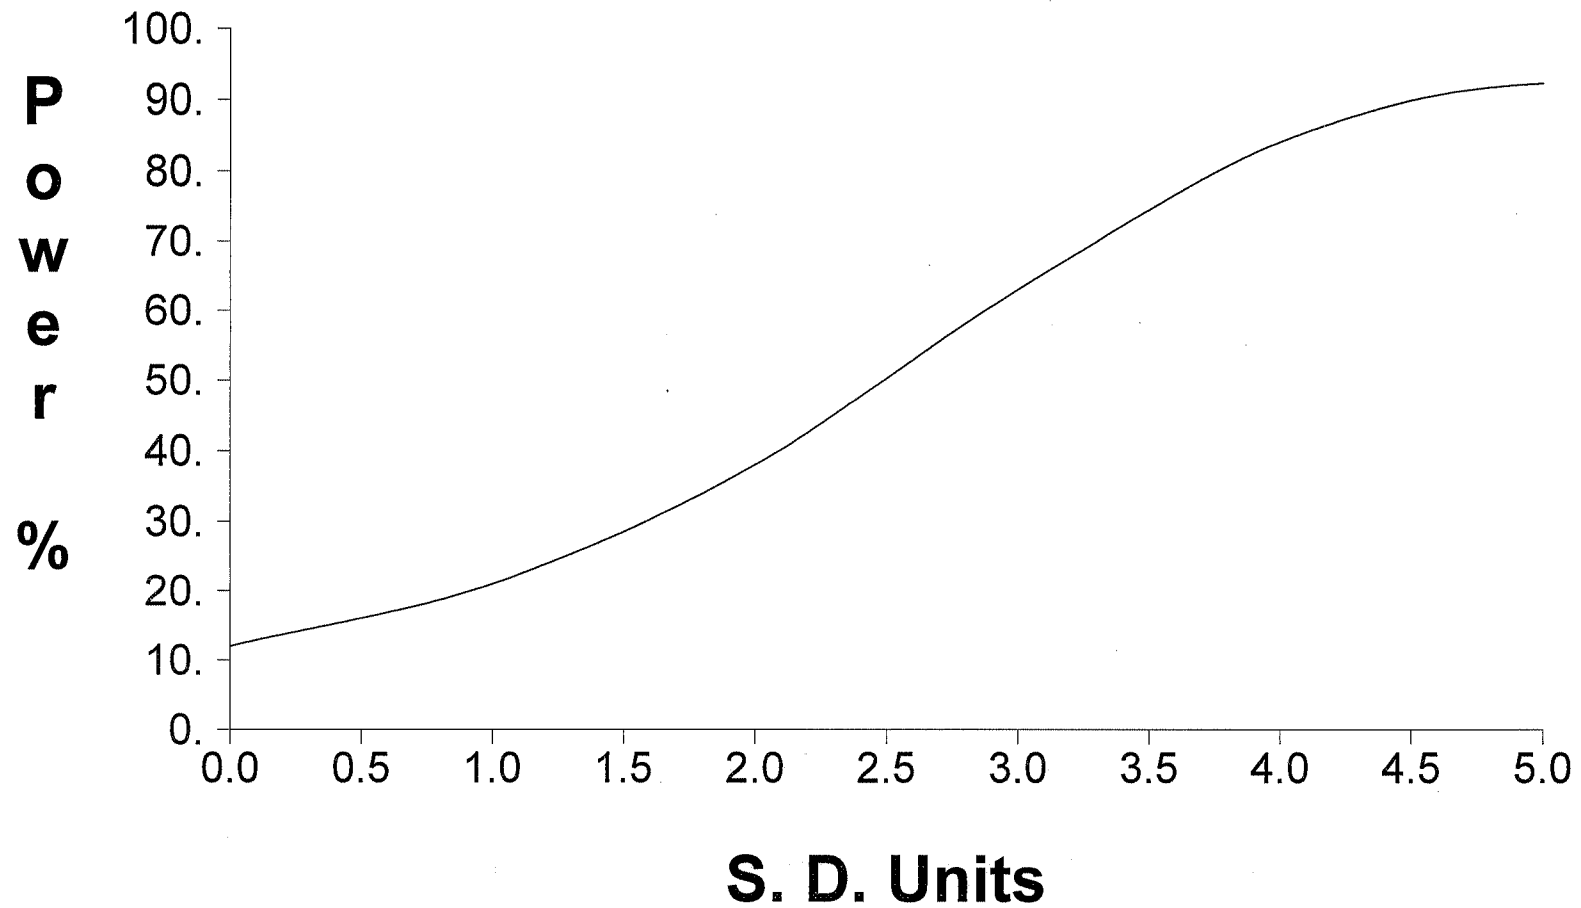
False Positive and False Negative Rates for Current Upgradient vs. Downgradient Monitoring Program

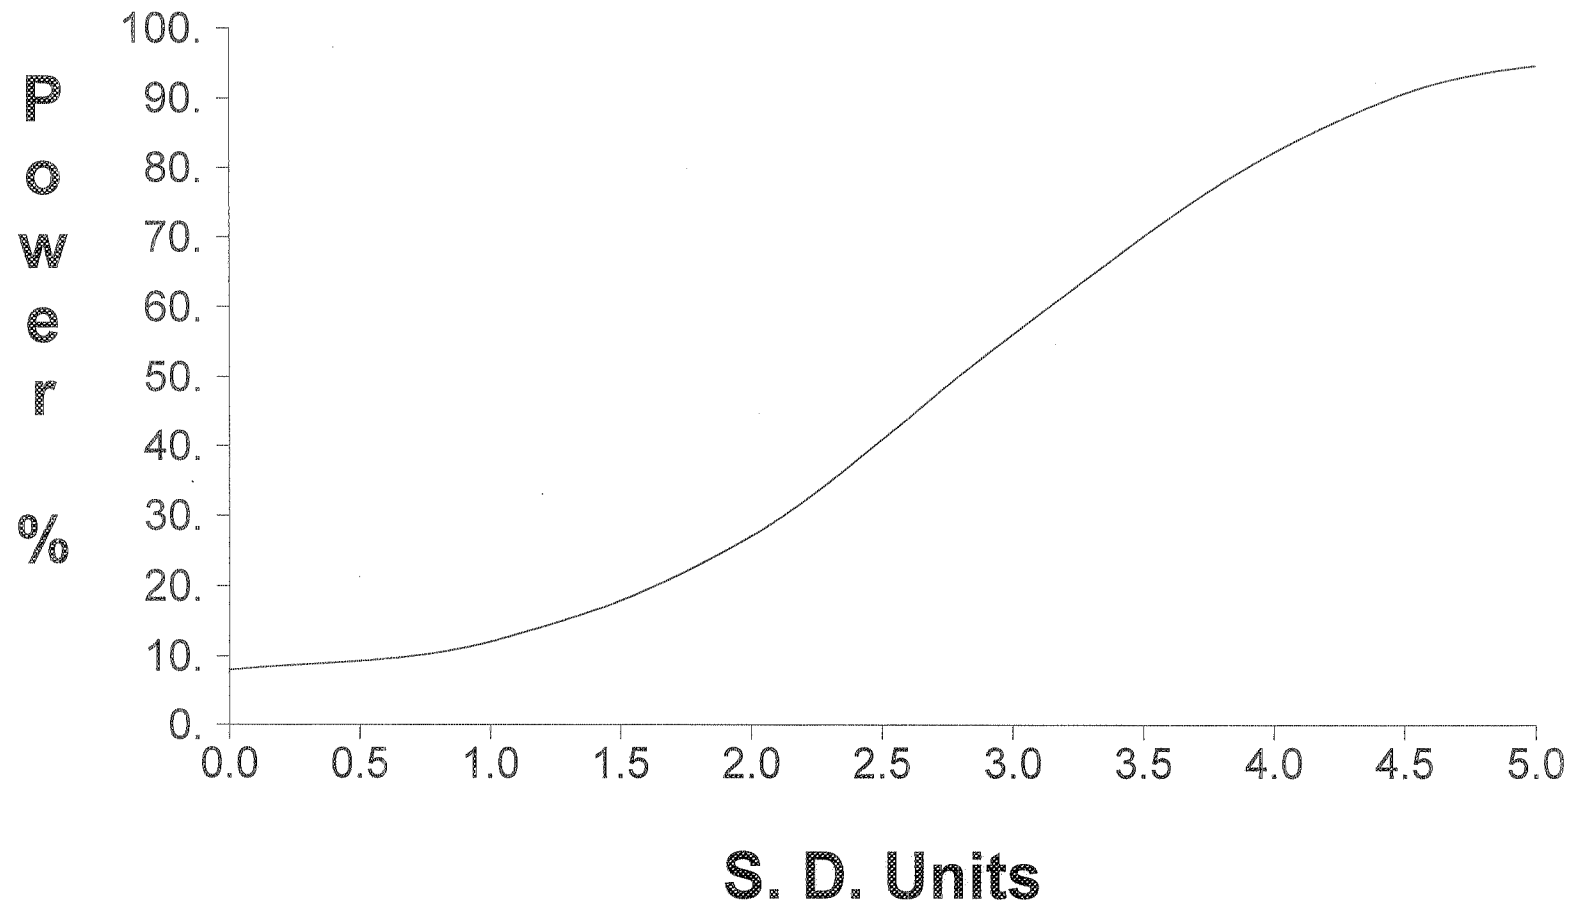
False Positive and False Negative Rates for Current Intra-Well Prediction Limits Monitoring Program
