Lake Goodwin Landfill

2011 1st Quarter Groundwater

Monitoring Report

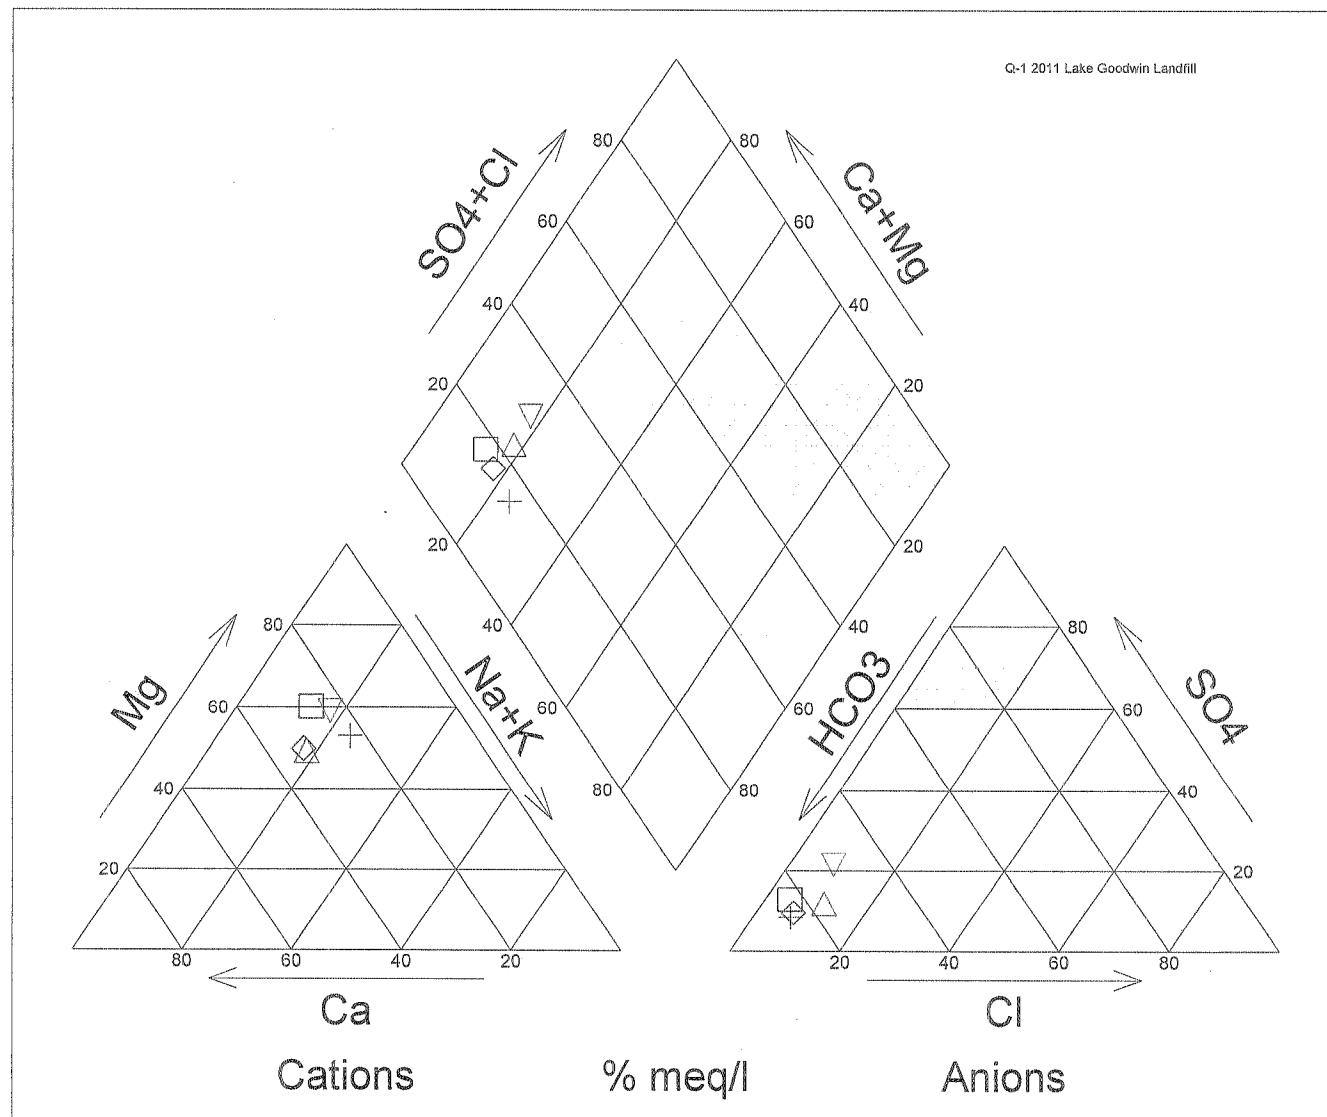
□ LG-01	1/18/2011 - 1/19/2011 (20.2%, 228.53ppm)
△ LG-02	1/18/2011 - 1/19/2011 (17%, 158.04ppm)
▽ LG-03	1/18/2011 - 1/19/2011 (14%, 541.53ppm)
◇ LG-04	1/18/2011 - 1/19/2011 (13.3%, 204.11ppm)
+ LG-05	1/18/2011 - 1/19/2011 (16.8%, 474.27ppm)

Stiff Diagrams, Trilinear Diagrams and Statistically Significant Trends Analyses results are included in *Appendix C* of this report.

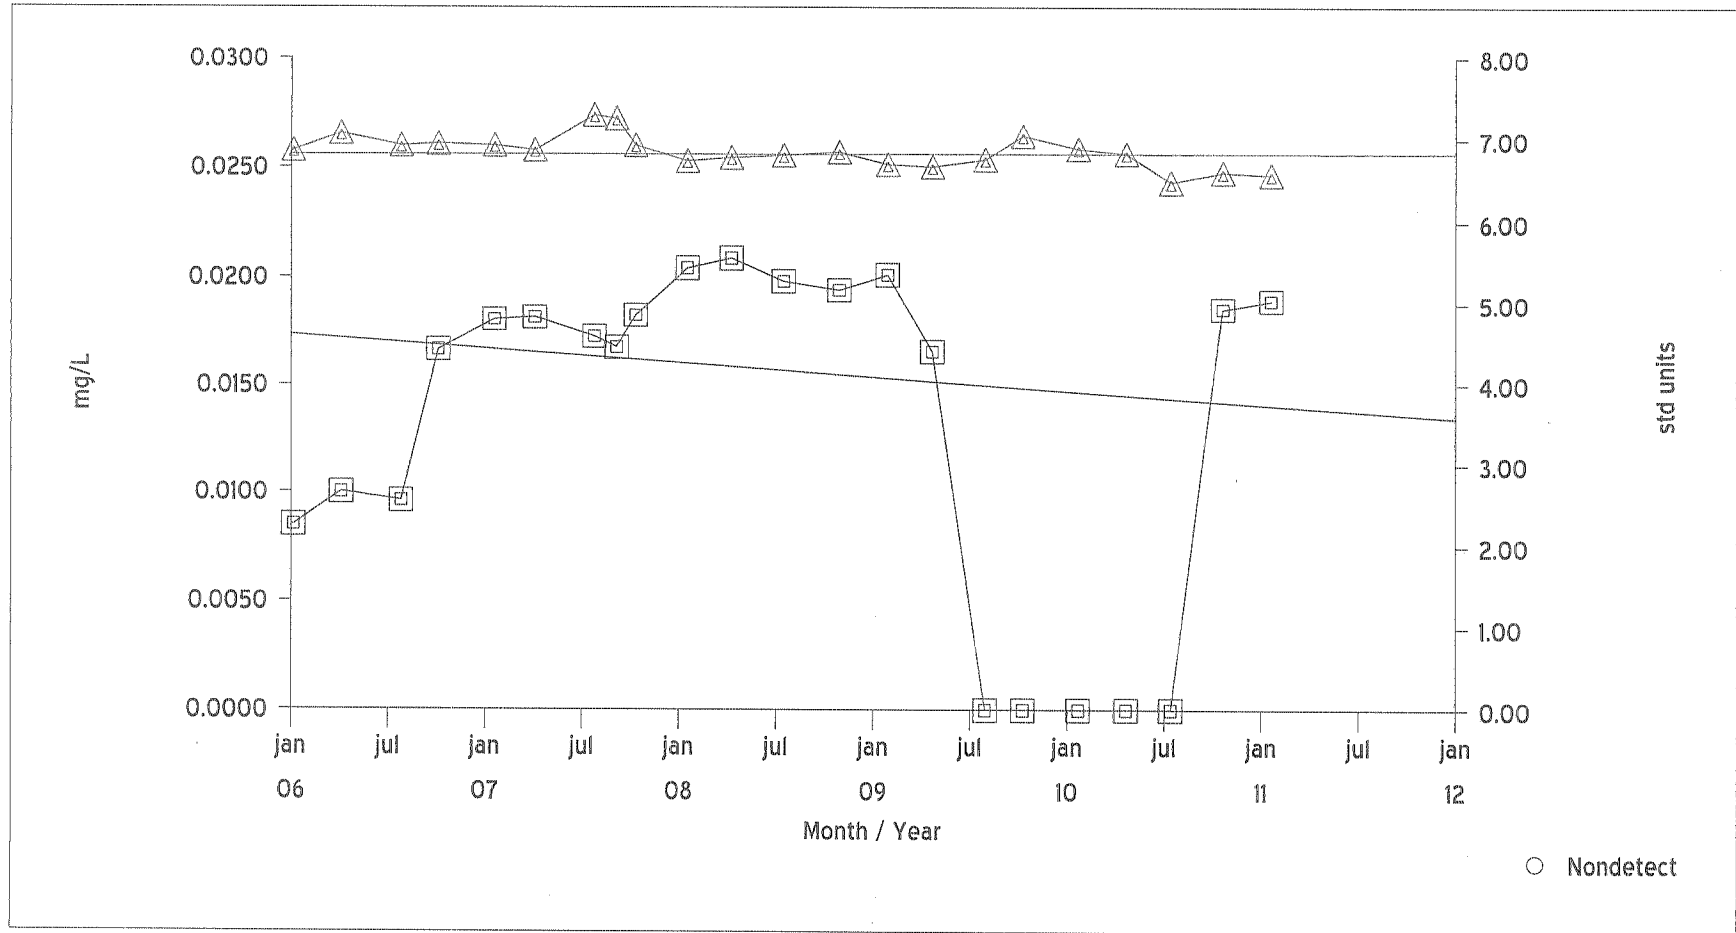
Time Series Plot for LG-01

□ Dissolved barium (cc: -.31f)

△ pH (cc: .033)

- Statistical analysis did show significant impacts to wells *LG-03* and *LG-05*. Lesser impacts were indicated in wells *LG-01* and *LG-04*. Time series plots based on the **DUMPStat** analysis indicates that the majority of the other impact trends are decreasing in the monitoring wells at this time.

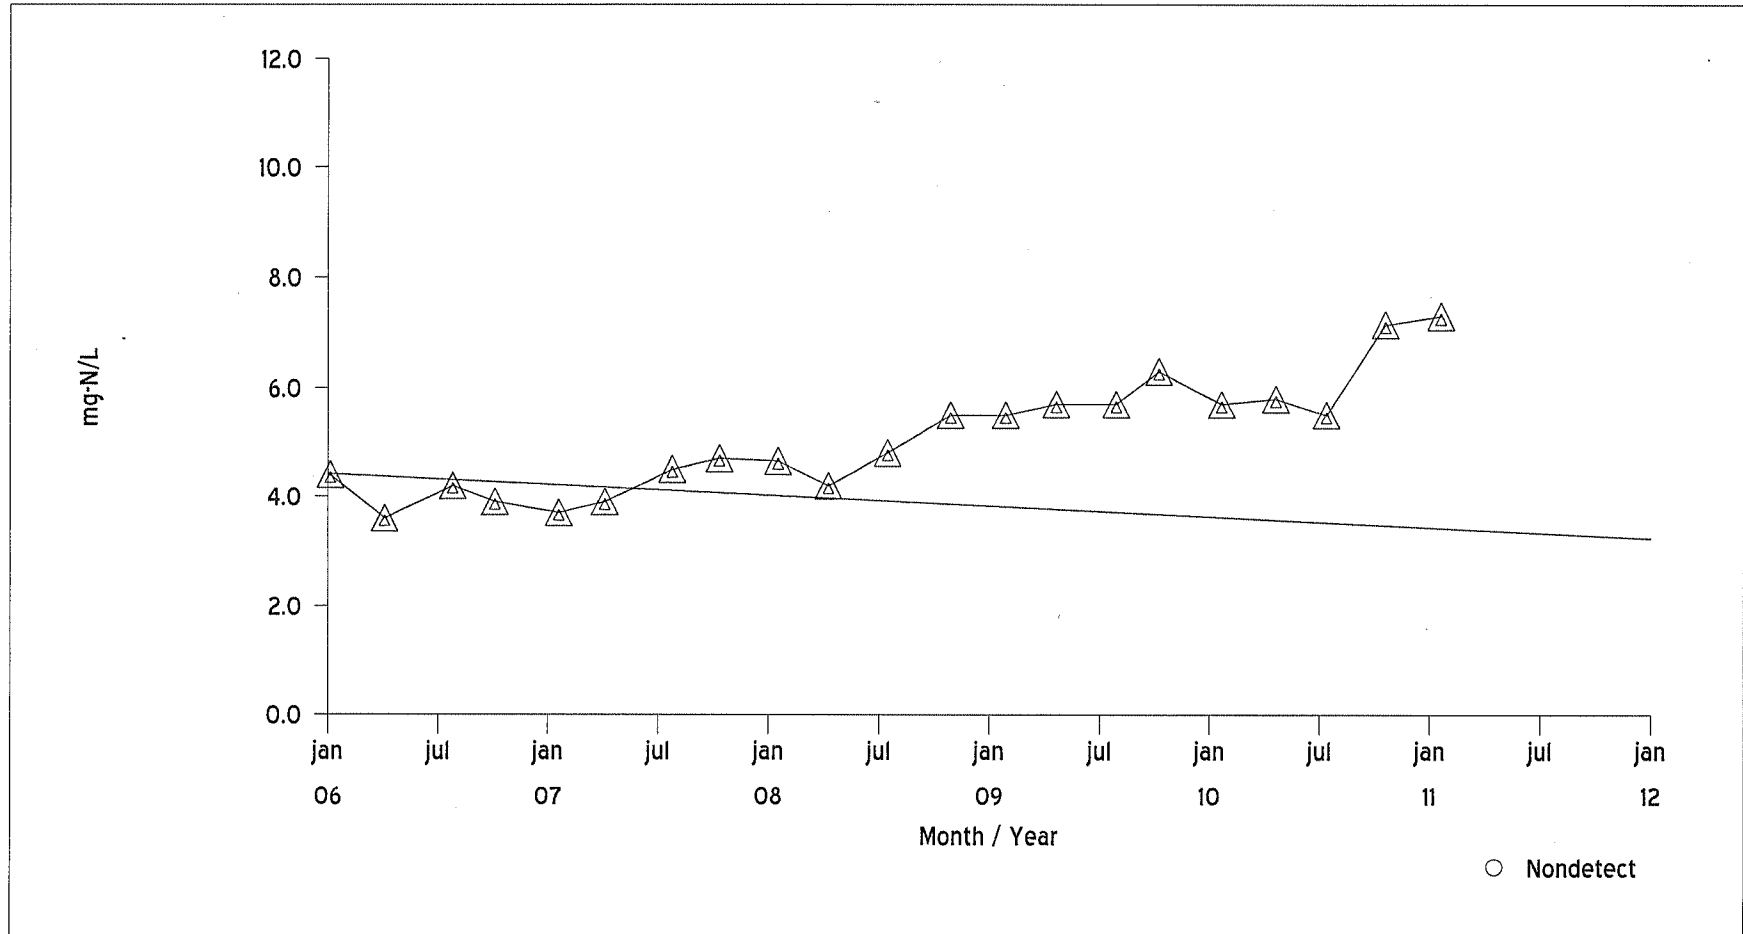
Time Series Plot for LG-03

△ Nitrate nitrogen (cc: -.501)

- VOC's were not detected in any monitoring well during the sampling event.
- Measured conductivity was above background levels (*LG-02*) in all down gradient wells during this sampling event. Conductivity levels observed at wells *LG-03* and *LG-05* was significantly higher than the surrounding wells during this sampling event. Nitrate levels are increasing in *LG-03*.

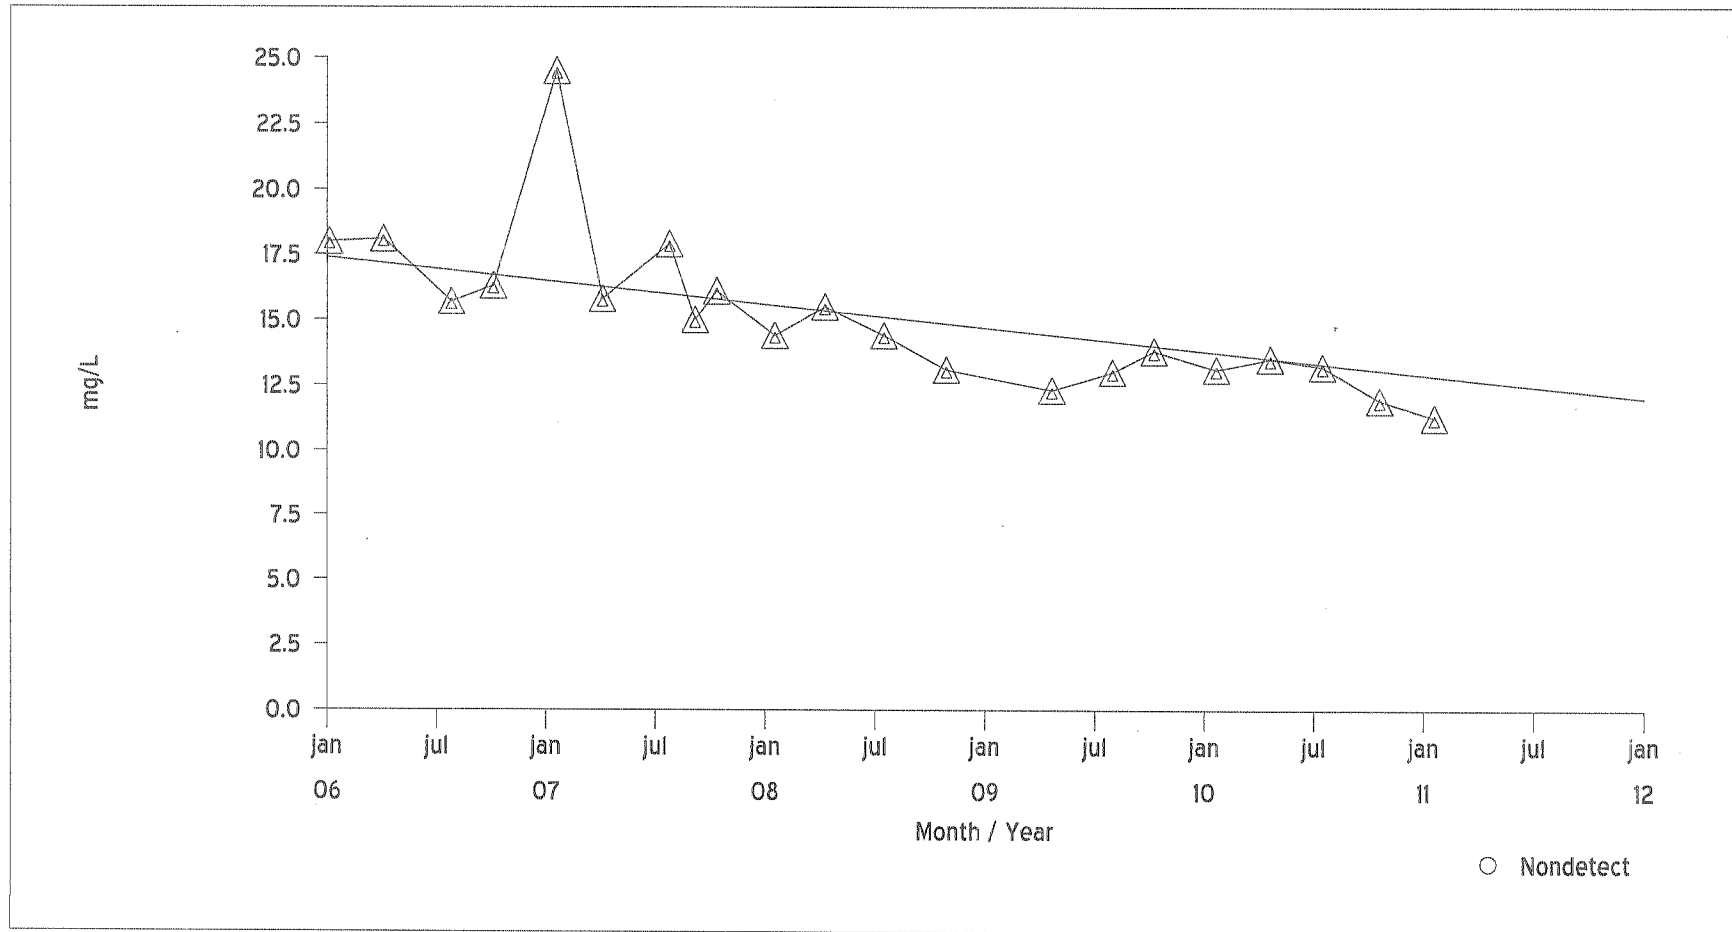
Time Series Plot for LG-04

△ Dissolved sodium (cc: -.610)

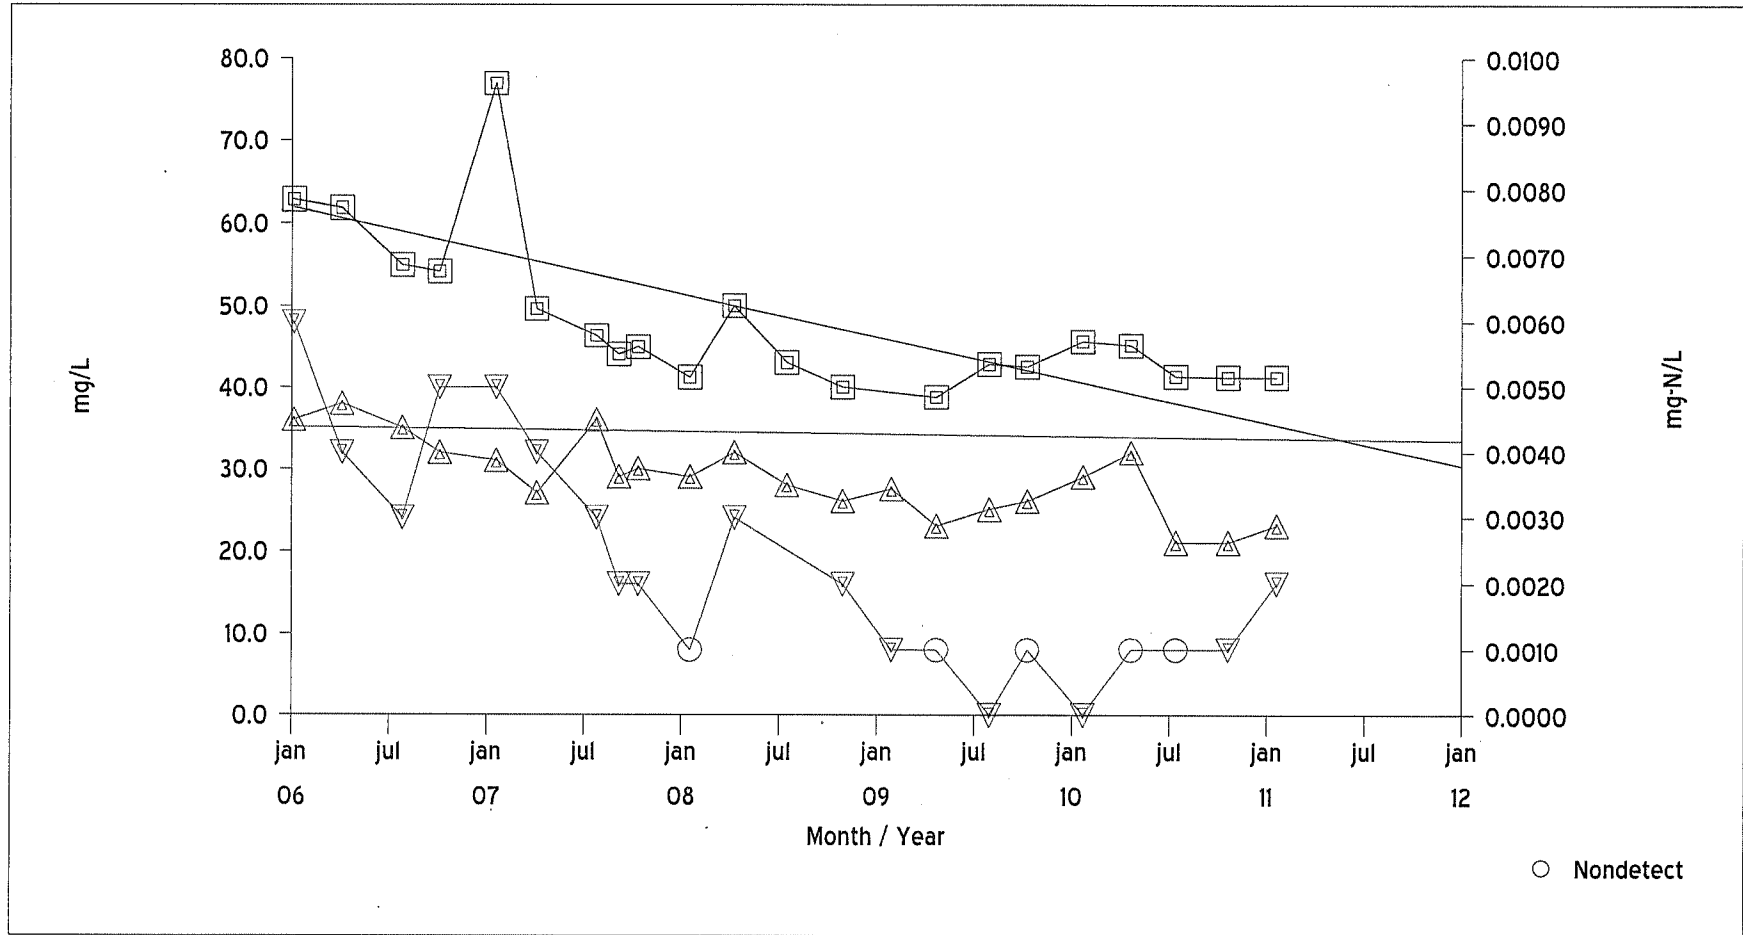
Time Series Plot for LG-05

□ Dissolved sodium (cc: -.883)
 ▲ Sulfate (cc: -.159)

▼ Nitrite nitrogen

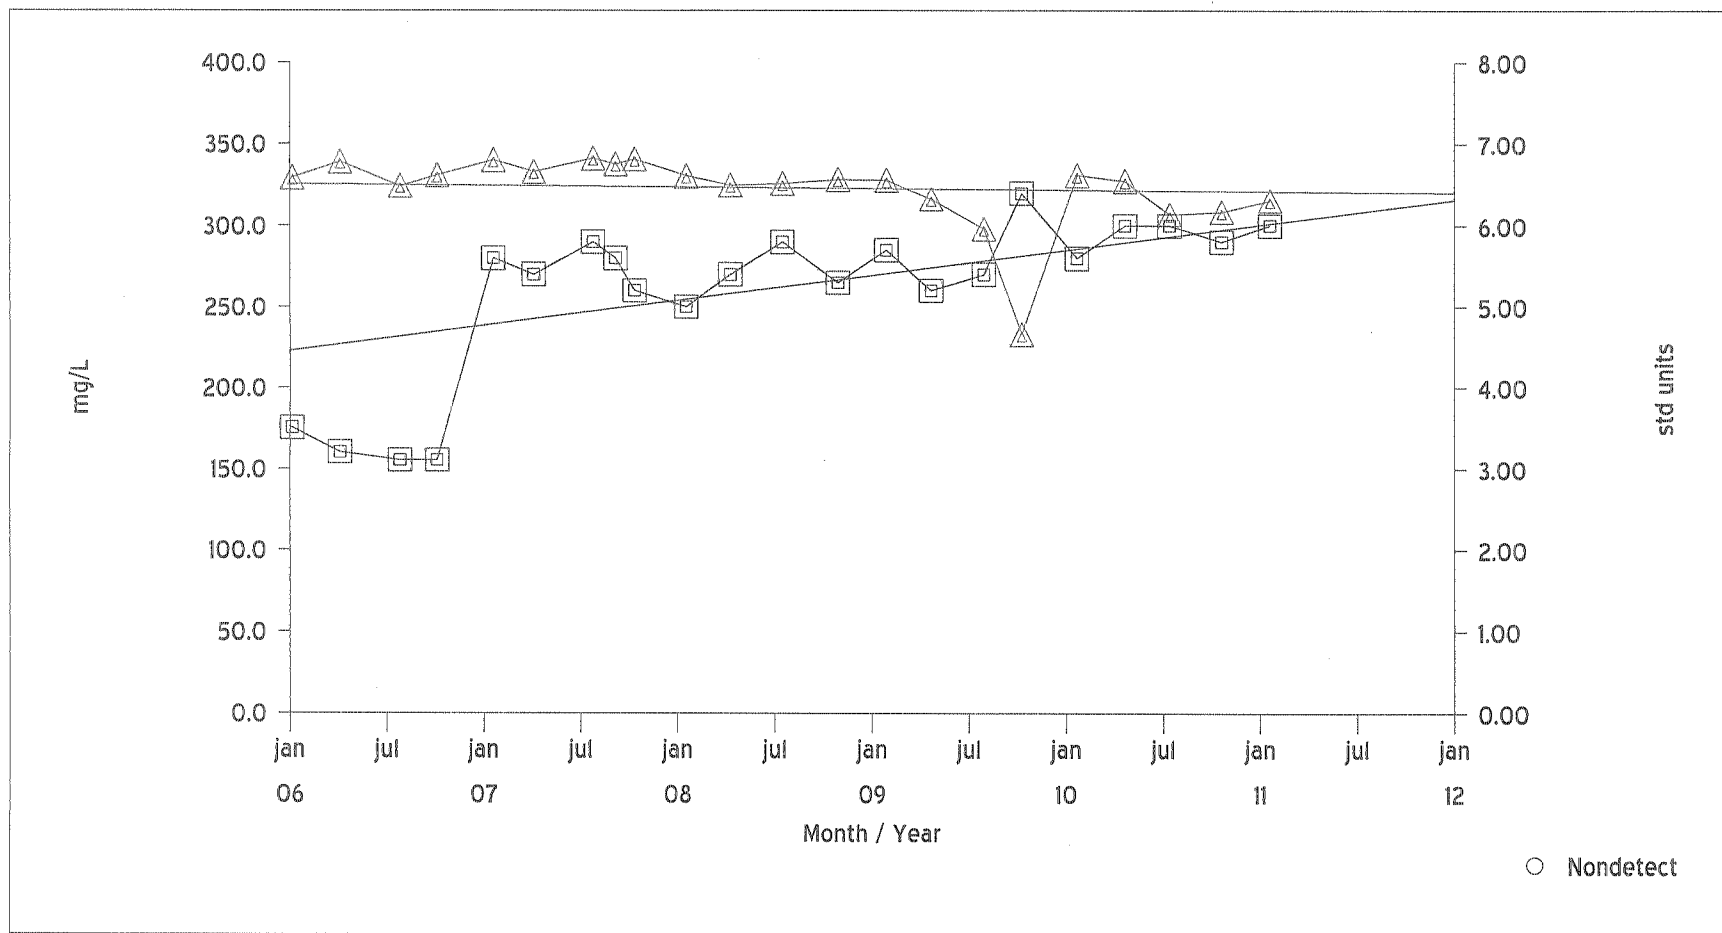
Time Series Plot for LG-05

□ Alkalinity (as CaCO₃) (cc: .741)

△ pH (cc: -.339)
