Lake Goodwin Landfill

2011 2nd Quarter Groundwater

Monitoring Report

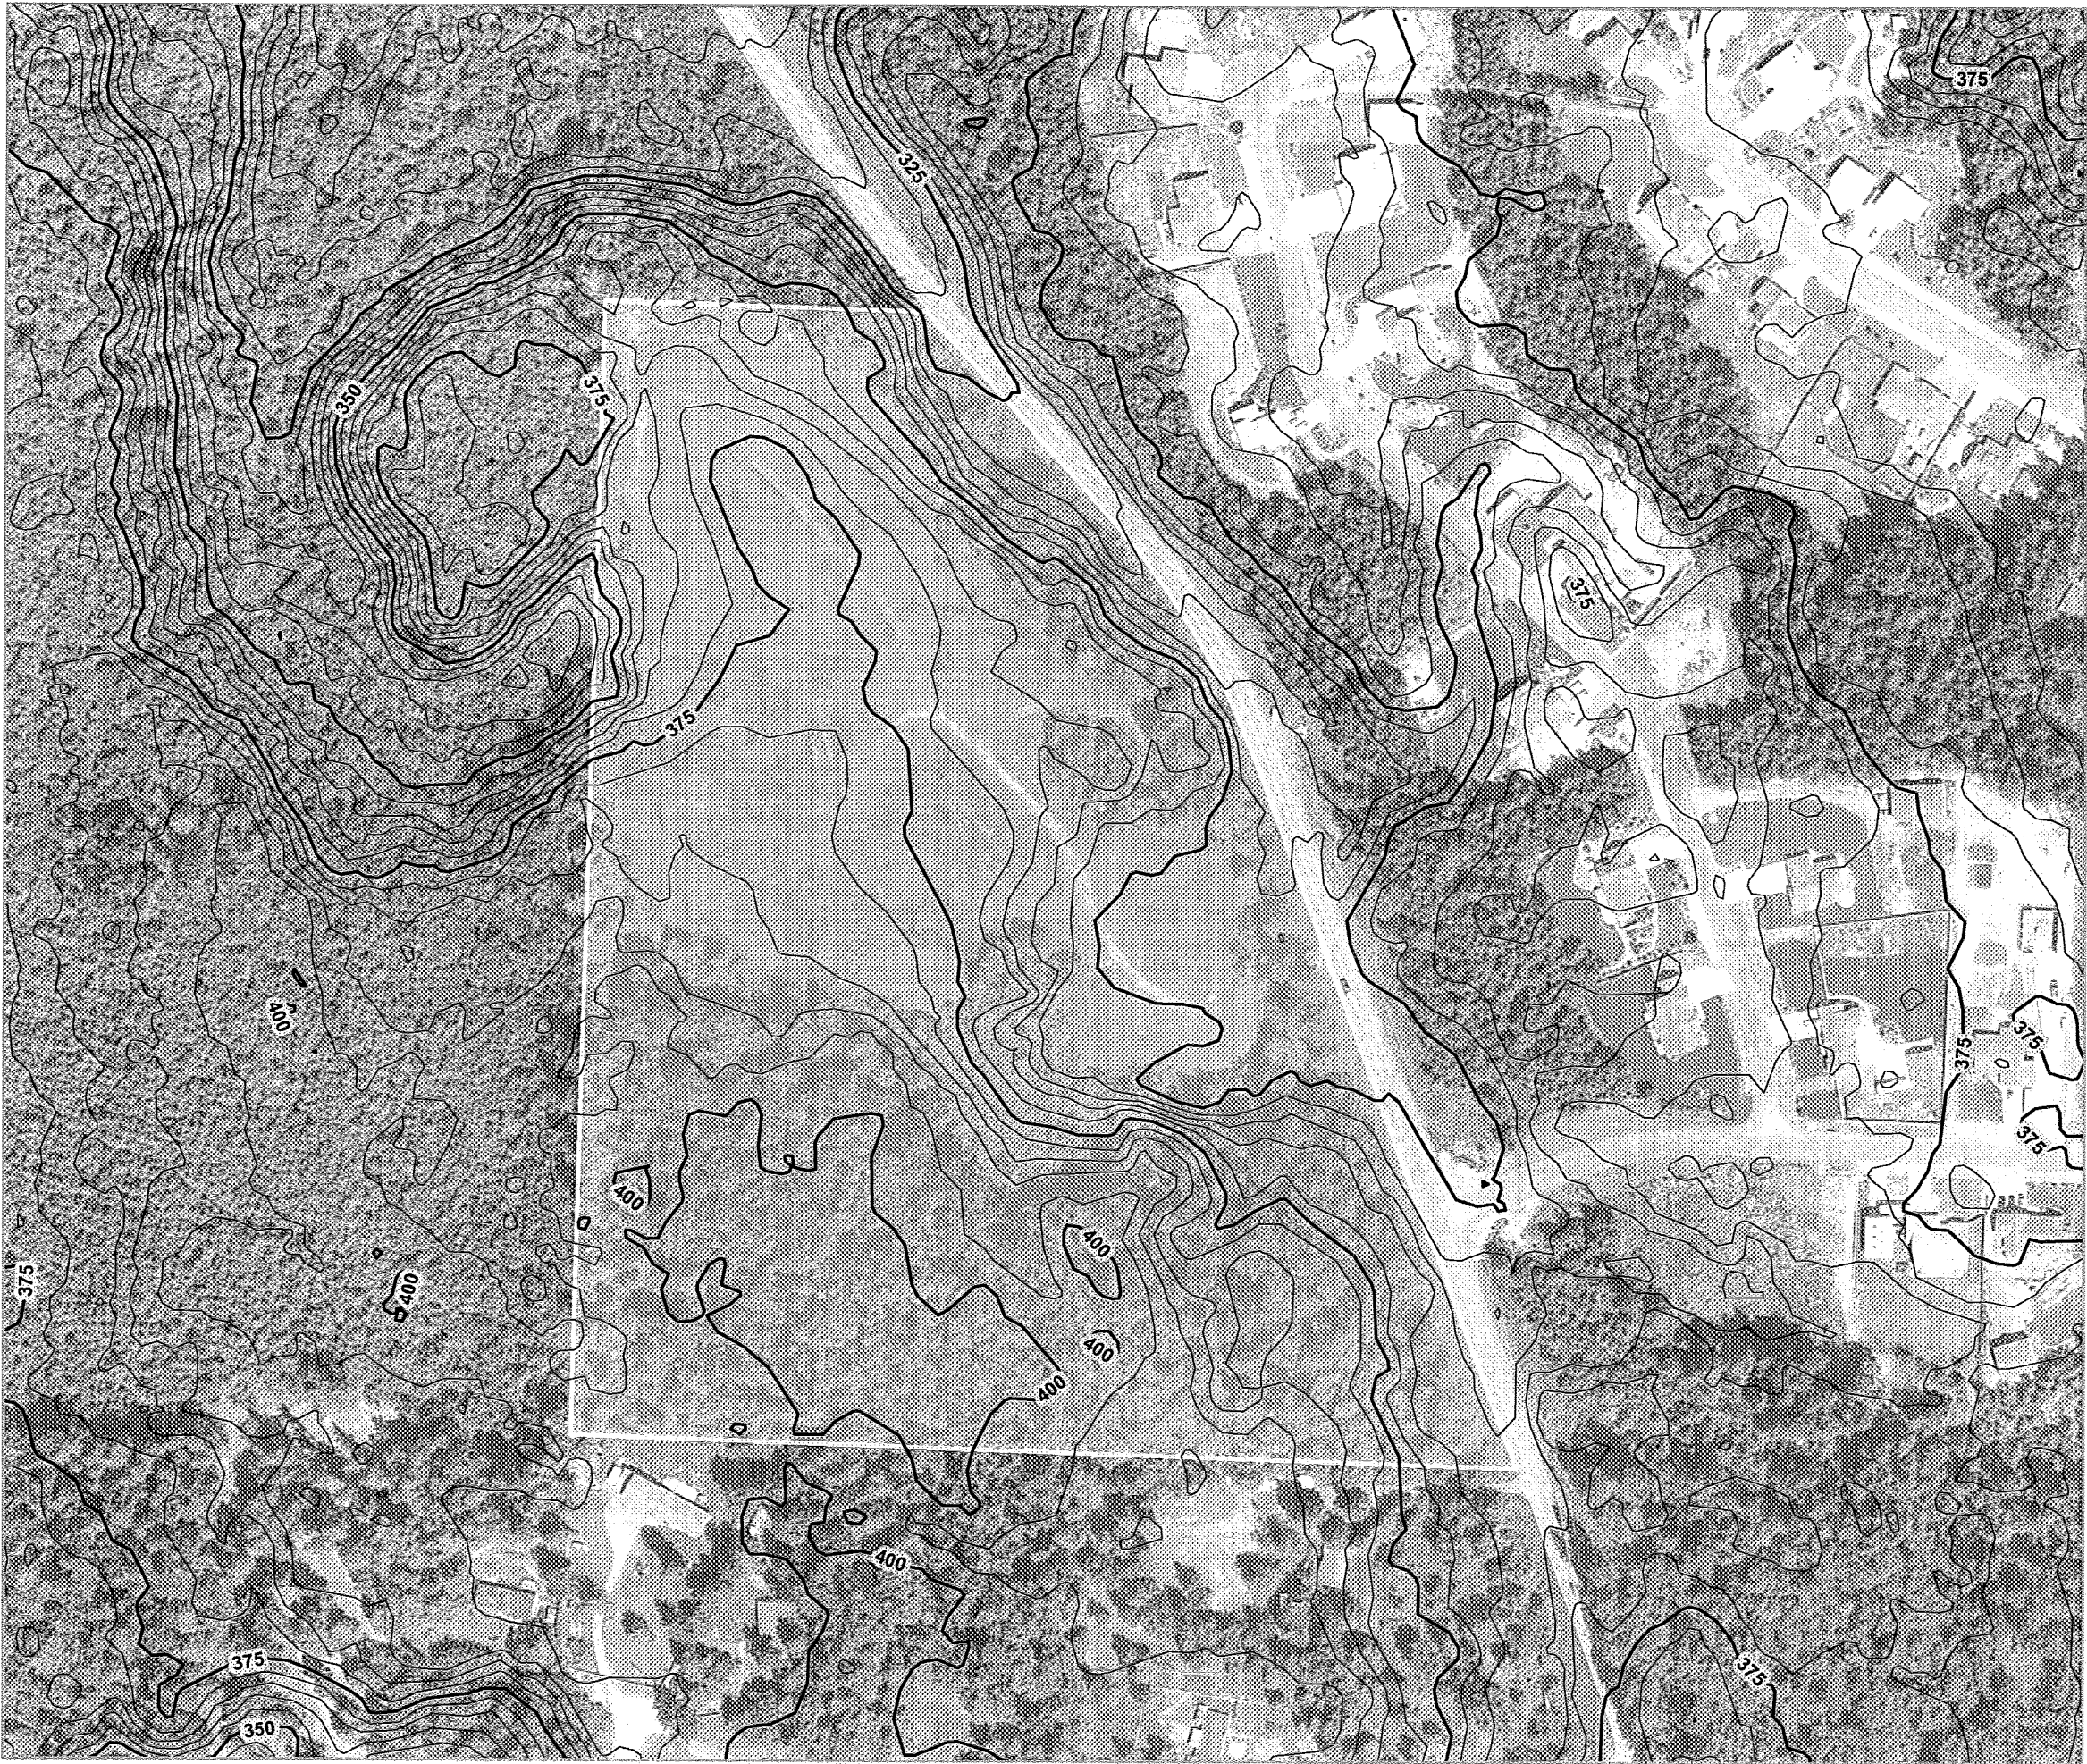
5 Foot Contours

rapid change in the ground water elevation has been observed in these wells in the past. It is not consistent with observed aquifer behavior and may possibly be due to reading error. Readings suggest that the aquifer is unconfined in the immediate vicinity of the site. The **Second Quarter Ground Water Contour Map** developed from the field data is shown in *Figure 6* of this report.

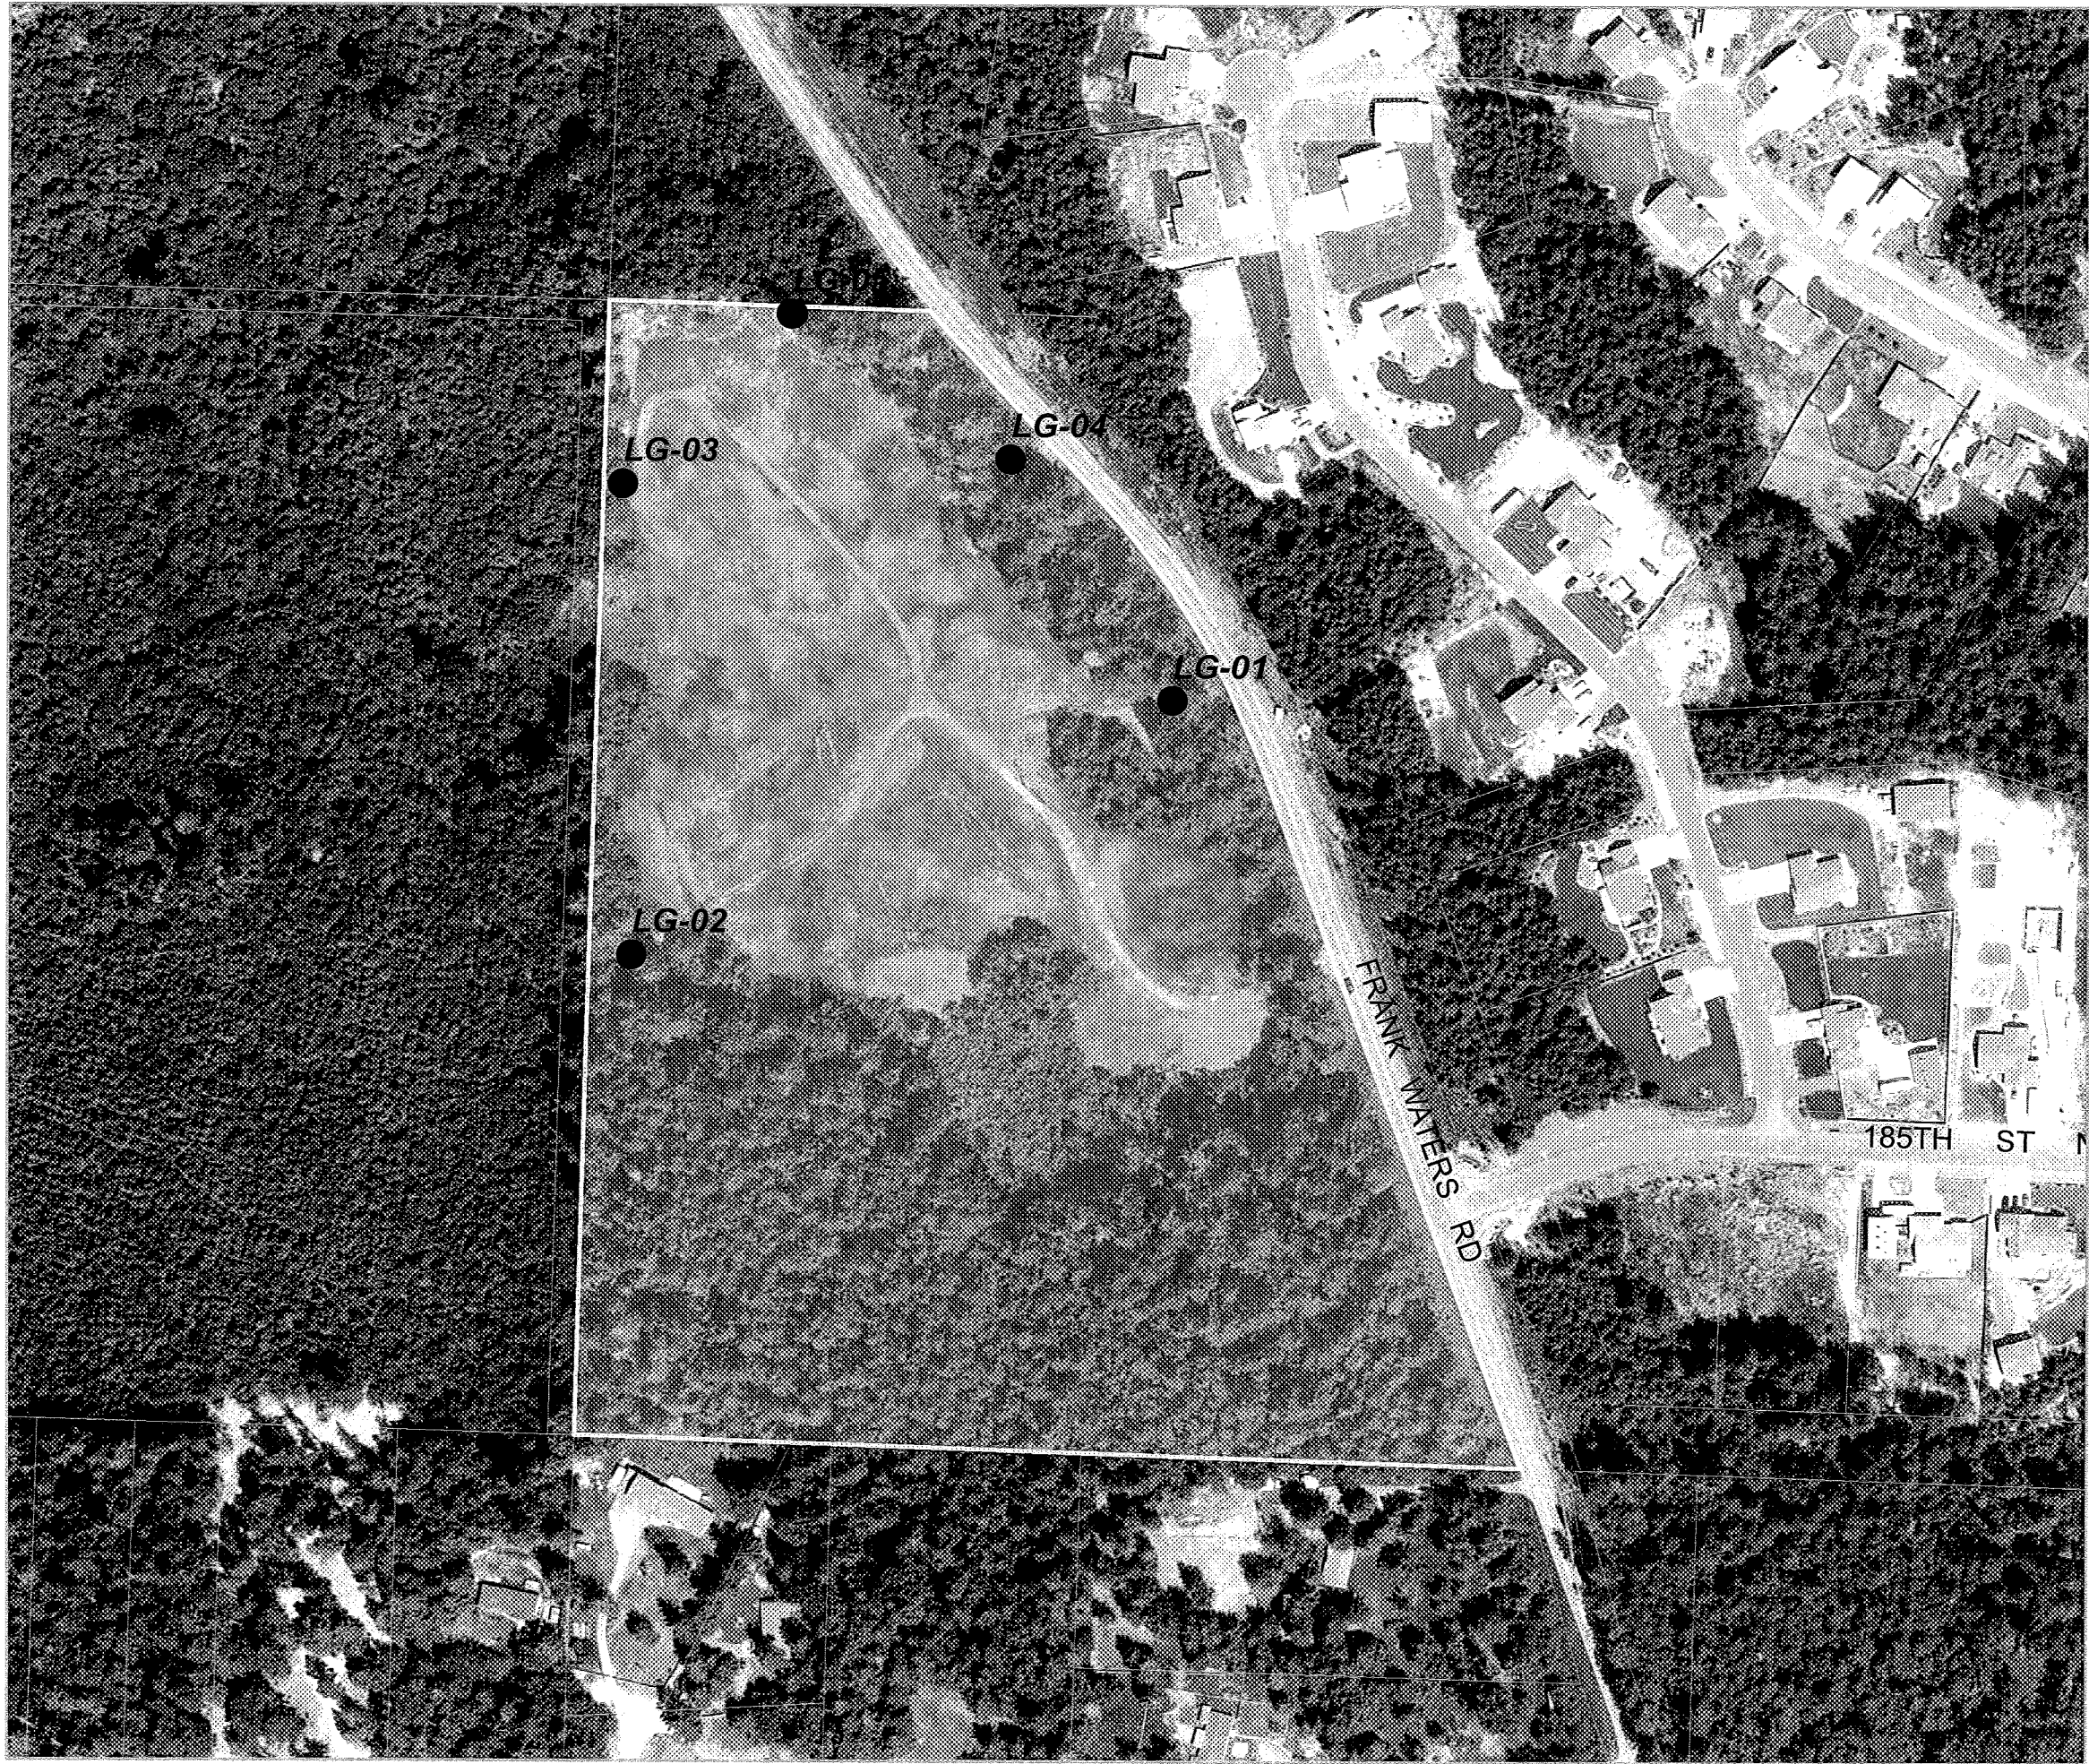
Aquifer Unit (Active Wells)

- Deep Aquifer

As outlined in the Solid Waste Facility Permit SW-085, quarterly monitoring of ground water is required at the Lake Goodwin Landfill. There are currently five-(5) ground water monitoring wells (LG-01 thru LG-05) at the Lake Goodwin Landfill site that are read on a quarterly basis. Well locations are shown on the **Network Monitoring Map** (figure 5). Of these wells, one-(1) is considered to be an up-gradient well monitoring background ground water conditions in the immediate vicinity of the site (LG-02). The remaining four-(4) wells are located in and/or down gradient of the landfill (LG-01, and LG-03 thru LG-05) and monitor ground water conditions that may be impacted from the site. Second quarter monitoring results are discussed in section 2.0 below.

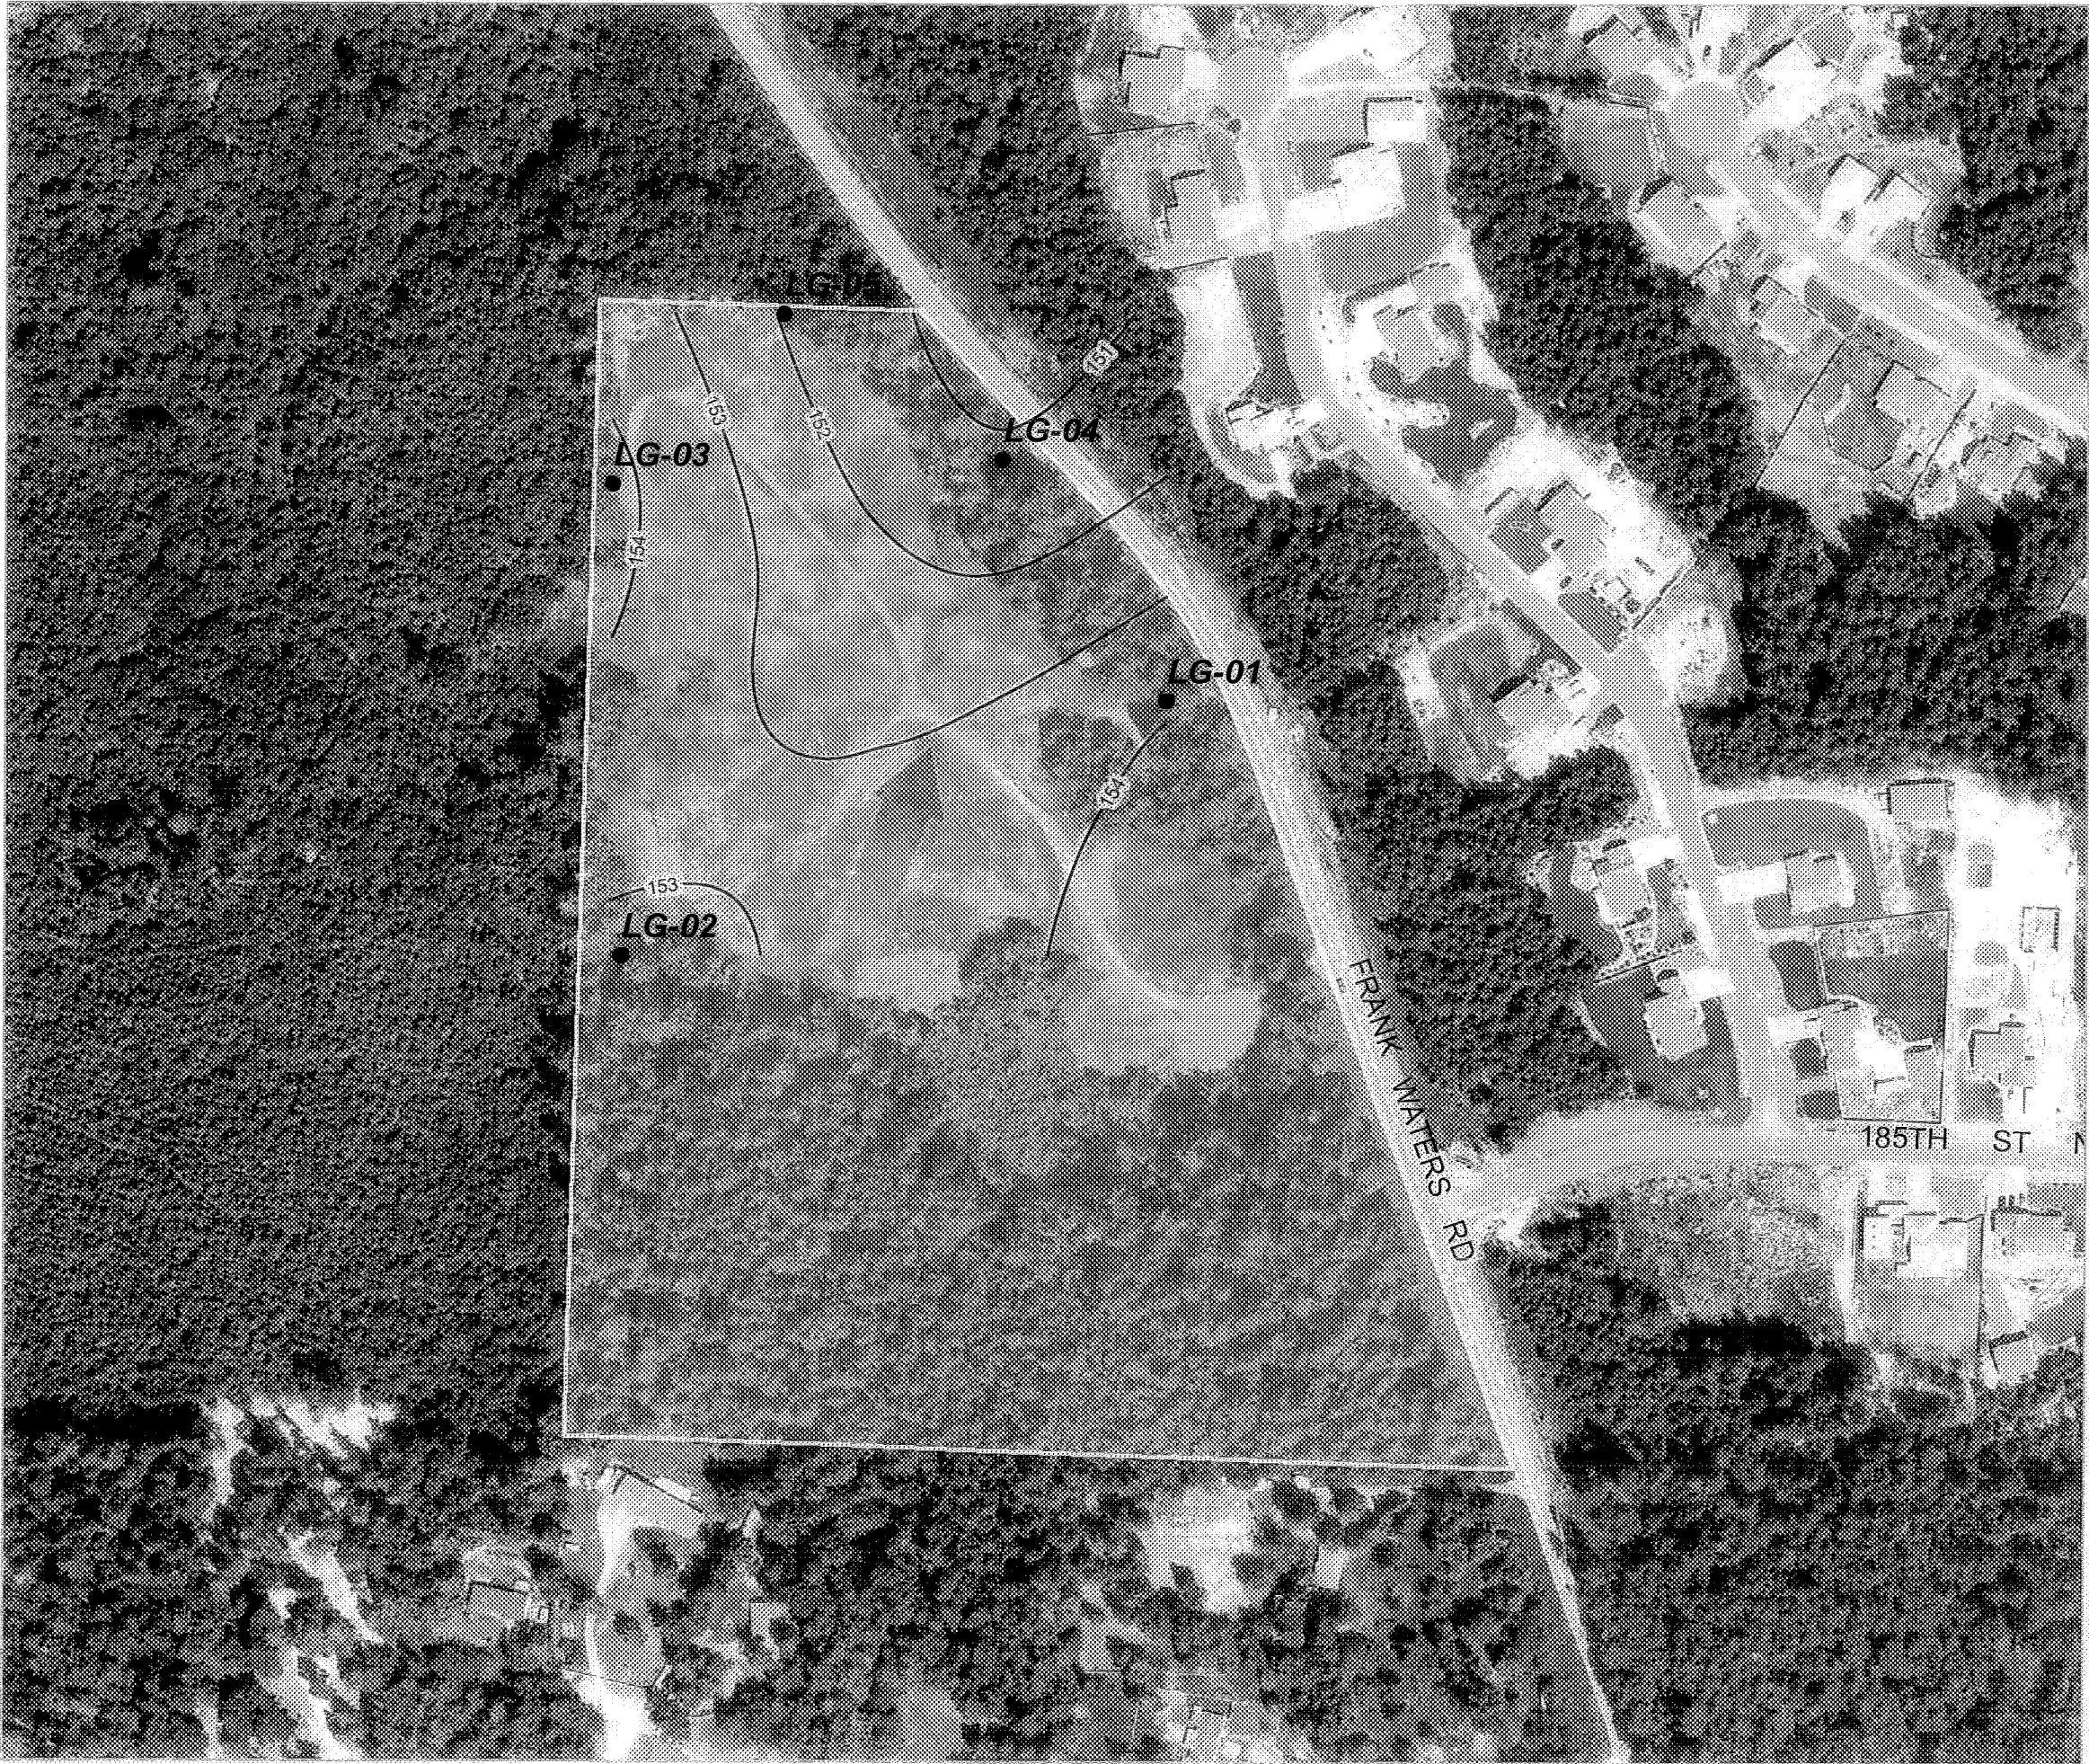
Figure 6

Water Elevation Contours
2nd Quarter 2011

- DIRECTION OF GROUNDWATER FLOW
.661 ft/day
241 ft/year
68.75 degrees to the positive x-axis
- PARCEL BOUNDARY
- SUBJECT PROPERTY BOUNDARY
- 1 FT CONTOUR
- WELL LOCATION

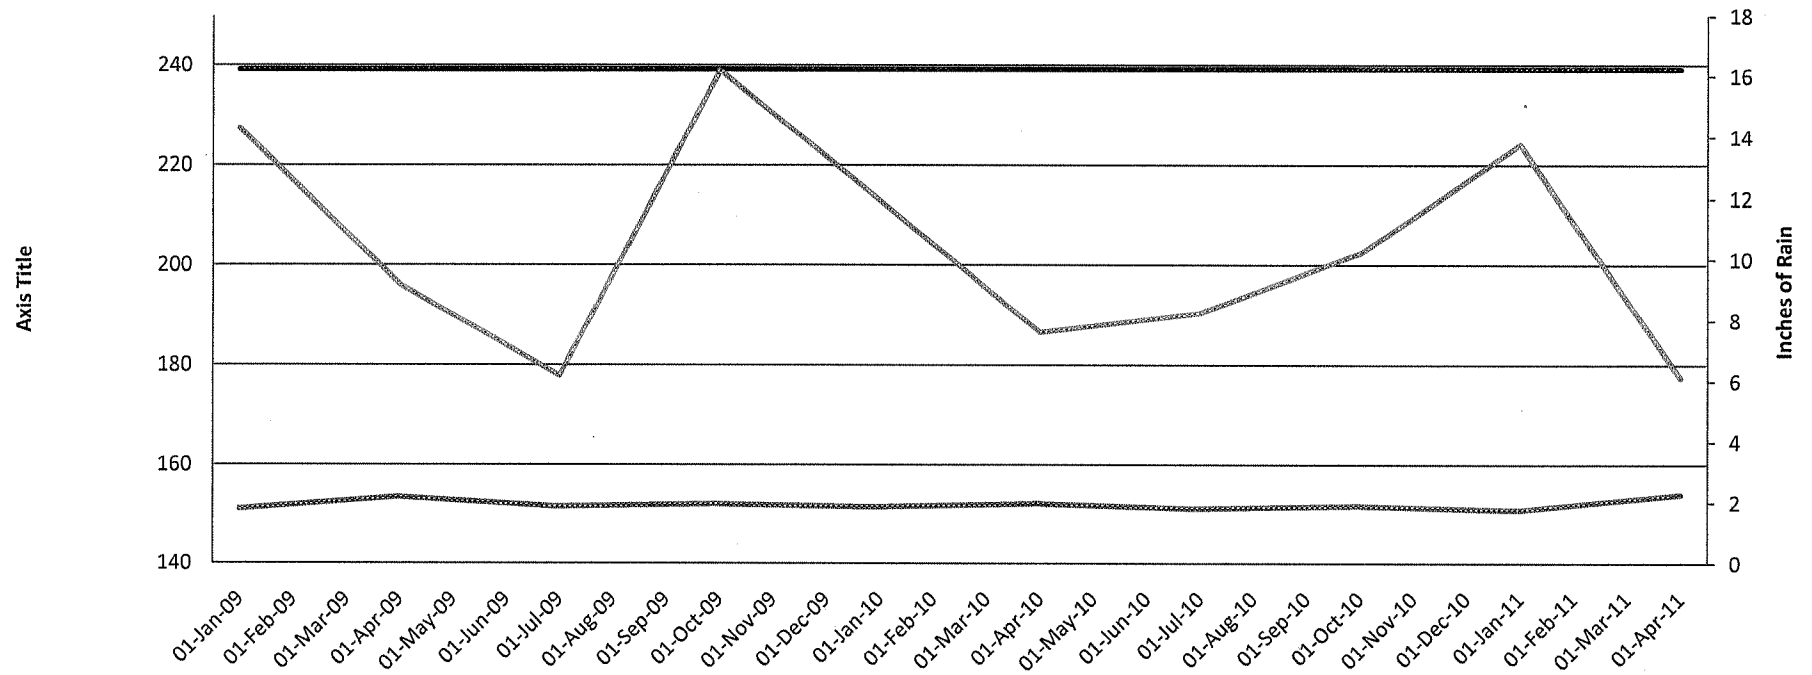
Lake Goodwin Well LG-01

| | 27-Jan-09 | 21-Apr-09 | 29-Jul-09 | 08-Oct-09 | 20-Jan-10 | 20-Apr-10 | 7/13/2010 | 10/19/2010 | 1/8/2011 | 4/12/2011 |
|---|---|---|---|---|---|---|---|---|---|---|
| Depth to Water | 151.06 | 153.43 | 151.48 | 152.04 | 151.46 | 152.09 | 151.05 | 151.56 | 150.71 | 153.87 |

Second Quarter Ground Water Measurements are shown in *Table 1* below. **Hydrographs** of the second quarter 2011 monitoring well readings are contained in *Appendix A* of this report. Based on the ground water readings for all wells except LG-01 and LG-03, small fluctuations in the ground water gradient below the site were observed. Down-gradient wells LG-01 and LG-03 showed a 3+ foot increase in ground water elevation over their previous readings. This fairly

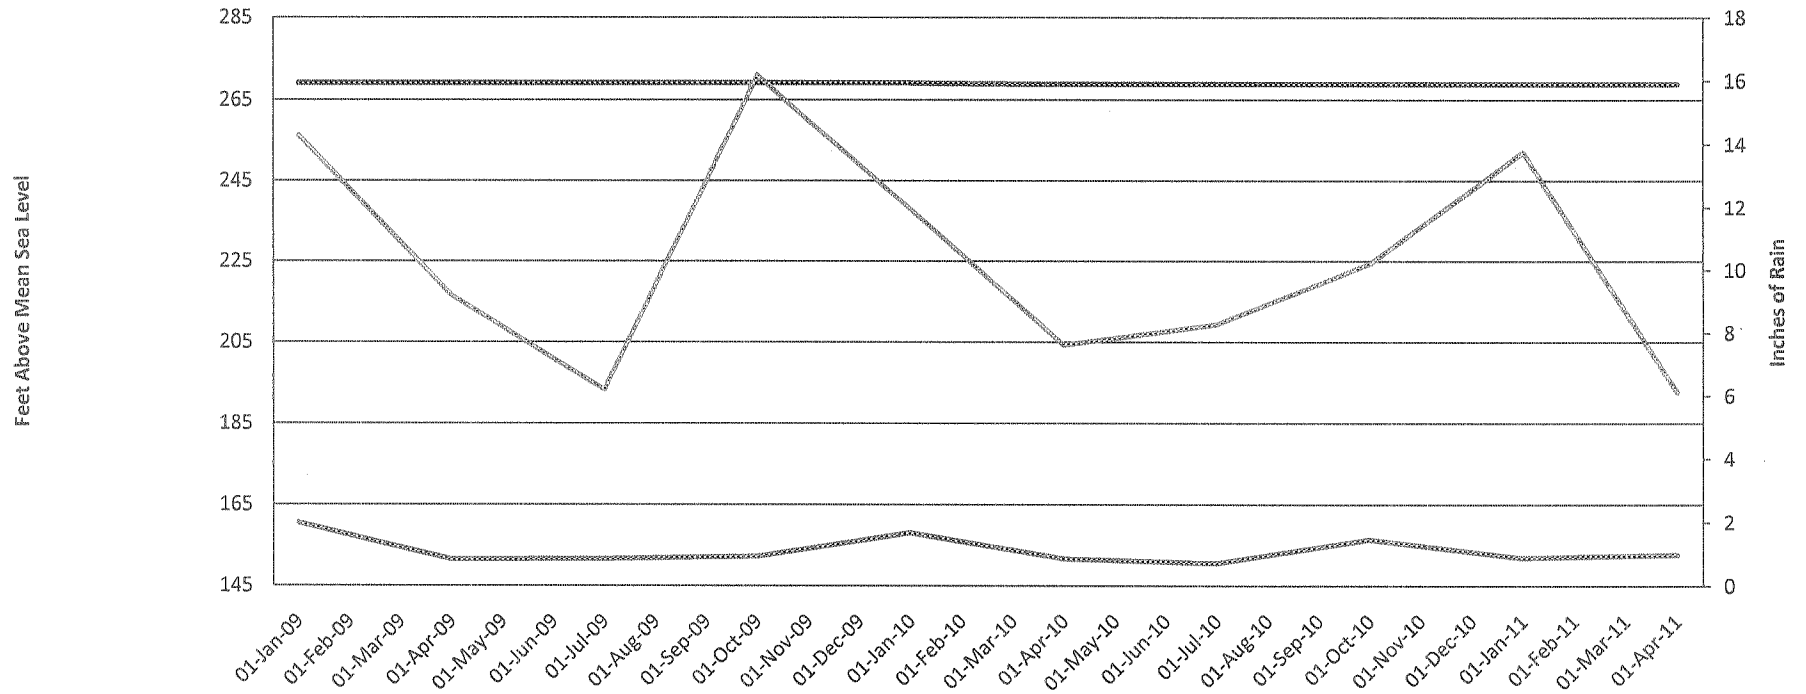
Lake Goodwin Well LG-02

| | 27-Jan-09 | 21-Apr-09 | 29-Jul-09 | 08-Oct-09 | 20-Jan-10 | 4/20/2010 | 7/13/2010 | 10/19/2010 | 1/18/2011 | 4/12/2011 |
|---|---|---|---|---|---|---|---|---|---|---|
| Groundwater Elevation | 160.57 | 151.56 | 151.59 | 152.25 | 158.1 | 151.67 | 150.54 | 156.37 | 151.74 | 152.53 |

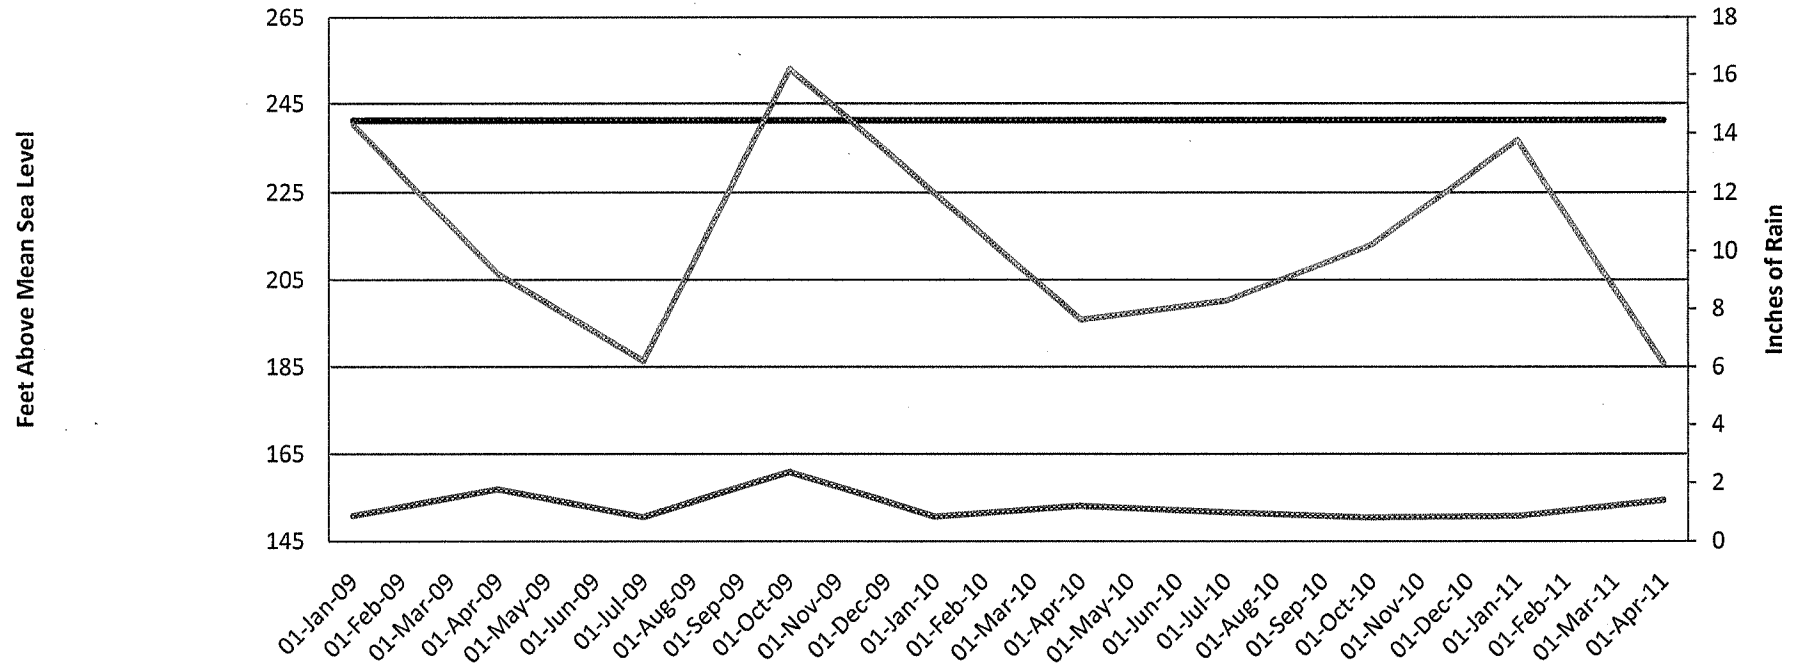
Lake Goodwin Well LG-03

| | 27-Jan-09 | 21-Apr-09 | 29-Jul-09 | 08-Oct-09 | 20-Jan-10 | 4/20/2010 | 7/13/2010 | 10/19/2010 | 1/19/2011 | 4/12/2011 |
|---|---|---|---|---|---|---|---|---|---|---|
| Groundwater Elevations | 150.86 | 156.82 | 150.51 | 160.84 | 150.59 | 153.1 | 151.59 | 150.35 | 150.64 | 154.19 |

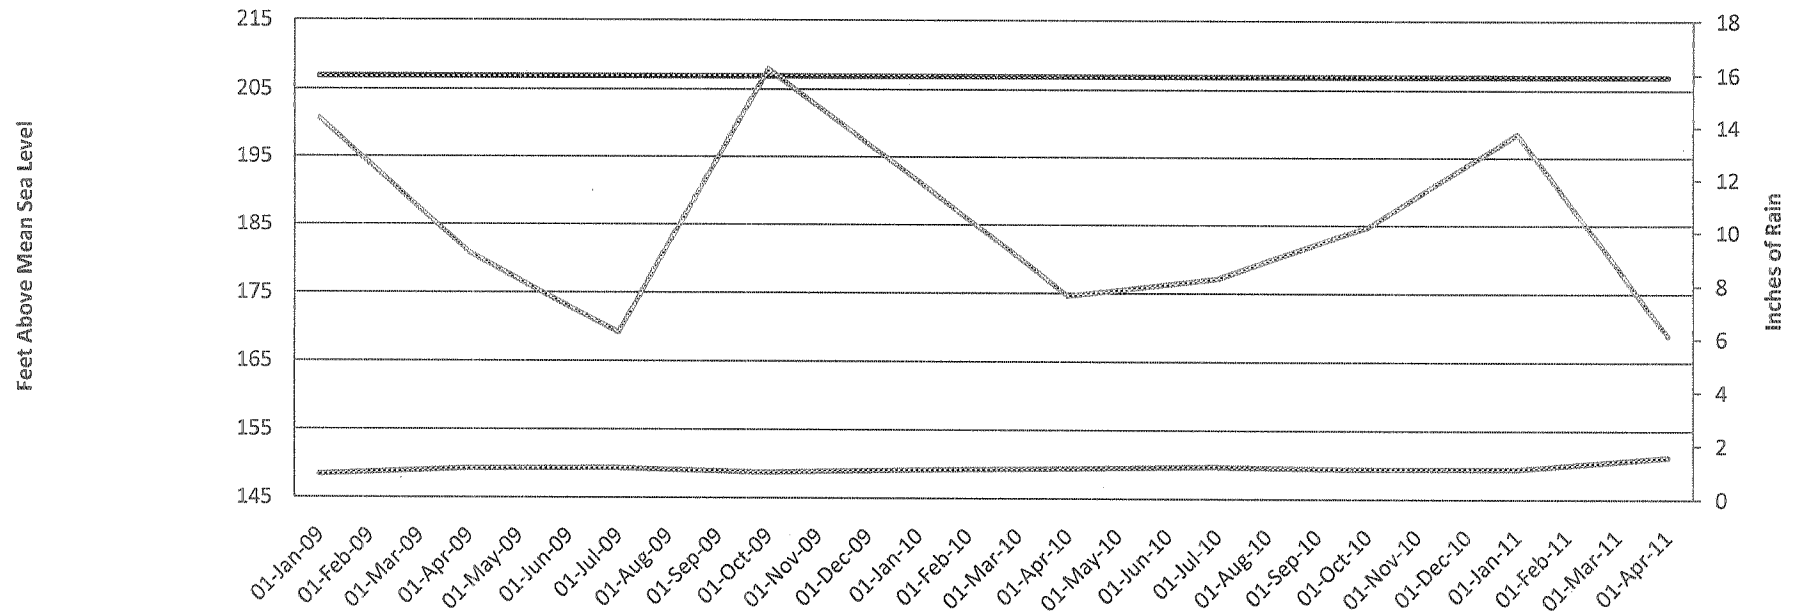
Lake Goodwin Well LG-04

| | 27-Jan-09 | 21-Apr-09 | 31-Jul-09 | 08-Oct-09 | 20-Jan-10 | 4/20/2010 | 7/13/2010 | 10/19/2010 | 1/19/2011 | 4/12/2011 |
|---|---|---|---|---|---|---|---|---|---|---|
| Groundwater Elevation | 148.5 | 149.34 | 149.46 | 148.84 | 149.22 | 149.42 | 149.72 | 149.39 | 149.4 | 151.14 |

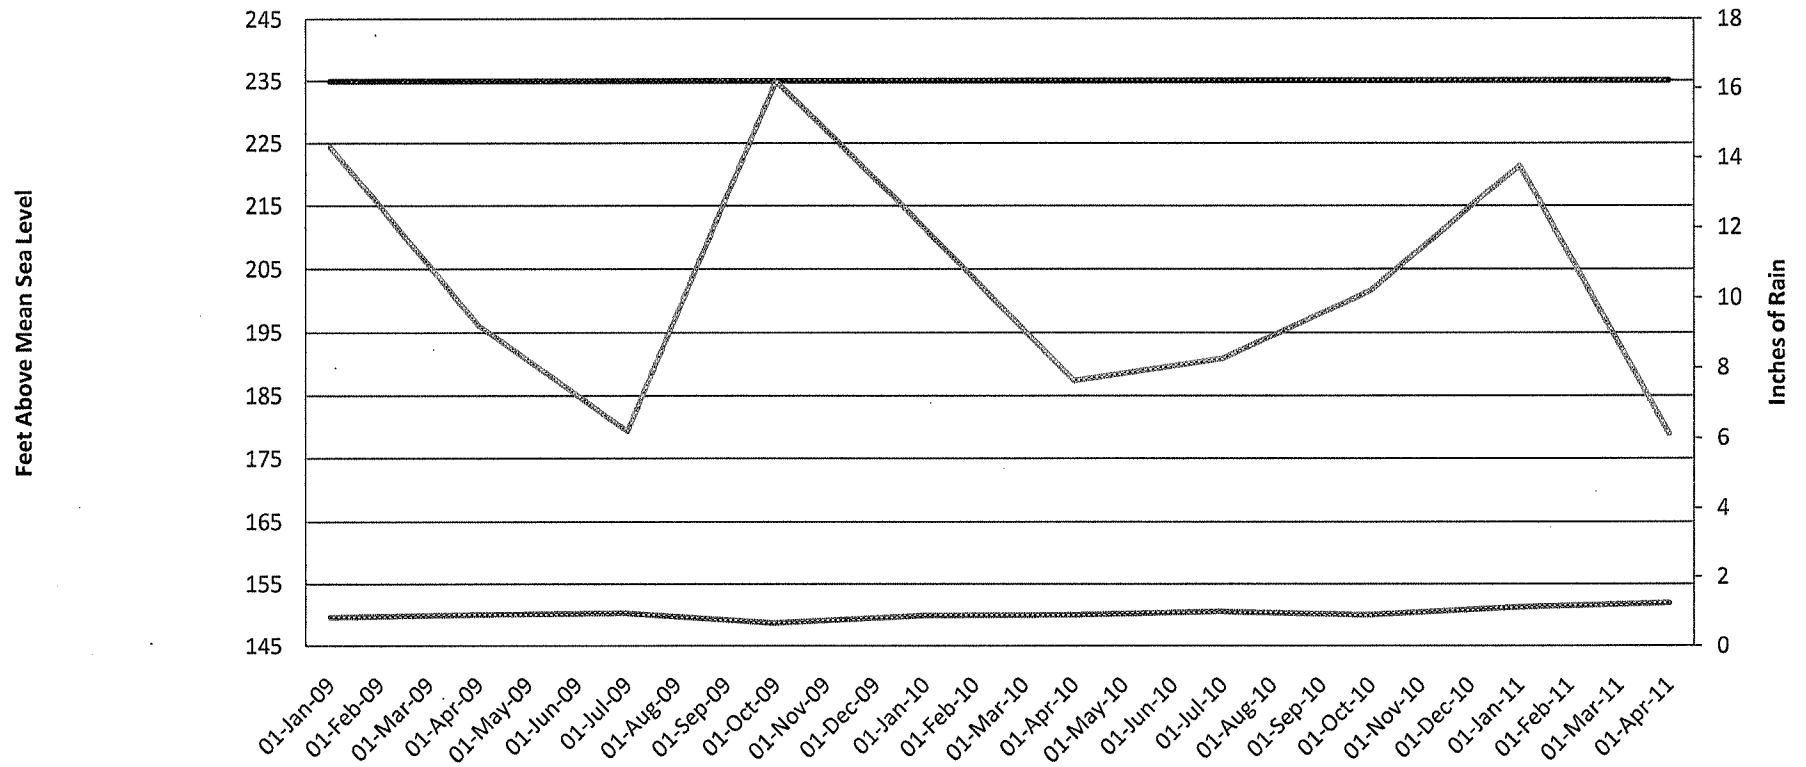
Lake Goodwin Well LG-05

| | 27-Jan-09 | 21-Apr-09 | 29-Jul-09 | 08-Oct-09 | 20-Jan-10 | 4/20/2010 | 7/13/2010 | 10/19/2010 | 1/18/2011 | 4/12/2011 |
|---|---|---|---|---|---|---|---|---|---|---|
| Groundwater Elevation | 149.71 | 150.11 | 150.39 | 148.79 | 149.98 | 150.09 | 150.62 | 150.05 | 151.28 | 151.93 |

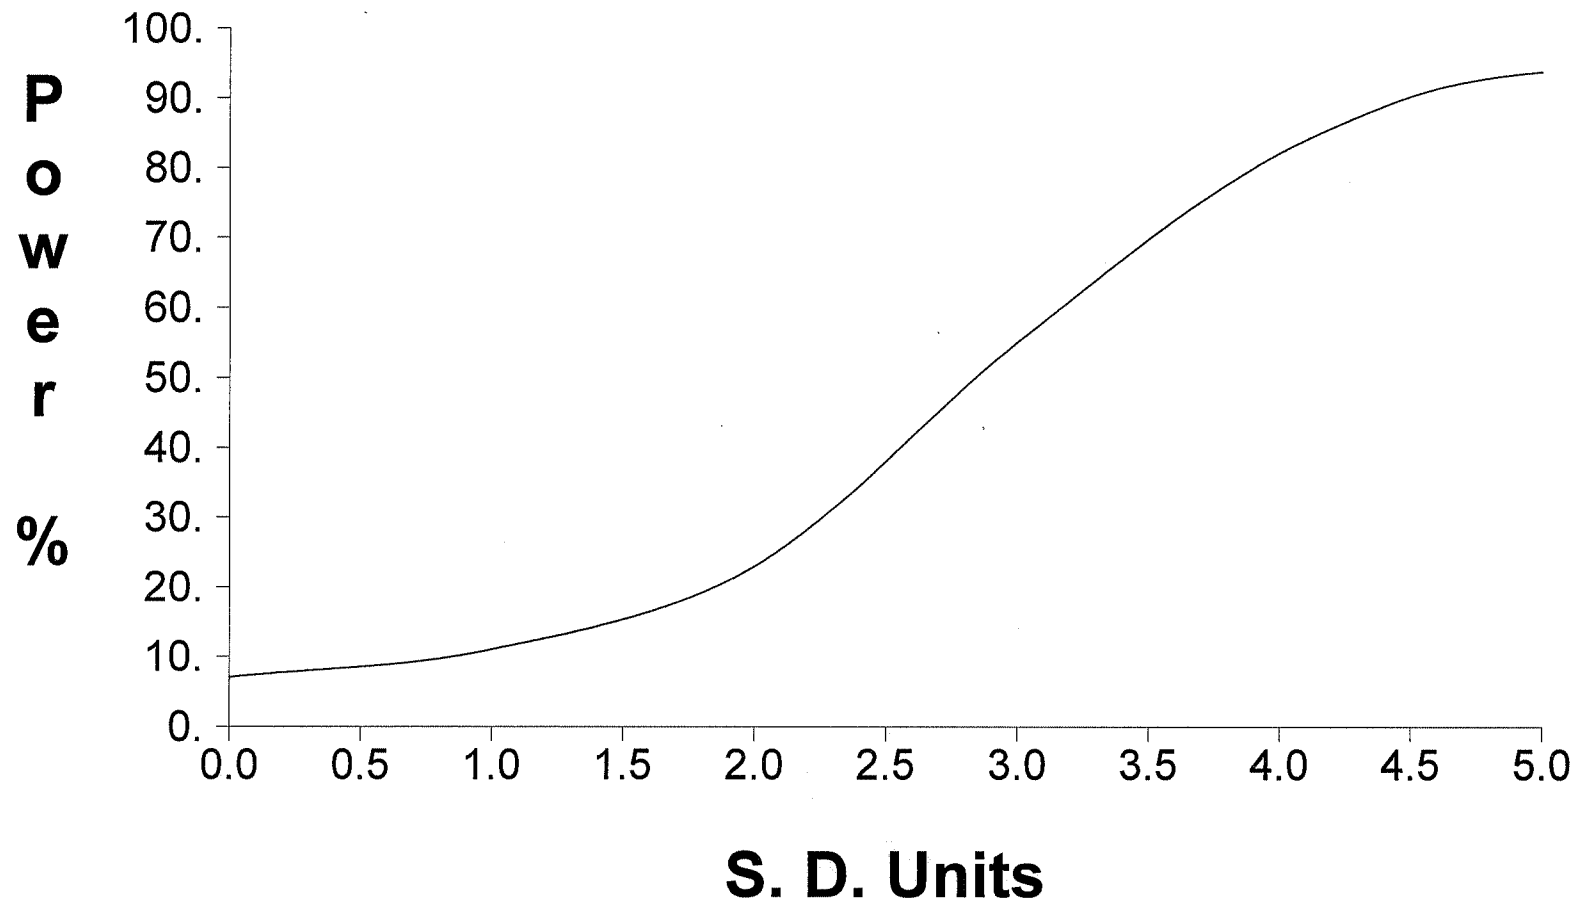
False Positive and False Negative Rates for Current Intra-Well Prediction Limits Monitoring Program

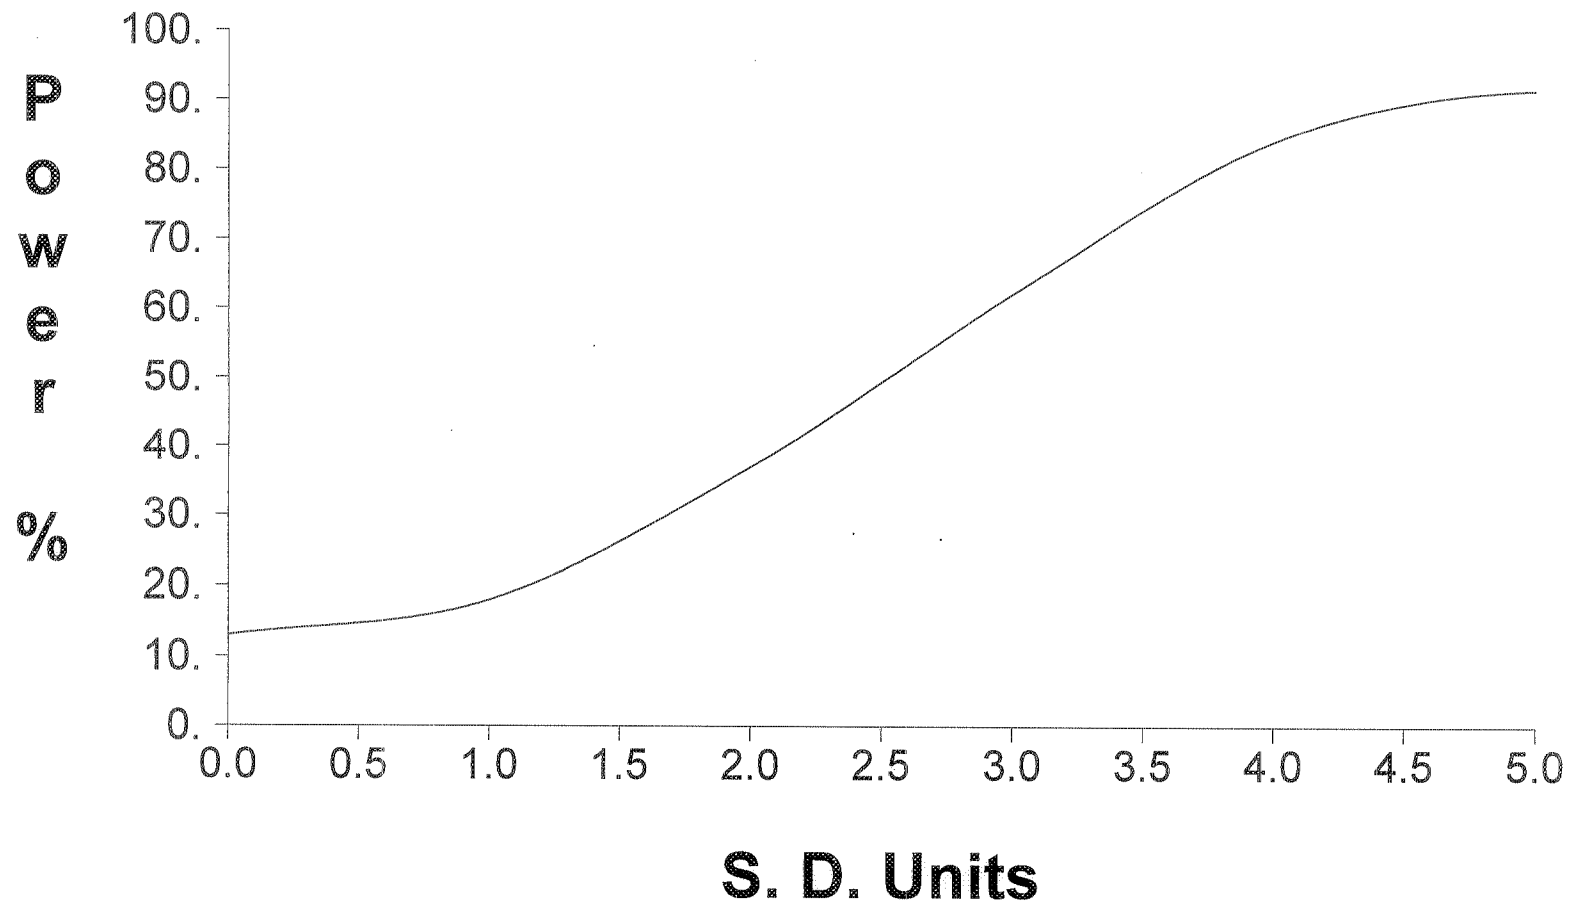
False Positive and False Negative Rates for Current Upgradient vs. Downgradient Monitoring Program

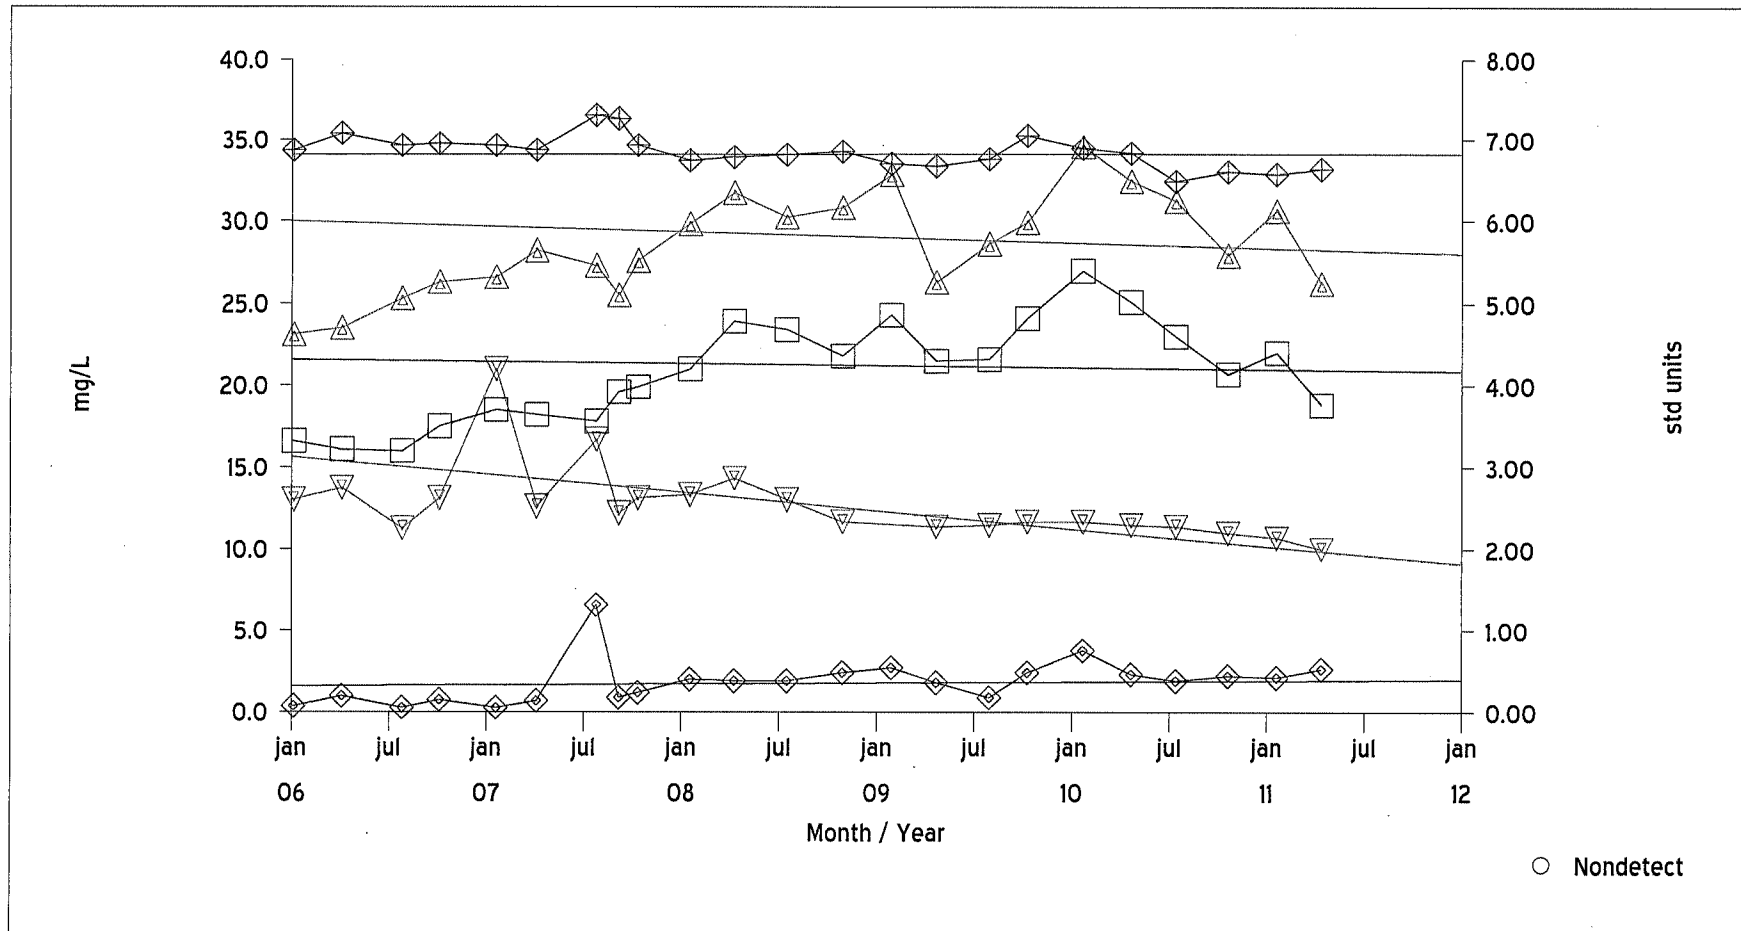
Time Series Plot for LG-01

□ Dissolved calcium (cc: .056)
 ▲ Dissolved magnesium (cc: .181)
 ▼ Dissolved sodium (cc: .783)
 ◆ Nitrate nitrogen (cc: .415)

◆ pH (cc: .015)
 ○ Nondetect

the ground water below the landfill is decreasing at this time, however, several increasing trends have been monitored in down gradient well LG-01 and at least one increasing trend was found in LG-03. The data also suggests that the leachate plume impacting ground water extends beyond the landfill boundaries following the ground water gradient to the north-northeast through LG-03 and LG-05.
