Lake Goodwin Landfill

2011 2nd Quarter Groundwater

Monitoring Report

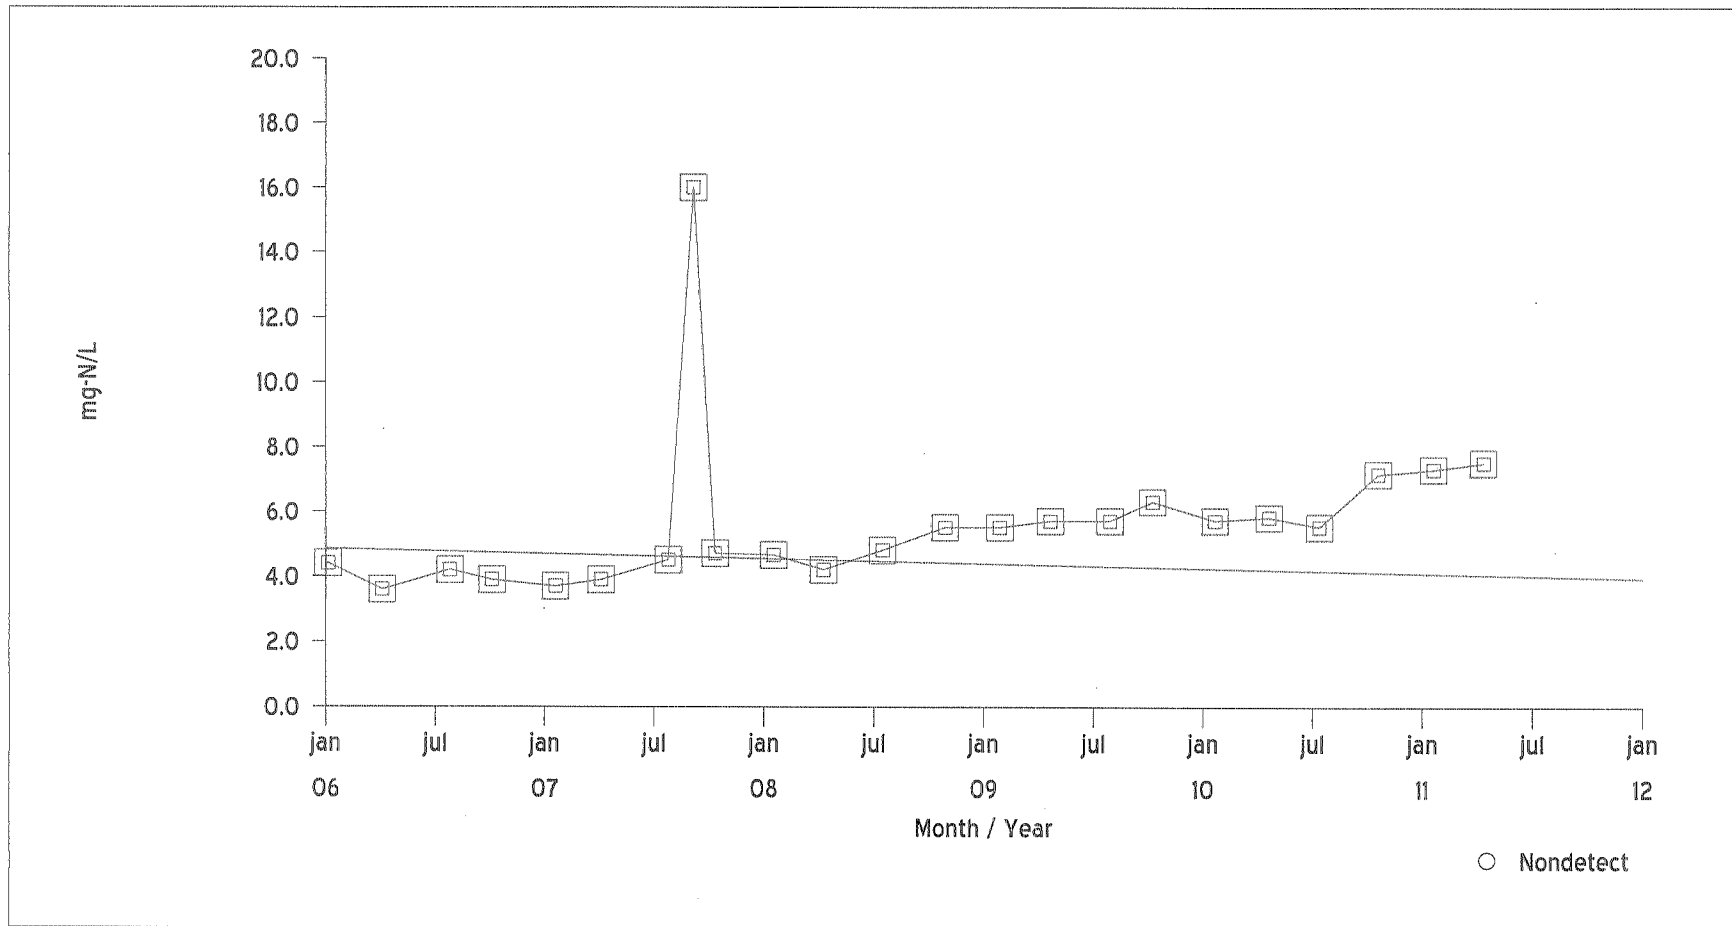
Time Series Plot for LG-03

□ Nitrate nitrogen (cc: -.349)

○ Nondetect

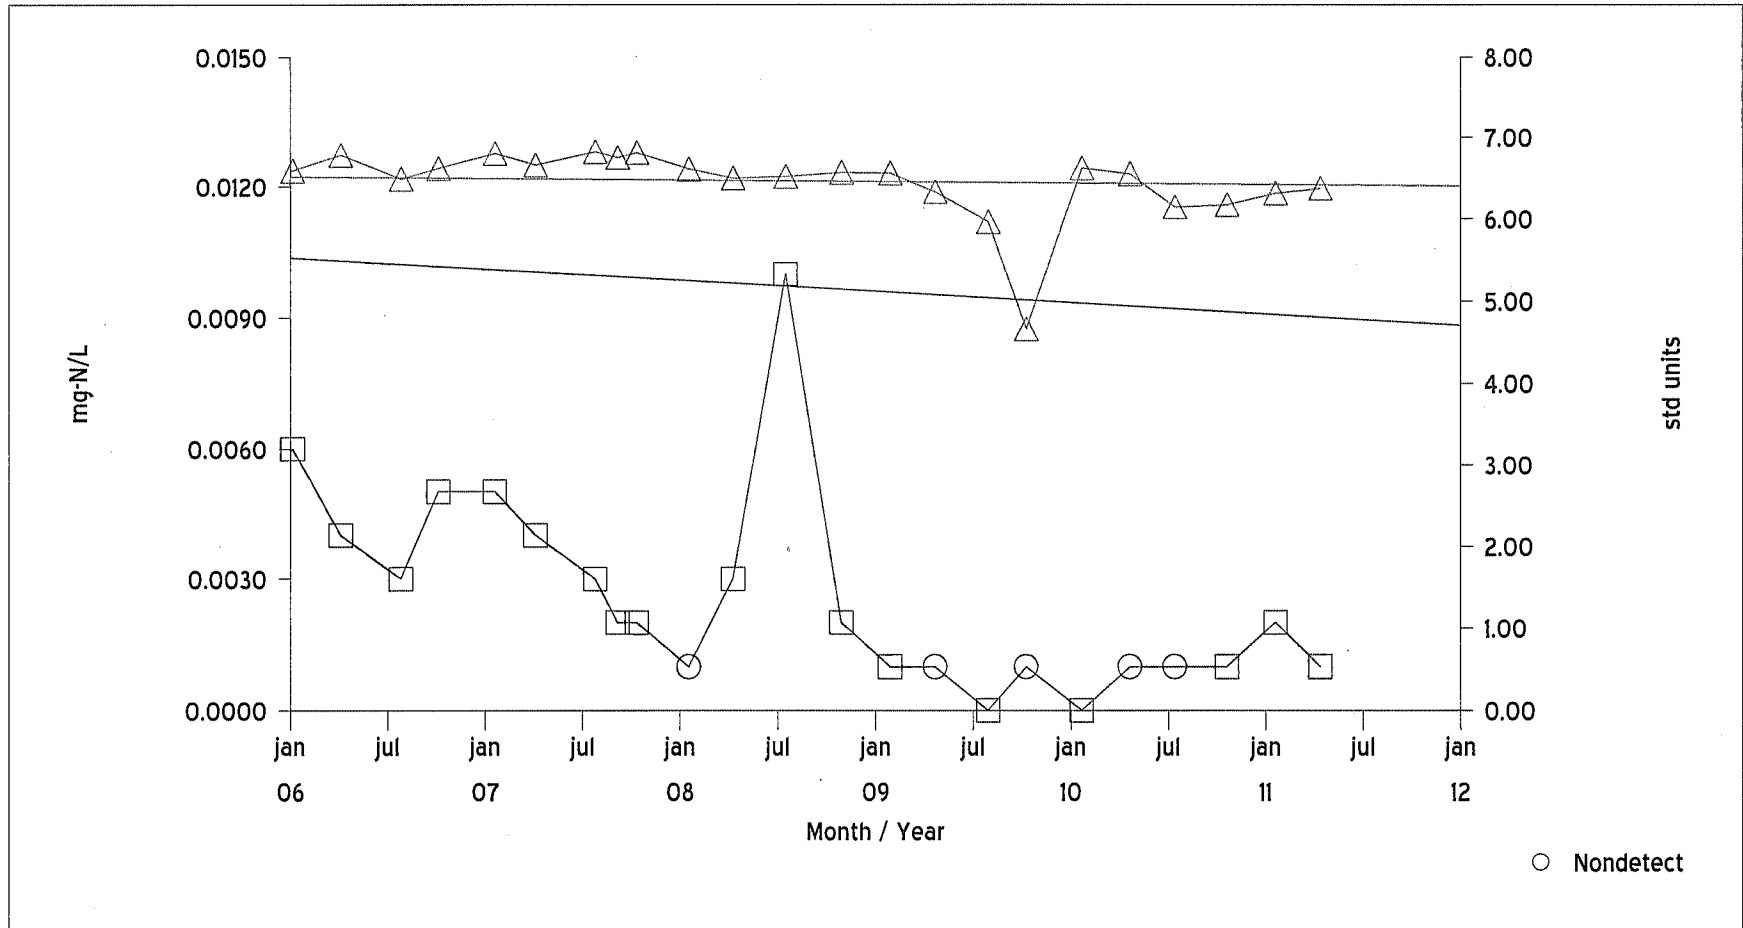
Time Series Plot for LG-05

□ Nitrite nitrogen (cc: -.146)

△ pH (cc: -.347)
