RECEIVED
JAN 23 2012
DEPARTMENT OF ECOLOGY

Lake Goodwin Landfill 2011 4th Quarter Groundwater Monitoring Report

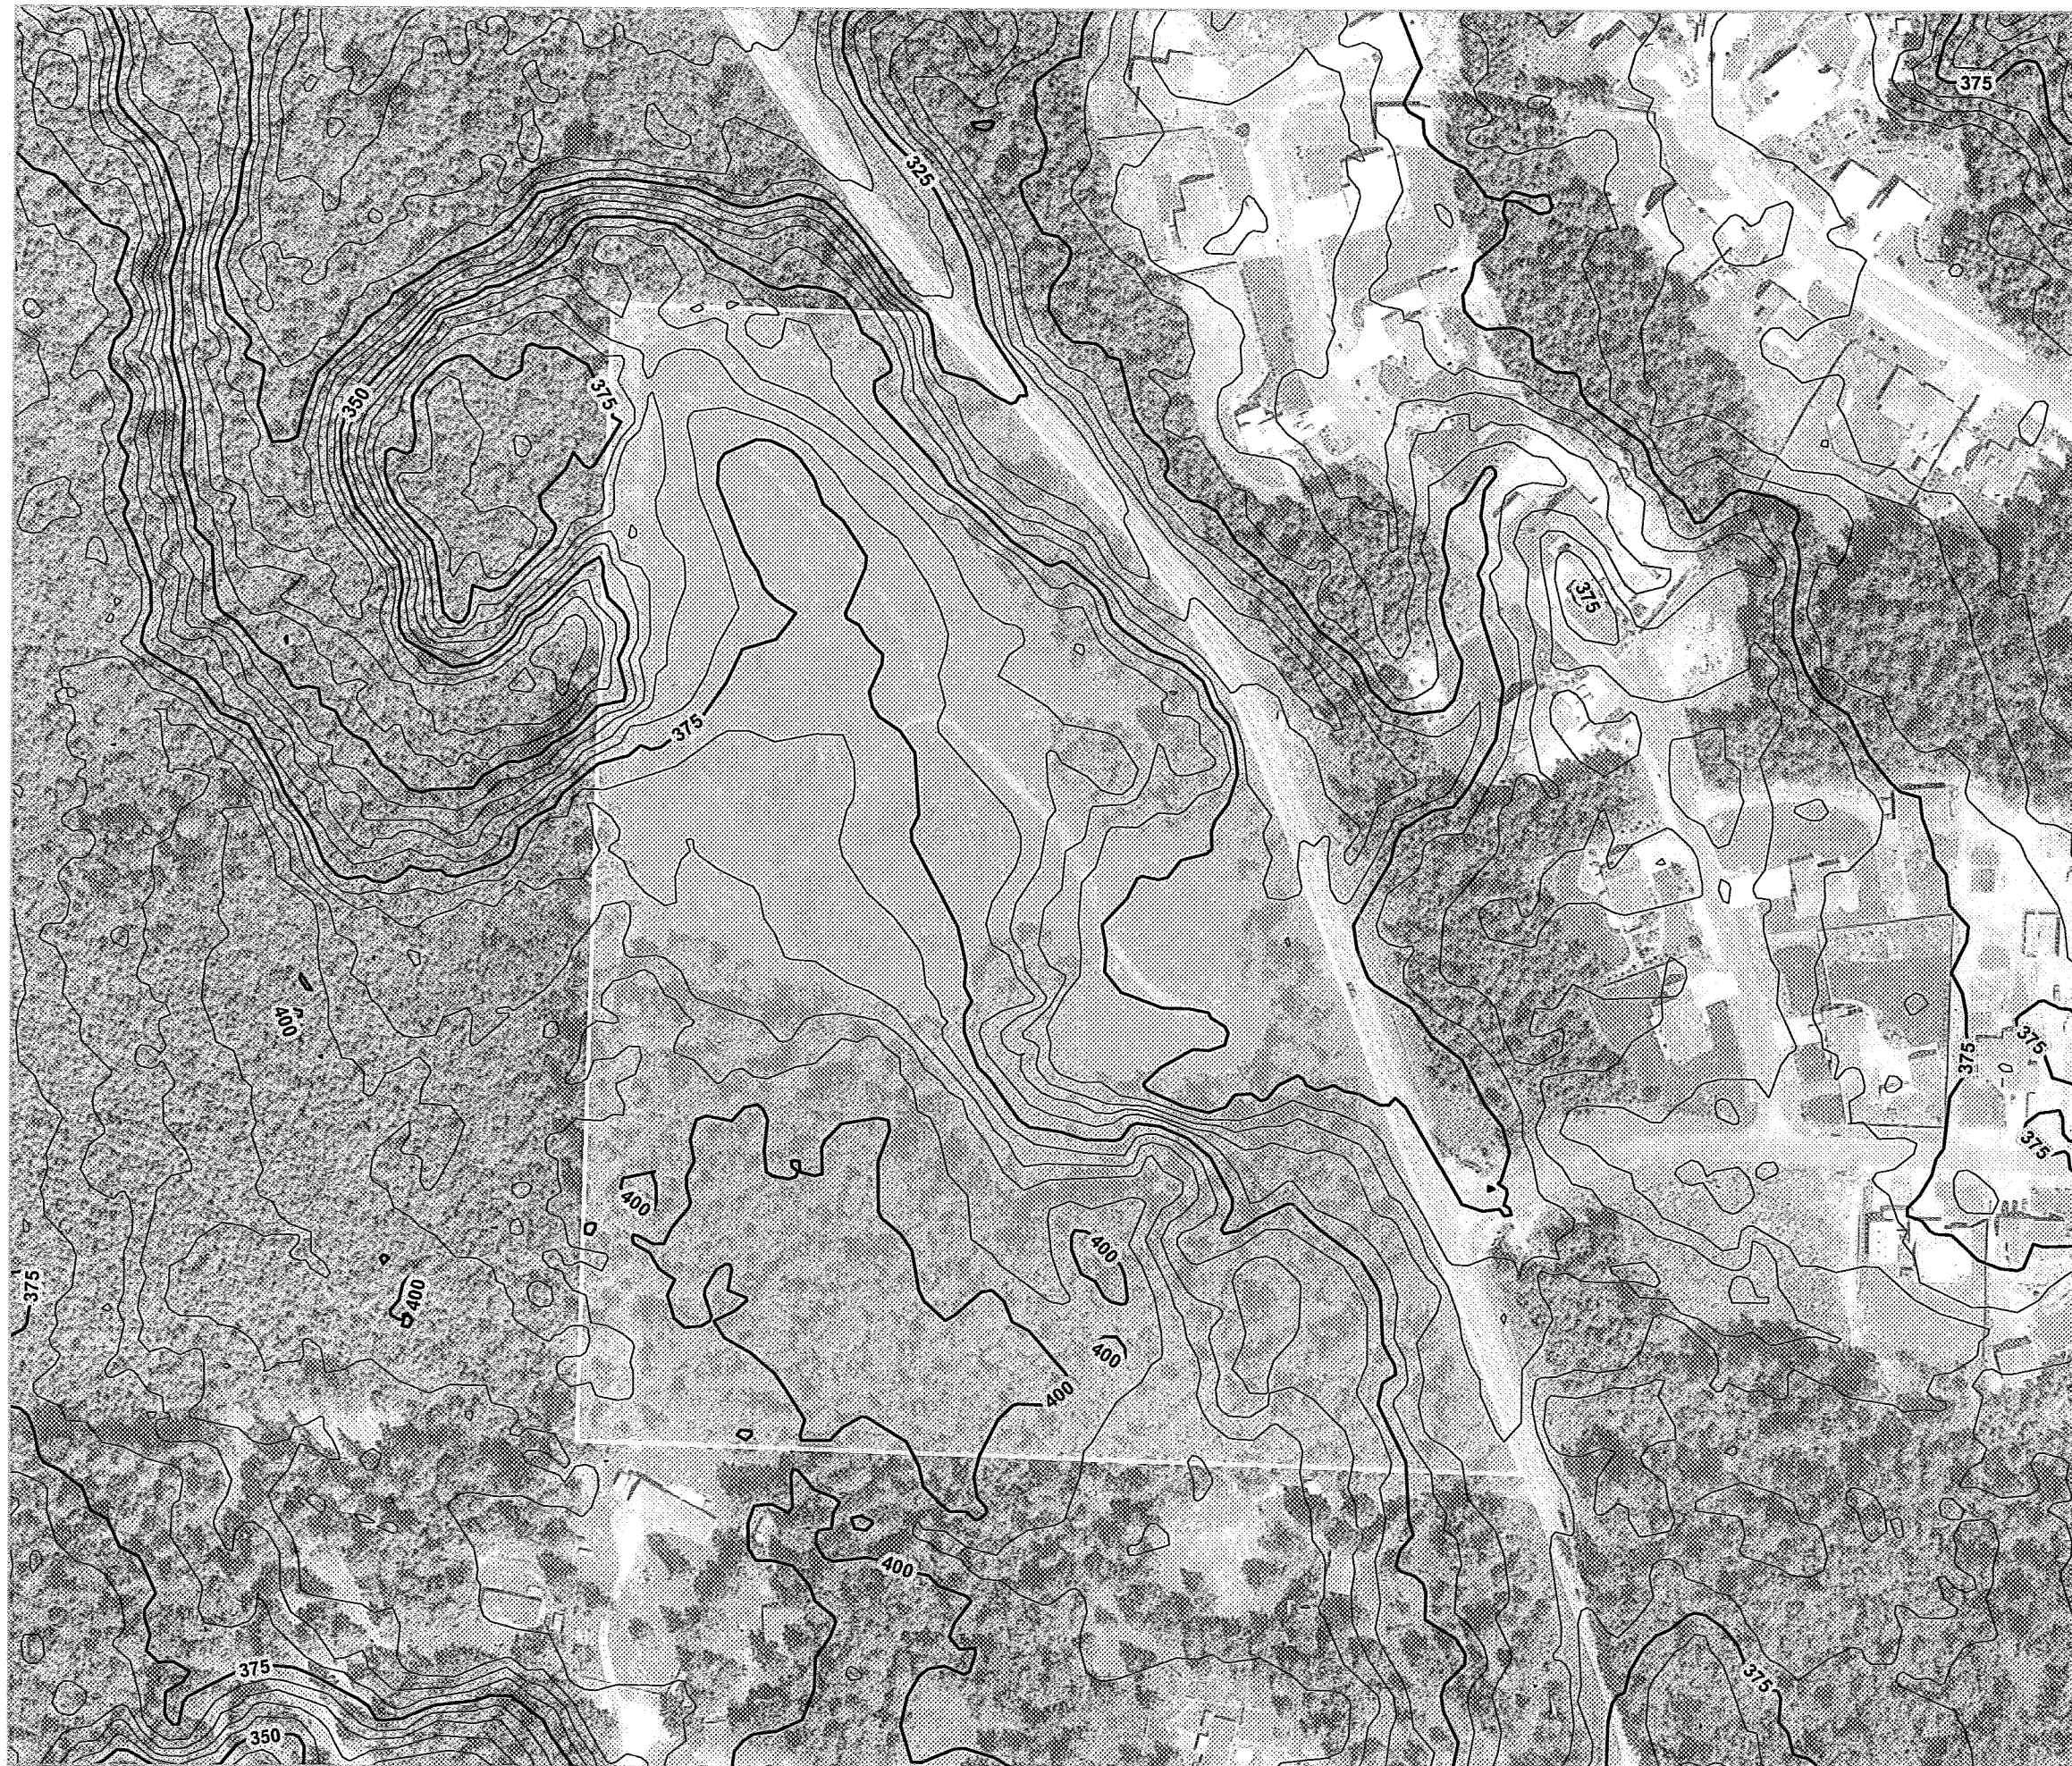
Figure 3

Lake Goodwin Landfill Topography

The Lake Goodwin Landfill is located on a topographic feature known as the Tulalip Plateau, a rolling upland area bounded by the Stillaguamish River to the north, the Puget Sound to the west and south, and by a topographic low called the Marysville Trough to the east. The general topography in the immediate vicinity of the site is typical of glaciated areas within western Washington State – gently rolling landscapes bisected by seasonal and/or year round drainages, creeks and rivers. Several small to medium sized lakes are found in the immediate vicinity of the site. Lake Martha, Lake Howard and Lake Goodwin are all located within a few miles of the Landfill. There are no named drainages, creeks or rivers located in the immediate vicinity of the site. Elevations in the immediate vicinity of the landfill range from approximately el. 320 to el. 380 feet above mean sea level. Relative to existing surrounding topography the landfill itself is approximately 60 ft high. It has been graded and slopes gently in a north to northeast direction. Site Topography is shown on the **Topographic Map** (figure 3). In most places the landfill cover is well vegetated with grass, clover and weeds. A few Douglas fir have naturally reseeded in the fill cover near the edge of the site. There are no stormwater detention ponds or leachate collection ponds located on the site.

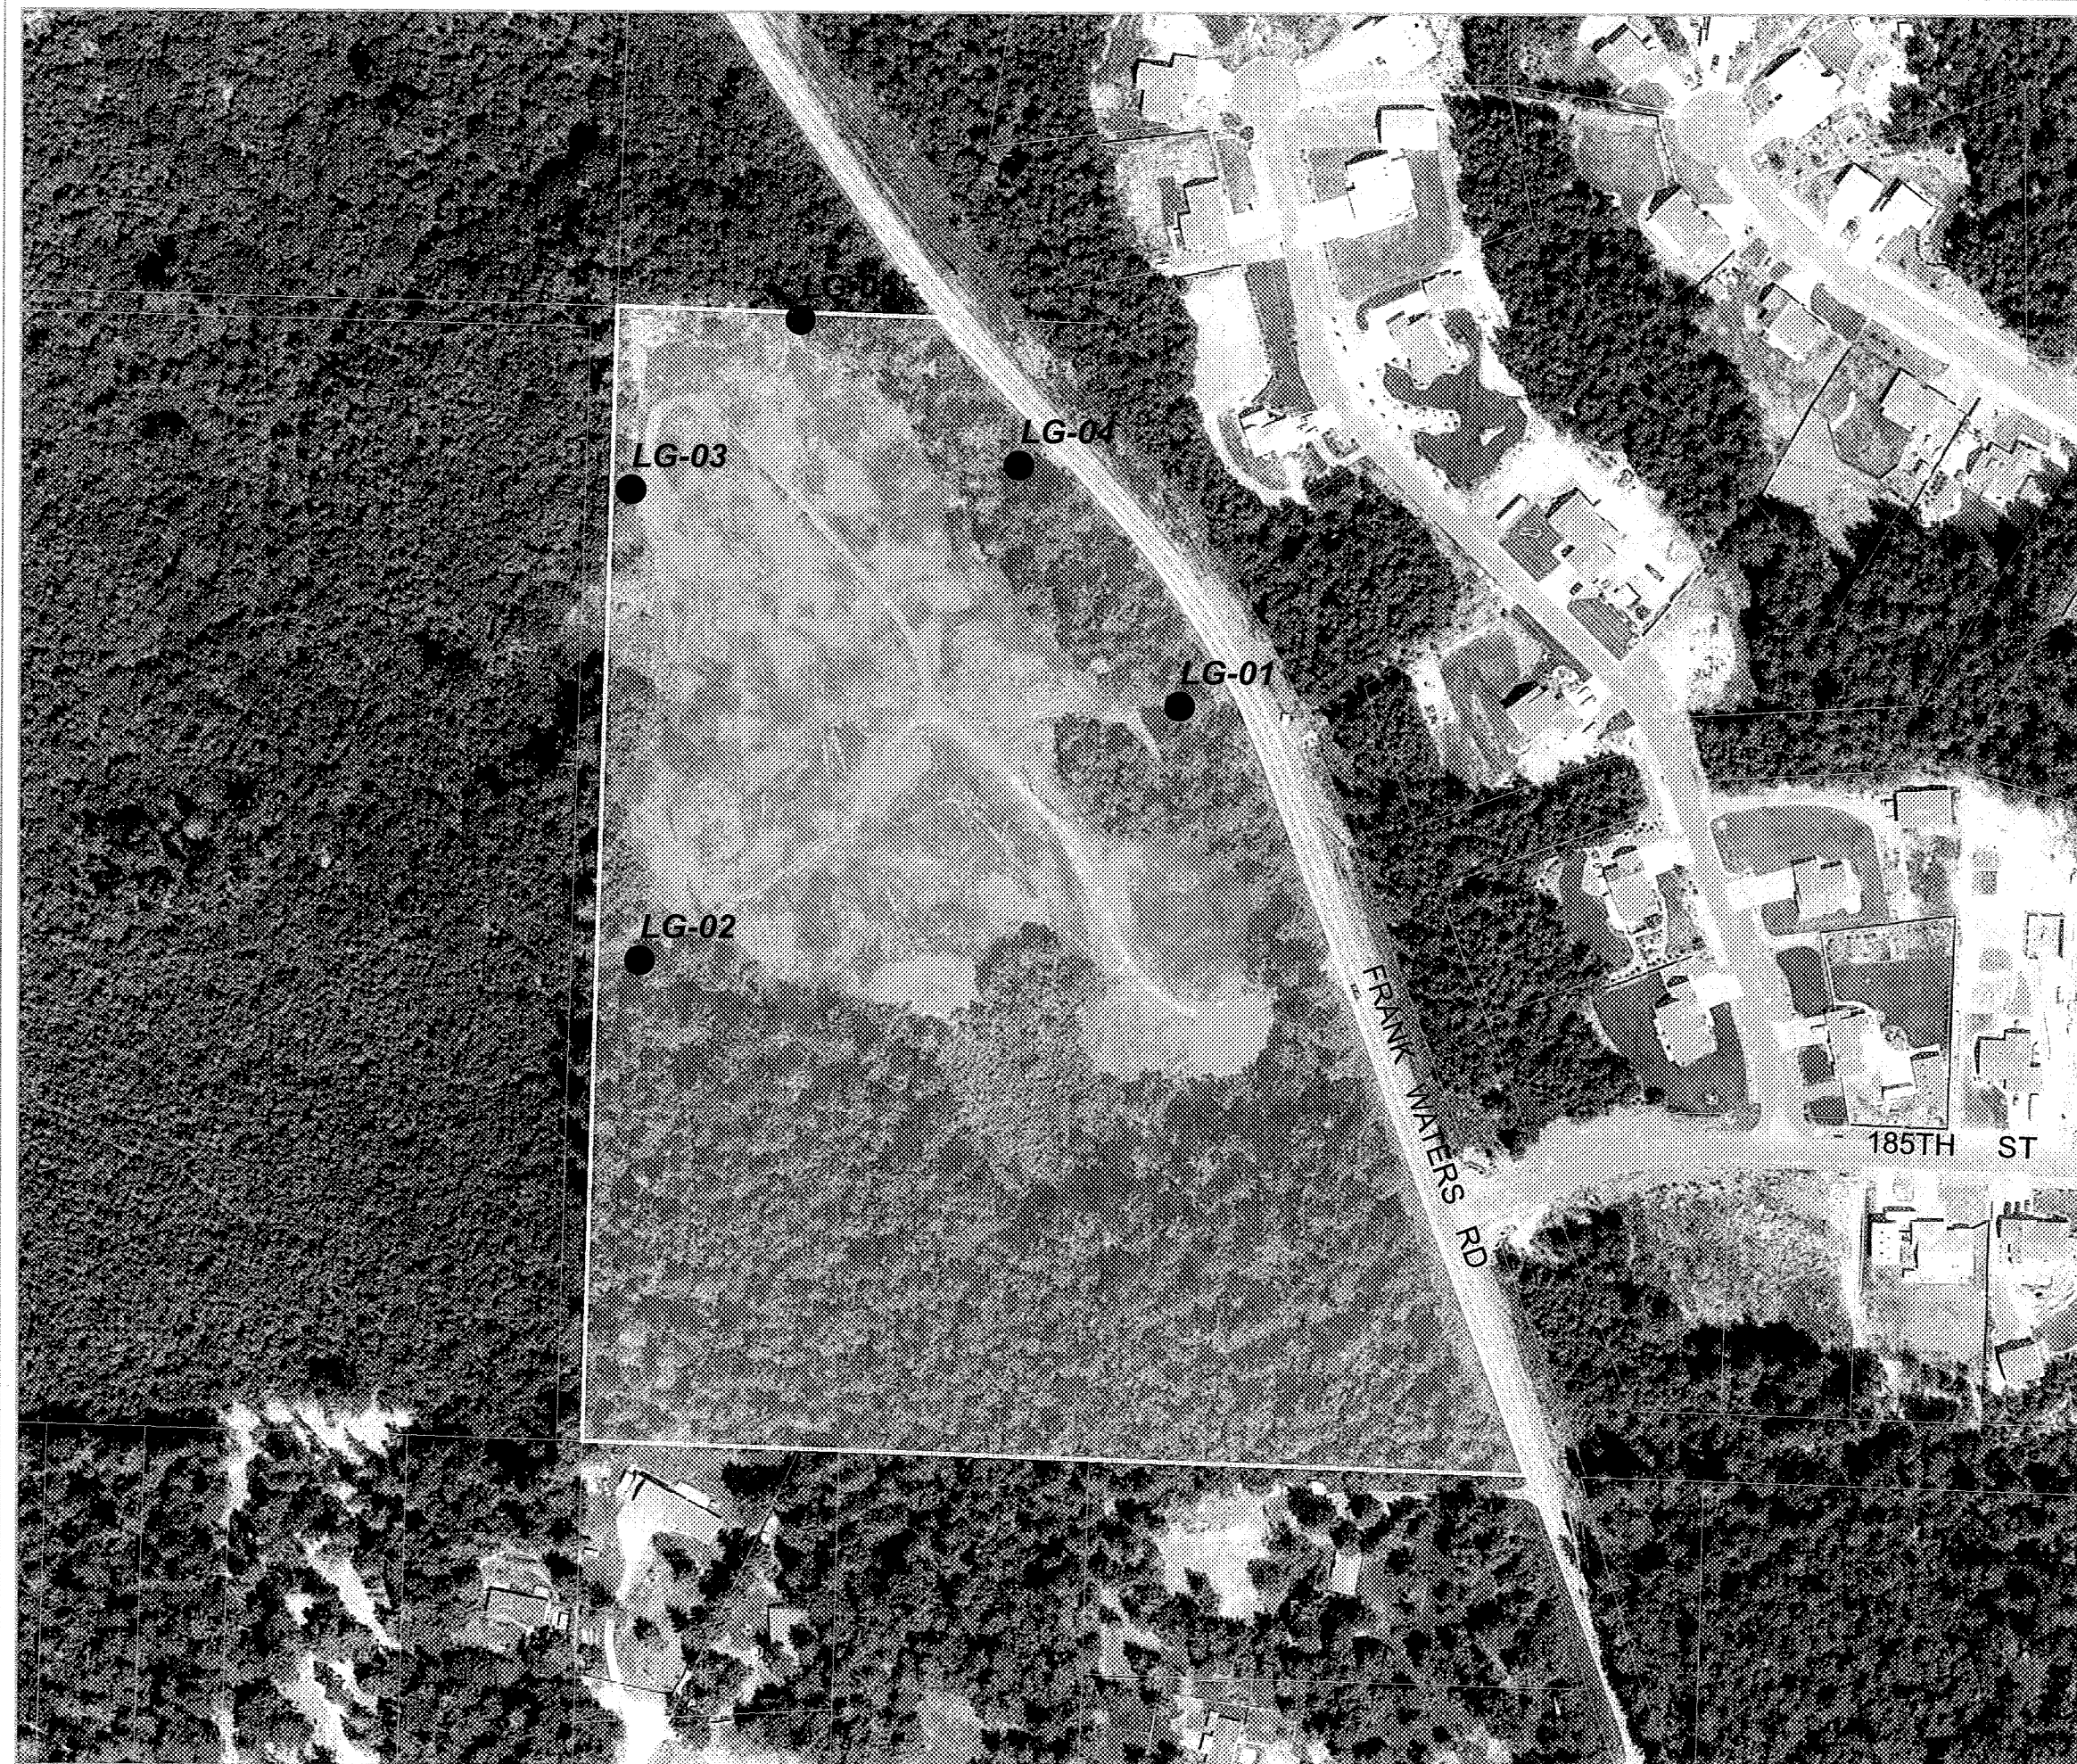
Figure 5

Lake Goodwin Landfill

Groundwater Monitoring Network

As outlined in the Solid Waste Facility Permit SW-085, quarterly monitoring of ground water is required at the Lake Goodwin Landfill. There are currently five-(5) ground water monitoring wells (LG-01 thru LG-05) at the Lake Goodwin Landfill site that are read on a quarterly basis. Well locations are shown on the **Network Monitoring Map** (figure 5). Of these wells, one-(1) is considered to be an up-gradient well monitoring background ground water conditions in the immediate vicinity of the site (LG-02). The remaining four-(4) wells are located in and/or down gradient of the landfill (LG-01, and LG-03 thru LG-05) and monitor ground water conditions that may be impacted from the site. Fourth quarter monitoring results are discussed in section 2.0 below.
