Lake Goodwin Landfill
2012 4th Quarter Environmental
Monitoring Report

1.0 INTRODUCTION

The following report presents the fourth quarter ground water monitoring results for 2012 at the Lake Goodwin Landfill (*Lake Goodwin Landfill, Site*). The site is located immediately west of Frank Waters Road in northwestern Snohomish County, about one and one half (1.5) miles northwest of Lake Goodwin and about five-(5) miles south of Stanwood (*T31N, R4E, sections 17, 20 Willamette Meridian*). The landfill is located at 18520 Frank Waters Road, Stanwood, Washington, 98292. The location of the site relative to existing municipal improvements is shown on the **Vicinity Map** (*figure 1*).

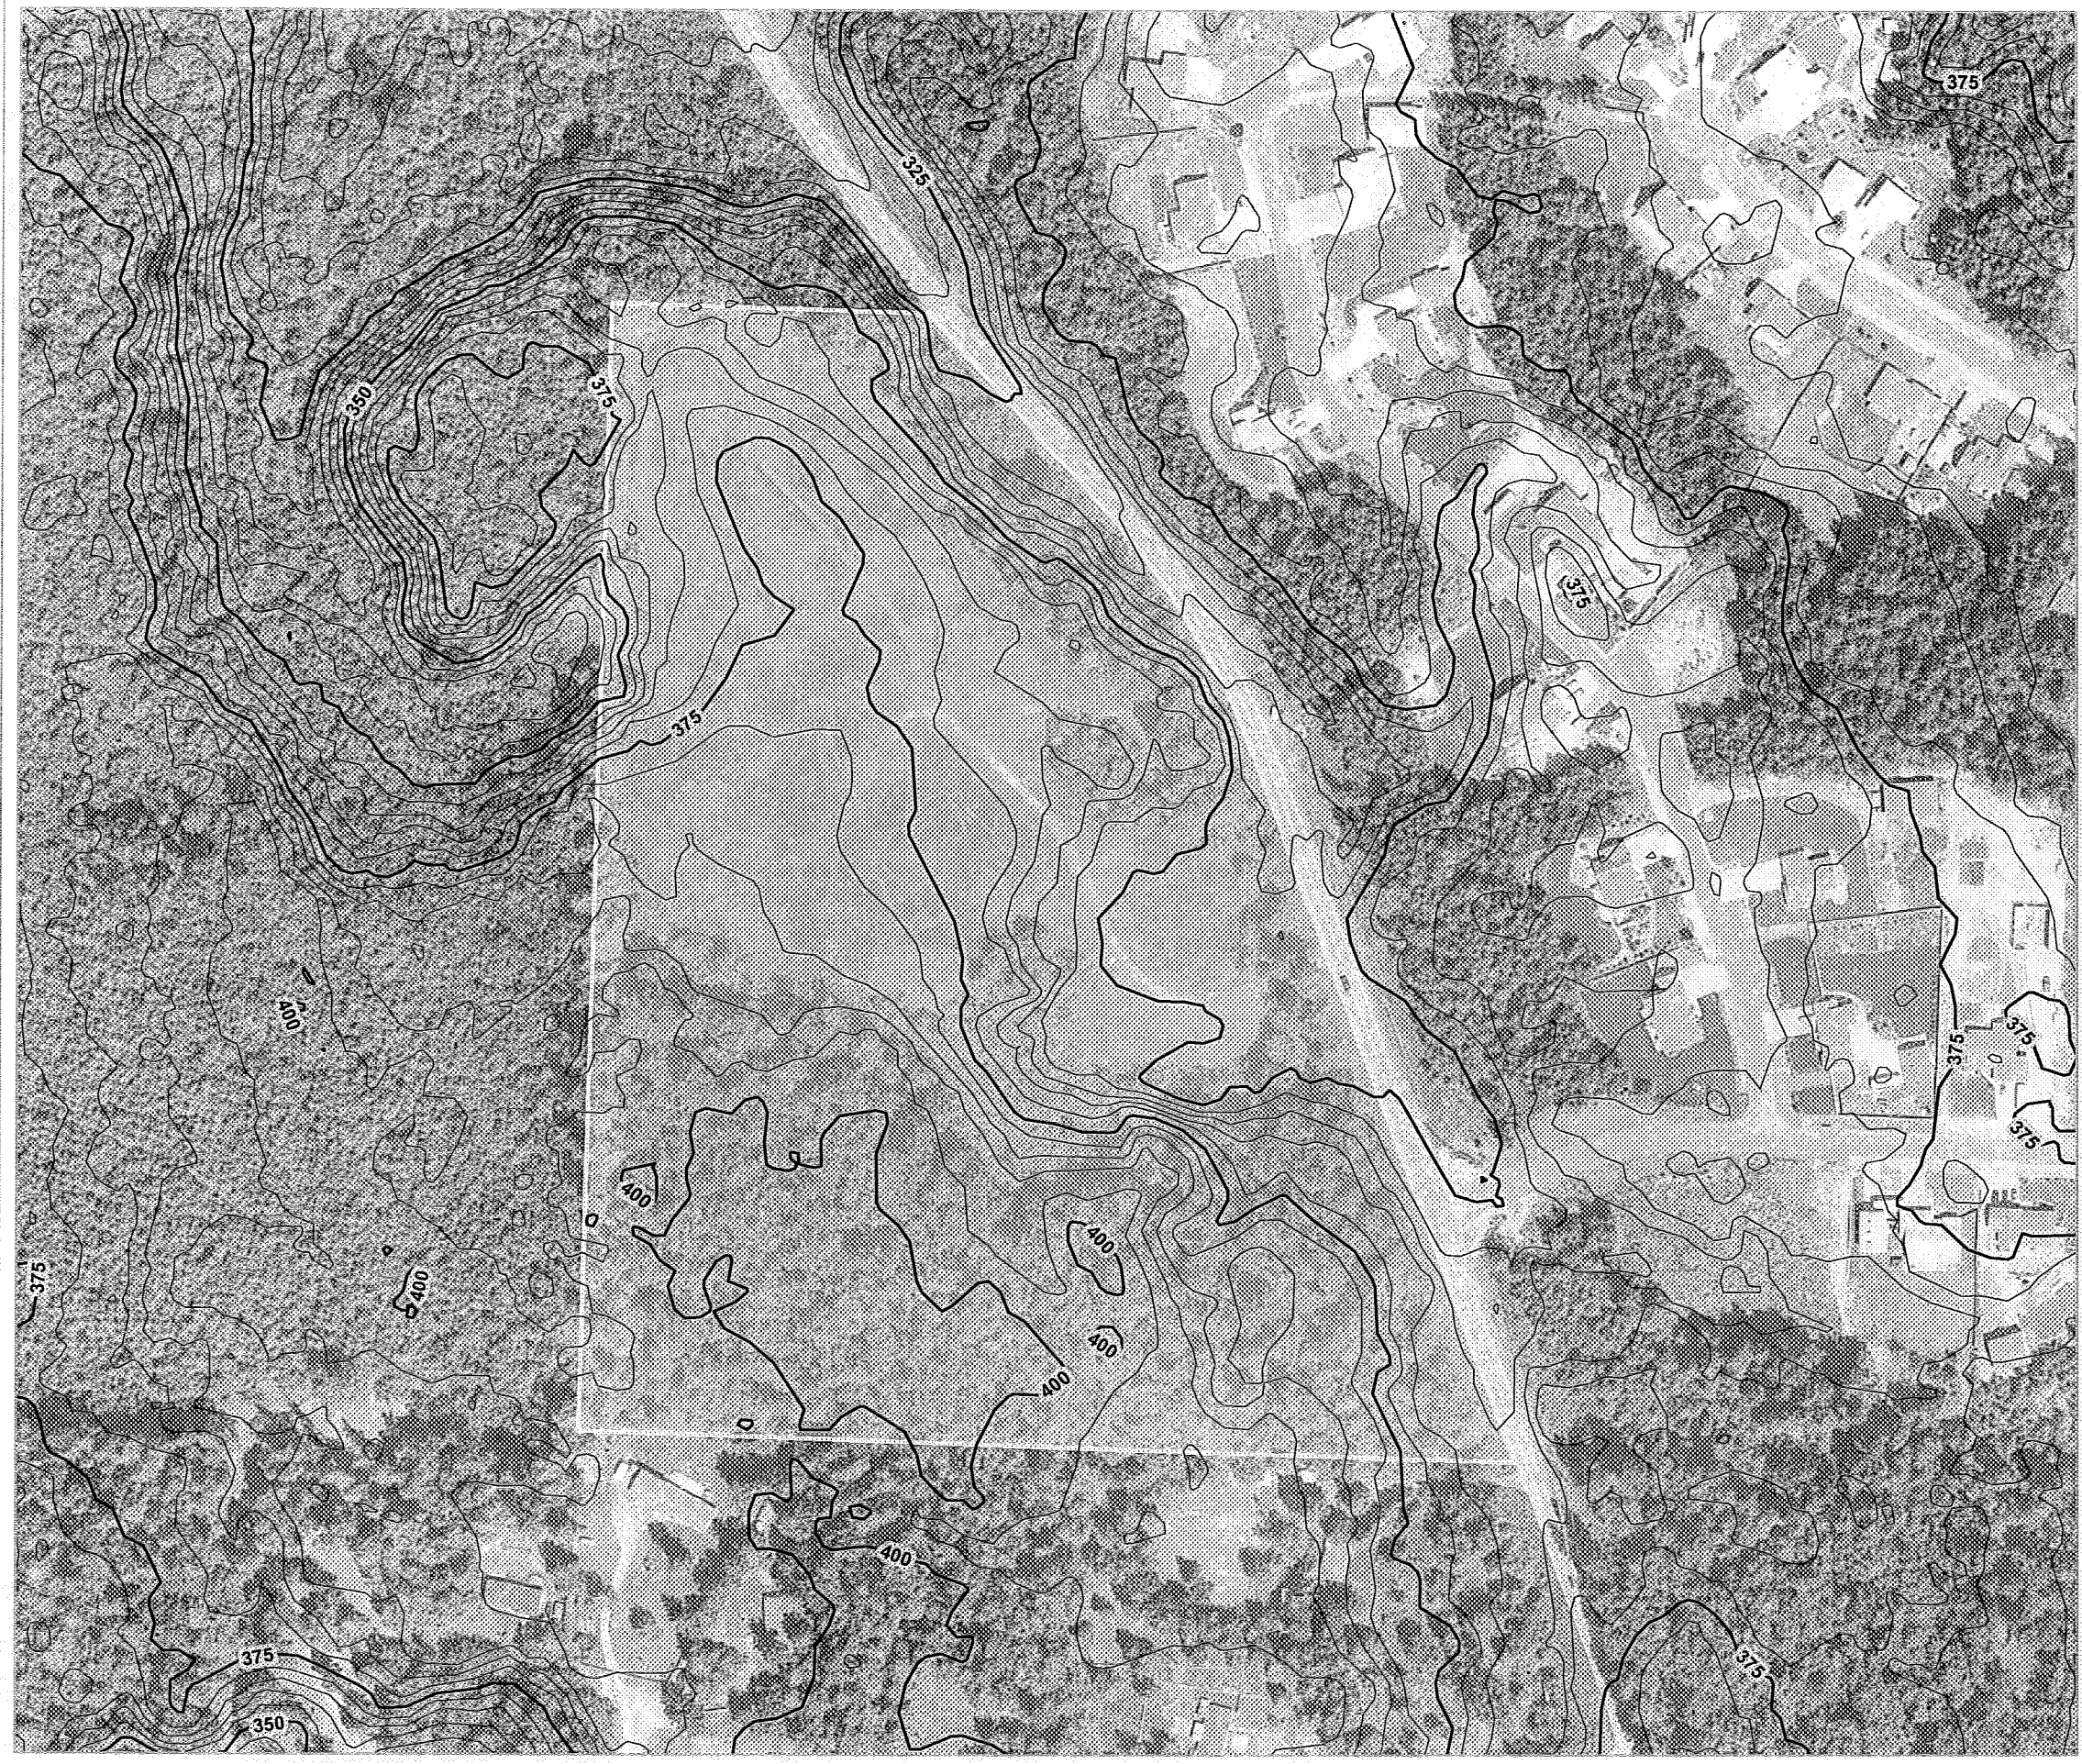
Figure 3

Lake Goodwin Landfill Topography

The Lake Goodwin Landfill is located on a topographic feature known as the Tulalip Plateau, a rolling upland area bounded by the Stillaguamish River to the north, the Puget Sound to the west and south, and by a topographic low called the Marysville Trough to the east. The general topography in the immediate vicinity of the site is typical of glaciated areas within western Washington State – gently rolling landscapes bisected by seasonal and/or year round drainages, creeks and rivers. Several small to medium sized lakes are found in the immediate vicinity of the site. Lake Martha, Lake Howard and Lake Goodwin are all located within a few miles of the Landfill. There are no named drainages, creeks or rivers located in the immediate vicinity of the site. Elevations in the immediate vicinity of the landfill range from approximately el. 320 to el. 380 feet above mean sea level. Relative to existing surrounding topography the landfill itself is approximately 60 ft high. It has been graded and slopes gently in a north to northeast direction. Site Topography is shown on the **Topographic Map** (figure 3). In most places the landfill cover is well vegetated with grass, clover and weeds. A few Douglas fir have naturally reseeded in the fill cover near the edge of the site. There are no stormwater detention ponds or leachate collection ponds located on the site.

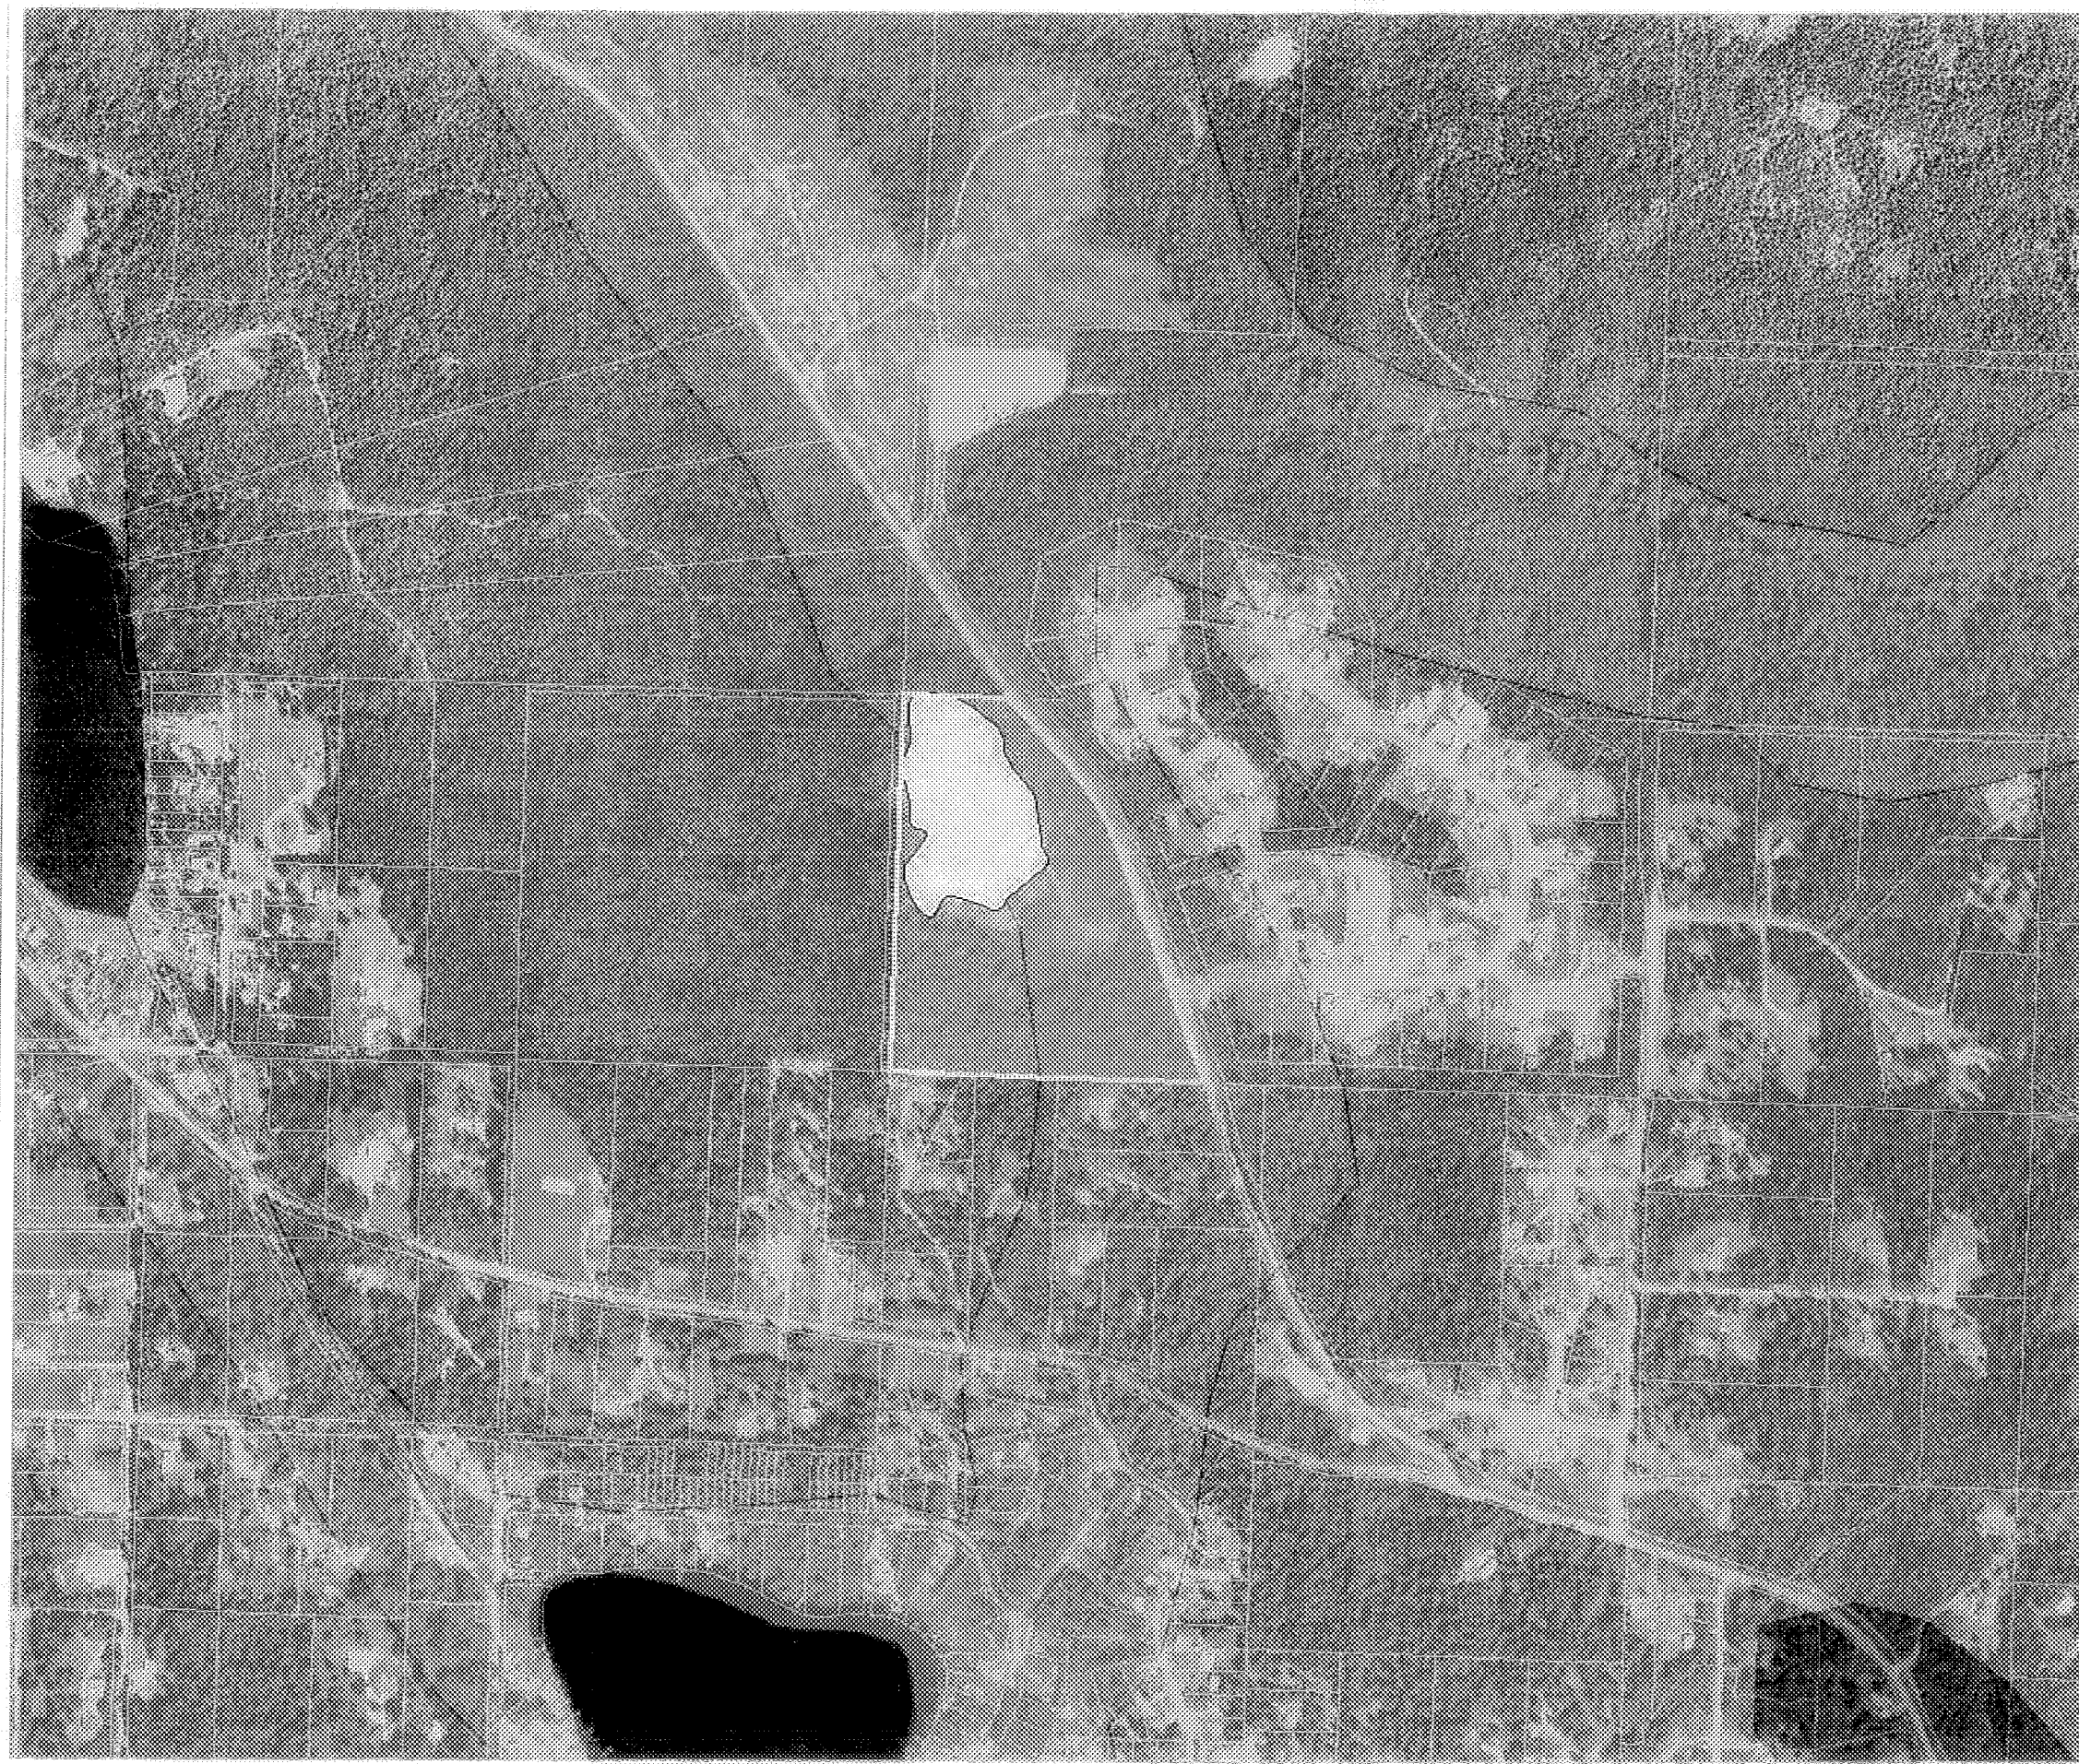
Figure 4

Lake Goodwin Landfill Geologic Map

- Vashon advance outwash (Qva)
- Vashon recessional outwash
- Vashon till (Qvt)
- Water
- Modified Land

Surficial geology of the site area is shown on the **Geologic Map** (figure 4). Based on the Geologic Map and the site explorations, surficial geology at the landfill site consists of Advance Outwash (Qva) sands and gravels locally overlain by sandy silts to silty sands and gravels – Glacial Till (Qvt).

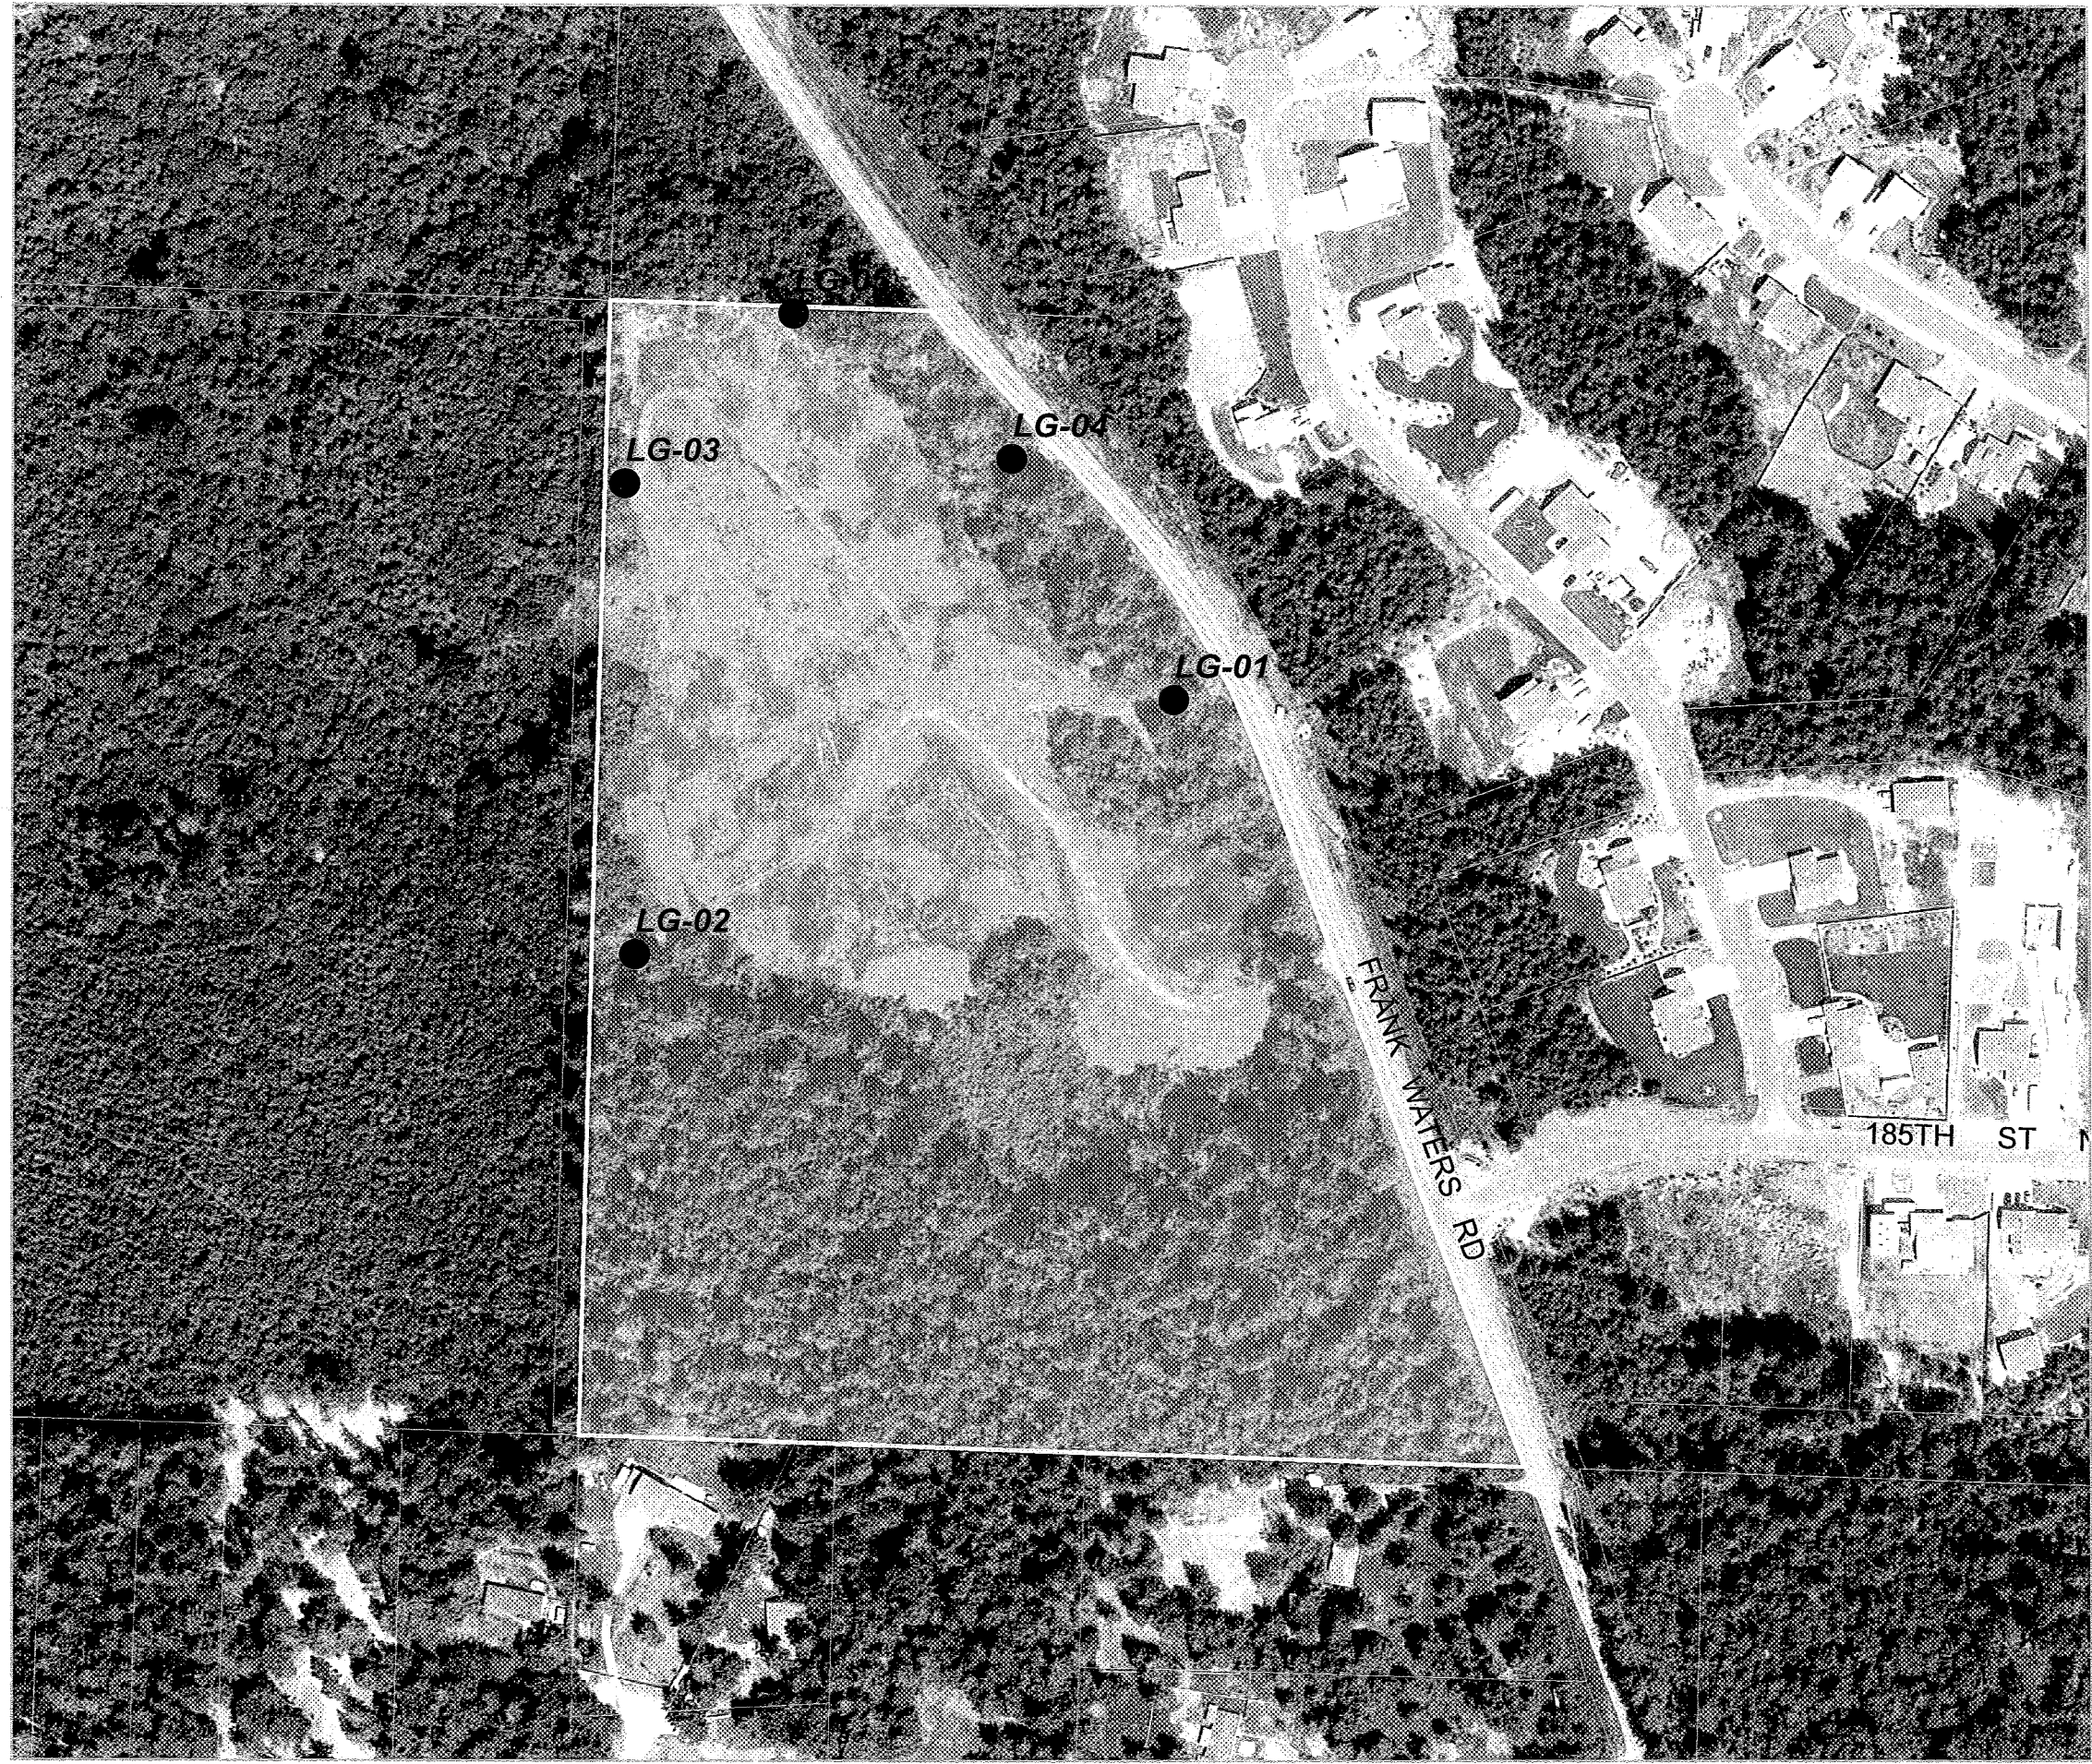
Figure 5

Groundwater Monitoring Network

- Deep Aquifer

As outlined in the Solid Waste Facility Permit SW-085, quarterly monitoring of ground water is required at the Lake Goodwin Landfill. There are currently four-(4) ground water monitoring wells (*LG-01*, *LG-02*, *LG-04*, and *LG-05*) at the Lake Goodwin Landfill site that are read on a quarterly basis. Well locations are shown on the **Network Monitoring Map** (*figure 5*). Of these wells, one-(1) is considered to be an up-gradient well monitoring background ground water conditions in the immediate vicinity of the site (*LG-02*). The remaining three-(3) wells are located in and/or down gradient of the landfill (*LG-01*, and *LG-04* and *LG-05*) and monitor ground water conditions that may be impacted from the site. Fourth quarter monitoring results are discussed in section 2.0 below.

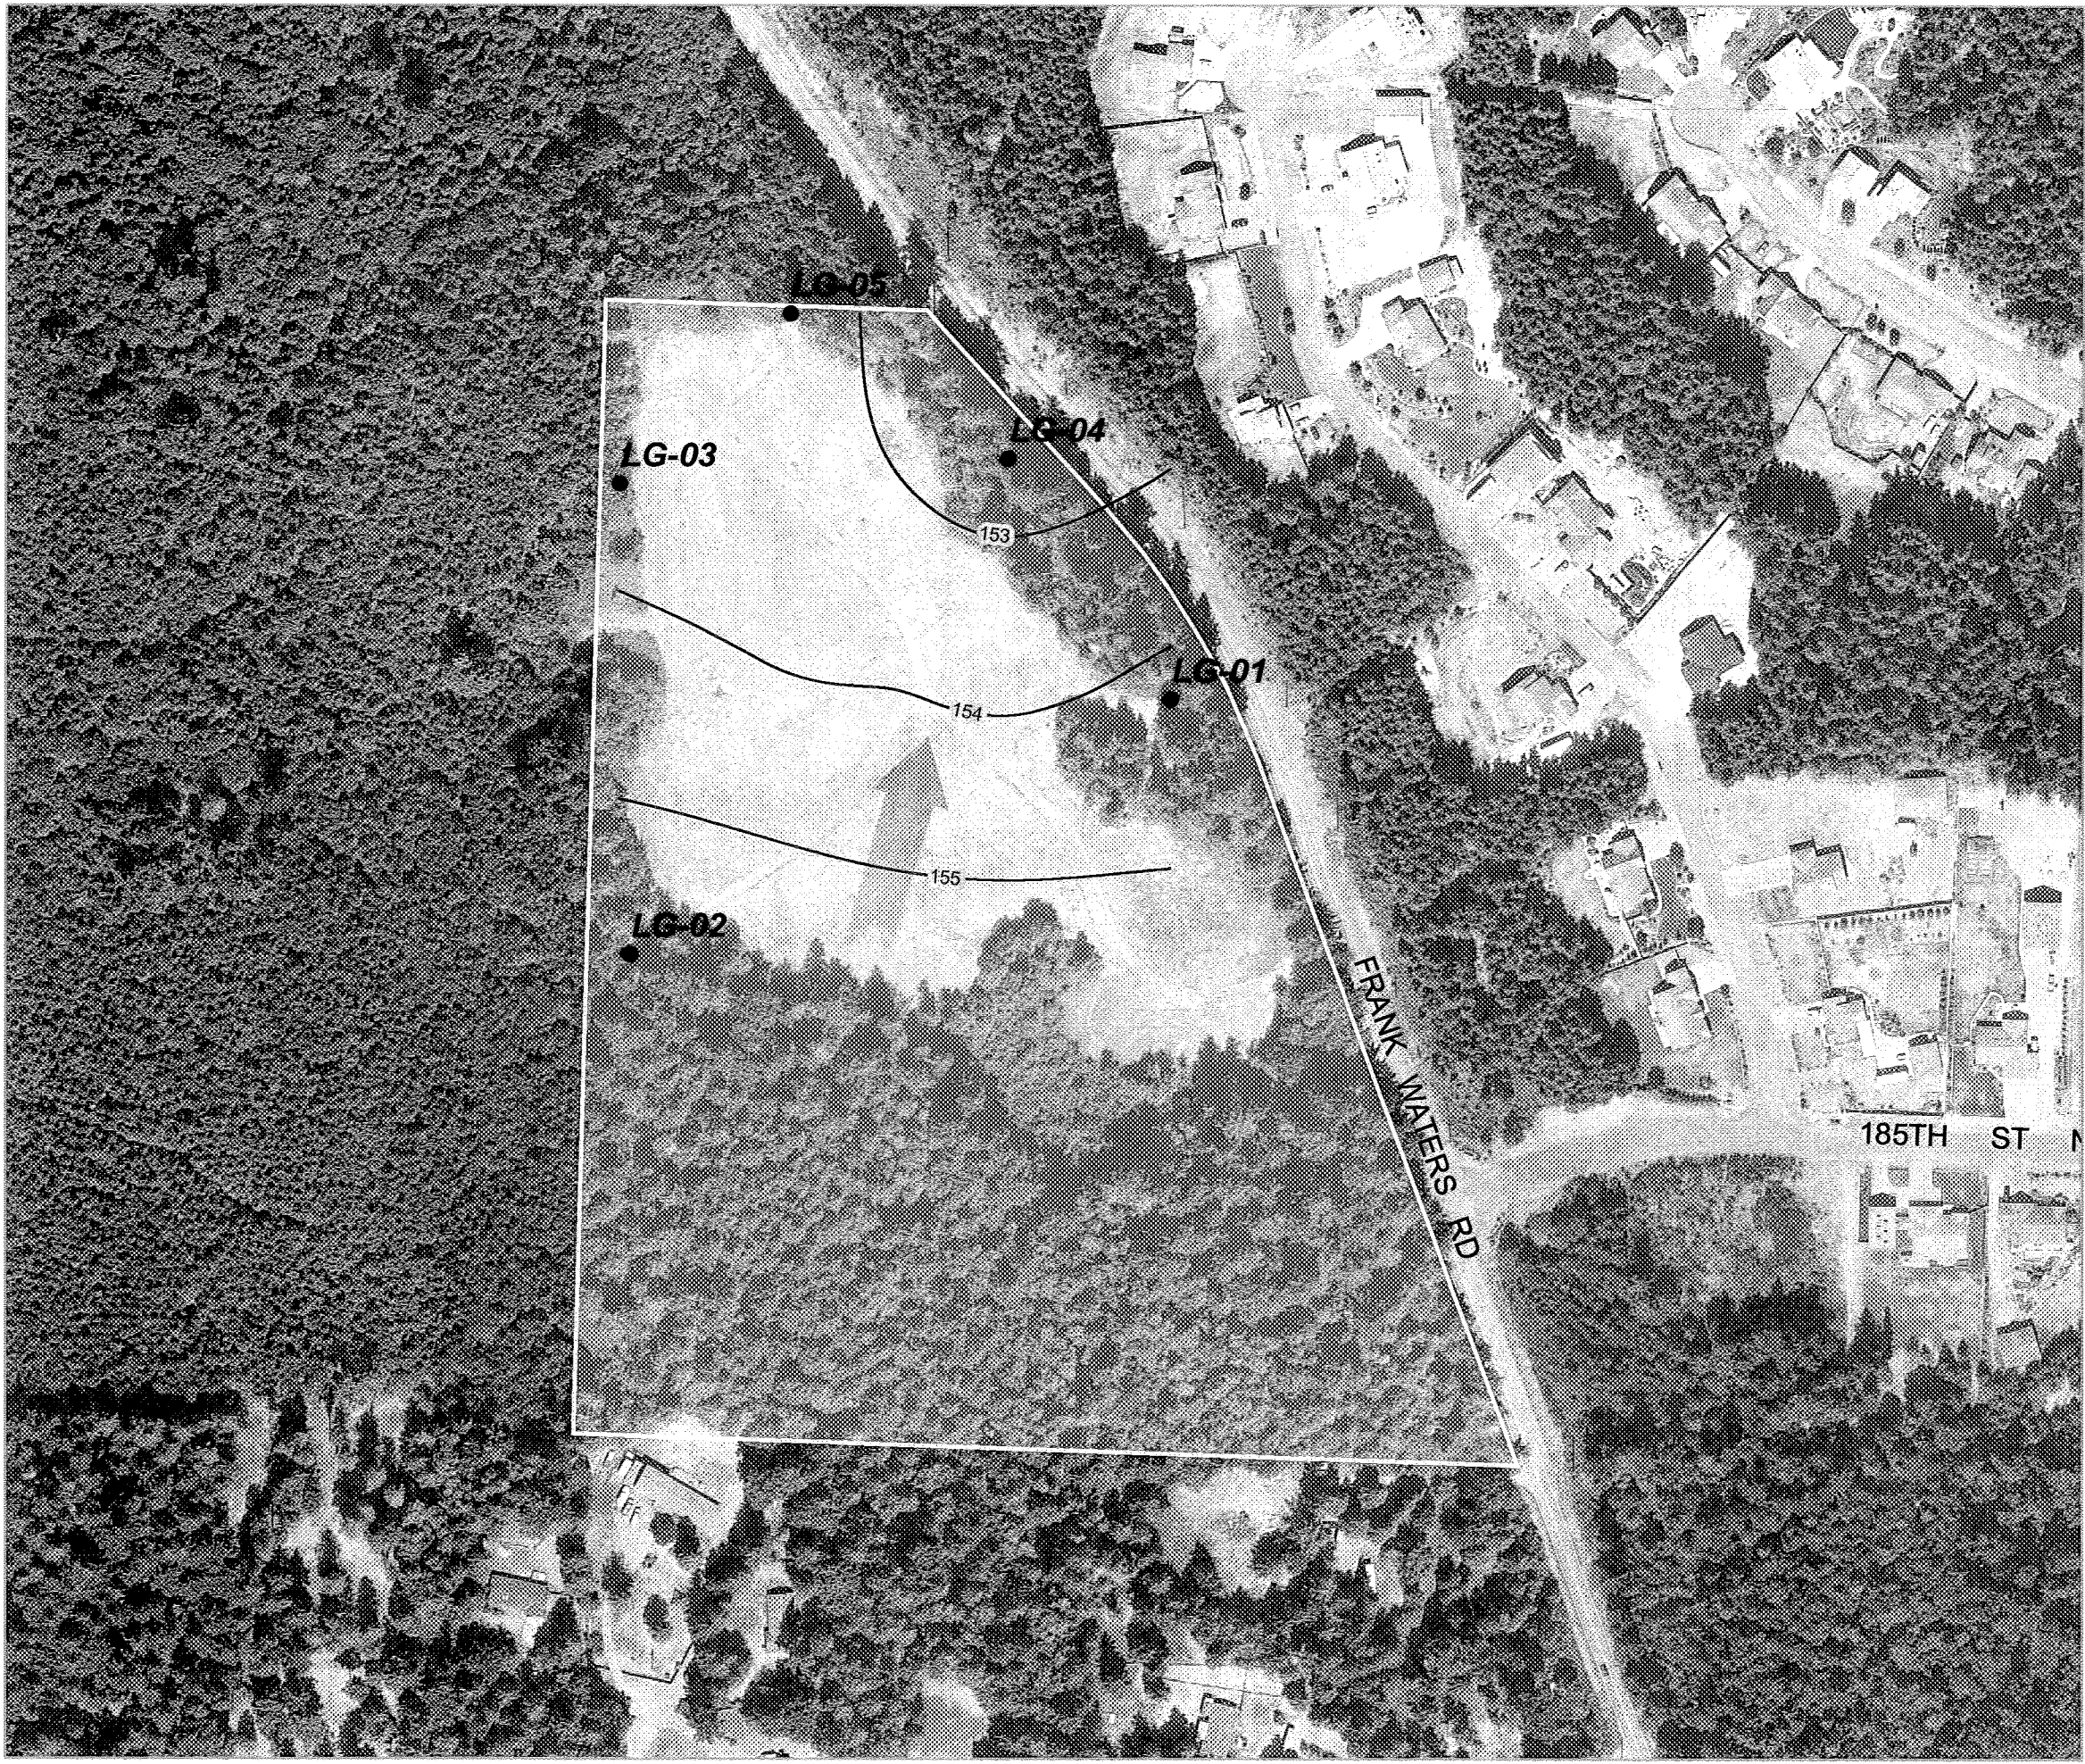
Figure 6

Water Elevation Contours
4th Quarter 2012

- DIRECTION OF GROUNDWATER FLOW
1.58 ft/day
576 ft/year
74.08 degrees to the positive x-axis
- PARCEL BOUNDARY
- SUBJECT PROPERTY BOUNDARY
- 1 FT CONTOUR
- WELL LOCATION

WELL_ID	SAMP_DATE	MEAS_HEAD
LG-01	10/9/2012	154.26
LG-02	10/9/2012	155.75
LG-03	10/9/2012	153.62
LG-04	10/9/2012	152.65
LG-05	10/9/2012	153.25

precipitation (2.86") and a dryer start to the fourth quarter (3.32" as of 10/28/12). Variances from third quarter measurements are as much as 2.6 feet. Readings confirm that the aquifer is unconfined in the immediate vicinity of the site. The **Fourth Quarter Ground Water Contour Map** developed from the field data is shown in *Figure 6* of this report.
