Lake Goodwin Landfill

2012 Annual Environmental

Monitoring Report

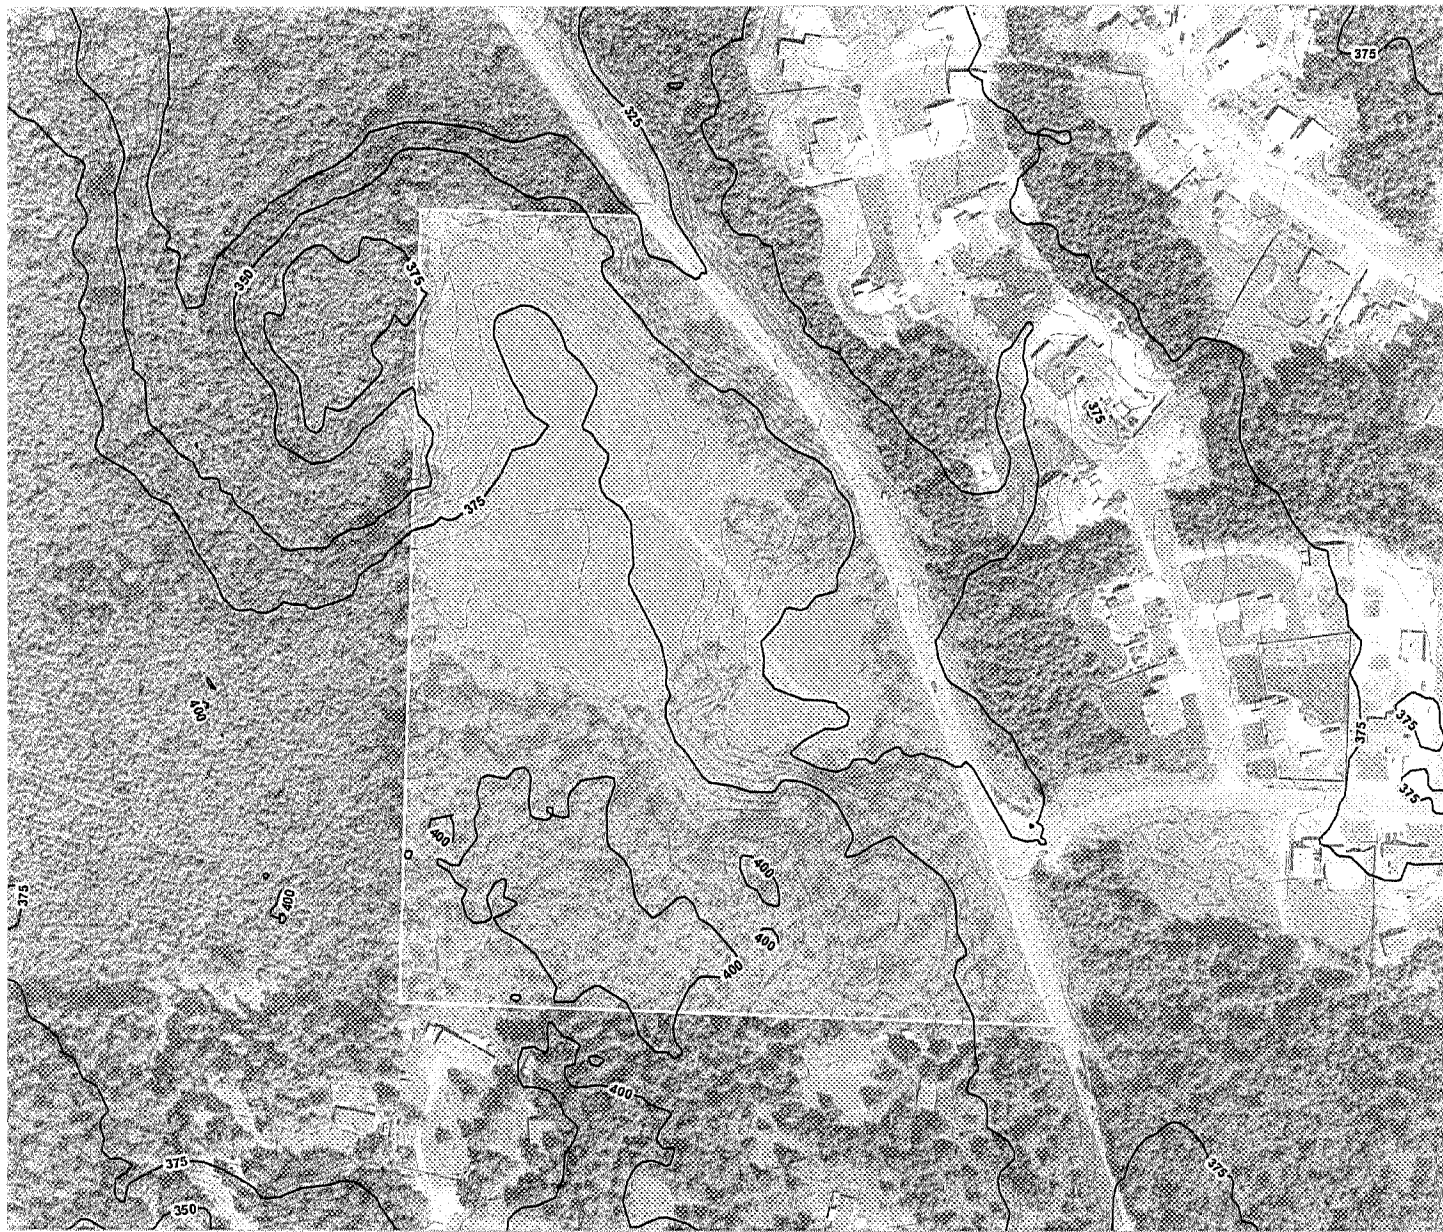
Figure 3

Lake Goodwin Landfill Topography

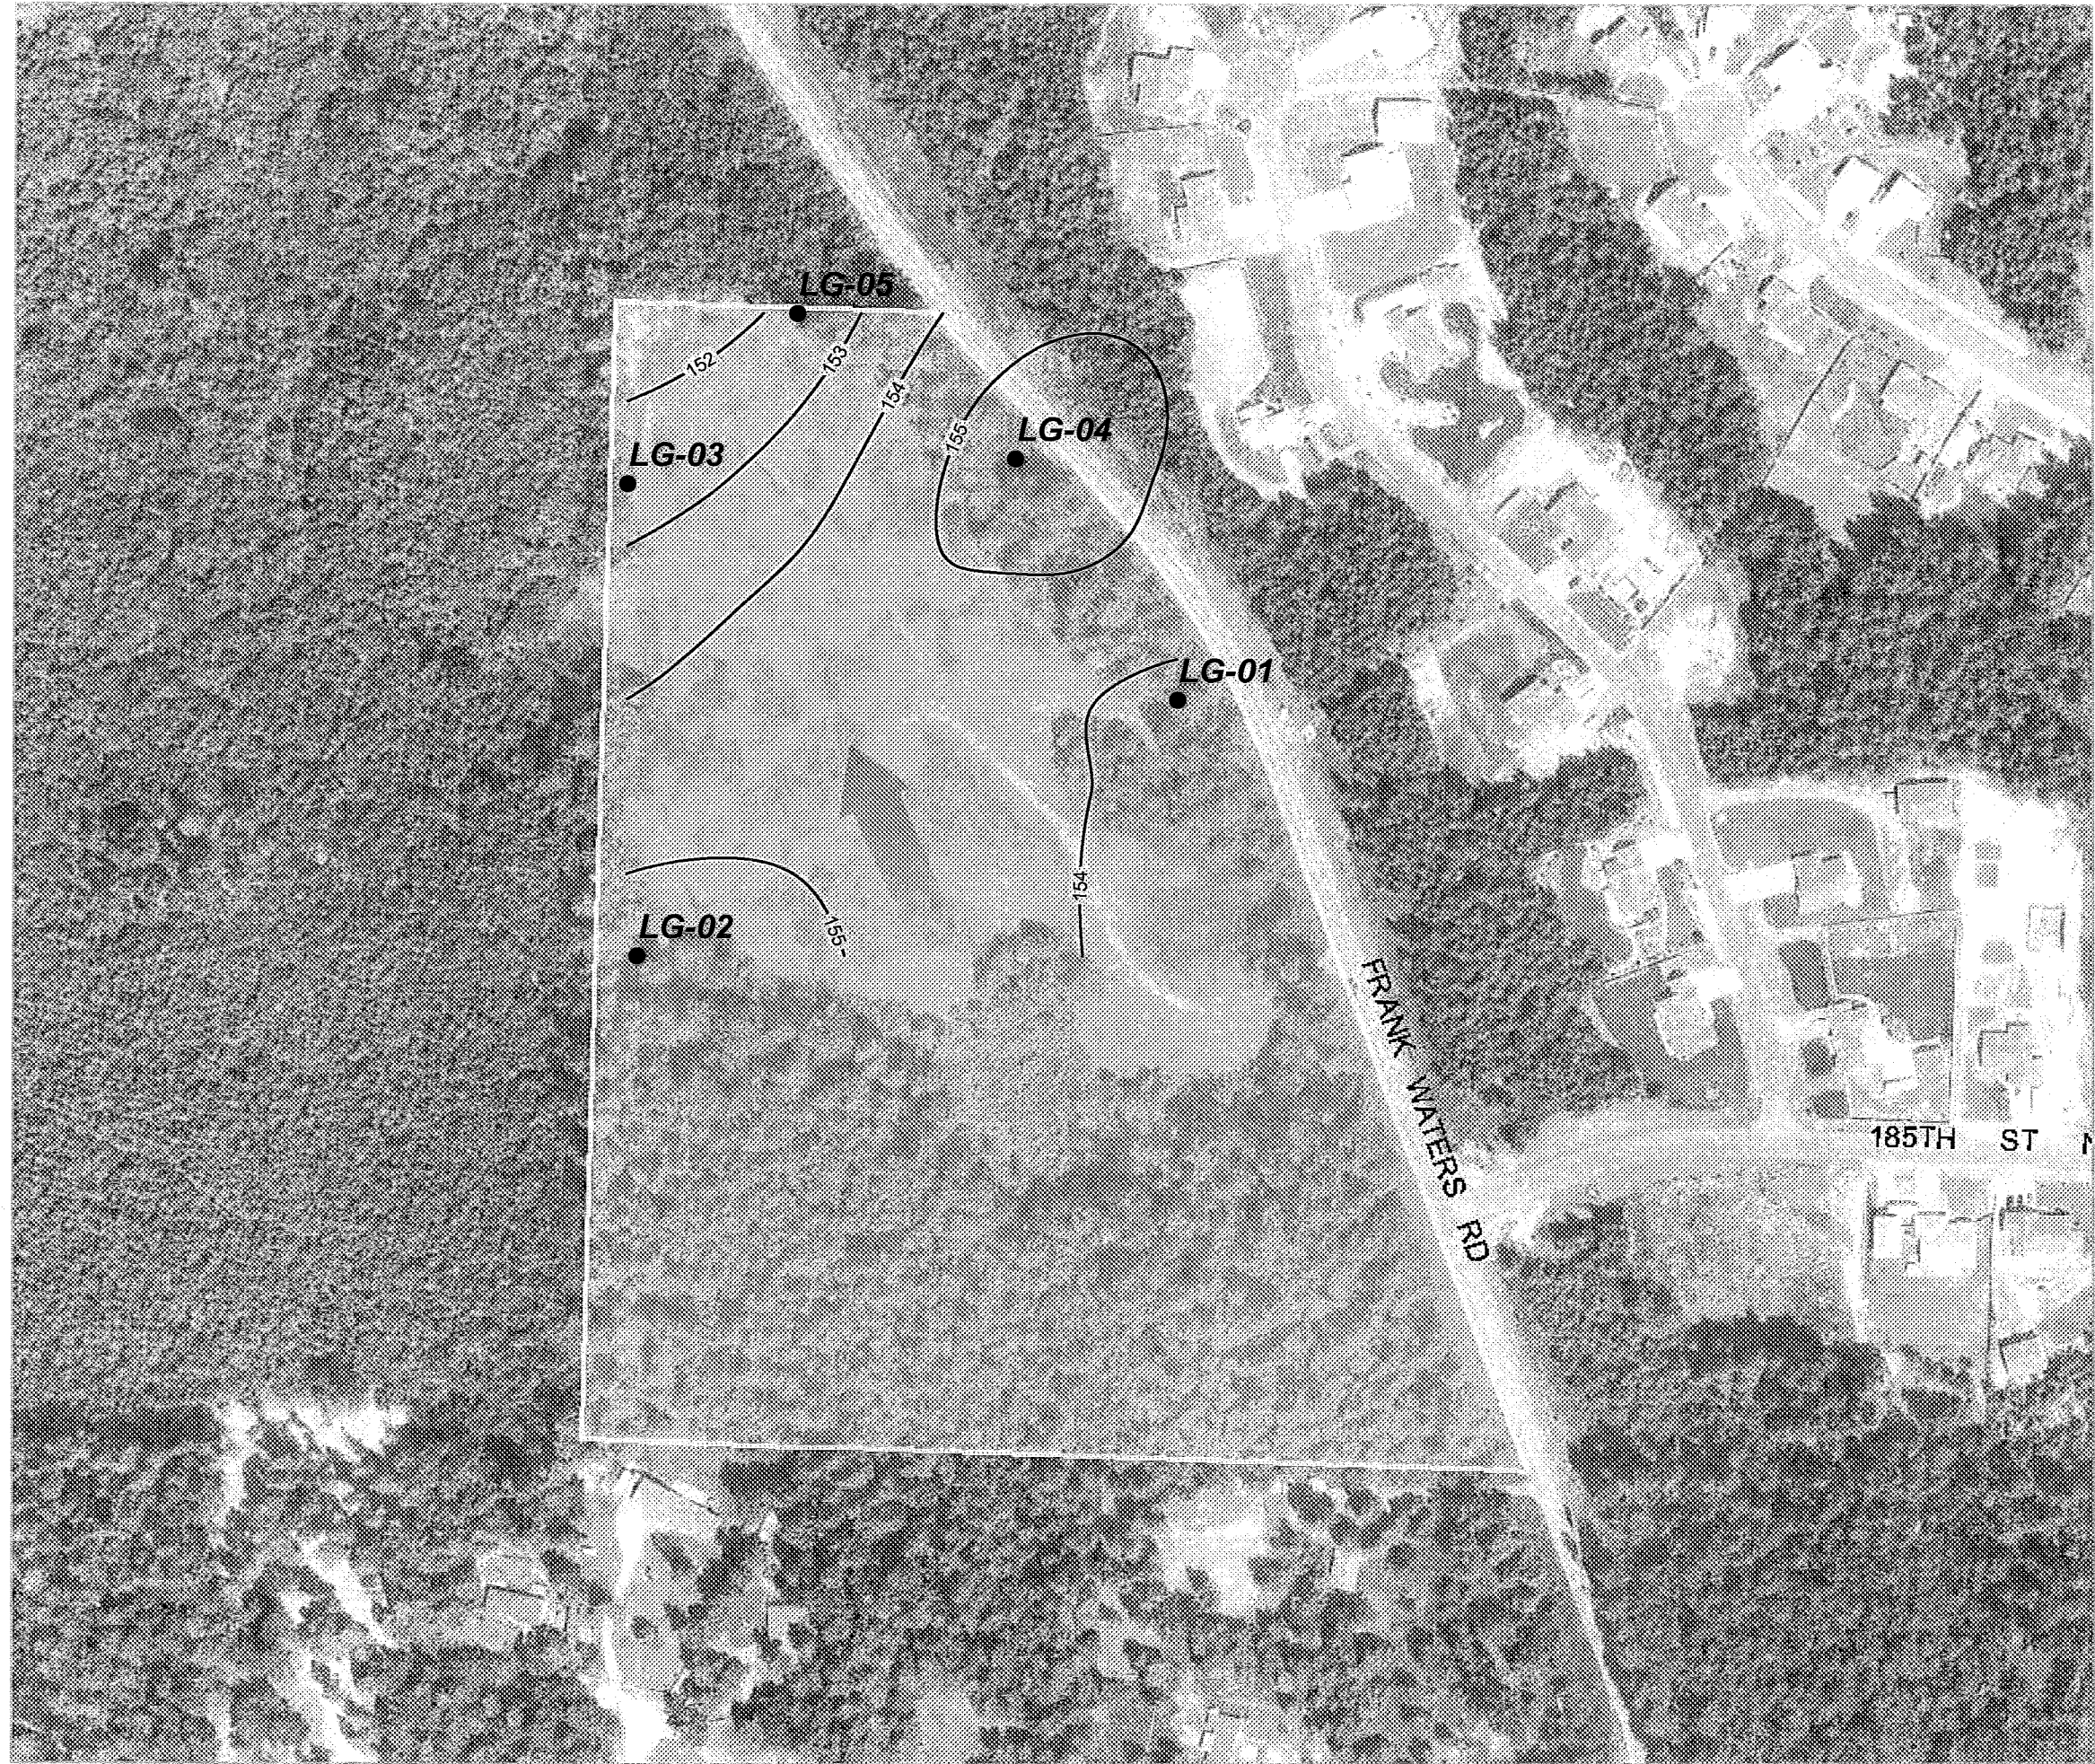
Figure 6

Lake Goodwin Landfill

WELL_ID	SAMP_DATE	MEAS_HEAD
LG-01	4/17/2012	158.17
LG-02	4/17/2012	154.62
LG-03	4/17/2012	153.25
LG-04	4/17/2012	152.28
LG-05	4/17/2012	153.54

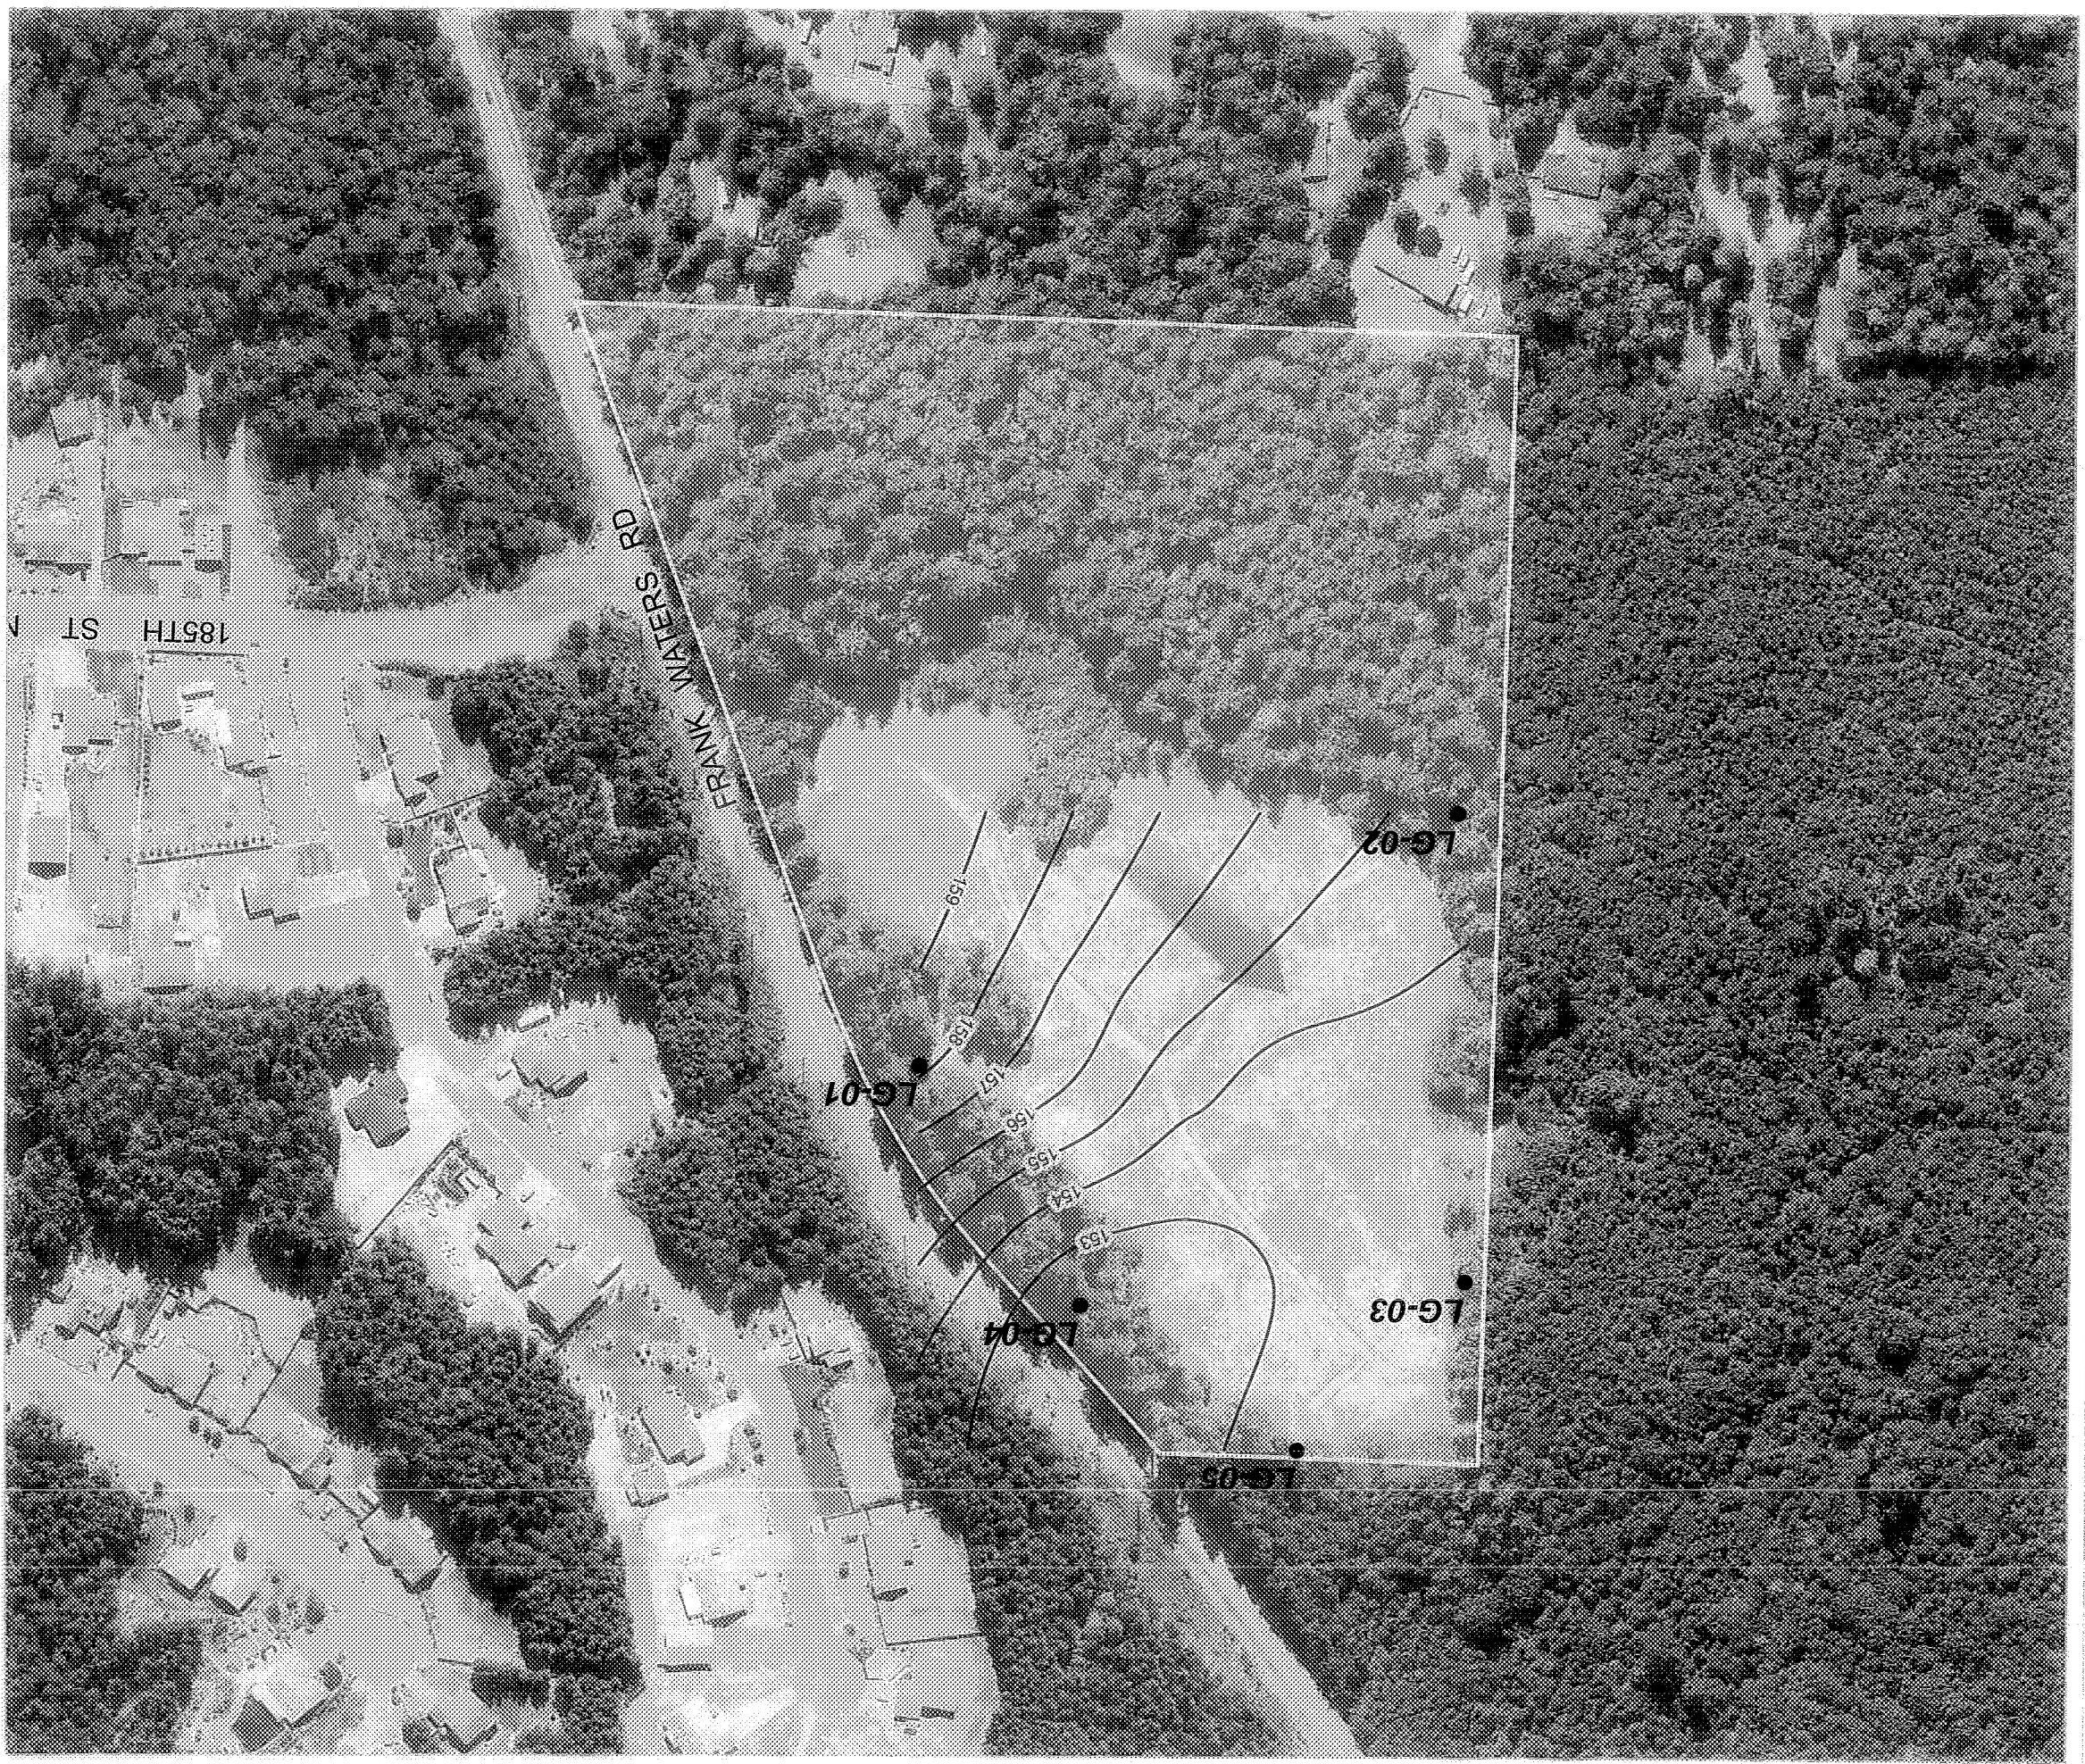
Figure 6

Lake Goodwin Landfill

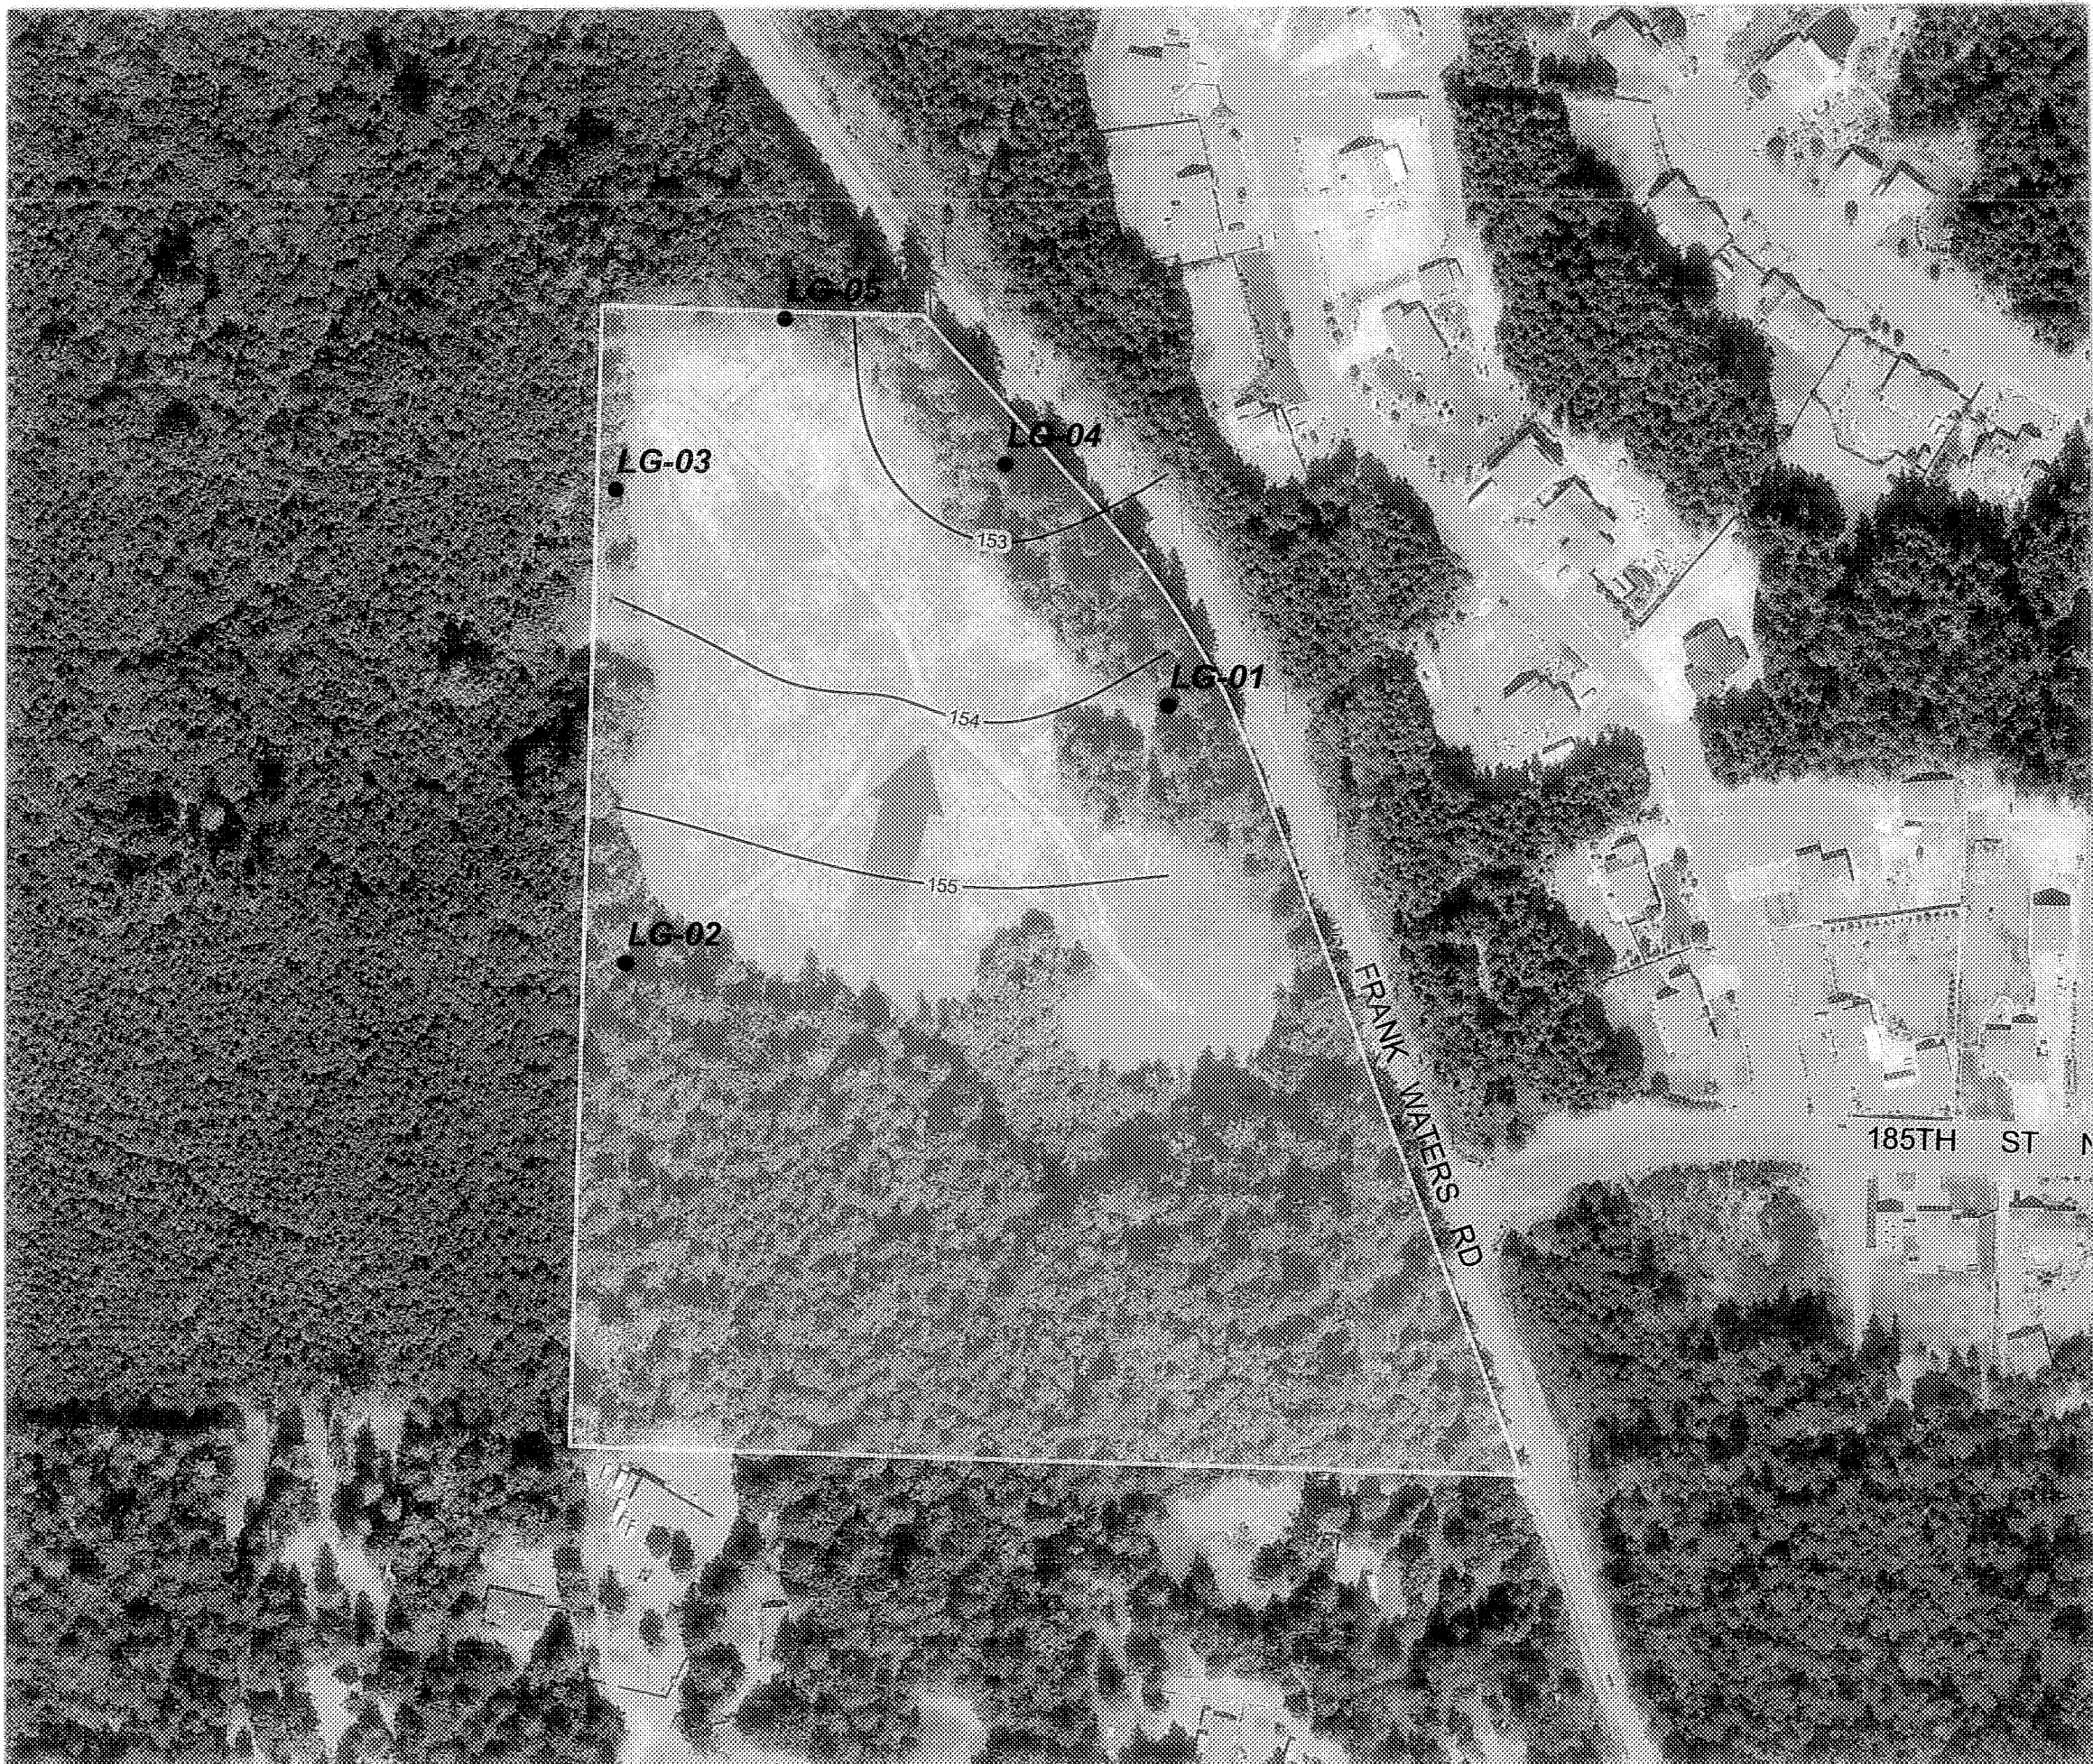
Lake Goodwin Landfill

Water Elevation Contours
4th Quarter 2012

- DIRECTION OF GROUNDWATER FLOW
1.58 ft/day
576 ft/year
74.08 degrees to the positive x-axis
- PARCEL BOUNDARY
- SUBJECT PROPERTY BOUNDARY
- 1 FT CONTOUR
- WELL LOCATION

WELL_ID	SAMP_DATE	MEAS_HEAD
LG-01	10/9/2012	154.26
LG-02	10/9/2012	155.75
LG-03	10/9/2012	153.62
LG-04	10/9/2012	152.65
LG-05	10/9/2012	153.25
